Site Number	Location	Name	Hwy	km
PH080	Hwy 688:02 C1 15.4	McKinney Creek Slide	688:02	Km 15.4
Legal Description: 16-16-84-20 W5		UTM Co-ordinates		
		11U E 494733	N	6238402

**ALBERTA TRANSPORTATION AND ECONOMIC CORRIDORS GRMP (CON0022164)
PEACE REGION (PEACE RIVER DISTRICT)
INSTRUMENTATION MONITORING RESULTS**

FALL 2024

SITE PH080: HWY 688:02 MCKINNEY CREEK SLIDE (KM 15.4) - BF72477

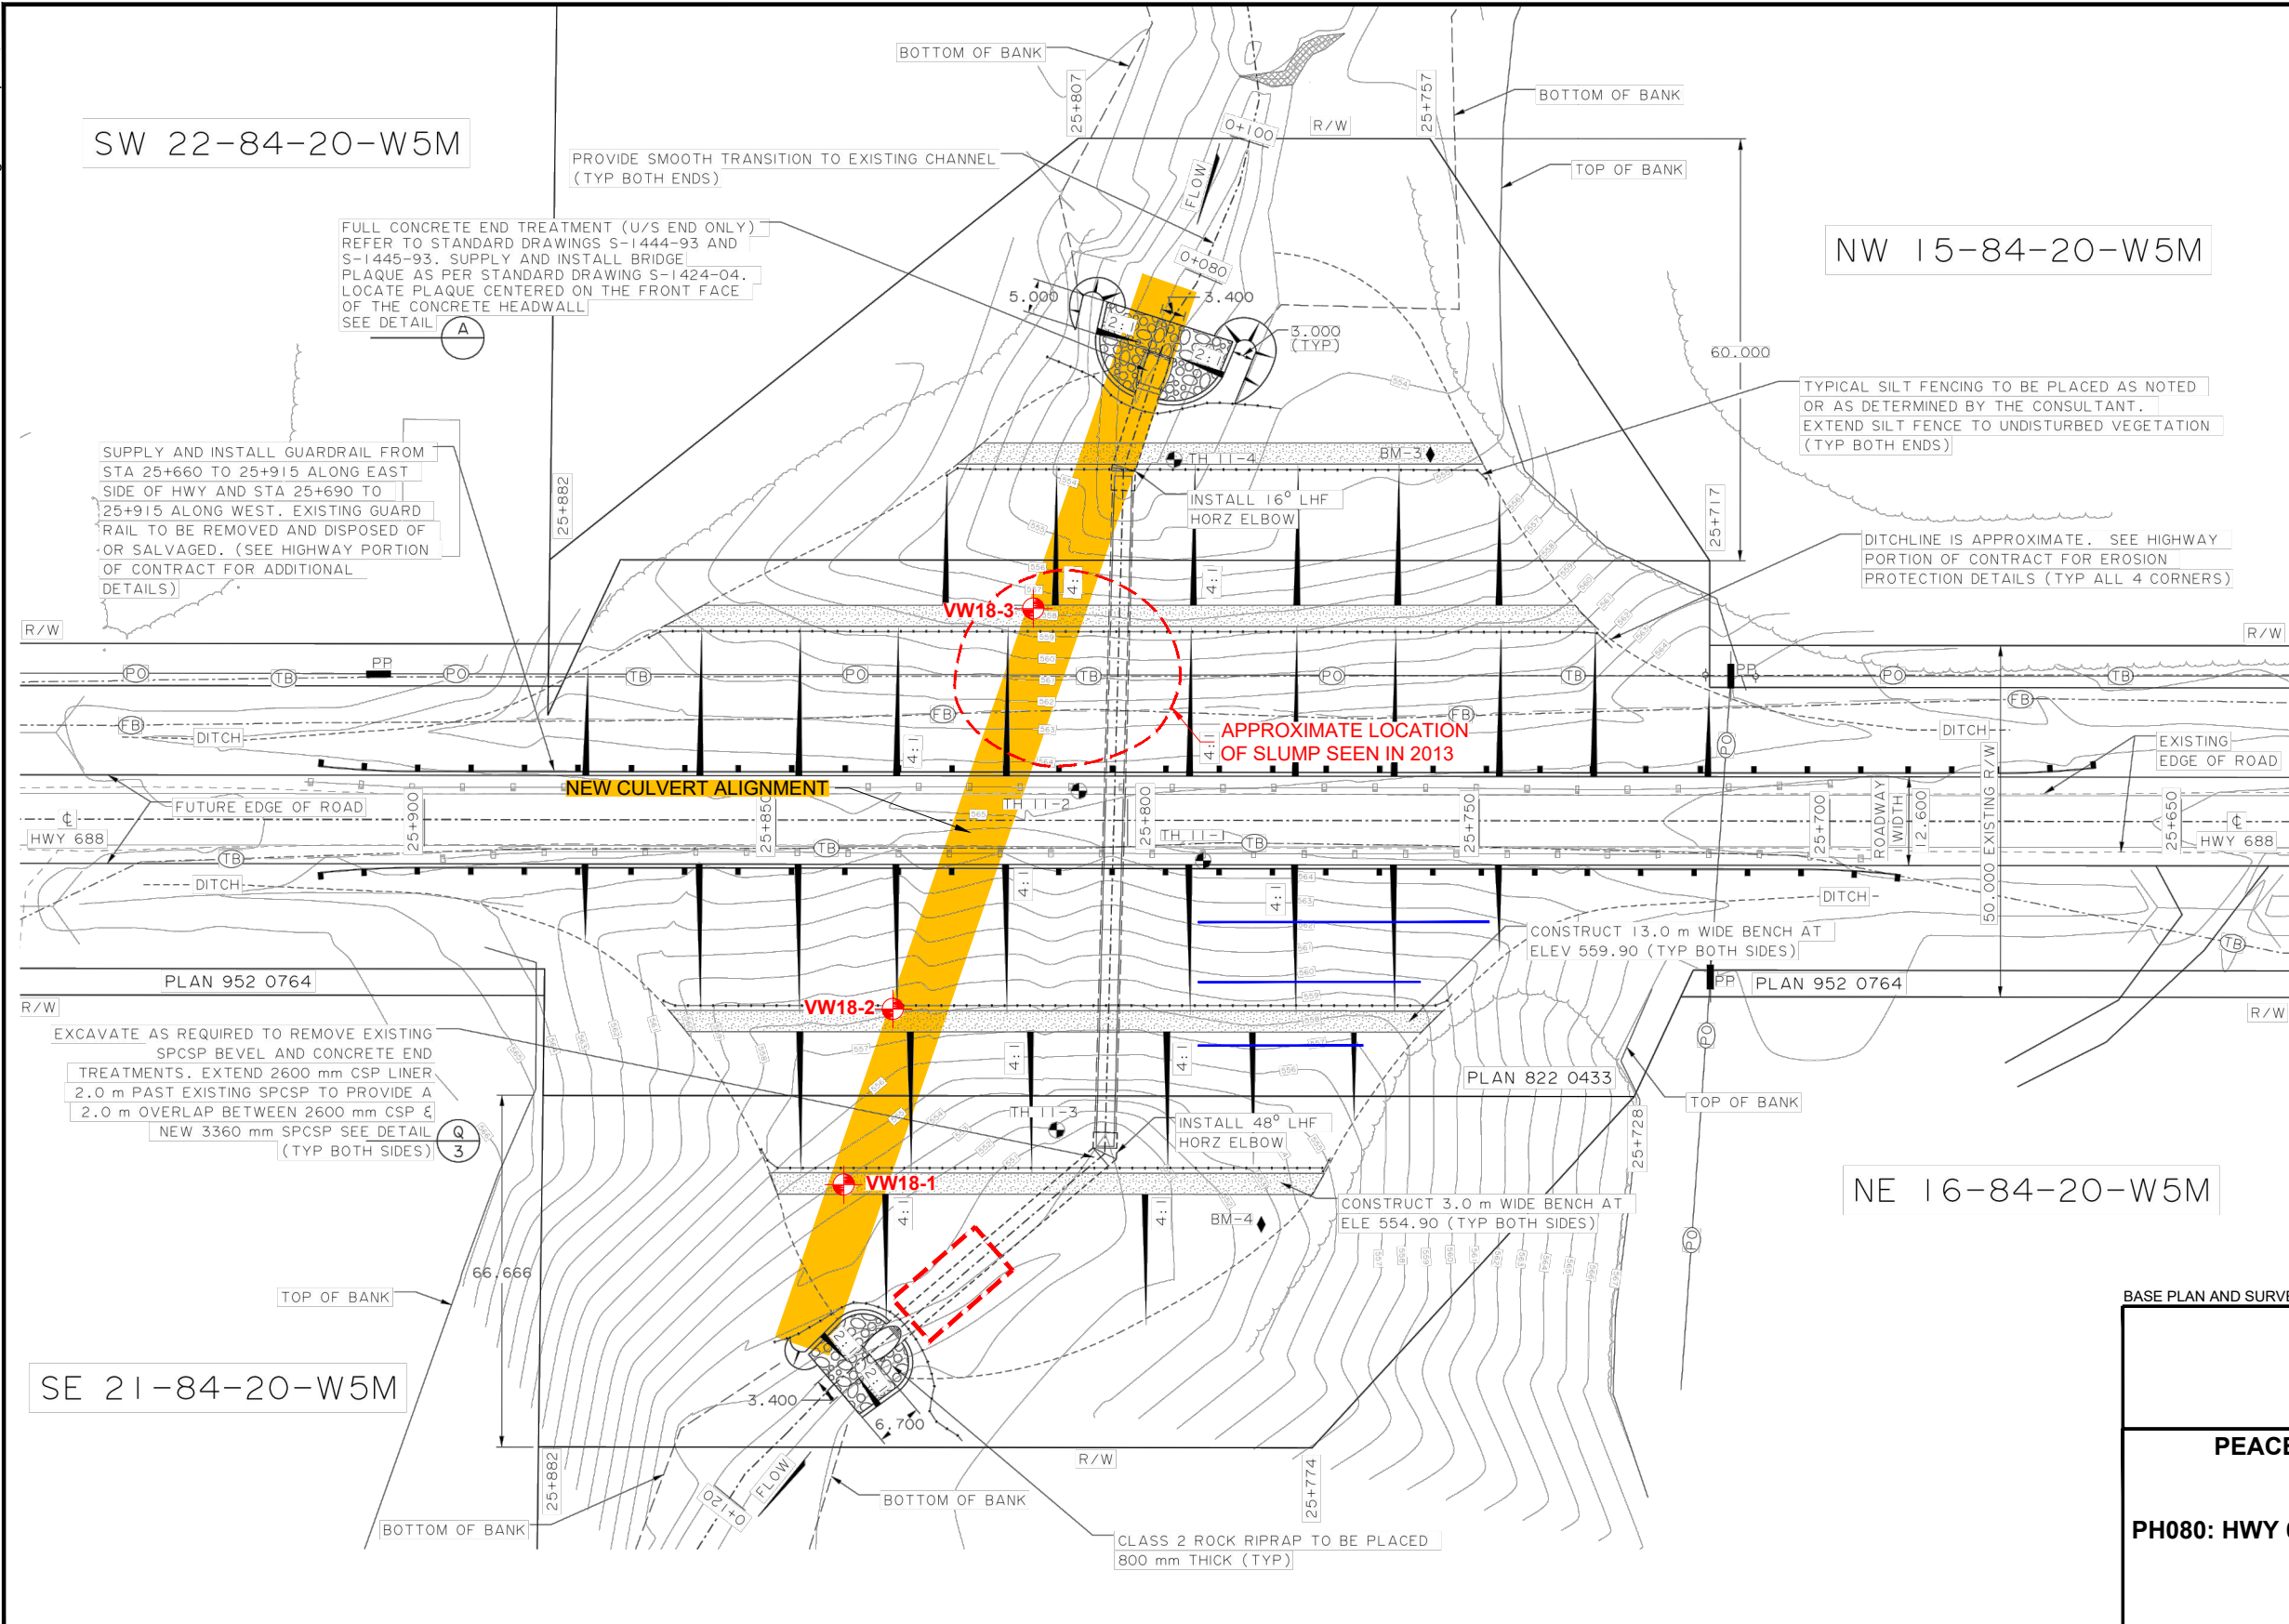
DWG No. 32121-PH080

VW18-1 and VW18-2 cables are west of the highway, north of the culvert outlet near the bush line. VW18-3 cable is east of the highway, north of the creek near the crest of the hill
VW 18-1,18-2 and 18-3 needs stickup protector or enclosure box. Currently the wires are lying on ground. See photographs

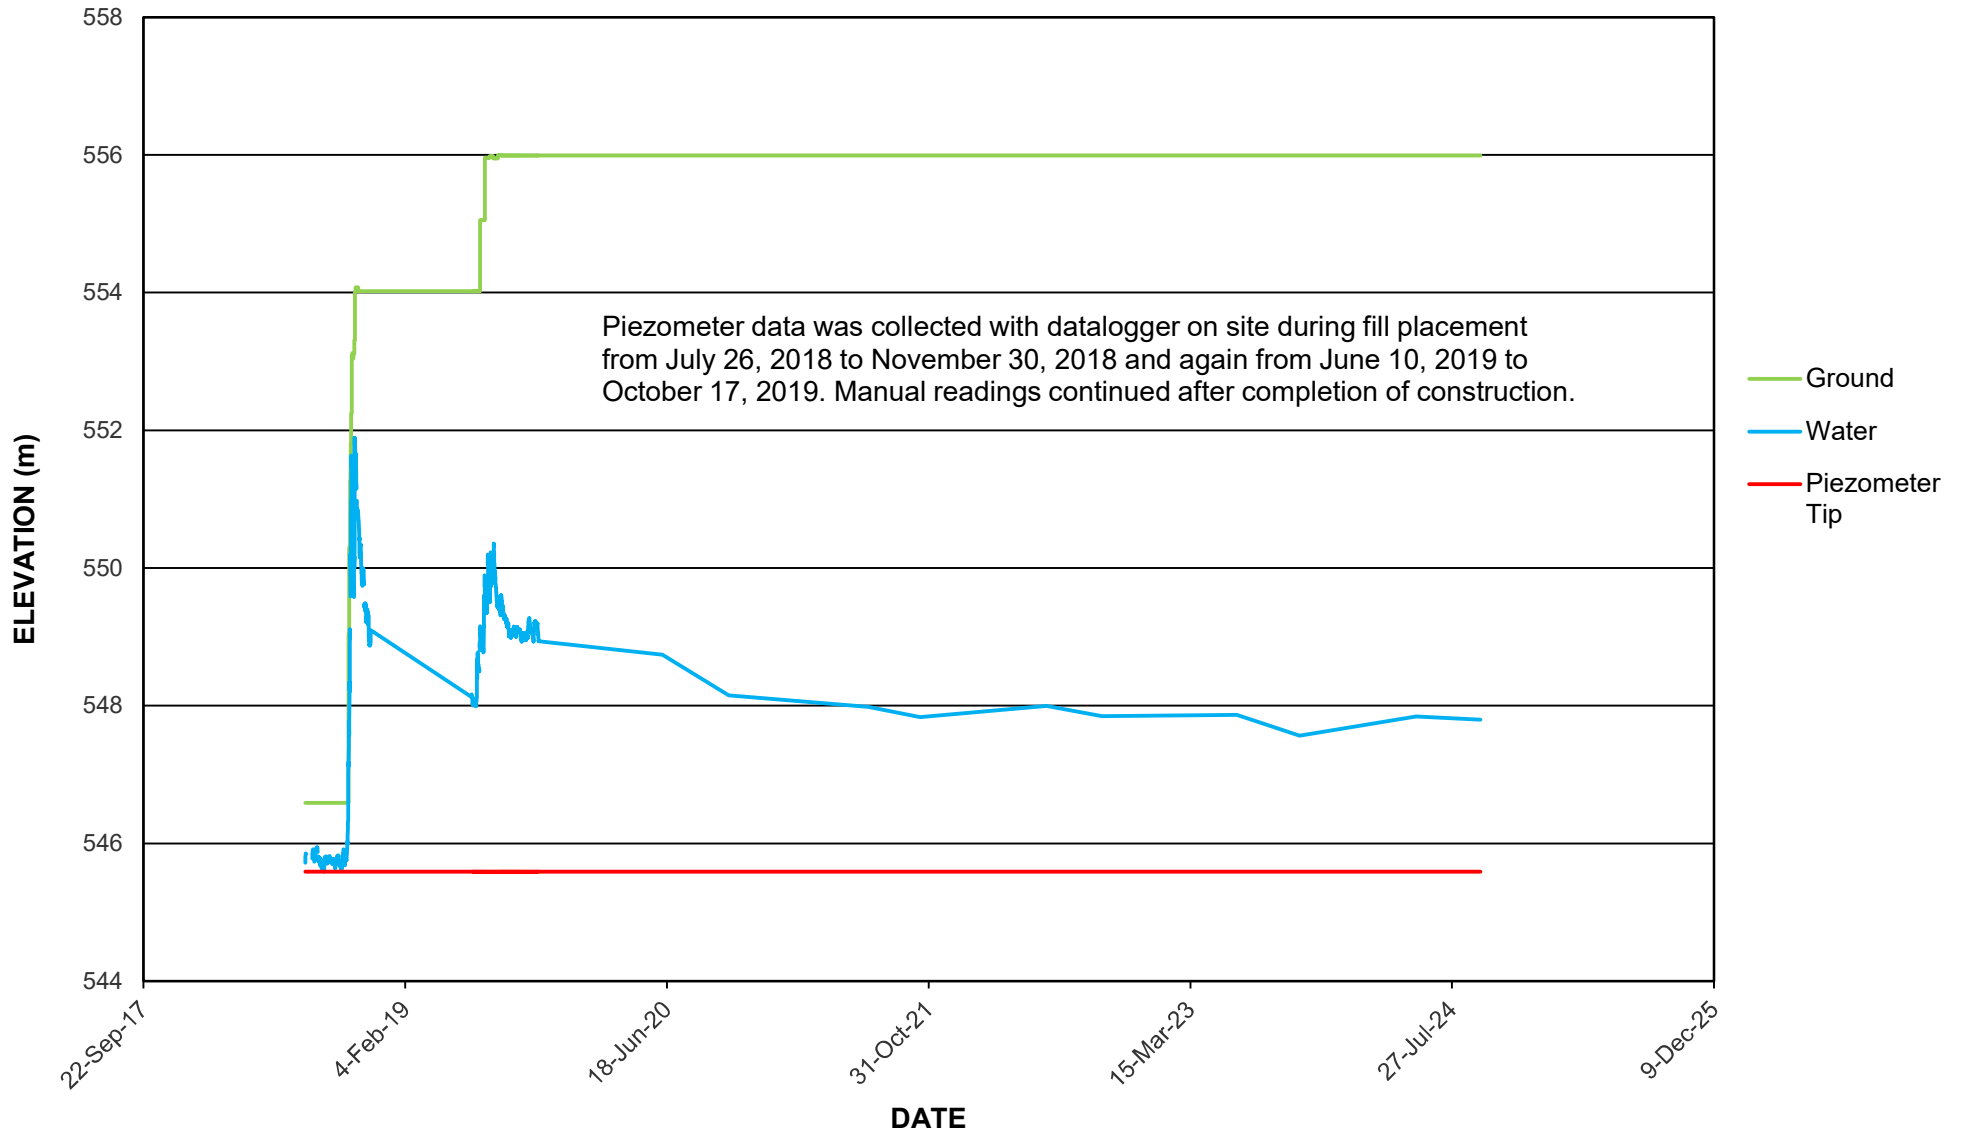
FIGURE PH080-1
HWY 688:02 MCKINNEY CREEK CULVERT SLIDE - VW18-1
(WEST SIDE OF CULVERT)

Discussion	
Zones of New Movement:	None
Interpretation of Monitoring Results:	<p>Vibrating wire piezometers VW18-1 showed a decrease in groundwater level of 0.04 m, respectively, since the spring of 2024 readings. VW18-2 and VW18-3 showed an increase in groundwater level of 0.60 m and 0.15 m, respectively, since the spring of 2024 readings. VW18-1 and VW18-3 showed a prior trend of diminishing groundwater levels since the completion of construction and the groundwater levels at these instrument locations appear to have levelled out. The piezometers had all previously shown their highest groundwater levels during construction as fill was placed at their respective locations.</p> <p>Figures PH080-1, PH080-2 and PH080-3 show the response of each of the piezometers relative to fill height during construction, as well as the subsequent decrease in pore water pressure. Figure PH080-4 shows a combined plot of the groundwater elevations of all three vibrating wire piezometers.</p>

Future Work:	These piezometers were installed to monitor conditions during fill placement during the culvert replacement project in 2019. The piezometers all show stable water level well below peaks reached during construction. As such it is suggested that these instruments have served their purpose and can now be removed from the monitoring program.
Instrumentation Repairs:	No instrument repairs are required at this time.
