**ALBERTA TRANSPORTATION
GEOHAZARD ASSESSMENT PROGRAM
PEACE REGION – SWAN HILLS
2022 INSPECTION**

Site Number	Location	Name	Hwy	km
SH011-3 SH011-4	Little Smoky River	Little Smoky River Valley, North Hill – Sites #3 and #4	744:02	18.26-18.52 18.62-18.90
Legal Description		UTM Co-ordinates		
Site 3: SE20-76-22-W5M		11U E 476,536	N	6,161,182
Site 4: SE20-76-22-W5M		11U E 476,872	N	6,161,121

**SH011-4: HWY 744:02 LITTLE SMOKY RIVER VALLEY
2022 SITE INSPECTION PLAN**

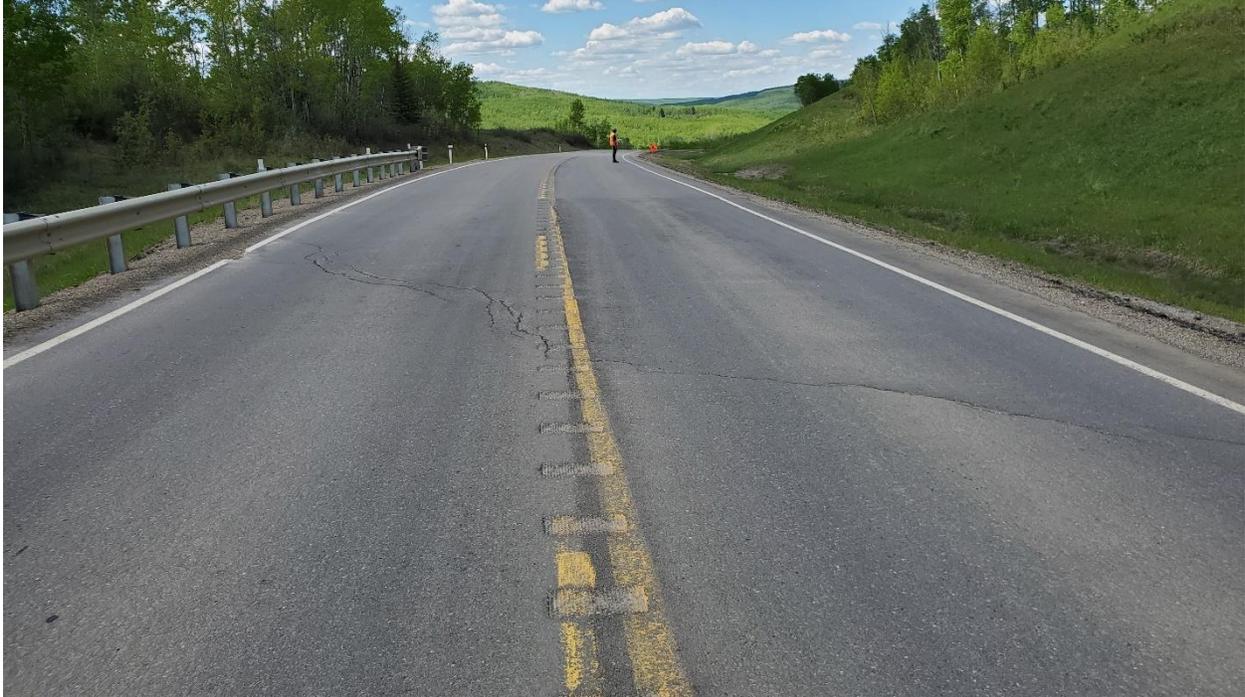
Photo 1, Site 4 – Looking west at ~km 18.750.

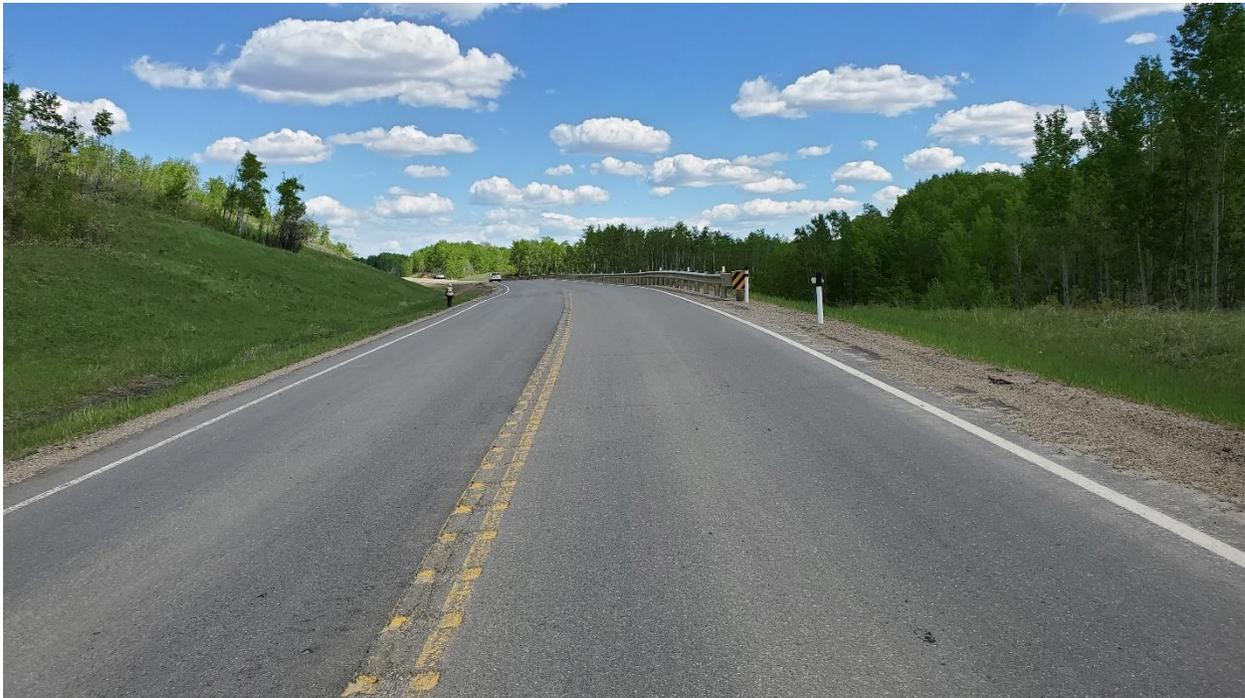
Photo 2, Site 4 – Looking east at ~km 18.700.

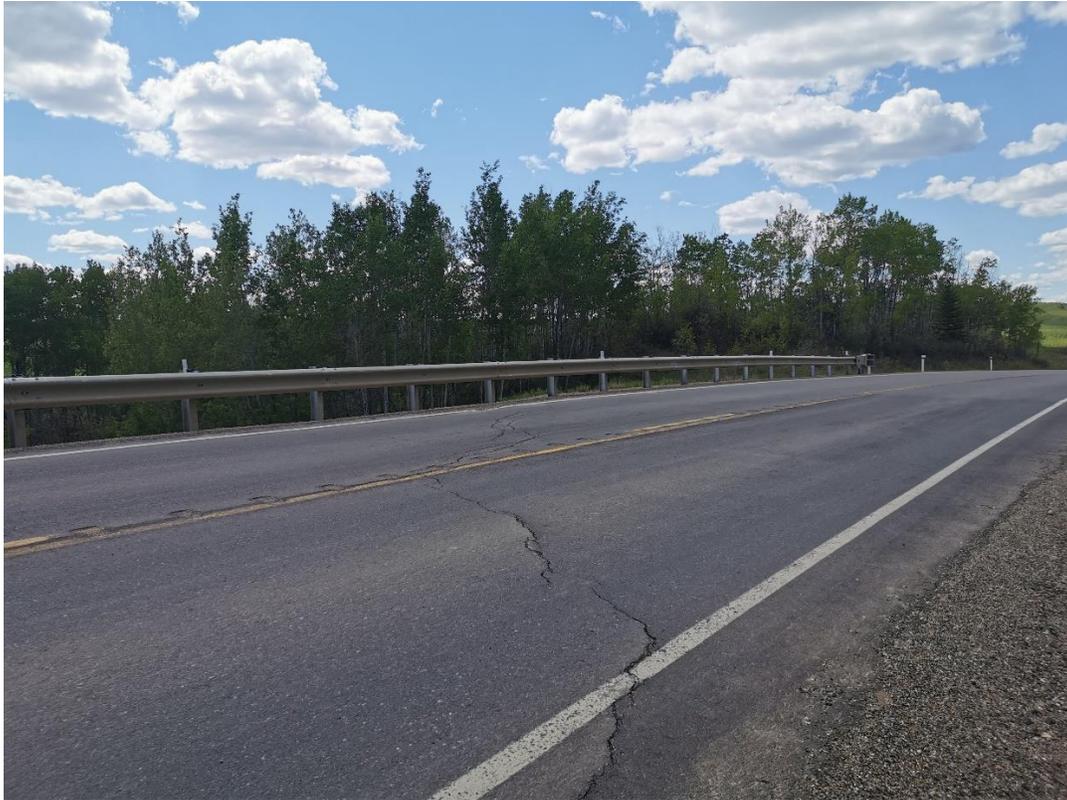
Photo 3, Site 4 – Looking southwest at cracking in highway surface at ~km 18.750.

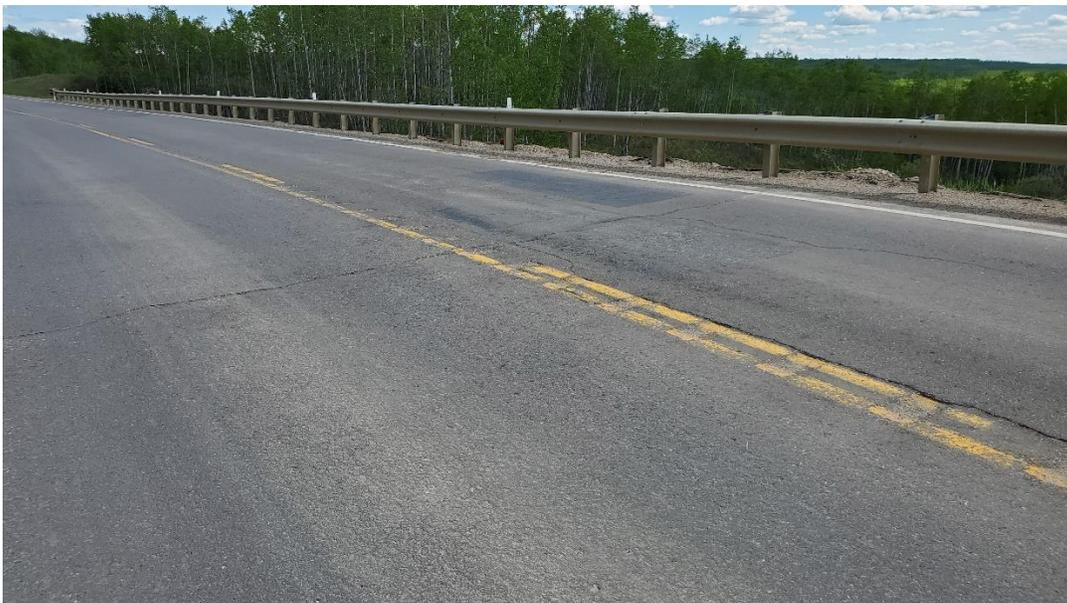
Photo 4 – Looking southeast at transverse cracking at km 18.84.
