**ALBERTA TRANSPORTATION  
GEOHAZARD ASSESSMENT PROGRAM  
PEACE REGION – SWAN HILLS  
2020 INSPECTION**

Site Number	Location	Name	Hwy	km
SH013-14 SH013-15	Little Smoky River	Little Smoky River Valley, North Hill – Sites #14 & #15	744:02	21.55-21.61 21.61-21.80
<b>Legal Description</b>		<b>UTM Co-ordinates</b>		
Site 14: SE28/SW27-76-22-W5M		11U E 478,675	N	6,163,221
Site 15: SE28/SW27-76-22-W5M		11U E 478,647	N	6,163,070

**SH013-14 & -15: HWY 744:02  
LITTLE SMOKY RIVER VALLEY  
2020 SITE INSPECTION PLAN**

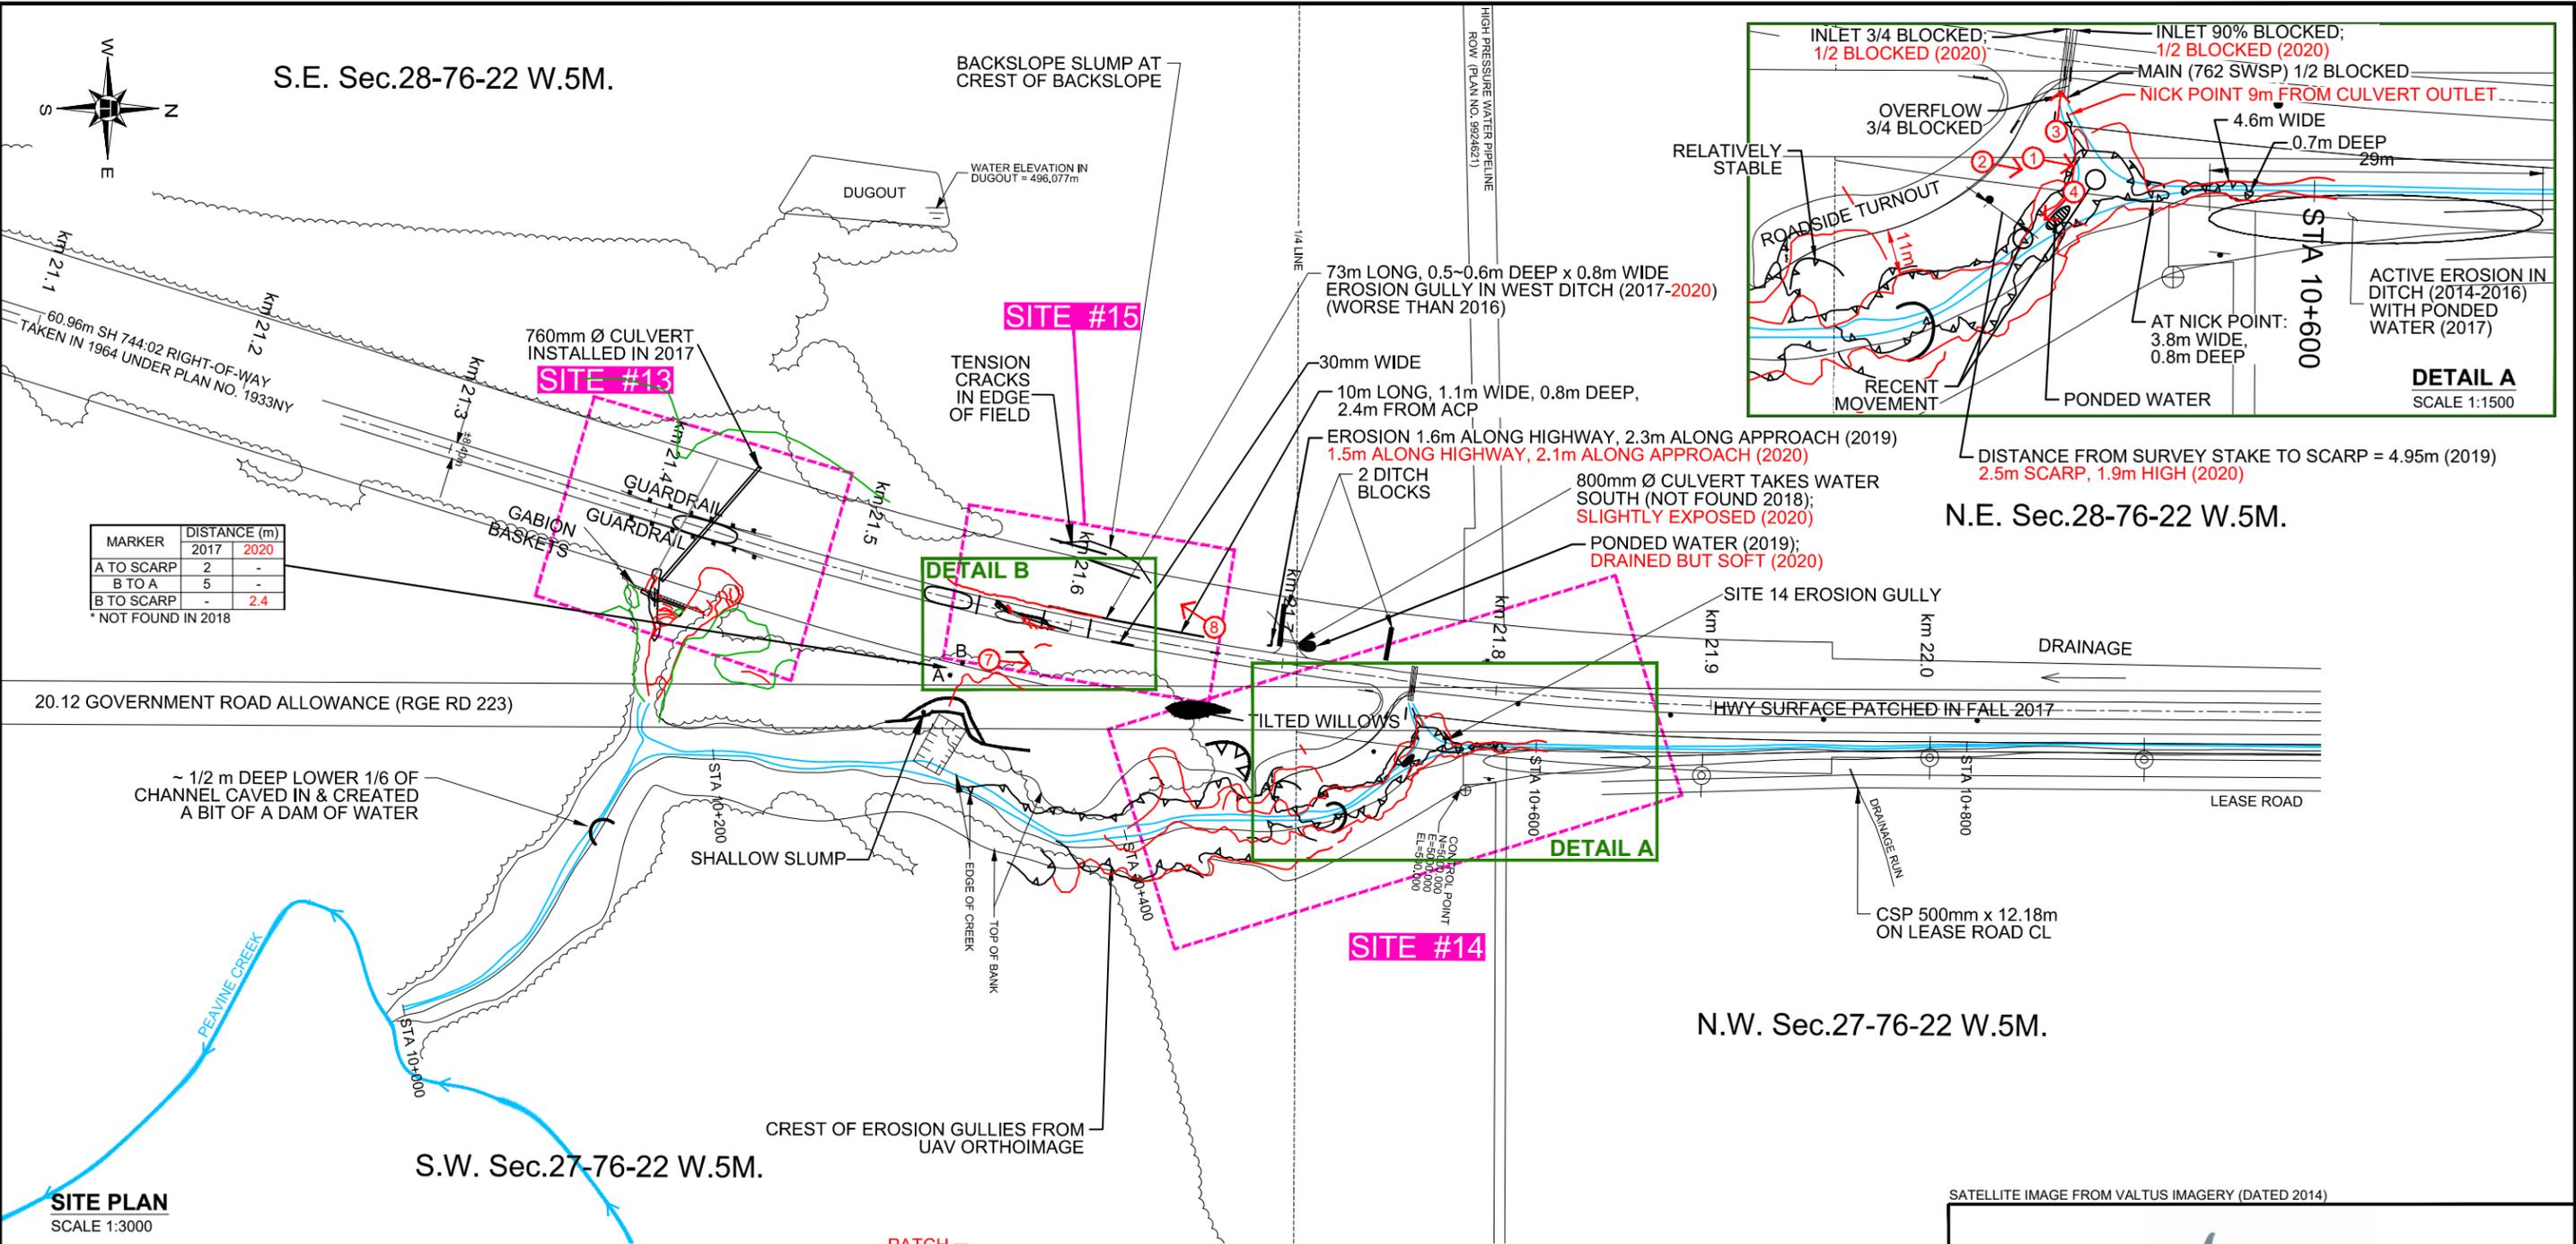
**SITE PLAN**  
SCALE 1:3000

MARKER	DISTANCE (m)	2017	2020
A TO SCARP	2	-	-
B TO A	5	-	-
B TO SCARP	-	-	2.4

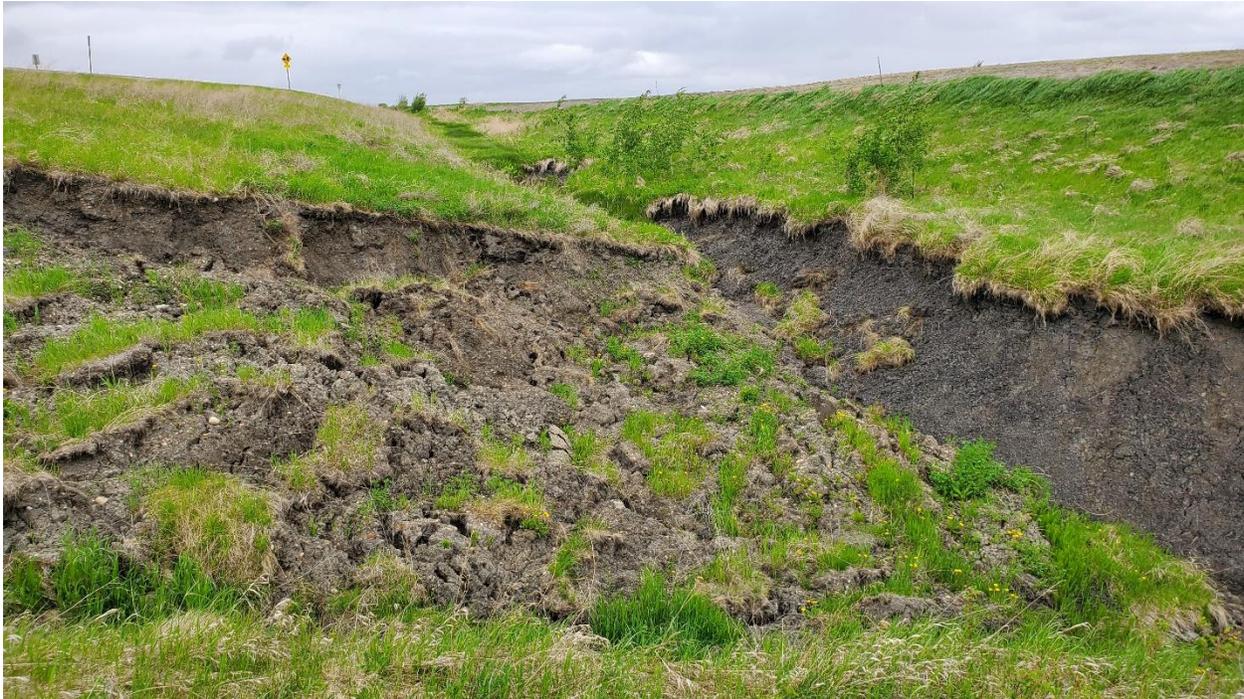
Photo 1, Site 14 – Looking north through east at increasing depth of erosion along the tributary.

- If the highway is not re-aligned, consideration should be given to remediating the erosion in the tributary channel at Site 14 by installing a series of rock check dams or armouring most of the channel bottom.
- Consideration could also be given to the installation of steel sheet piles along the highway at Site 14 as an interim measure if the gully regresses close enough to the highway that there is concern for the safety of the traveling public. A guardrail would also be required in this scenario. Preliminary engineering should be undertaken so that this remediation can be implemented quickly when required.

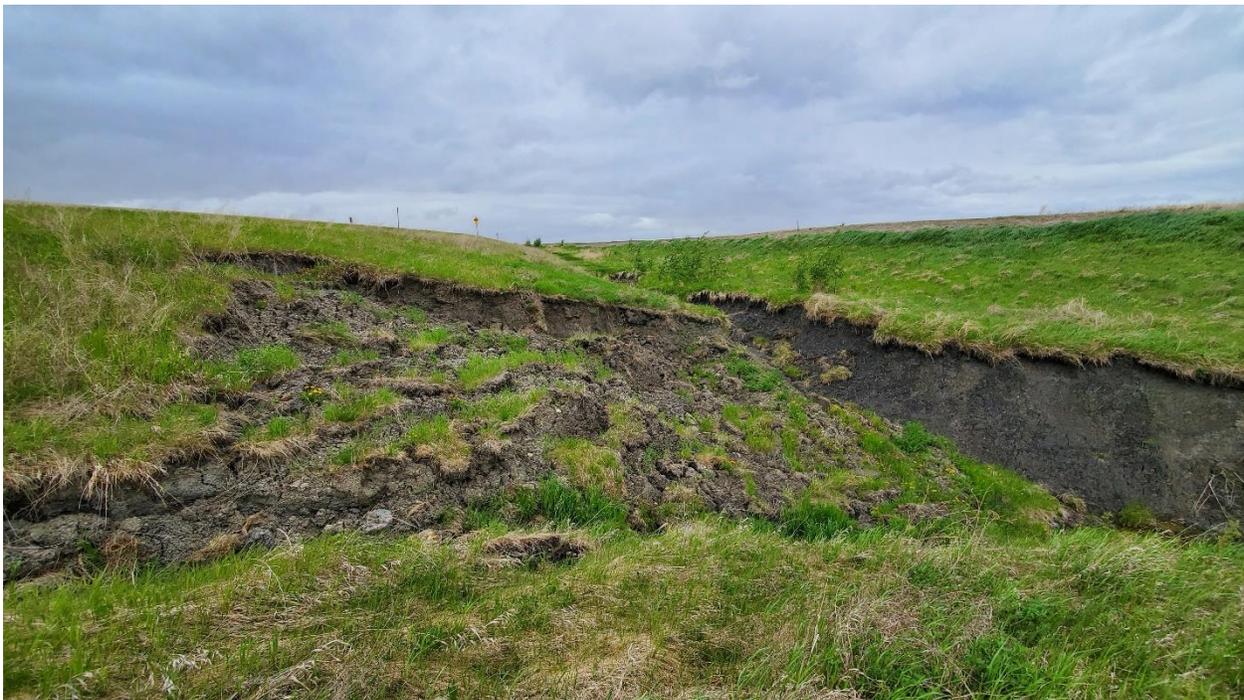
Photo 2, Site 14 – Looking north along the ditch where the erosion gully begins.

- Road maintenance should continue as necessary to maintain a safe roadway surface and may consist of milling, patching, and crack sealing of the ACP.
- Riprap could be placed at the headscarp of the erosion ravine to slow retrogression of the erosion up-gradient.

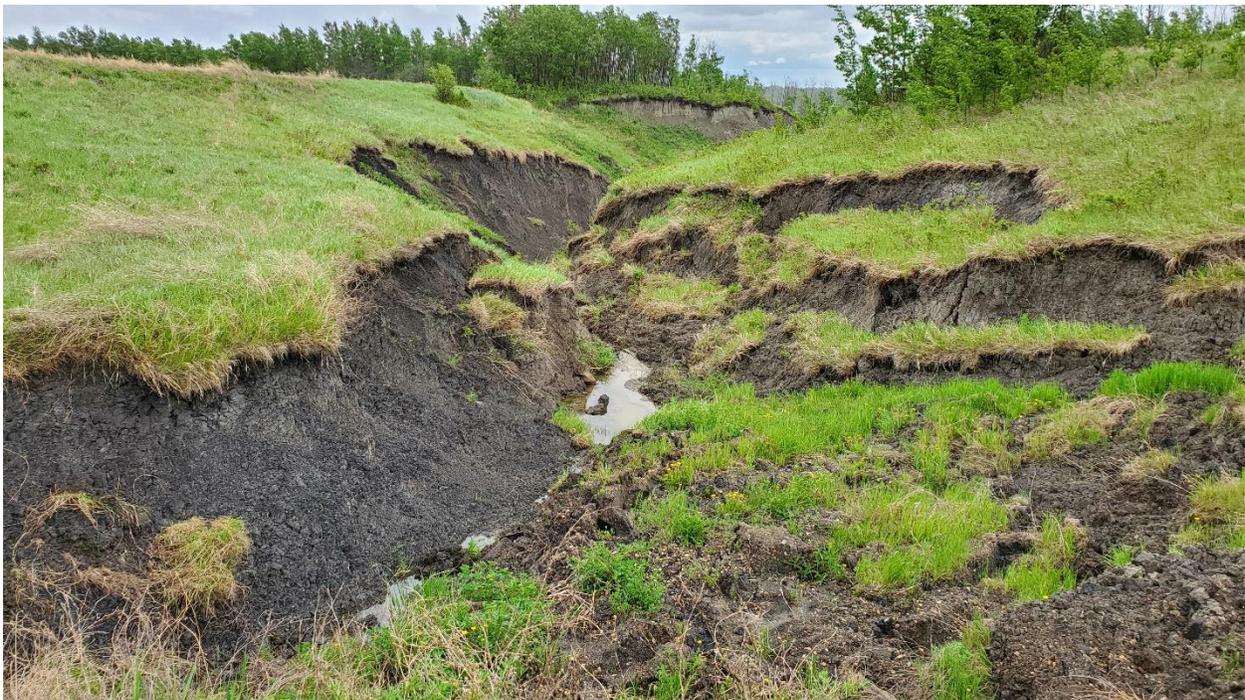
Photo 4, Site 14 – Looking south at slumping along tributary channel.

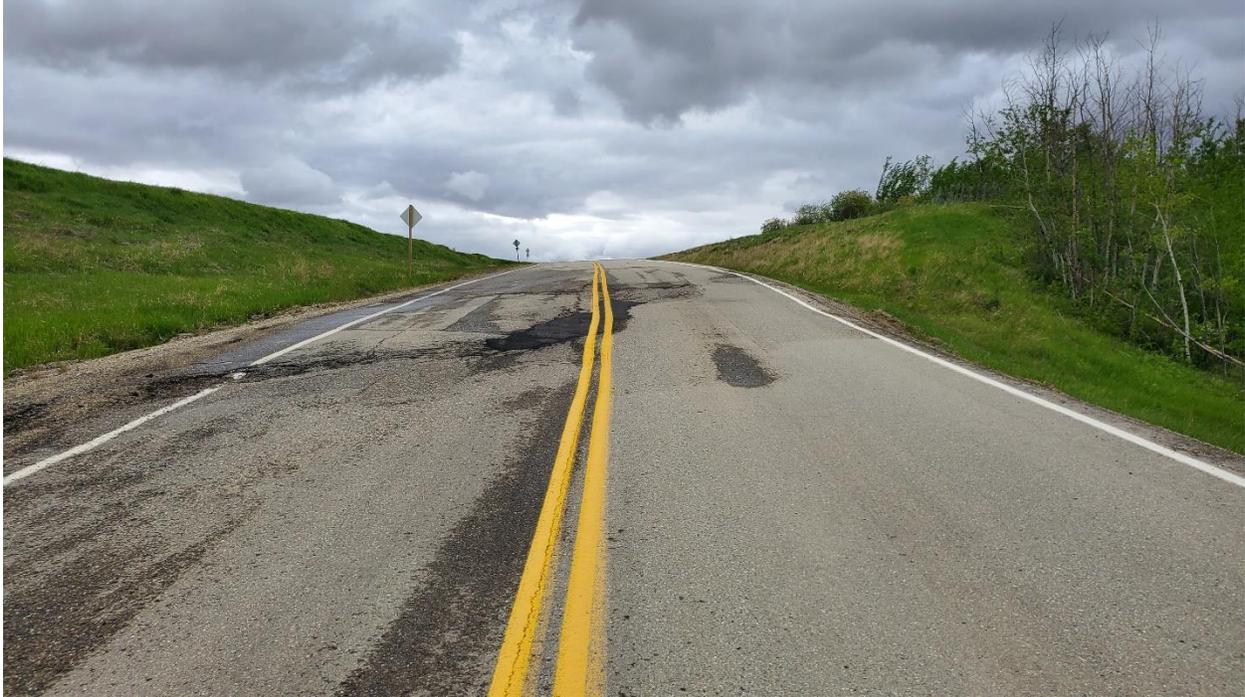
Photo 5, Site 15 – Looking north at diagonal crack intersecting the highway. There is a slight dip in the east lane on the south side (downslope) of the crack.

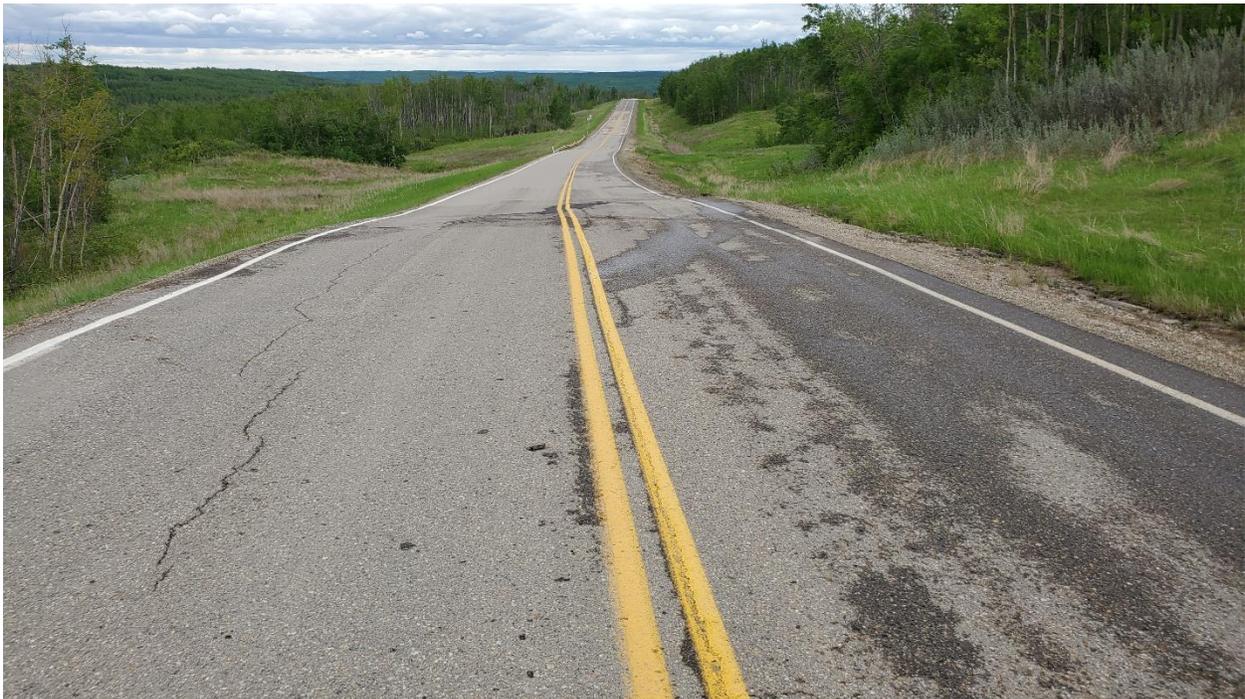
Photo 6, Site 15 – Looking south at the main crack.

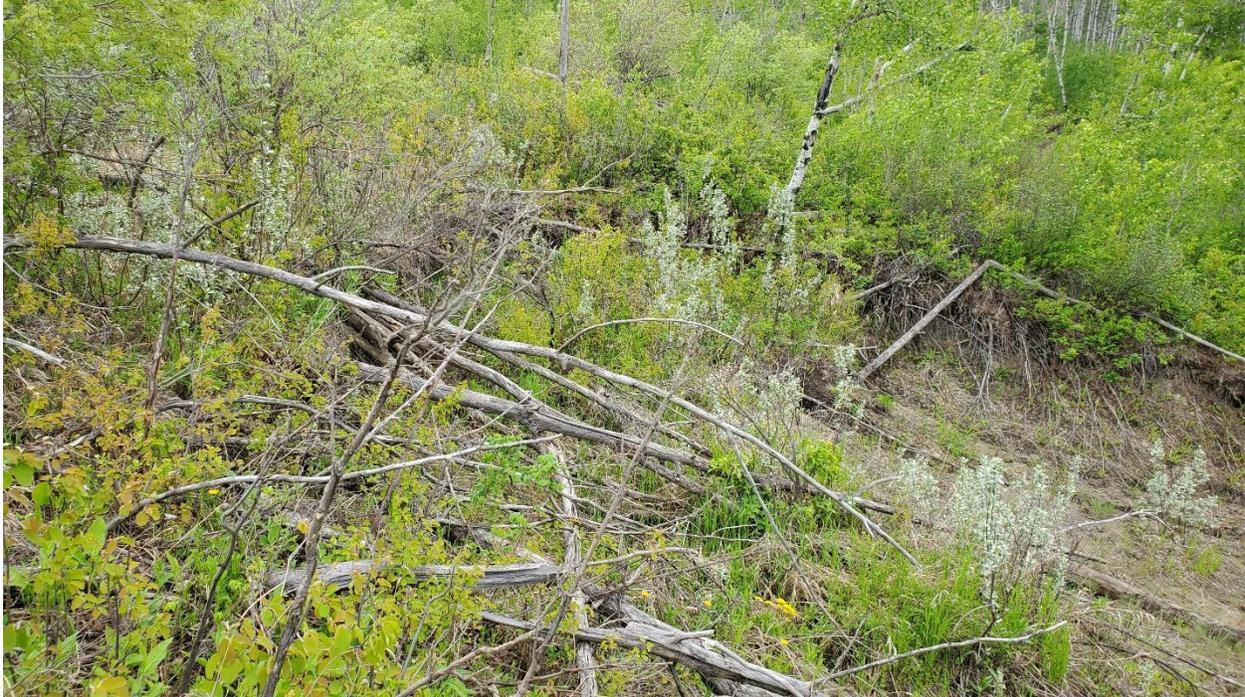
Photo 7, Site 15 – Looking north at head of shallow slump downslope of the highway.

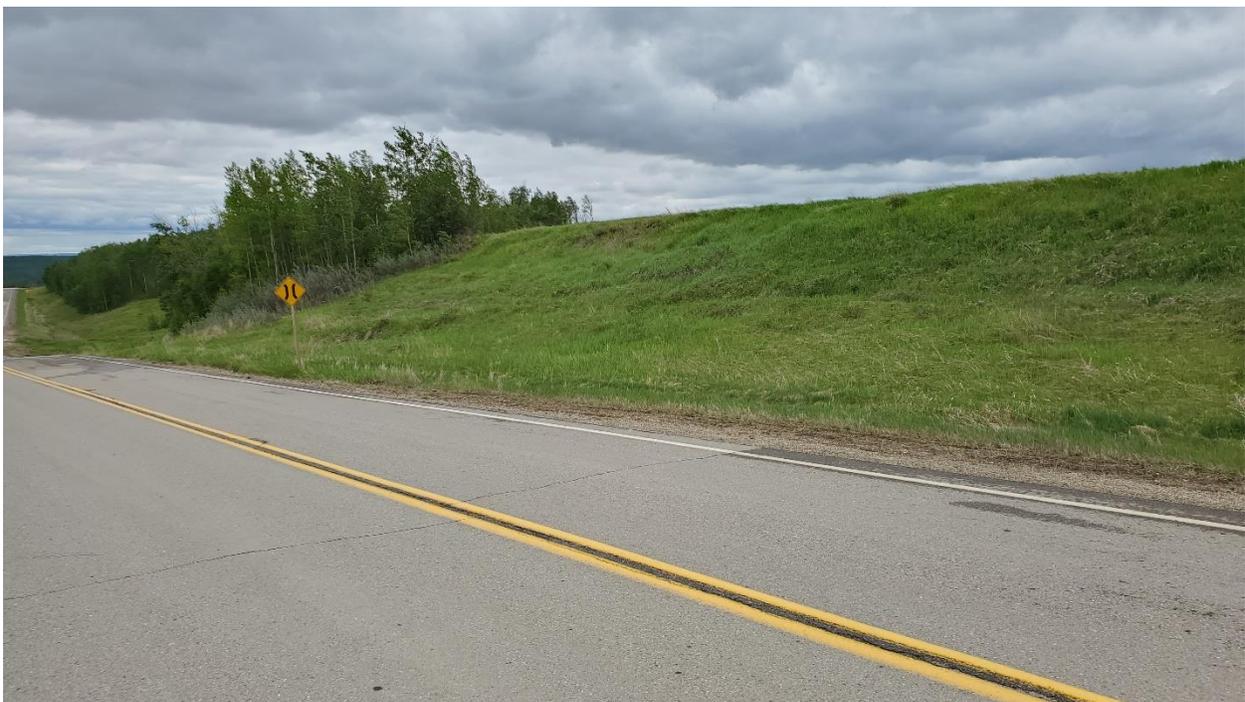
Photo 8, Site 15 – Looking southwest at backslope slump at valley crest.

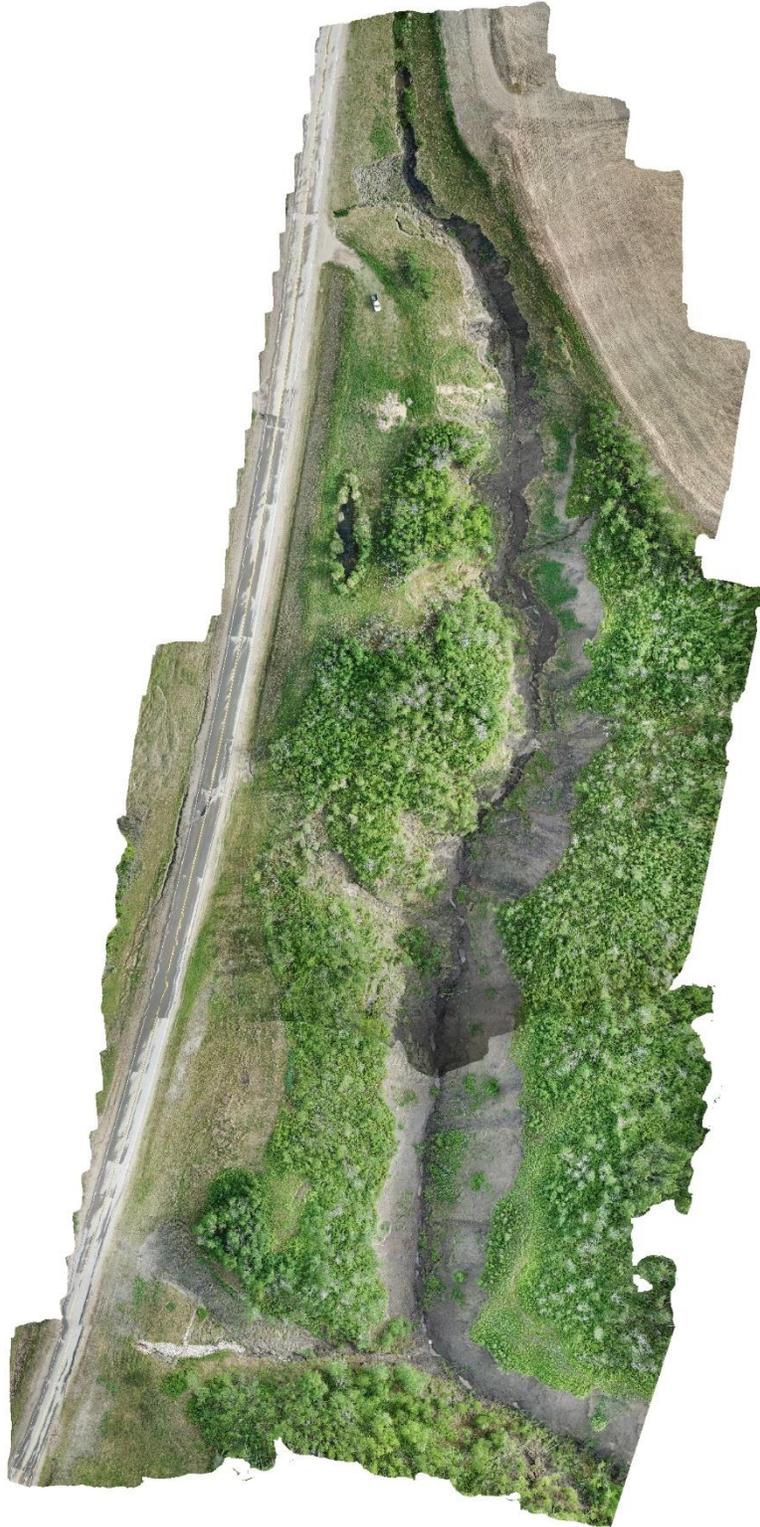
2020 UAV composite image of the erosion gully.
