**ALBERTA TRANSPORTATION
GEOHAZARD ASSESSMENT PROGRAM
PEACE REGION – SWAN HILLS
2022 INSPECTION**

Site Number	Location	Name	Hwy	km
SH013-14 SH013-15	Little Smoky River	Little Smoky River Valley, North Hill – Sites #14 & #15	744:02	21.55-21.61 21.61-21.80
Legal Description		UTM Co-ordinates		
Site 14: SE28/SW27-76-22-W5M		11U E 478,675	N	6,163,221
Site 15: SE28/SW27-76-22-W5M		11U E 478,647	N	6,163,070

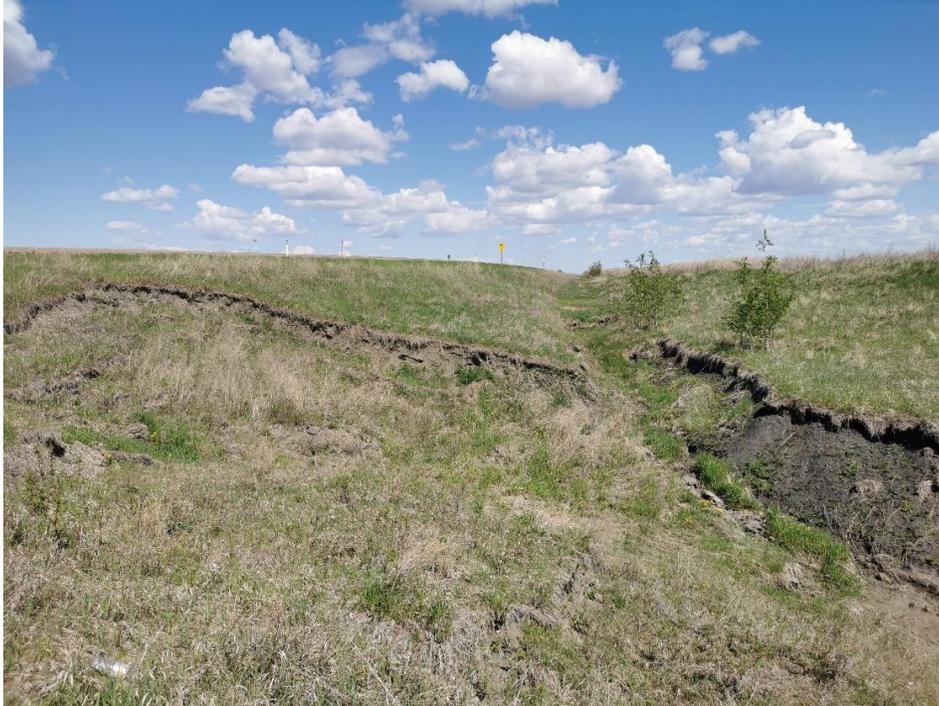
Photo 1, Site 14 – Looking north along the east ditch at increasing depth of erosion along the tributary.

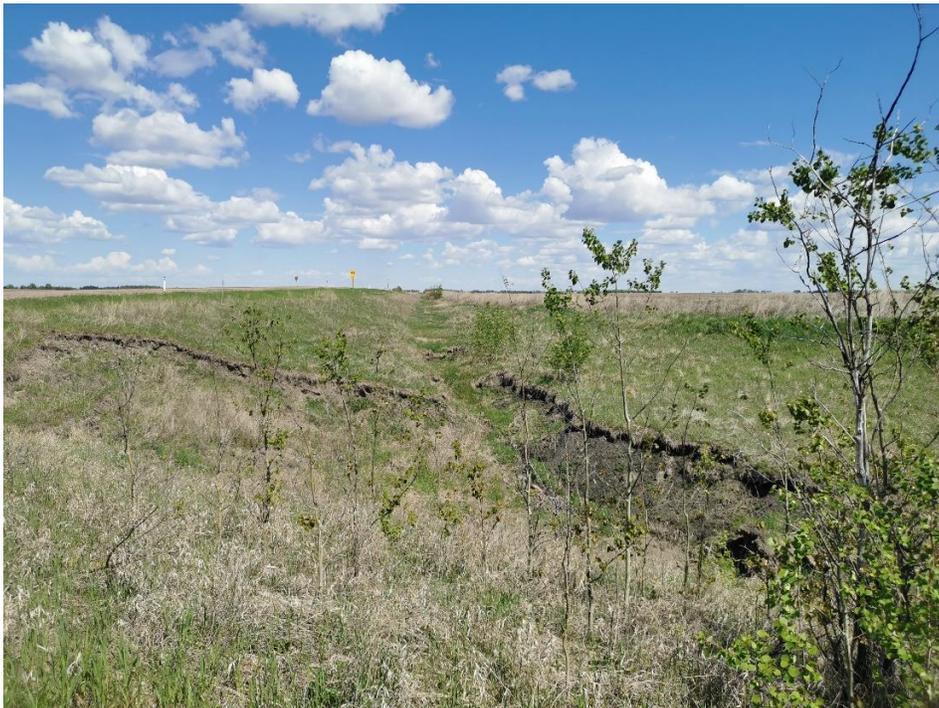
Photo 2, Site 14 – Looking north along the east ditch.

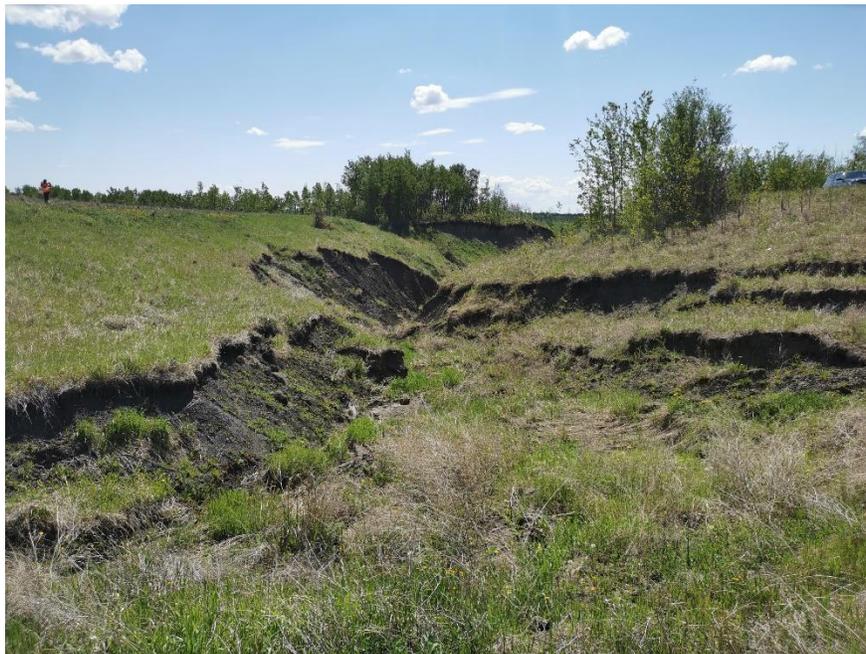
Photo 4, Site 14 – Looking south at slumping along the tributary channel.

- If the highway is not re-aligned, consideration should be given to remediating the erosion in the tributary channel at Site 14 by installing a series of rock check dams or armouring most of the channel bottom.
- Consideration could also be given to the installation of steel sheet piles along the highway at Site 14 as an interim measure if the gully regresses close enough to the highway that there is concern for the safety of the traveling public. A guardrail would also be required in this scenario. Preliminary engineering should be undertaken so that this remediation can be implemented quickly when required.

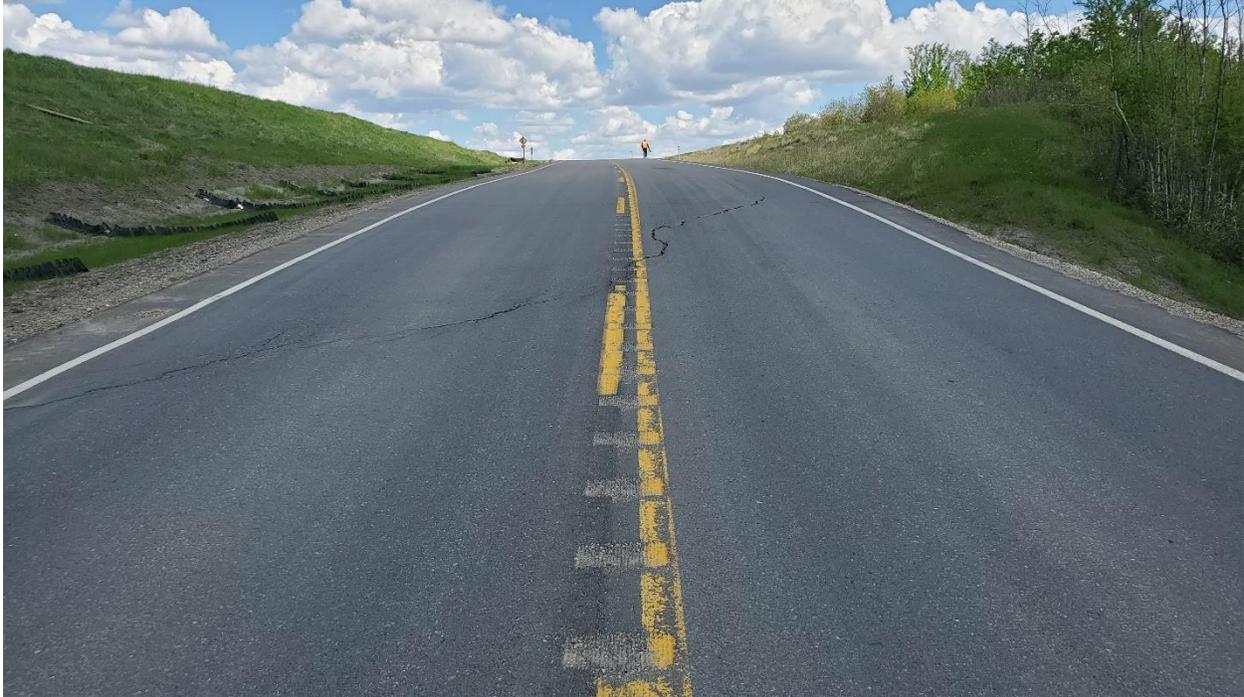
Photo 5, Site 15 – Looking north at diagonal crack intersecting the highway. There is a slight dip in the east lane on the south side (downslope) of the crack.

- Road maintenance should continue as necessary to maintain a safe roadway surface and may consist of milling, patching, and crack sealing of the ACP.
- Riprap could be placed at the headscarp of the erosion ravine to slow retrogression of the erosion up-gradient.

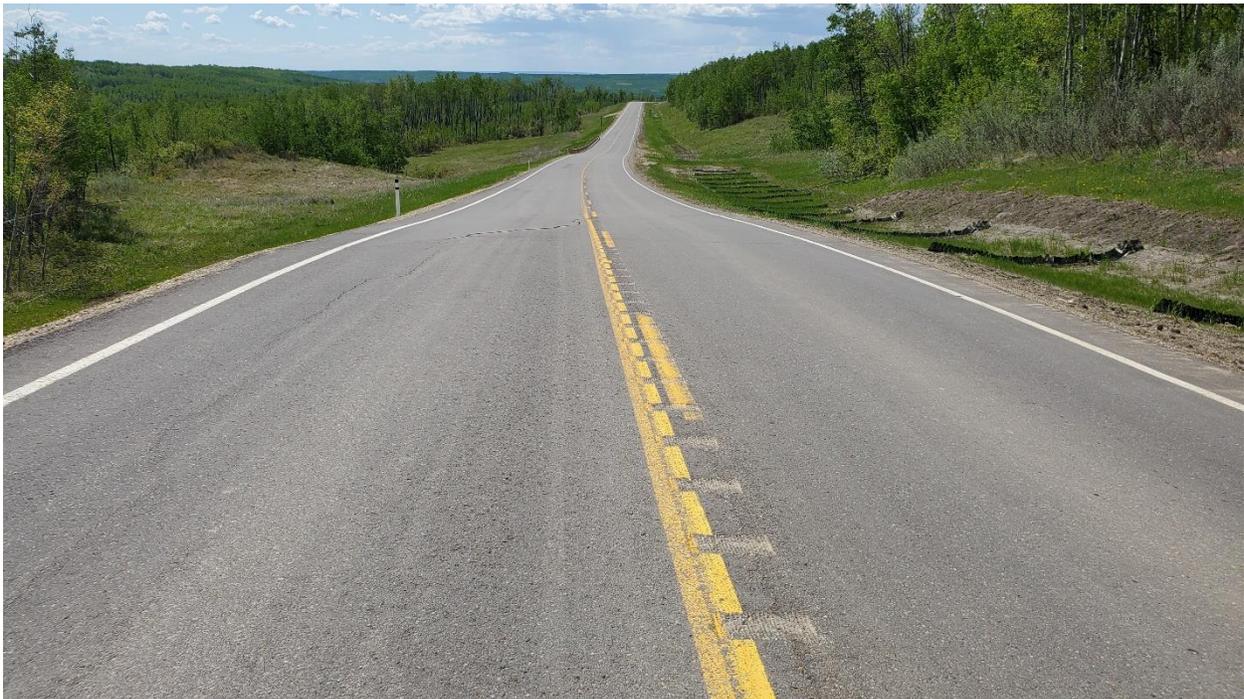
Photo 6, Site 15 – Looking south at the main crack (note grading and erosion protection in the west ditch).

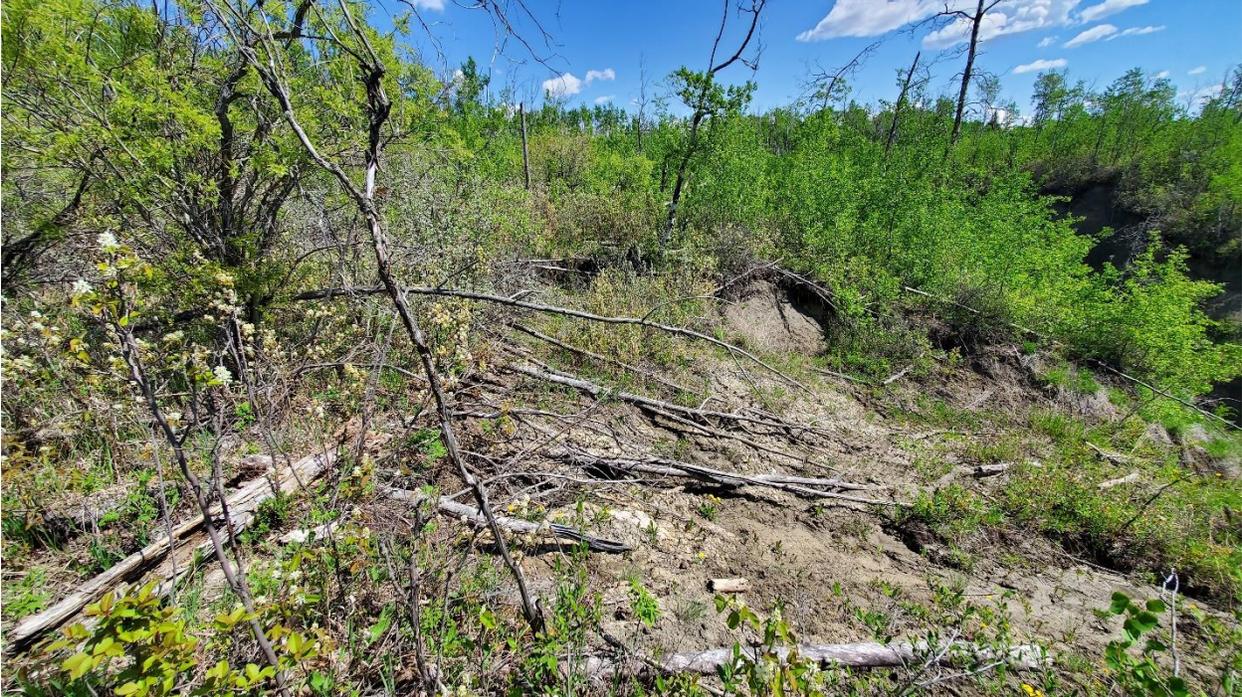
Photo 7, Site 15 – Looking north at head of shallow slump downslope of the highway.

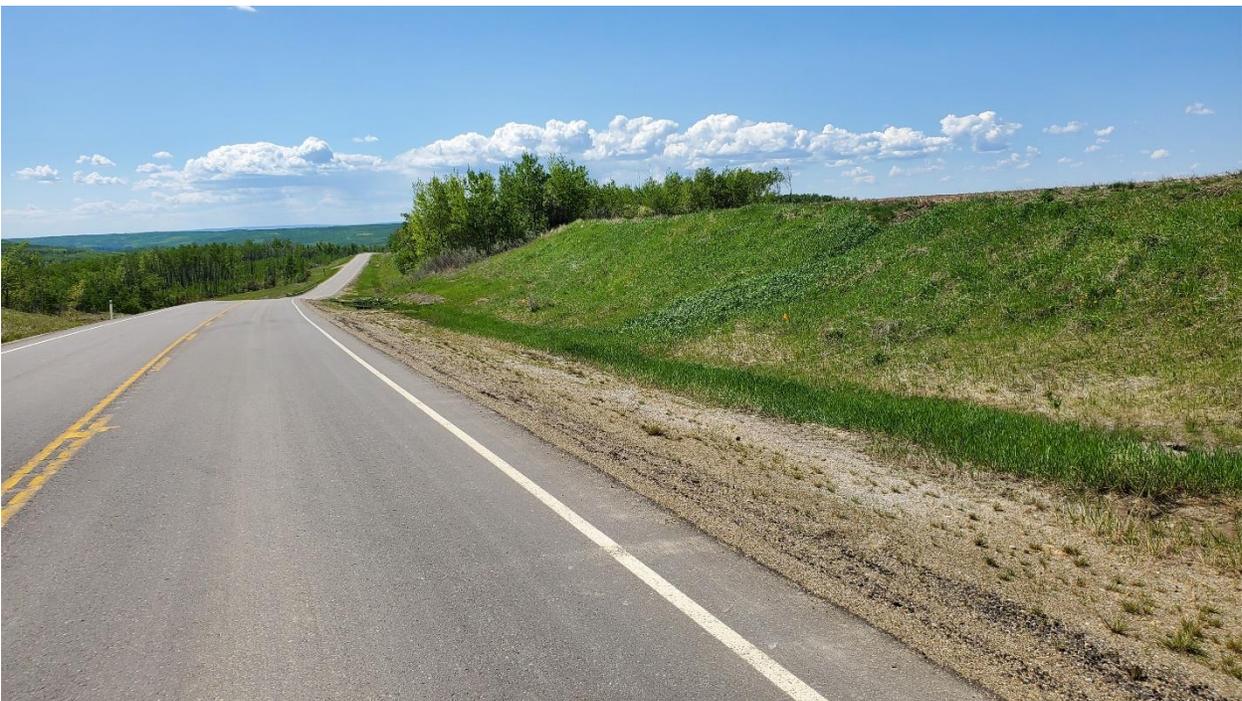
Photo 8, Site 15 – Looking southwest at backslope slump at valley crest.

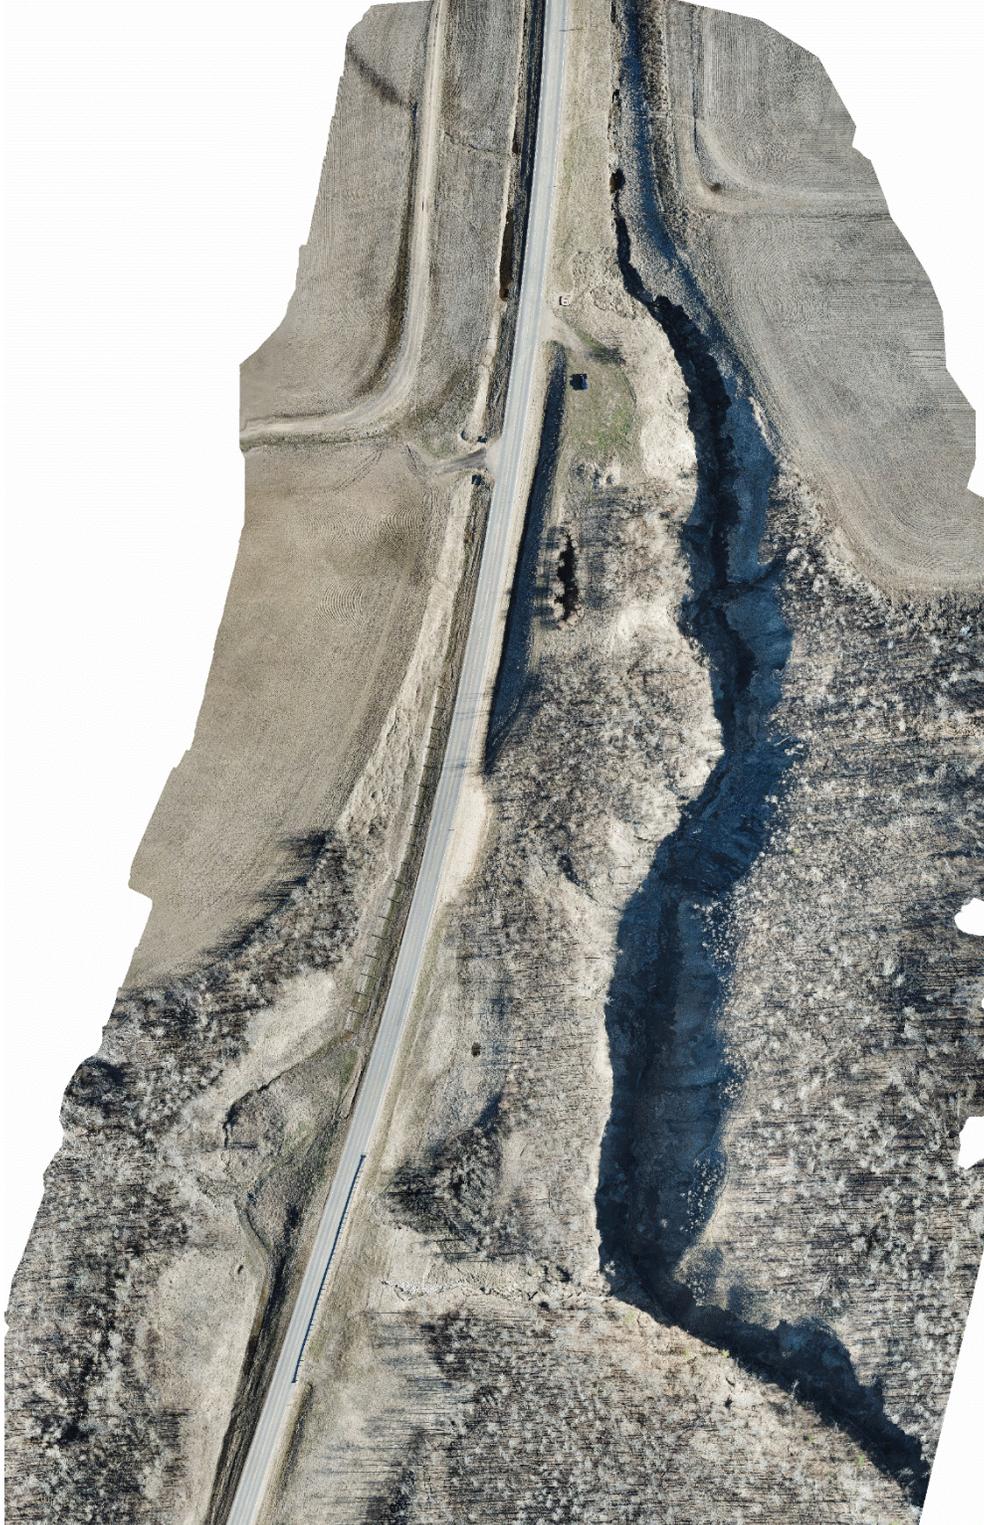
2022 UAV orthomosaic of the erosion gully at SH013.
