ALBERTA TRANSPORTATION AND ECONOMIC CORRIDORS GRMP PEACE REGION – (PEACE RIVER DISTRICT) INSTRUMENTATION MONITORING - SPRING 2024

Site Number	Location	Name	Hwy	km
PH030	HWY 744:04 C1 57.4	Lookout Slide - Judah Hill	744:04	km 57.4
Legal Description	1:	UTM Co-ordinates		
8-20-83-21 W5		11U E 483185	N 622	29488

SITE PH030: HWY 744:04, JUDAH HILL (LOOKOUT SLIDE)

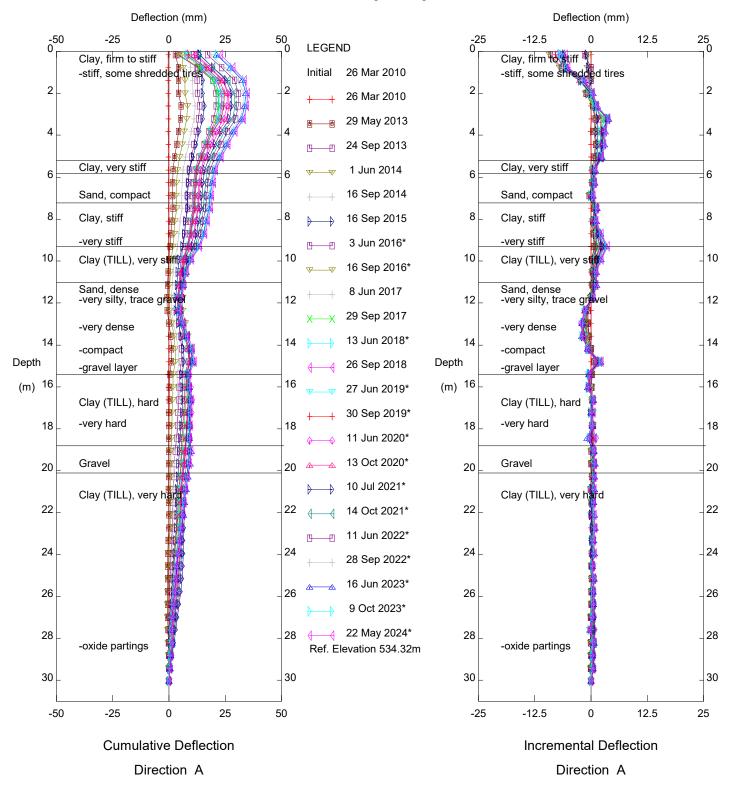
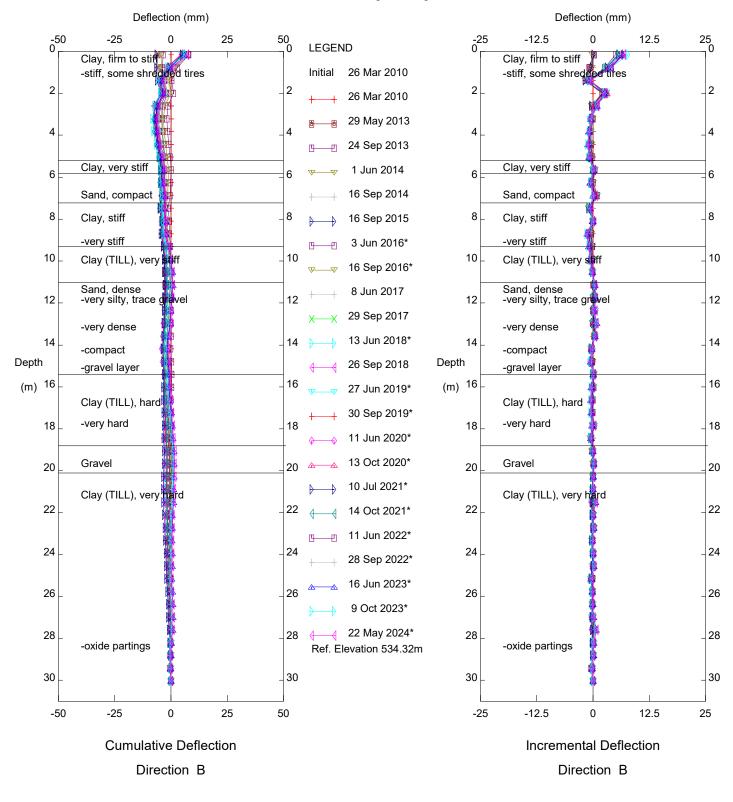
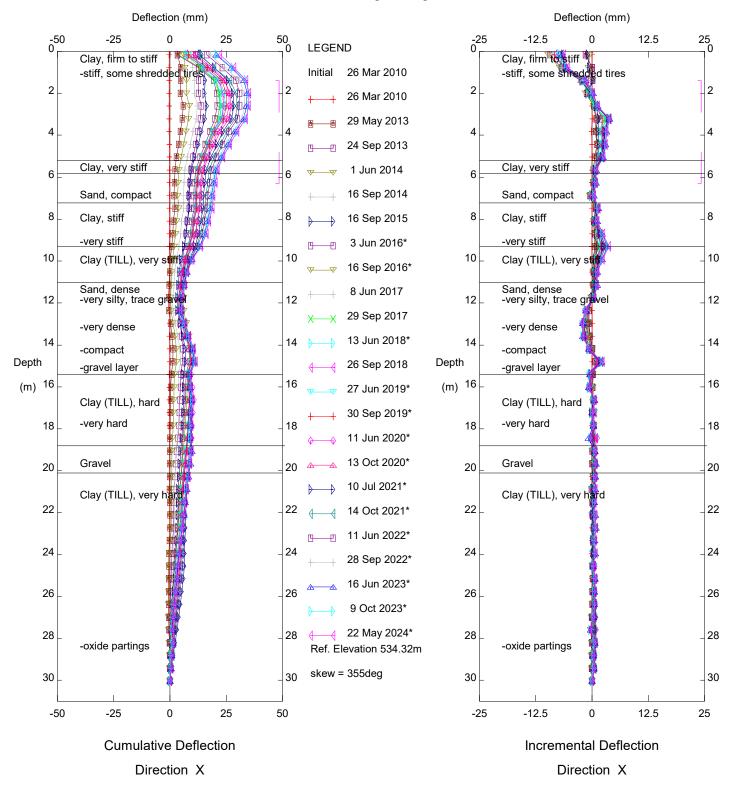
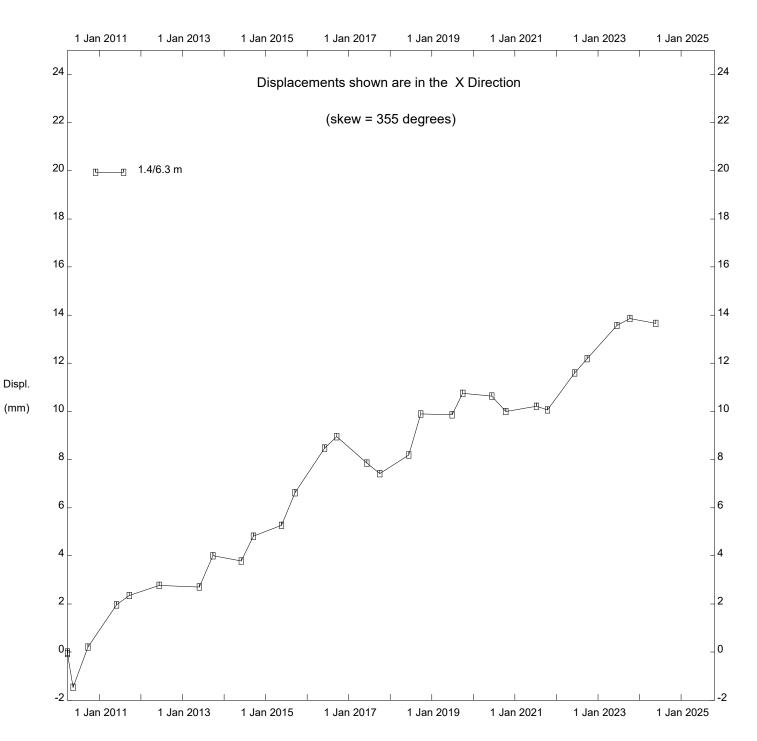
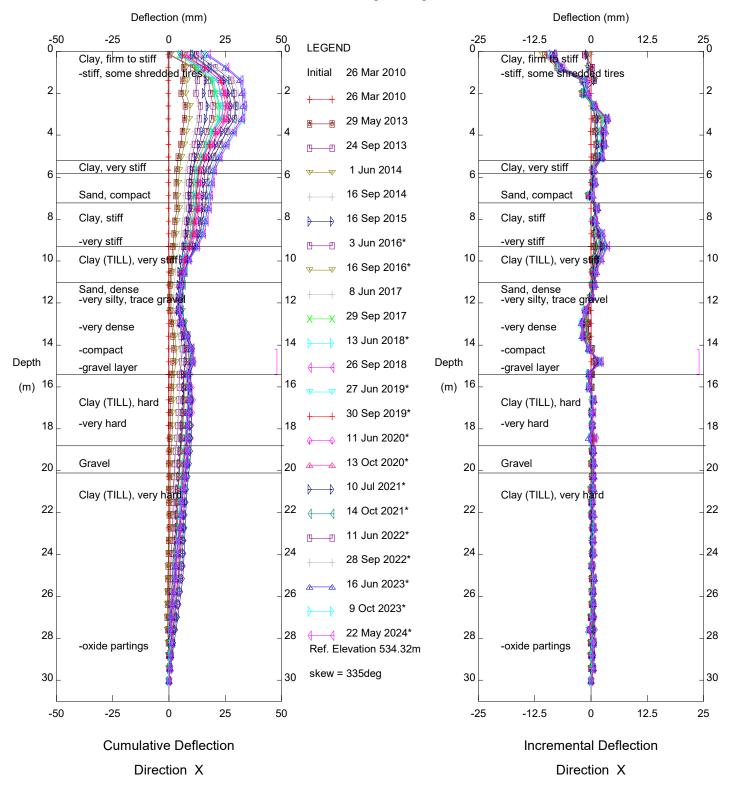
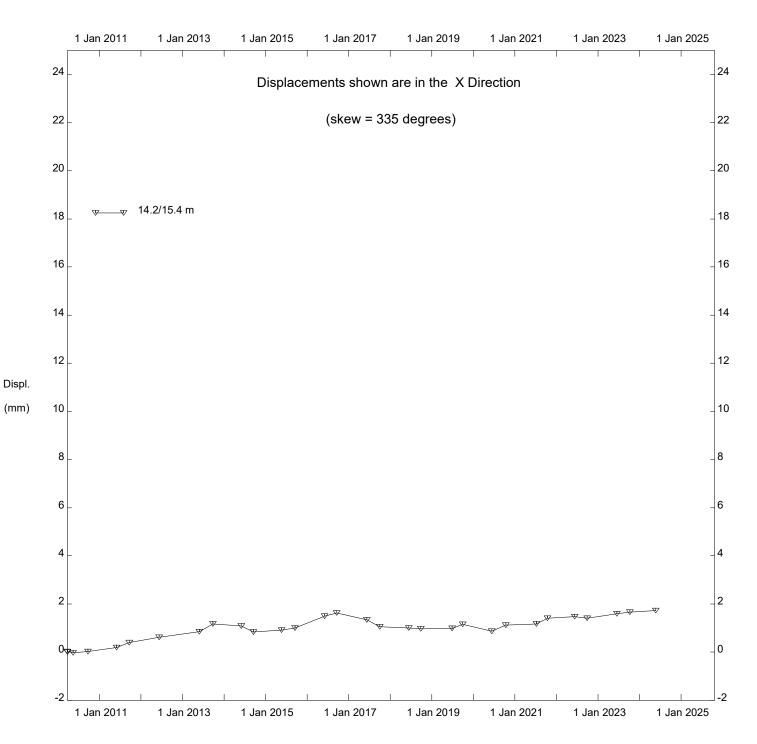
Judah Hill PH030, Inclinometer SI10-1

Zones of New Movement:	None
	Both SI10-1 and SI10-2 are located adjacent to slide areas near the Sagitawa Lookout. Movement zones are subtle and suggest several zones of movement may be occurring in response to loss of ground support within the main slide areas. The plots focus on movement within upper clay stratum and the base of a lower dense sand layer.
	SI10-1 showed no discernible movement over 1.4 m to 6.3 m depth and a rate of movement of 0.1 mm/yr over 14.2 m to 15.4 m depth since the fall of 2023 readings.
Interpretation of Monitoring Results:	SI10-2 showed a rate of movement of 4.4 mm/yr over 0.4 m to 4.1 m depth and a rate of movement of 4.1 mm/yr over 4.1 m to 8.3 m depth since the fall of 2023 readings. A trend of increased movement rates has been observed at approximately 6 m depth in SI10-2 since the fall 2021 readings. This correlates with an increase in landslide related pavement damage observed during the several annual inspections.

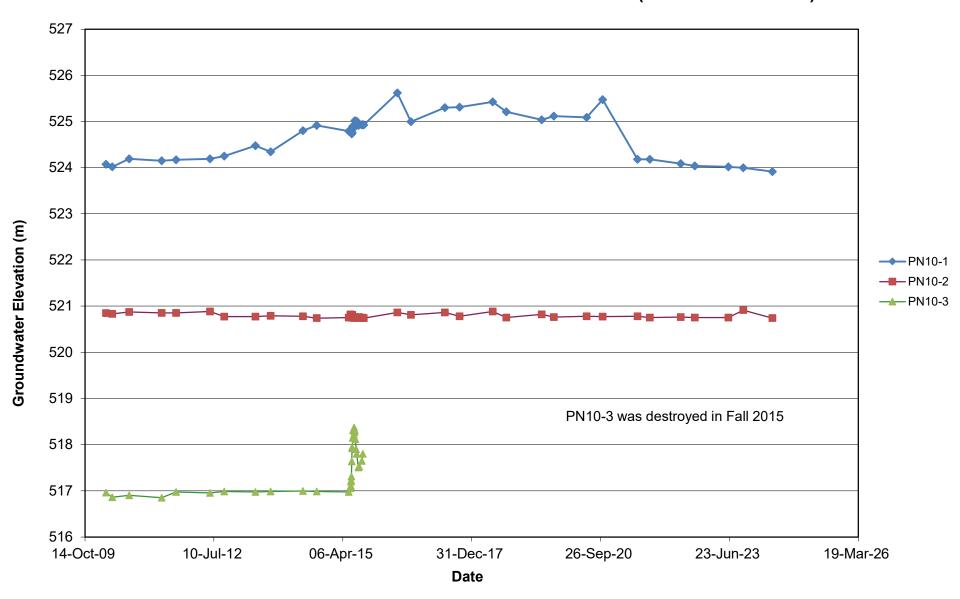
FIGURE PH030-1 PIEZOMETRIC ELEVATIONS FOR HWY 744:04: JUDAH HILL (LOOKOUT SLIDES)

Pneumatic piezometer PN10-1 showed a decrease in groundwater levels of 0.09 m compared to the fall of 2023 readings. The current groundwater level measured in PN10-1 is the lowest measured in the instrument since it was initialized. Pneumatic piezometer PN10-2 showed a decrease in groundwater level of 0.17 m since the fall of 2023 readings.
