THURBER ENGINEERING LTD.

File No.: 32121

**ALBERTA TRANSPORTATION GRMP (CON0022164)
PEACE REGION (PEACE RIVER DISTRICT)
INSTRUMENTATION MONITORING RESULTS – FALL 2022**

SITE PH031: HWY 744:04, JUDAH HILL (MICHELIN SLIDE)

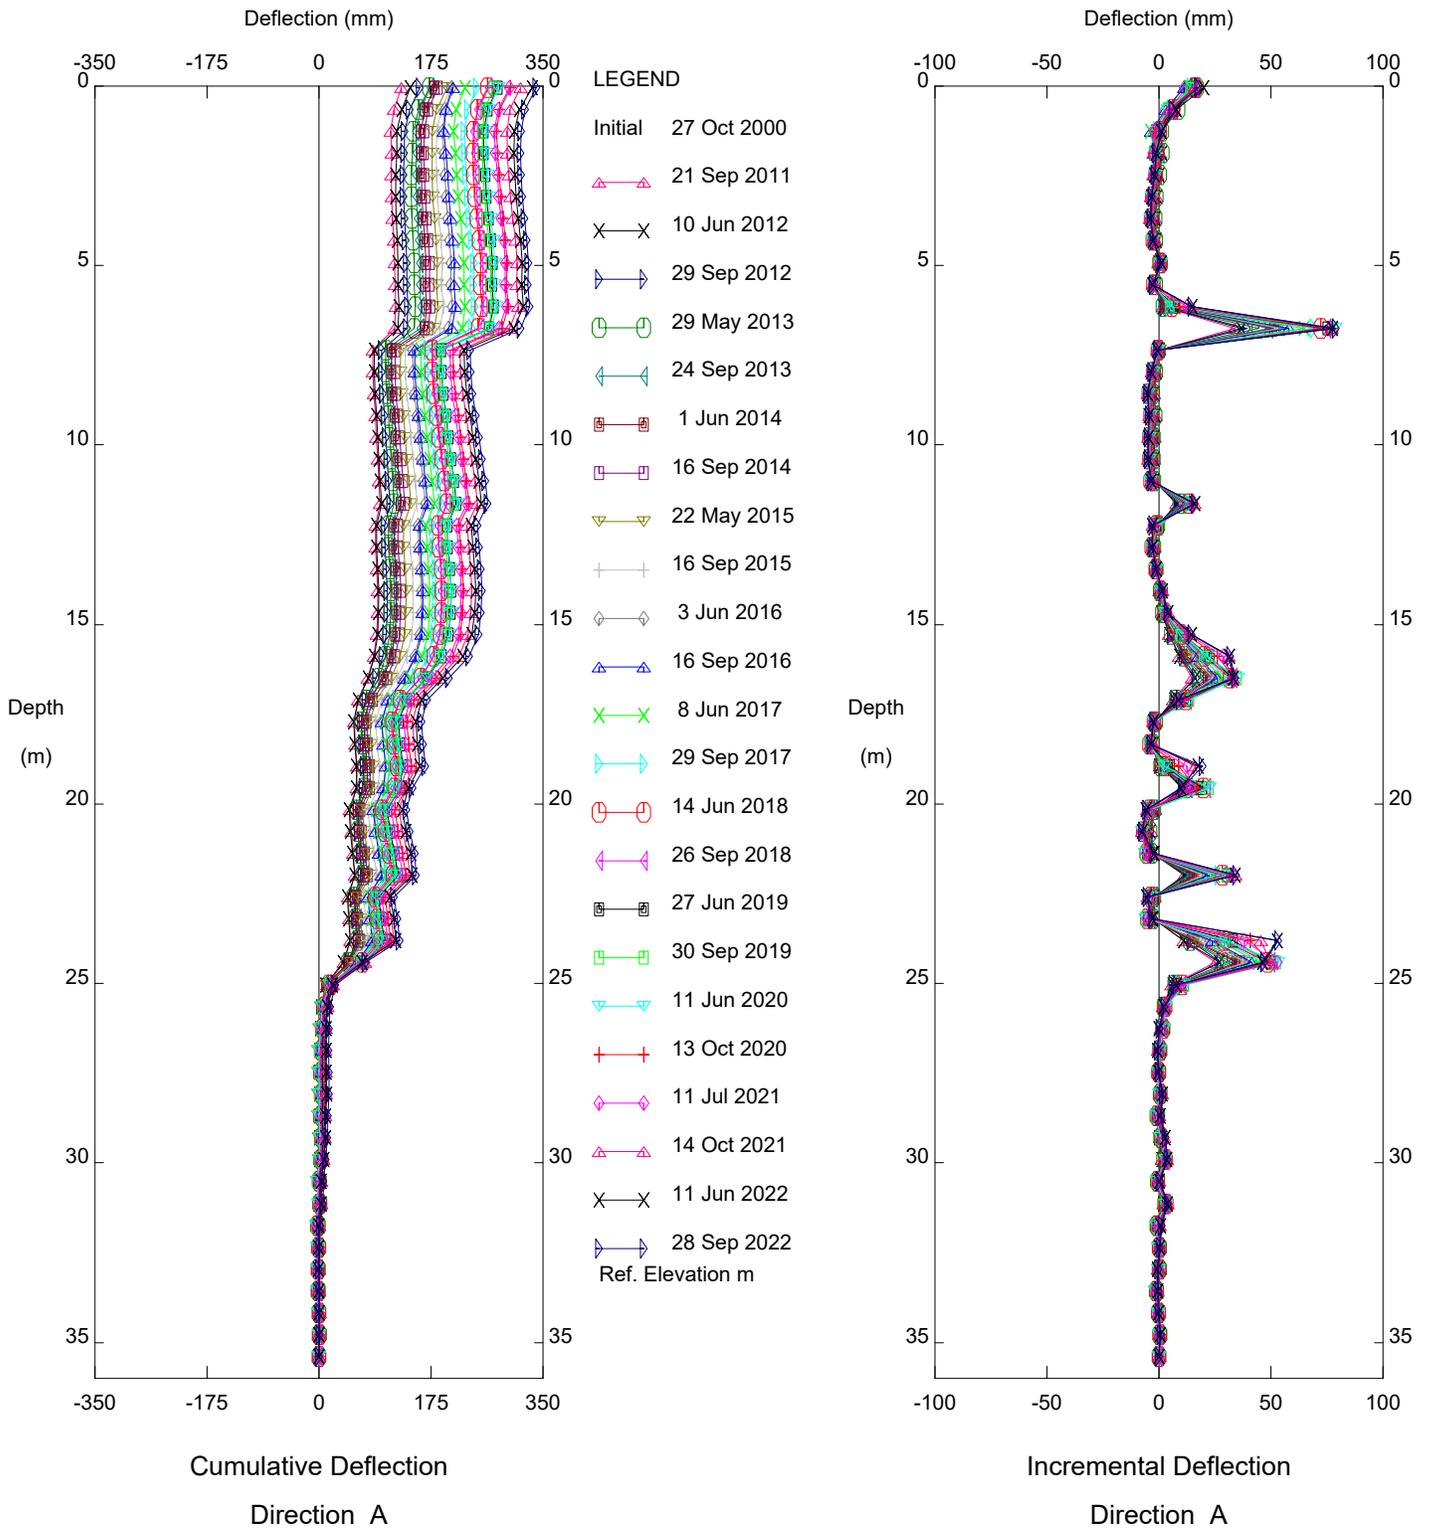
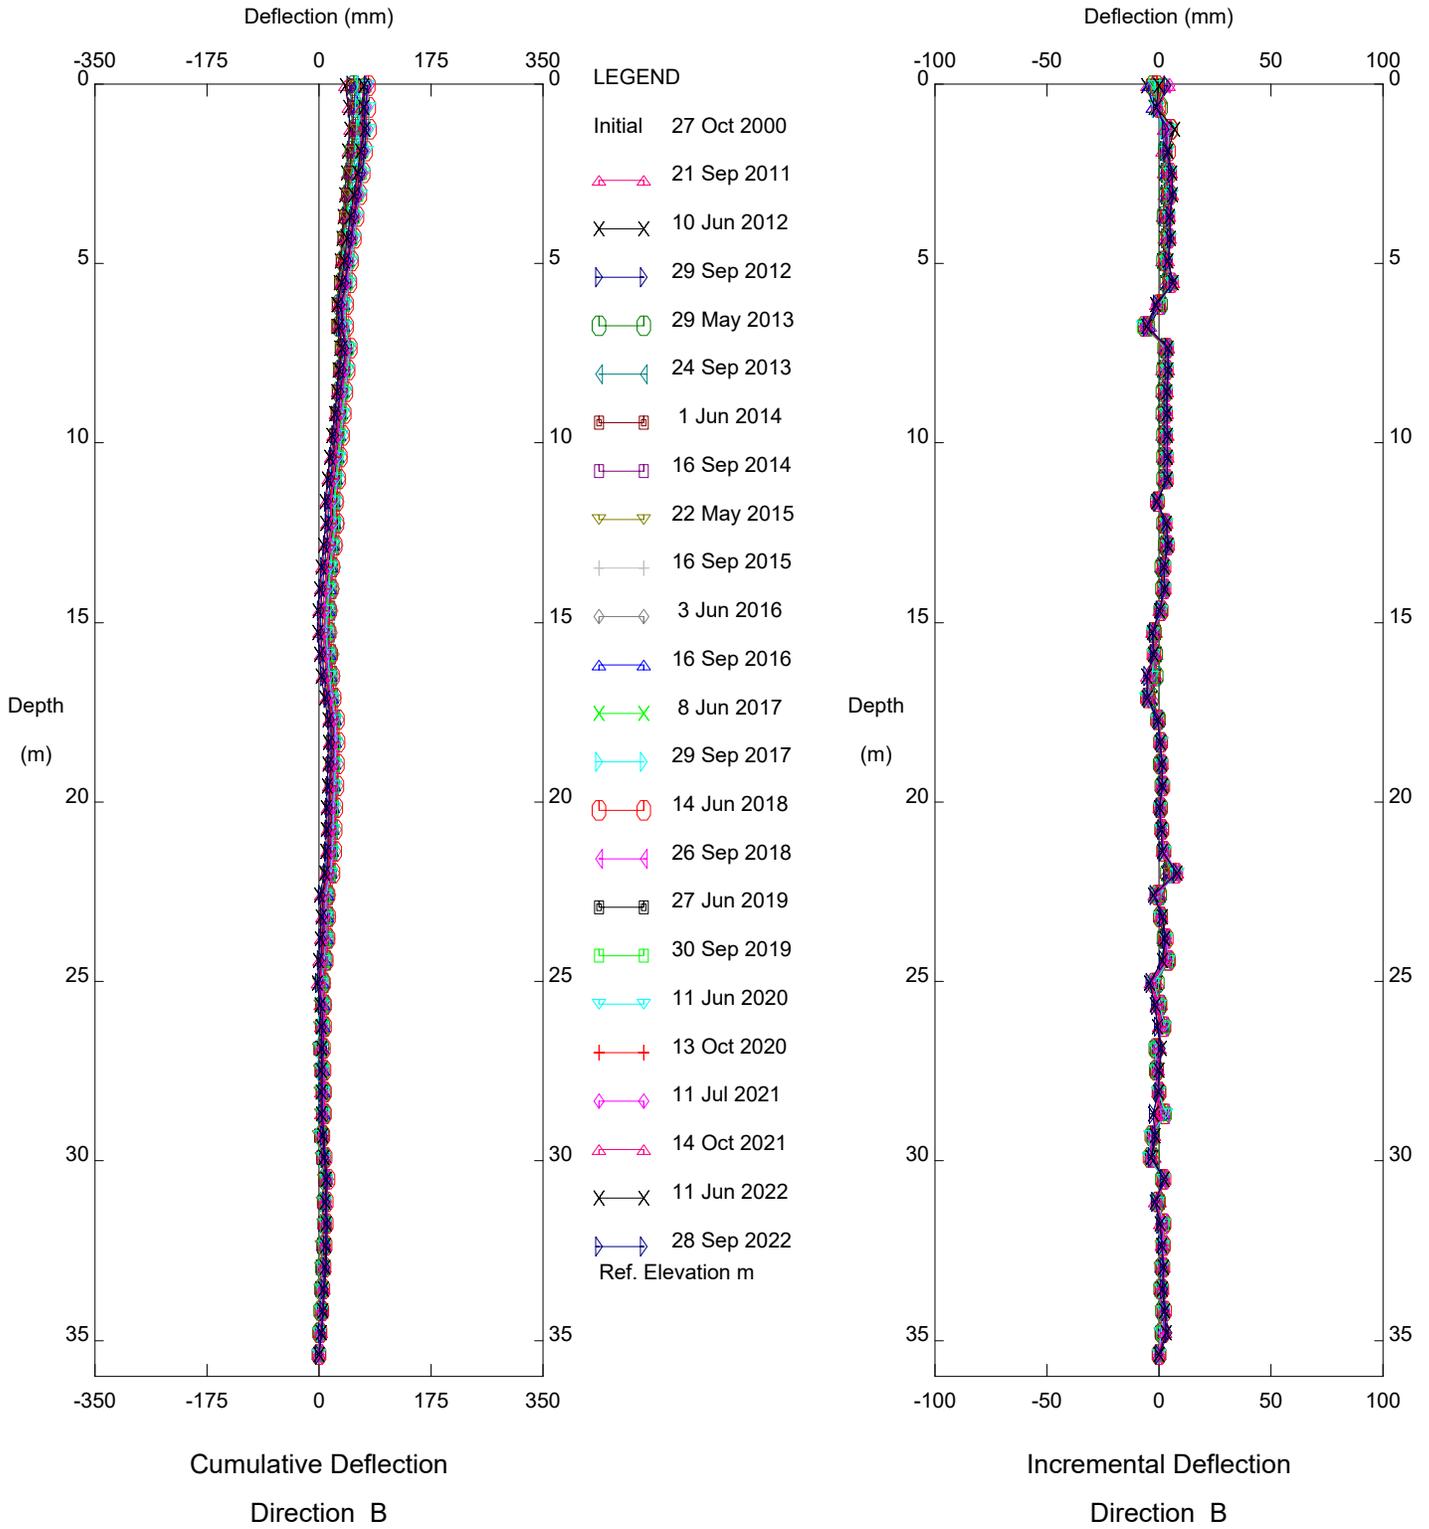
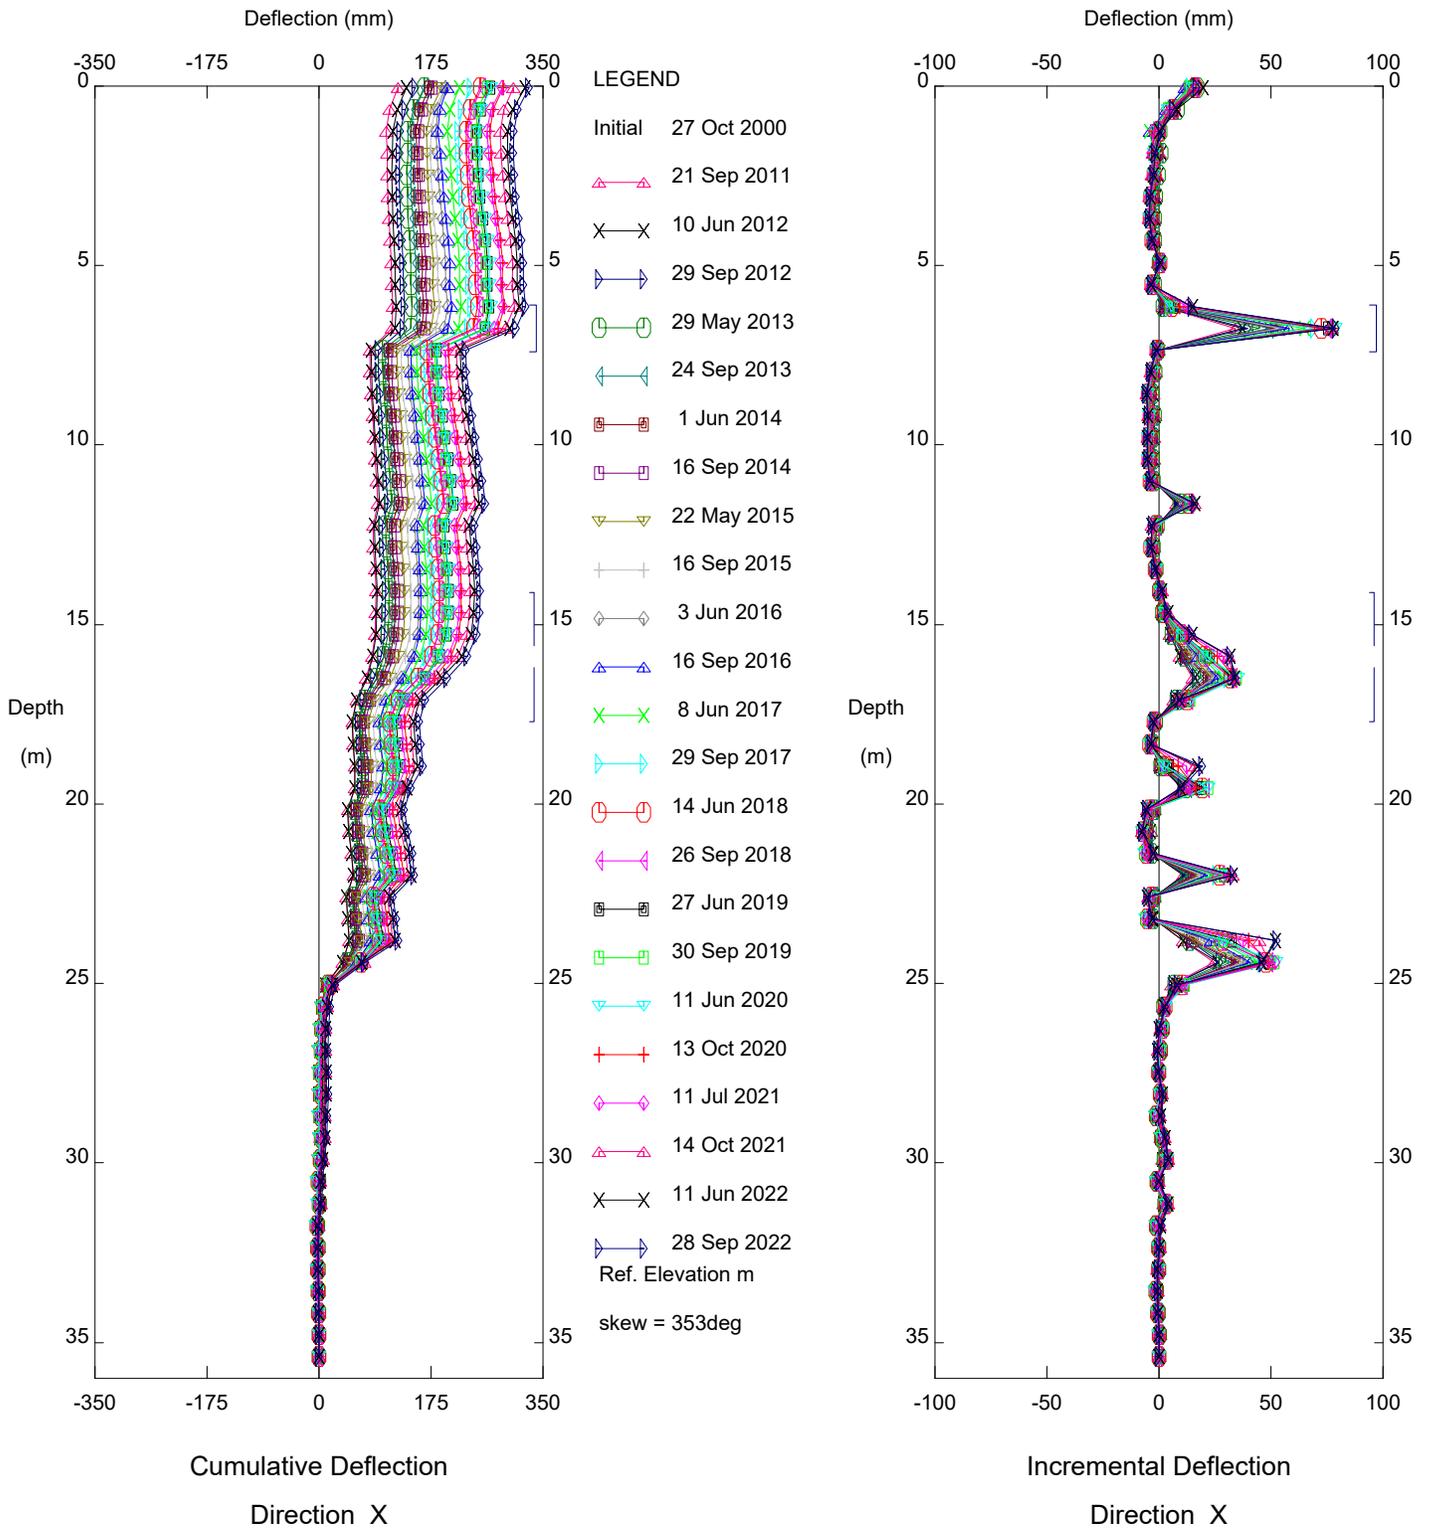
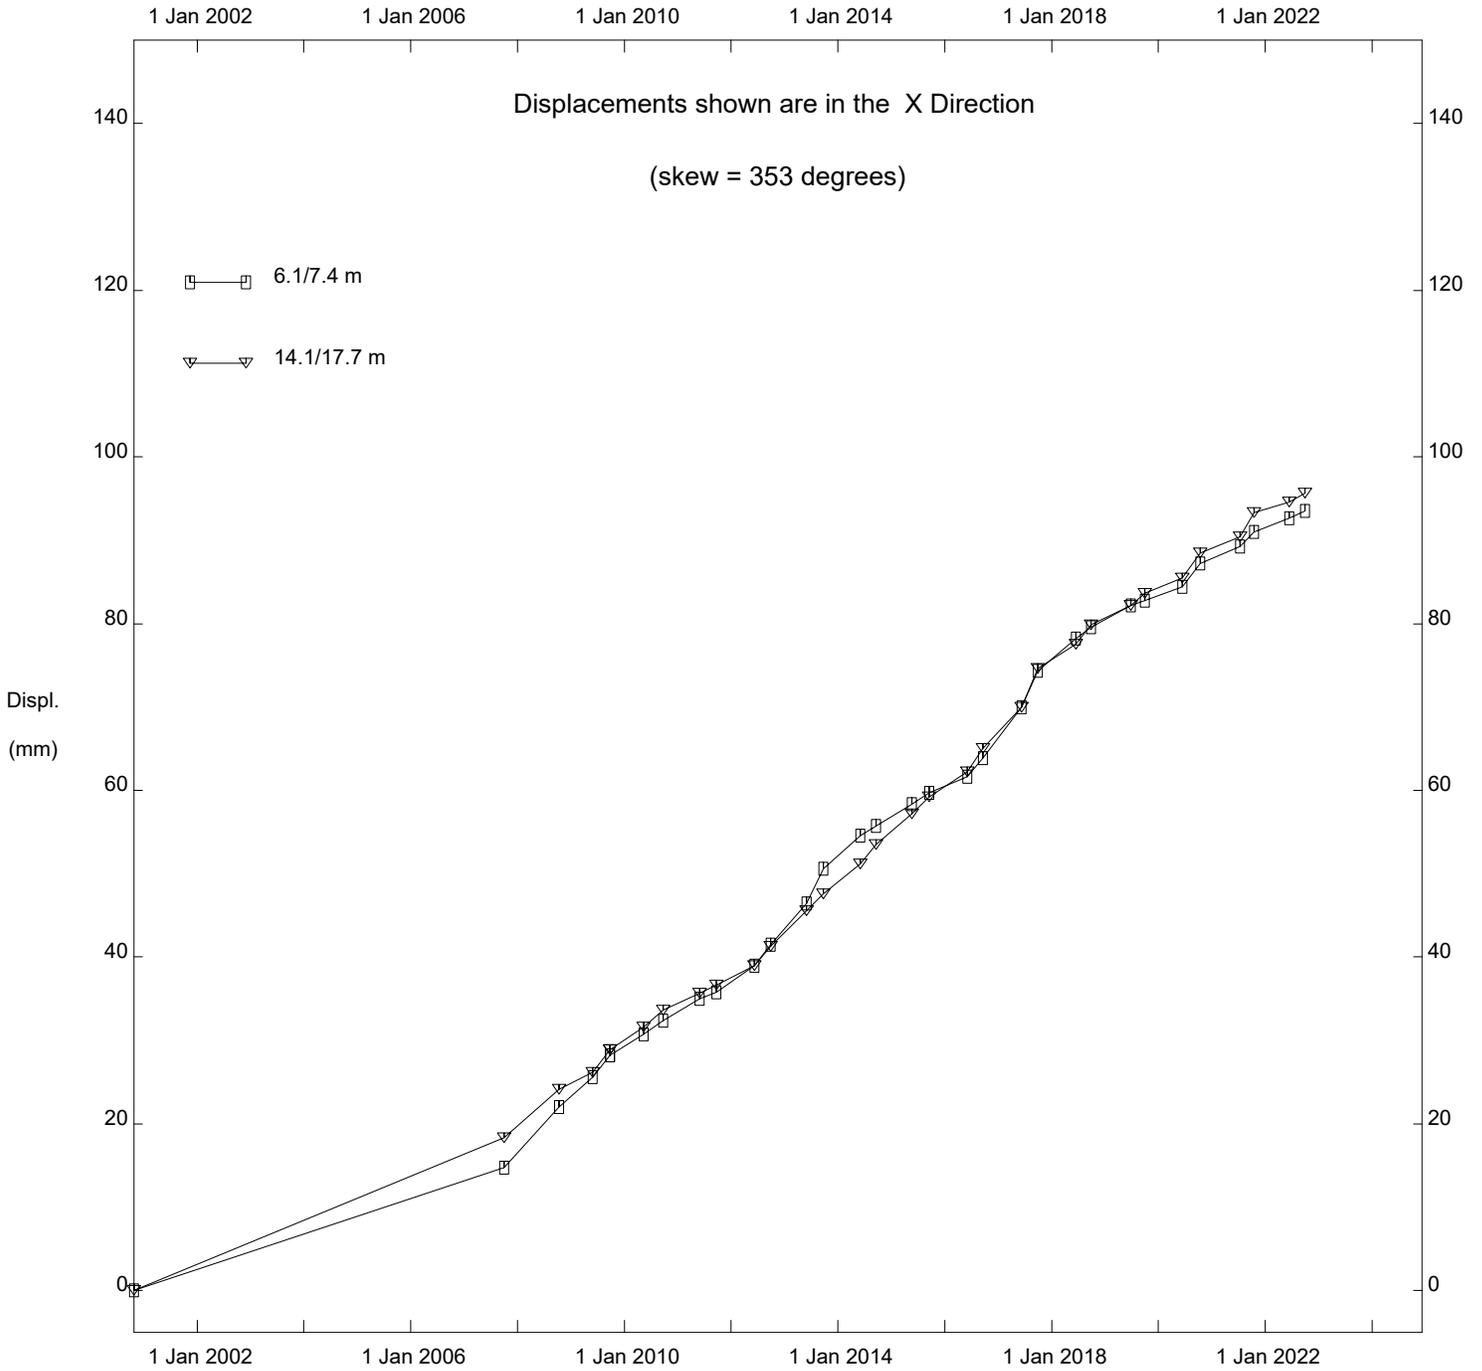
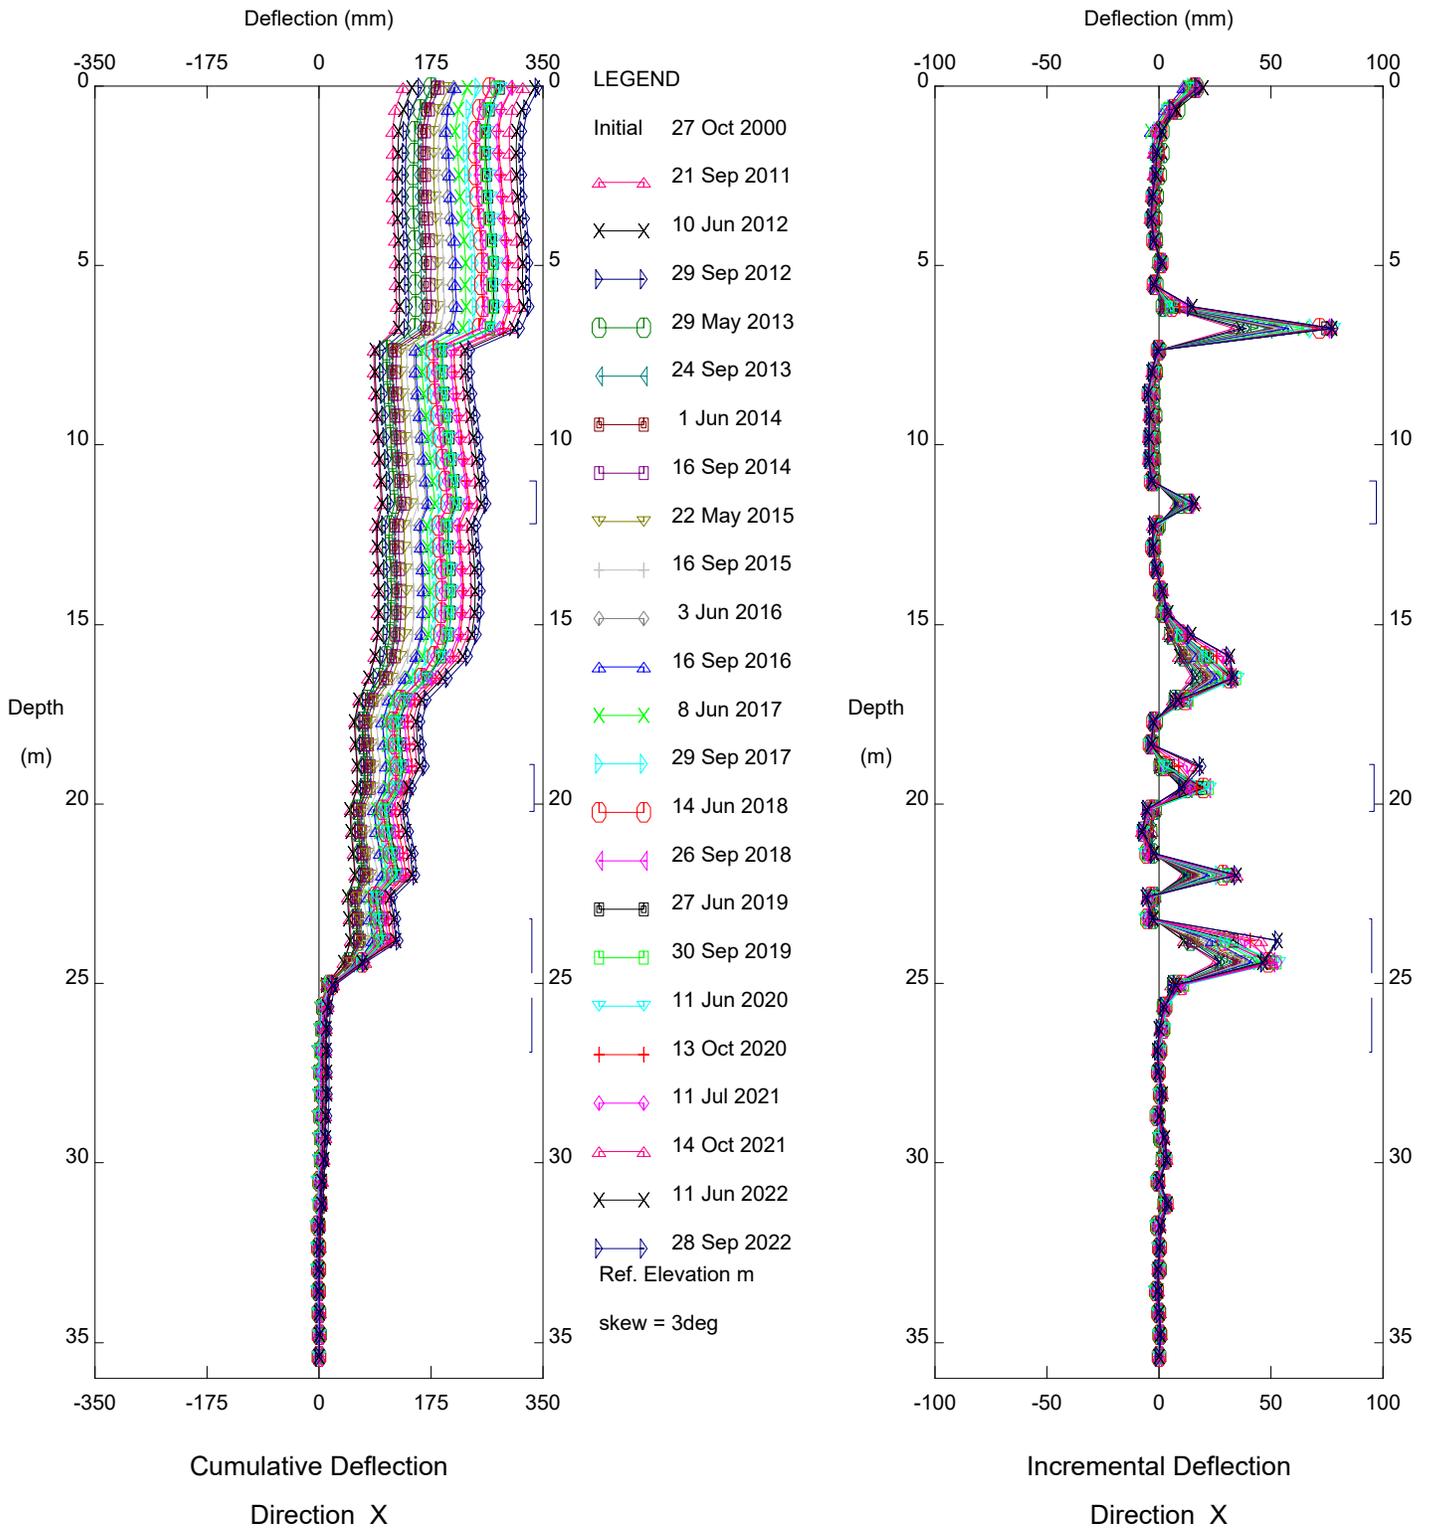
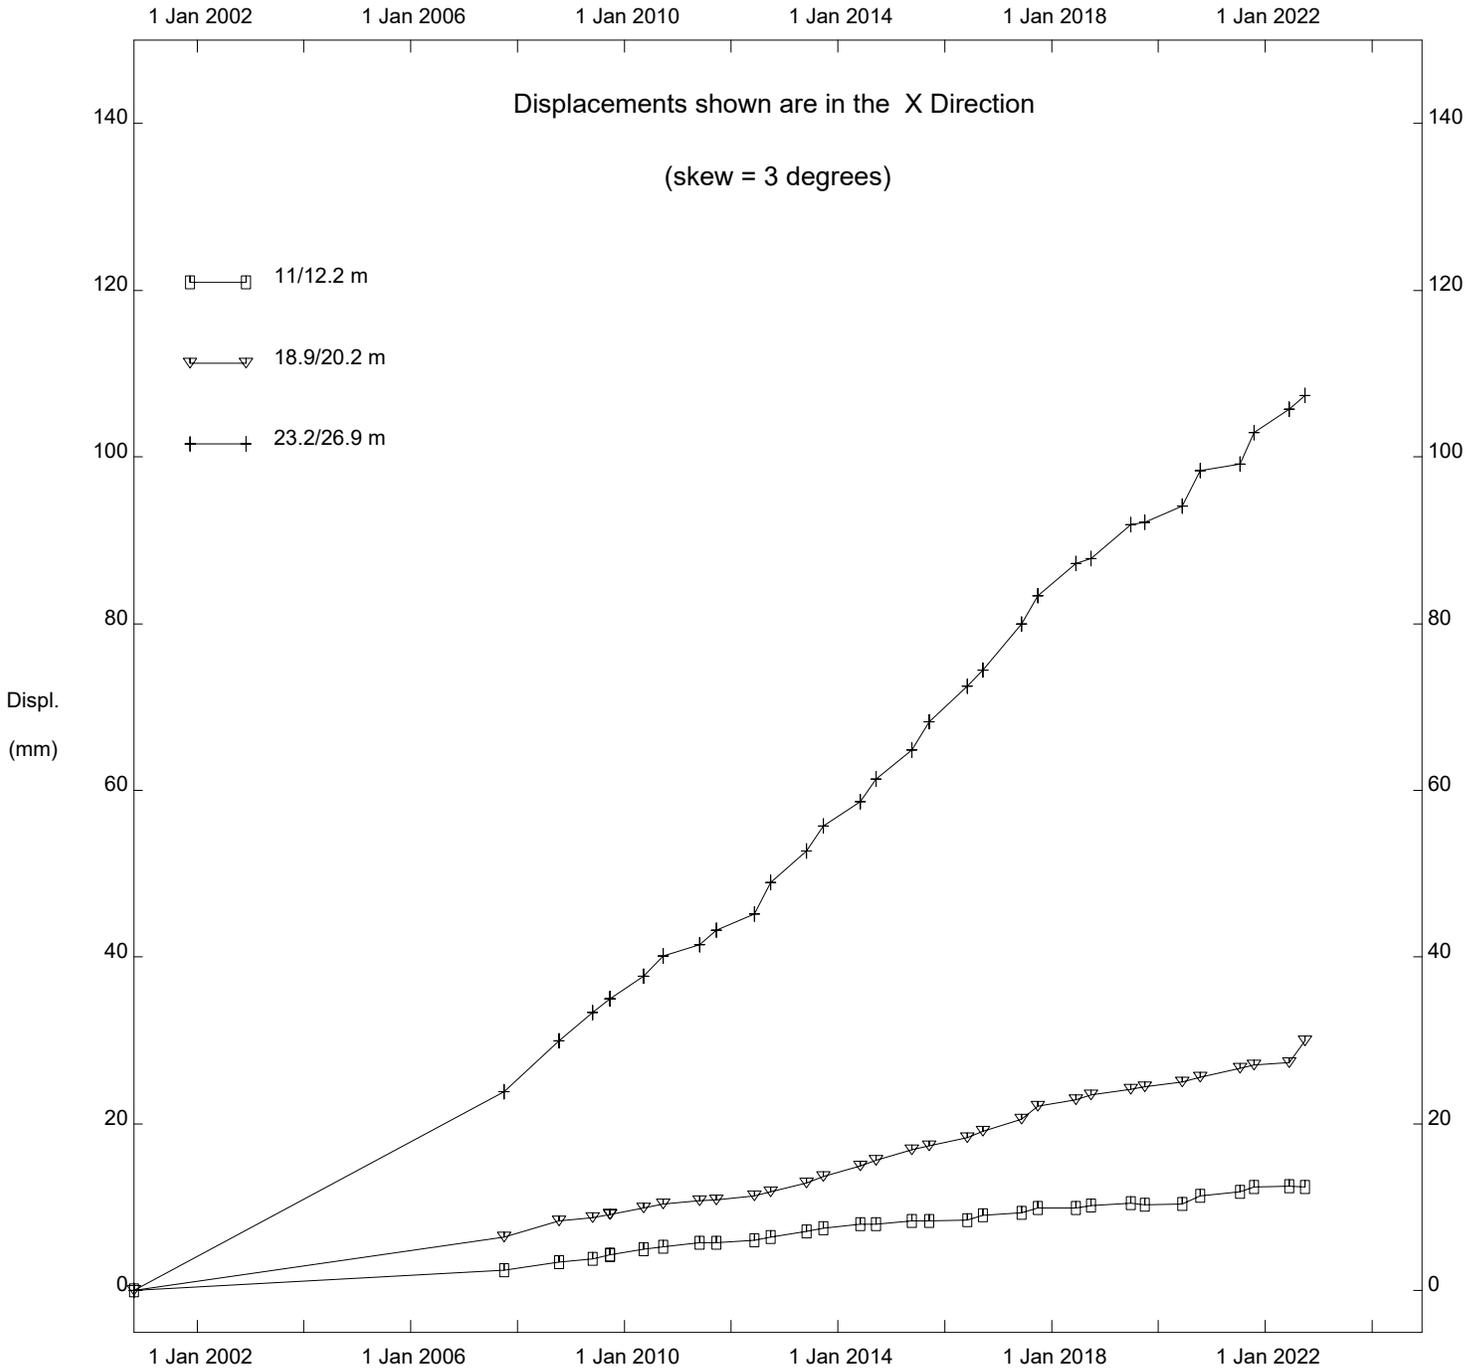
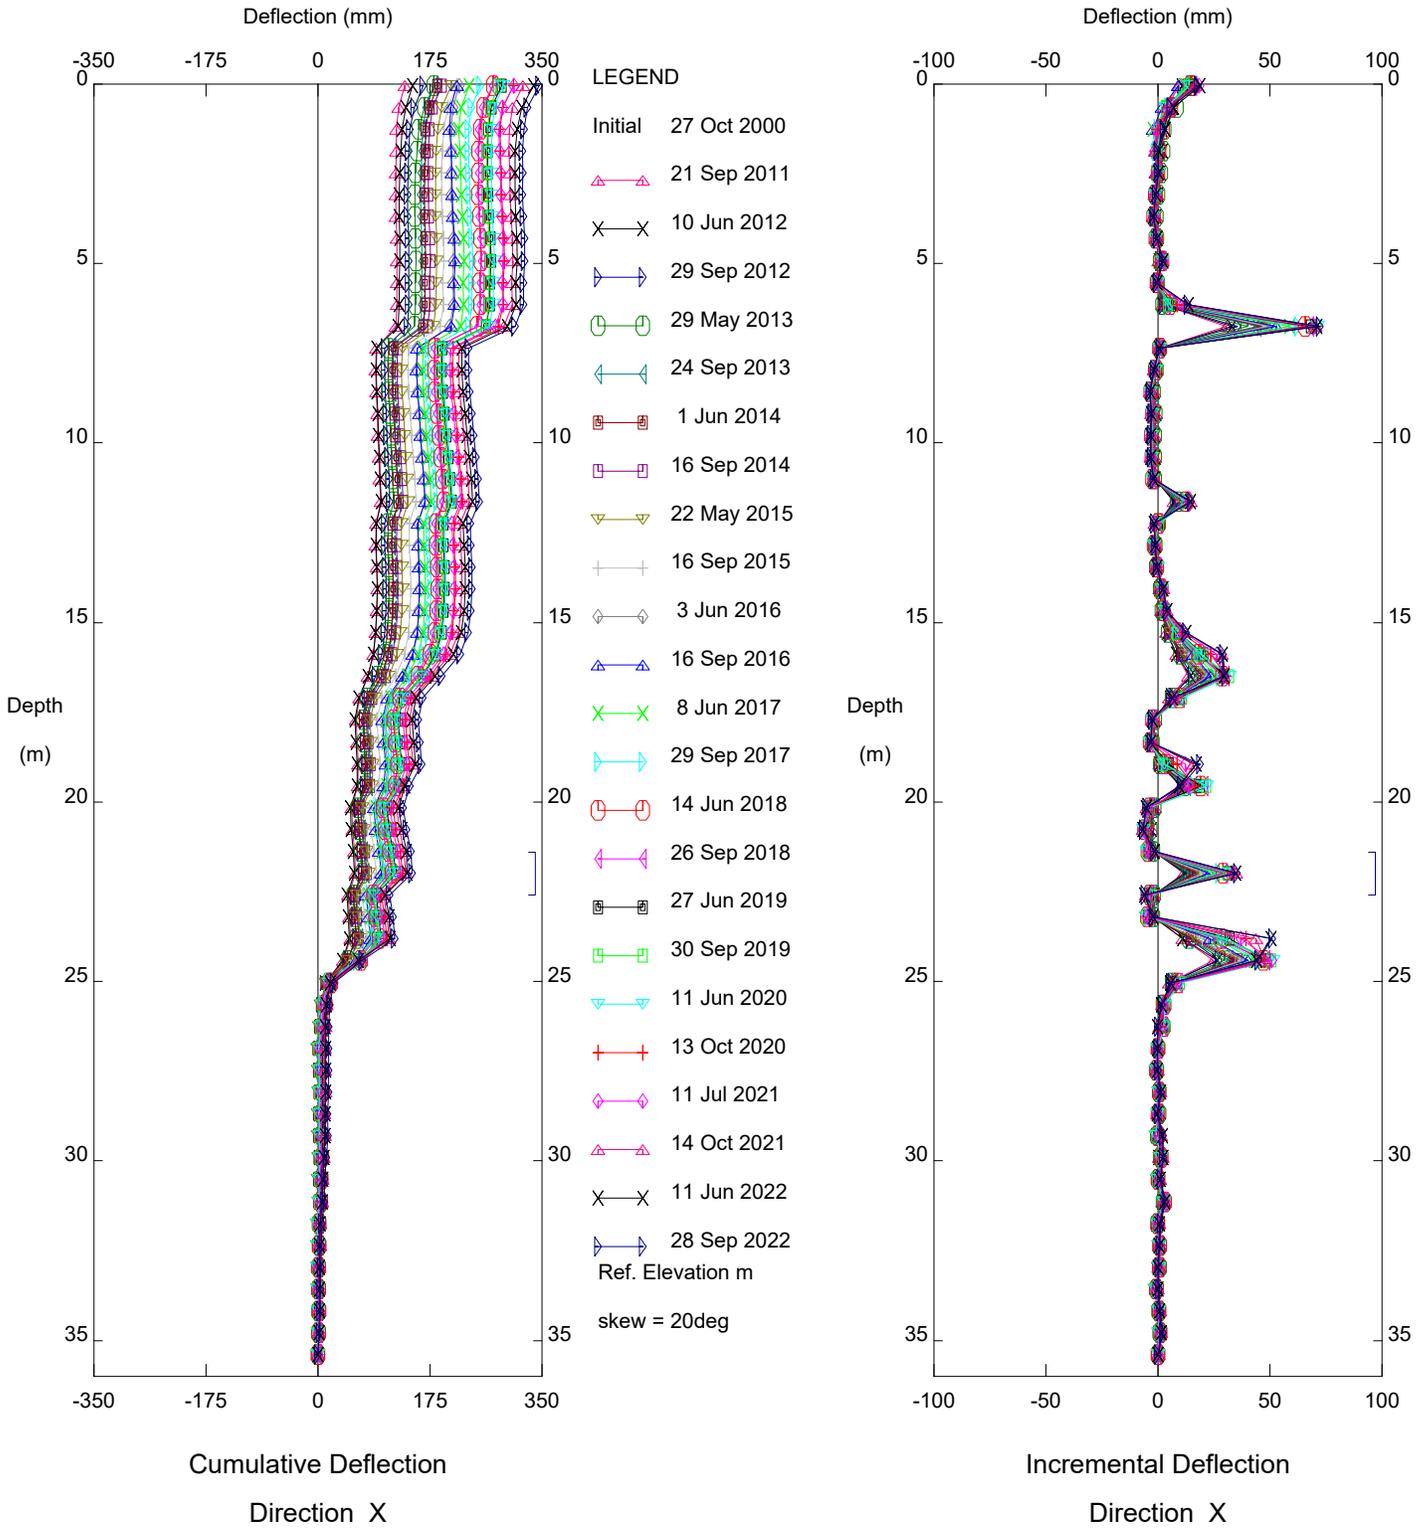
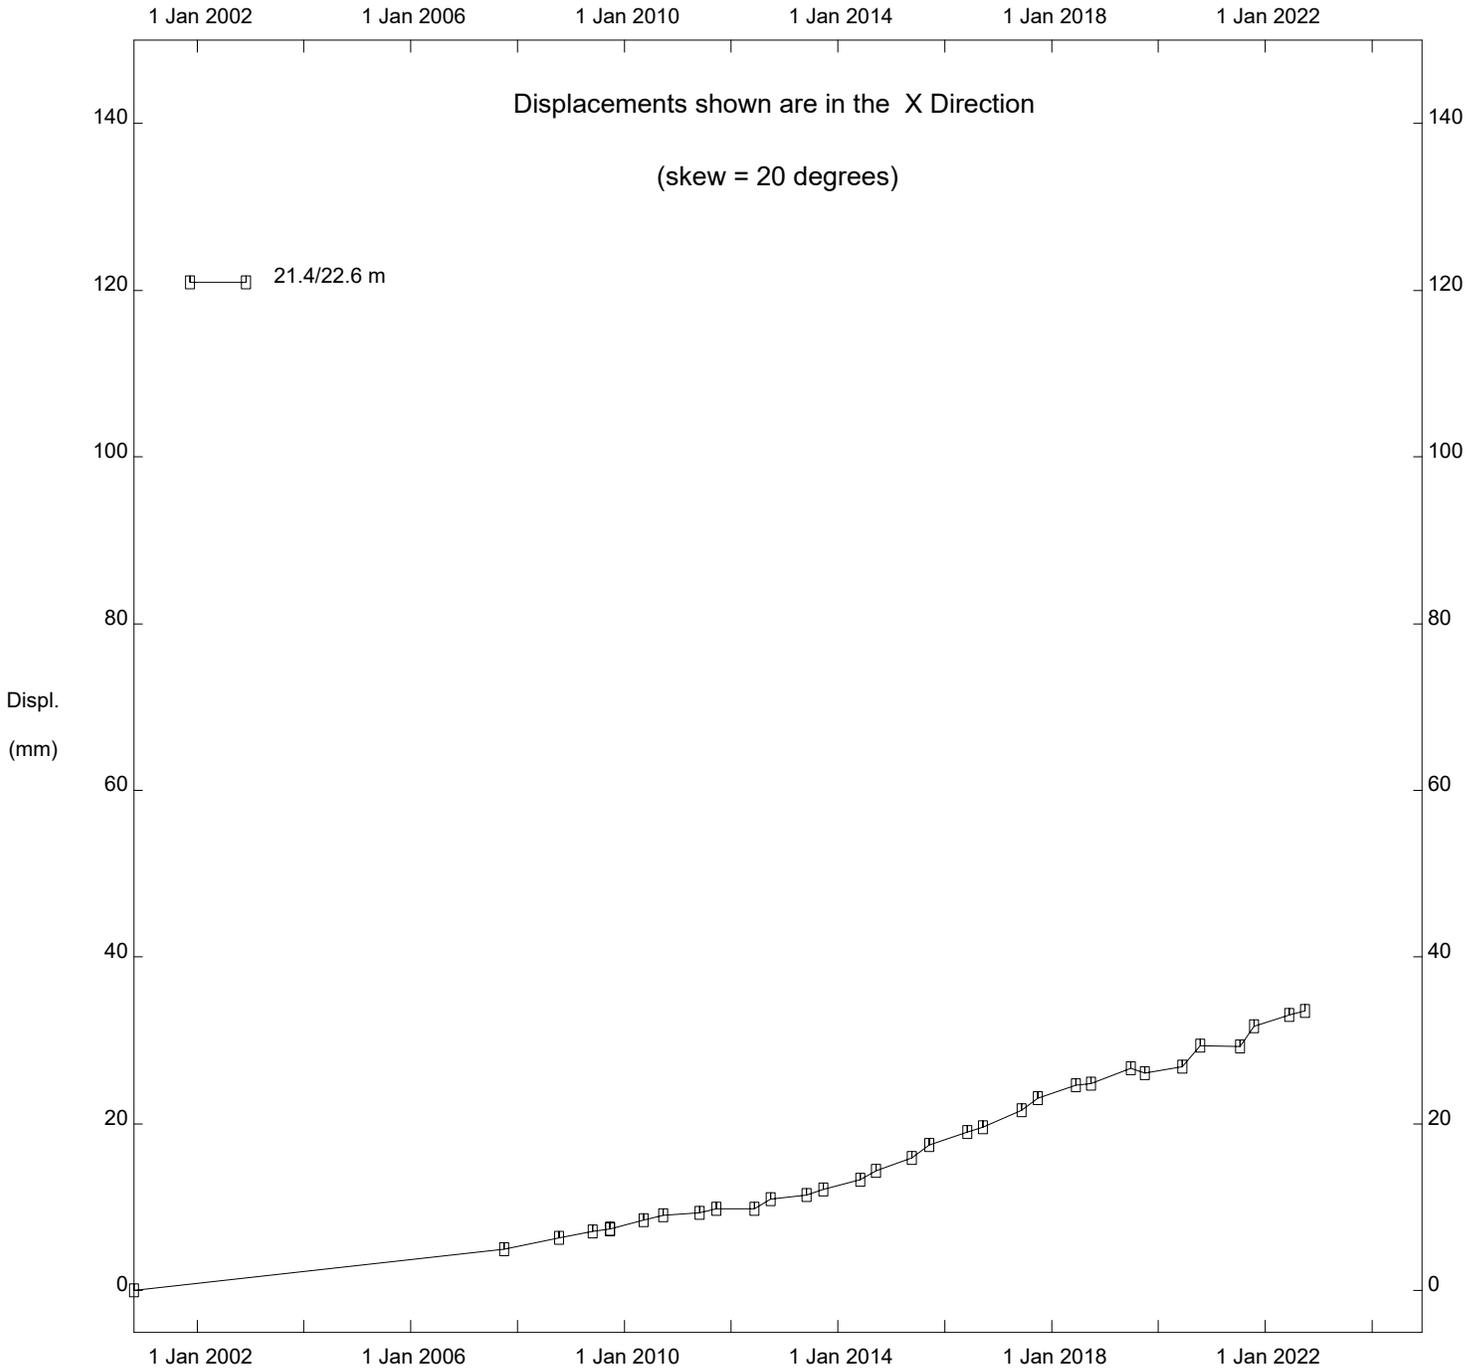
HWY 744:04 - STA. 57+700 to 58+000, Inclinometer SI98-10i

In slope inclinometer SI98-10i, which is installed beyond the toe of the Michelin slide, small incremental movements up to 2.6 mm were noticed along six distinct shear planes, since the spring 2022 readings. The sum of the movement of all these zones was 373 mm since its initialization in October 2000. The movement rates in these zones ranged from having no discernible movement to 8.7 mm/yr. The movement rates showed small changes since the previous readings in the spring of 2022, except for an increase in the rate of movement by 8.2 mm/yr over 18.9 to 20.2 m depth.
