THURBER ENGINEERING LTD.

File No.: 32121

**ALBERTA TRANSPORTATION GRMP (CON0022164)
PEACE REGION (PEACE RIVER DISTRICT)
INSTRUMENTATION MONITORING RESULTS – FALL 2022**

SITE PH031: HWY 744:04, JUDAH HILL (MICHELIN SLIDE)

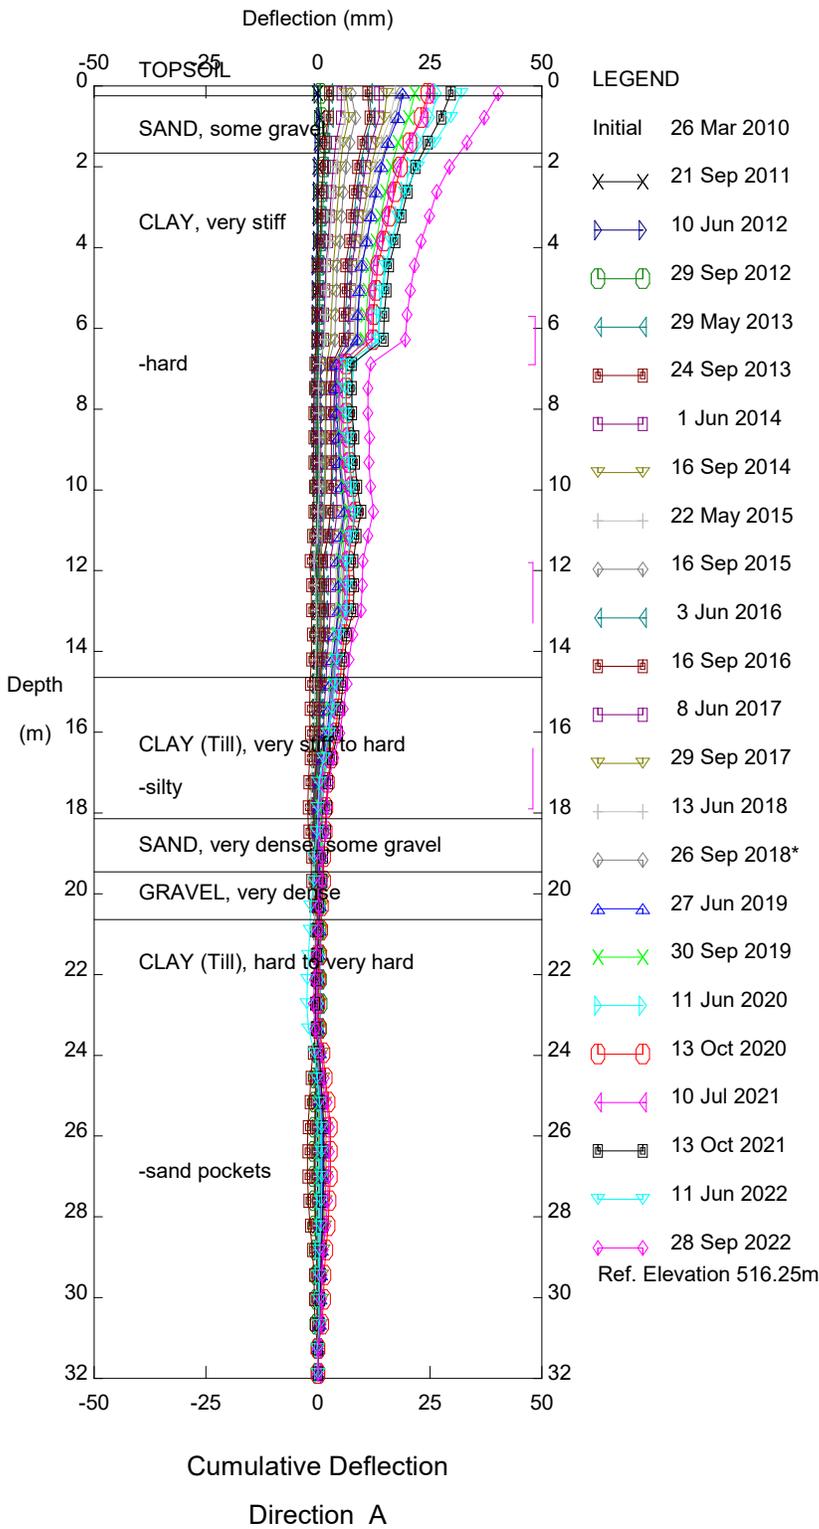
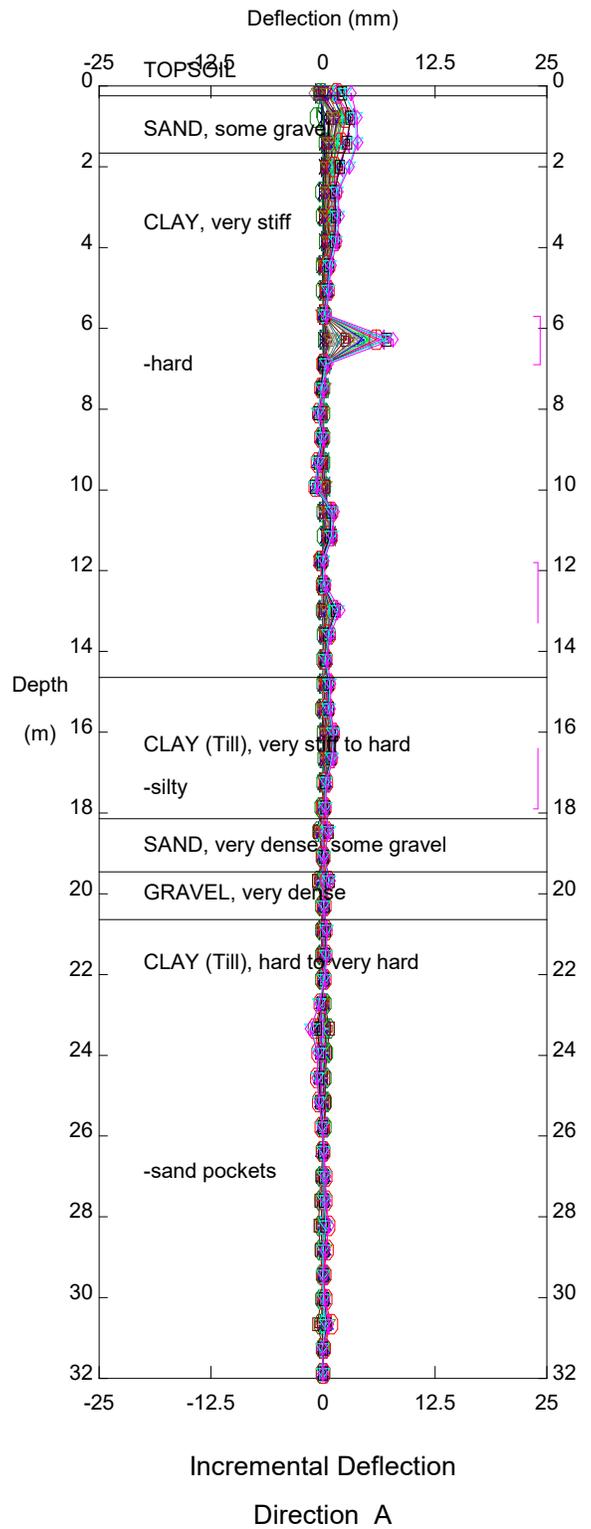
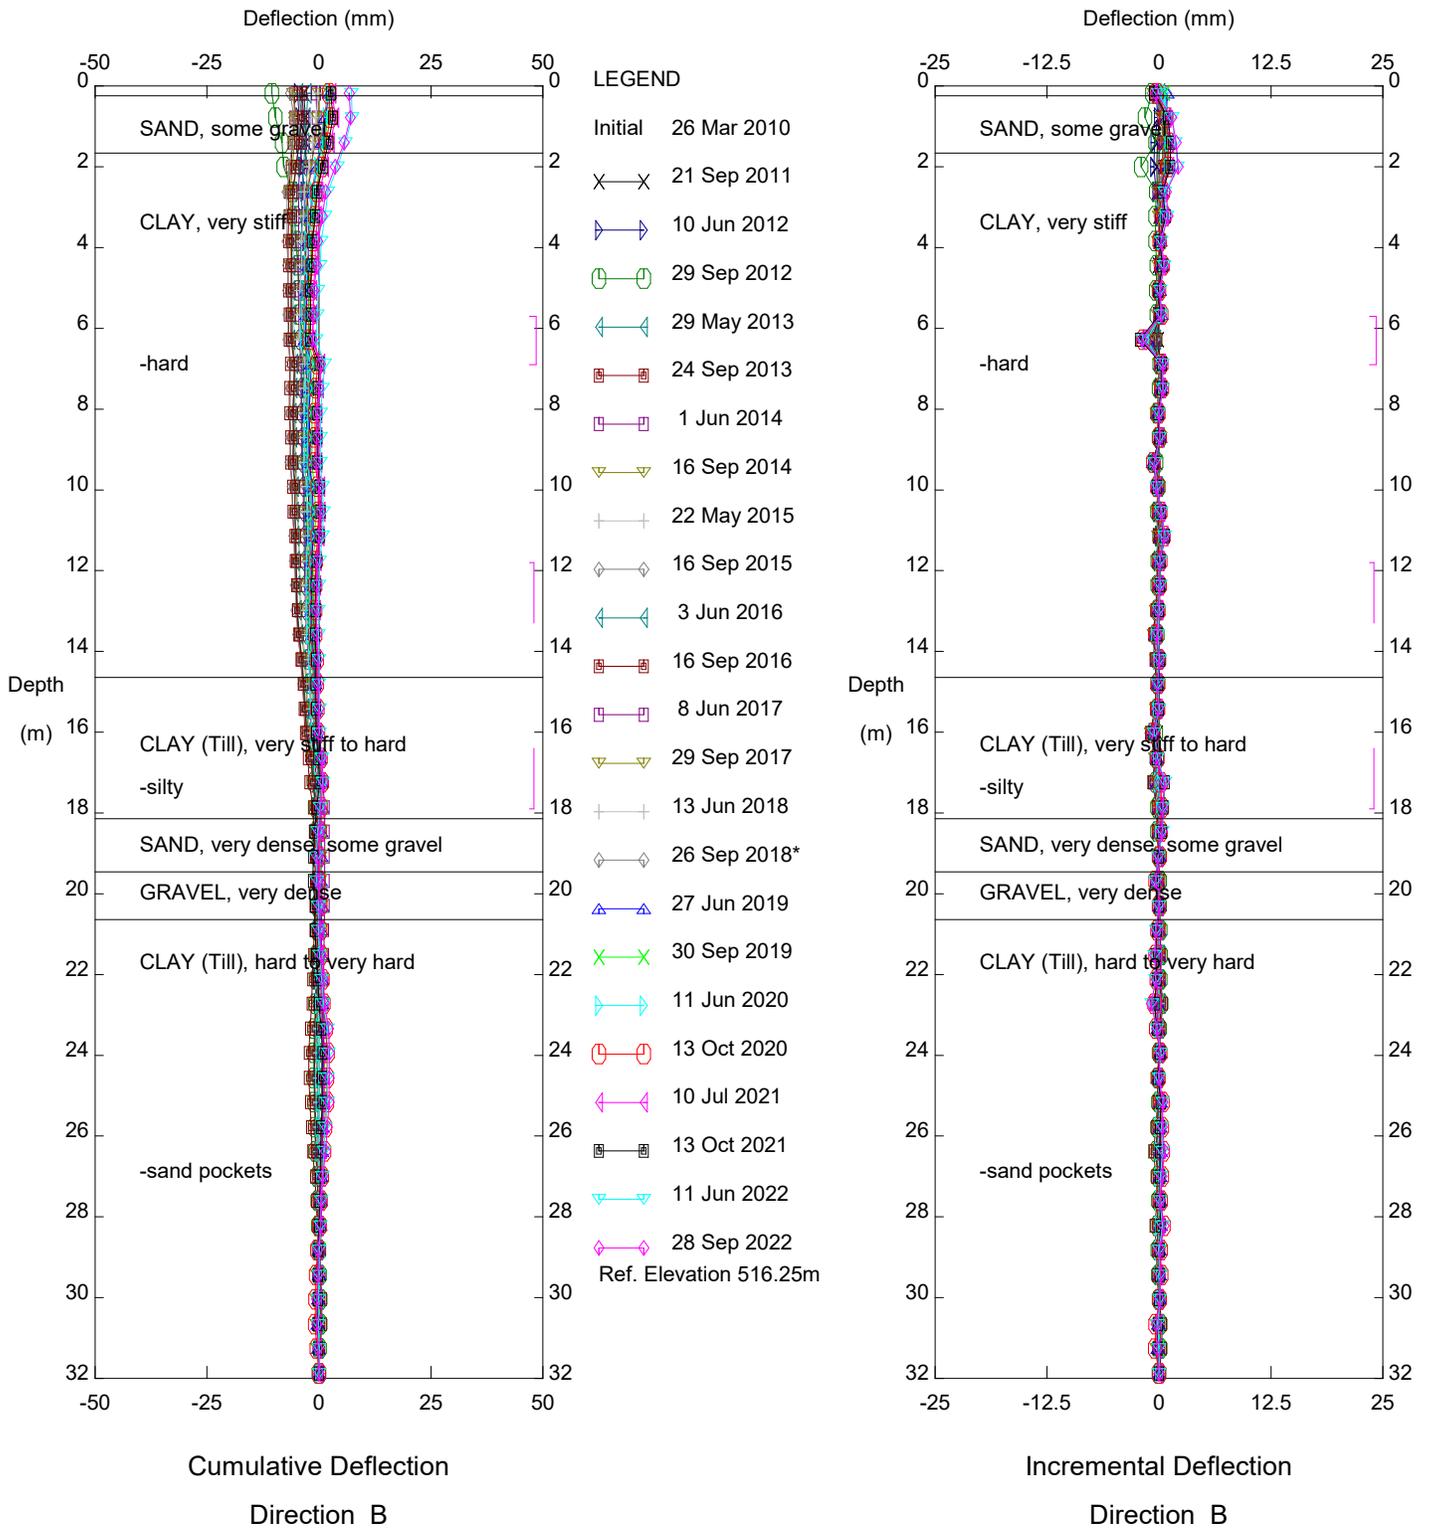
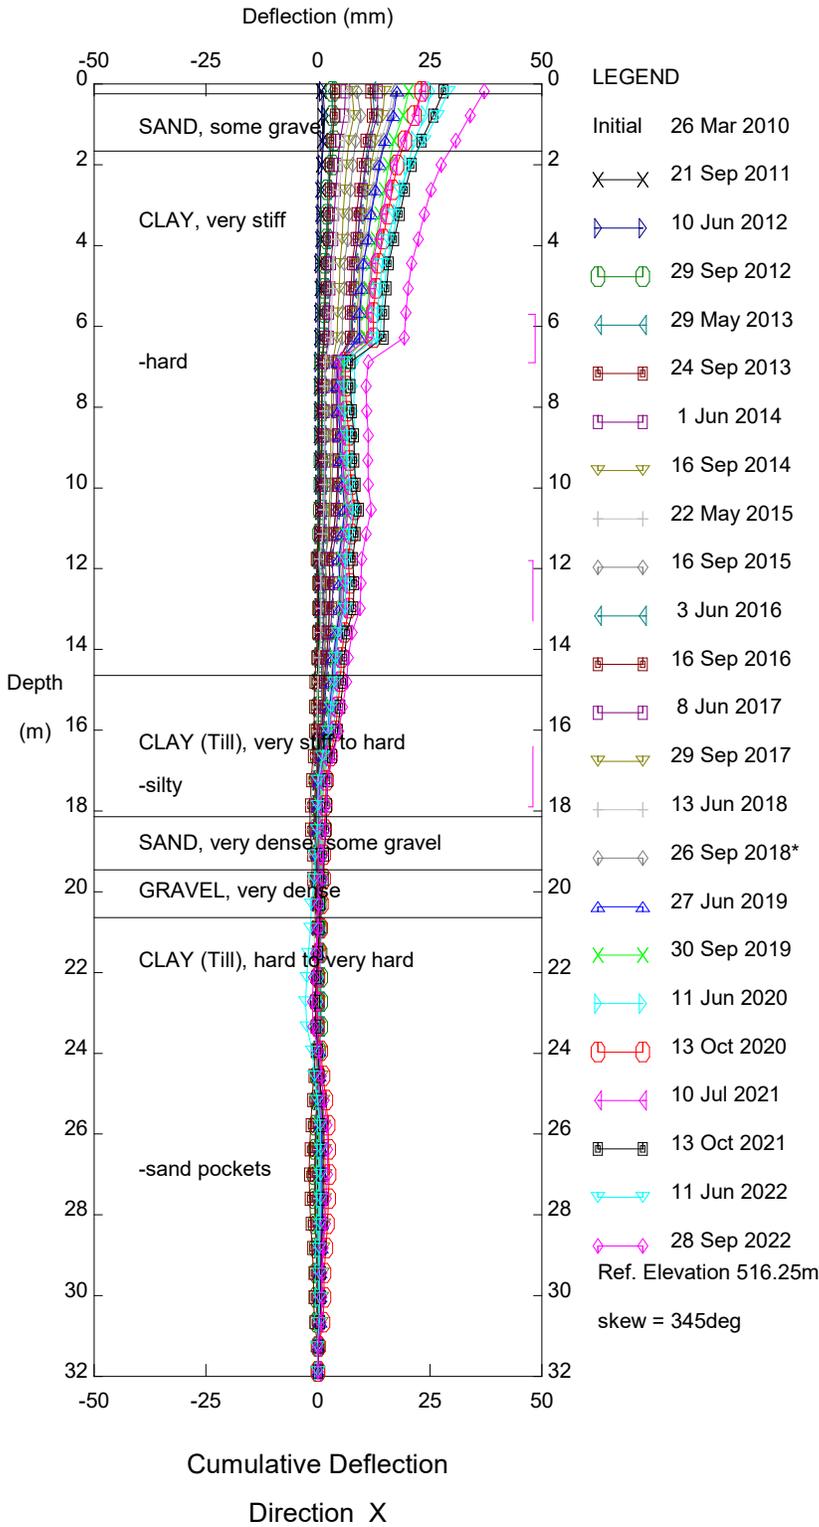
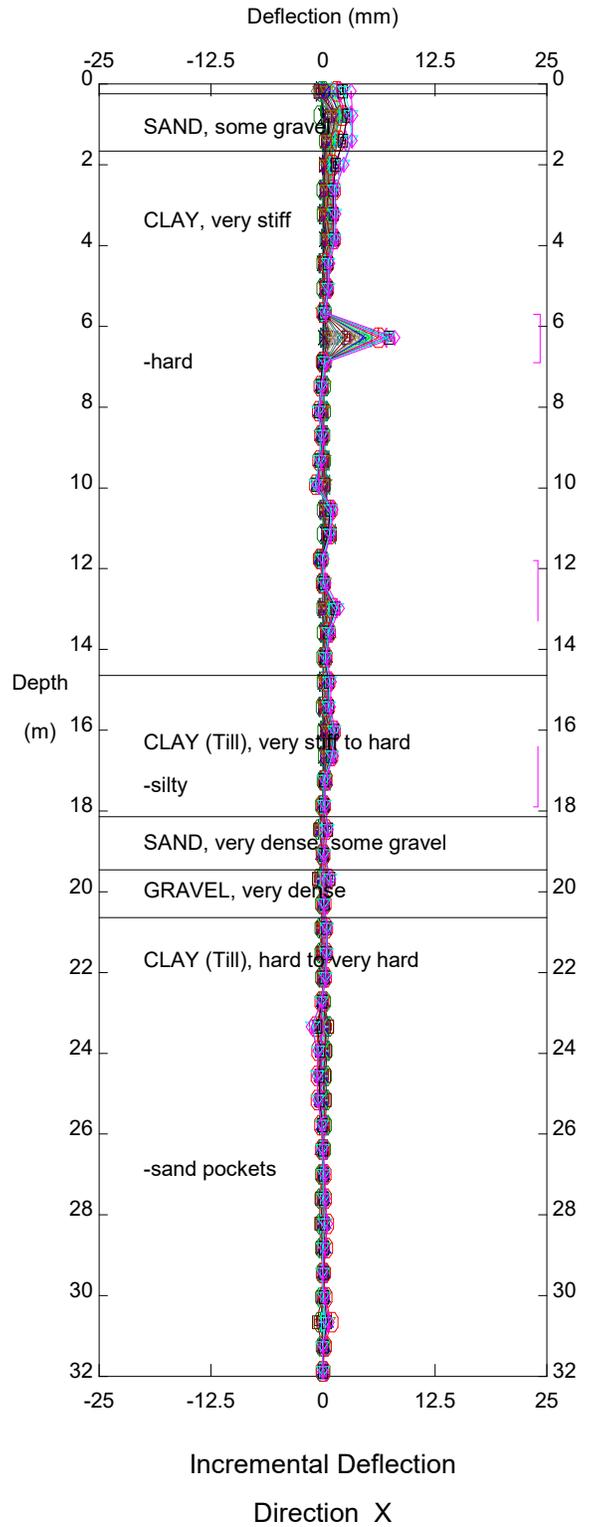
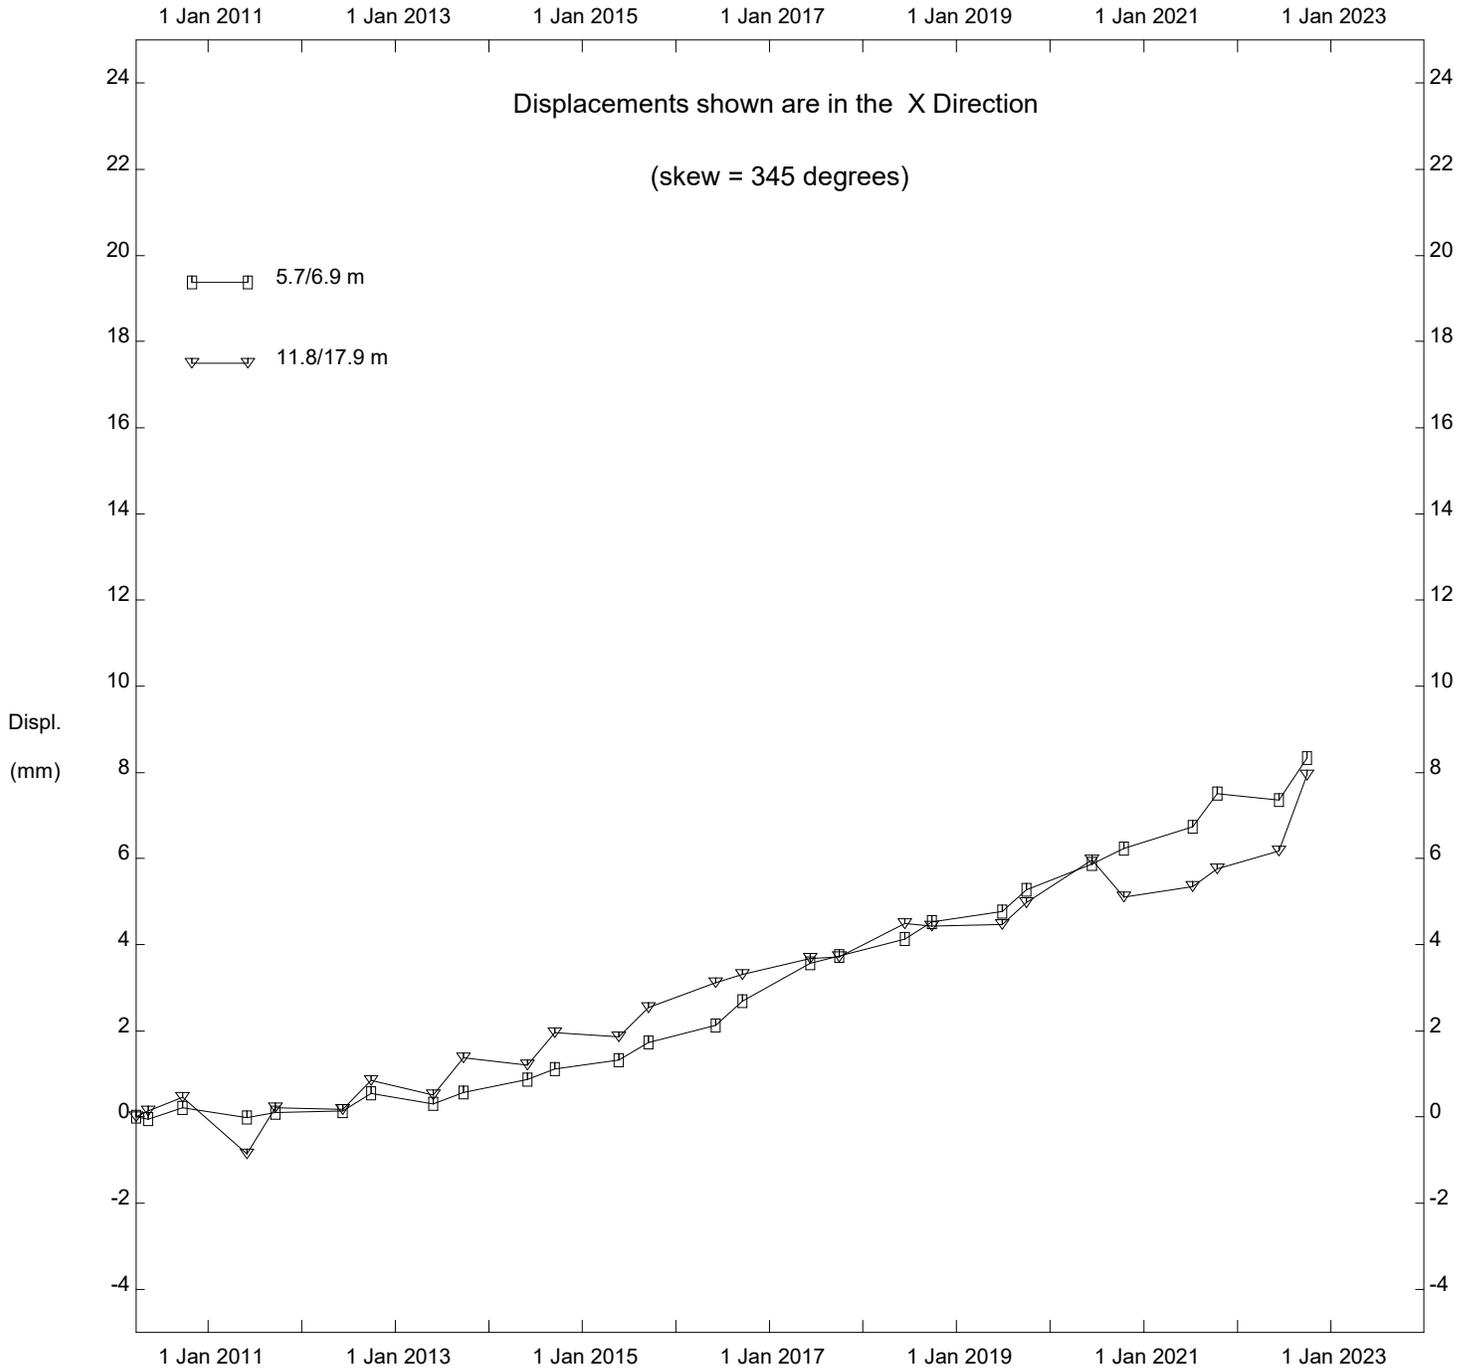
PH031 Judah Hill Michelin Slide, Inclinator SI10-4

Slope inclinometer SI10-4 showed a rate of movement of 3.2 mm/yr over 5.7 m to 6.9 m depth and 5.9 mm/yr over 11.8 m to 17.9 m depth since the spring of 2022 readings. The movement is in the direction of the active landslide in the Heart River valley slope. SI10-7 showed rates of movement of 1.2 mm/yr, less than 0.1 mm/yr, and no discernible movement over 1.9 m to 6.8 m depth, 8.6 m to 9.8 m depth and 14.1 m to 15.9 m depth, respectively, since the spring of 2022 readings. SI10-9 showed no discernible movement over 6.5 m to 7.7 m depth and a rate of movement of 1.7 mm/yr over 11.9 m to 14.4 m depth, respectively, since the spring of 2022 readings.

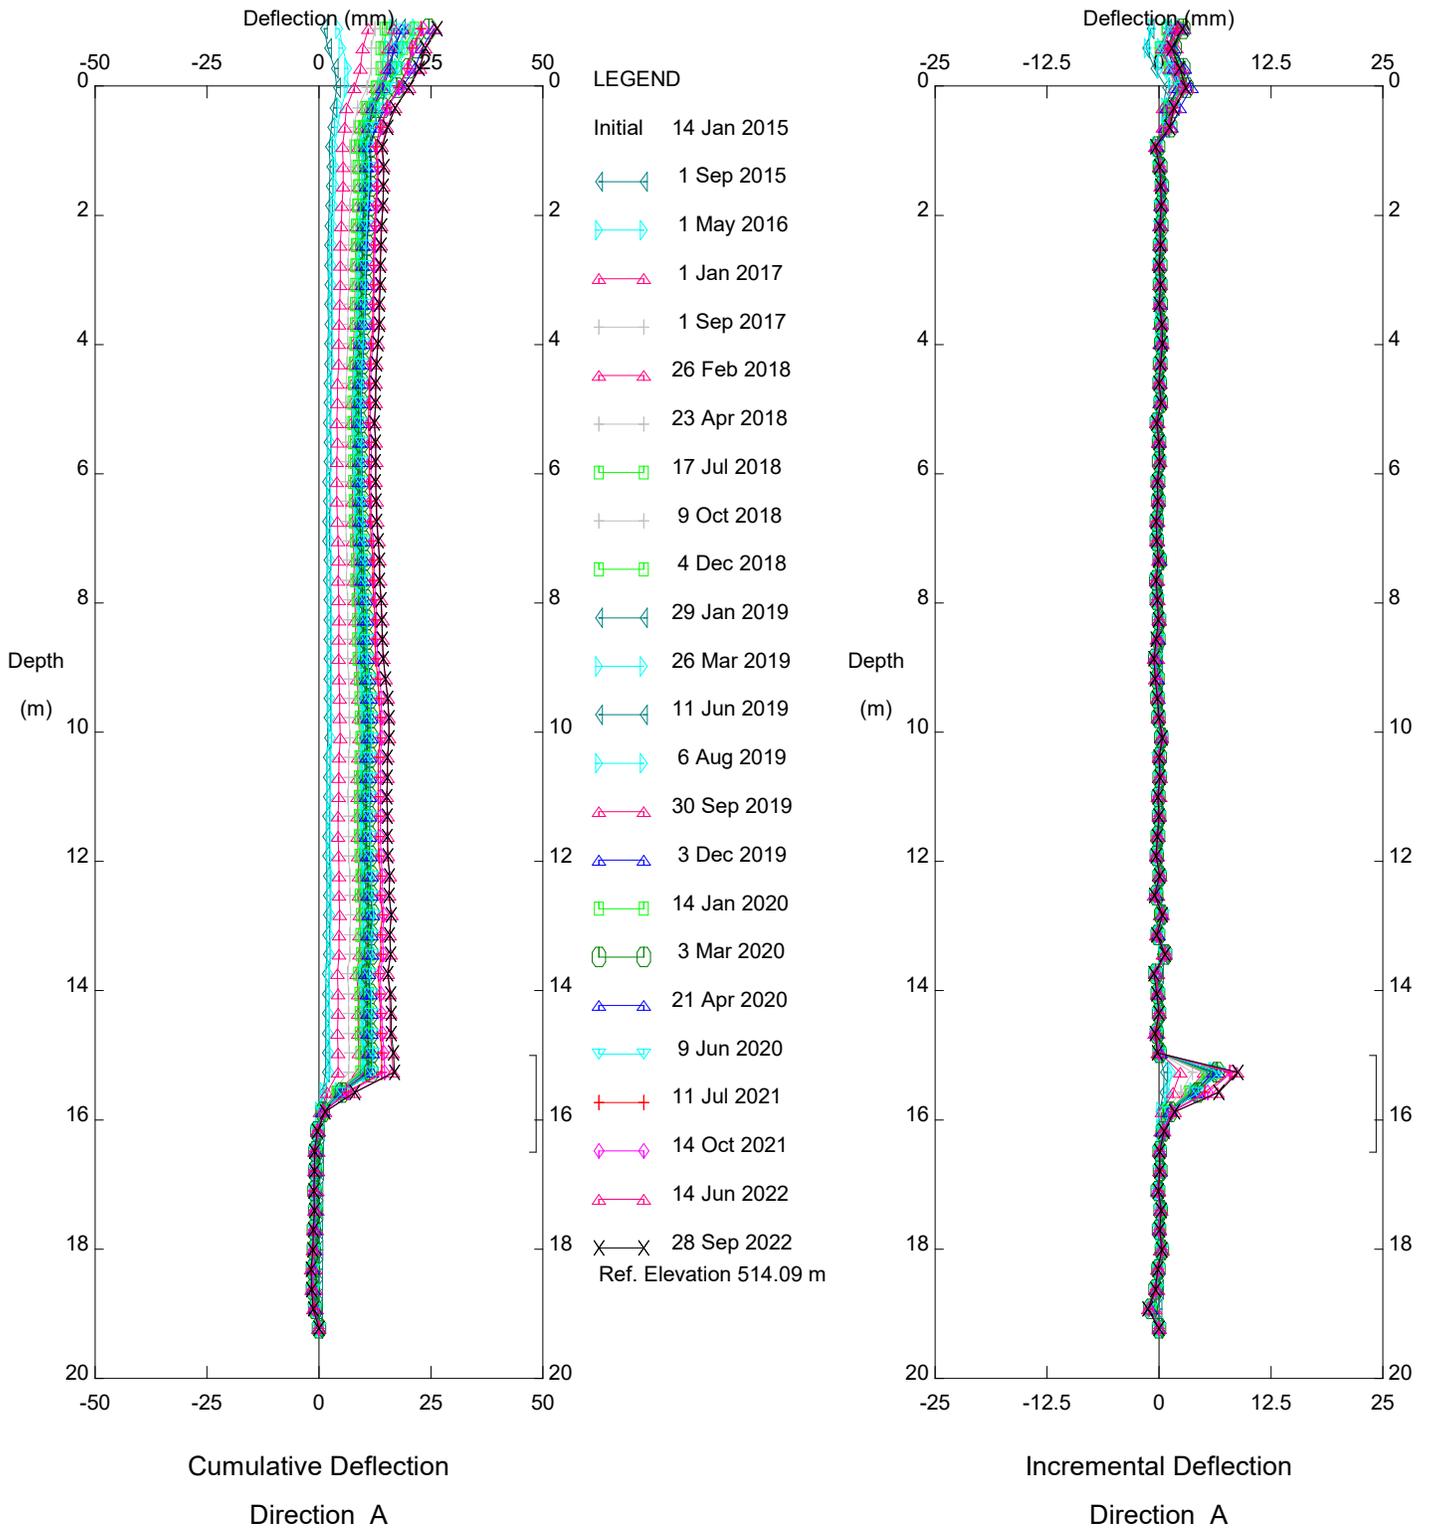
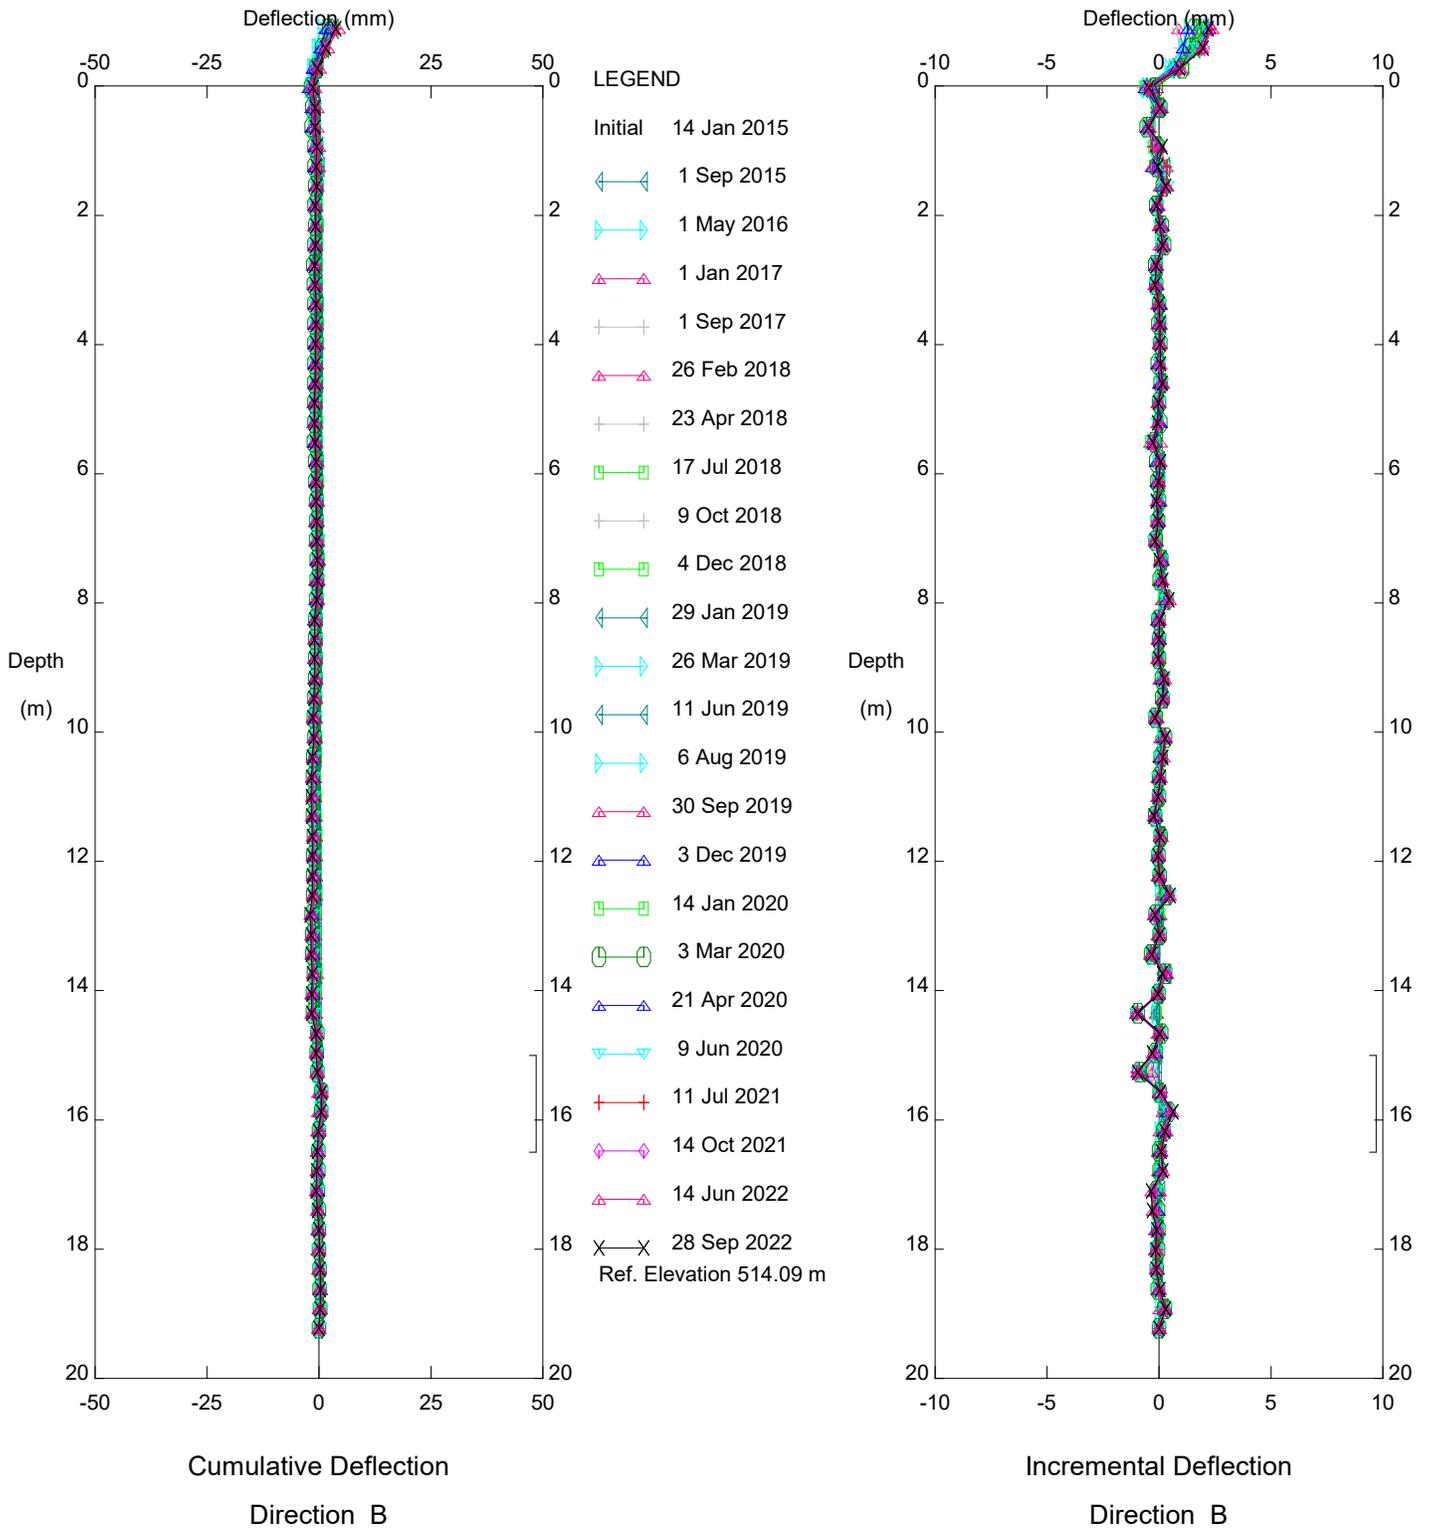
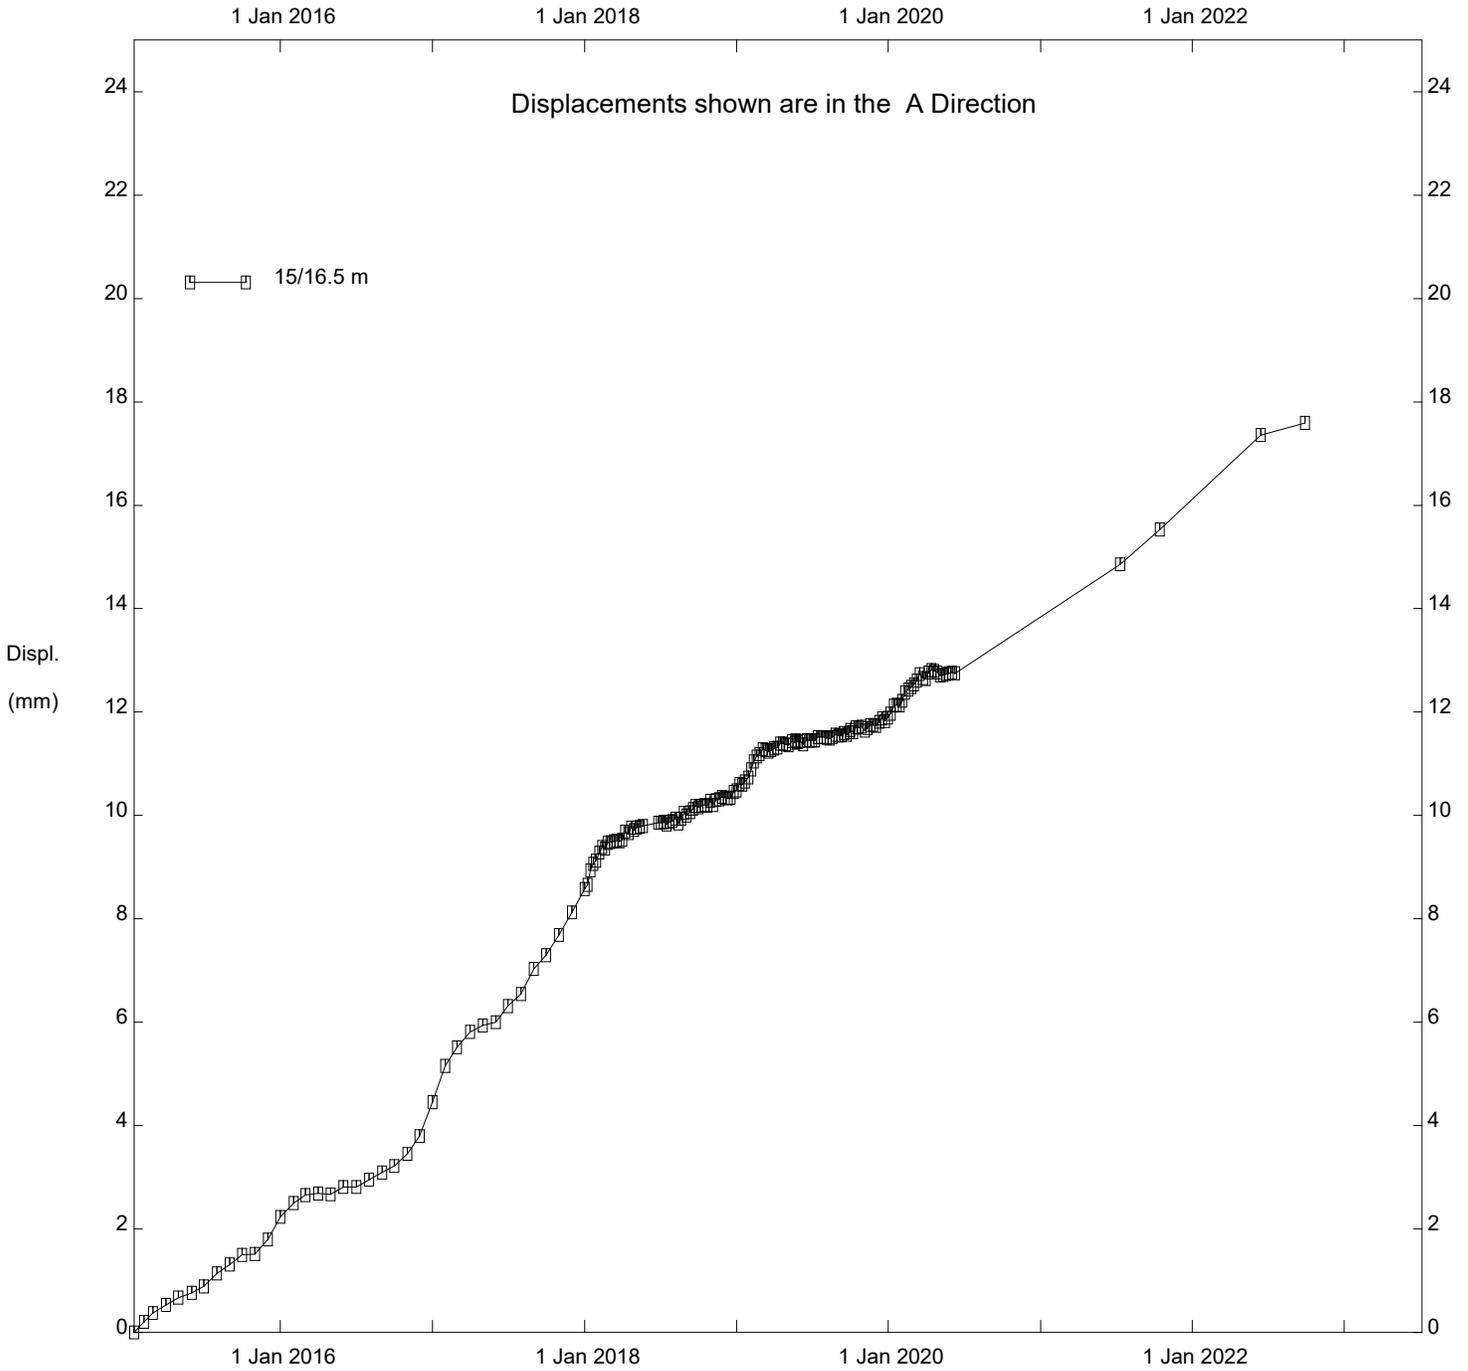
PH031 Judah Hill Michelin Slide, Inclinometer SAA10-8

The manual readings for SAA10-8 showed an incremental movement of 0.2 mm over 15.0 m to 16.5 m since the spring of 2022 readings, corresponding to an average rate of movement of 0.8 mm/yr over this zone. The overall trend of movement in the SAA seems to indicate that the average movement rate in the instrument has decelerated since the beginning of 2018, compared to the first three years of measurements.

The battery powering the SAA in SI10-8, VW17-1 VW17-2 and the datalogger for these instruments should be replaced so that continual readings can resume. The battery for this datalogger has been stolen twice, so a more secure enclosure and battery system should be

considered to prevent future thefts. In the meantime, manual readings should continue to be made from these instruments using a 12-volt battery.

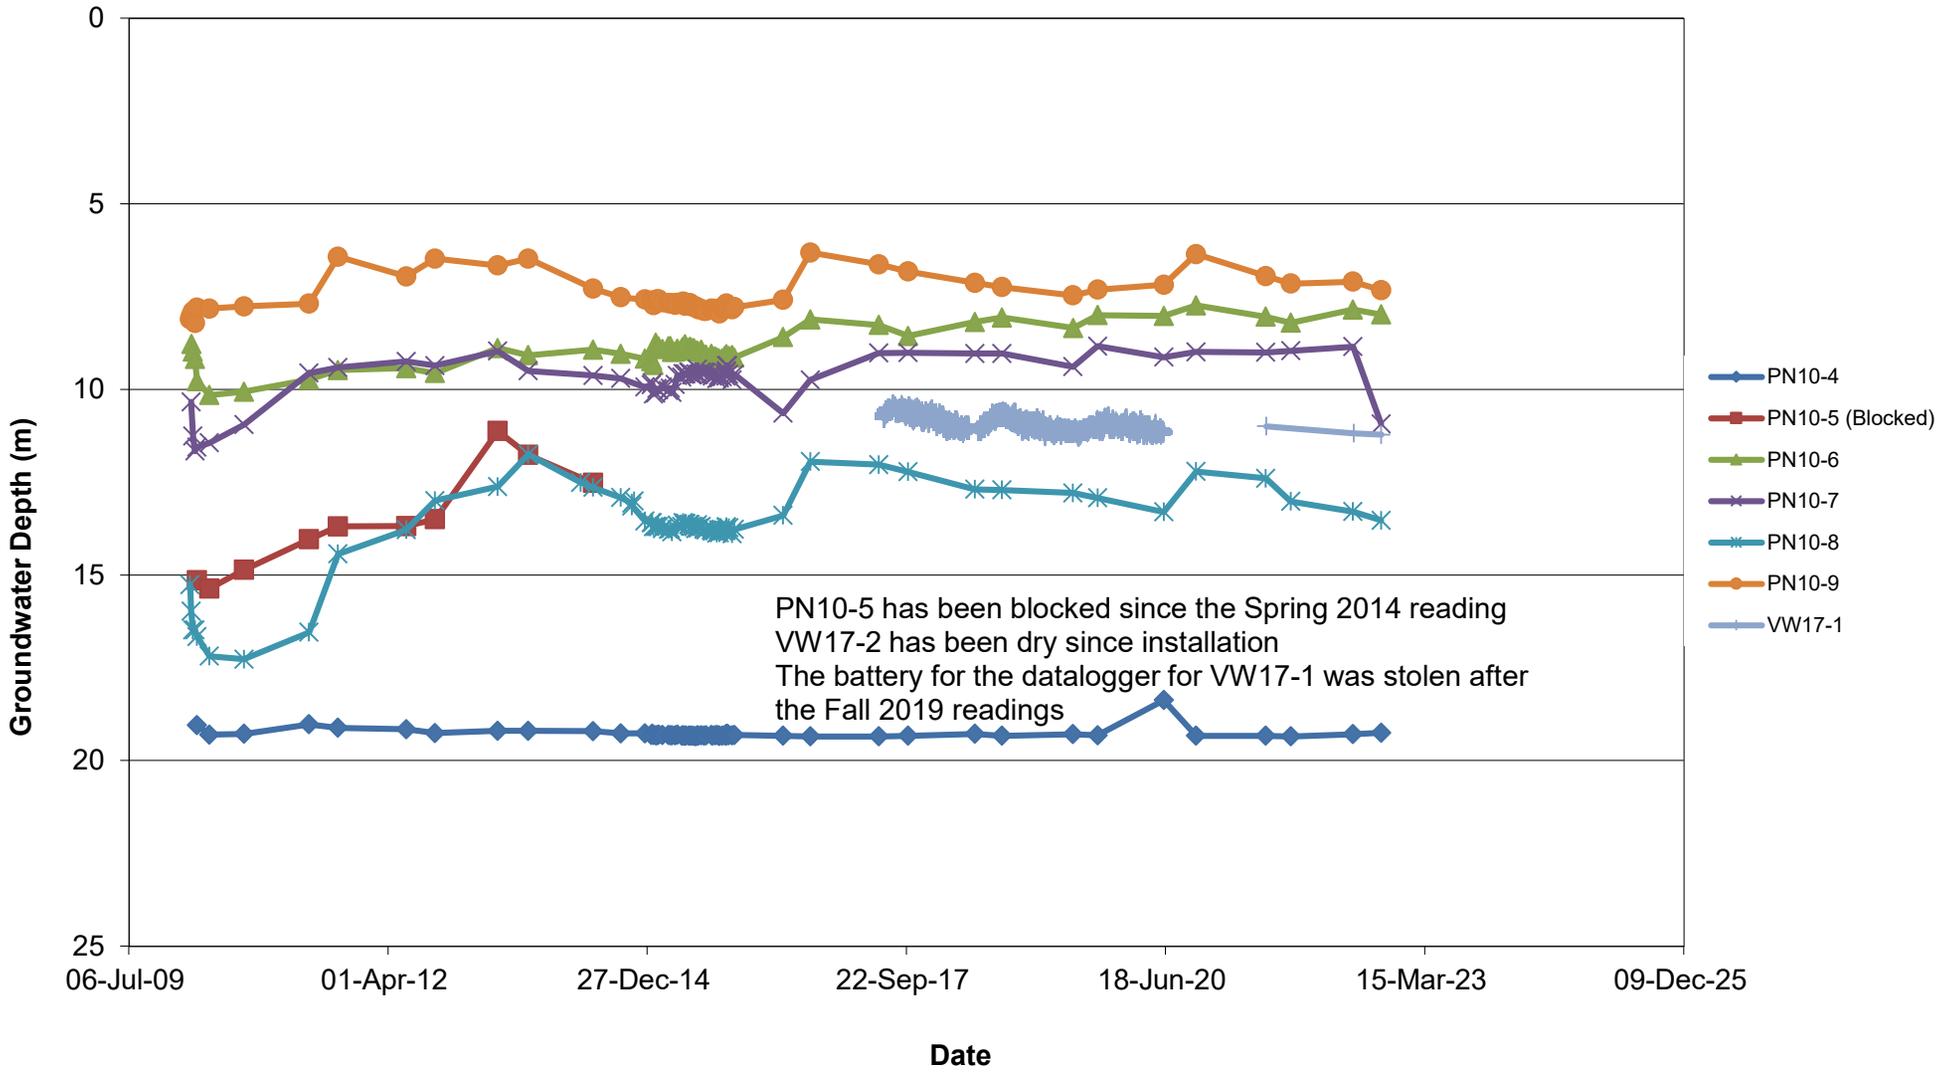
**FIGURE PH031-1
PIEZOMETRIC DEPTHS FOR HWY 744:04 JUDAH HILL (MICHELIN SLIDE)**

Pneumatic piezometers PN10-4 showed an increase in groundwater level of 0.04 m since the spring of 2022 readings. Pneumatic piezometers PN10-6, PN10-7, PN10-8, and PN10-9 showed decreases in groundwater level of 0.14 m, 2.08 m, 0.23 m, and 0.22 m, respectively, since the spring of 2022 readings. Vibrating wire piezometer VW17-1 showed a decrease in groundwater level of 0.04 m since the spring of 2022 readings. Pneumatic piezometer readings are summarized in Table PH031-2.

The groundwater readings in the piezometers are plotted by depth and elevation in Figures PH031-1 and PH031-2, respectively, in Appendix A.
