**ALBERTA TRANSPORTATION  
GEOHAZARD ASSESSMENT PROGRAM  
PEACE REGION – PEACE-HIGH LEVEL  
2020 INSPECTION**

<b>Site Number</b>	<b>Location</b>	<b>Name</b>	<b>Hwy</b>	<b>km</b>
PH032	Judah Hill	Makeout Landslide	744:04	57.924
<b>Legal Description</b>		<b>UTM Co-ordinates</b>		
NE¼ 20-083-21 W5M		11U E 483171	N 6229947

**2020 PH032 INSPECTION PLAN**

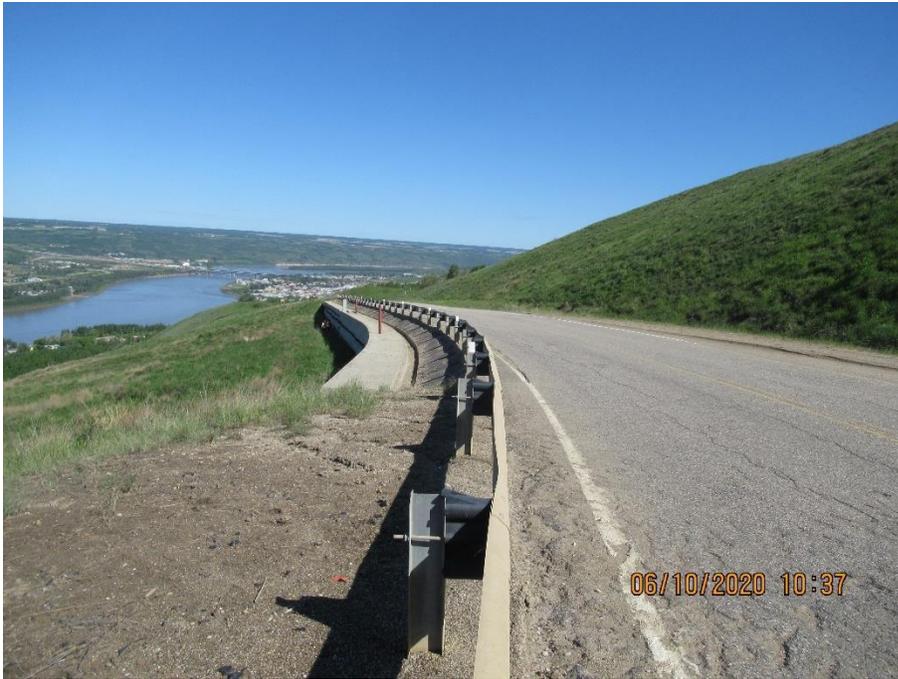
Observations:	Description	Worsened?
<input checked="" type="checkbox"/> Pavement Distress	Several cracks were observed in the ACP in 2013 (See Photos 1 and 9) prior to the construction of the km 58 and Makeout pile walls and have not changed since the previous inspection. A minor dip was observed in the SBL shoulder above the middle of the Makeout pile wall (km 58.15).	<input type="checkbox"/>
<input checked="" type="checkbox"/> Slope Movement	<p>The old landslide scarps below the pile wall that were regraded in 2015 have ongoing movement and most of the piles from the old wall are now exposed with the highest drop at 2.0 m from the top of the exposed piles (Photo 4). No major changes were observed immediately below either pile wall (Photos 2, 3, 4 and 10).</p> <p>Lower slide area below the 2015 Makeout slide bowl repair is active and has ongoing movement and retrogression of the scarps within the lower portion of the slope (Photo 6).</p>	<input checked="" type="checkbox"/>

**Photo 1.**  
Looking northwest from the SBL shoulder of Hwy 744:04 at km 57.96 along the guardrail above the km 58 pile wall. There has been no major changes in the cracks in the ACP since 2019.

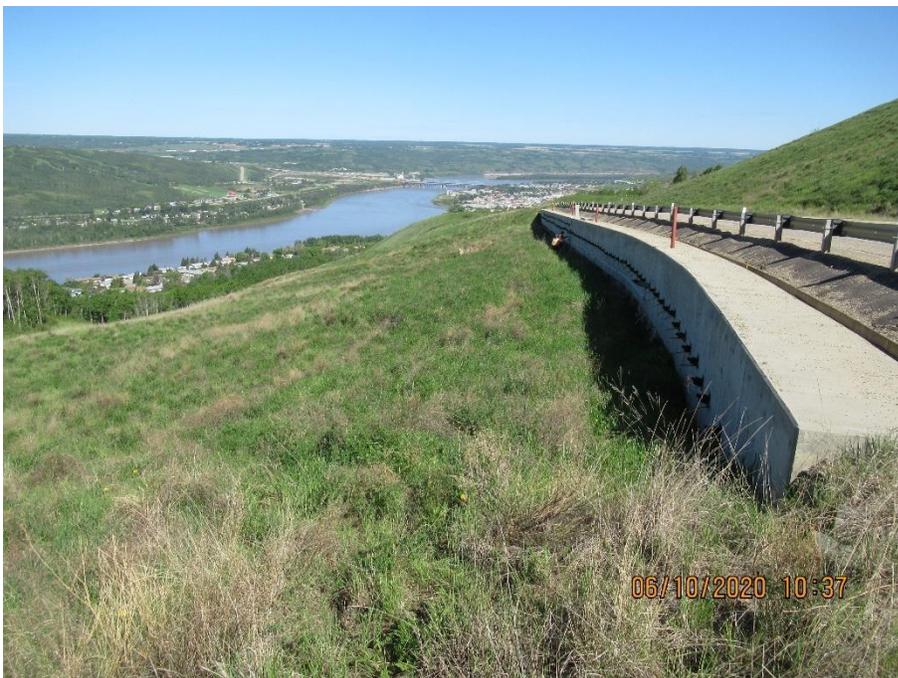
**Photo 2.**  
Looking northwest from the south end of the km 58 pile wall. The ACP shoulder protective cover was in good condition. No significant changes were noted downslope of the wall at this side relative to the 2019 condition.

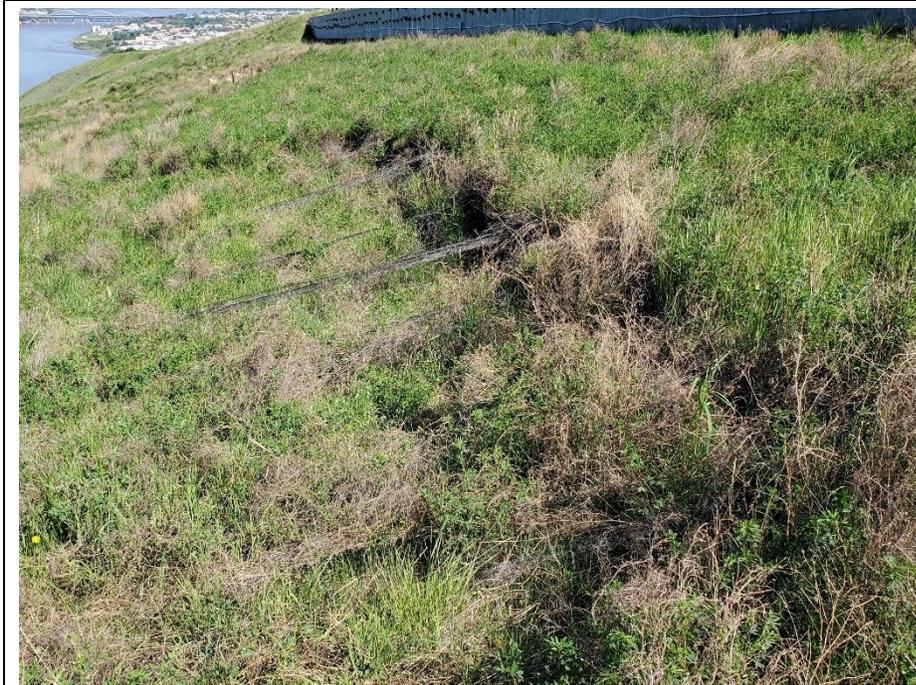
**Photo 3.**  
Looking northwest at a scarp in the bench below the south end of the wall with approximately 1.5 m maximum drop. Area is well vegetated has had only minor movement with no significant expansion since 2019.

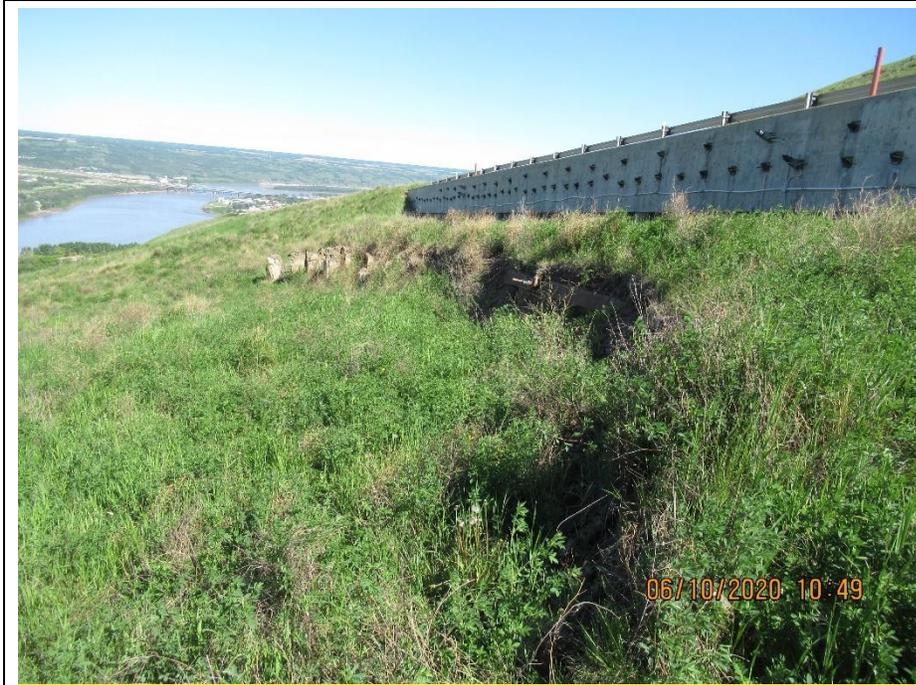
**Photo 4.**  
Looking north from below the north end of the km 58 pile wall. The old landslide scarps below the pile wall that were regraded in 2015 have ongoing movement and most of the piles from the old wall are now exposed with the highest drop at 2.0 m from the top of the exposed piles. No change from 2019.

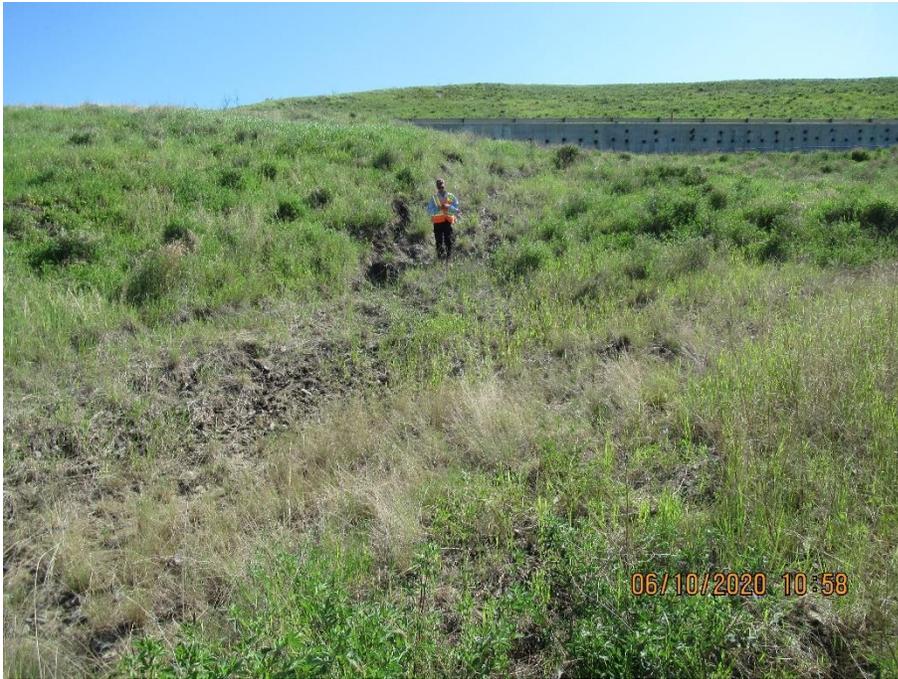
**Photo 5.**  
View upslope towards an active seepage and erosion area approximately 40 m downslope from the north end of the pile wall and disconnected drain pipe further upslope.

<table><tr> <th data-bbox="240 1398 1234 1430" style="text-align: left;"><b>Recommendations:</b></th> <th data-bbox="1250 1398 1433 1430" style="text-align: left;"><b>Cost</b></th> </tr><tr> <td data-bbox="240 1692 1234 1829">Some further drainage efforts might be required at the wet area as a future maintenance item as history has shown that persistent seepage can lead to significant slide movements. The disconnected drain pipe below the north end of the km 58 pile wall should be reconnected to help prevent further retrogression of the landslide scarp that has formed below it.</td> <td data-bbox="1250 1692 1433 1829">Maintenance</td> </tr></table>

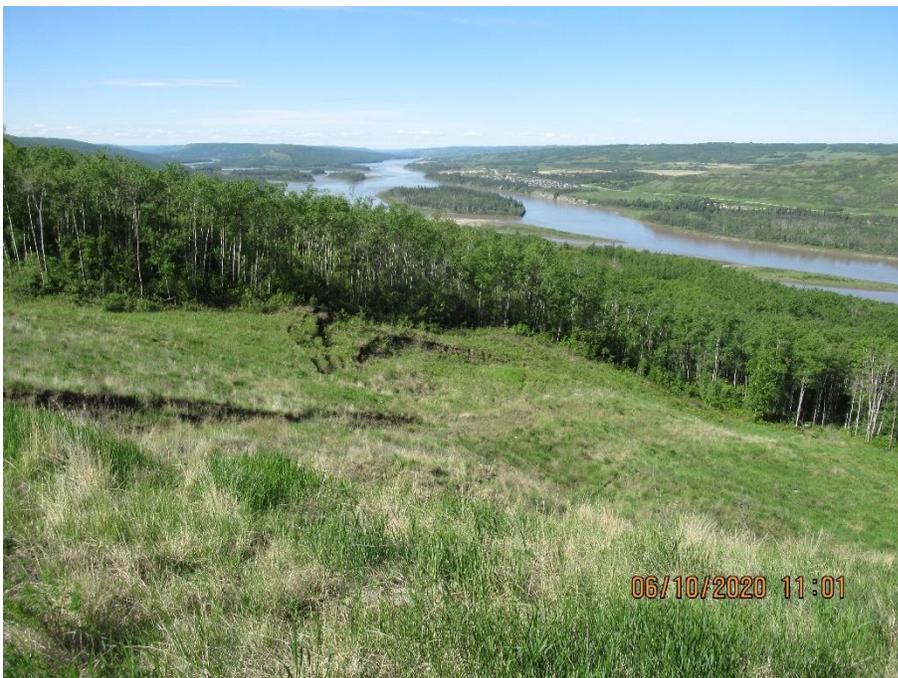
**Photo 6.**  
Looking west at the lower slide area between the pile walls. Area has ongoing movement and retrogression of the scarps especially within the lower portion of the slope. Expanded cracking and backscarps have further dropdown relative to the 2019 condition.

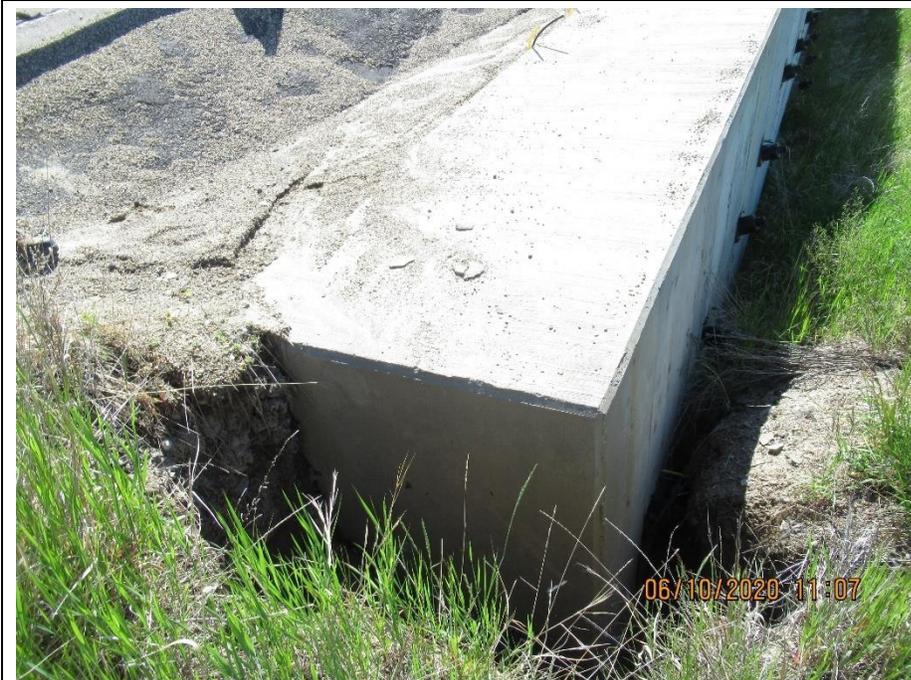
<input checked="" type="checkbox"/> Erosion	<p>Both ends of the km 58 pile wall have become eroded by runoff water and water overtopping the outlet of the pile wall due to blockage of the drain trough with sediment buildup (Photos 7 and 8). Scour at the north end of the wall has increased in size and was 2 m deep and 0.7 m wide.</p> <p>The solid HDPE outlet drain pipe for the clay backfilled area became disconnected from the perforated CSP drain pipe at the base in 2018 and erosion damage is ongoing (Photo 5).</p>	<input checked="" type="checkbox"/>
<input type="checkbox"/> Seepage		<input type="checkbox"/>
<input type="checkbox"/> Bridge/Culvert Distress		<input type="checkbox"/>
<input checked="" type="checkbox"/> Other	No change observed in the ACP shoulder protective cover at either pile walls (Photos 2 and 11).	<input type="checkbox"/>
<b>Instrumentation:</b>		
<b>Makeout Pile Wall</b>		
SI-PM12 and SI-PM24	<p>Two slope inclinometers were installed in retaining wall piles during construction. SI-PM12 has shown no incremental movement since Fall 2019. Since construction total cumulative deflection is 1 mm in the upslope direction over the length of the pile and 3 mm in the upslope direction over the combined length of the pile and waler.</p> <p>SI-PM24 has shown no incremental movement since Fall 2019. Since construction total cumulative deflection is 3 mm in the upslope direction over the length of the pile and 4 mm in the upslope direction over the combined length of the pile and waler.</p>

**Photo 8.**  
Increase soil loss around the north end of the km 58 pile wall due to drain trough overflow from being plugged with sediment. Scour hole has expanded and was approximately 2 m deep and 0.7 m wide.

<table><tr> <th data-bbox="240 1398 1234 1430" style="text-align: left;"><b>Recommendations:</b></th> <th data-bbox="1250 1398 1433 1430" style="text-align: left;"><b>Cost</b></th> </tr><tr> <td data-bbox="240 1566 1234 1661">The pile wall surface drainage gutters will require to be regularly cleaned in order to continue to provide erosion protection for the partially buried pile wall and avoid clogging of its solid down drain pipes.</td> <td data-bbox="1250 1566 1433 1661">Maintenance</td> </tr></table>

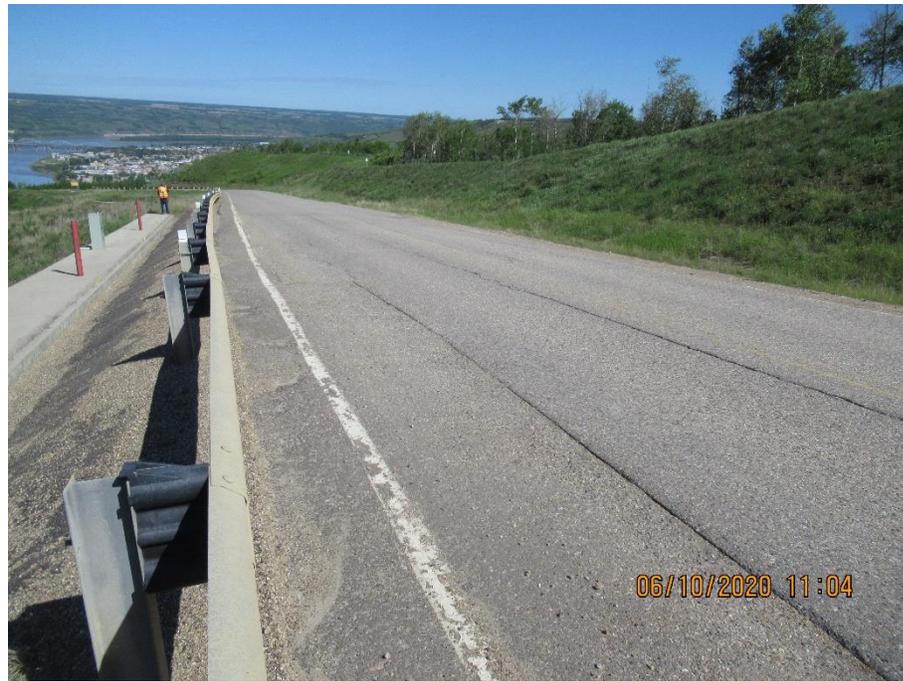
**Photo 9.**  
Looking northwest at the highway above the “Makeout” pile wall. A dip was noted around the SBL shoulder near the middle of the wall but otherwise ACP condition was unchanged from the 2019 condition.

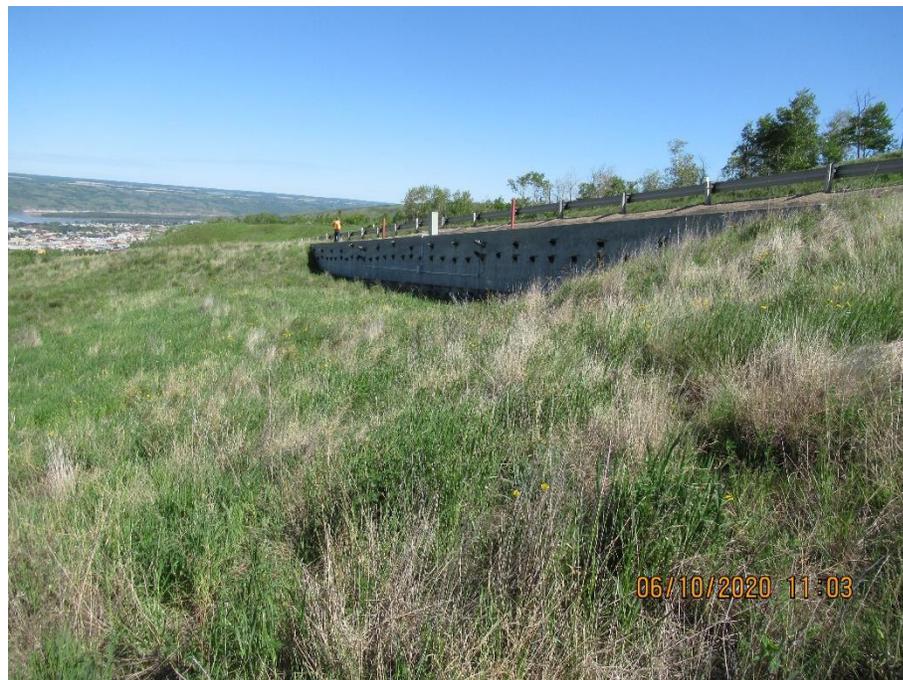
**Photo 10.**  
Looking north at the bench and graded area below the “Makeout” pile wall. Area appeared in good condition and had no observable changes from 2019.

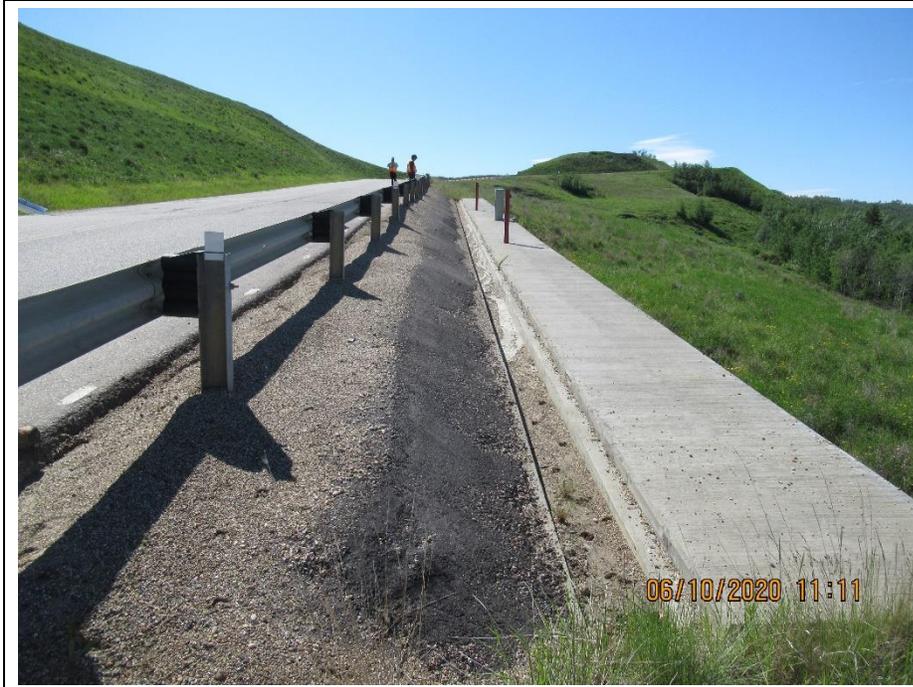
**Photo 11.**  
Looking south along the top of the “Makeout” pile wall. ACP shoulder protective cover was in good condition. Previous ridge of sediment building beneath the guardrail was removed/washed away. Drainage trough was relatively clear and functioning.
