**ALBERTA TRANSPORTATION
GEOHAZARD ASSESSMENT PROGRAM
PEACE REGION (PEACE RIVER DISTRICT)
2021 INSPECTION**

| Site Number | Location | Name | Hwy | km |
|---|---|---|---|---|
| PH043A | Daishowa East Hill | Site A - Pile Wall | 986:01 | 33.45 |

| PH043B | Daishowa East Hill | Site B | 986:01 | 33.74 |

**DAISHOWA
HWY 986:01 (PH043)
LOCATION PLAN**

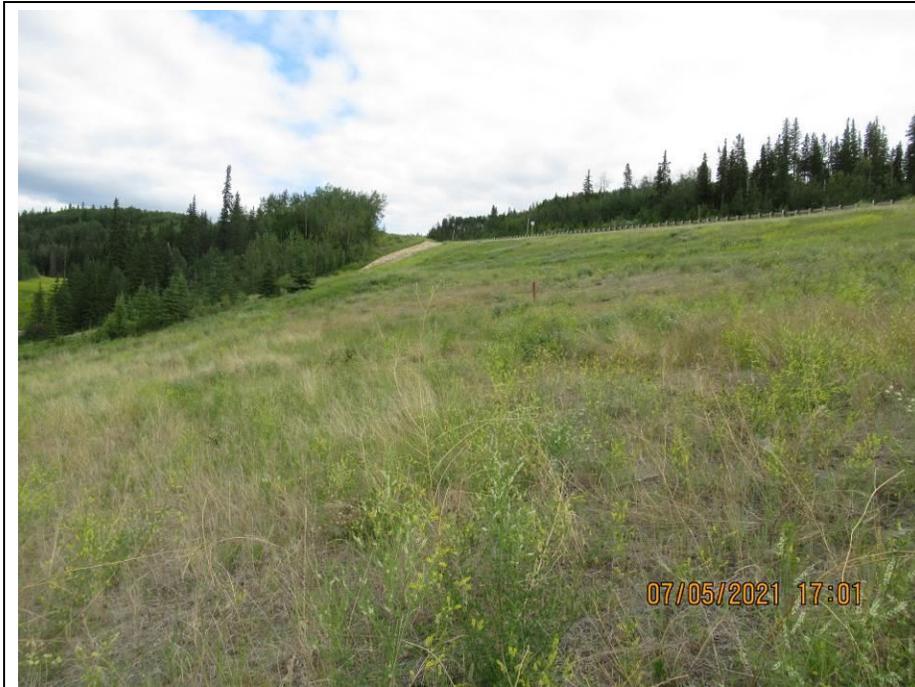
| <input checked="" type="checkbox"/> Slope Movement | <p>During mitigation work a slide was initiated within the lower slope near the new drop structure that was mitigated via a driven steel pile wall (Photo 43-03). There is shallow slide activity with minor retrogression and expansion at the west end of the older buried tangent pile wall on the upper embankment (Photo 43-02). Previous cracking further east from this area have been graded during the mitigation work (Photo 43-01 and 43-04). No evidence of slope movement was observed upslope of the buried pile wall (Photo 43-01).</p> | <input checked="" type="checkbox"/> |

Photo 43-01.
At the west edge of Site A looking east towards the buried tangent pile wall. Slope shaping and straw matting was installed within this portion of the slope due to slide movement and access disturbance for the culvert repairs. No change from 2020.

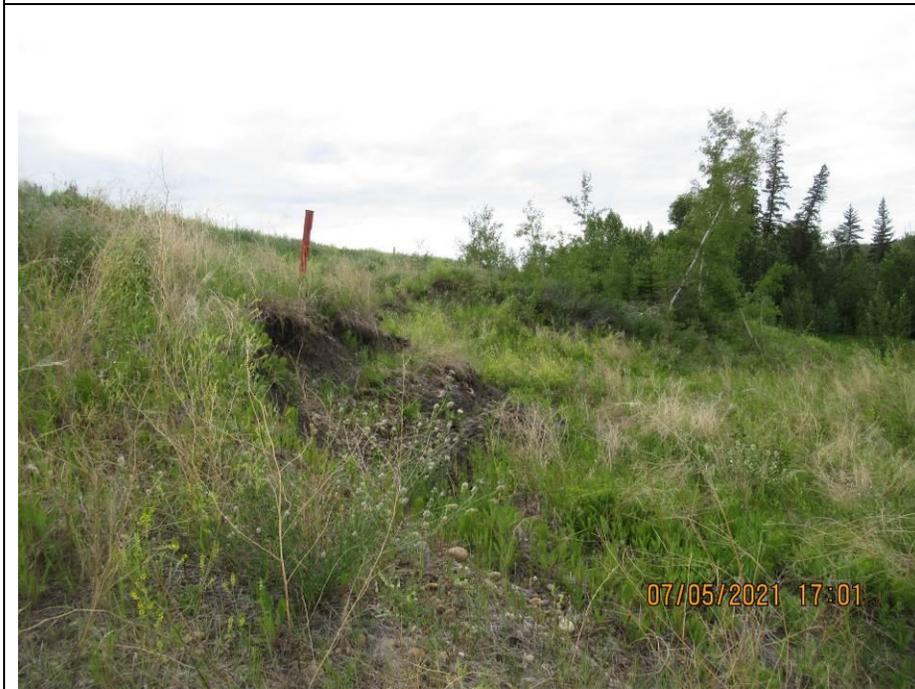
Photo 43-02.
Main slide scarp of active shallow failure downslope of the buried pile wall (33+325) first observed in 2017. Area is vegetated and has shown only minor retrogression and expansion since the previous inspection.

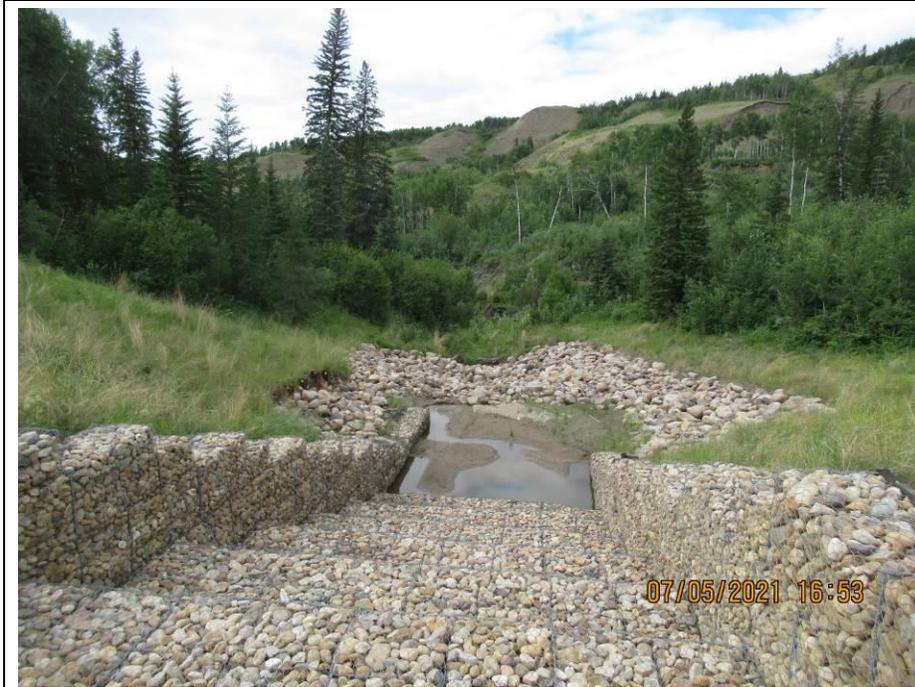
| <input checked="" type="checkbox"/> Erosion | Erosion rills observed at the steel pile wall (Photo 43-03). Vegetation is much more established relative to the 2020 inspection. At the culvert inlet (km 33+500) the south channel bank had worse erosion and additional riprap had fallen away. (Photo 43-06). The swale riprap at the east end of Site A had been washed out (1.7 m wide, 0.8 m deep) and an erosion gully had formed likely the result of a high flow event. (Photo 43-13) | <input checked="" type="checkbox"/> |
| <input checked="" type="checkbox"/> Bridge/Culvert Distress | Gabion drop structure had some additional silt buildup at the base (Photo 43-03). Silt buildup at the culvert inlet (Photo 43-06). | <input checked="" type="checkbox"/> |

Photo 43-03. Overflow gabion drop structure and dissipation bowl at the previous culvert outlet that had extensive erosion and gully erosion below Site A (33+430). Some rill erosion was noted within the fill areas that were still vegetating. Base of drop structure had a large amount of silt buildup. Minor change from 2020 condition.

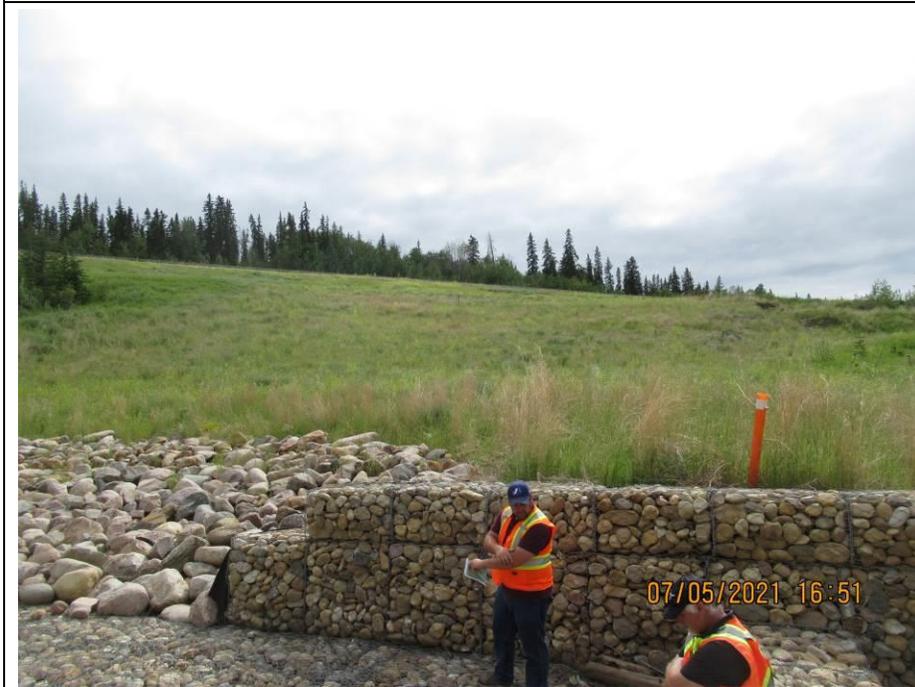
Photo 43-04. Looking southwest at the area of previous slumping associated with culvert erosion below pile wall (33+430). Area has since been graded and finished with straw matting.

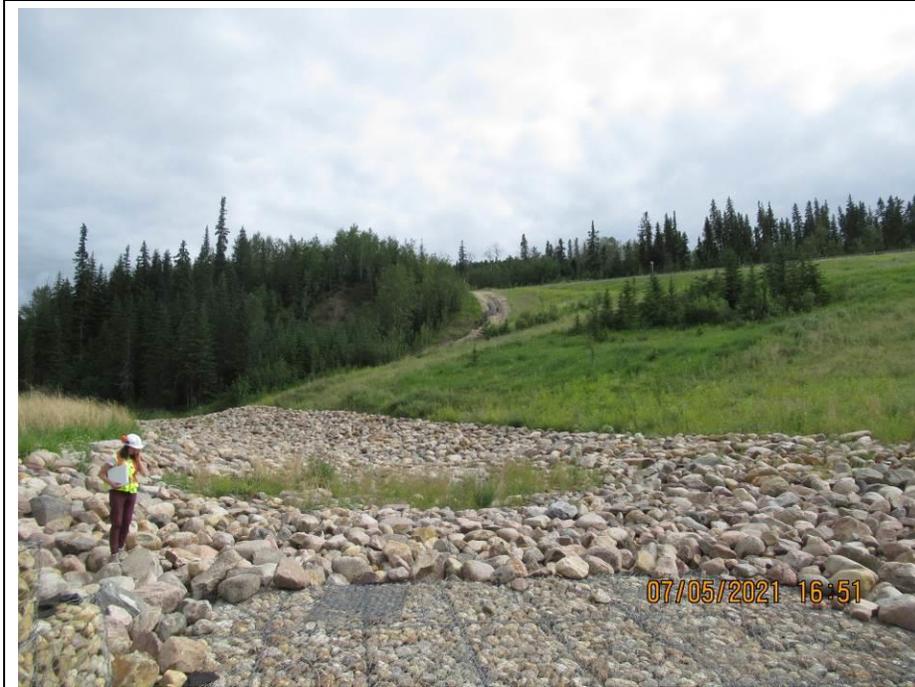
Photo 43-05.
 Standing at the top of the gabion drop structure looking east towards the overflow channel riprap (33+450). Vegetation has re-established.

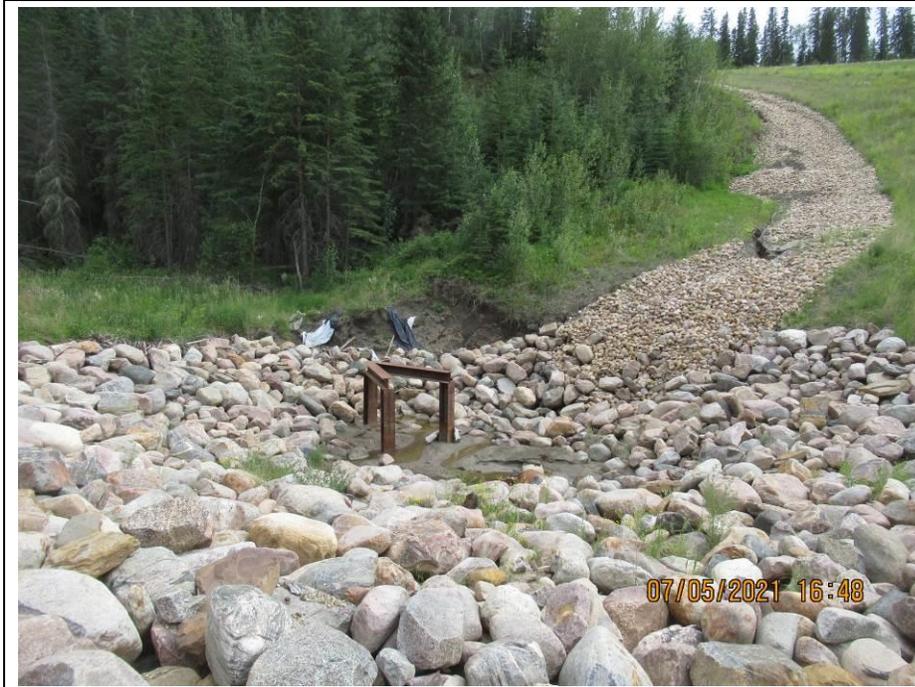
Photo 43-06.
 Looking south towards the culvert inlet riprap, riprap swale, and debris deflector (33+500). Note south channel bank erosion, silt buildup and erosion within the riprap swale. Worse from the 2020 condition.

Sediment buildup at the culvert should be monitored and cleaned out as required.

Maintenance work required at the culvert inlet, swale riprap south channel bank requires shaping and additional riprap placement. \$ 30,000

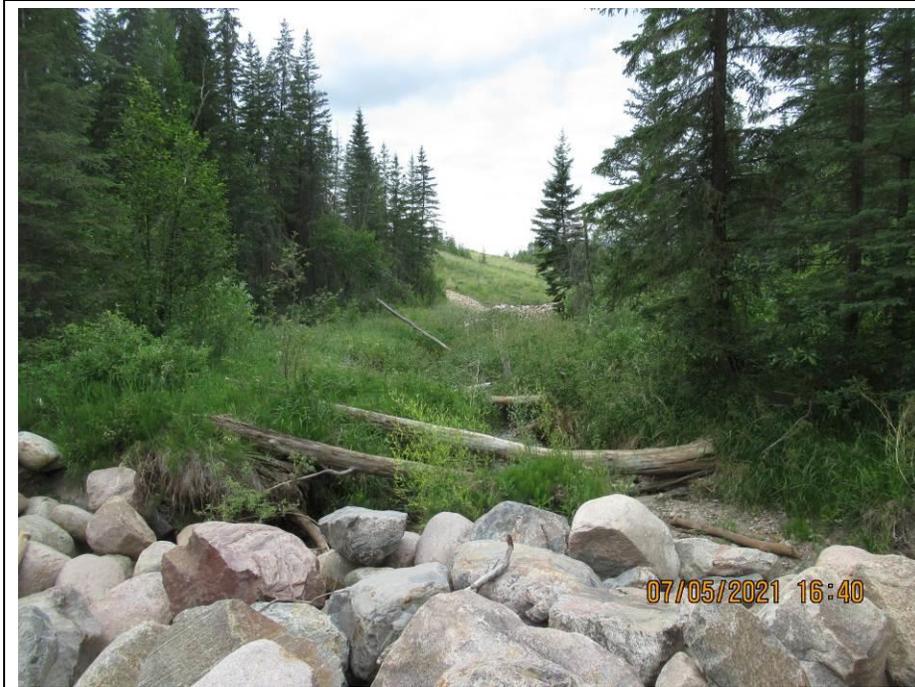
| <input checked="" type="checkbox"/> Other | No significant beaver activity noted at the creek between Sites A and B (Photo 43-07). | <input type="checkbox"/> |

Photo 43-07.
Looking west towards Site A at creek upstream of culvert inlet to Site A (33+500). No significant beaver dam construction was noted.

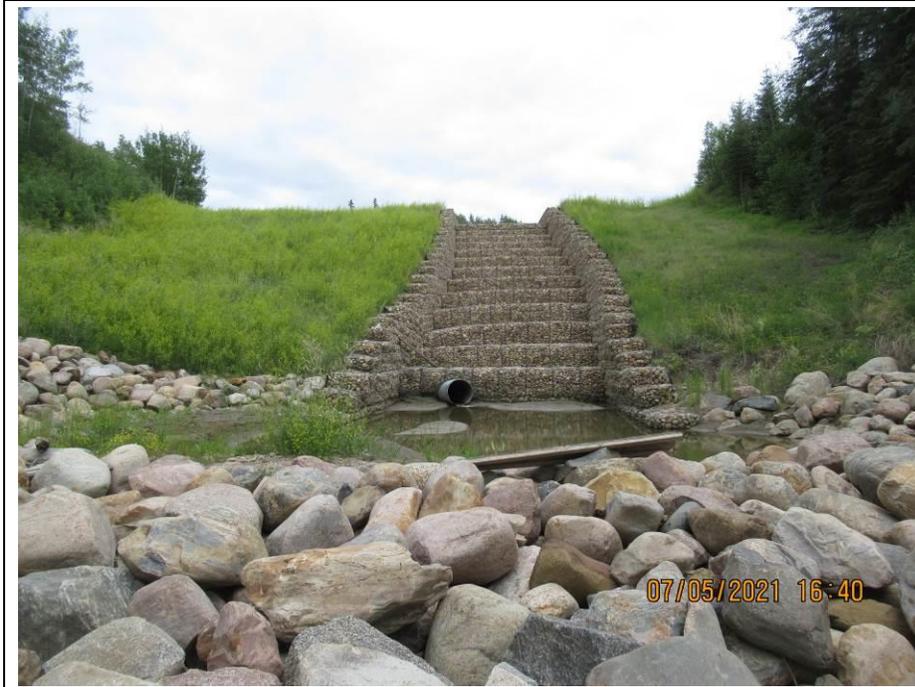
| | (Photo 43-19) Ongoing erosion was noted near the outlet of the CPP down pipe (33+800) due to a leaking joint caused by a local landslide movement (Photo 43-16). No new issues noted at armored swale, gabion drop structure or riprap berm (Photos 43-08 43-11, 43-18). | |
| <input checked="" type="checkbox"/> Bridge/Culvert Distress | Culvert inlet at 33+800 is still damaged from high flow event and has severely reduced flow capacity. Additional riprap above the inlet had collapsed above it and slid down partially burying it (Photo 43-15). The gabion baskets and mattresses in the bottom two steps of the drop structure have locally settled over the culvert alignment but don't show any significant change in condition since completing the grouting repairs in 2019 (Photo 43-08). | <input checked="" type="checkbox"/> |

Photo 43-08.
View of the gabion drop structure and riprap dissipation bowl at the culvert outlet at Site B. (33+600). Vegetation has established well and no apparent additional gabion deformation near the culvert sink hole (left side).

The outlet of the drop structure should be carefully cleared of excess ice and the outlet of the CSP steamed open in early Spring to reduce the risk of another sinkhole forming.

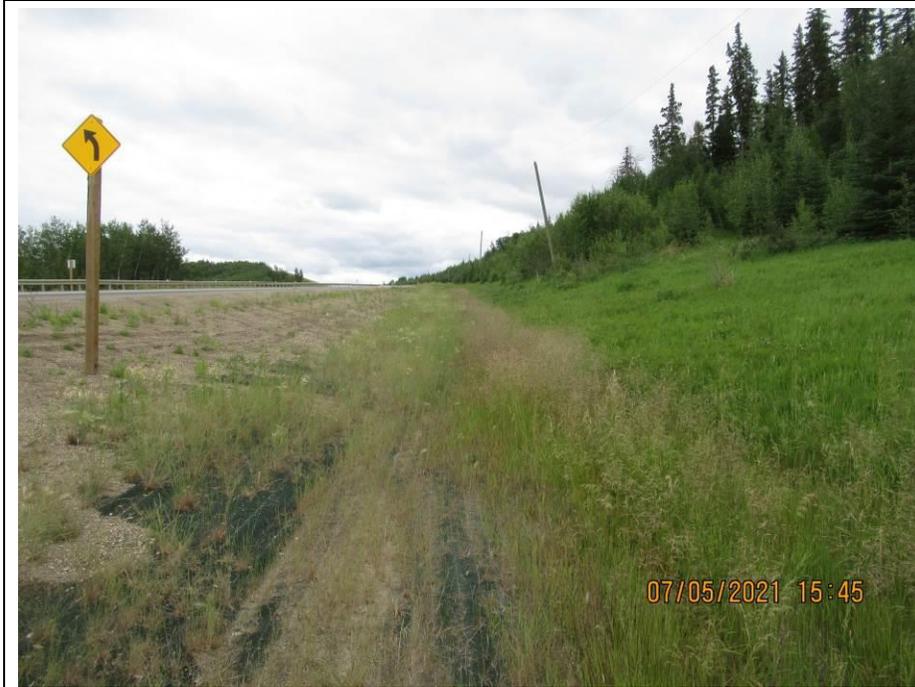
| <input checked="" type="checkbox"/> Erosion | South ditch erosion has been repaired with TRM near km 34+125 (Photos 43-09). Minor rills were noted between the road and north ditch gabion armour at km 34+000 (Photo 43-10) Previous area of erosion rills at top of embankment at the east end of the site has been graded and TRM installed with vegetation regrowth starting (Photo 43-12). Where the TRM ends at the west end of the site there was increased rill erosion near km 33+650 | <input checked="" type="checkbox"/> | |

Photo 43-09.
South ditch TRM installation at Site B to repair erosion damage and mitigate against future erosion (34+125).

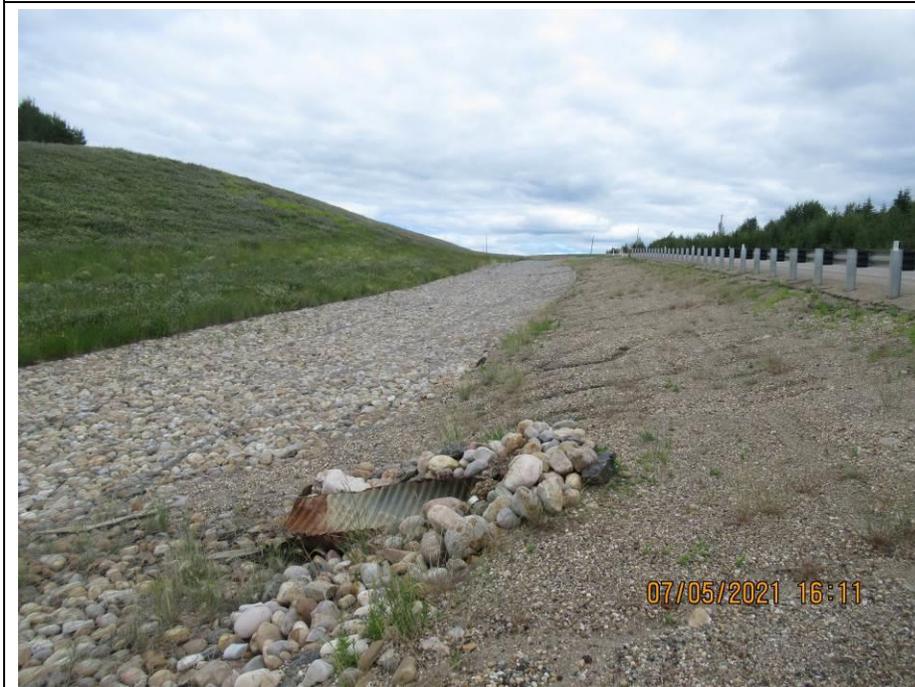
Photo 43-10.
Looking east towards the north ditch gabion mattress installation at Site B (34+00).

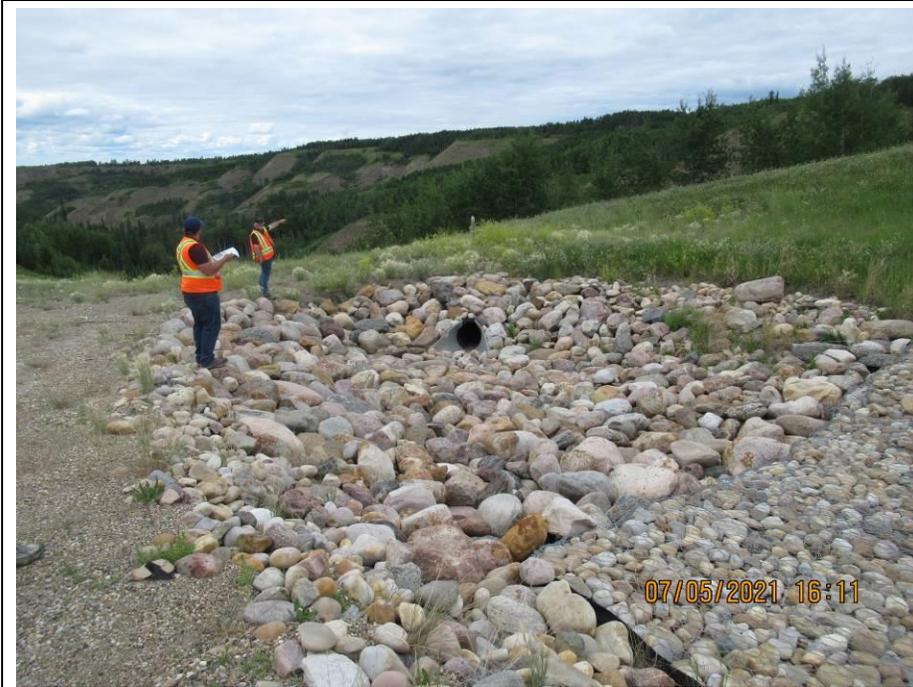
Photo 43-11.
View of culvert inlet and riprap protection near 33+900 on north side of road.

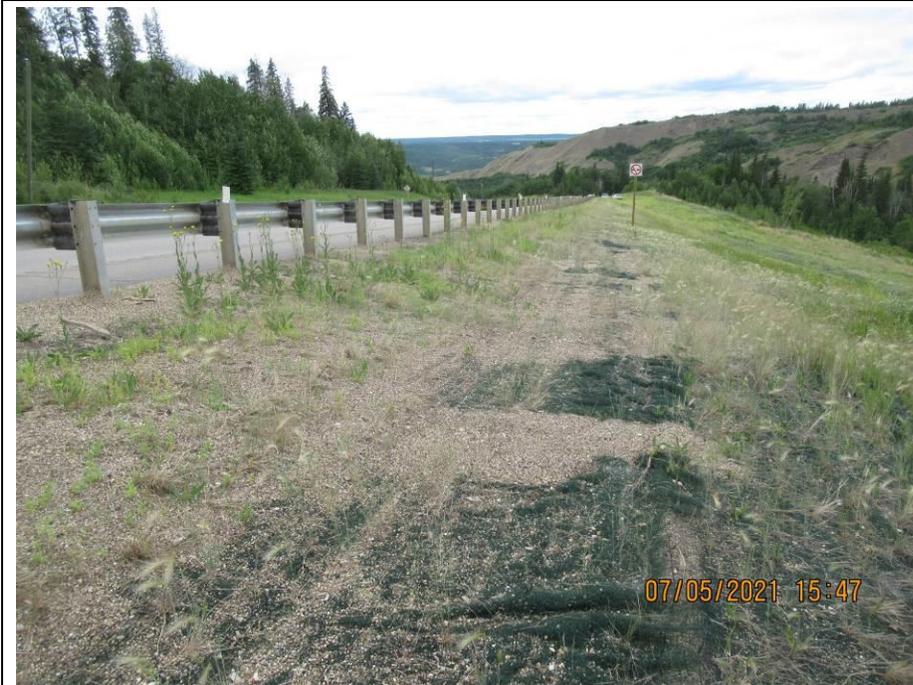
Photo 43-12.
Looking west towards the TRM installation on the upper portion of the slope north of the road (33+700). Some vegetation growth has started.

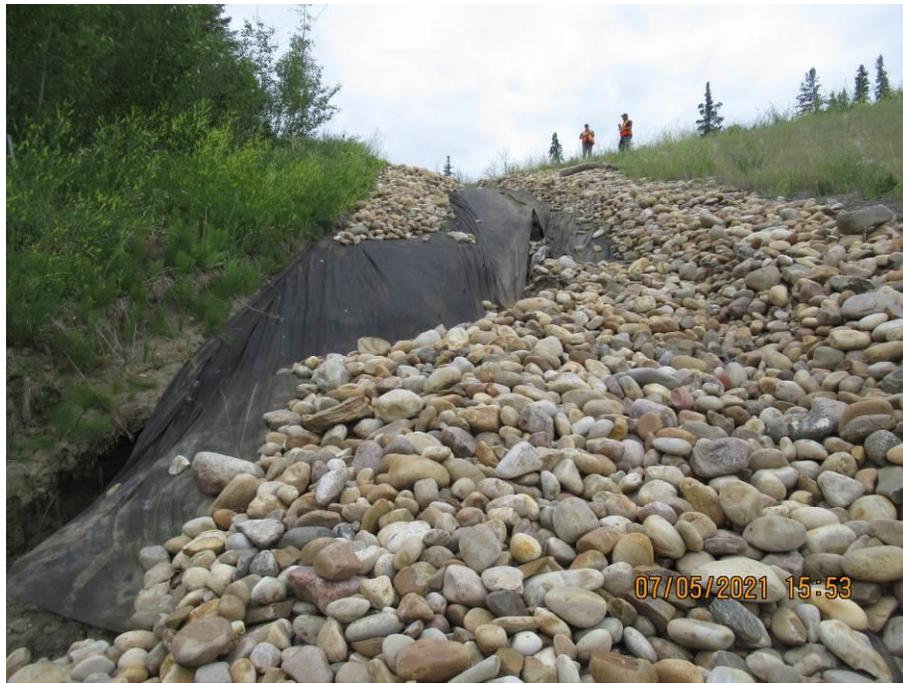
Photo 43-13. Looking south, upslope towards washed out riprap and extensive erosion damage within the riprap swale at the east side of Site A (33+500), likely the result of a high-flow event.

| <p>Assessment:</p> <p>Pile wall appears to be limiting sliding of area upslope of the wall and is protecting the west portion of Site A embankment. The repair work should reinforce the embankment toe and reduce rates of soil loss from this area and the potential of destabilizing the upper embankment slope.</p> <p>Slide activity in the lower part of the valley slope was initiated during construction that was mitigated via driven steel piles which appears effective. Instruments at the existing buried tangent pile wall indicated increased shallow slide movement rates but this is attributed to the lower slide activity during construction. There is ongoing slide activity directly below the west end of the old wall but it appears shallow and not currently a direct threat to the highway. The embankment above the old pile wall has not exhibited signs of slide movement and slide related pavement damage has not been observed.</p> <p>Erosion and sedimentation buildup was observed around the new erosion mitigation structures. Some maintenance / warranty work is required around the culvert inlet but overall erosion potential is expected to reduce as vegetation becomes better established. The swale riprap requires repair to prevent expansion of the erosion damage. Due to the gradient in this area it may need to have</p> | | |

angular riprap or gabion mattress installed at a select points as check dams to offer containment and help reduce flow energy to reduce the risk of future washouts.

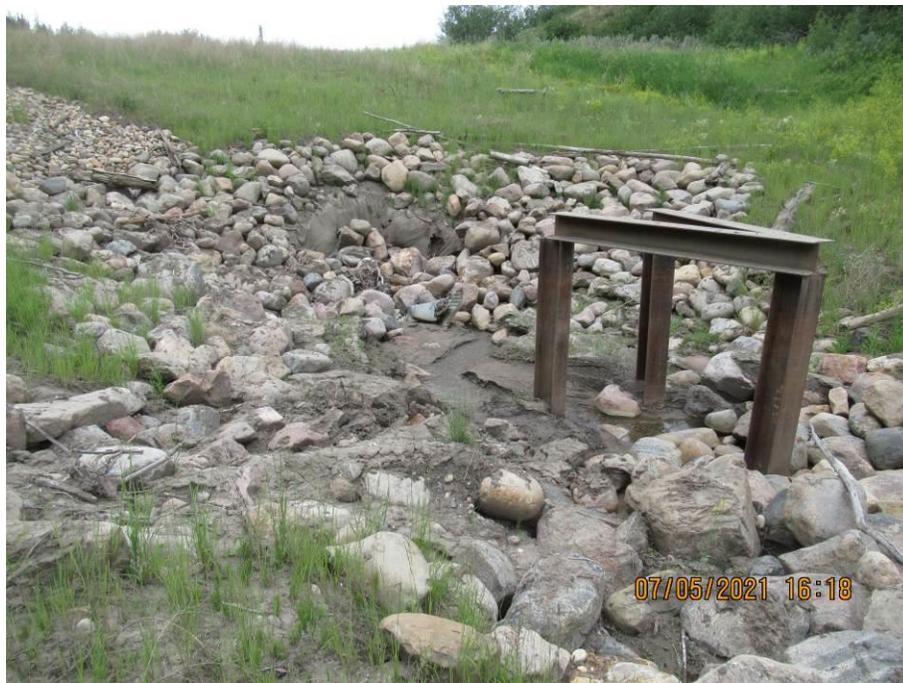
Photo 43-14. Site B culvert inlet with riprap protection and steel H-beam debris deflector. Inlet become severely damaged and blocked with fallen riprap during a high flow event in 2019/2020 (33+800). Repairs required in this area.

Repairs required at the culvert inlet at the creek including, inlet replacement, riprap placement and reconfiguration, and joint repair at the CPP down pipe.

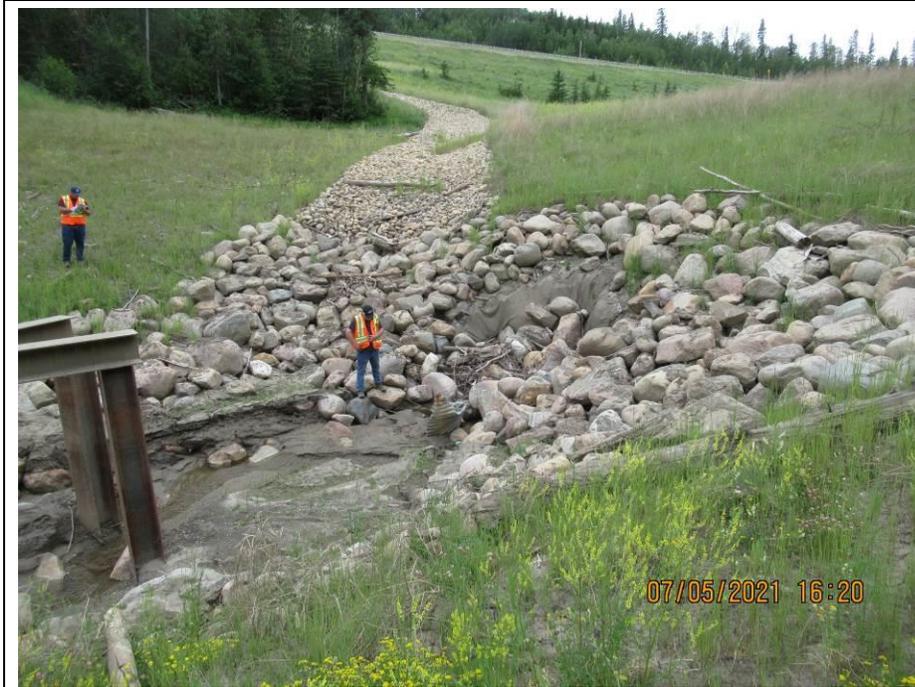
| <input checked="" type="checkbox"/> Other | Sediment buildup near the culvert inlet indicative of a flooding during a high flow event. (Photo 43-15) Overland flow and construction access area soils had good vegetation regrowth (Photo 43-17). | <input type="checkbox"/> |

Photo 43-15.
Damage around culvert inlet due to a high flow event. Culvert pipe at the inlet was effectively pinched and twisted shut and was filled with woody debris. Riprap above the inlet had collapsed and slid down over it. Repairs required in this area (33+800).

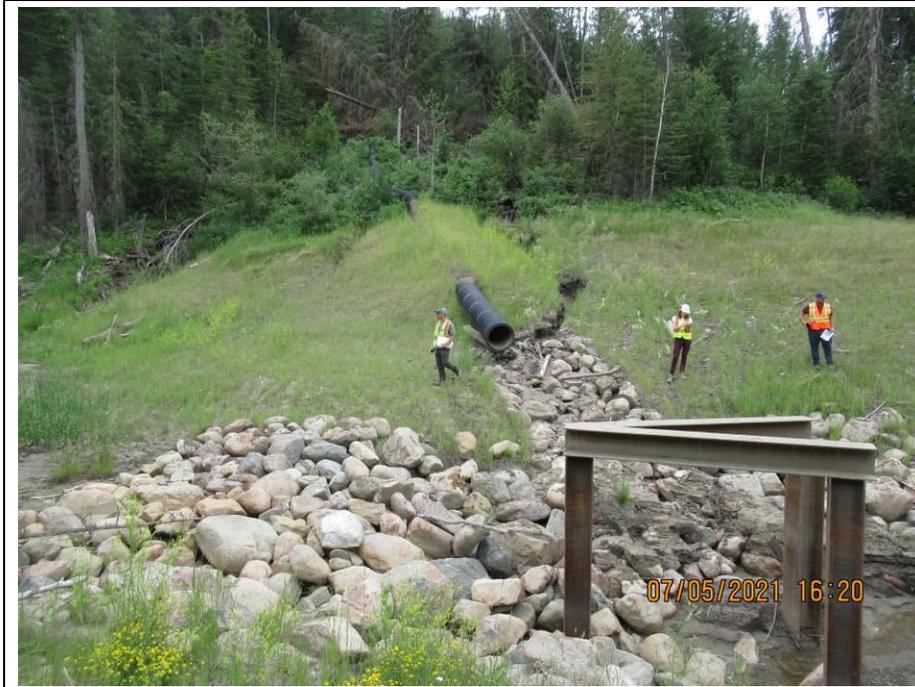
| <input checked="" type="checkbox"/> Slope Movement | A landslide in the natural creek valley slope has moved and severed the CPP downpipe. | <input checked="" type="checkbox"/> | |

Photo 43-16.
Looking south towards the outlet of the CPP down pipe near the culvert inlet (33+800). Rill erosion was noted to be occurring upslope from the pipe outlet due to a leaking joint that requires repair. Increased gully erosion was noted on the right side of the pipe.

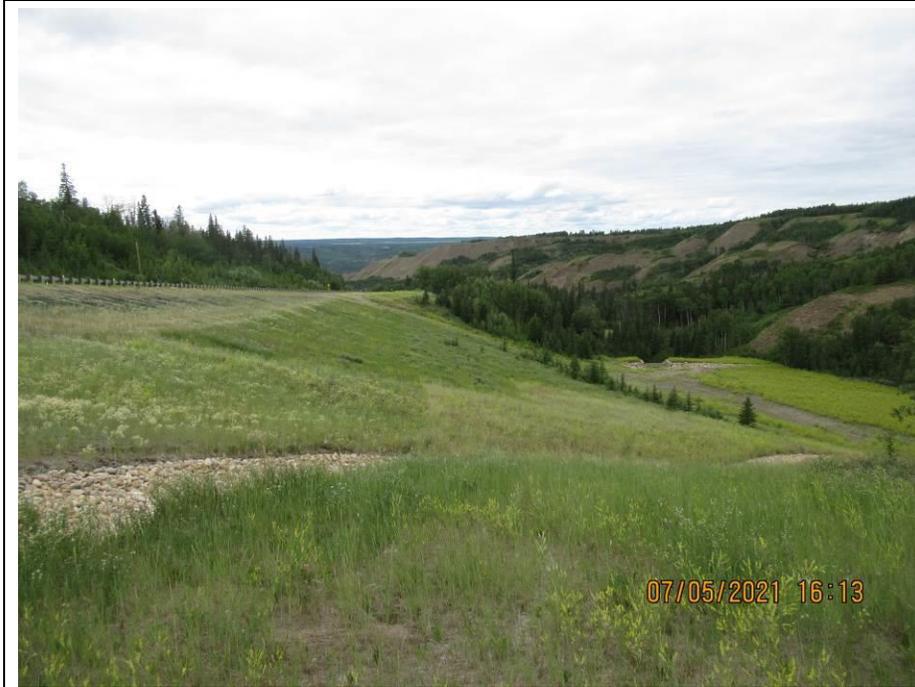
Photo 43-17.
Looking west towards the highway slope, overland flow area of Site B.

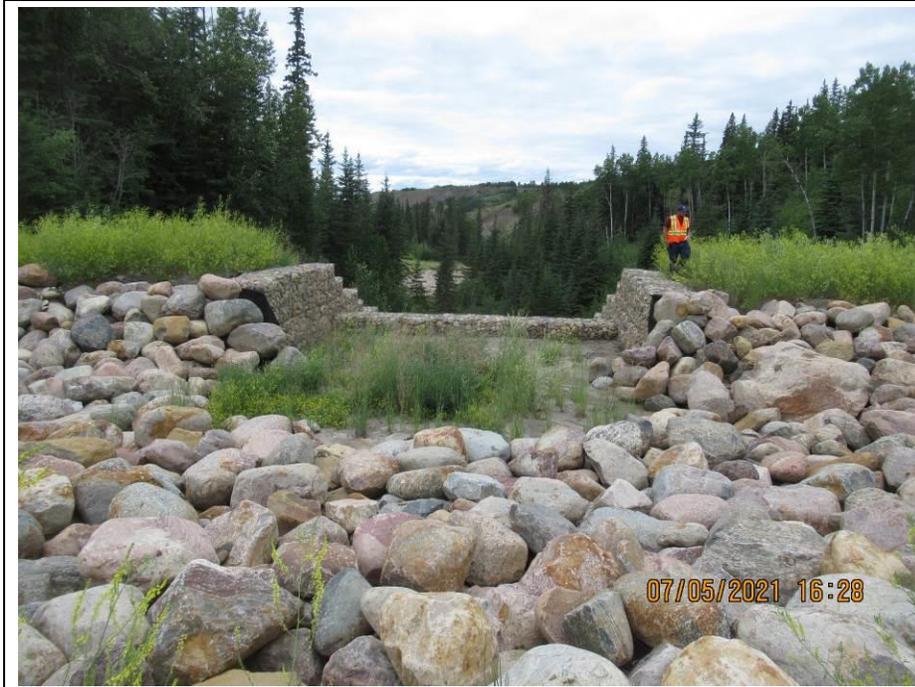
Photo 43-18.
View of the riprap berm located near the top of the gabion drop structure (33+650)

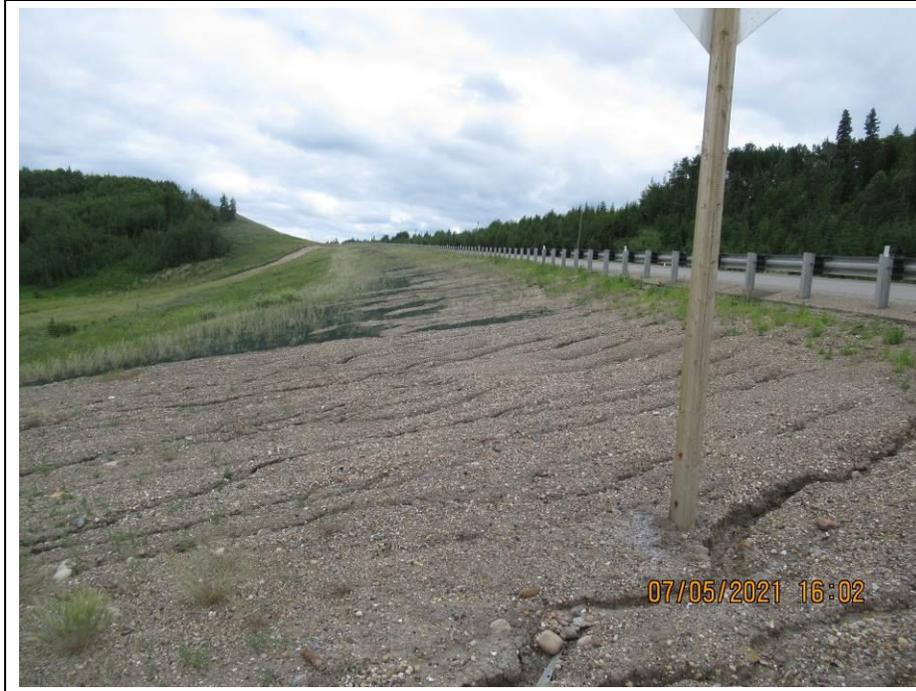
Photo 43-19.
View of the minor rill erosion near the top of the embankment of Site B (33+650) where TRM is not installed.

Remove sand accumulation from side of roadway which is causing channelization of surface runoff on embankments and highway ditch.
