**ALBERTA TRANSPORTATION GEOHAZARD ASSESSMENT PROGRAM
PEACE REGION – PEACE-HIGH LEVEL
2012 INSPECTION**

Site Number	Location	Name	Hwy	km
PH41	Daishowa East Hill	31+600 to 32+0 Site 5	986:01	31.8
Legal Description		UTM Co-ordinates		
NE12-85-21 W5M		11V E 489760	N 6246210

**DAISHOWA
HWY 986:01 (PH41)
LOCATION PLAN**

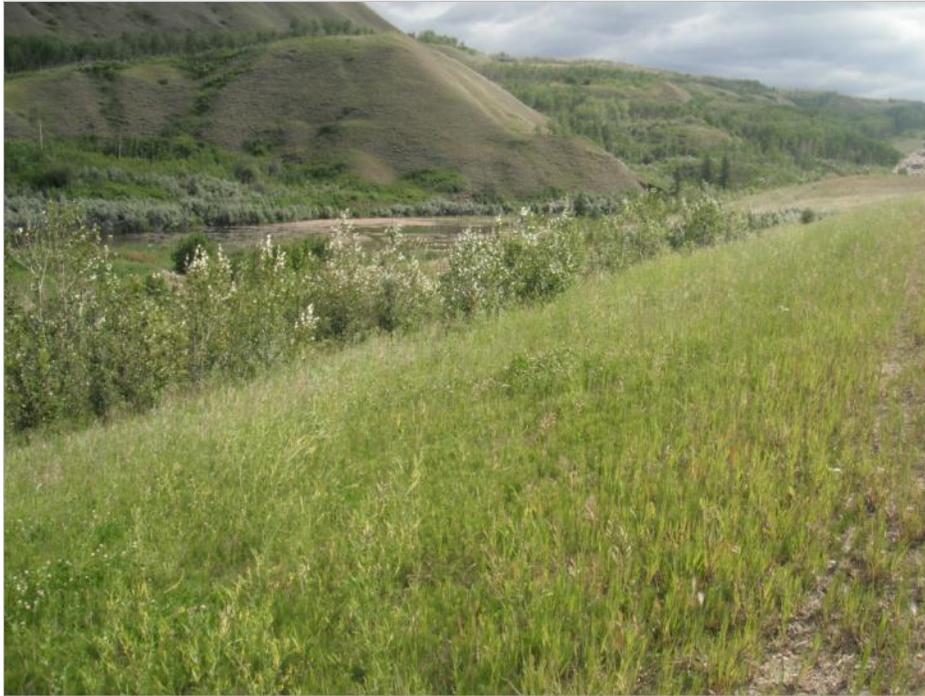
<input type="checkbox"/> Erosion	No new erosion. Old erosion of natural creek banks downstream of gabion energy dissipation outlet (Photo 41-01 and 41-06).	<input type="checkbox"/>	
<input type="checkbox"/> Seepage		<input type="checkbox"/>

Photo 41-01. Looking northeast at slope below roadway. Slope inclinometer SI 1 in bushes in distance (31+850).

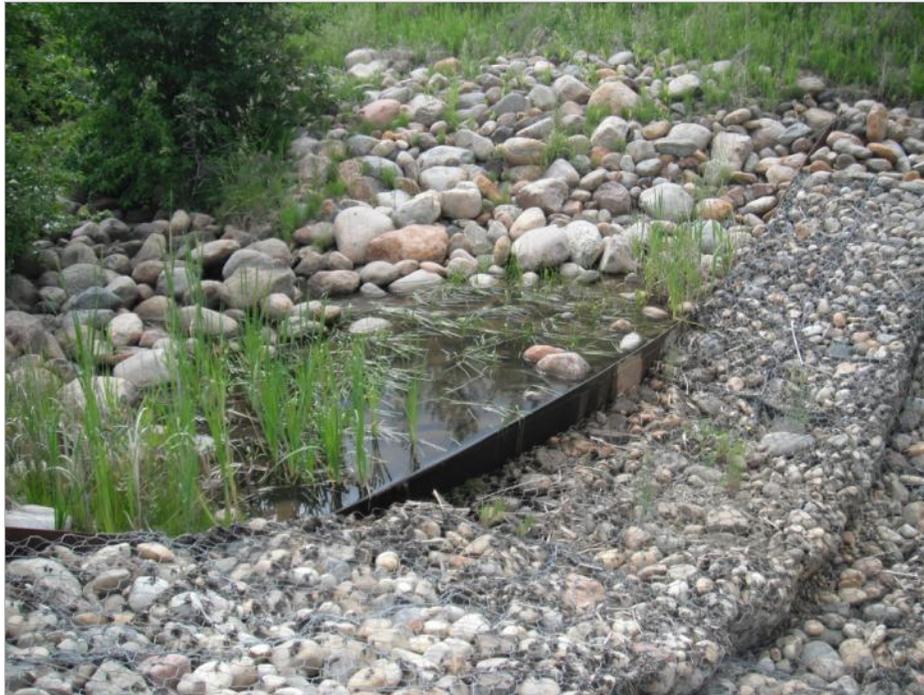
<input type="checkbox"/> Bridge/Culvert Distress		<input type="checkbox"/>
<input checked="" type="checkbox"/> Other	Minor gabion basket distress and locally torn baskets (Photo 41-05). Settlement of gabions at inlet downstream of steel plate (Photo 41-02). Willows in channel should be cut so as to not impede flow capacity of channel.	<input type="checkbox"/>
Instrumentation:		
<p>SI 1 - 5 mm/yr between 1.2 m and 3 m depth; 1.5 mm/yr between 3 m and 6.1 m depth; < 1 mm/yr between 8.5 m and 9.8 m depth. SI 2 - 14 mm/yr between 0.6 m and 2.4 m depth; < 1 mm/yr between 14 m and 15.2 m depth</p>		
Assessment:		
Creep movements are occurring within the embankment below the roadway. Most active zones of movement are relatively shallow (less than 3 m) and is not a significant threat to the roadway at this time.		
Recommendations:		Cost
Repair gabion baskets in energy dissipation structure		\$2,500
Continue to monitor instruments twice yearly and undertake annual inspections.		-

Photo 41-02. Close-up of steel plate at top of gabion energy dissipation structure. Gabions continue to settle downstream but are still functional (31+800).

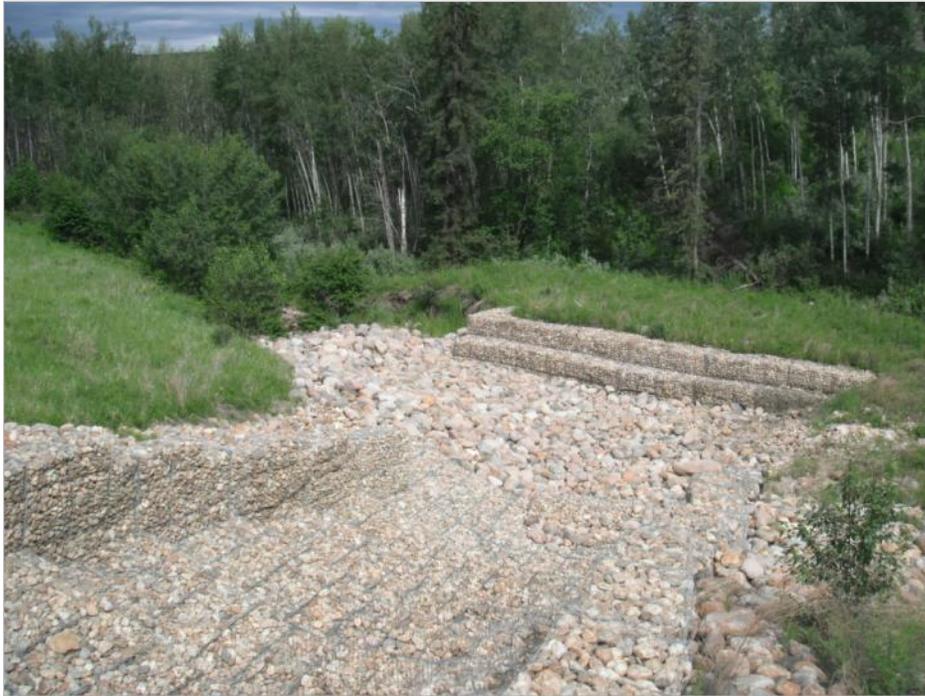
Primary Site Issue:	Prior to implementation of major erosion control and drop structure on unnamed creek on north side of roadway, fill embankment was adversely affected by erosion and instability. Site in good condition since installation of erosion control measures (Photos 41-03 and 41-04).		
Dimensions:	Site 5 is approximately 600 m. Channel inlet to gabion structure outlet is 200 m. Roadway is approximately 30 m above creek in this area.		
Maintenance:	No maintenance activity since 2011.		
Observations:	Description	Worsened?	
<input type="checkbox"/> Pavement Distress		<input type="checkbox"/>	
<input checked="" type="checkbox"/> Slope Movement	No visual evidence of ongoing slope instability on fill embankment above channel and gabion energy dissipation structure (Photo 41-01). Slope inclinometers indicate shallow creep movements are occurring. Some acceleration in SI 2 since 2011 readings.	<input checked="" type="checkbox"/>

Photo 41-03. Looking downslope at gabion energy dissipation structure. Outlet to natural creek in distance (31+800).

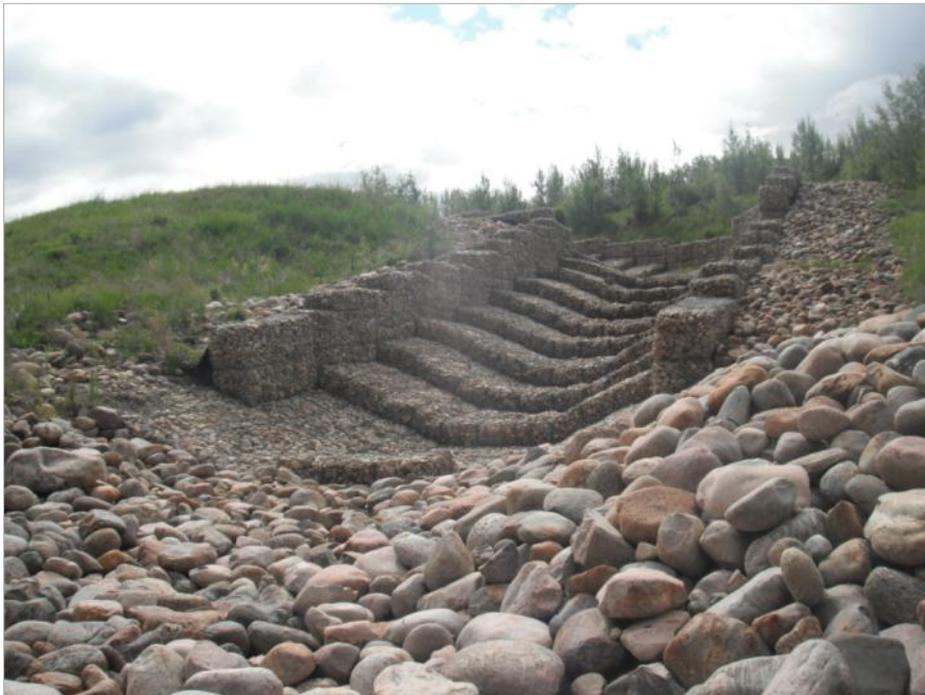
Photo 41-04. Looking upslope at gabion energy dissipation structure (31+800).

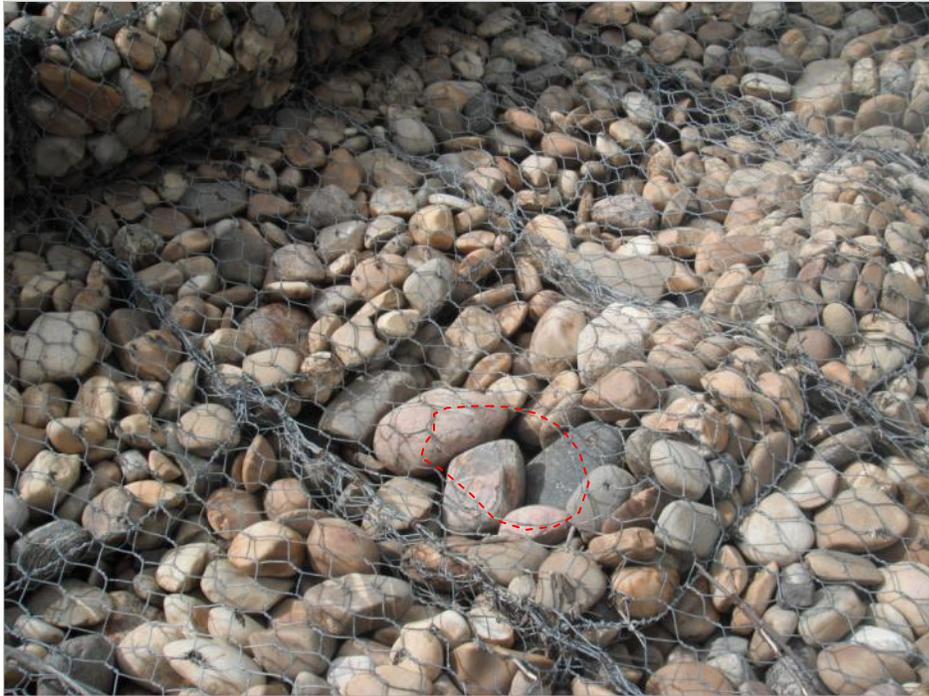
Photo 41-05. Close-up of torn gabion baskets (31+800).

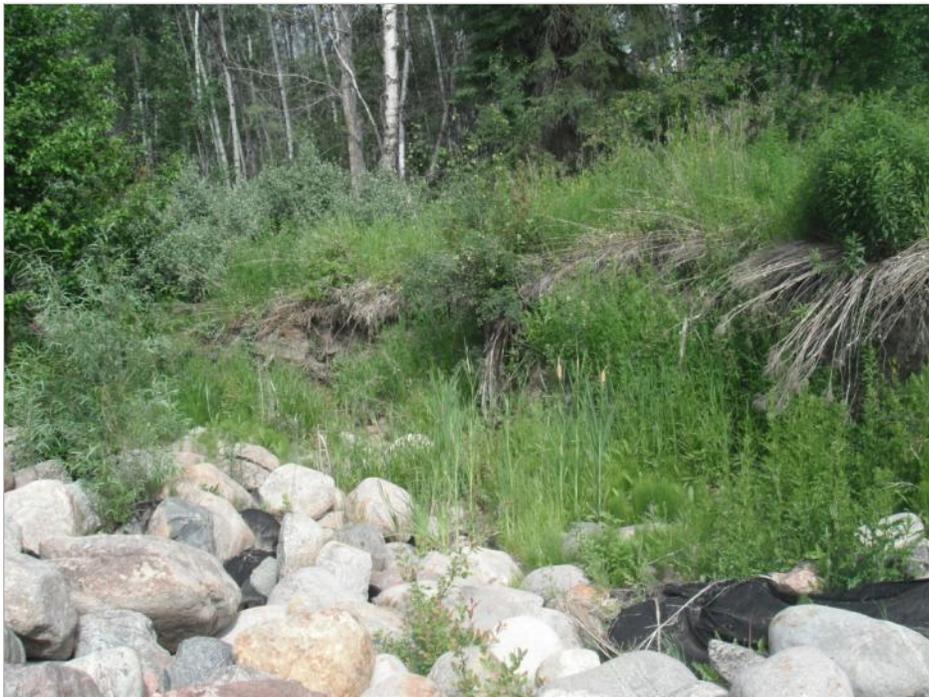
Photo 41-06. Outlet of gabion structure to natural creek. Bank slumping becoming effaced (31+780).
