SITE NUMBER AND NAME: <b>S045-II Threepoint Creek</b>		HIGHWAY & KM: 549:02, 12.315	PREVIOUS INSPECTION DATE: July 5, 2021	INSPECTION DATE: <b>May 9, 2023</b>
LEGAL DESCRIPTION: 02-08-021-03 W5M	NAD 83 COORDINATES: UTM    Northing    Easting 11       5626611    684647		RISK ASSESMENT: PF: 7    CF: 8    TOTAL: 56	
AVERAGE ANNUAL DAILY TRAFFIC (AADT): 800 (east), (Ref. No. 65170)			CONTRACTOR MAINTENANCE AREA (CMA): 27

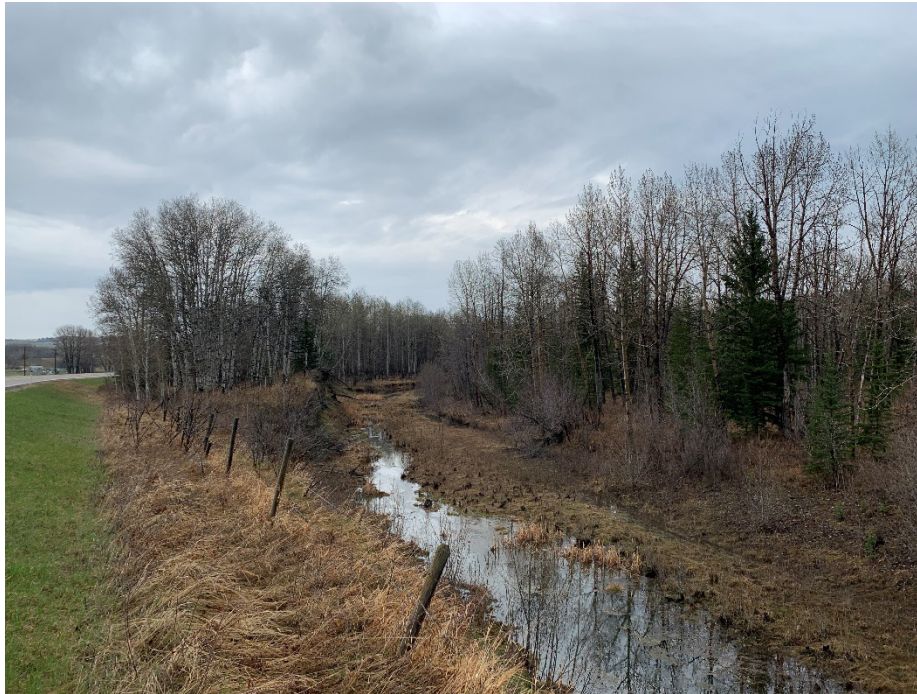
**Photo 1** Highway slope above area of toe erosion on secondary channel S045-II. Photo was taken facing northeast on May 9, 2023. (Photo 2 shows 2021 water level)

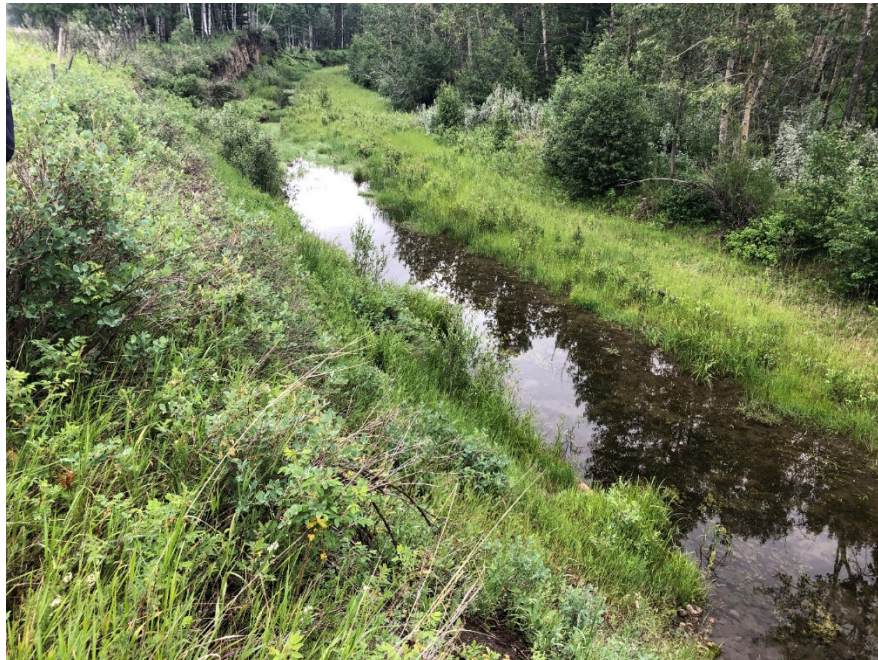
**Photo 2** Flow from 2021 appears to be similar or higher than 2023. Photo was taken facing southwest on July 5, 2021.

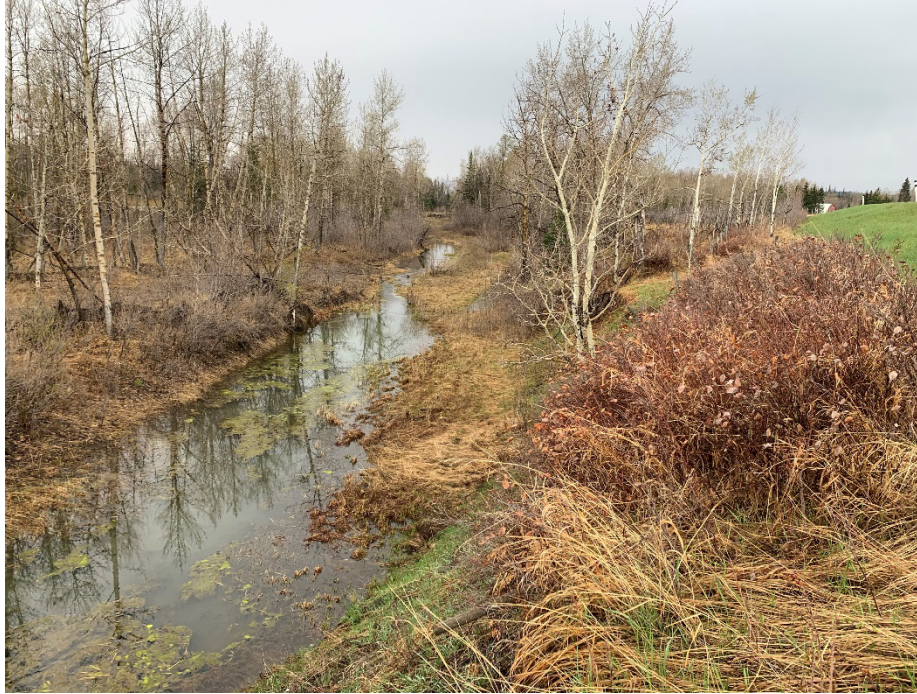
**Photo 3** Similar or slightly decreased flow observed in the side channel when compared to 2021. Photo was taken facing southwest on May 9, 2023. (Photo 4 shows 2021 water level)

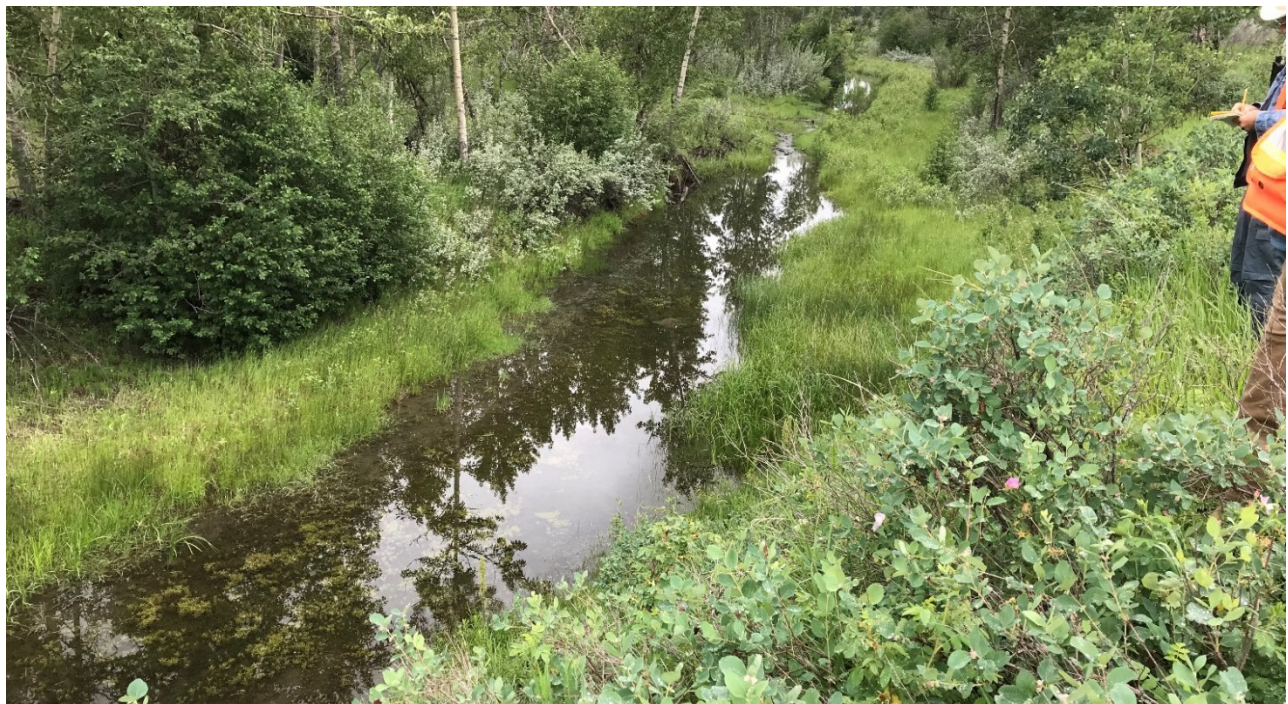
**Photo 4** Flow from 2021 appears to be similar or higher than 2023. Photo was taken facing southwest on May 9, 2023.
