BI-ANNUAL GRMP REVIEW MEETING NORTH CENTRAL REGION: ATHABASCA DISTRICT

Kehiwin Lake Landsides, Hwy 41:23 Near Elk Point, Alberta (NC24): Remedial Measures and Challenges

NC04 Erosion Issues, Hwy 55:10 & 813:02 in Athabasca, Alberta: Remedial Measures

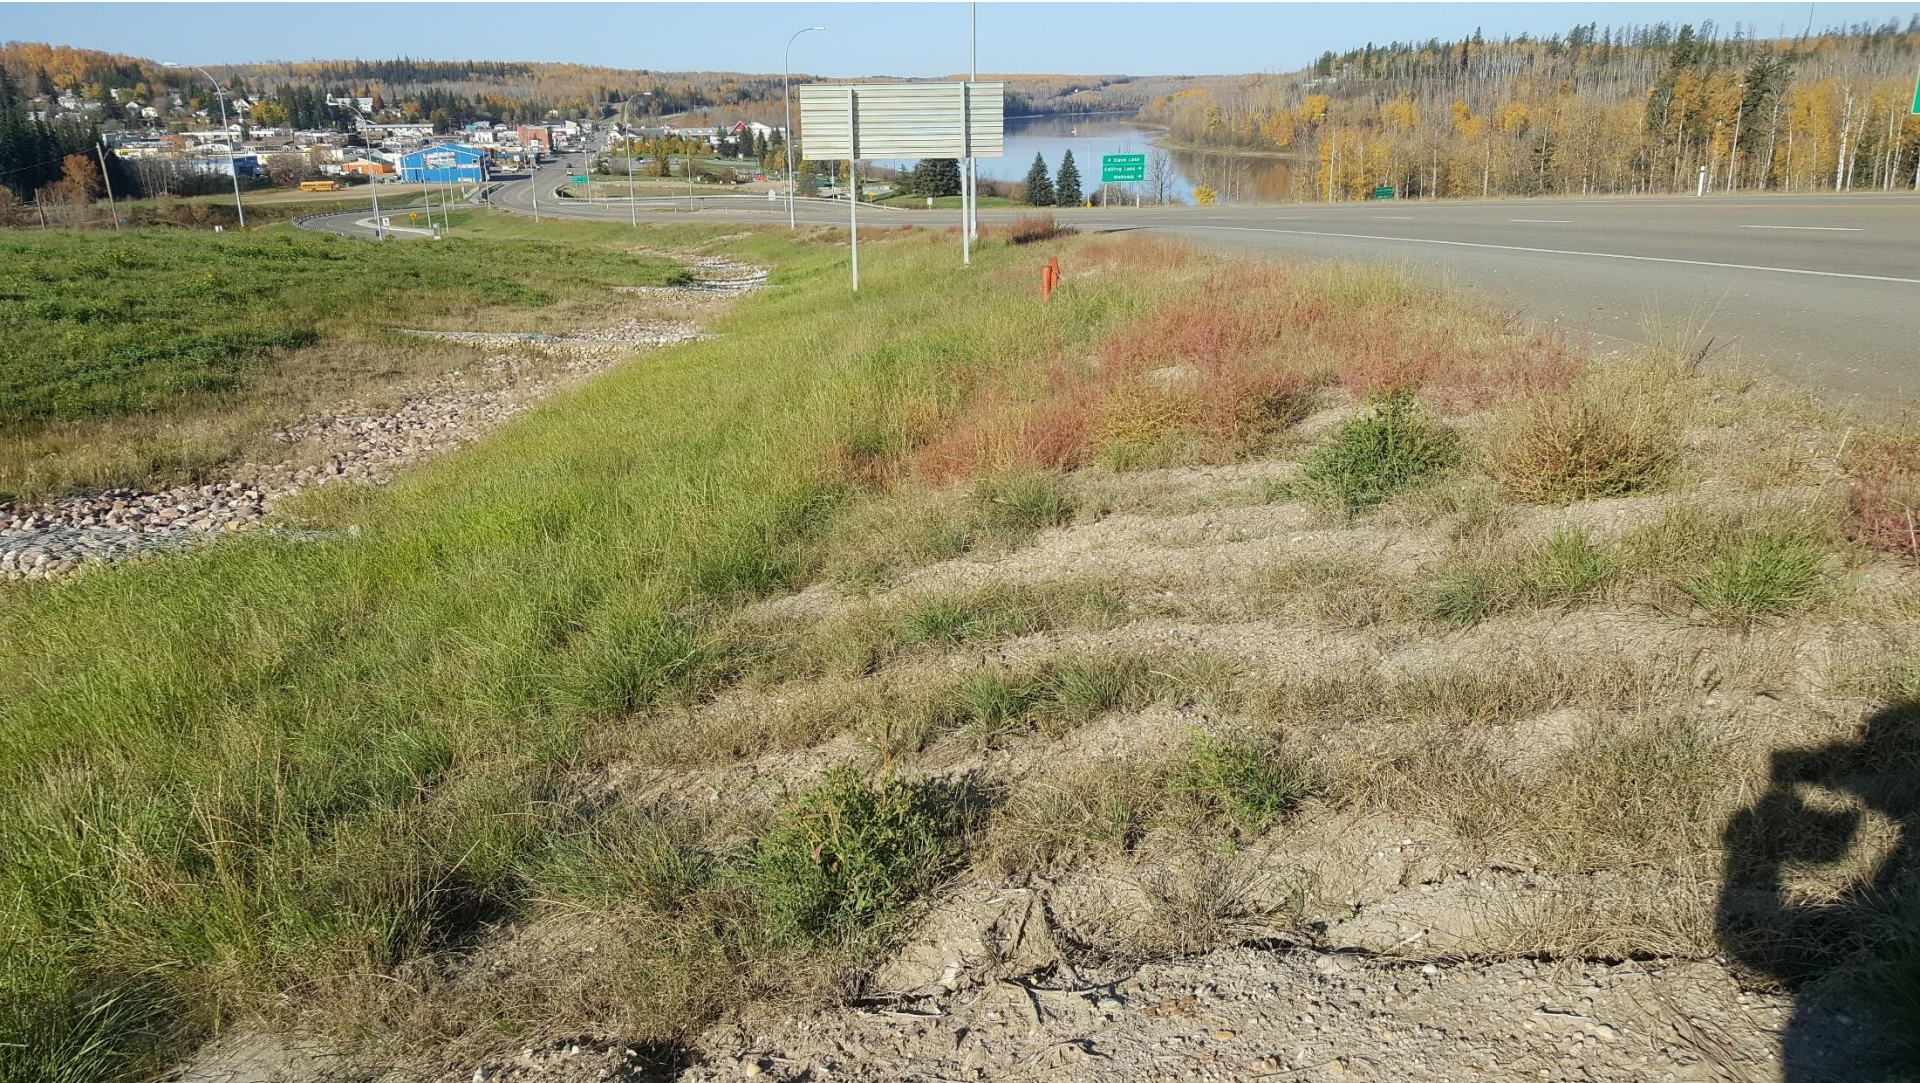
- Concentrated runoff flowing over bare slopes
- Bare slopes possibly due to excessive salting of the hill
- Soils in area are sandy and susceptible to erosion
- Gabion weirs at the bottom are space far apart

Hwy 55 south ditch: poor vegetation growth with resulting erosion

Regrade ditches and line with combination of Flexamat (rolled concrete blanket) and Class 1M riprap

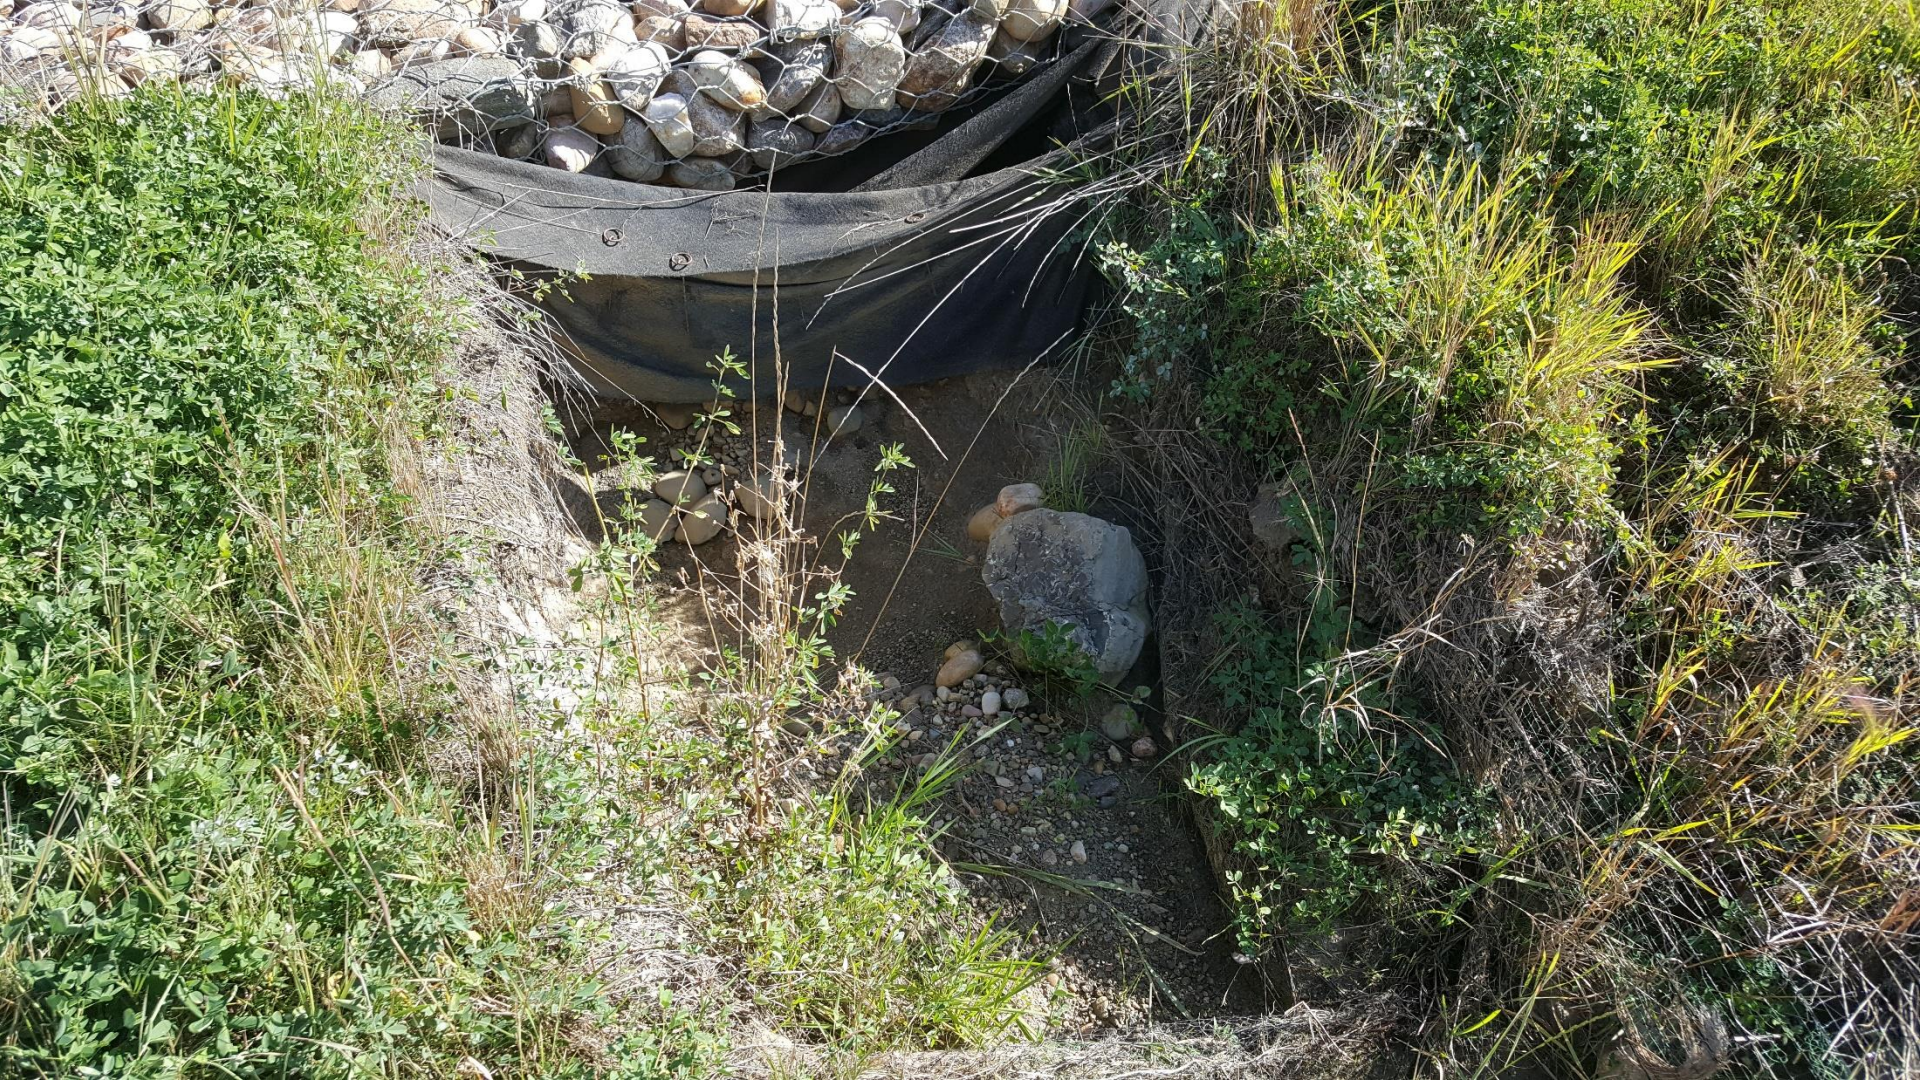
Hwy 55 north ditch: undercutting of gabion splash pad

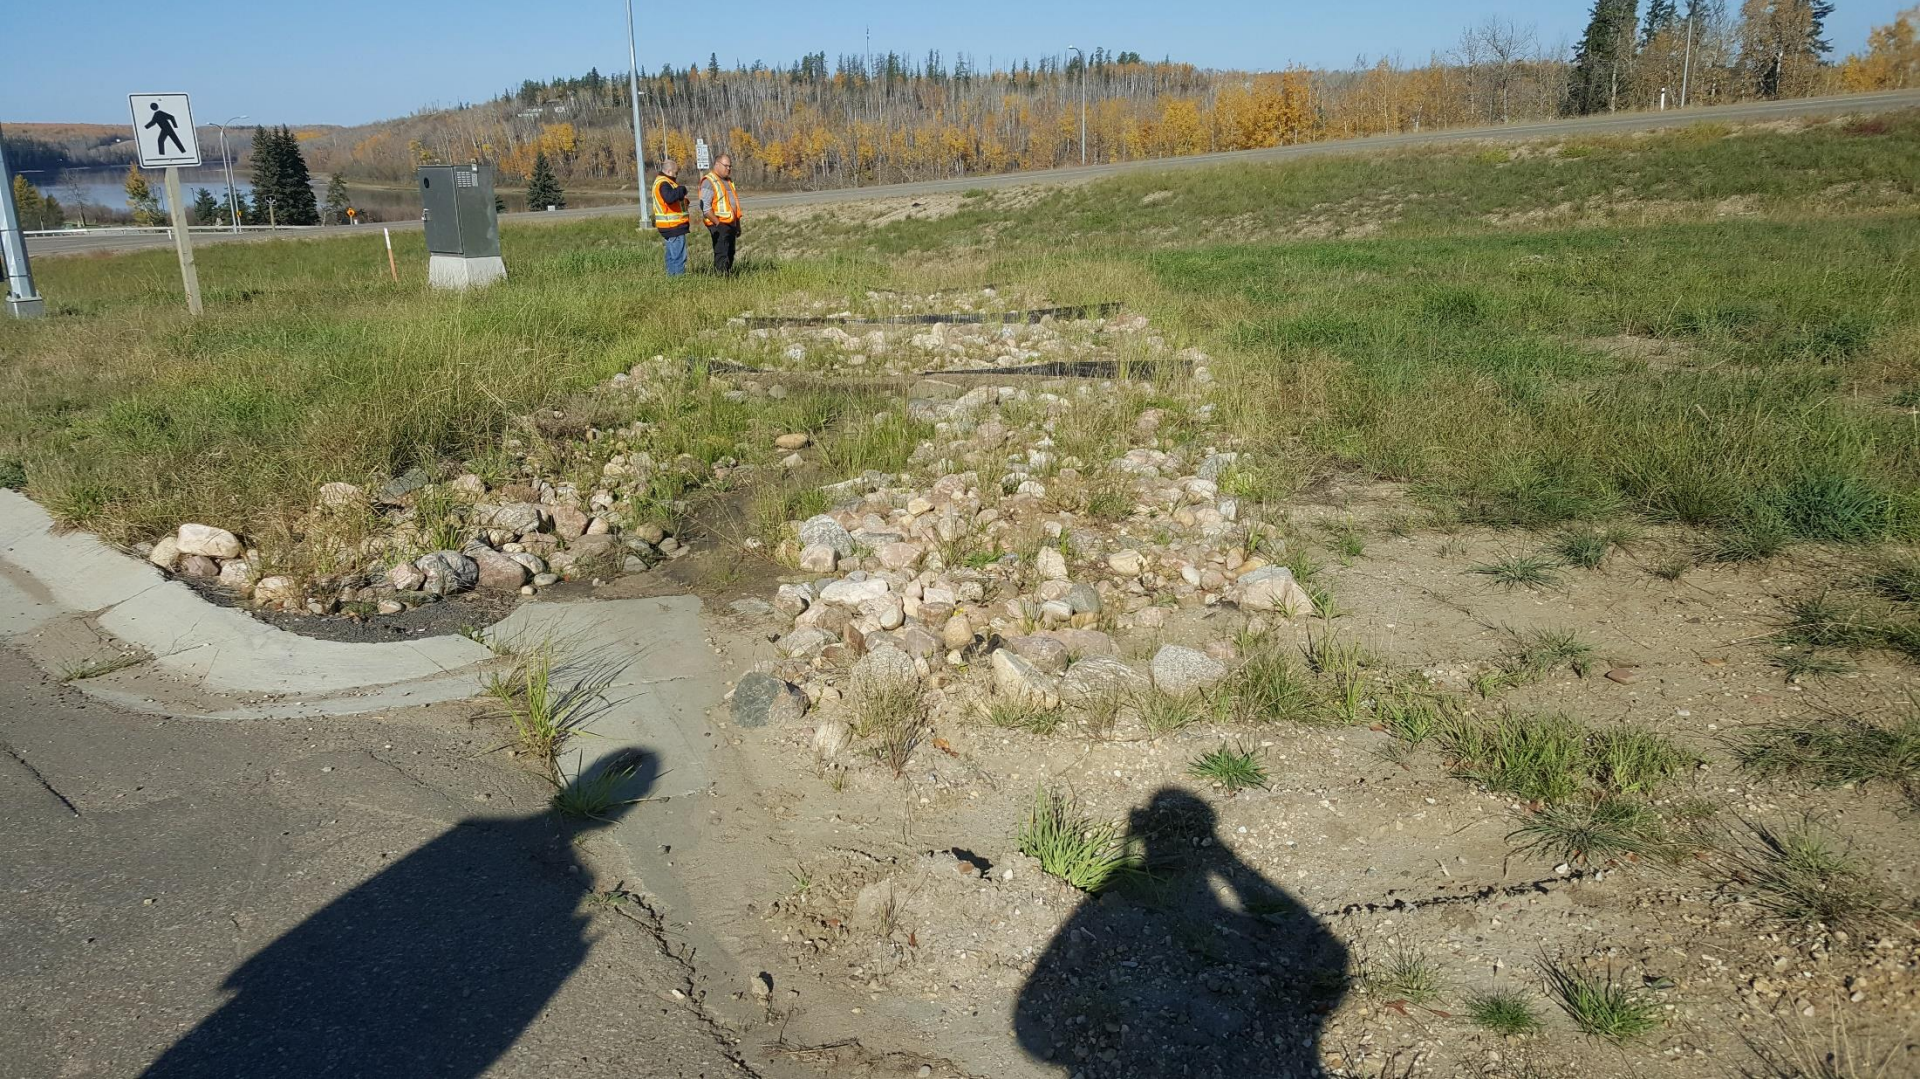
50 Avenue: sediment accumulation in channel
added after runoff flooded electrical box

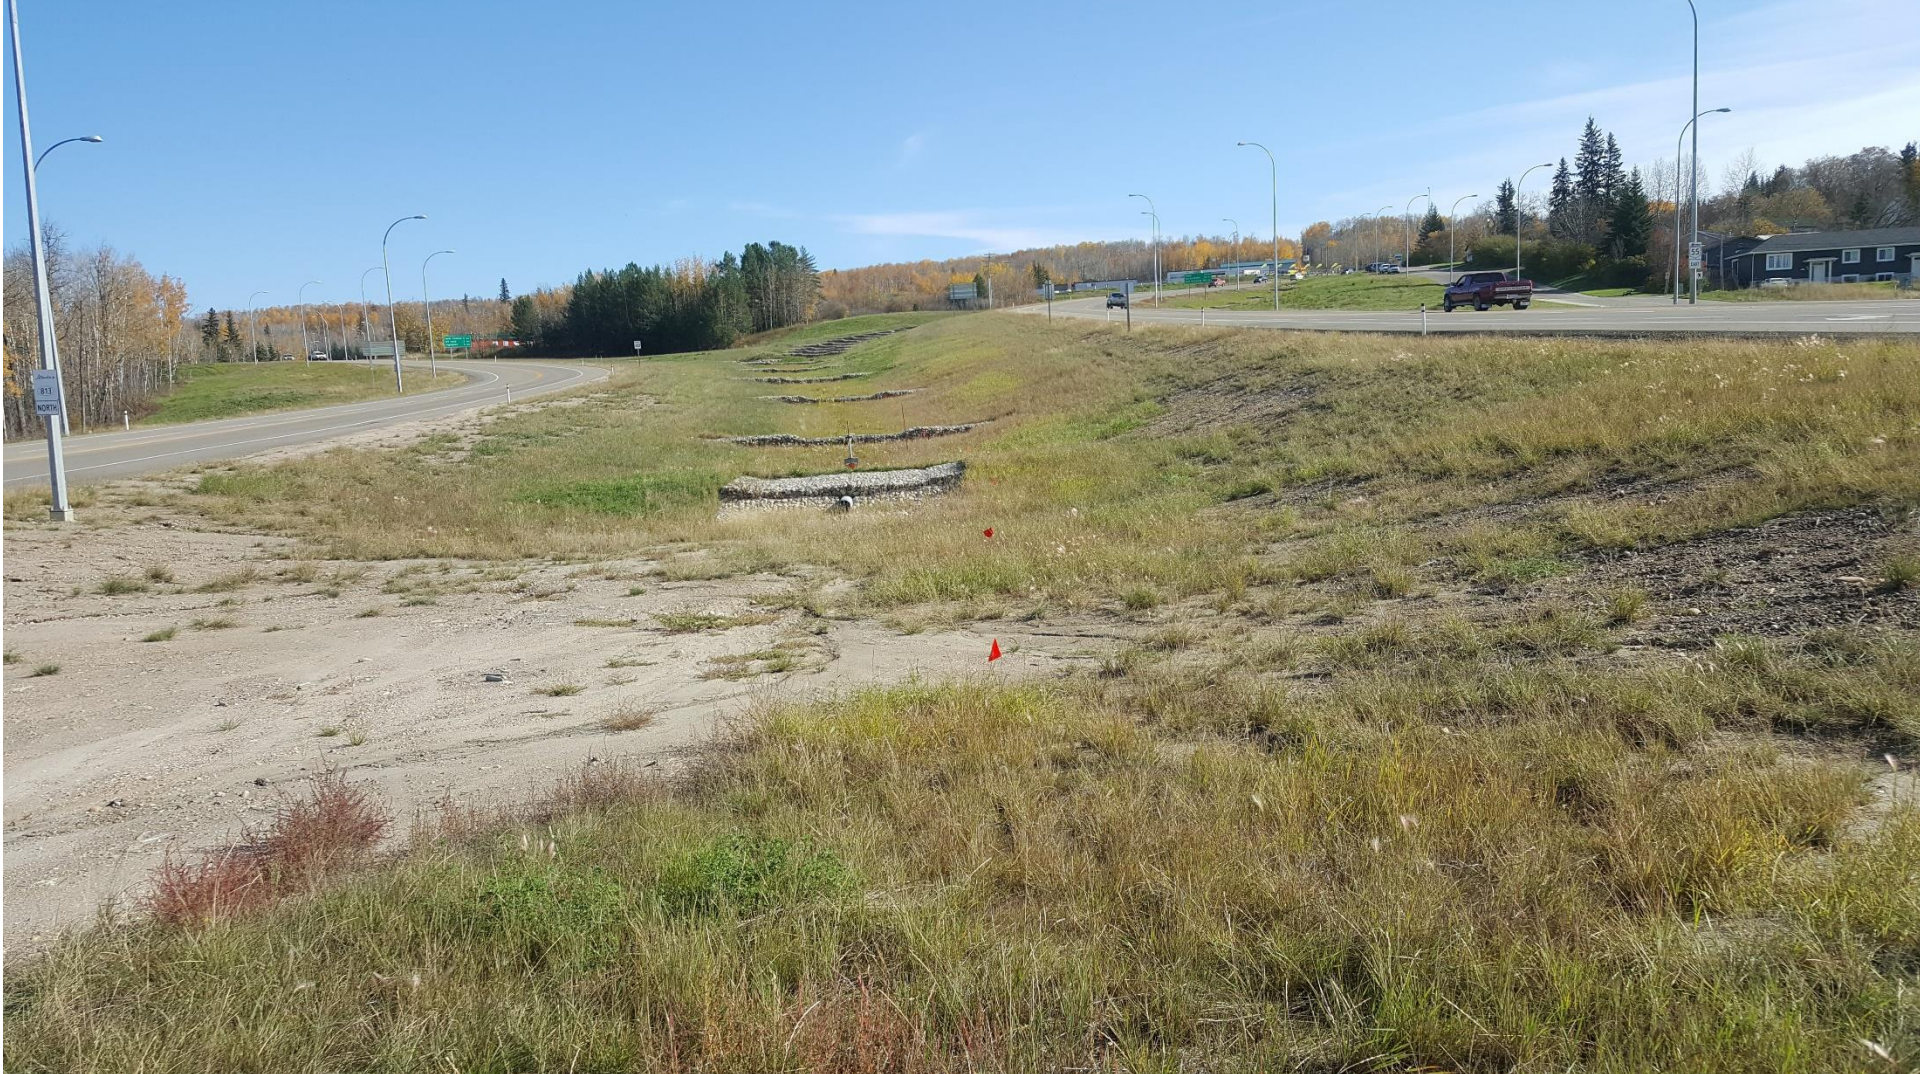
Hwy 813: salt flat

Seed mix was unique blend suggested by Nilex as more salt-resistant than typical AT blends

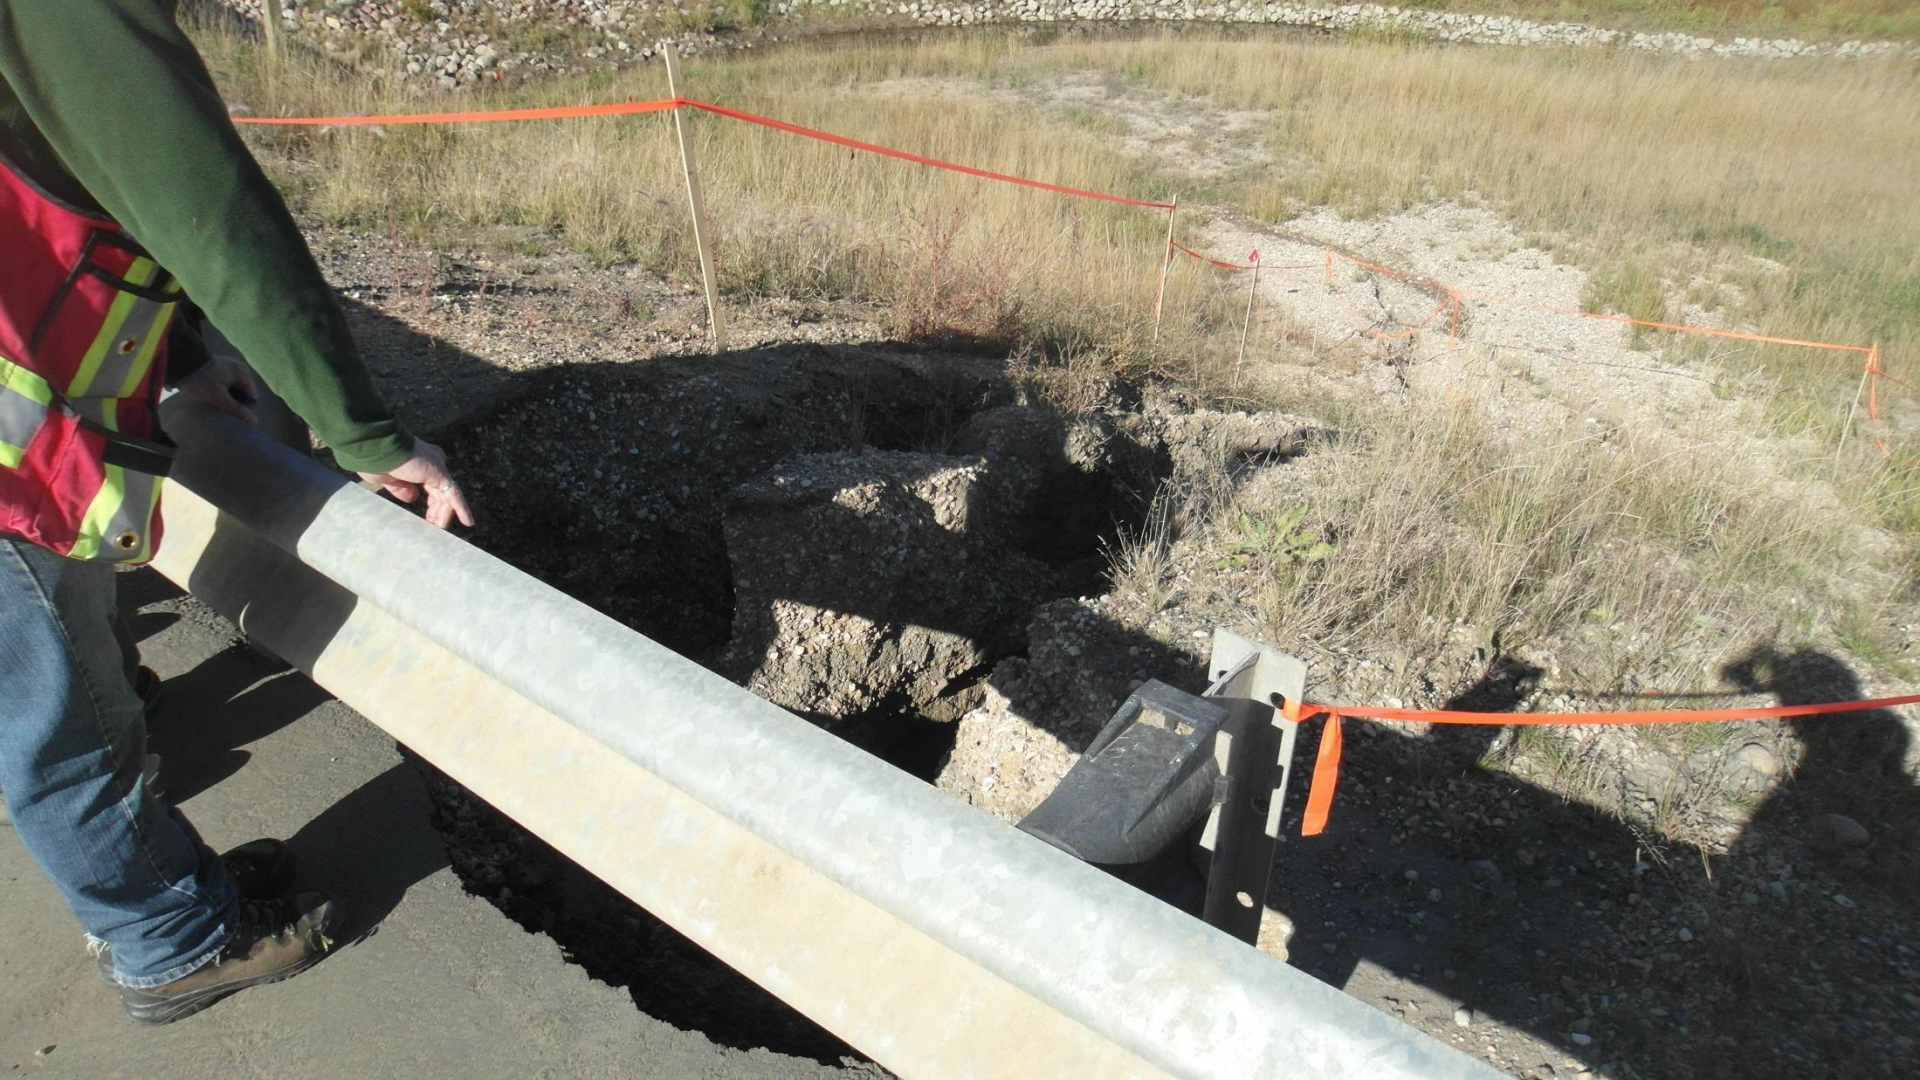
Hwy 55 NE corner of bridge: erosion encroaching

Add drain trough at NE side of bridge

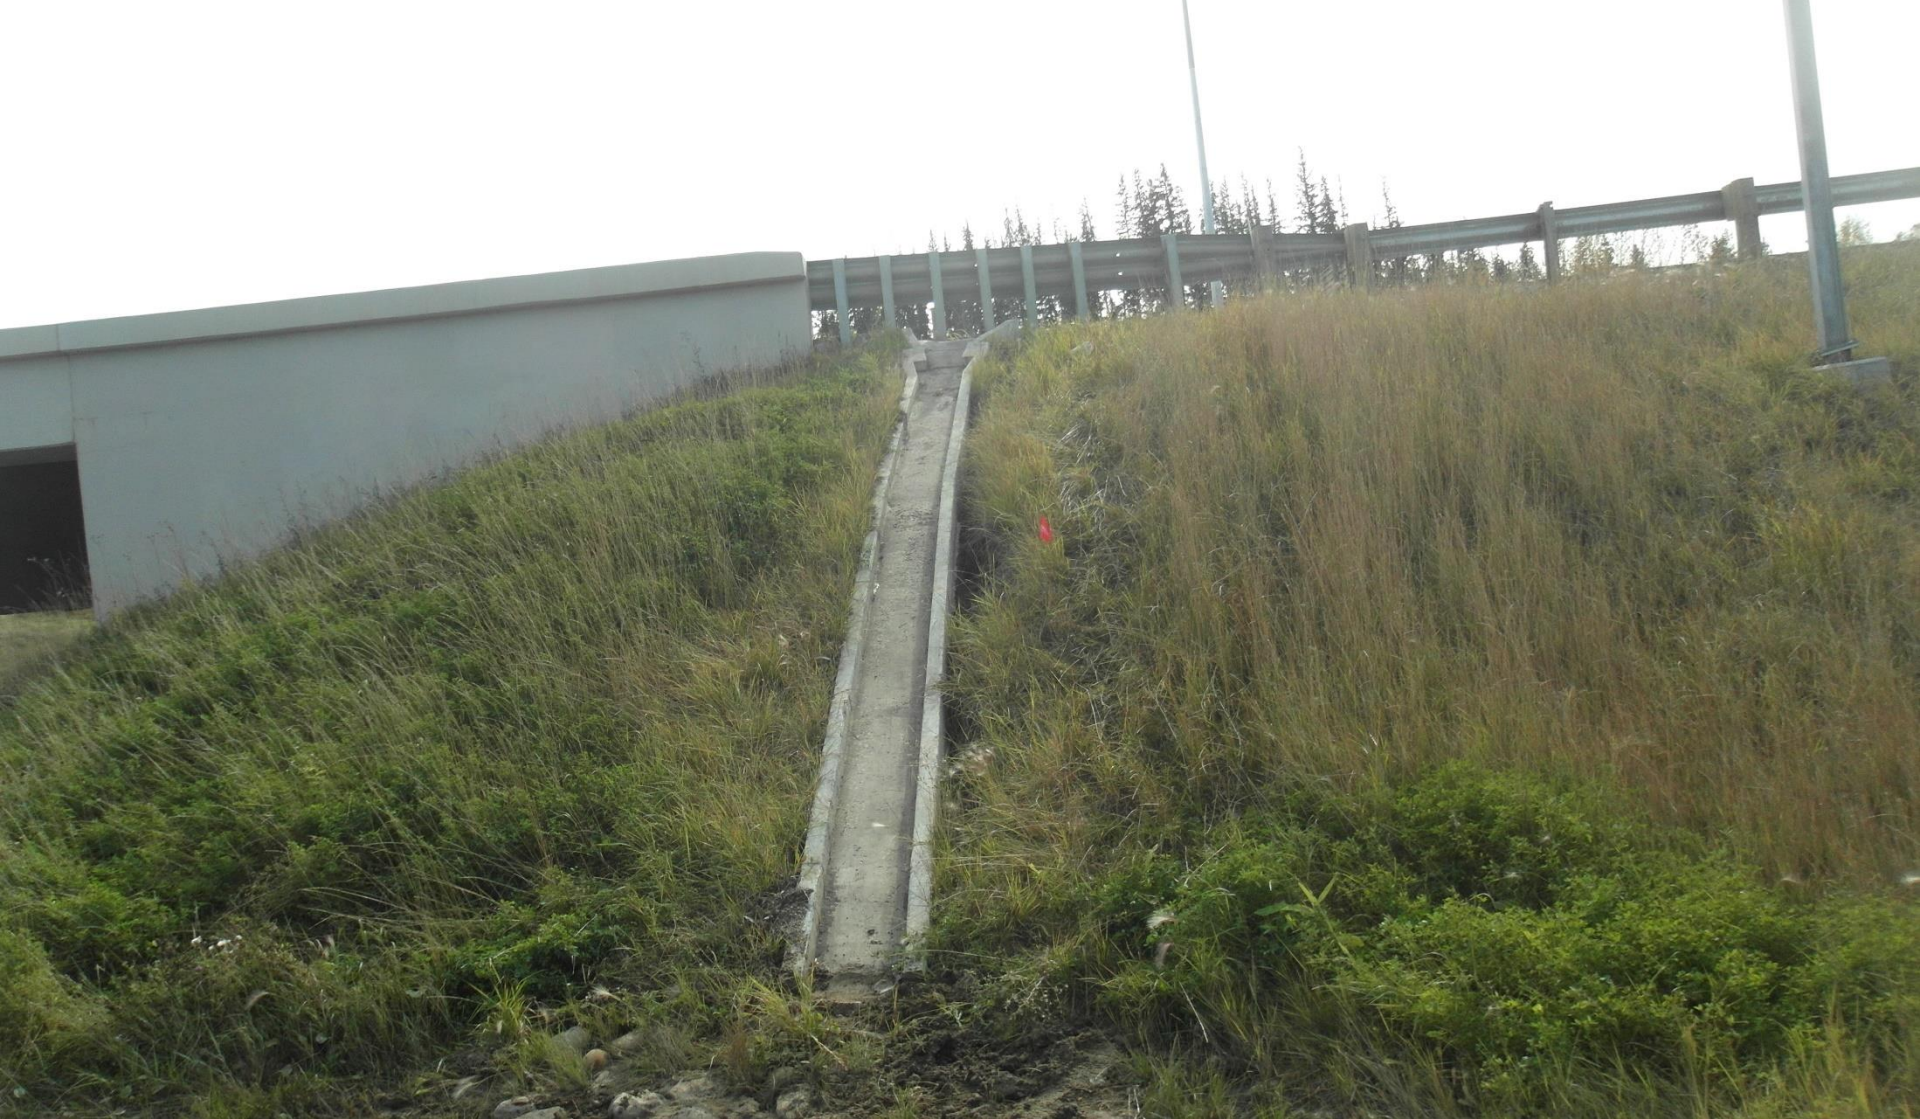
Hwy 55 NW corner of bridge – undercutting trough

Widen NW trough and add settling basin

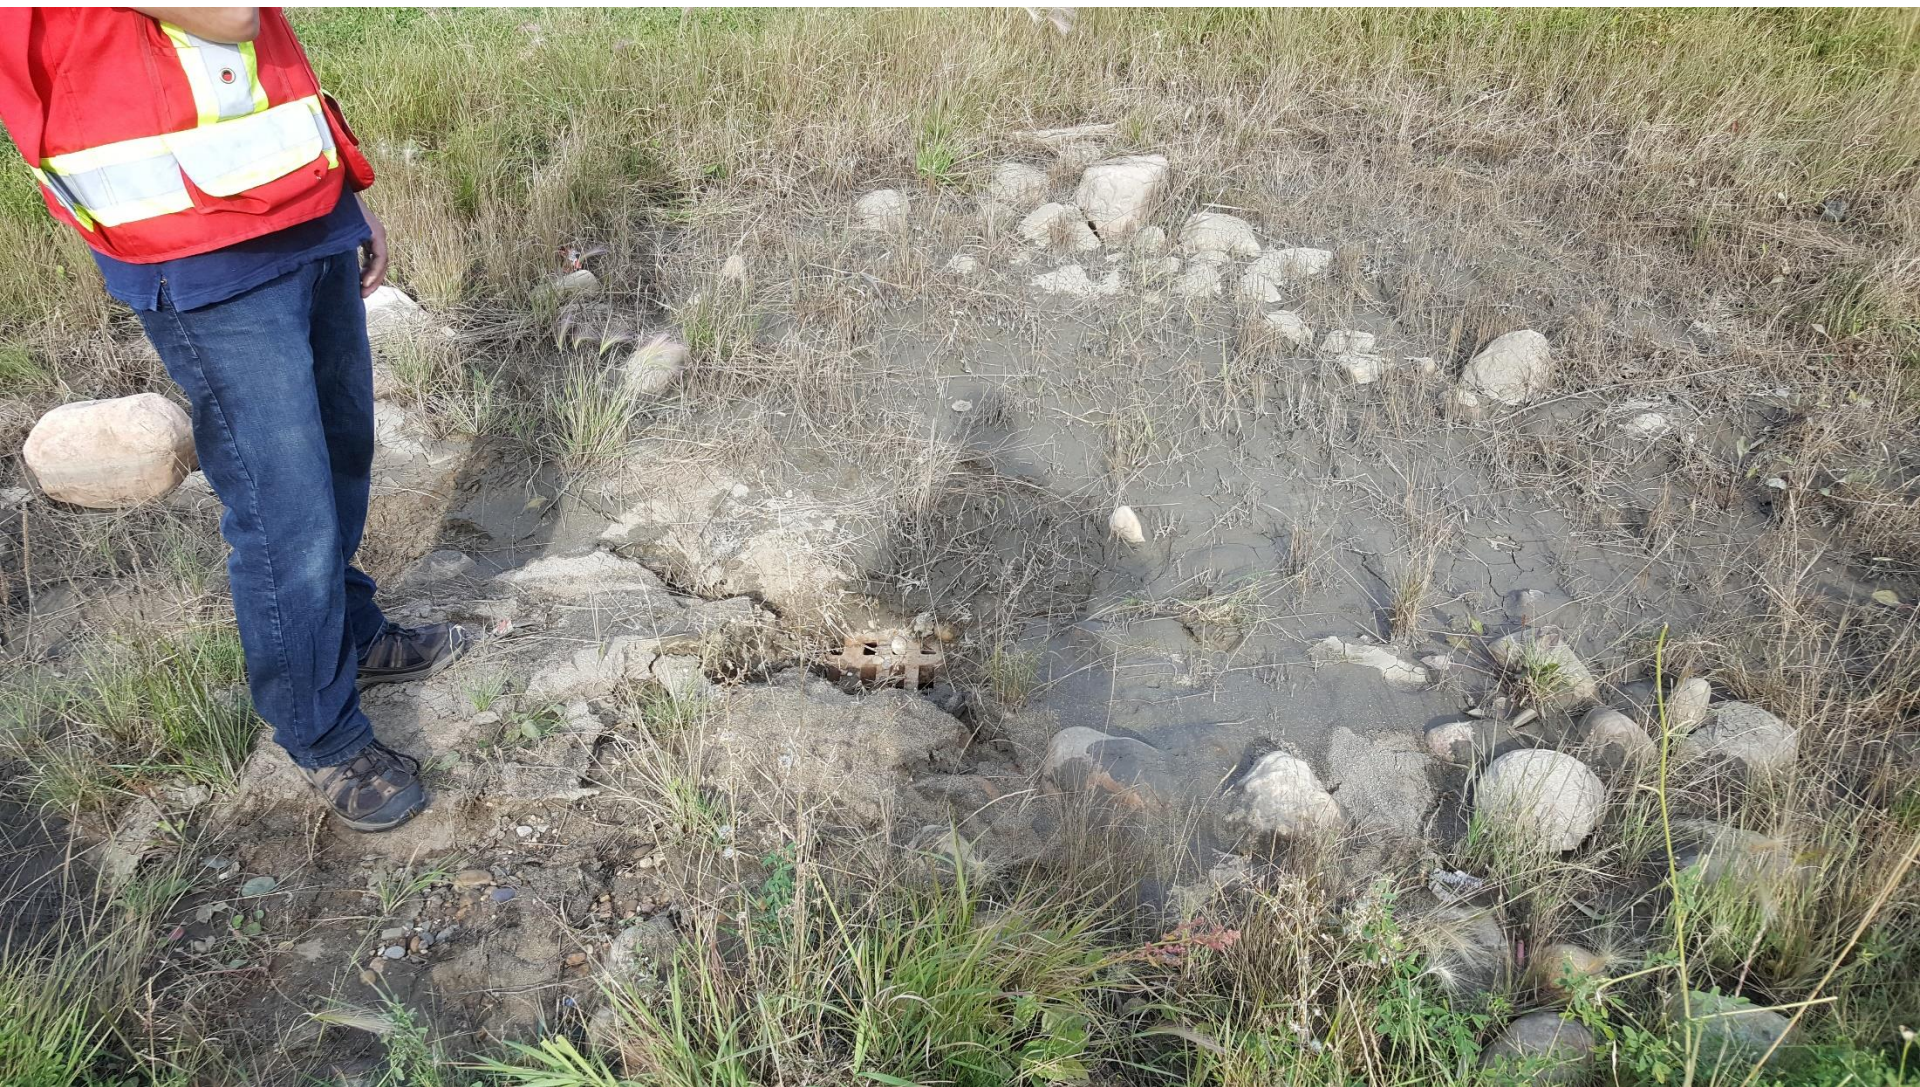
Hwy 55 NW corner of bridge – catch basin at toe
