Note: Photos taken on July 17, 2008

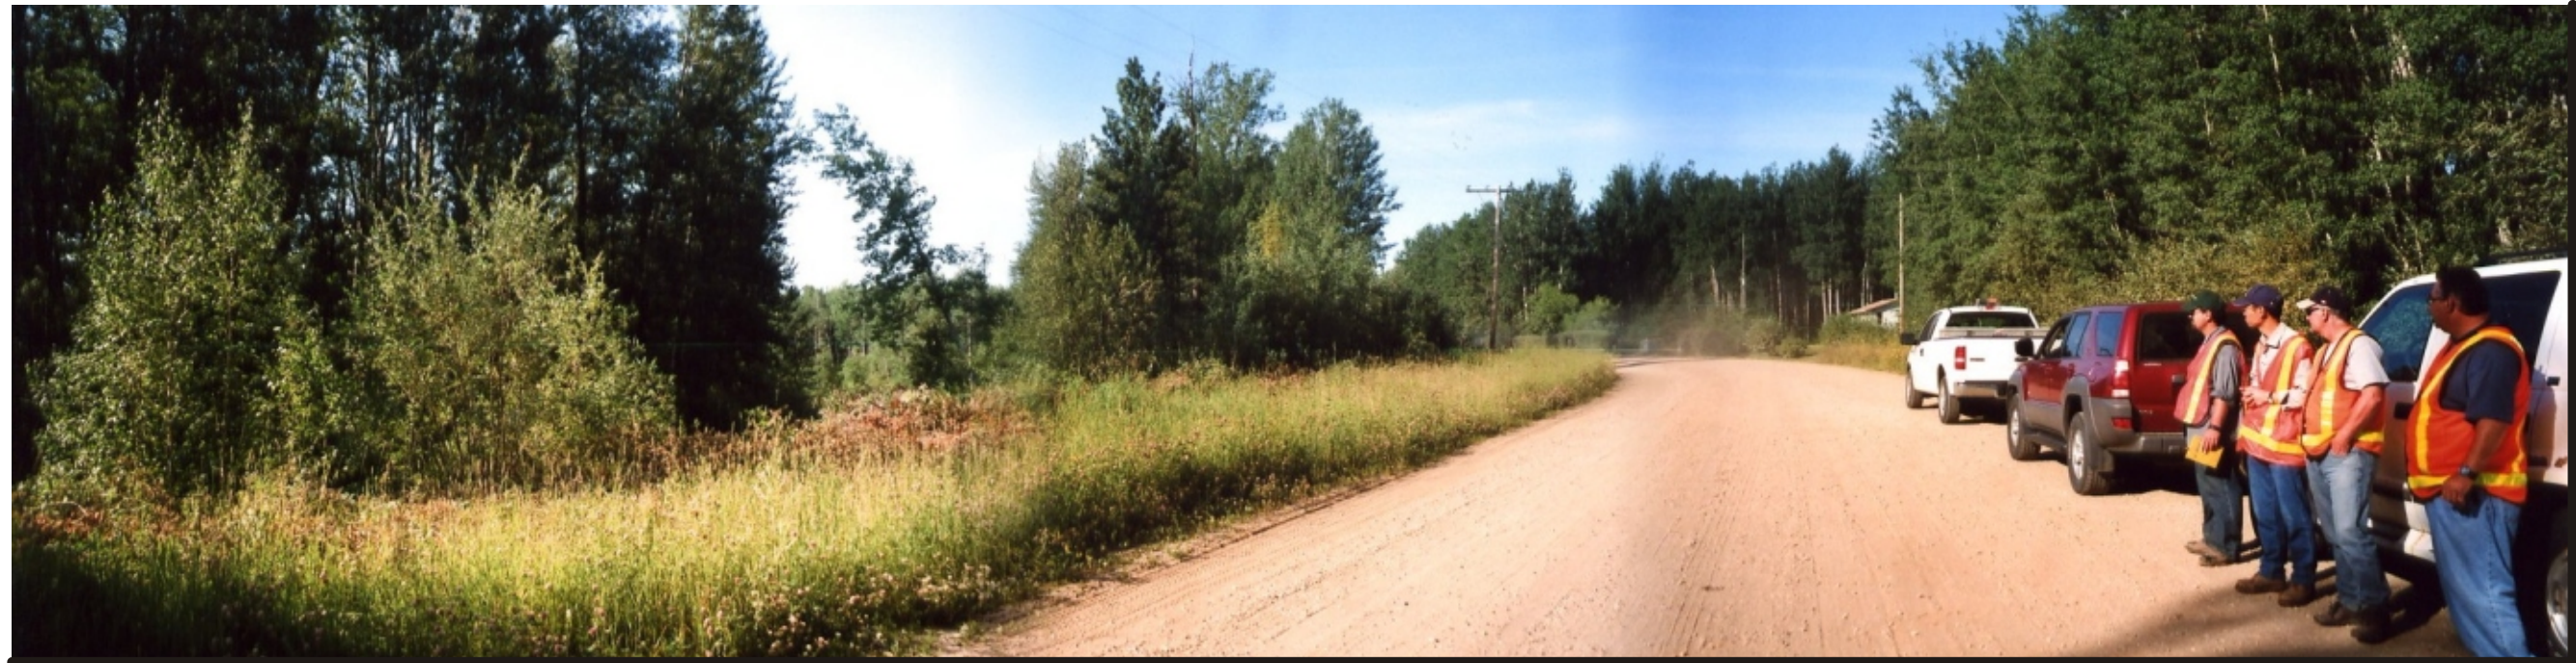
Photo 1

Looking south away from Hwy 2:50 junction

- Drift Pile River running north (on left of photo) (on east side) beside local road
- On left (east) side, top of eroded bank at about 7m setback to edge of local road
- On right (west) side, edge of local road is offset about 14m from a dugout pond

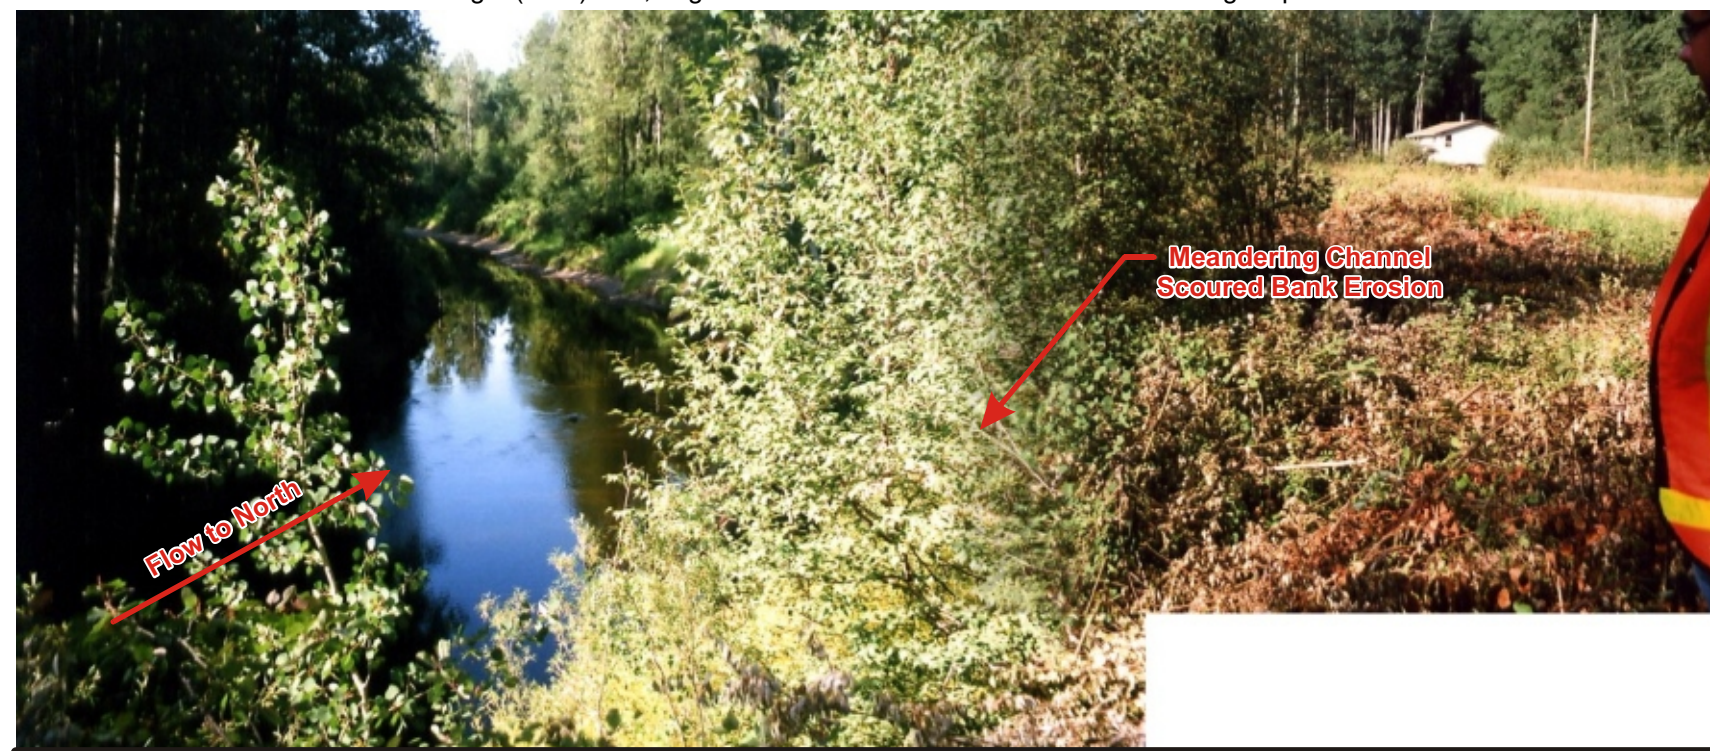
Photo 2

Looking south upstream from top of setback

- A meander scour bank is being eroded to encroach towards the roadway
- Roadway on right side of photo

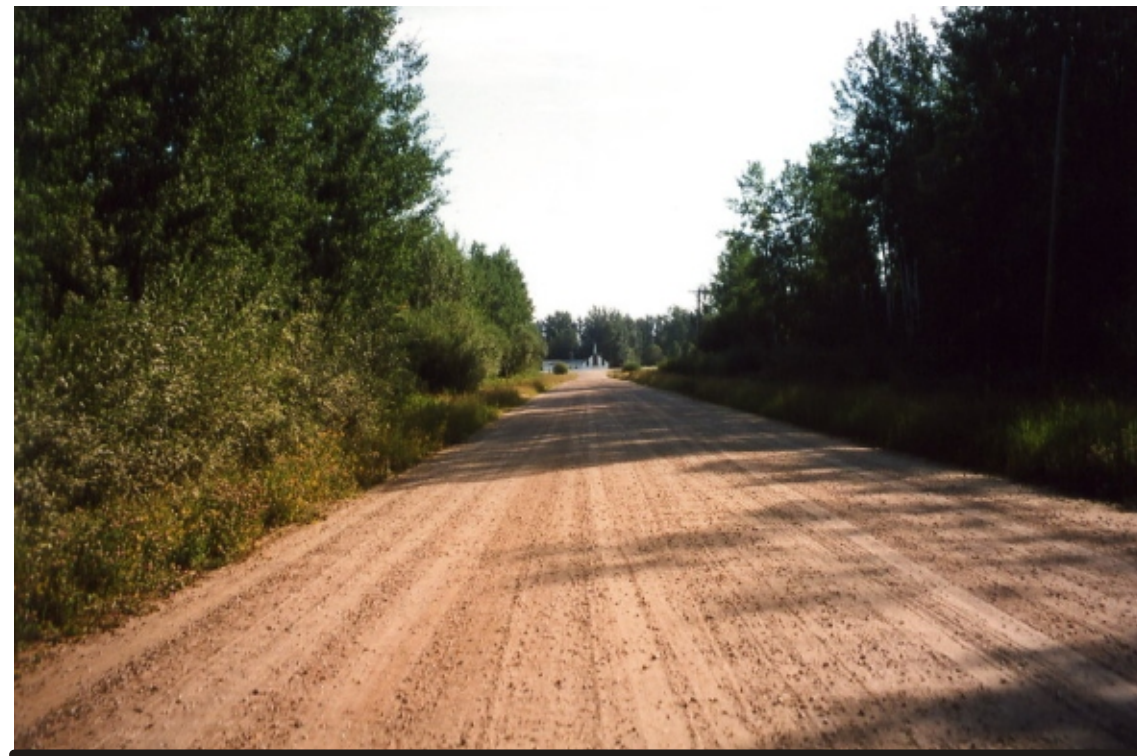
Photo 3
Looking north towards junction Hwy 2:50
- Drift-Pile River on east side (right of photo)
- Dugout pond on west side (left of photo)
