SITE NUMBER AND NAME <b>C48 H575:04 Road Settlement</b>		HIGHWAY & KM km 9	PREVIOUS INSPECTION DATE June 14, 2012	INSPECTION DATE <b>May 16, 2013</b>
LEGAL DESCRIPTION 11-29-23-W4	NAD 83 COORDINATES N 5704031 E 351107		RISK ASSESMENT PF: 9    CF: 4    TOTAL: <b>36</b>

**Central Region GeoHazard Assessment  
Site C48B H575:04 Pavement Settlement  
May 2013 Inspection Report**

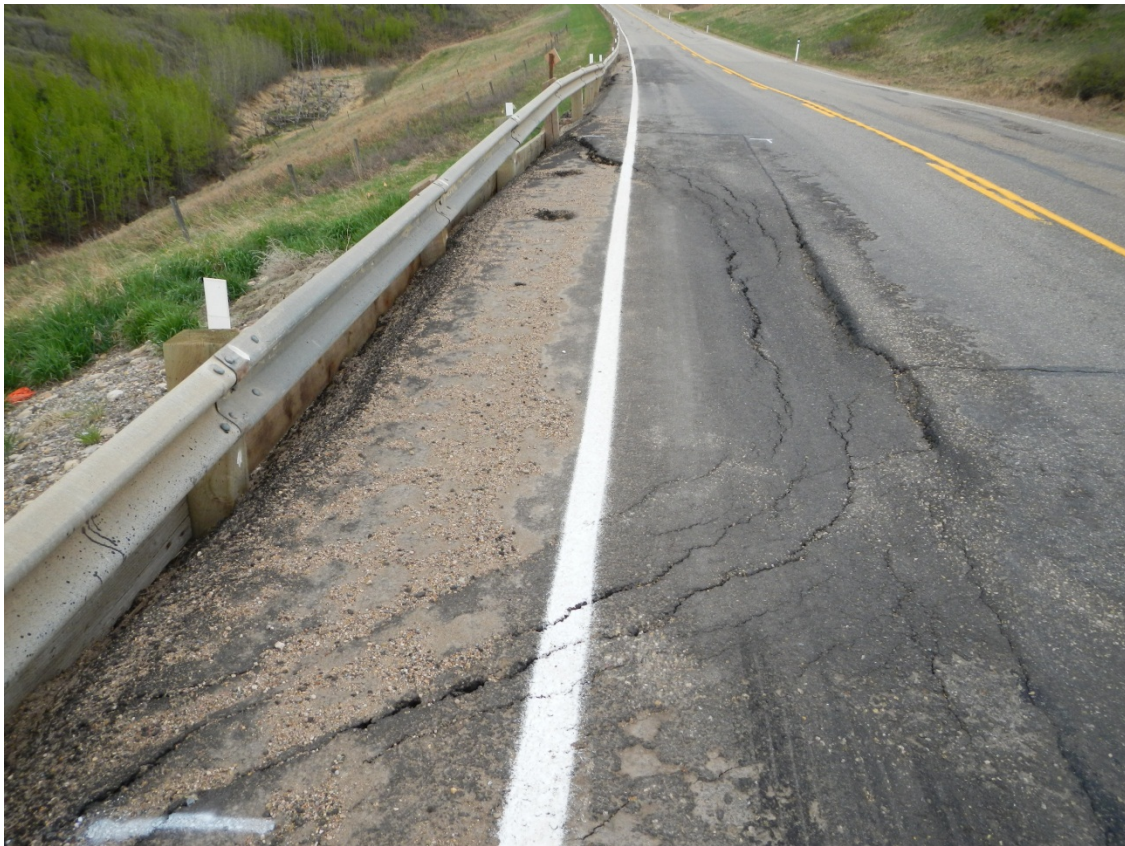
- Settlement of the approx. 15 m long zone has continued with a semi-circular crack pattern extending into the road. Displacement of the reset guardrail to the south is also apparent.
- The slope below the highway is slightly undulating possibly indicating some surficial movement. An area of vegetation is also located in the slide area indicating a source of groundwater may be present at this site.

The site observations indicate that the downslope movements continue at this site and are worse in wet years. The movement appears to be contained to the upper portion of the slope below the highway (less than 3 m depth). However, the fact that movement rates are increasing indicates that some form of repair will likely be required to mitigate movements and reduce the required patching frequency. The elevated water table may also be contributing to the movement observed; however, the water table is likely below the zone of movement at highway level.

Patching should be continued as required to reduce the hazard to traffic. To reduce the patching frequency, the following methods could be adopted:

For this site, it is considered that the driven pile wall provides the lowest risk approach to reduce the slide movements at a cost similar to other repair methods. To reduce costs further, it is possible to install the piles only over the 15 m long critical section (say 20 piles) to assess the effectiveness of the approach. The estimated cost for this would be about \$60,000.
