July 15, 2025

CON0022160 Central Region GRMP Instrumentation Monitoring
Site C067; H21:14, km 12.988 Kneehill Creek Slide
Section C – 2025 Spring Readings

PROJECT
CENTRAL REGION GEOHAZARD RISK MANAGEMENT PROGRAM

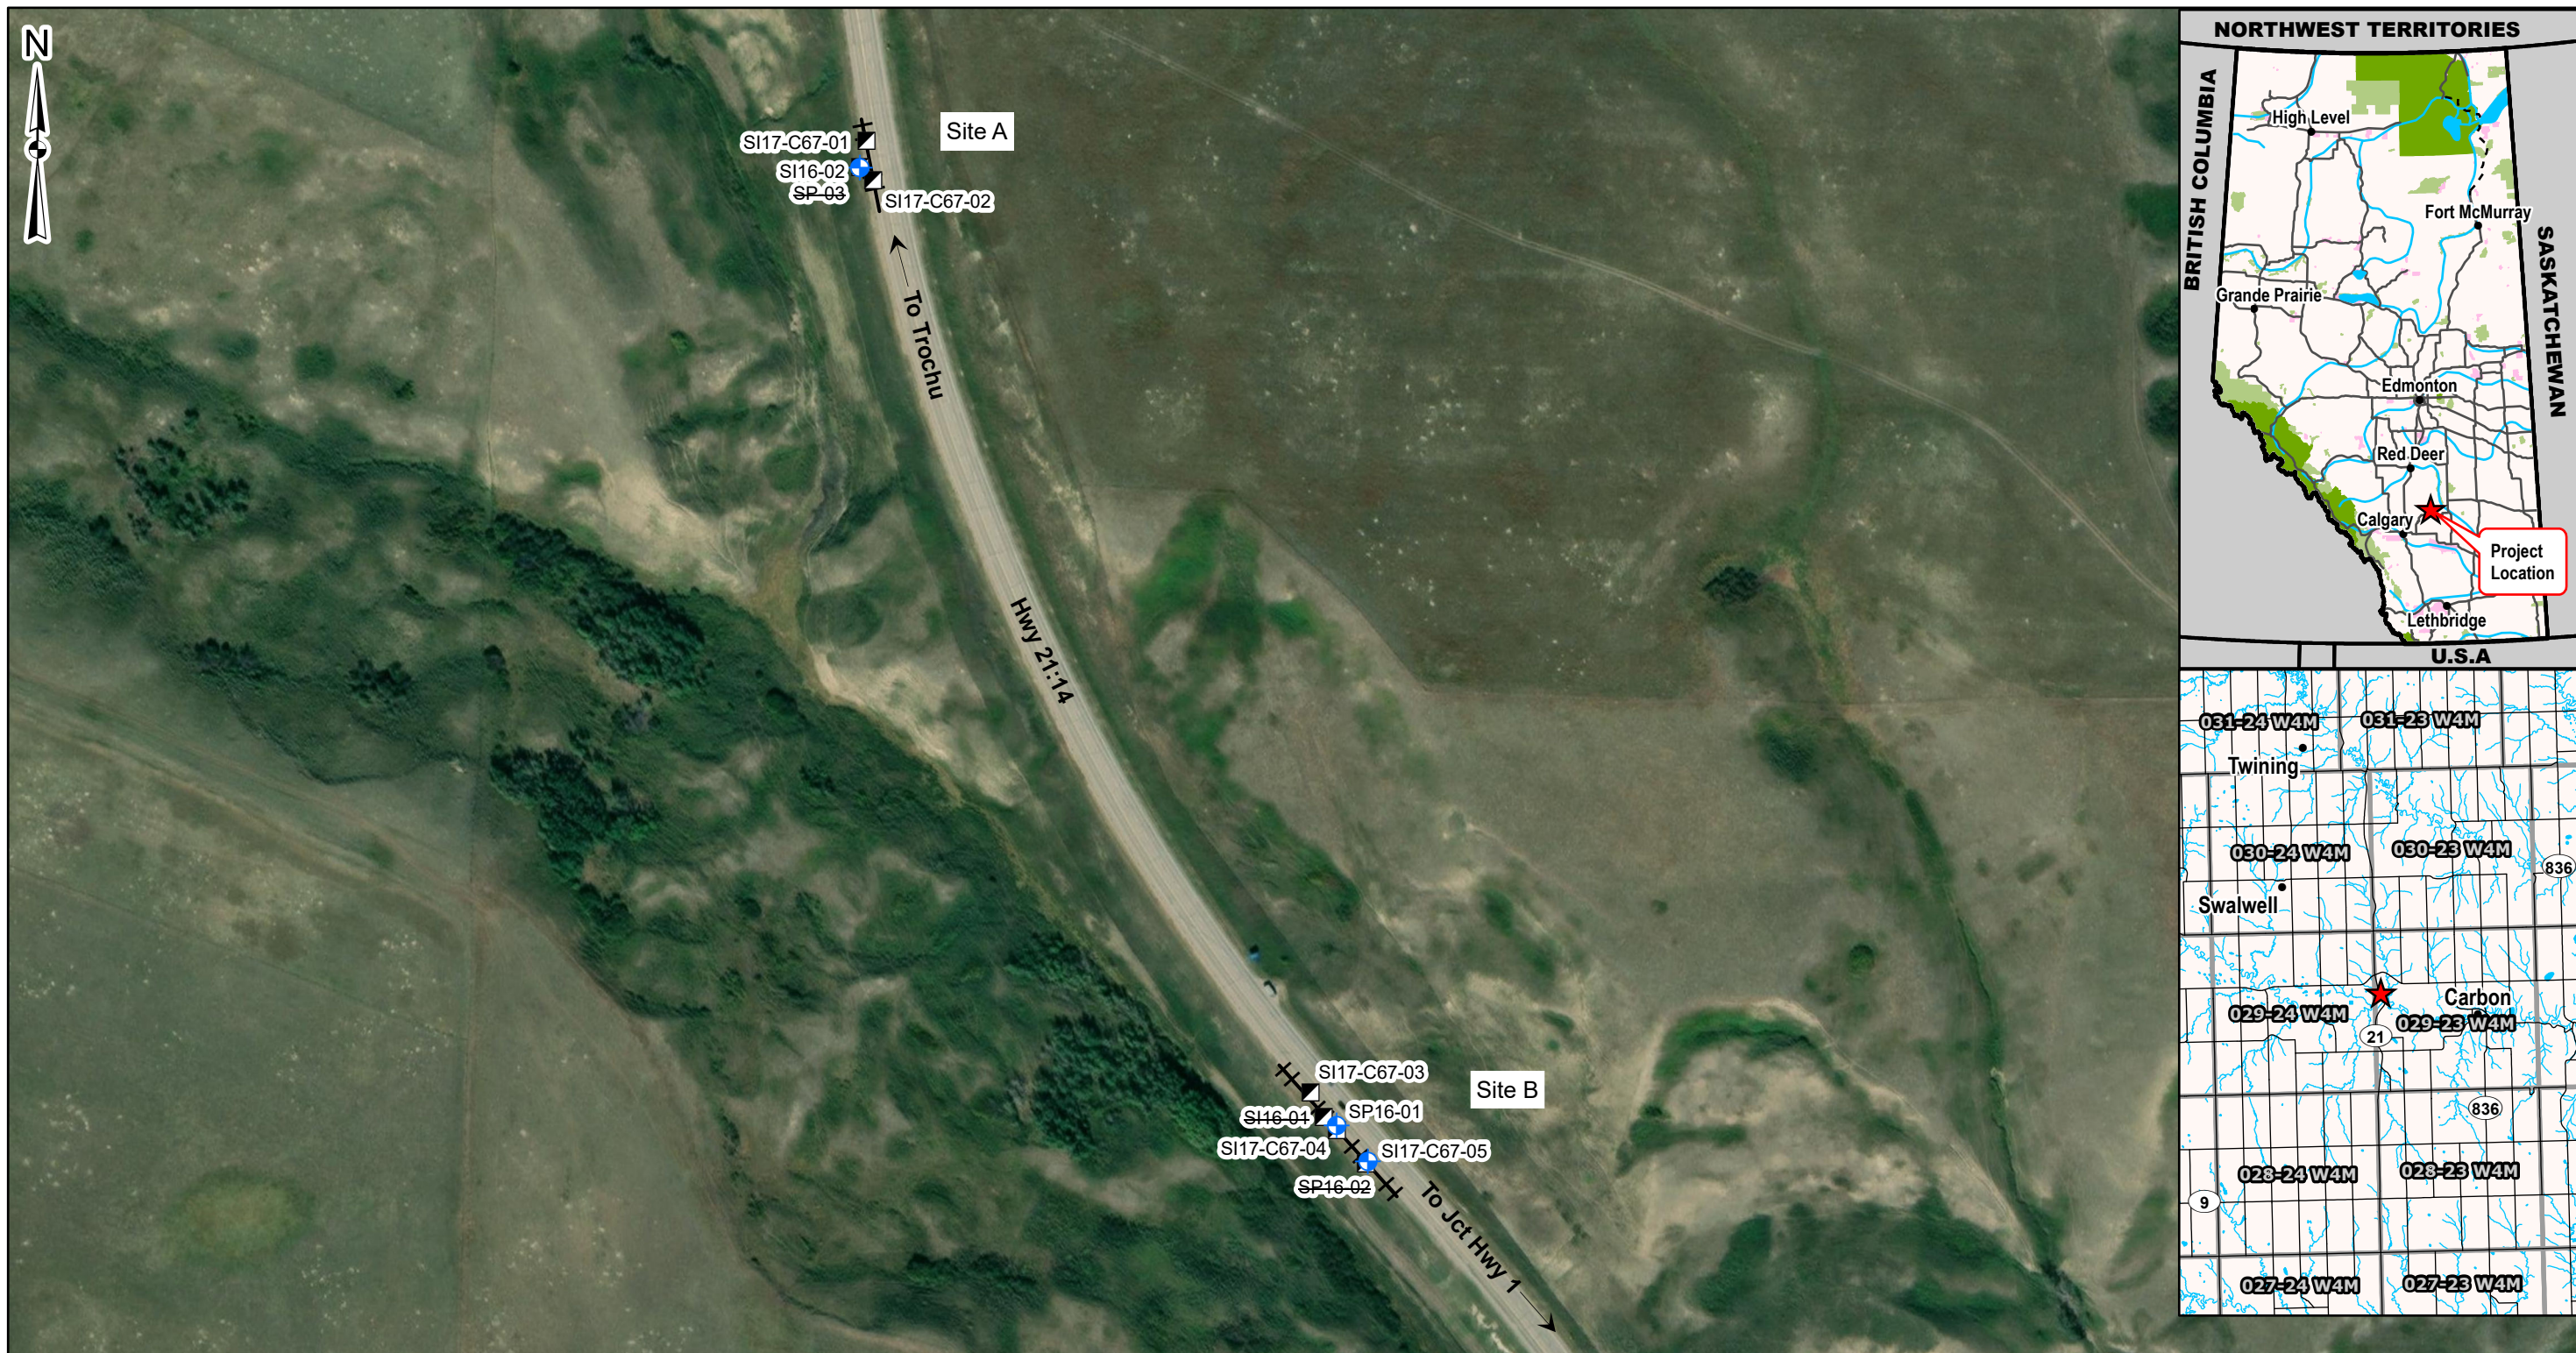
TITLE
Site Plan
C067 - Kneehill Creek Slide
Hwy 21:14, km 12.988

The geohazard at the C067 site consists of two slope failures along the west highway embankment slope. The two slope failures are referred to as Site A, which is at the north extent of the site, and Site B, which is at the south extent of the site (higher and lower elevations, respectively).

In April 2017, a 15-m-deep, 80-m-long H-pile wall (H360X132) consisting of 112 piles was installed at Site A, and a 16-m-deep, 42.5-m-long H-pile wall (H360X132) consisting of 60 piles was installed at Site B. The location and extents of the H-pile walls are presented in Figure 1. Additional remedial actions include regular pavement maintenance (e.g., patching or chip sealing).

In 2016, KCB installed one SI (SI16-02) and one SP (SP16-03) at Site A, and one SI (SI16-01) and two SPs (SP16-01 and SP16-02) at Site B to monitor depth of movement and groundwater conditions, respectively. The instruments were installed on the west shoulder of Hwy 21:13 between the guardrail and H-pile walls. By May 2019, SI16-01, SP16-02, and SP16-03 were inoperable.

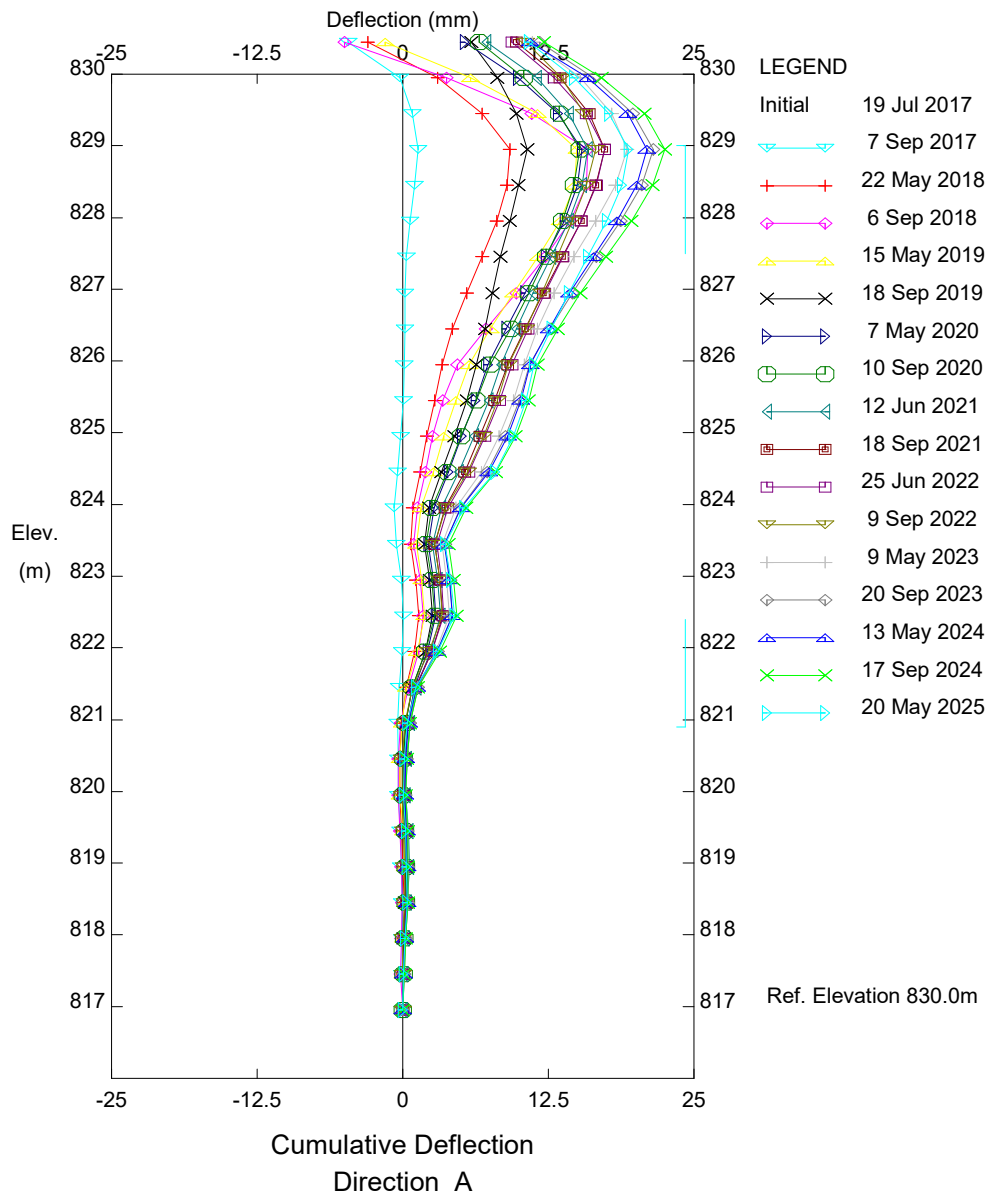
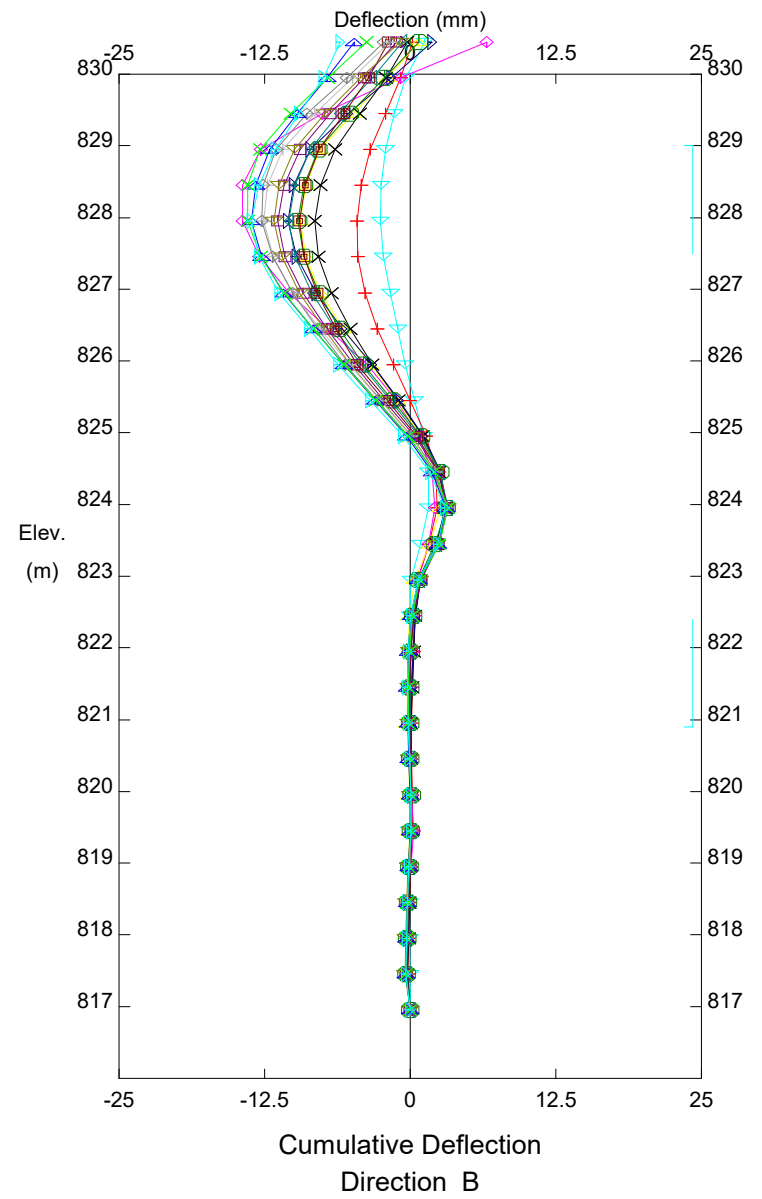
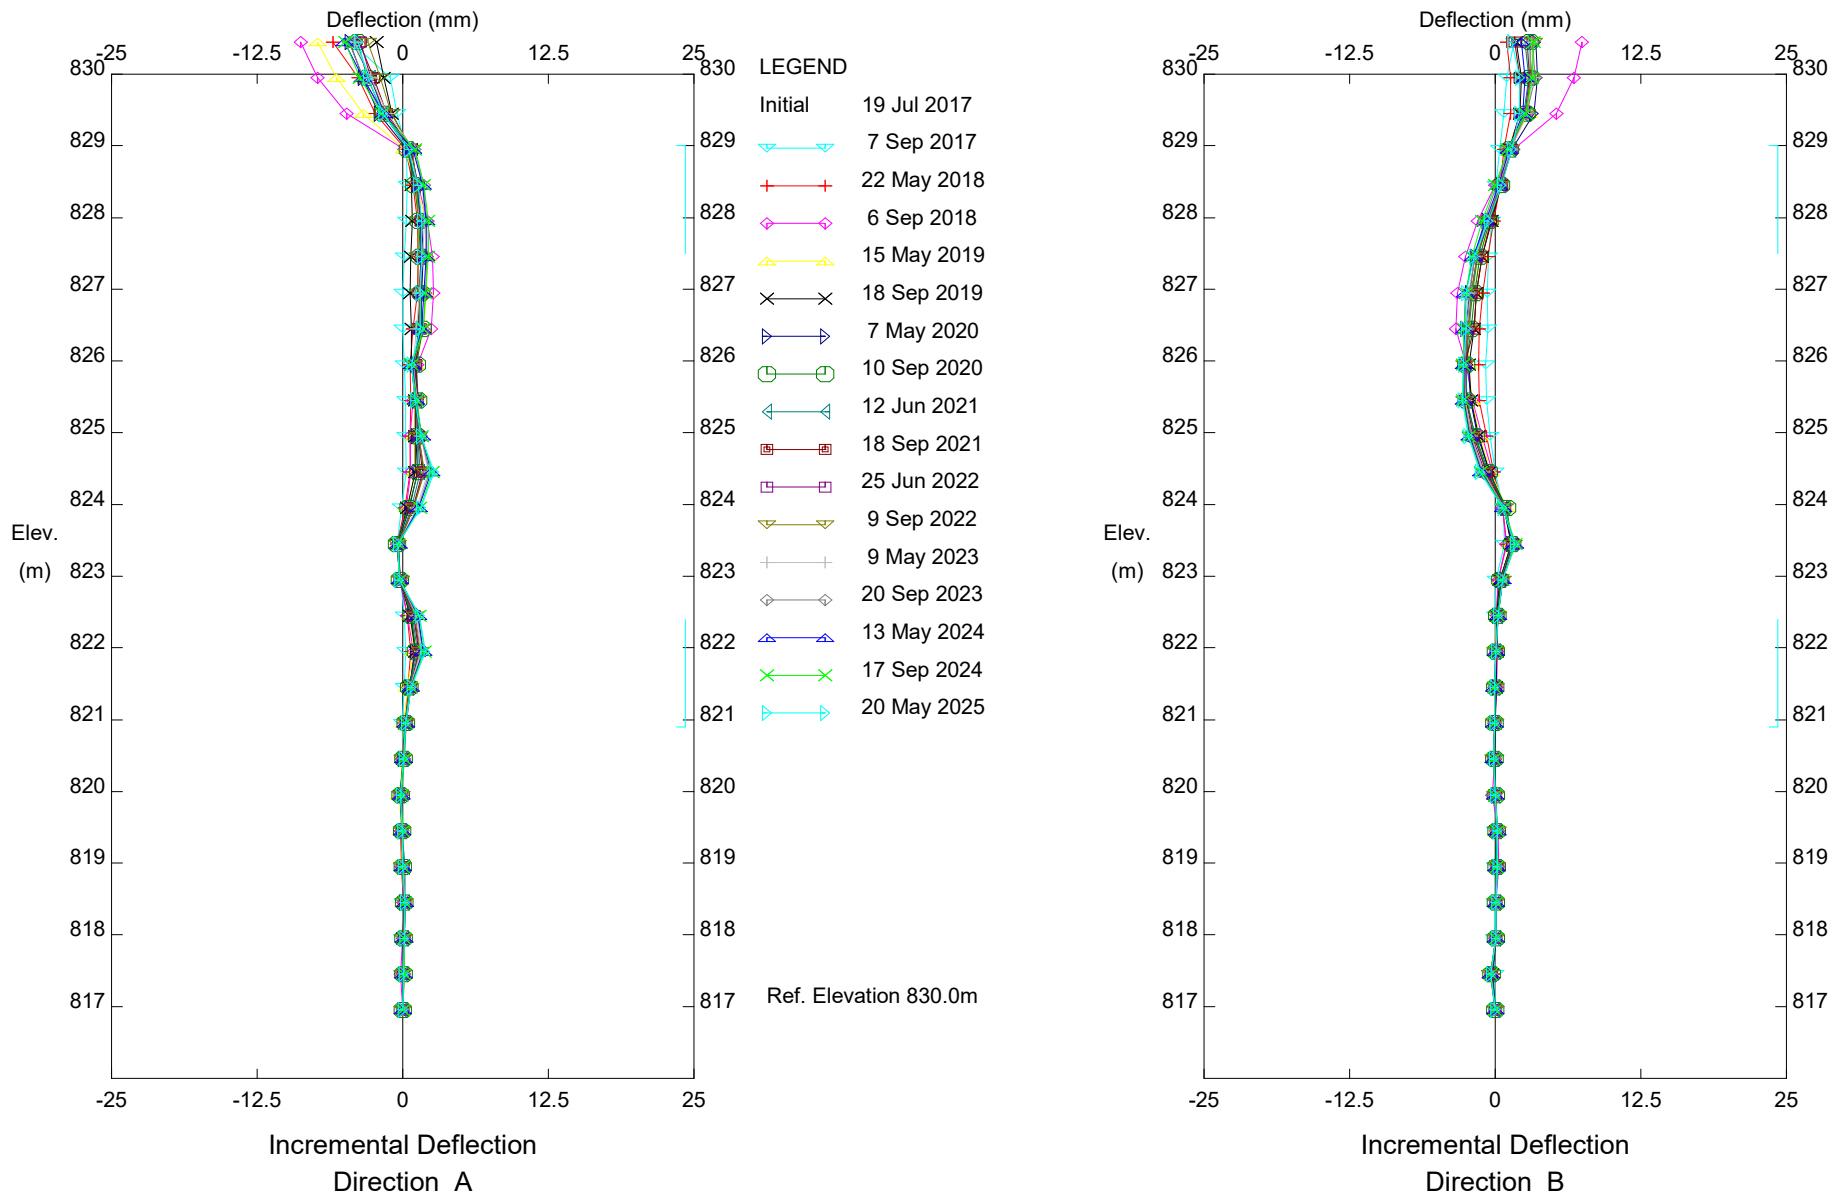
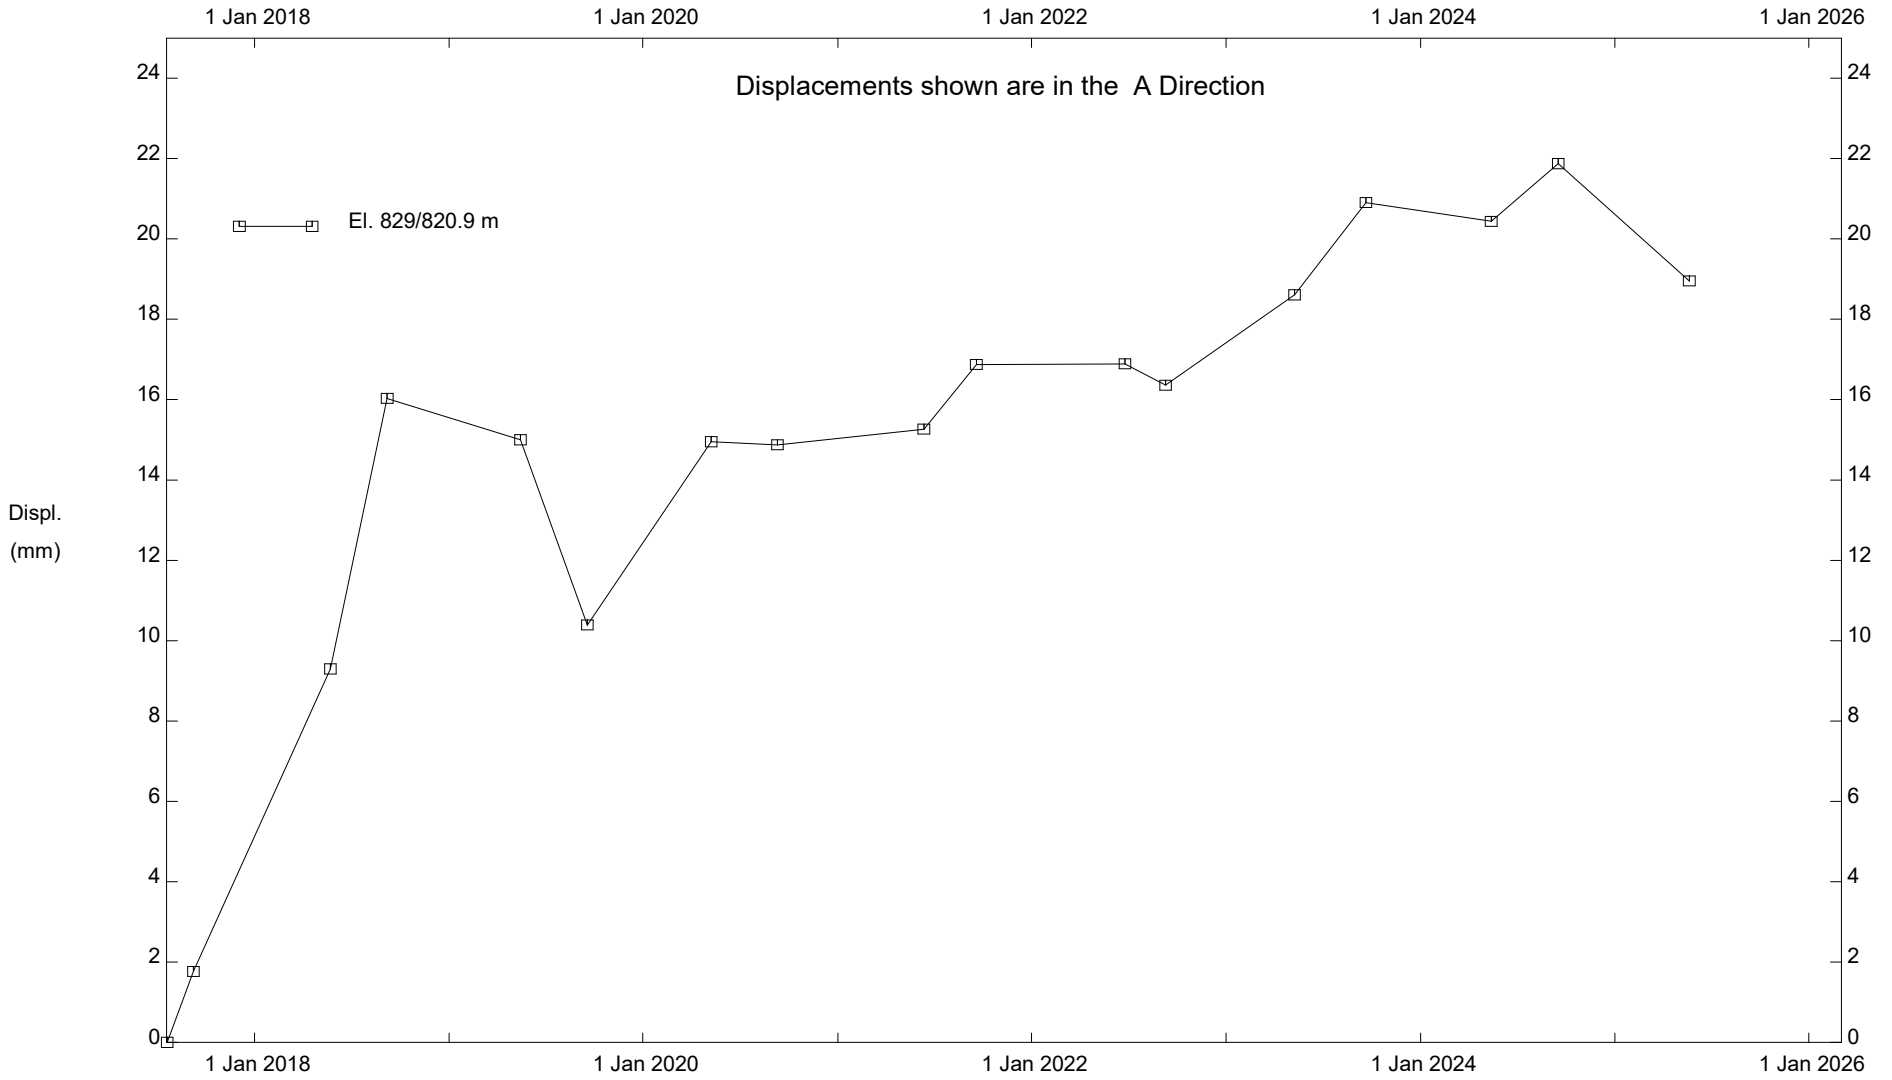
C067; H21:14, Kneehill Creek Slide, Inclinometer SI16-02

Distributed movement is being recorded in SI16-02 (downslope of the Site A H-pile wall) from near ground surface to approximately 9 m below ground surface or approximately 6.5 m above the base of the H-pile wall.

Data obtained from SI16-02 (installed upslope of the H-pile wall) indicates the active block upslope of the H-pile wall continues to creep as the H-pile wall stabilizes the sliding mass. Before the H-pile wall was installed, the maximum rate of movement recorded in SI16-02 was approximately 205 mm/year on February 21, 2017. Between April and May 2017, after installation of the H-pile wall, the rate of movement recorded in SI16-02 increased to approximately 345 mm/year. Since September 2018, the overall rate of movement recorded in this instrument has been relatively steady (less than approximately 3 mm/year). The relatively large negative displacement recorded in May 2025 may be due to noise.

Negative rates of movement recorded in May 2025 in both SI16-02 and SI17-C067-01 indicate the movement in Site A is slow and within the reading accuracy of the SI equipment.

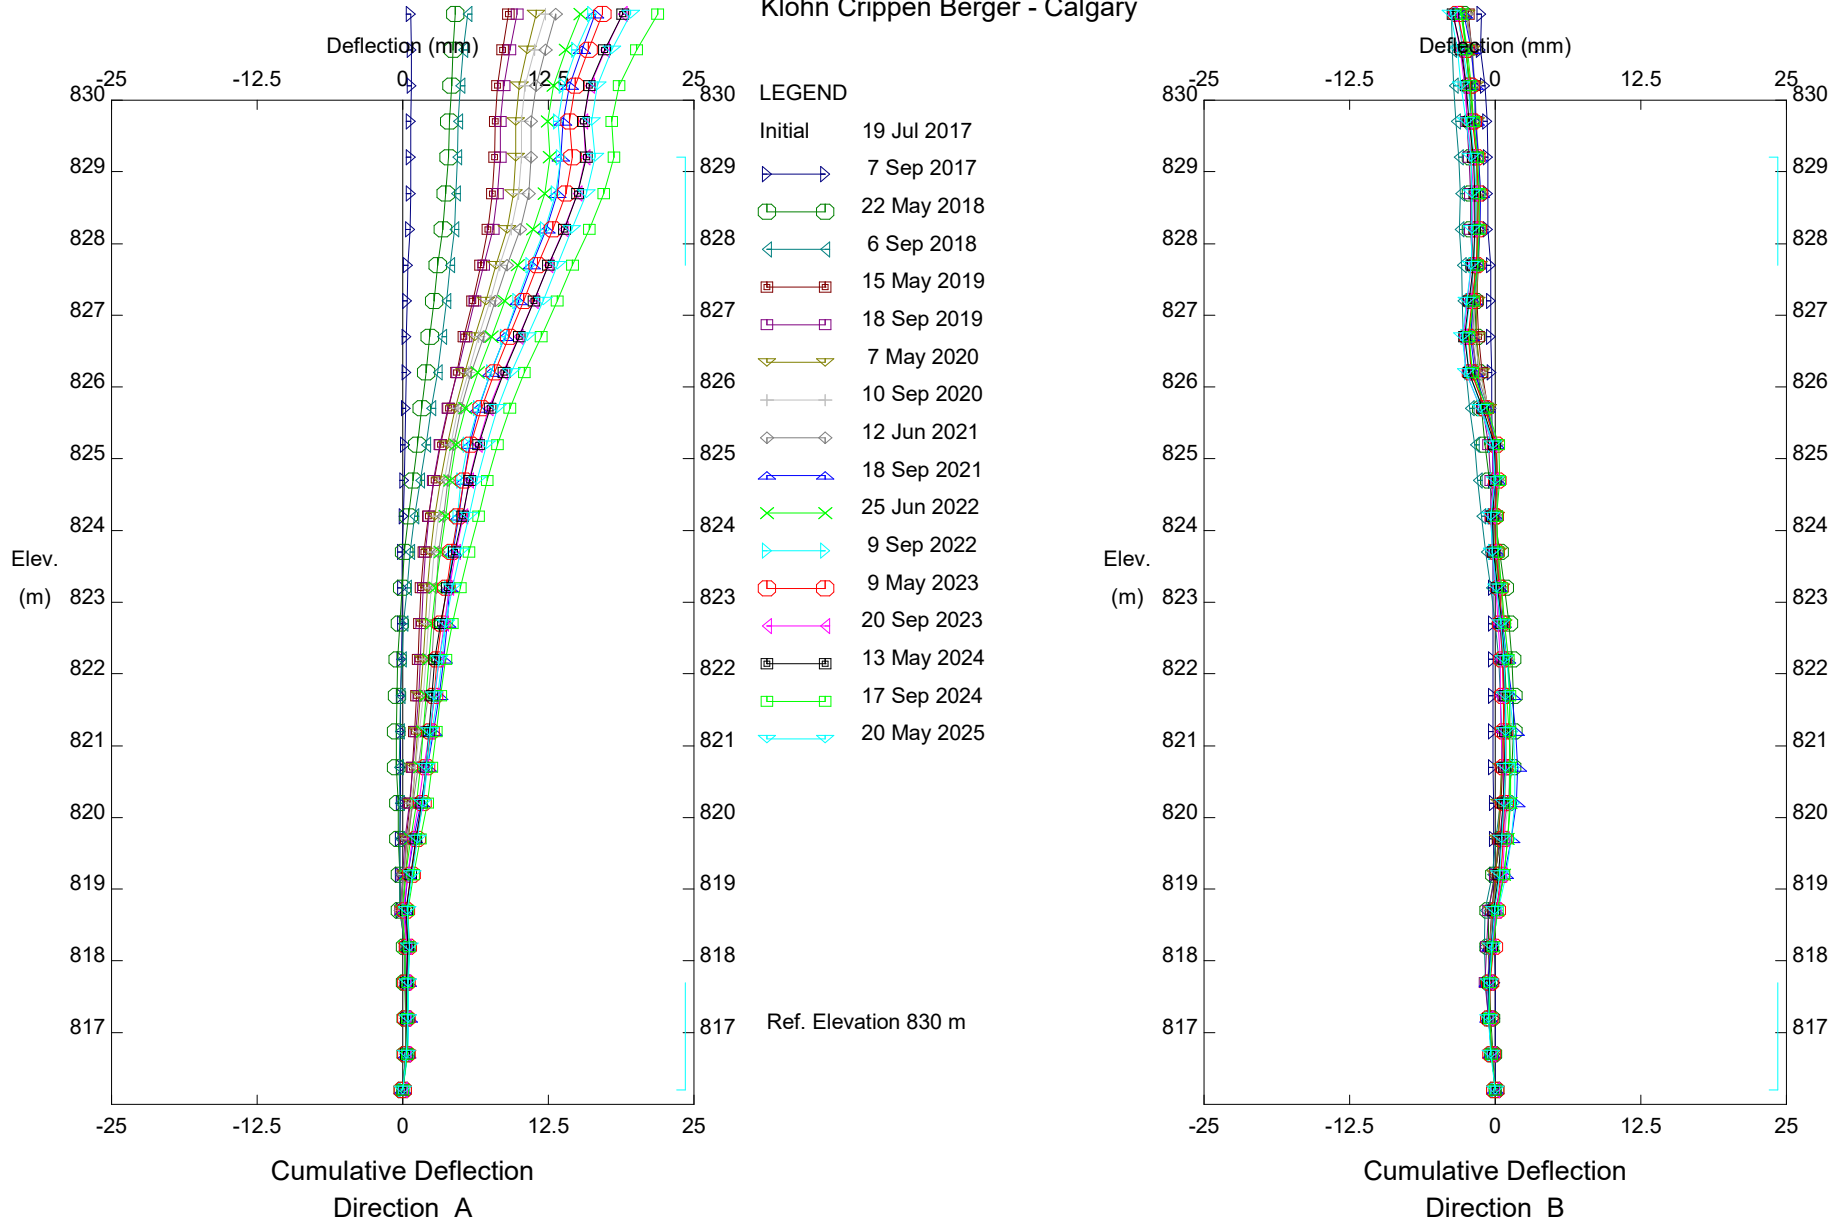
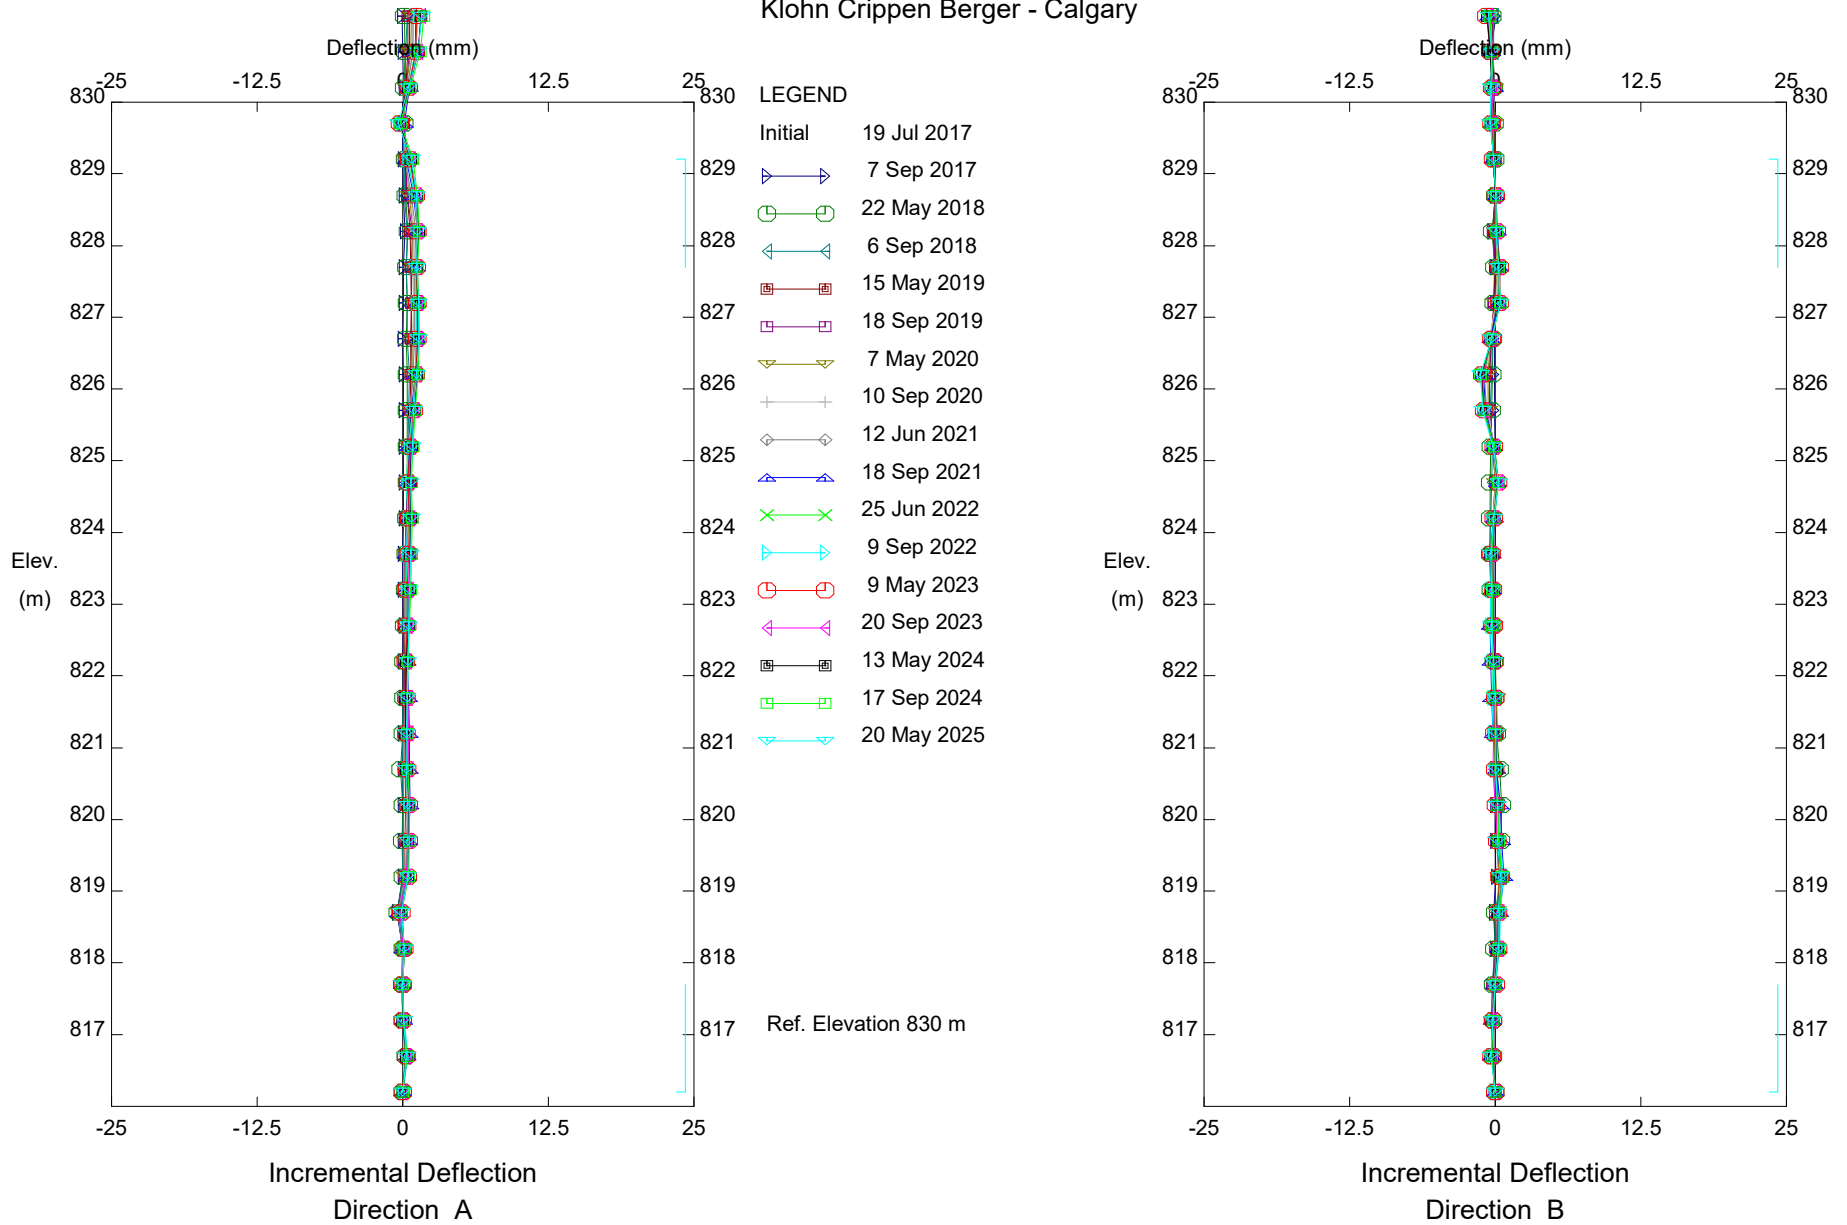
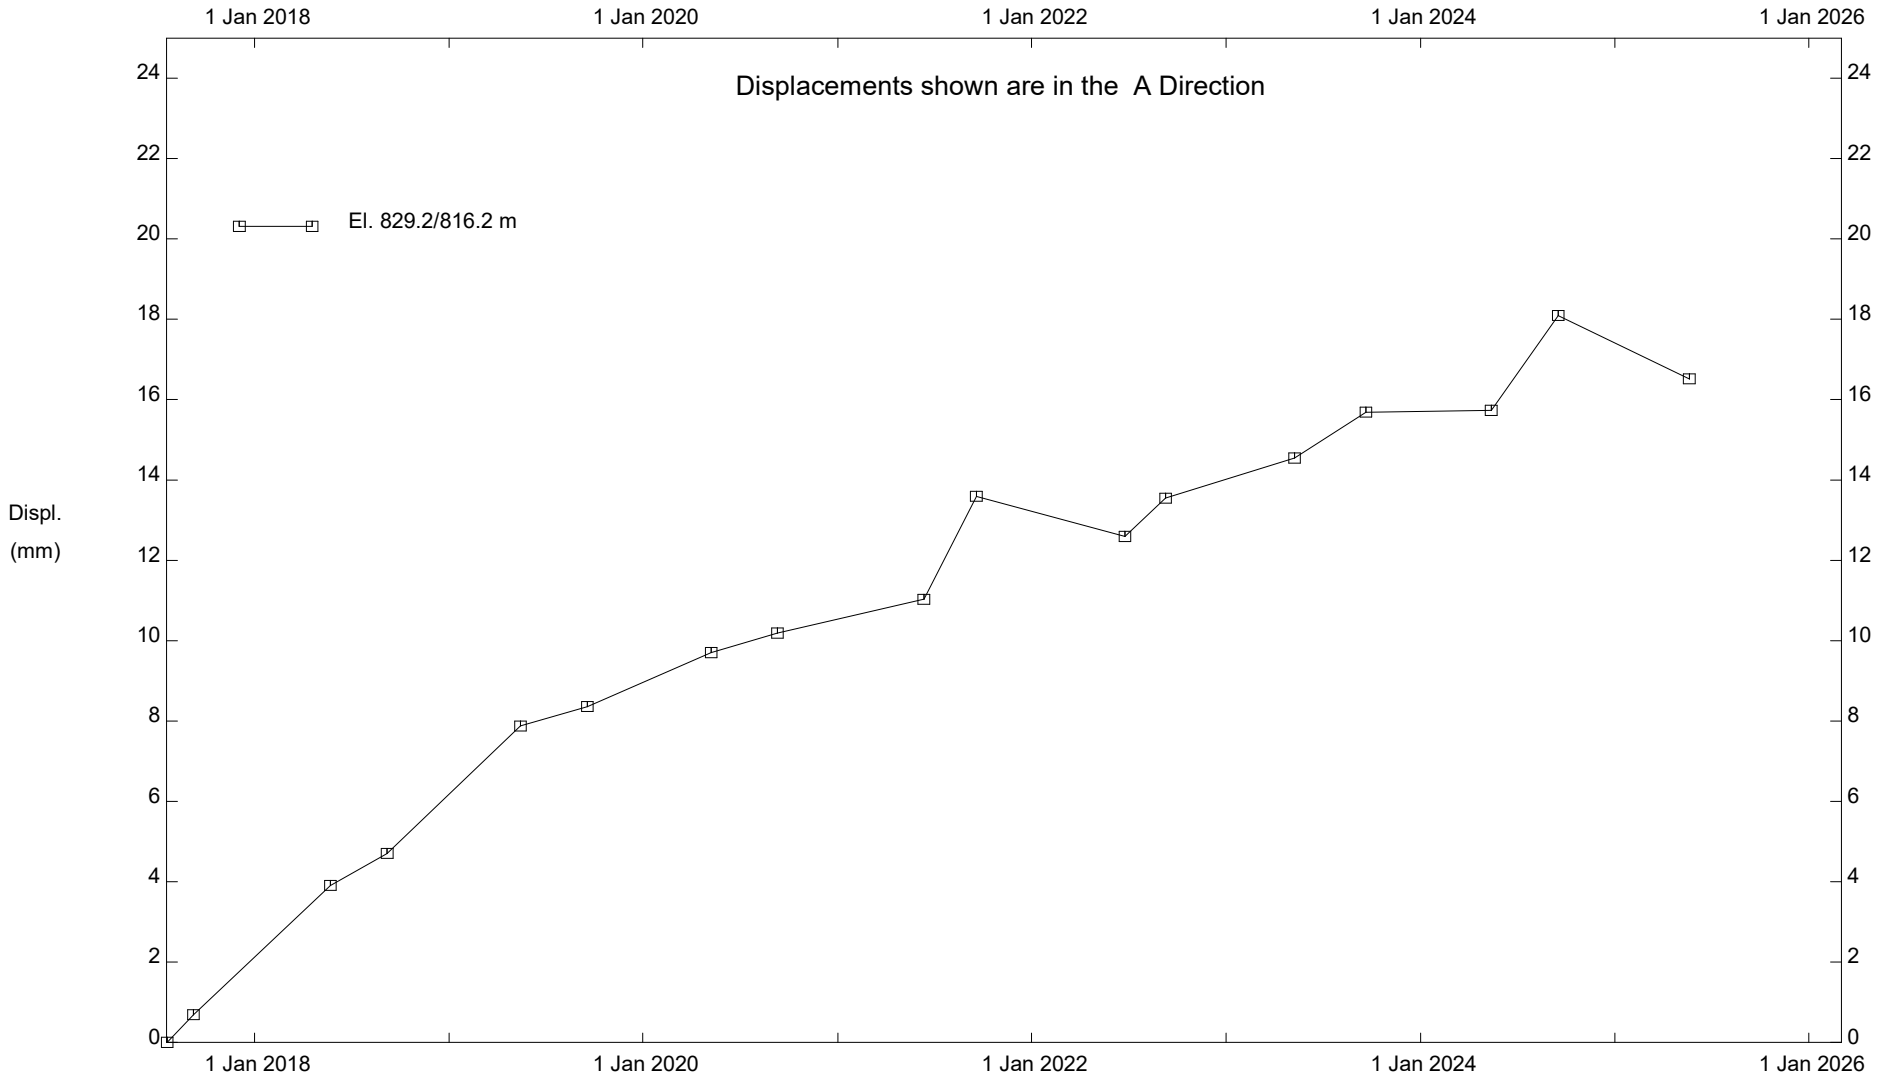
C067; H21:14, Kneehill Creek Slide, Inclinometer SI17-C67-01

Distributed movement is being recorded in the SIs installed in the H-pile wall (SI17-C67-01 and SI17-C67-02) from top of casing to an approximate depth of 11 m below ground surface or approximately 4 m above the base of the H-pile wall.

The deepest zone of movement being recorded in the pile-wall SIs (SI17-C67-01 and SI17-C67-02) appears to be approximately 2 m below the depth of movement recorded in SI16-02. This indicates the H-pile wall has intercepted the failure surface and is continuing to deflect, transferring load to depths below the failure plane as the piles stabilize the sliding mass.

The May 2025 data obtained from SI17-C67-01 and SI17-C67-02 indicates the top of the H-pile wall at Site A has deflected approximately 20 mm since installation. In May 2017, the maximum rate of movement recorded in SI17-C67-01 and SI17-C67-02 was approximately 45 mm/year, one month after the H-pile wall was installed. The rate of movement has since slowed and is now generally less than 3 mm/year, excluding:

- between May and September 2021, when an increased rate of movement of approximately 10 mm/year was recorded in SI17-C067-01, which may be attributed to wet weather in summer 2021. A similar increase was not recorded in SI17-C067-02.
- between June and September 2022, when an increased rate of movement of approximately 4 mm/year and 9 mm/year was recorded in SI17-C67-01 and SI17-C67-02, respectively, likely in response to wet weather in June and July 2022; and
- increased rate of movement was recorded in SI17-C67-01 between May and September 2024 of approximately 7 mm/year. The increased rate of movement may be attributed to construction activities on site (chip sealing along the C067 site was completed in summer 2024) and wet weather in August 2024 (approximately 55 mm precipitation versus the average of 45 mm recorded between 2015 and 2024).
