July 15, 2025

CON0022160 Central Region GRMP Instrumentation Monitoring
Site C067; H21:14, km 12.988 Kneehill Creek Slide
Section C – 2025 Spring Readings

PROJECT
CENTRAL REGION GEOHAZARD RISK MANAGEMENT PROGRAM

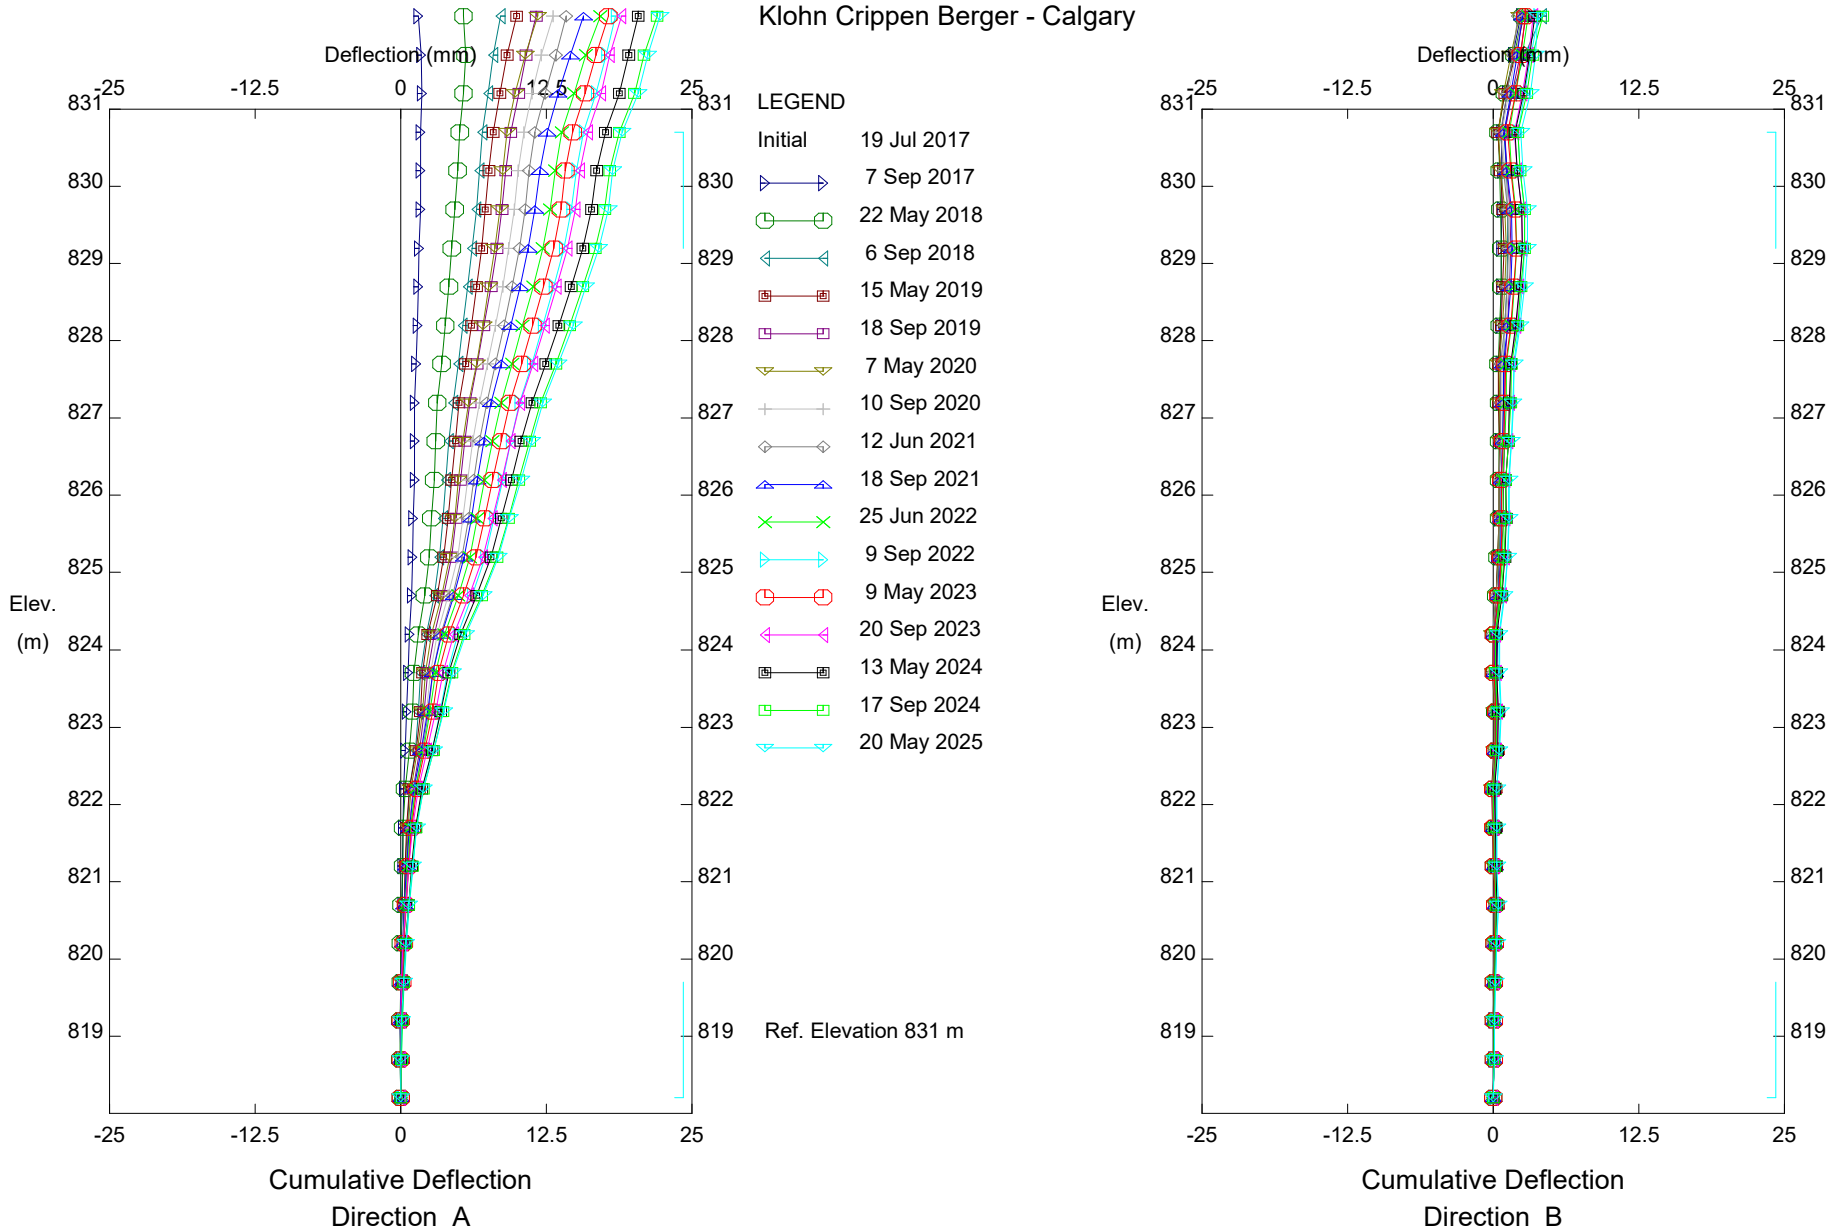
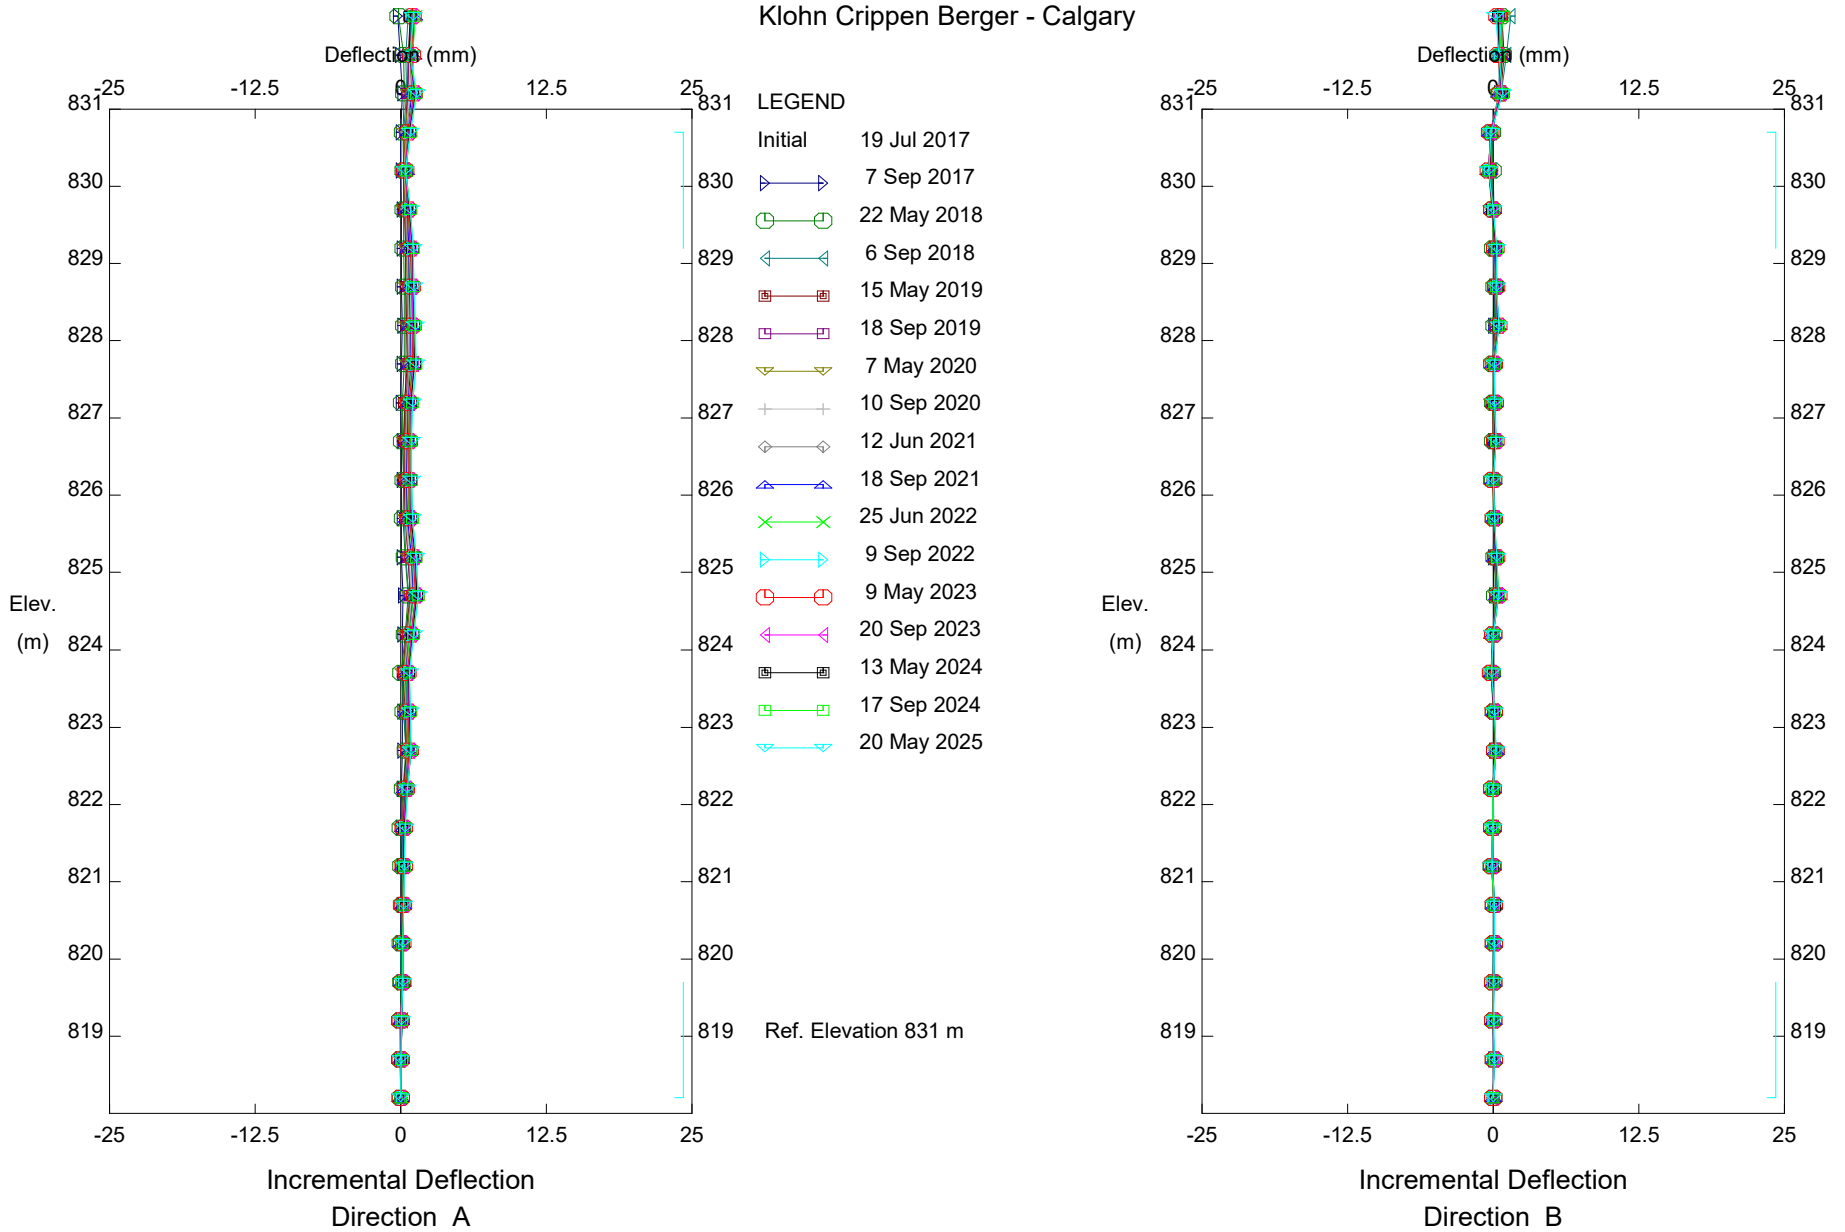
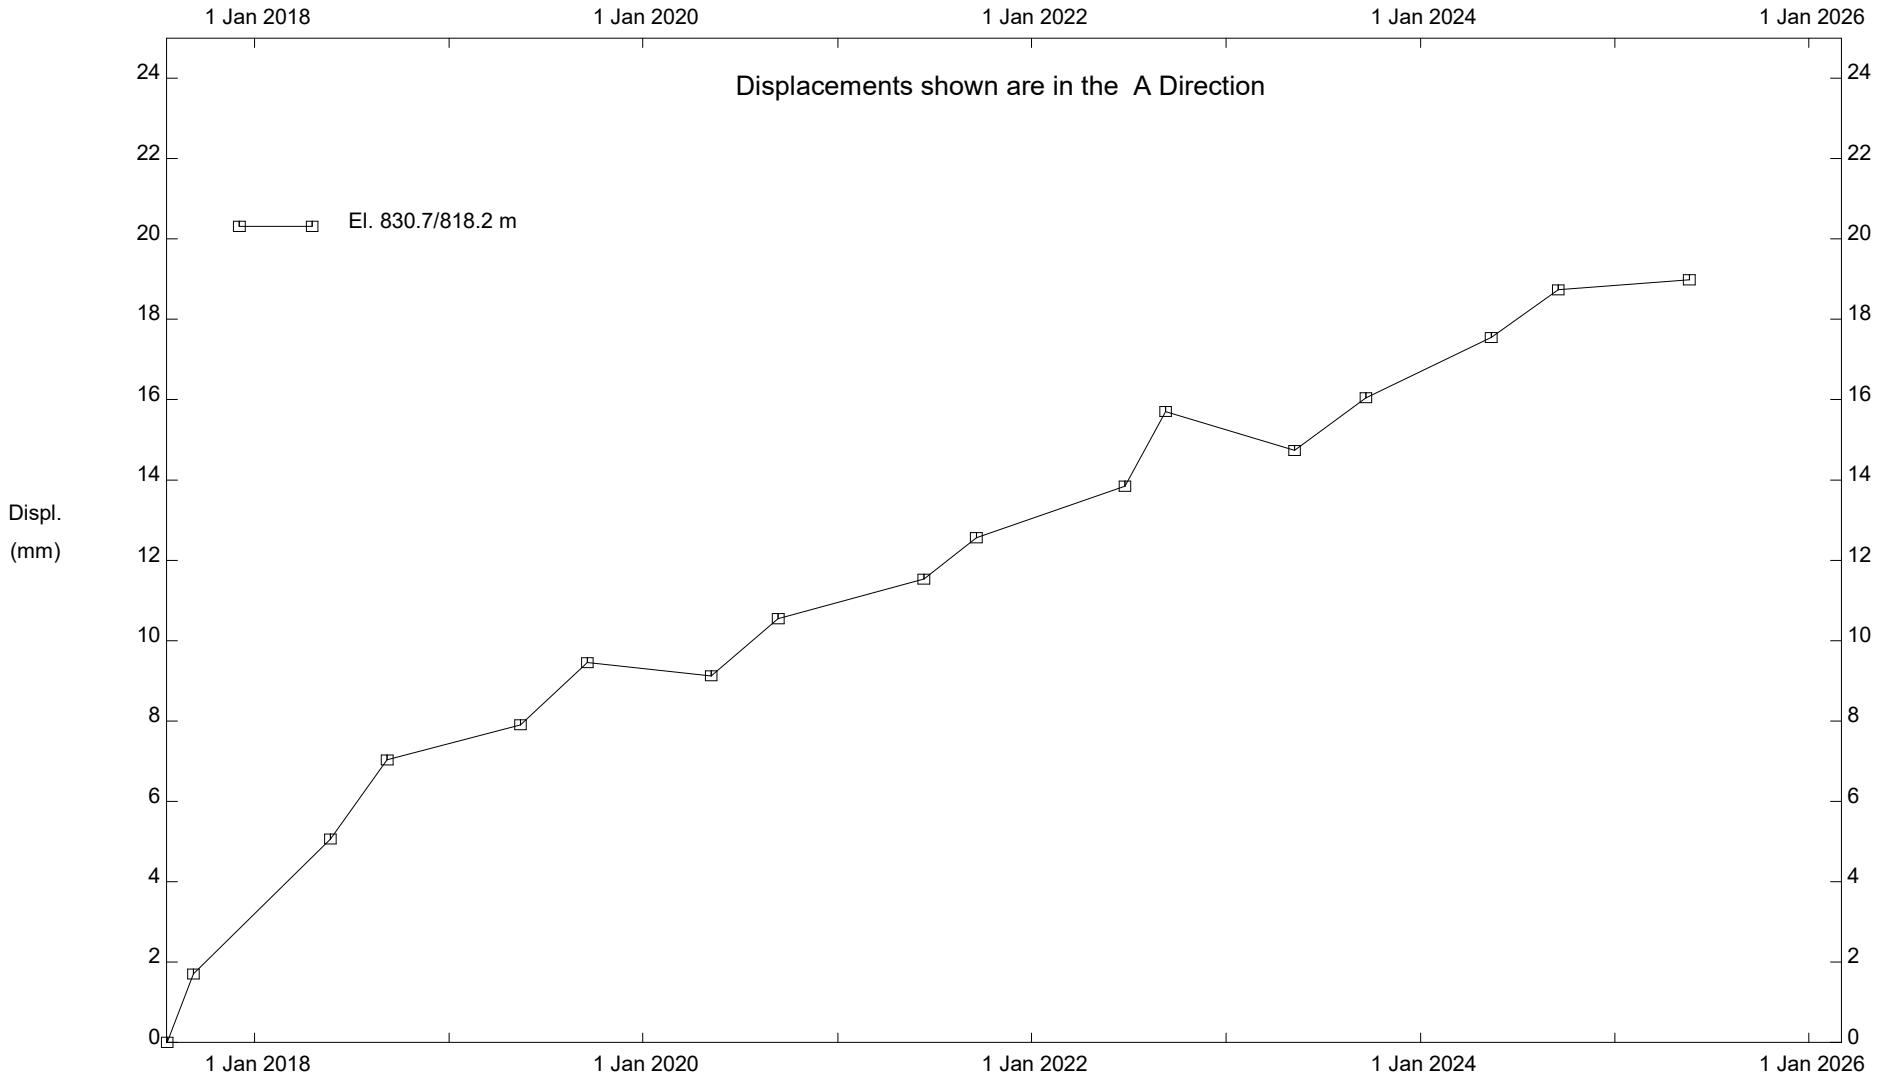
C067; H21:14, Kneehill Creek Slide, Inclinometer SI17-C67-02

Distributed movement is being recorded in the SIs installed in the H-pile wall (SI17-C67-01 and SI17-C67-02) from top of casing to an approximate depth of 11 m below ground surface or approximately 4 m above the base of the H-pile wall.

The deepest zone of movement being recorded in the pile-wall SIs (SI17-C67-01 and SI17-C67-02) appears to be approximately 2 m below the depth of movement recorded in SI16-02. This indicates the H-pile wall has intercepted the failure surface and is continuing to deflect, transferring load to depths below the failure plane as the piles stabilize the sliding mass.

The May 2025 data obtained from SI17-C67-01 and SI17-C67-02 indicates the top of the H-pile wall at Site A has deflected approximately 20 mm since installation. In May 2017, the maximum rate of movement recorded in SI17-C67-01 and SI17-C67-02 was approximately 45 mm/year, one month after the H-pile wall was installed. The rate of movement has since slowed and is now generally less than 3 mm/year, excluding:

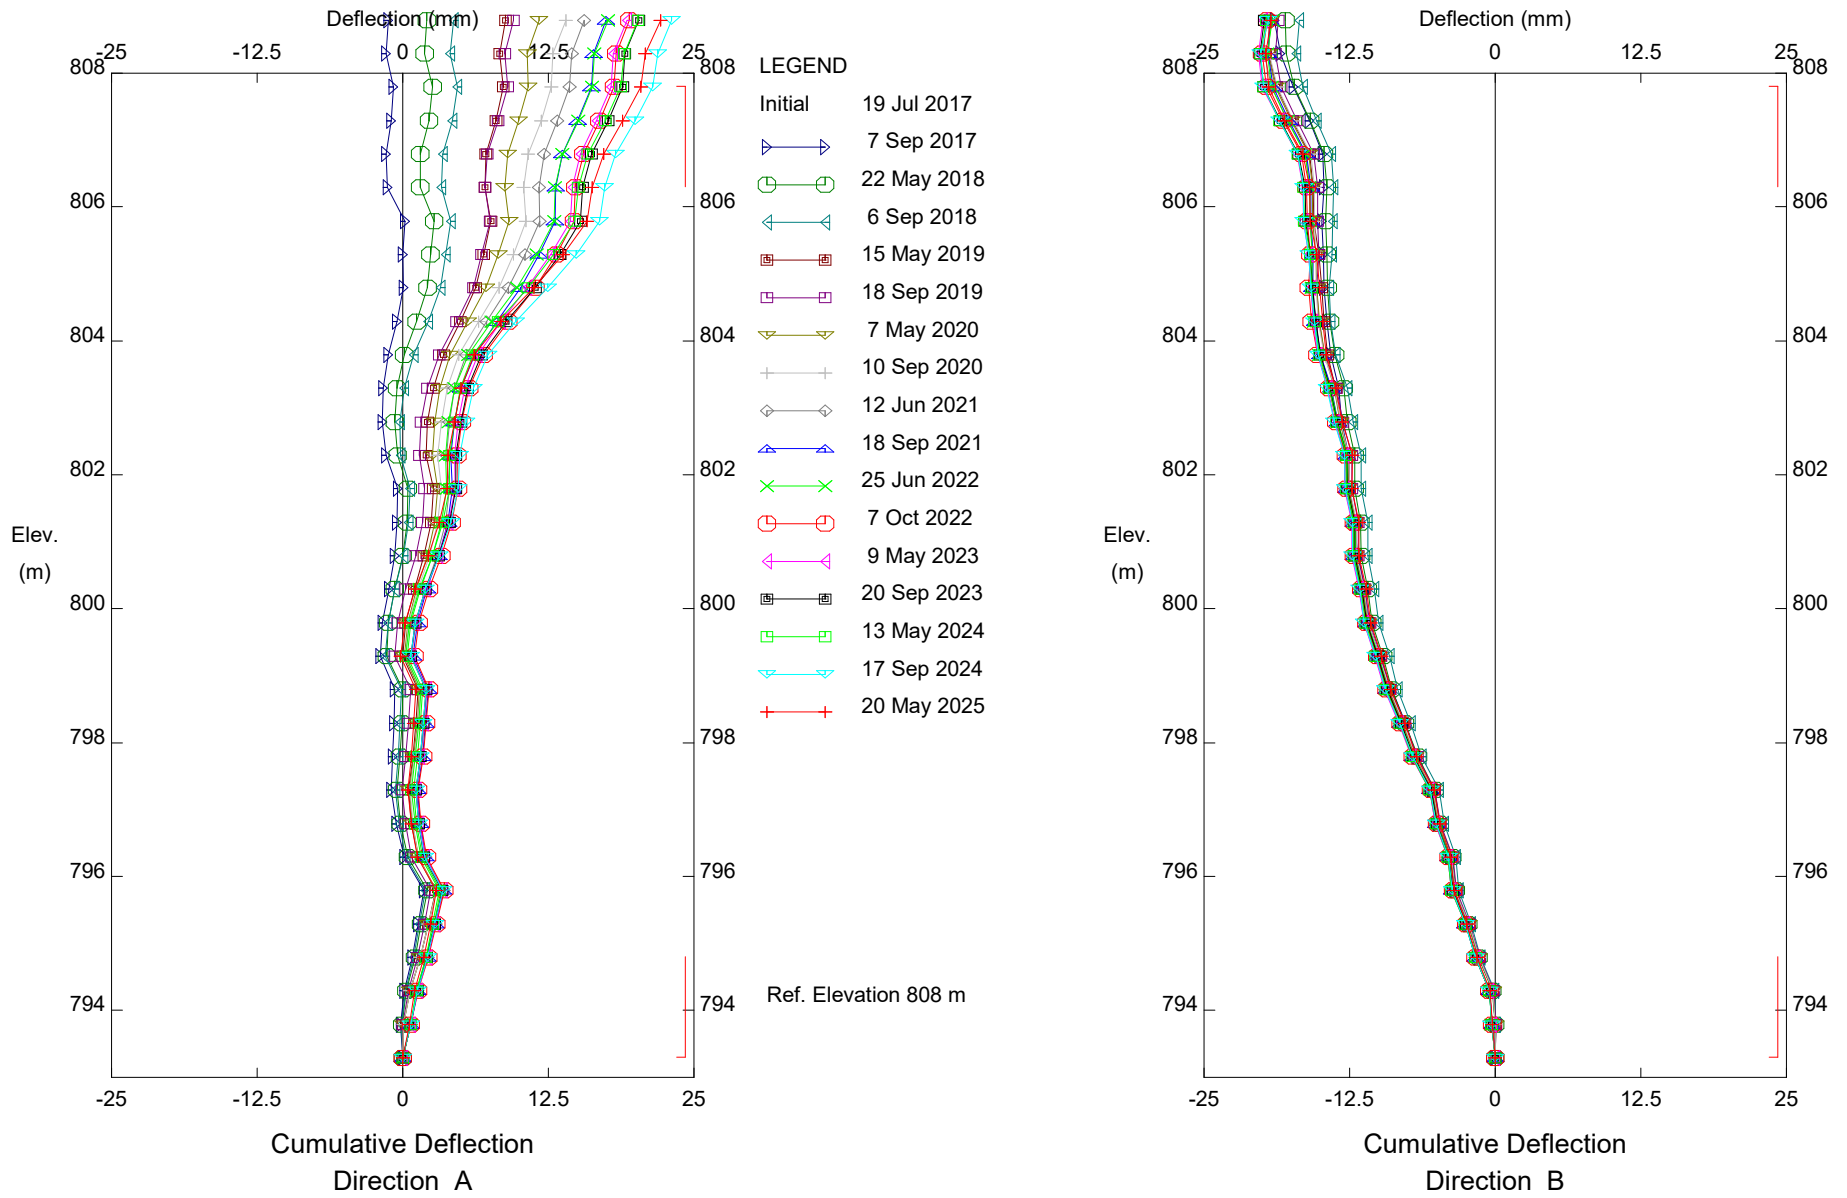
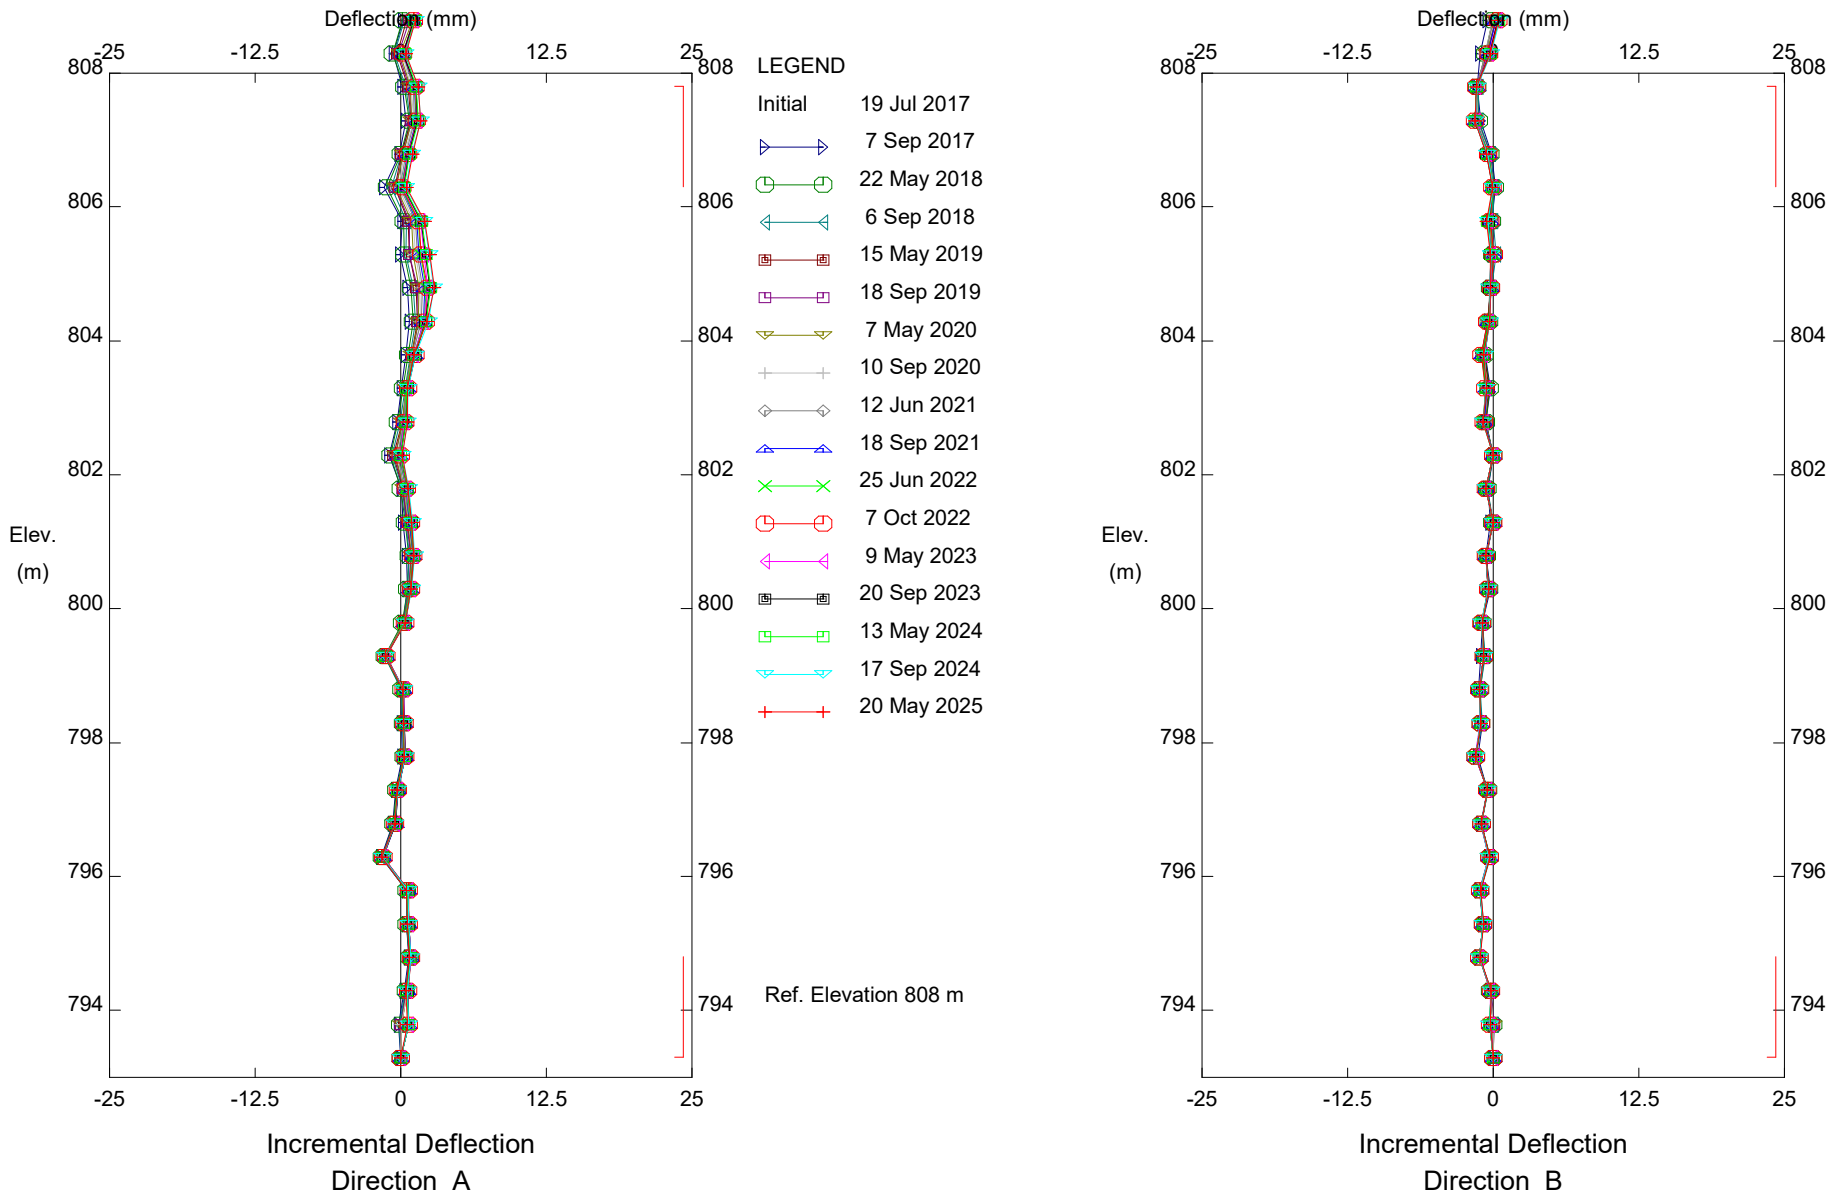
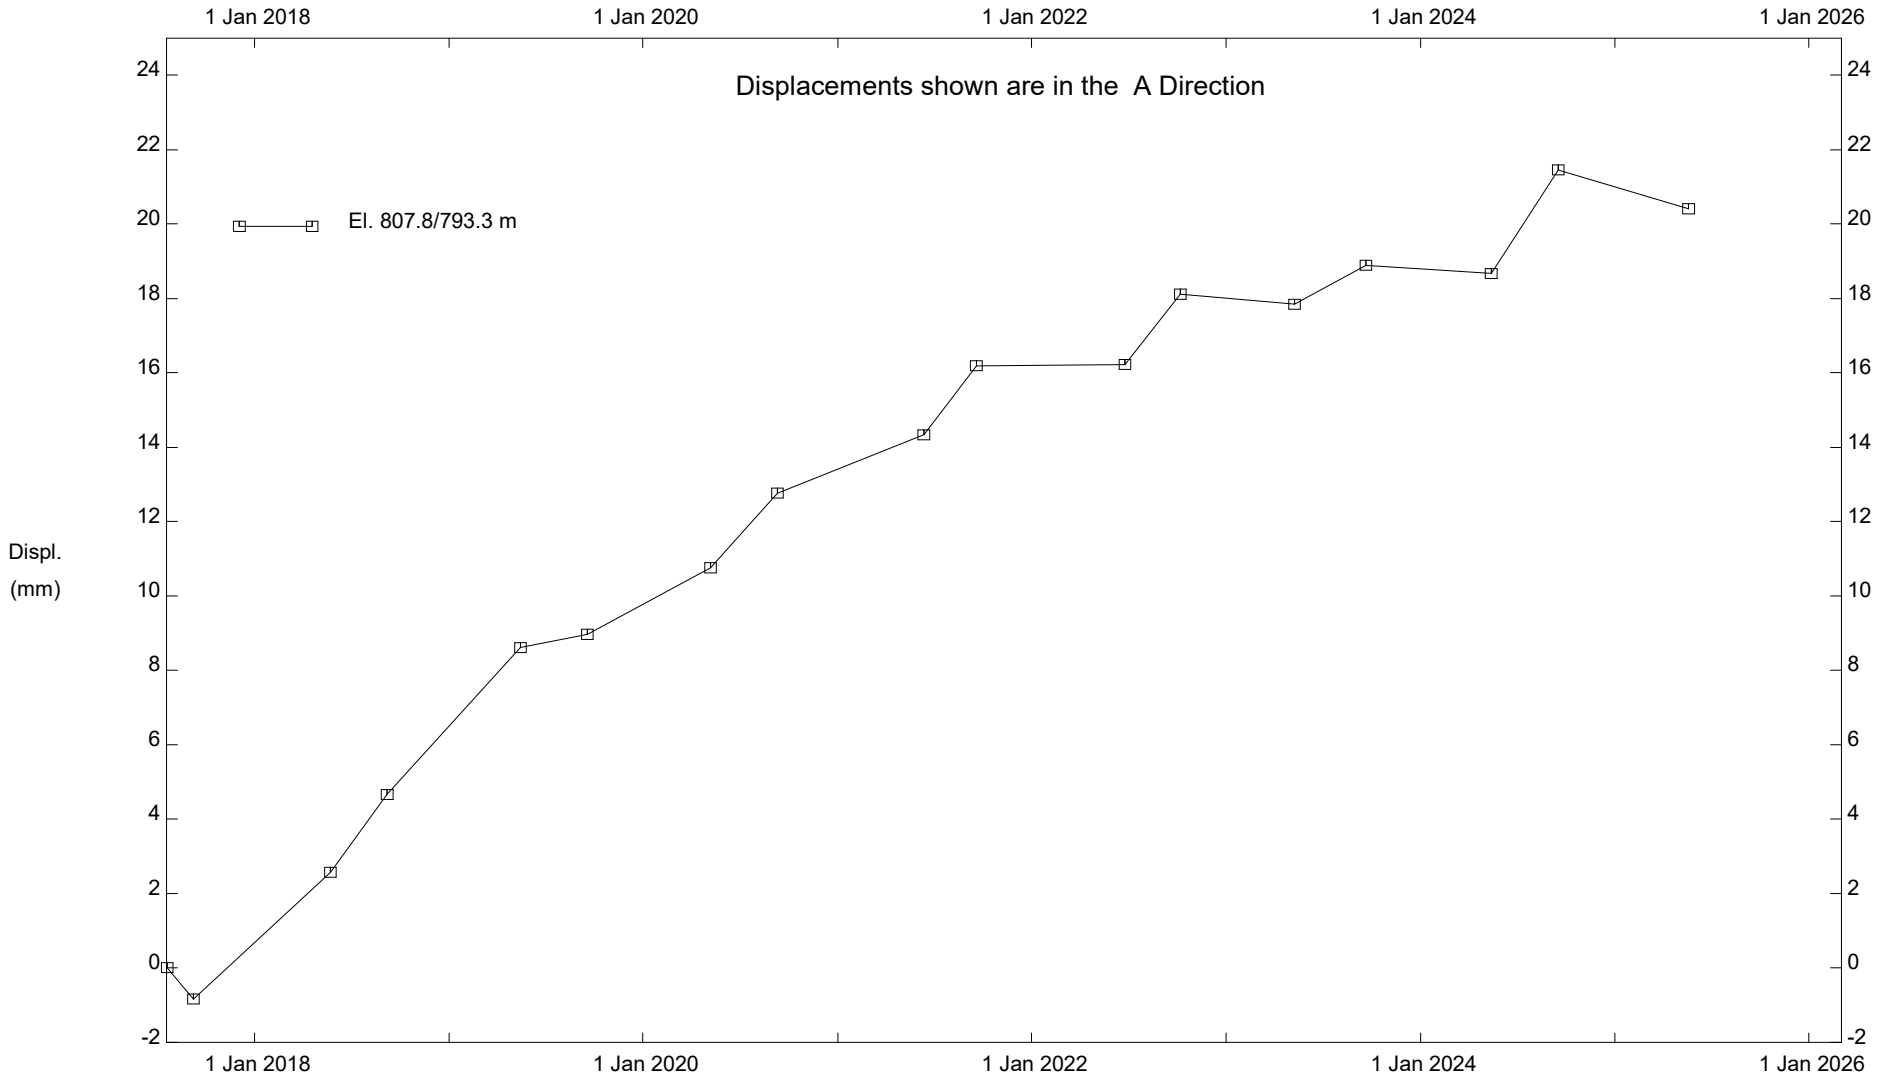
C067; H21:14, Kneehill Creek Slide, Inclinometer SI17-C67-03

Distributed movement is being recorded in the SIs installed in the H-pile wall (SI17-C67-03 though and SI17-C67-05) from top of casing to an approximate depth of 8.7 m, 7.8 m, and 6.5 m, respectively.

The depth of movement being recorded in the pile-wall SIs (SI17-C67-03 through SI17-C67-05) appears to be occurring 2 m to 4 m below the depth of movement previously recorded in SI16-01.

The May 2025 data obtained from SI17-C67-03 through SI17-C67-05 indicates the top of the H-pile wall has deflected between approximately 19 mm and 32 mm, since installation. The maximum rate of movement recorded in SI17-C67-03 through SI17-C67-05 was approximately 71 mm/year to 115 mm/year in May 2017, one month after the H-pile wall was installed. The rate of movement has since decreased and is now generally less than 3 mm/year, excluding:

- In September 2023, the rate of movement recorded in SI17-C067-03 through -05 increased to up to approximately 7 mm/year. Although the movement recorded in September 2023 was within historical trends for these instruments, evidence of movement (pavement cracking and settlement) primarily in the south (eastbound) lane was observed during the 2023 Section B Inspection. The increased rate of movement recorded may be attributed to settlement of the highway subgrade and fill due to H-pile wall movement between 2017 and 2023.

- In September 2024, the rate of movement recorded in SI17-C67-03 through SI17-C67-05 increased from less than approximately 2 mm/year to up to approximately 8 mm/year. The increased rate of movement may be attributed to construction activities on site (chip sealing along the site was completed in summer 2024) and wet weather in August 2024 (approximately 55 mm precipitation versus the average of 45 mm recorded between 2015 and 2024).

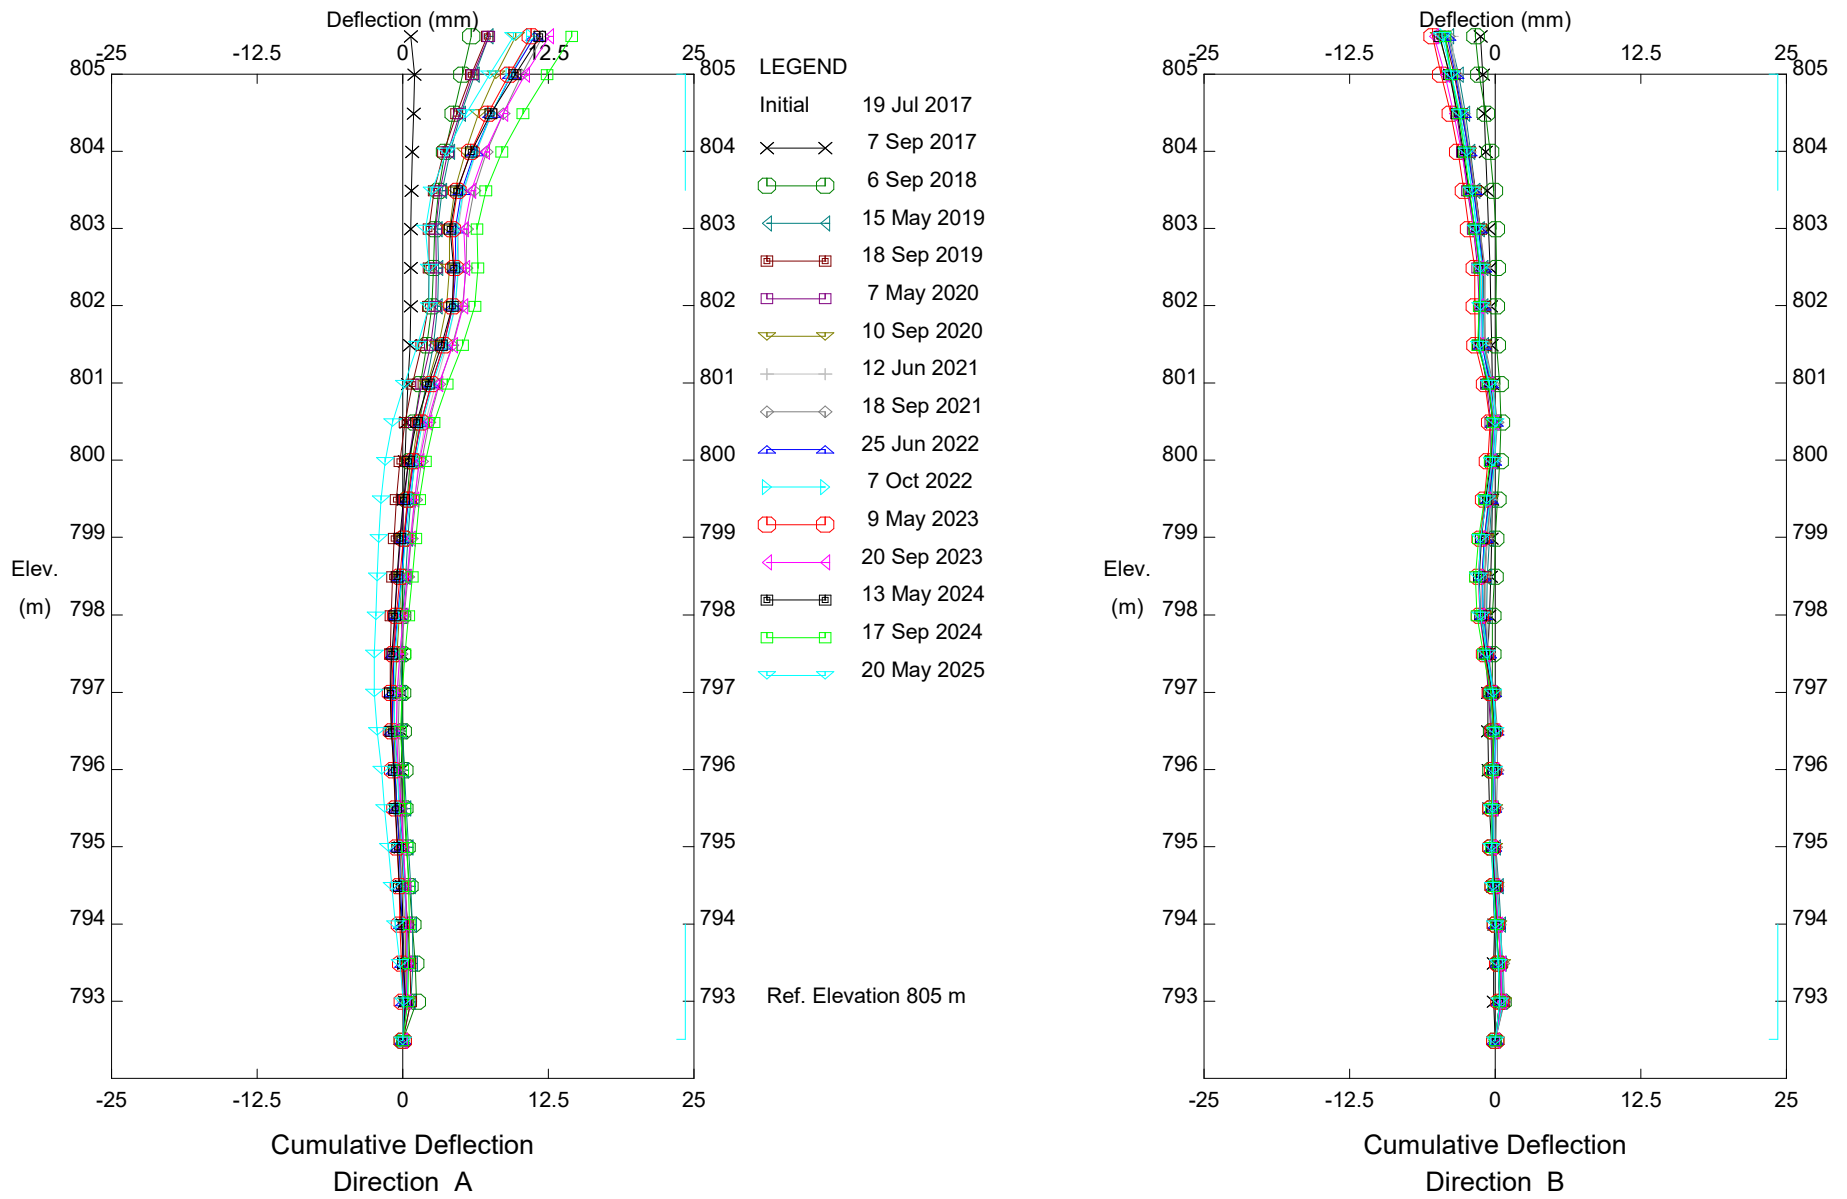
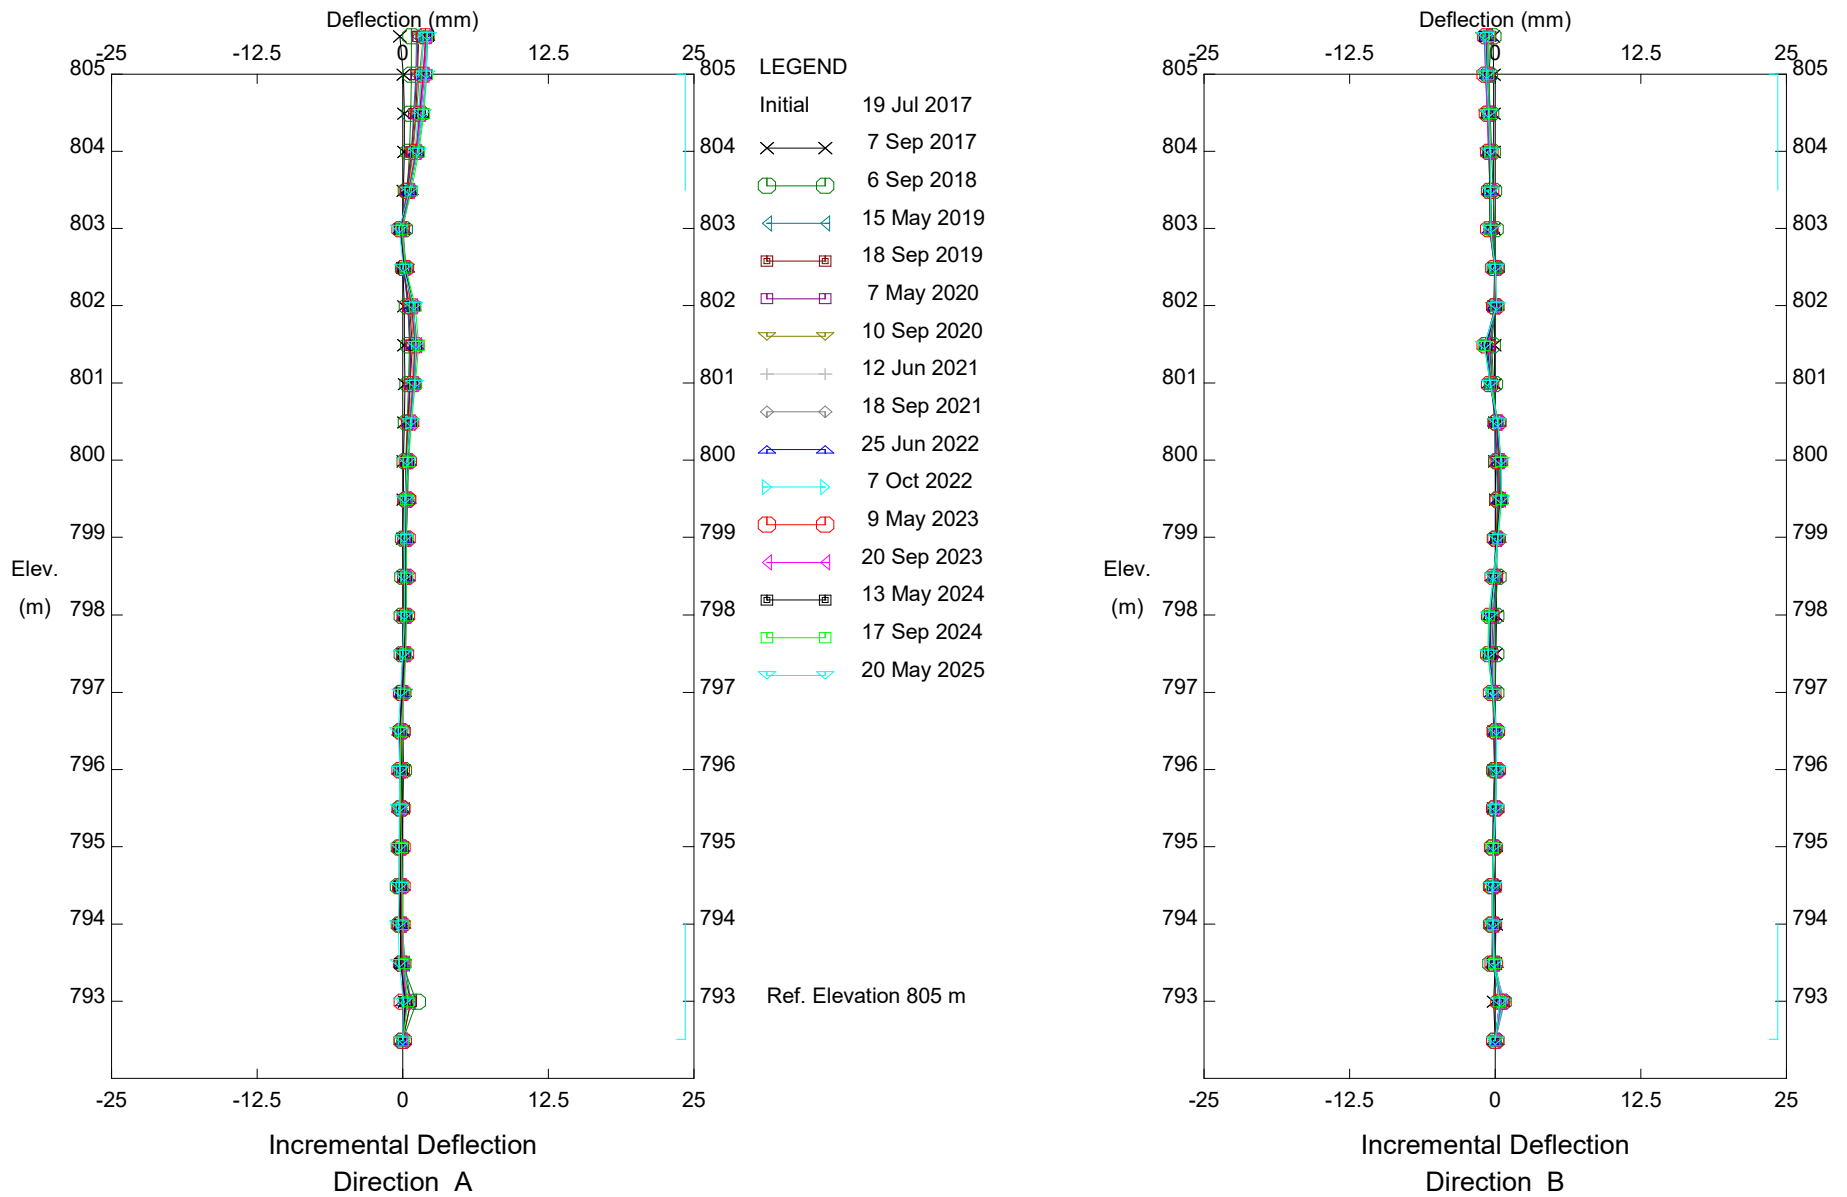
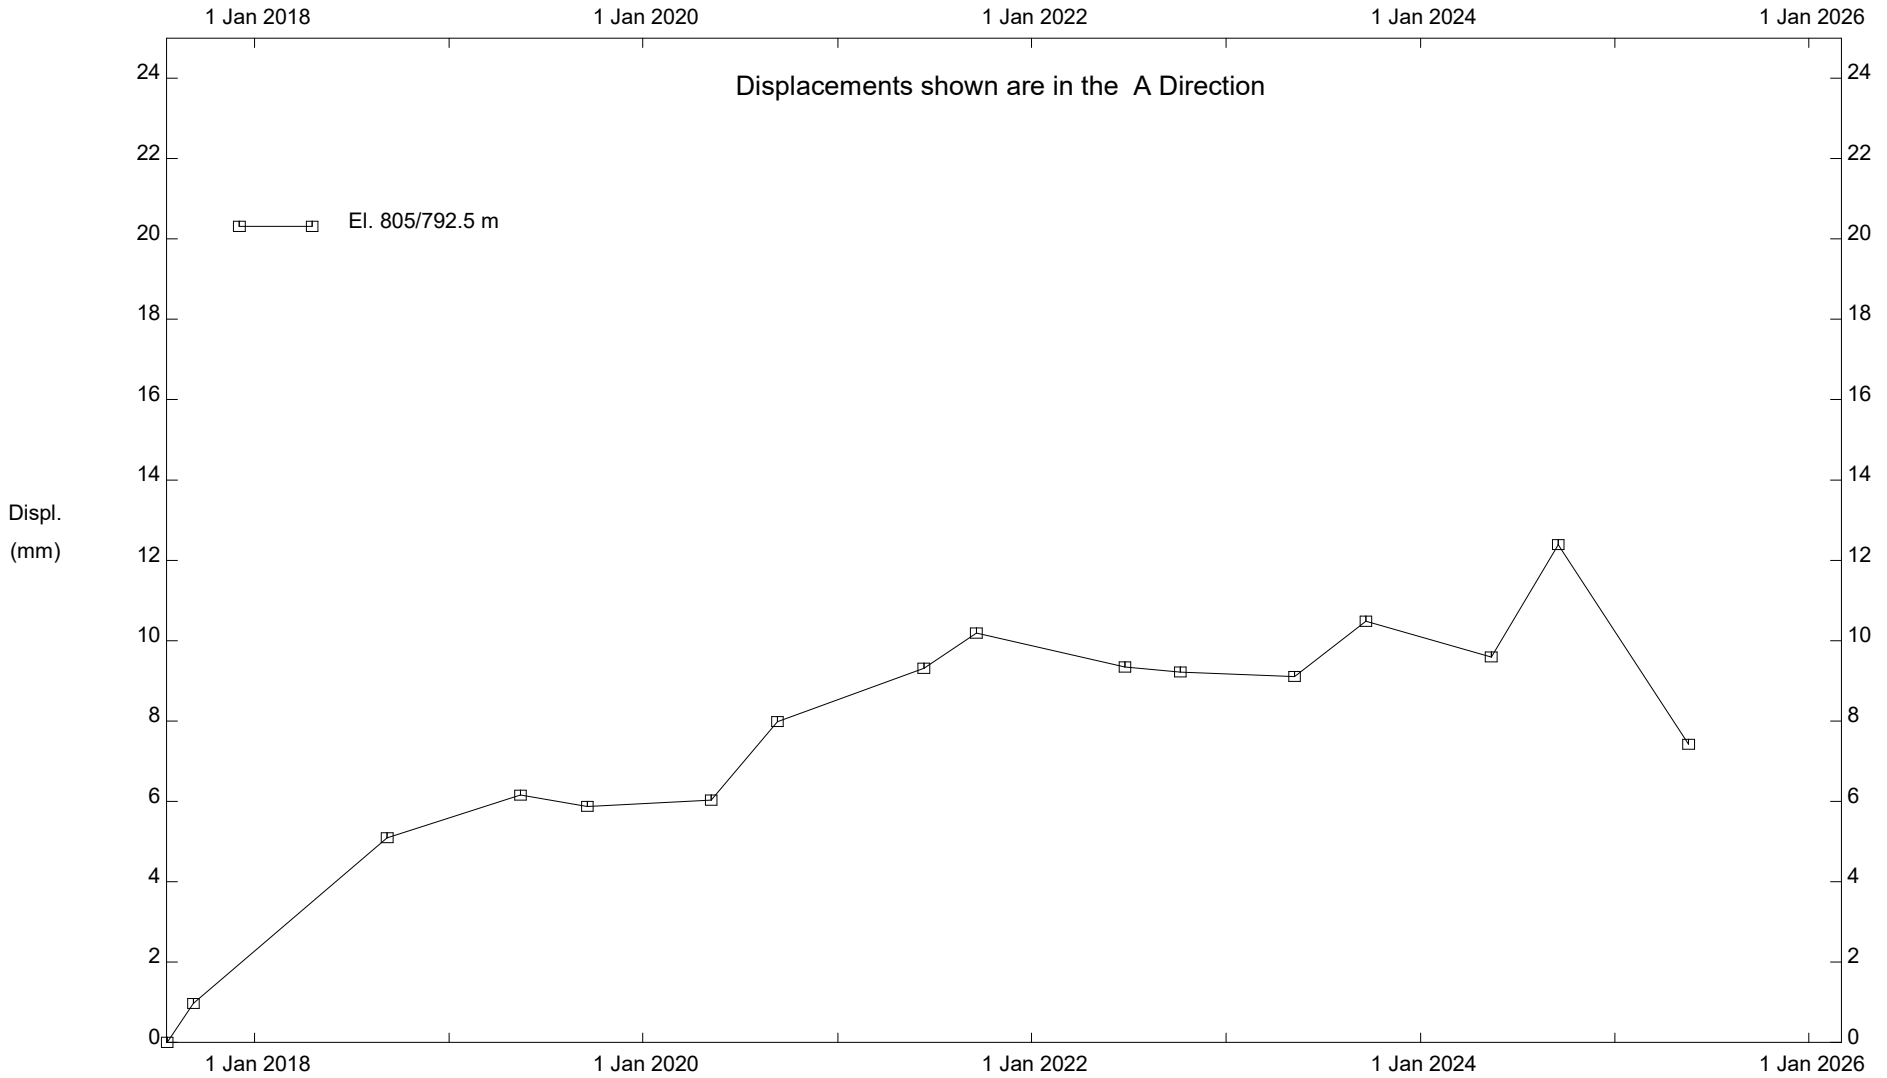
C067; H21:14, Kneehill Creek Slide, Inclinometer SI17-C67-05

The relatively large negative displacement recorded in May 2025 may be due to noise, as the instrument was re-read during the May 2025 readings. The second reading replicated the negative displacement.

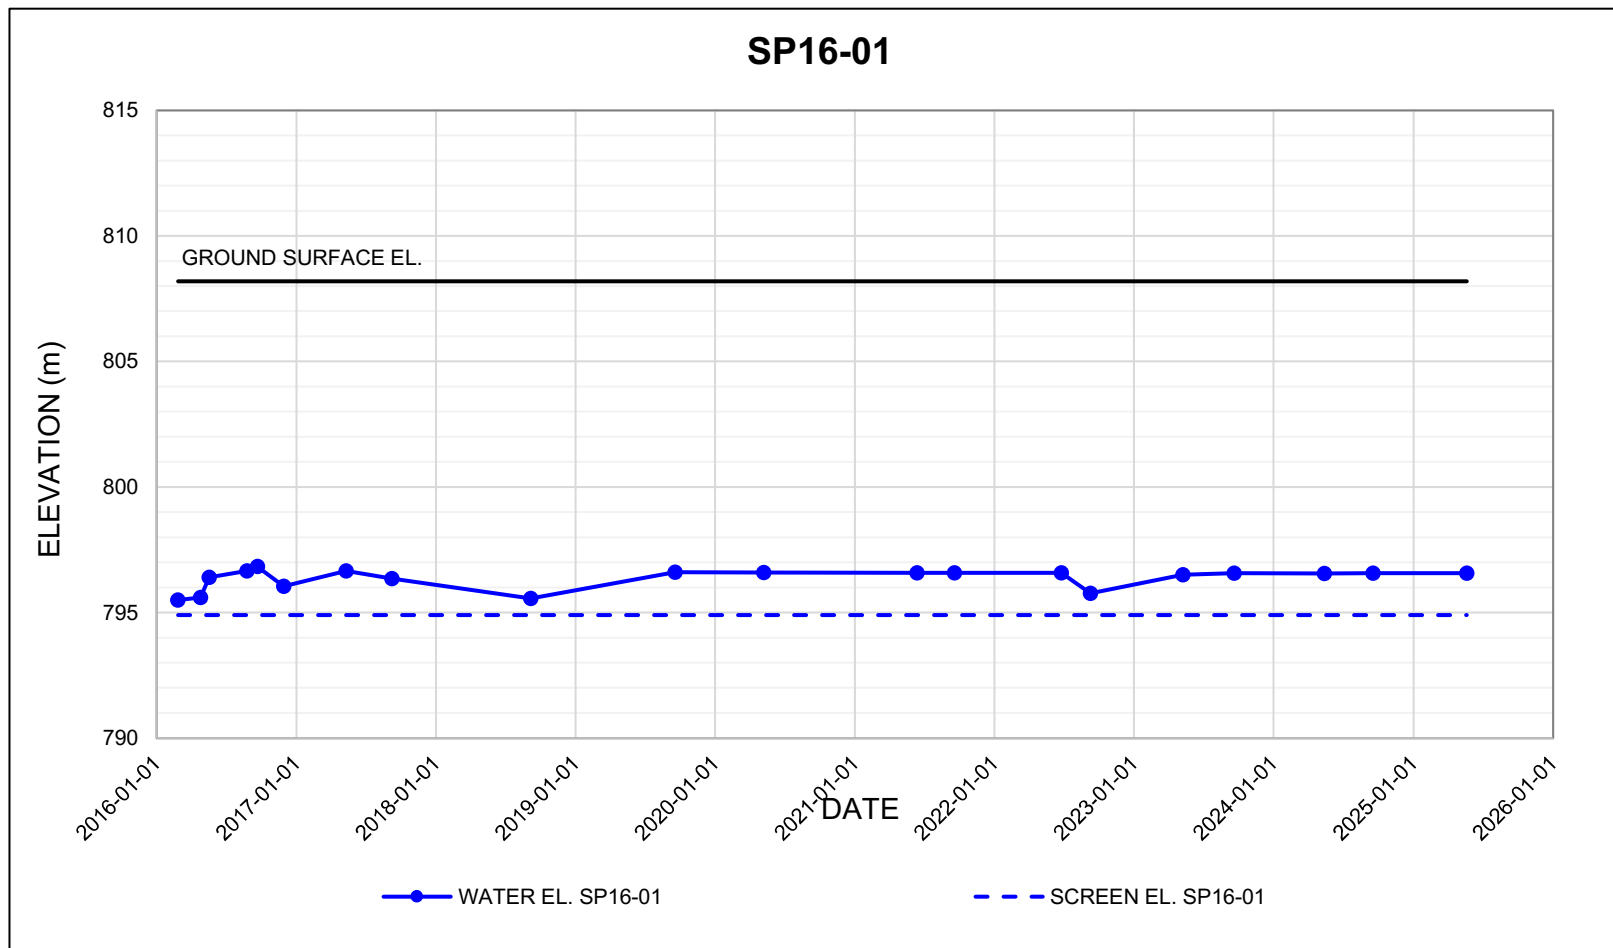
PROJECT CENTRAL REGION GEOHAZARD RISK MANAGEMENT PROGRAM	
	TITLE Piezometer Data C067 - Kneehill Creek Slide Hwy 21:14, km 12.988	
SCALE N/A	PROJECT No. A05116A02	FIG No. I-19

Since installation in February 2016, water levels recorded in SP16-01 have been relatively steady varying from 11.4 m to 12.7 m below ground surface. The May 2025 reading of 11.6 m below ground surface was the same as the previous reading in September 2024 and is consistent with historical trends observed in this instrument.
