July 15, 2025

**CON0022160 Central Region GRMP Instrumentation Monitoring
Site C062; H41:02, km 2.889 Vermillion Backslope
Section C – 2025 Spring Readings**

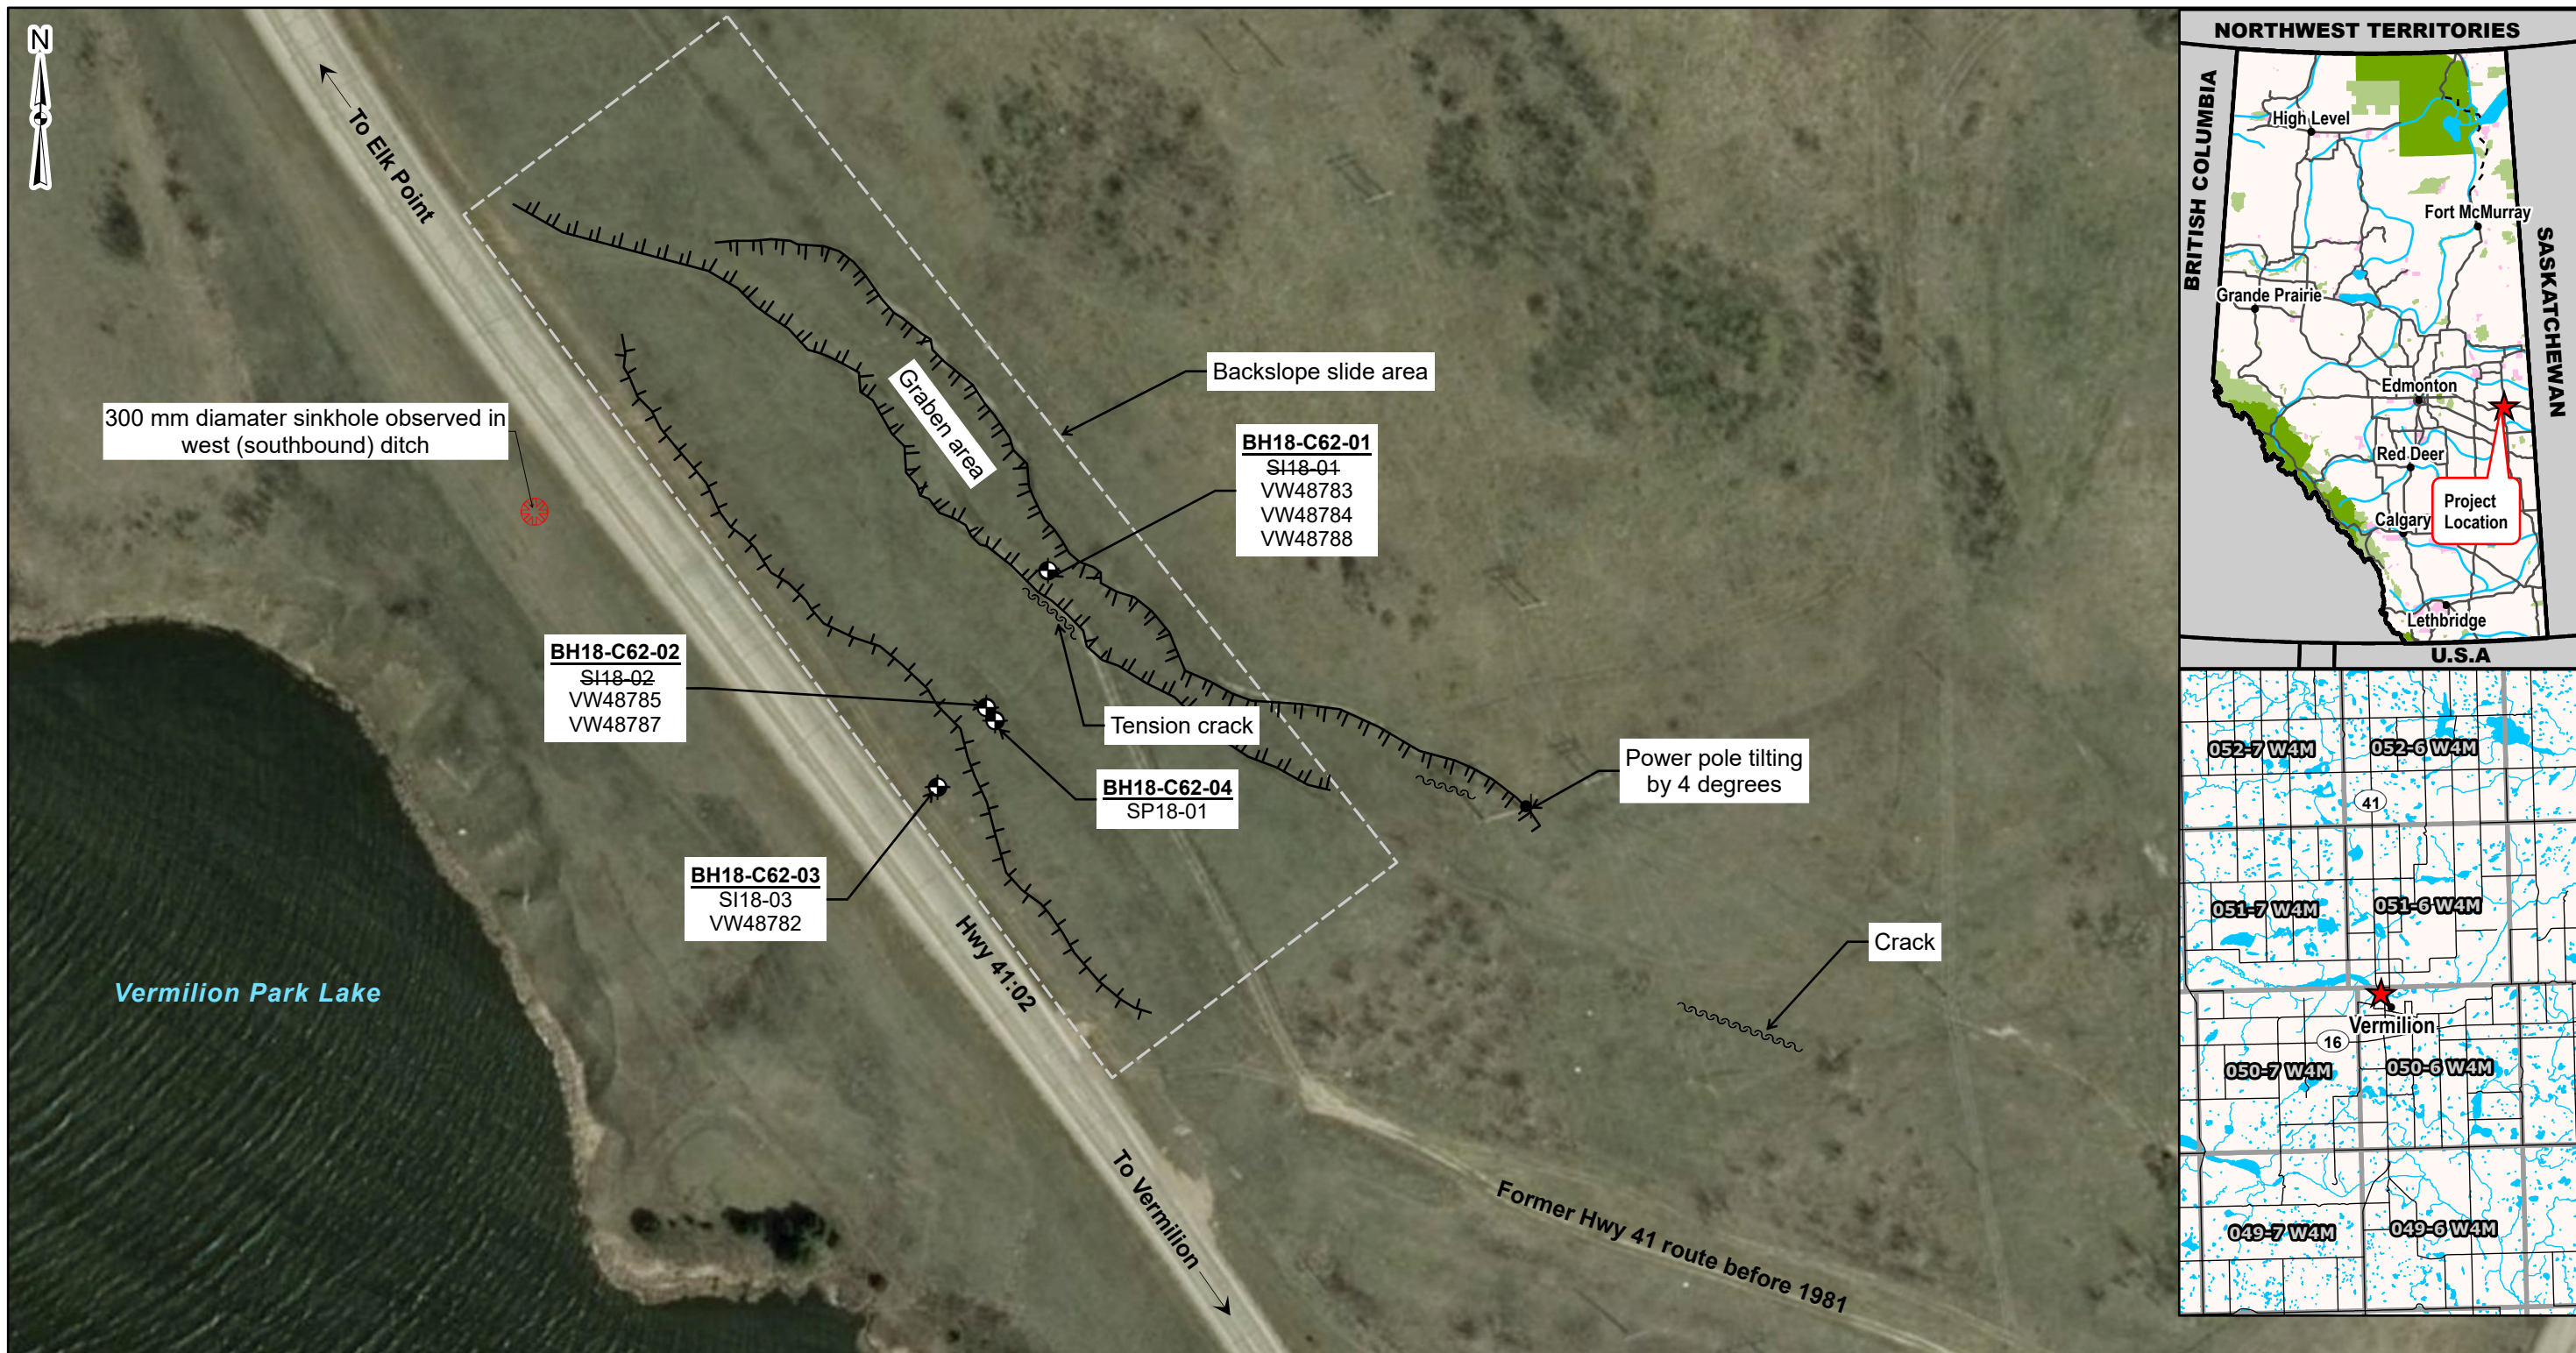
PROJECT CENTRAL REGION GEOHAZARD RISK MANAGEMENT PROGRAM		
TITLE Site Plan C062 - Vermilion Backslope Hwy 41:02, km 2.889		
SCALE 1:1,500	PROJECT No. A05116A02	FIG No. 1

300 mm diameter sinkhole observed in west (southbound) ditch

Tension crack

Power pole tilting by 4 degrees

Crack

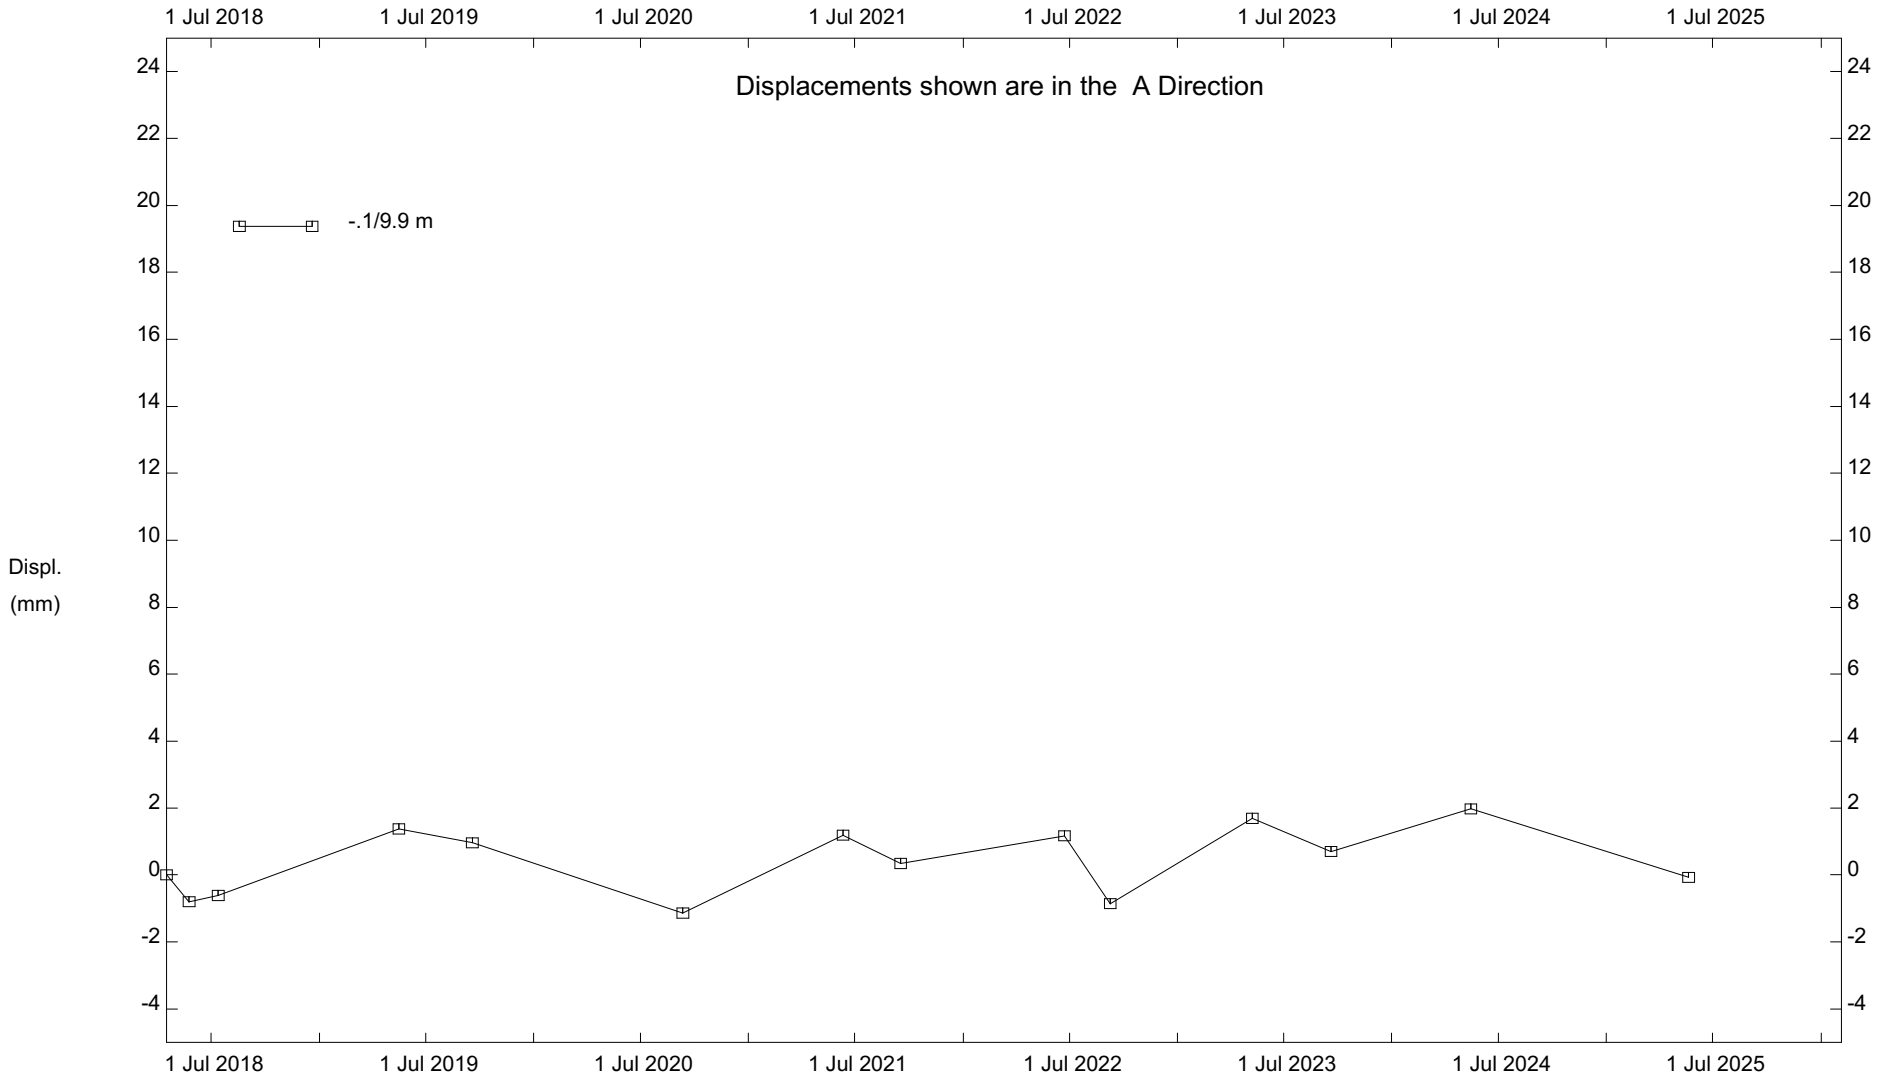
C062; H41:02, Vermilion Backslope, Inclinator SI18-C62-03

No discernible movement has been recorded in SI18-C62-03 (toe of slope) since installation.

All operable instruments should continue to be read once per year (spring only).

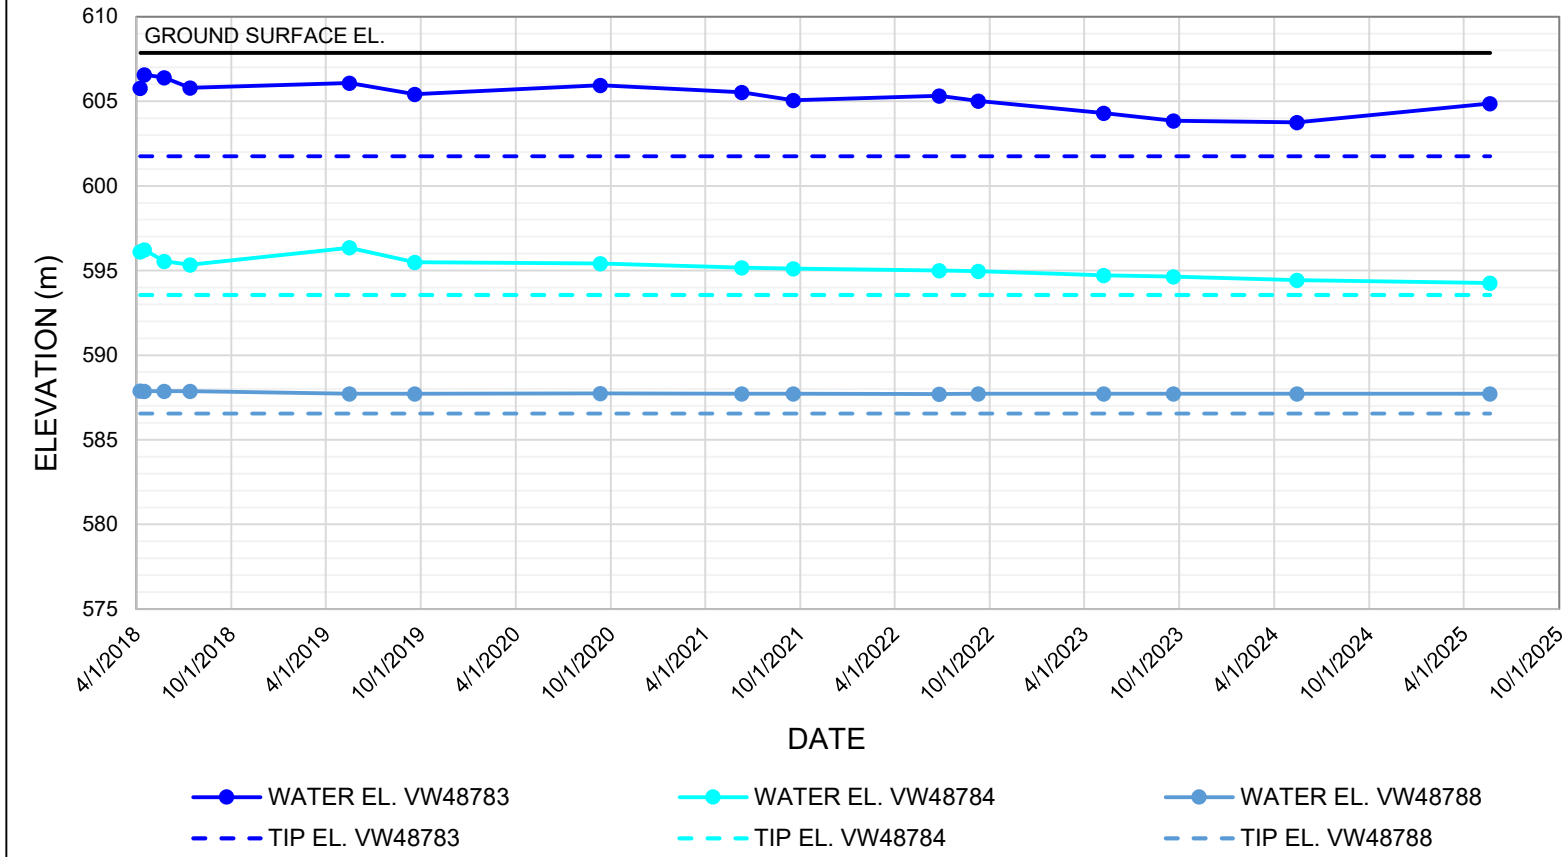
VW48783, VW48784, AND VW48788 (CREST OF SLOPE)

The piezometers have been either relatively steady (± 1.5 m) or dry since installation. The May 2025 readings were consistent with historical trends observed in these instruments, except for VW48783 at the crest of the slope, where a 1.1 m increase was recorded between May 2024 and May 2025, despite lower-than-average precipitation recorded by the Vermillion ADGM weather station in the winter and spring months.

In the nested piezometers installed in BH18-C62-01 (VW48783, VW48784, and VW48788) at the crest of the slope, two independent water levels were detected in the clay till, which could indicate the presence of two perched groundwater tables. This is likely due to the presence of sand and silt lenses found interbedded within the clay till layer.
