September 29, 2025

**CON0022160 Central Region GRMP Instrumentation Monitoring  
Site C017-3; H575:04, km 26.631 Truckstop Slide  
Section C – 2025 Fall Readings**

TITLE  
Site Plan  
C017-1, -2, and -3 Truckstop Slide  
Hwy 575:04, km 26.631

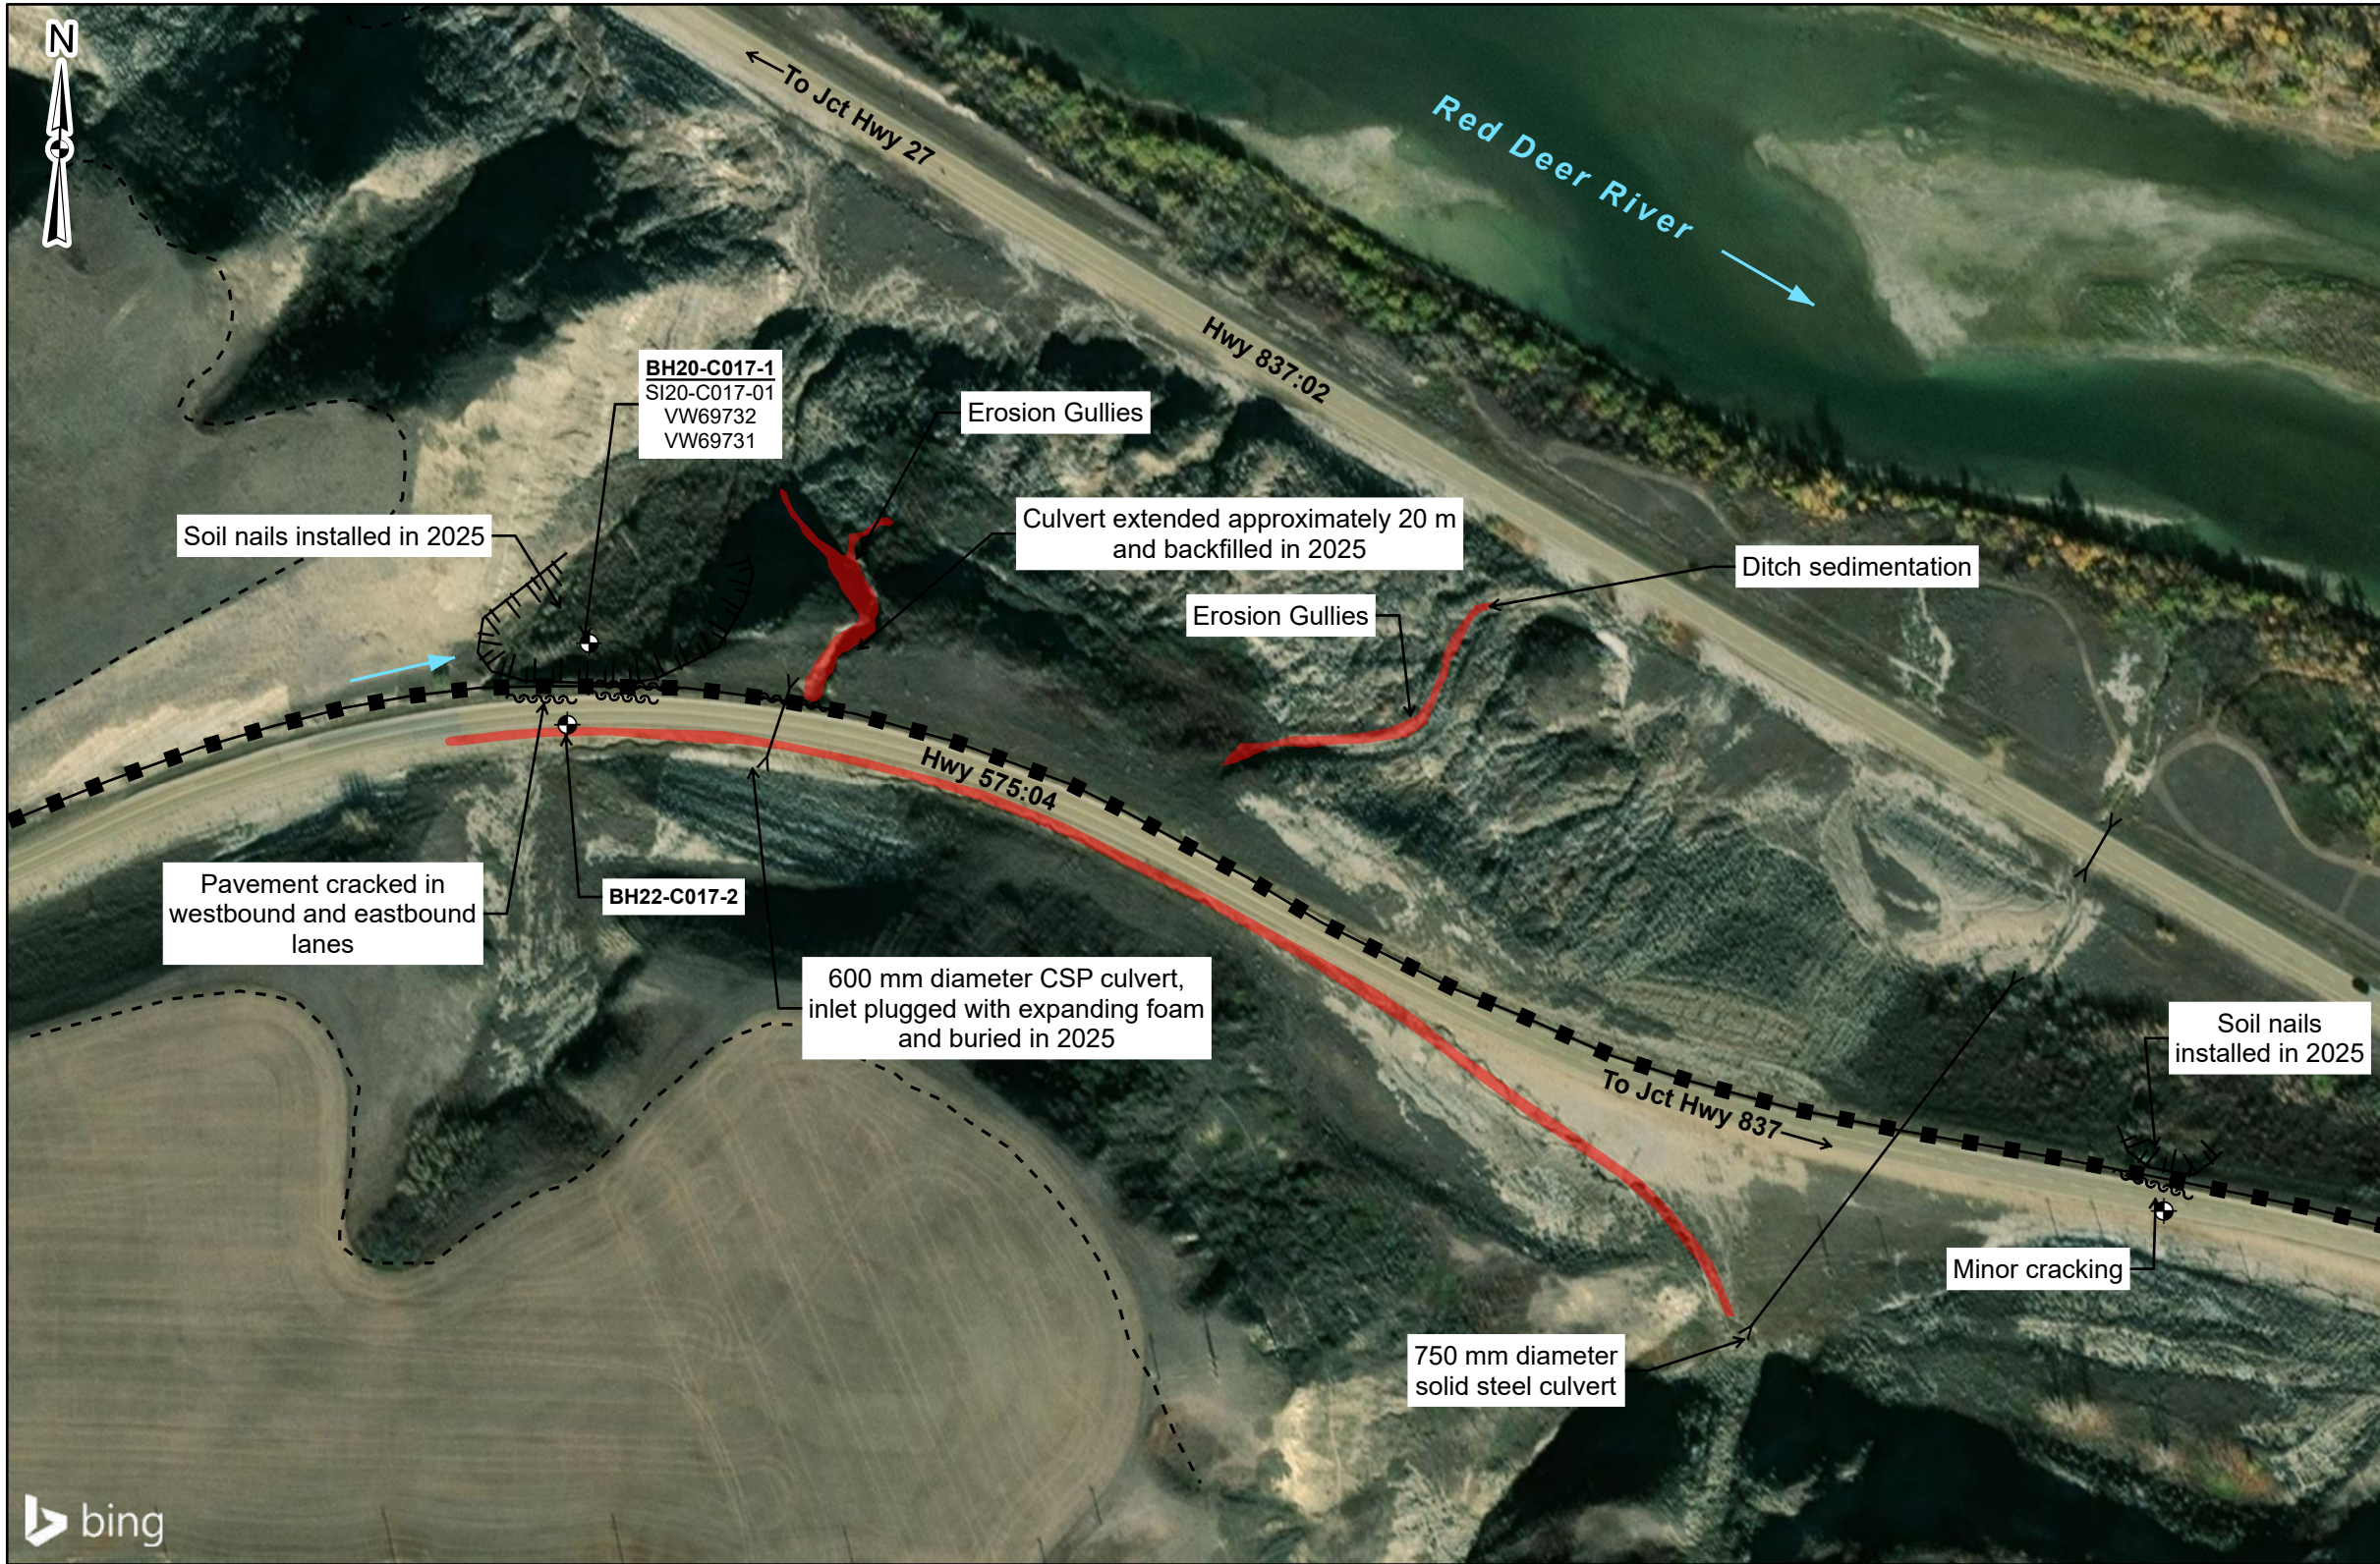
SCALE 1:2,500 PROJECT No. A05116A02 FIG No. 1

- C017-1: a shallow embankment slope failure on the north side (westbound lane) of Hwy 575:04;
- C017-2: an erosion gully that has formed downslope of a culvert outlet on the north side (westbound lane) of Hwy 575:04; and,
- C017-3: a moderately deep-seated slide on the north side (westbound lane) of Hwy 575:04 where the highway crosses a creek and enters a cut section in the valley wall.

In October 2020, KCB installed one SI (SI20-C017-01) and two VWPs (VW69731 and VW69732) to monitor depth of movement and groundwater conditions, respectively. The instruments were installed in borehole BH20-C017-1, located on the north (downslope) side of Hwy 575:04, within the C017-3 slide mass.

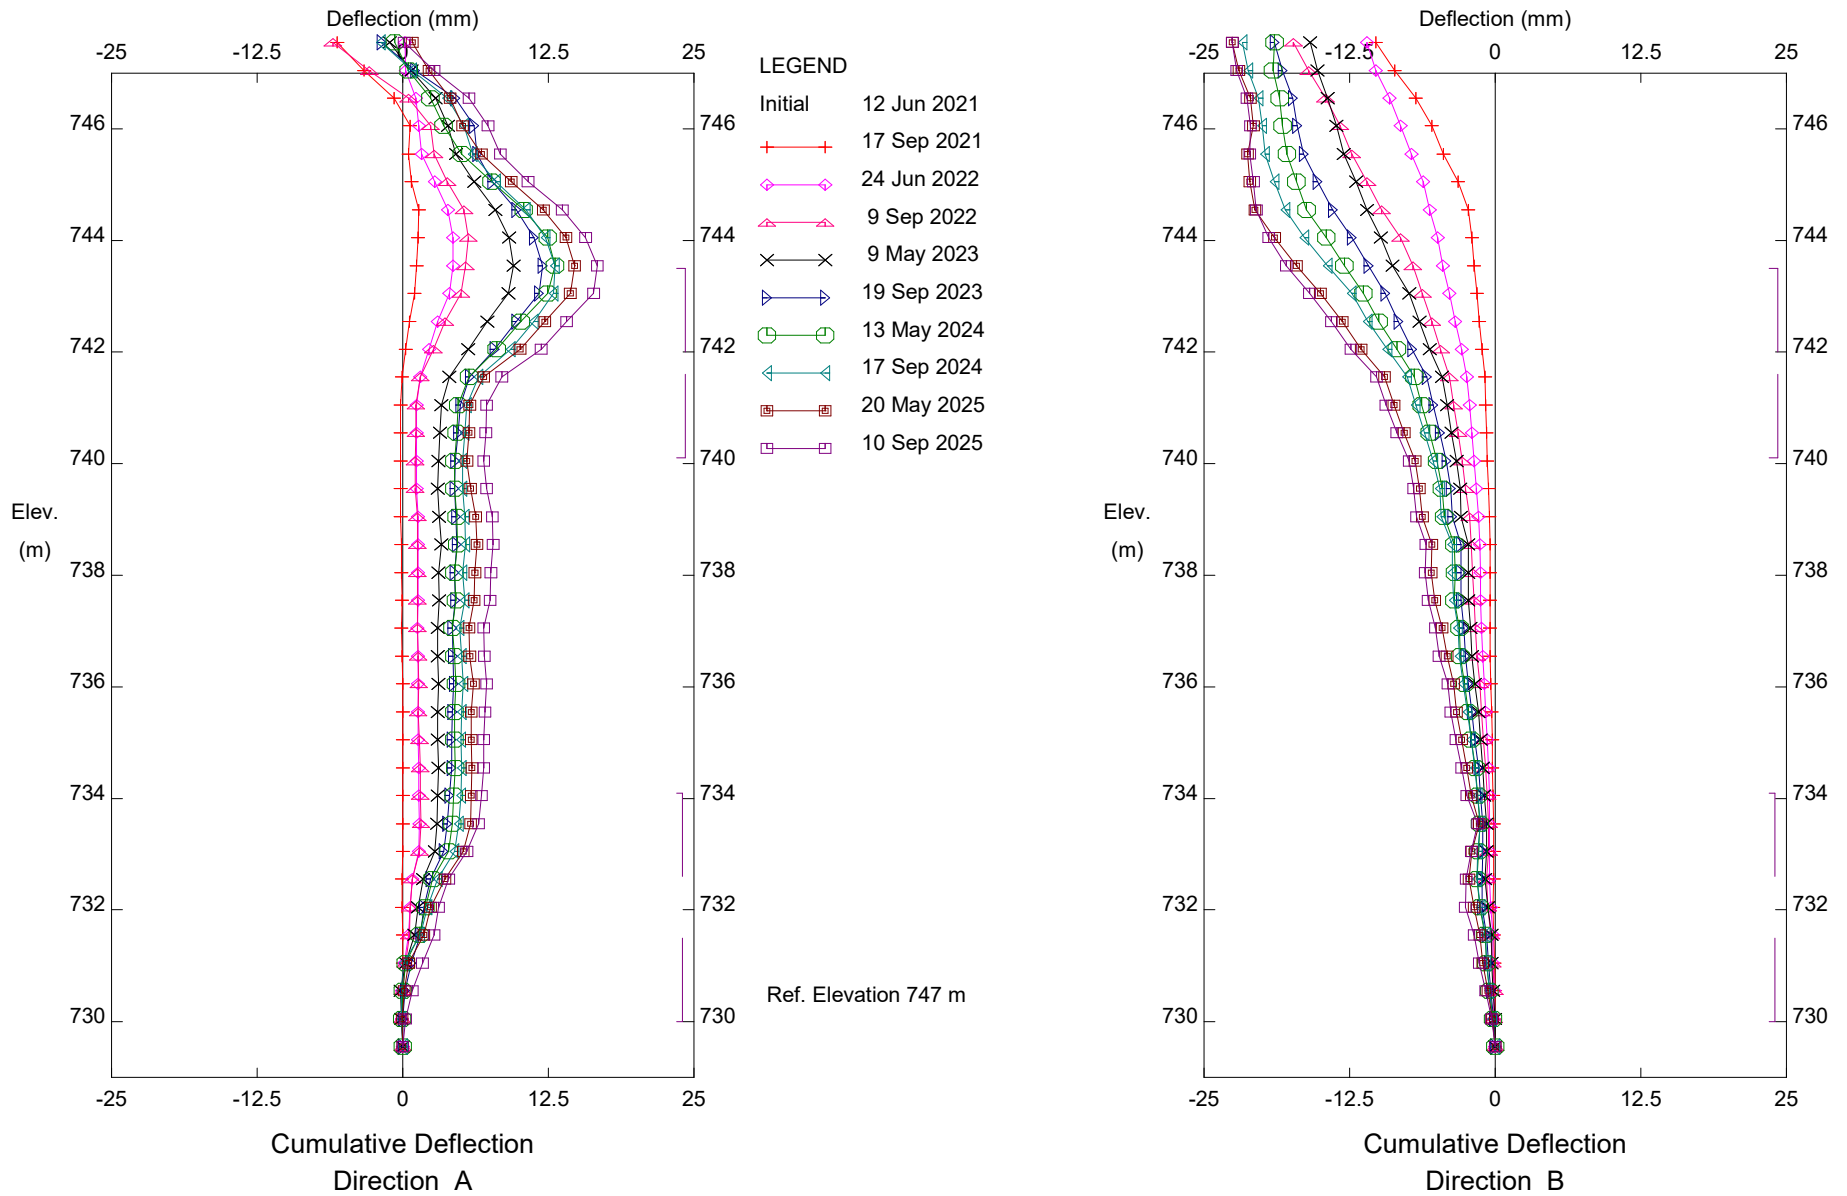
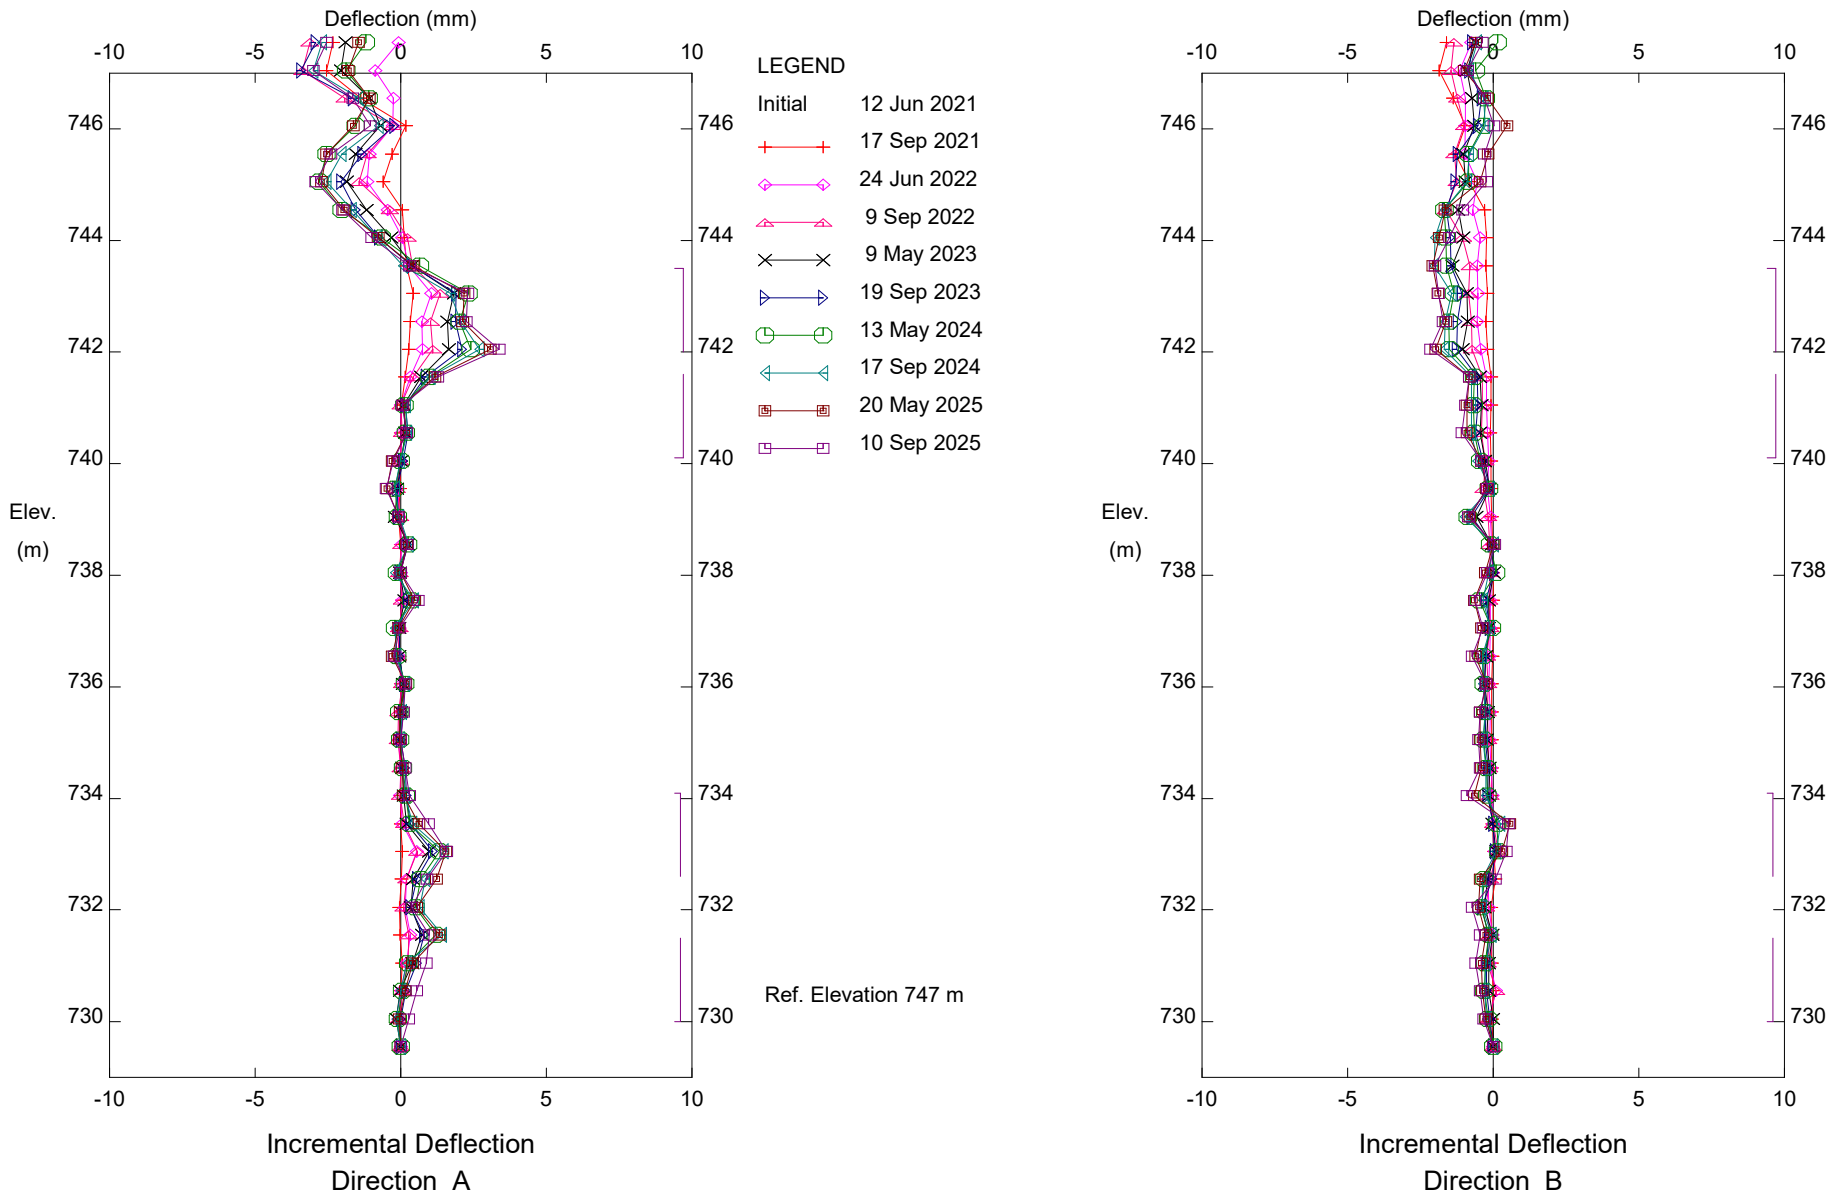
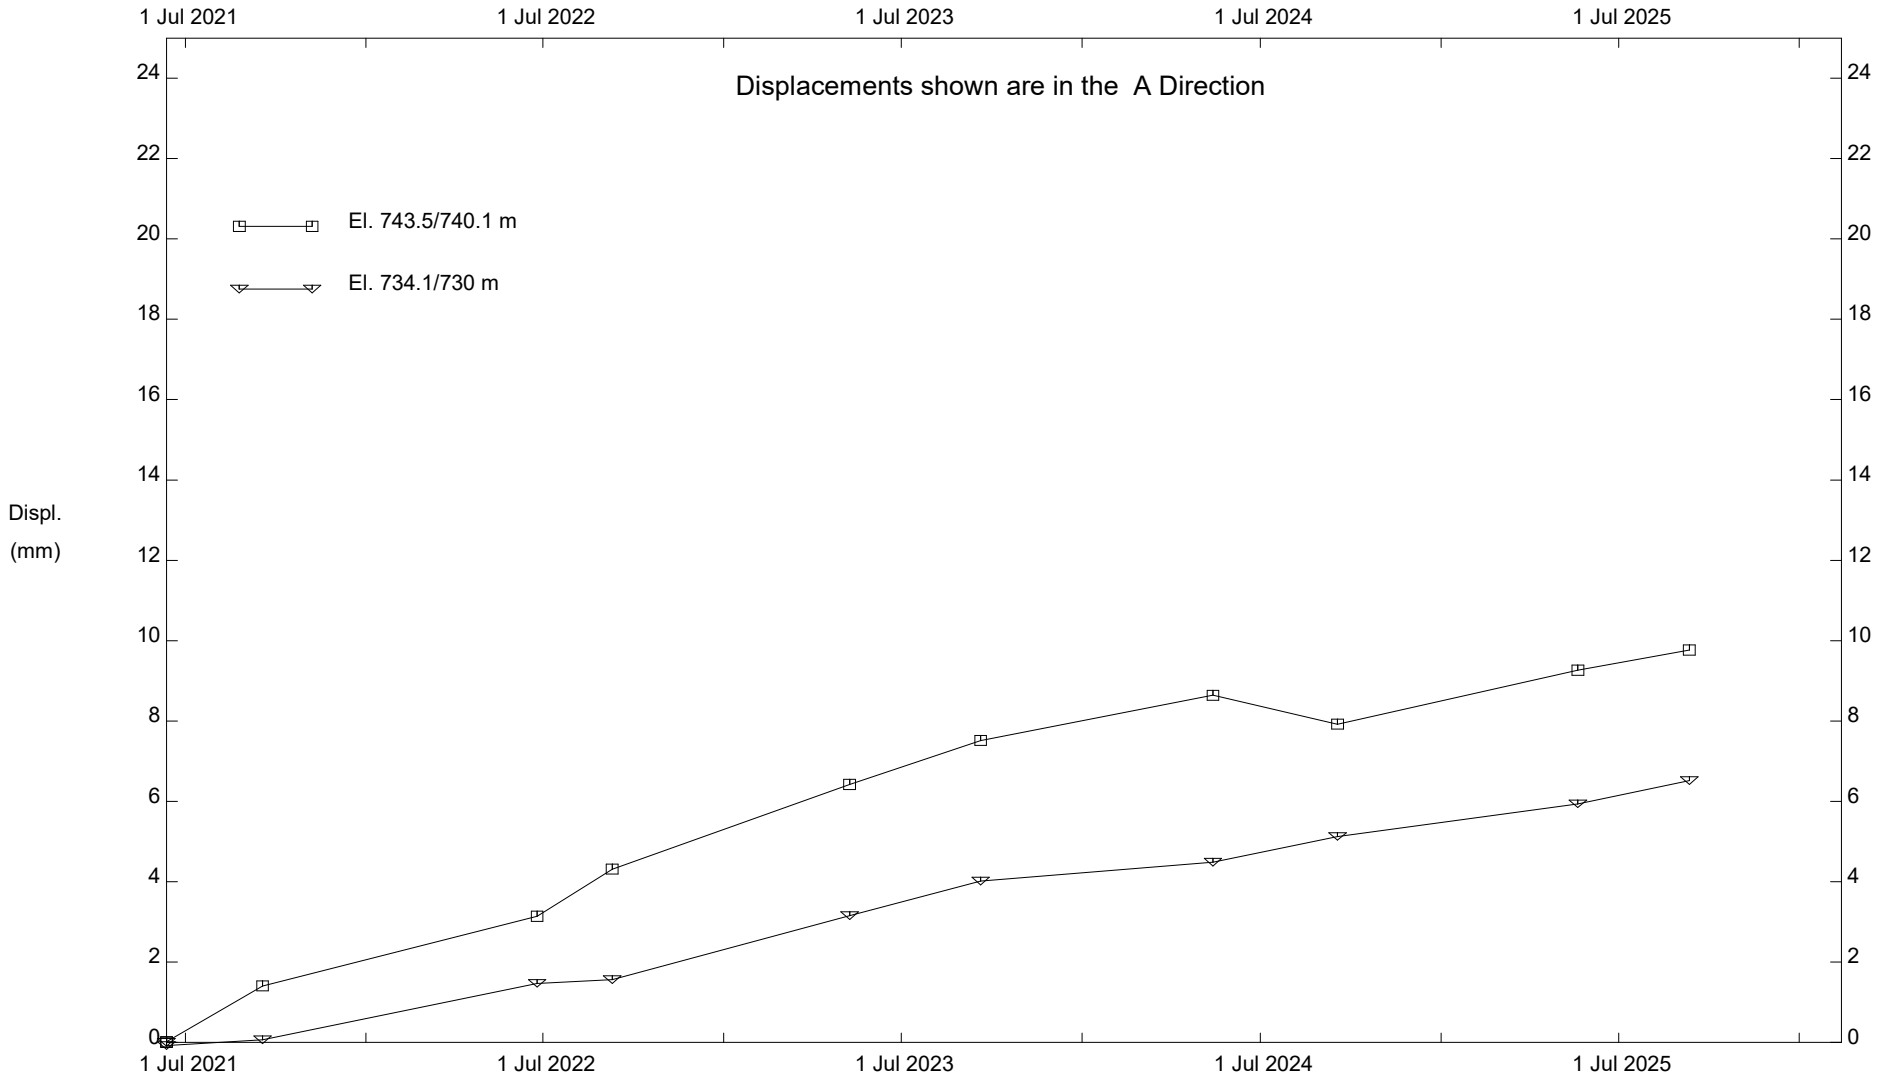
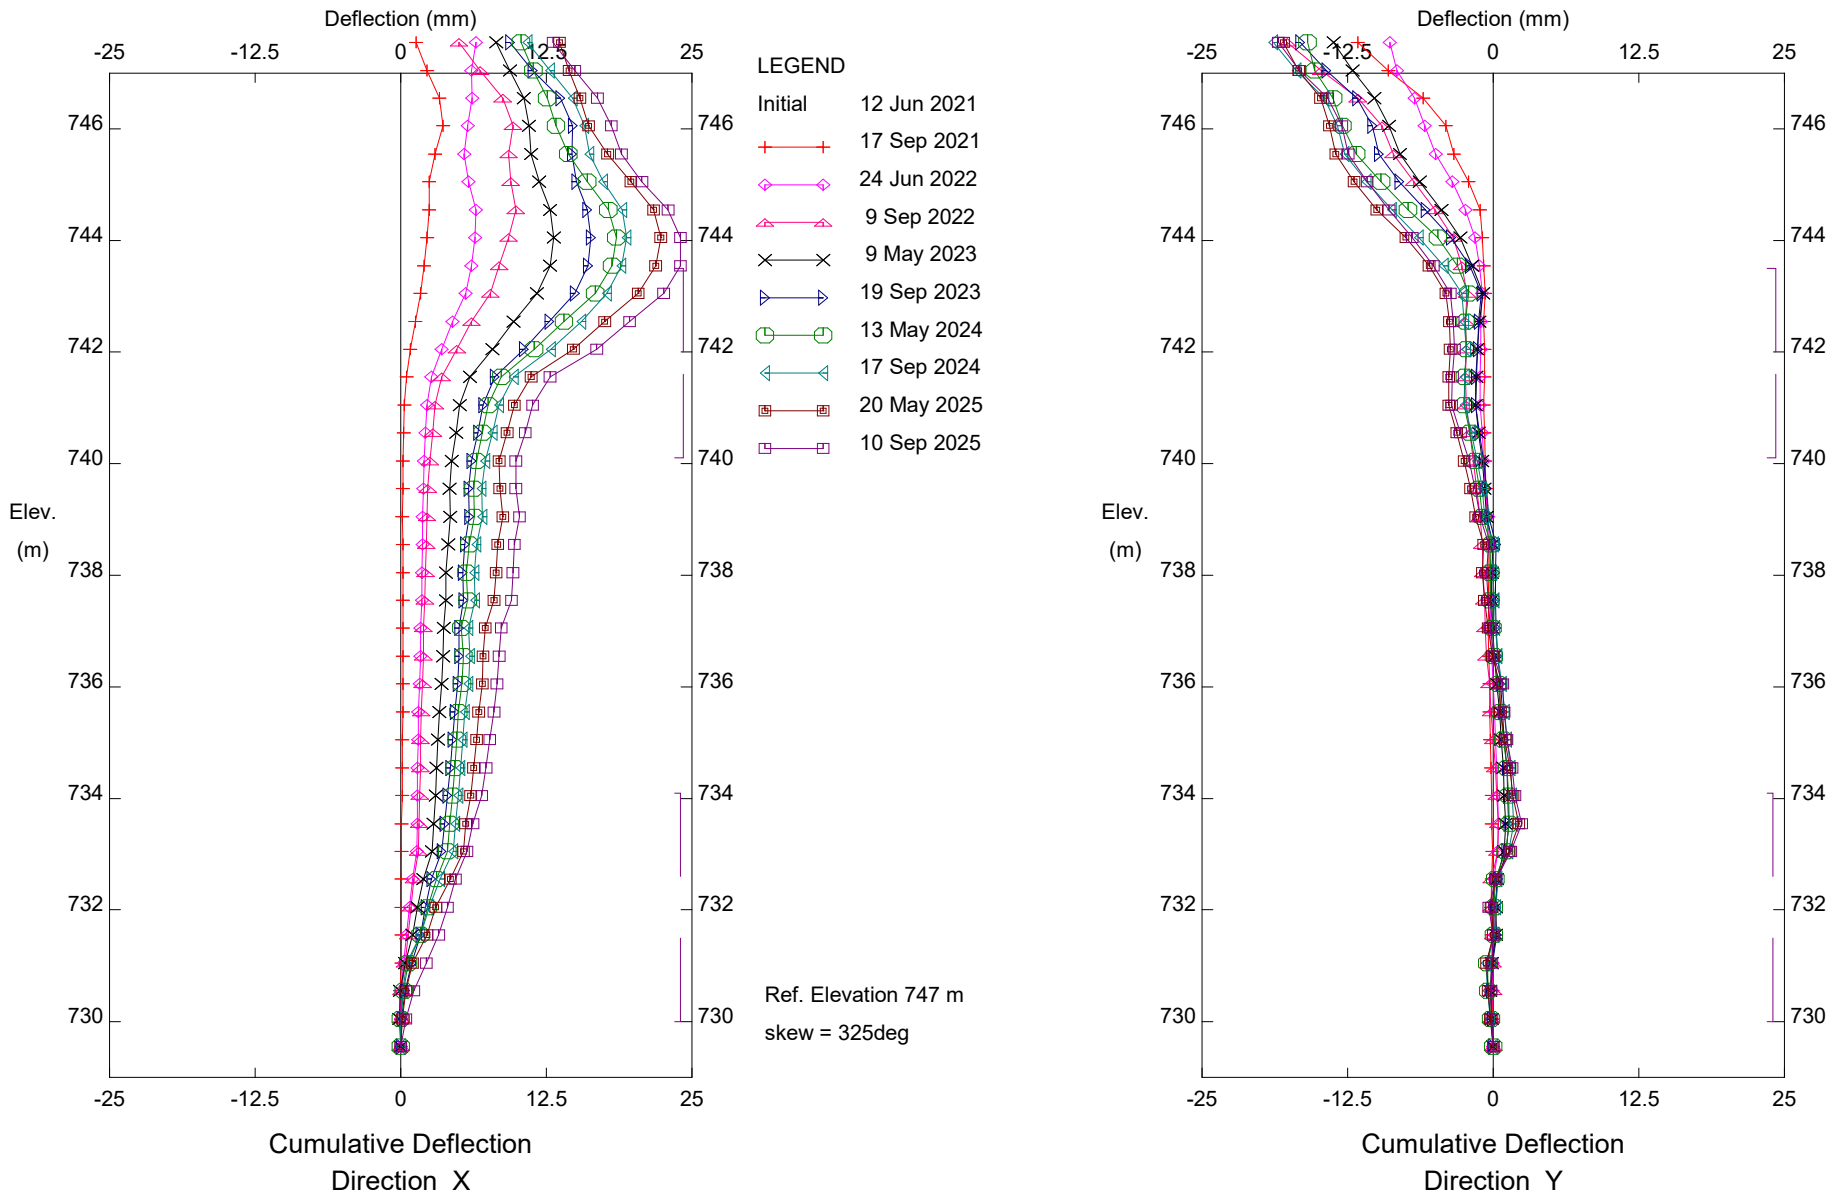
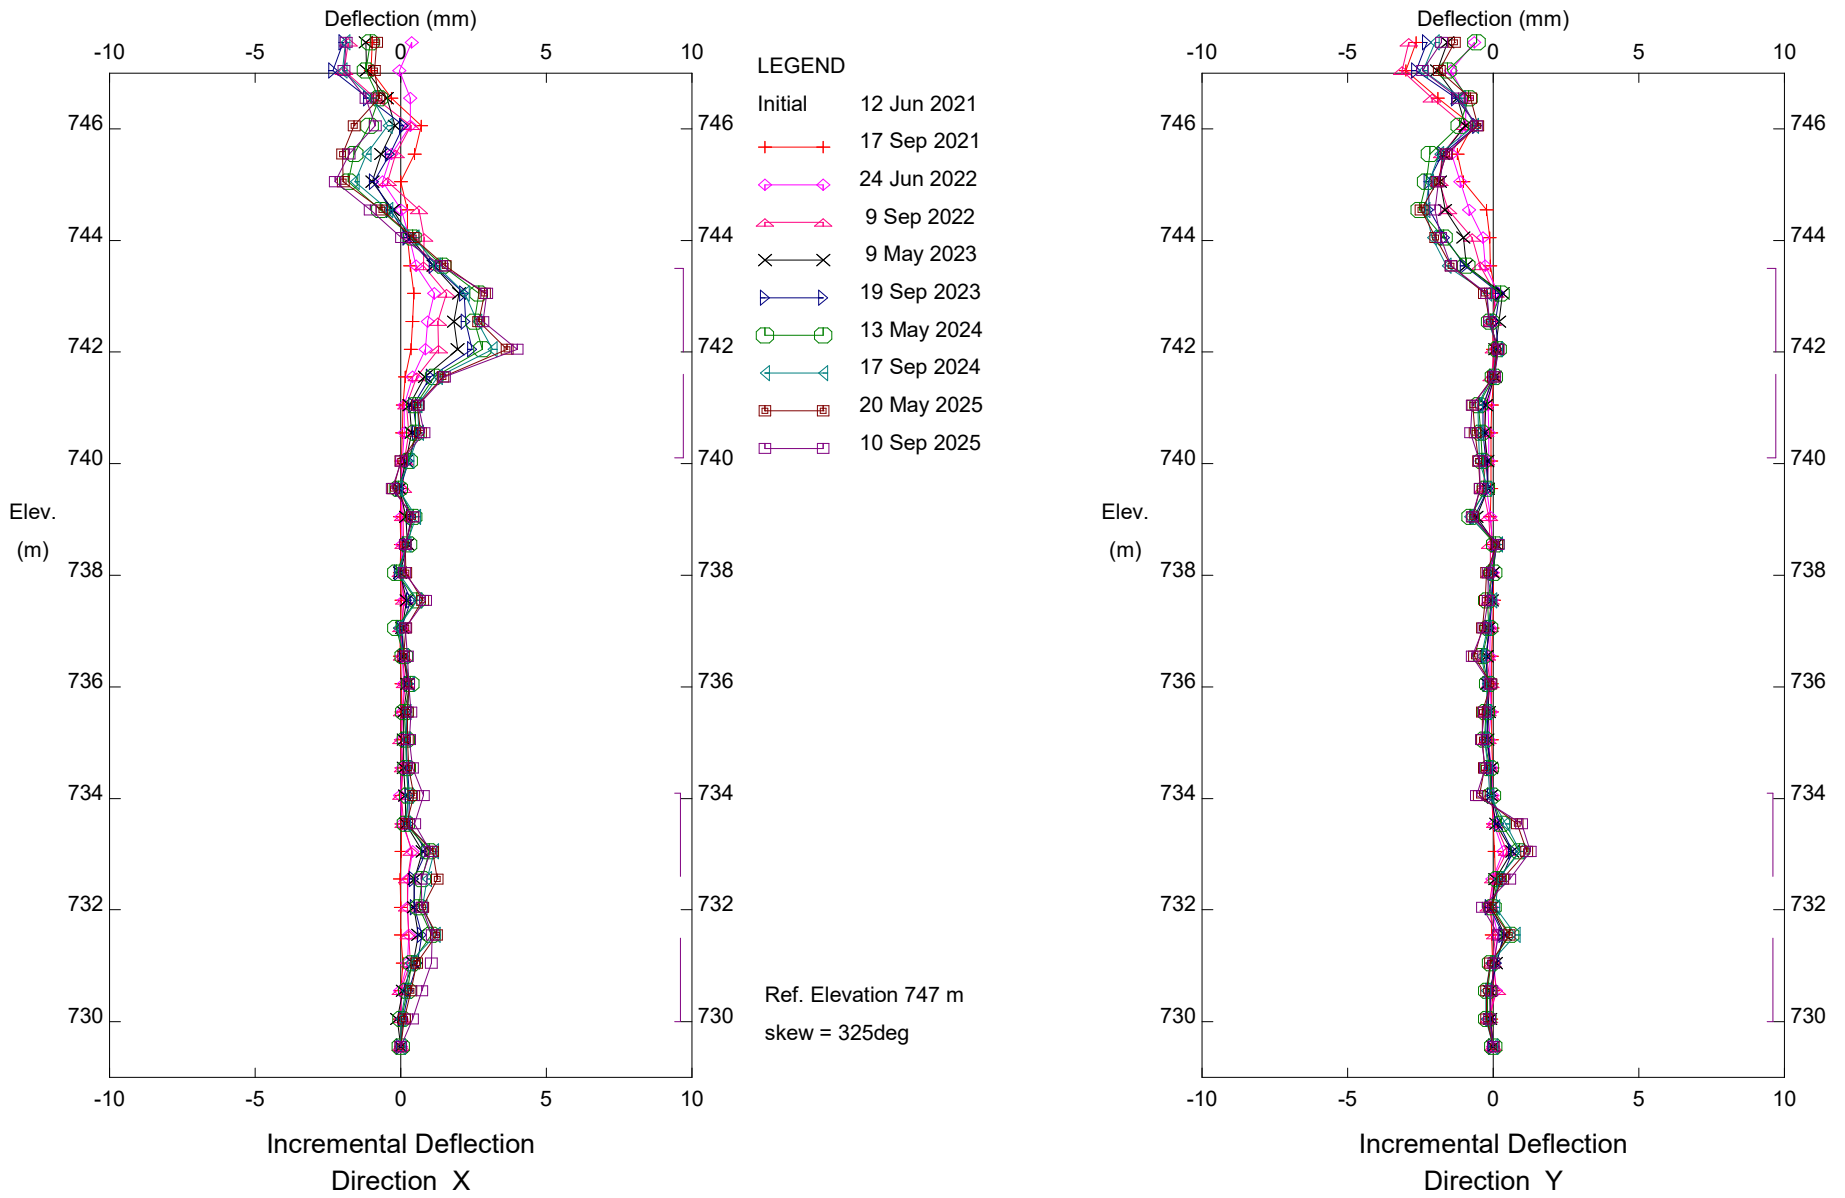
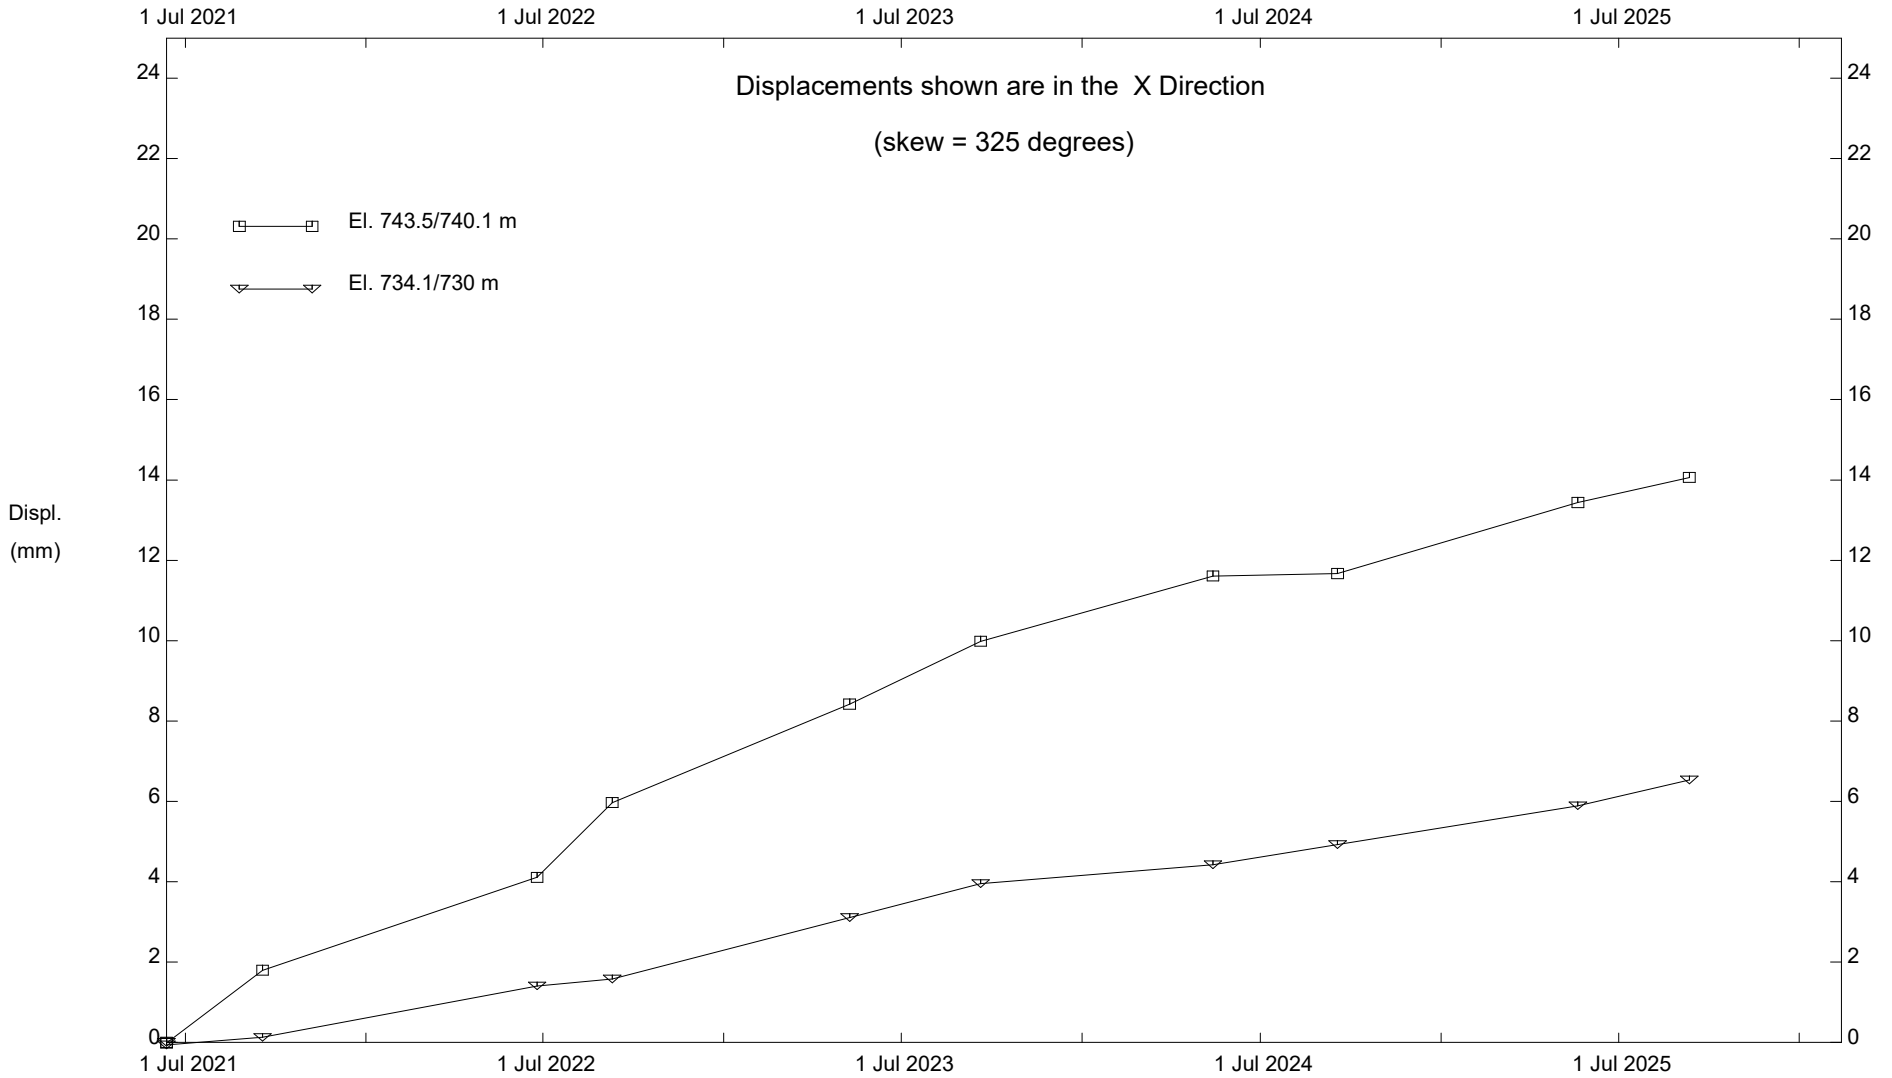
C017-III; H575:04; Truckstop Slide, Inclinometer SI20-01

Distributed movement is being recorded in SI20-C017-01 in the upper 6 m and from approximately 14 m to 16 m below ground surface.

Based on the stratigraphy encountered during the 2020 drilling investigation, the upper and lower zones of movement recorded in SI20-C017-01 appear to be occurring in a soft zone in the embankment fill (silty clay and sand) and in the underlying foundation material (sandy silt), respectively.

An overall relatively slow steady rate of movement (less than approximately 5 mm/year) has been recorded in the SI since June 2021, excluding an increased rate of movement (approximately 9 mm/year) recorded in fall 2022 after wet weather in summer 2022. There was no increased rate of movement observed in response to construction activities at the site in winter/spring 2025 to stabilize the slope (consisting of slope grading and soil nail installation). The movement recorded in fall of 2025 of approximately 2 mm/year is consistent with historical trends.

All operable instruments should continue to be read twice per year (spring and fall).

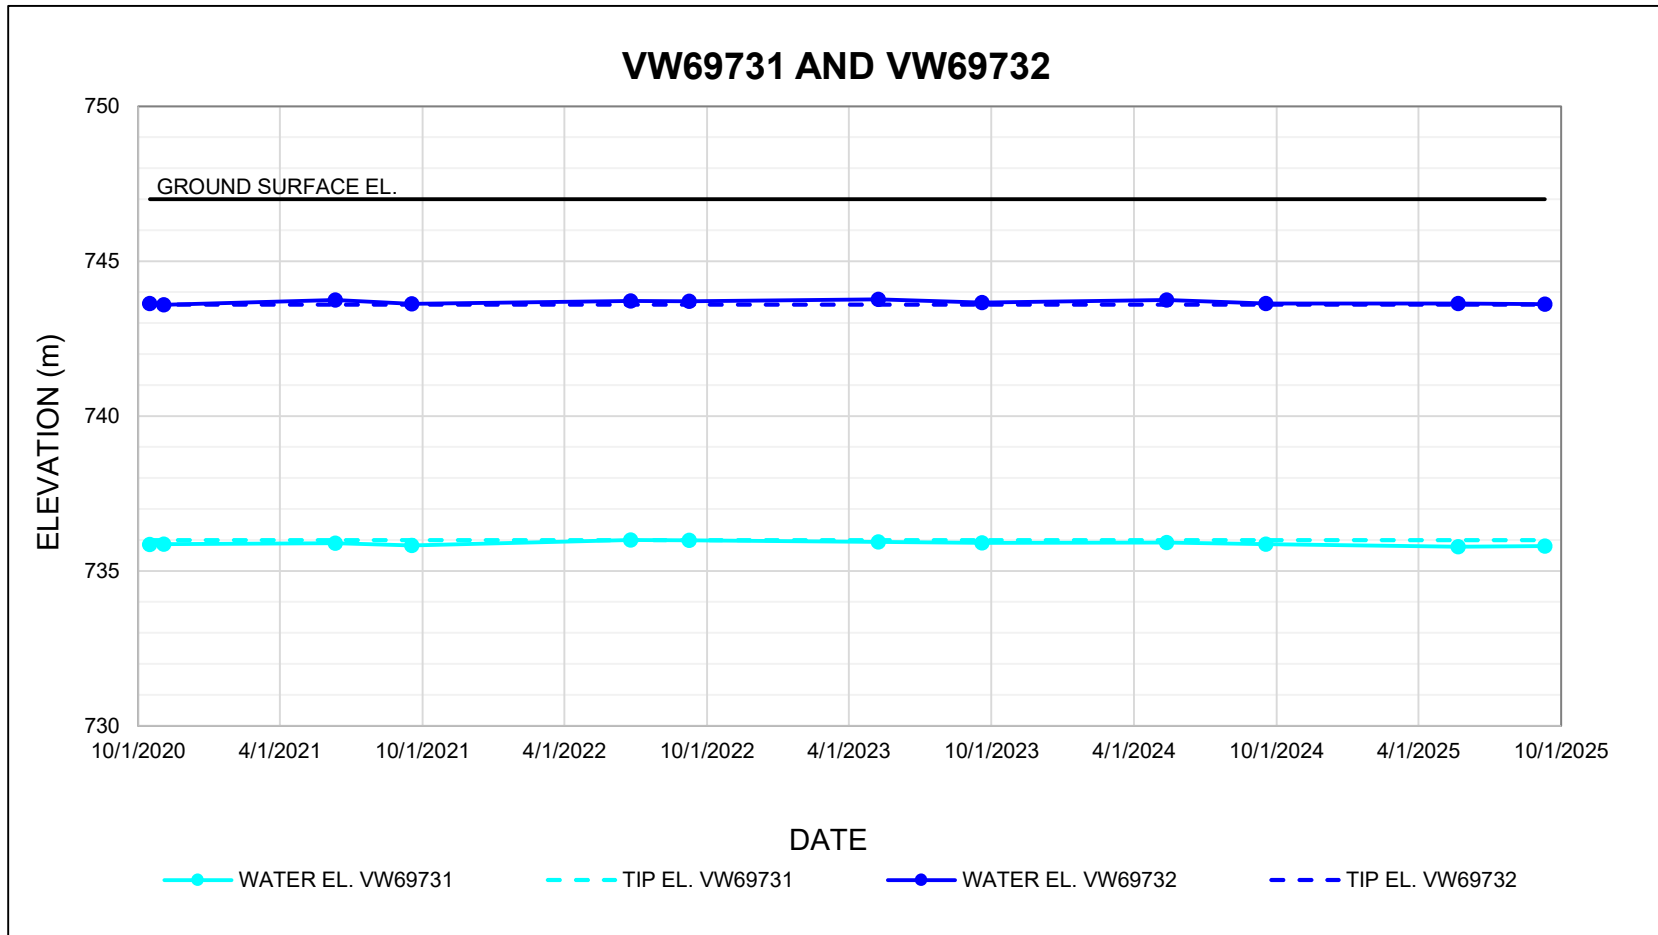
TITLE	
		Piezometer Data C017-3 - Truck Stop Slide Hwy 575:04, km 26.341	
SCALE	N/A	PROJECT No.	A05116A02
			FIG No.
			I-7

Since installation in October 2020, porewater pressures recorded in the two VWP's (VW69731 and VW69732) have been within  $\pm 0.2$  m of the tip elevation for each instrument, indicating these instruments are dry. Since an elevated groundwater level is believed to be one of the factors that was driving instability of the slide (repaired in 2025) at the C017-3 site, KCB believes the piezometers may have been installed at depths that do not record transient changes in groundwater or that the current bi-annual reading frequency of the instruments does not capture short-term fluctuations (i.e., increases and decreases) in water level that could be occurring in response to heavy rainfall events or freshet infiltration between readings. The fall 2025 data was consistent with historical readings for the instruments.

No instrument repairs or maintenance is required. However, installation of a data logger with one or more of the VWP's may be beneficial, as more frequent readings may capture short-term fluctuations (i.e., increases and decreases) in groundwater level that could be occurring in response to periods of heavy or prolonged rainfall or freshet infiltration between readings.
