July 15, 2025

**CON0022160 Central Region GRMP Instrumentation Monitoring
Site C042; H579:02 km 36.540 West of Water Valley Slide
Section C – 2025 Spring Readings**

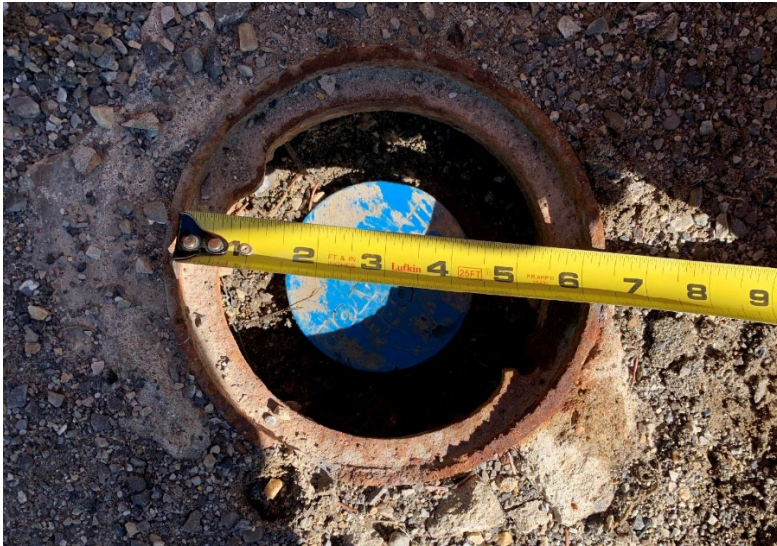
The flush-mounted casing protectors installed in the south shoulder of Hwy 579:02 to protect SI05-07 is missing a cover (Photo 1). KCB attempted to attach a new cover during the spring 2022 readings. However, it could not be attached to the existing flush-mounted casing protector. The old flush-mounted casing protector should be replaced.

Photo 1 Flush-mounted casing protector installed in the south shoulder of Hwy 579:02 to protect the SI05-07.

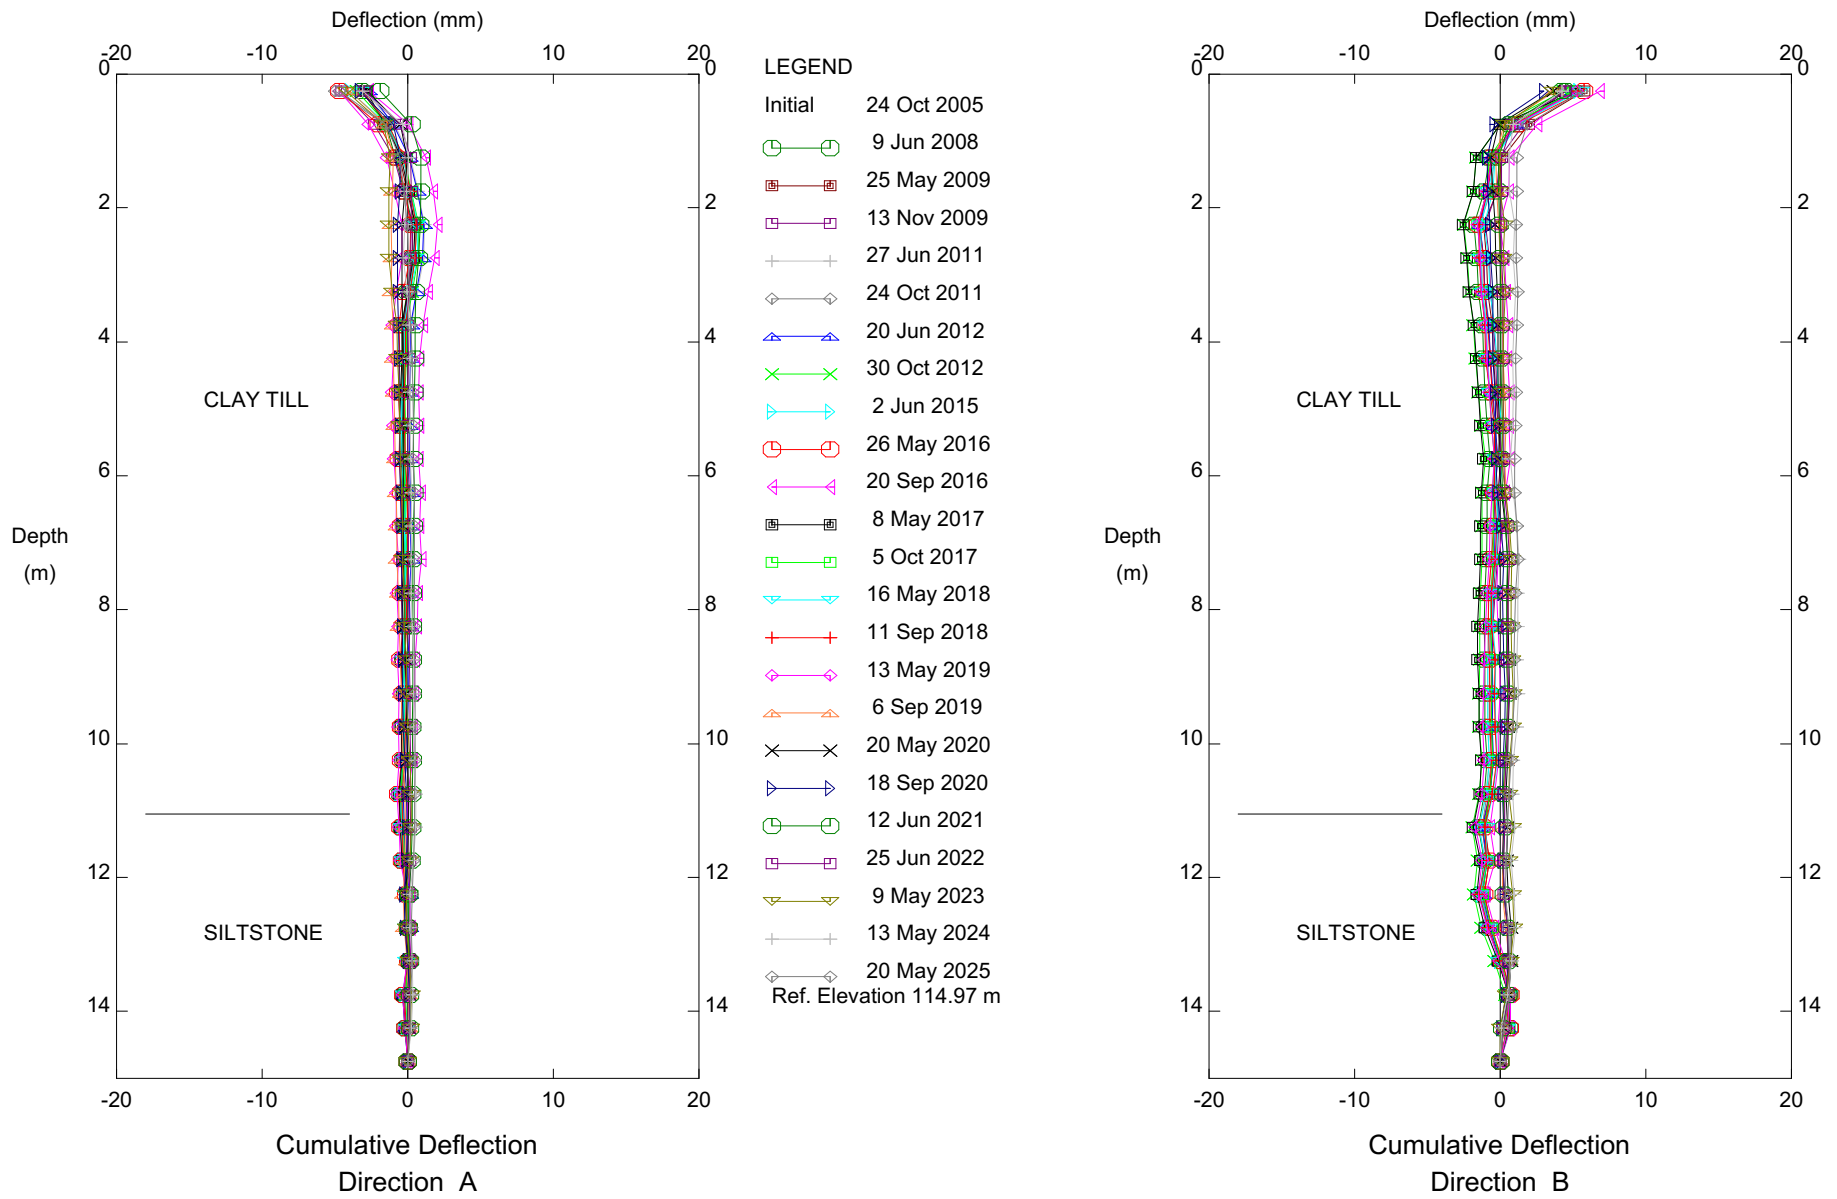
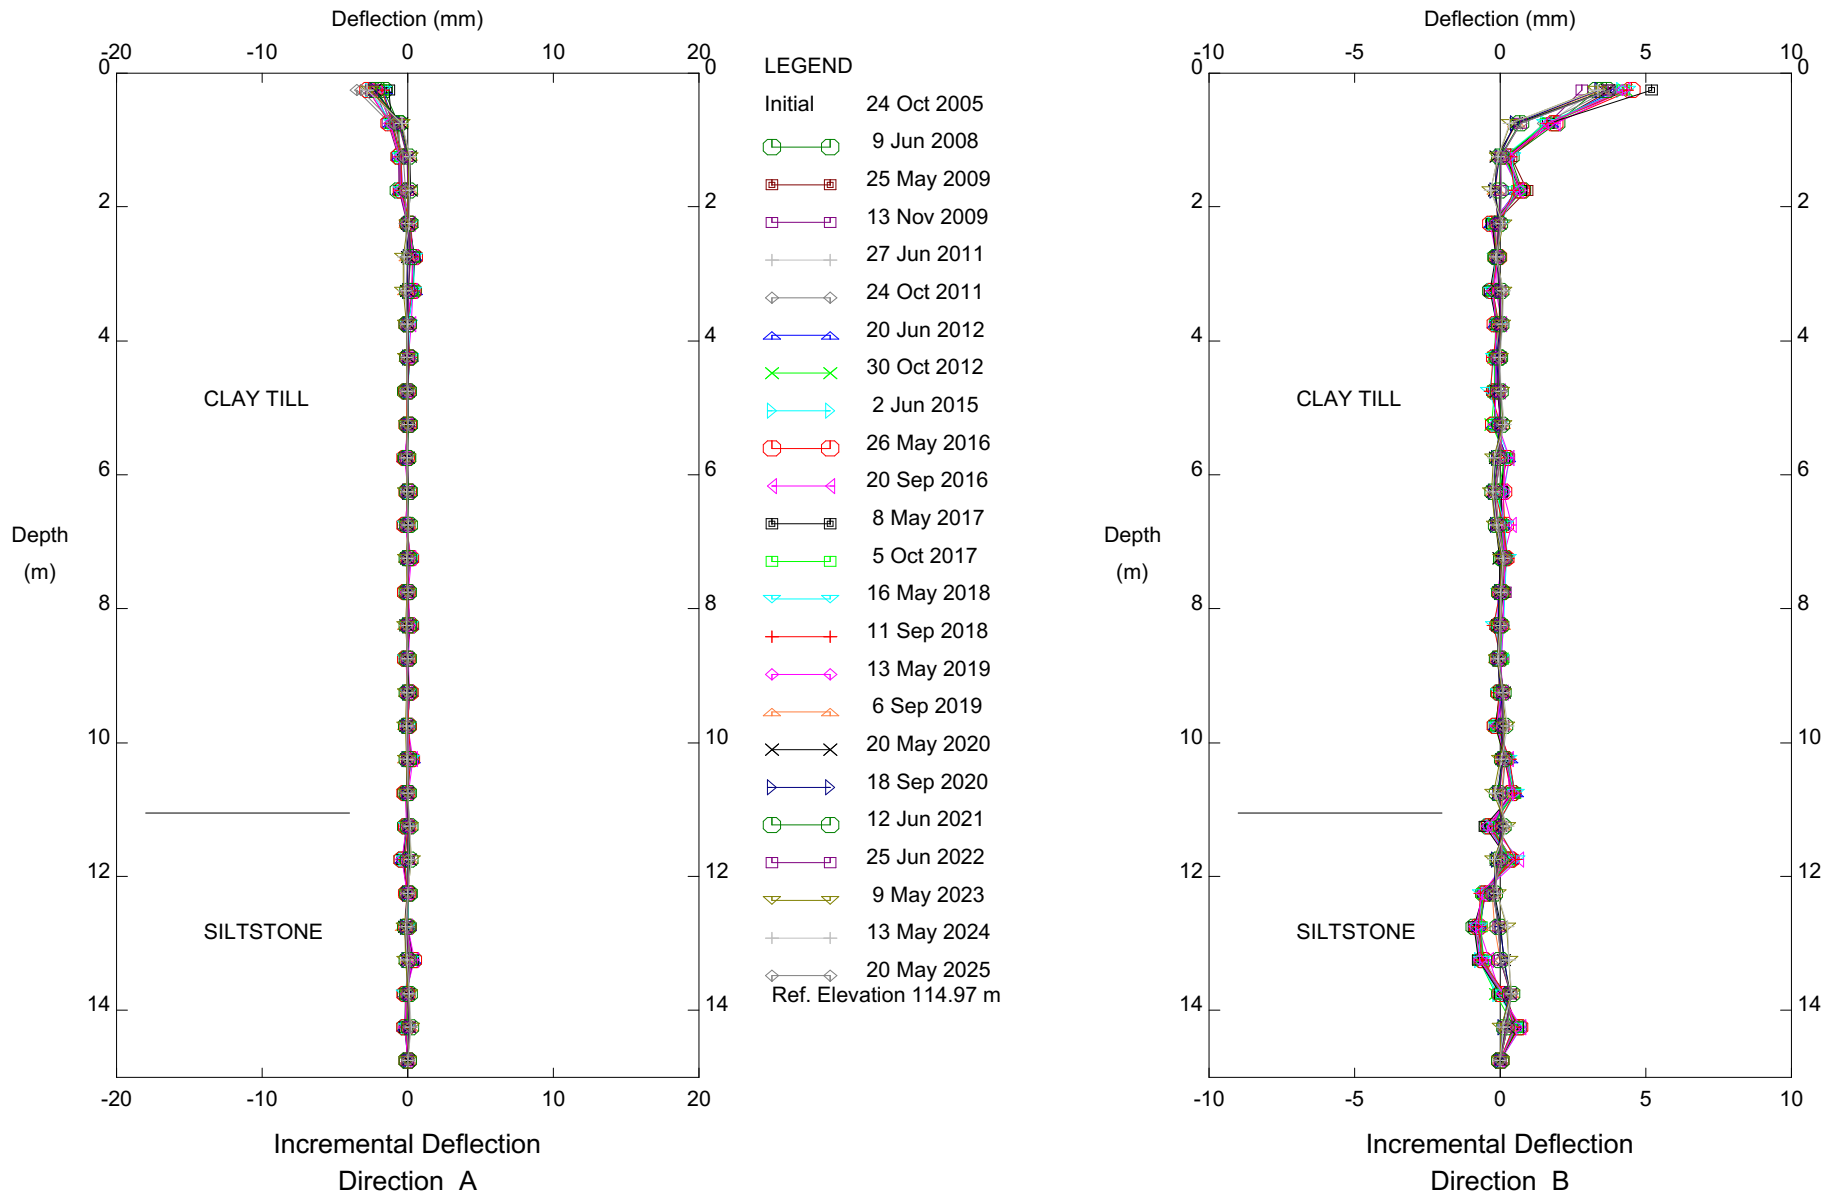
C042; H579:02, West of Water Valley Slide, Inclinometer SI05-05

No discernible movement has been recorded in SI05-05 since installation.

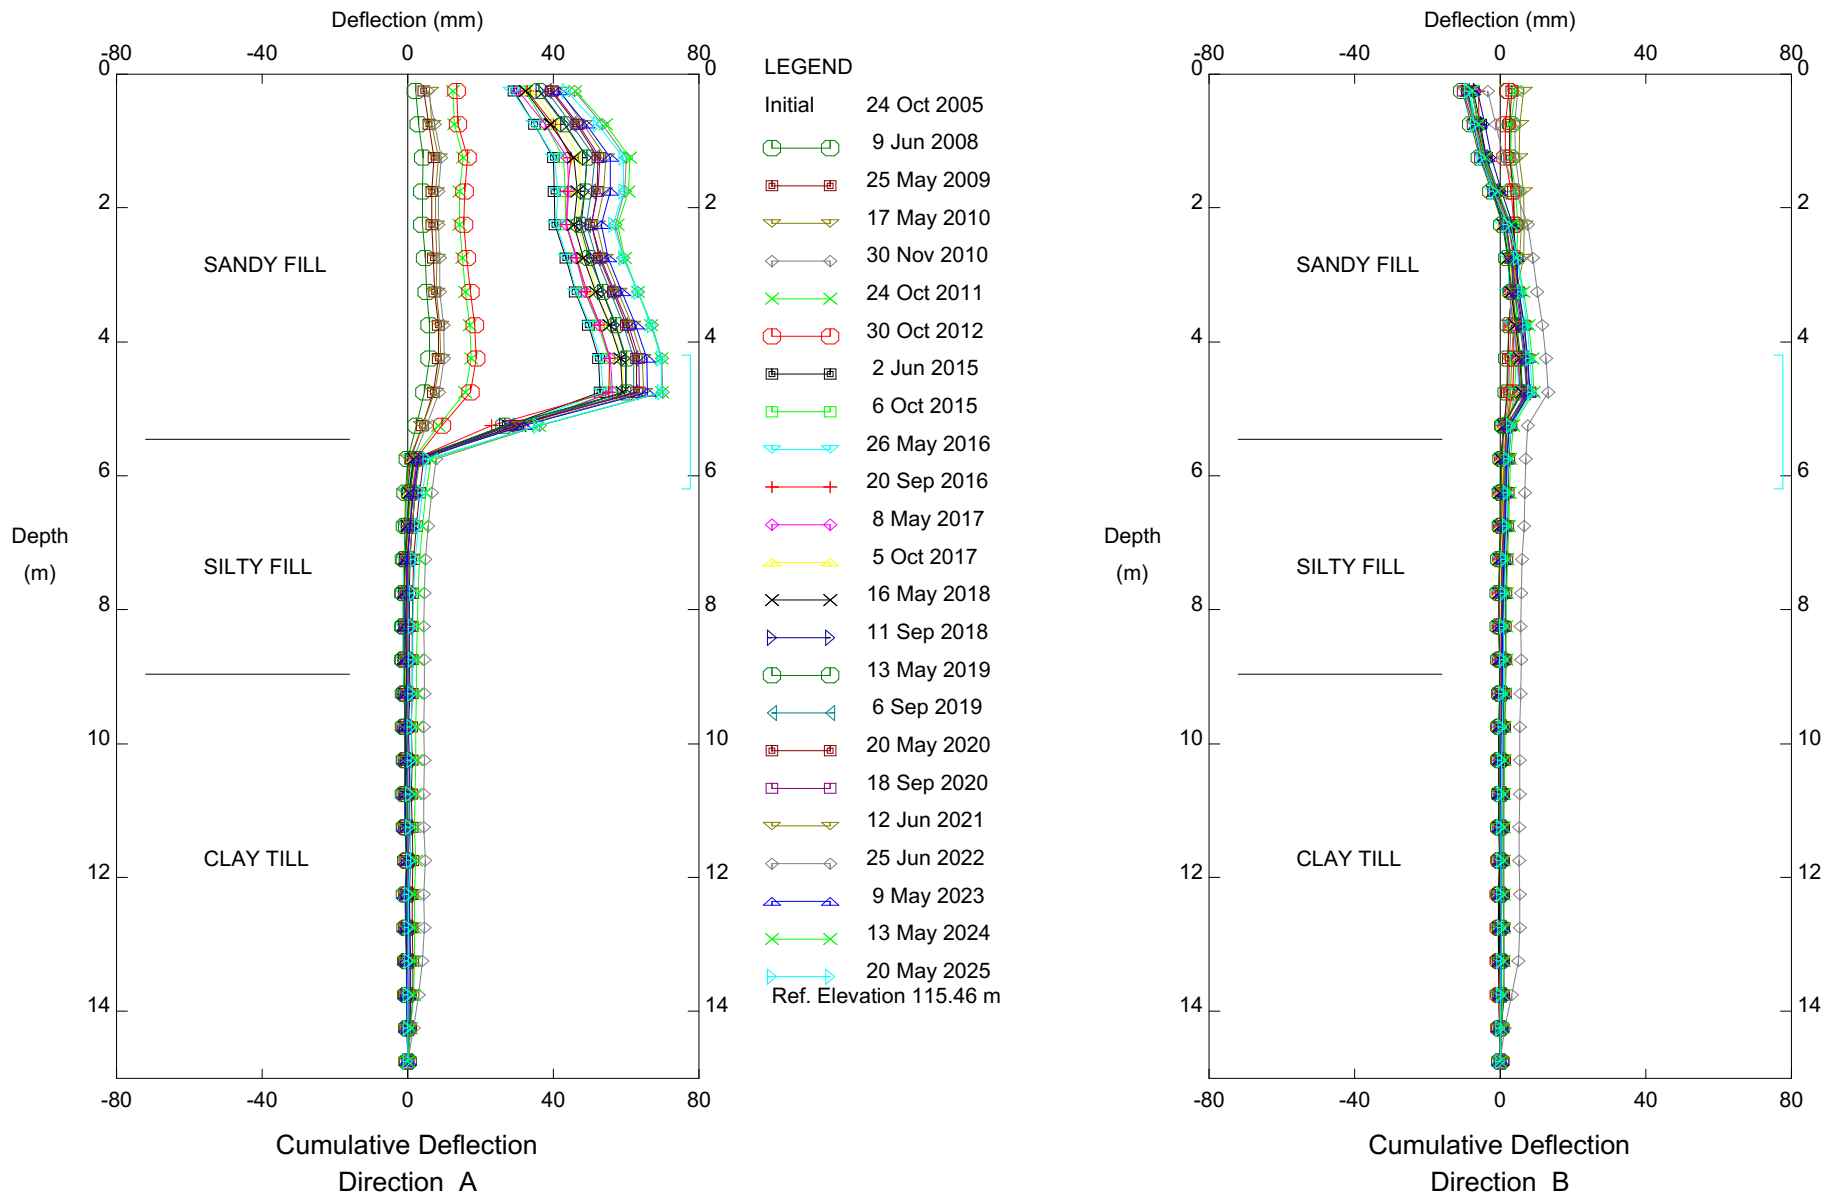
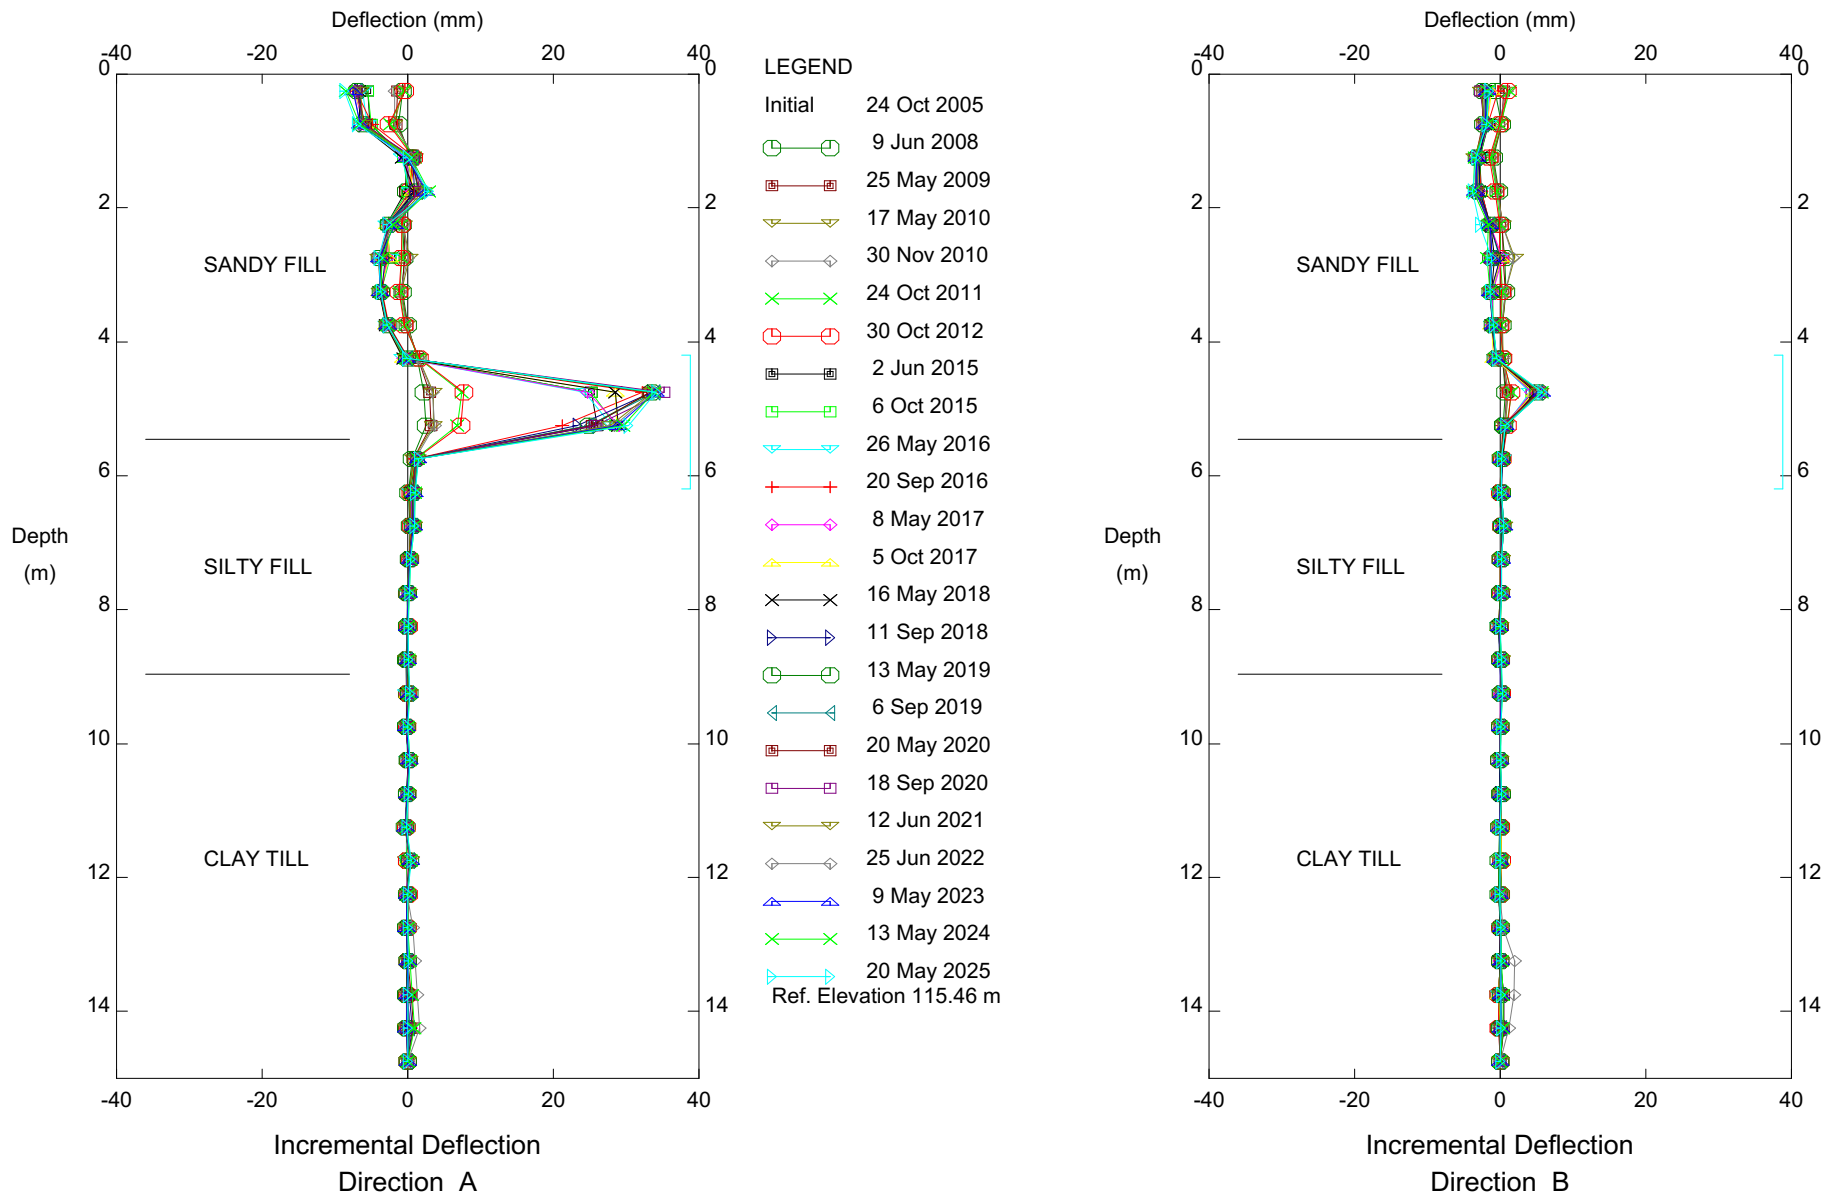
C042; H579:02, West of Water Valley Slide, Inclinometer SI05-07

Discrete movement is being recorded in SI05-07 between approximately 4.5 m and 6.0 m below ground surface, in the highway embankment fill.

Historically, movement was recorded in SI05-07 at a rate of less than 10 mm/year, except between August 2013 and June 2015, when the rate of movement increased to approximately 17.5 mm/year. Since June 2015, the rate of movement being recorded in SI05-07 is generally negligible during the winter months (i.e., between the fall and spring readings) and up to 10 mm/year (overall) during the summer months (i.e., between the spring and fall readings).

The rate of movement recorded since spring 2021 has been slow (less than 1 mm/year). This was likely due to relatively dry weather throughout the past four years (excluding June and July 2022, see the precipitation data plotted on the piezometer plots). For comparison, the rate of movement in the previous wet year (2020) was approximately 7 mm/year. Increased movement may occur in response to periods of heavy or prolonged rainfall, resulting in higher groundwater conditions.

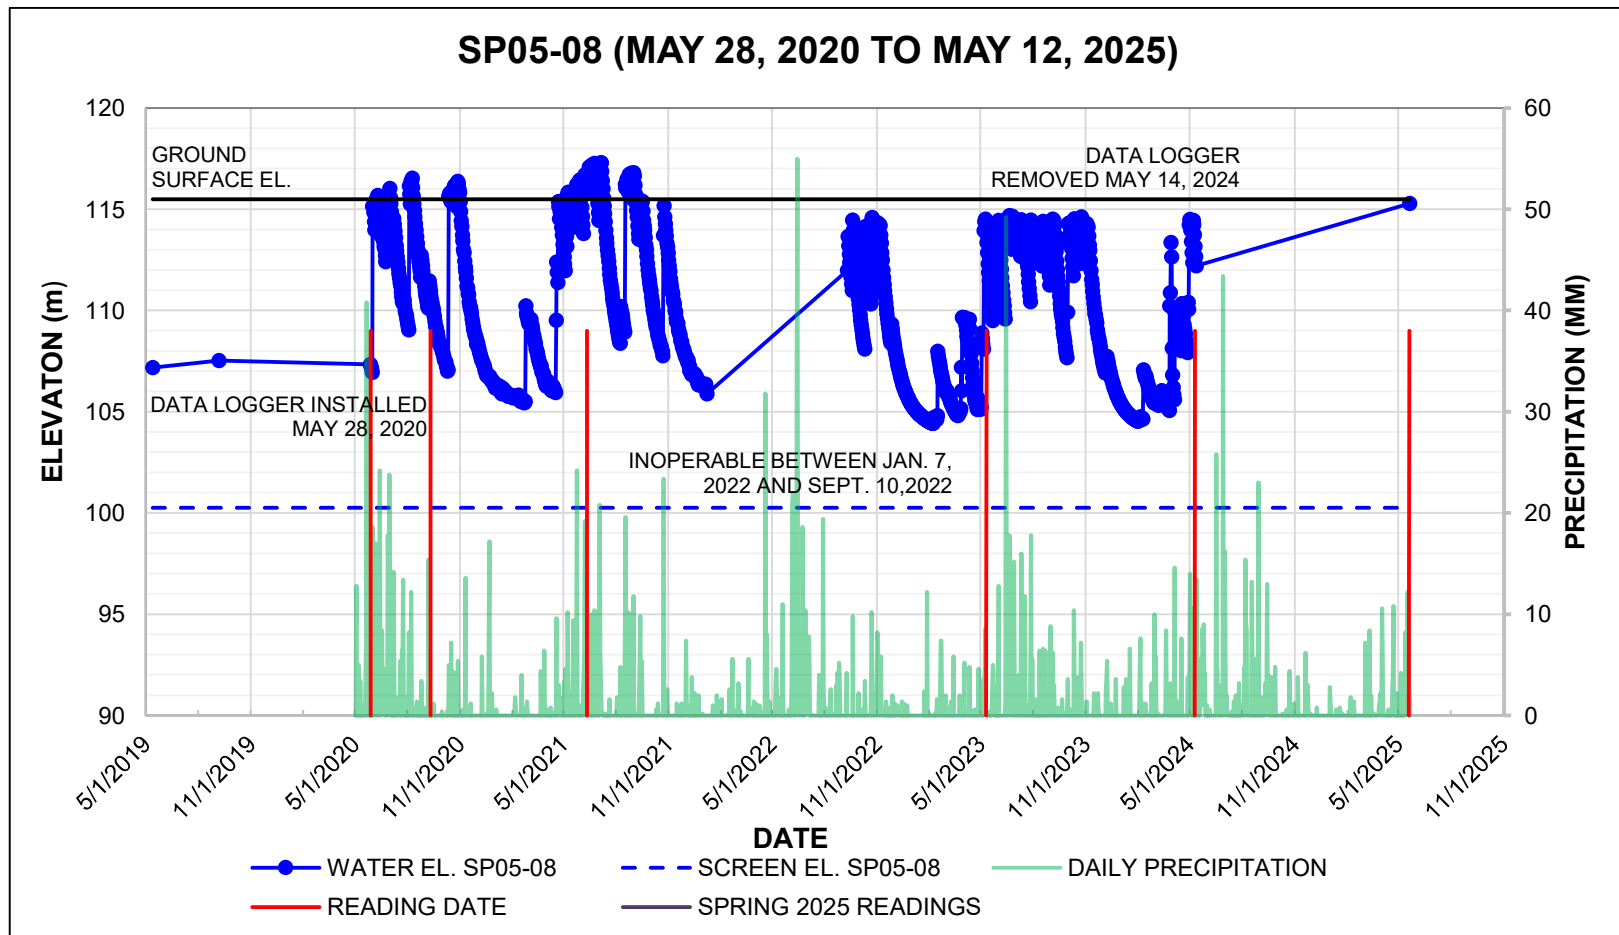
CENTRAL REGION GEOHAZARD RISK MANAGEMENT PROGRAM	
		TITLE	
		Piezometer Data C042 - West of Water Valley Slide Hwy 579:02, km 36.540	
SCALE	PROJECT No.	A05116A02	FIG No.
			I-7

Upon review of the data obtained from the Heron data logger between May 2020 and May 2024, there appears to be a relatively strong relationship between precipitation and water level response (e.g., water level increases in response to increased rainfall in fall 2021). There are multiple precipitation events where there is no response recorded in SP05-08. However, these events were during winter months when the ground was frozen and there was no infiltration. It also appears that increases in the groundwater table in response to precipitation events were short-lived. However, these increases in groundwater could lead to increased rates of movement, before decreasing as the groundwater table decreases.

A manual reading was taken in spring 2025 for SP05-08 since the data logger was removed. The recorded water level increased (approximately by 3.8 m) between spring 2024 and 2025 and was within 0.3 of ground surface. KCB suspects the instrument casing may have cracked between the 2024 and 2025 readings, leading to infiltration into the casing, as the rainfall for April and May 2025 were similar to historic averages and do not support such a large increase.
