July 15, 2025

Alberta Transportation and Economic Corridors
4th Floor, Provincial Building
4920 – 51st Street
Red Deer, Alberta
T4N 6K8

**CON0022160 Central Region GRMP Instrumentation Monitoring
Site C003; H872:06, km 0.278 Burma Park Slide
Section C – 2025 Spring Readings**

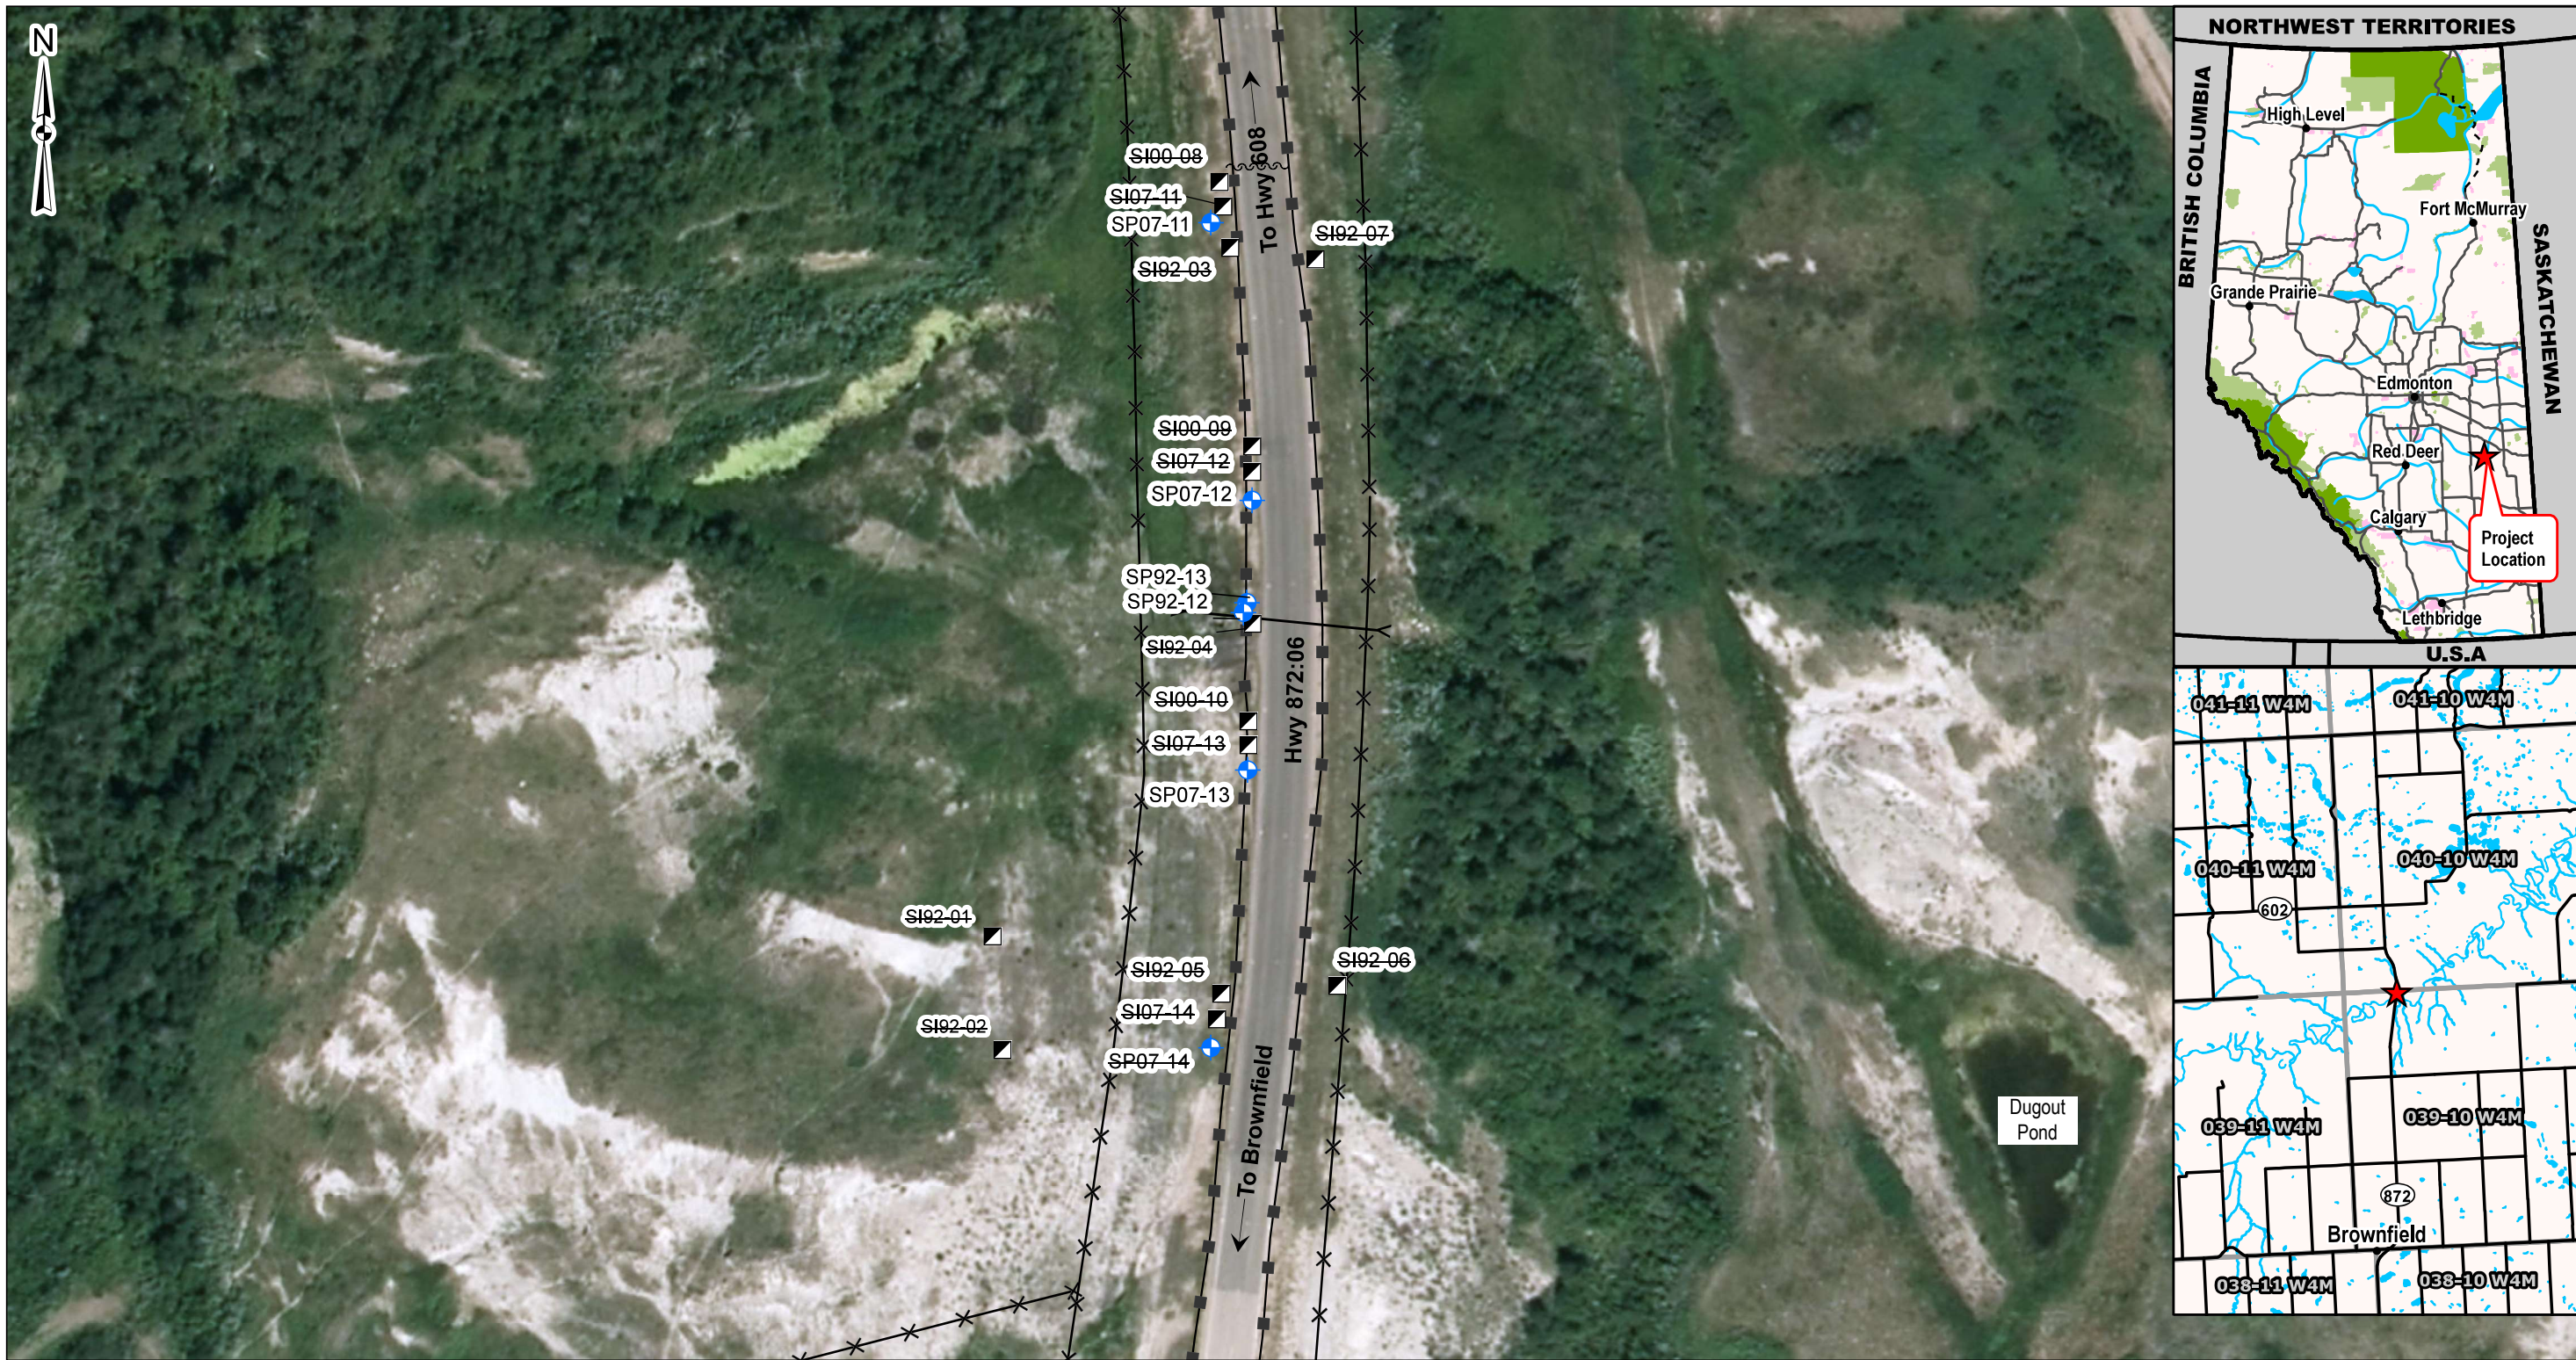
PROJECT CENTRAL REGION GEOHAZARD RISK MANAGEMENT PROGRAM		
TITLE Site Plan C003 - Burma Park Slide Hwy 872:06, km 0.278		
SCALE 1:1,000	PROJECT No. A05116A02	FIG No. 1

Five standpipe piezometers (SPs) (SP92-12, SP92-13, and SP07-11 through SP07-13) were read at the C003 site in the Central Region on May 21, 2025 by Evan Hergott, E.I.T. of Klohn Crippen Berger Ltd. (KCB). These instruments were read as part of the Central Region Geohazard Risk Management Program (GRMP). The site is located on Hwy 872:06, km 0.278, approximately 0.5 km north of the Battle River crossing and 10 km north of Brownfield, Alberta. The approximate site coordinates are 5806345 N, 471780 E (UTM Zone 12, NAD 83). A site plan is presented in Figure 1.

In 2021, KCB began reading the instruments at the C003 site as part of the GRMP. TEC did not request KCB to complete readings before 2021 due to most of the instruments being inoperable, and no significant changes being observed during the Central Region GRMP Section B inspections. As part of the 2019 Section B inspection, KCB read the instruments at the site to assess which SPs were operable, measure water levels inside the SPs (if operable), and to measure the depth of shearing in the SIs (all inoperable). Instrumentation installation details are tabulated in Table 1.1. Instrument locations are presented in Figure 1.

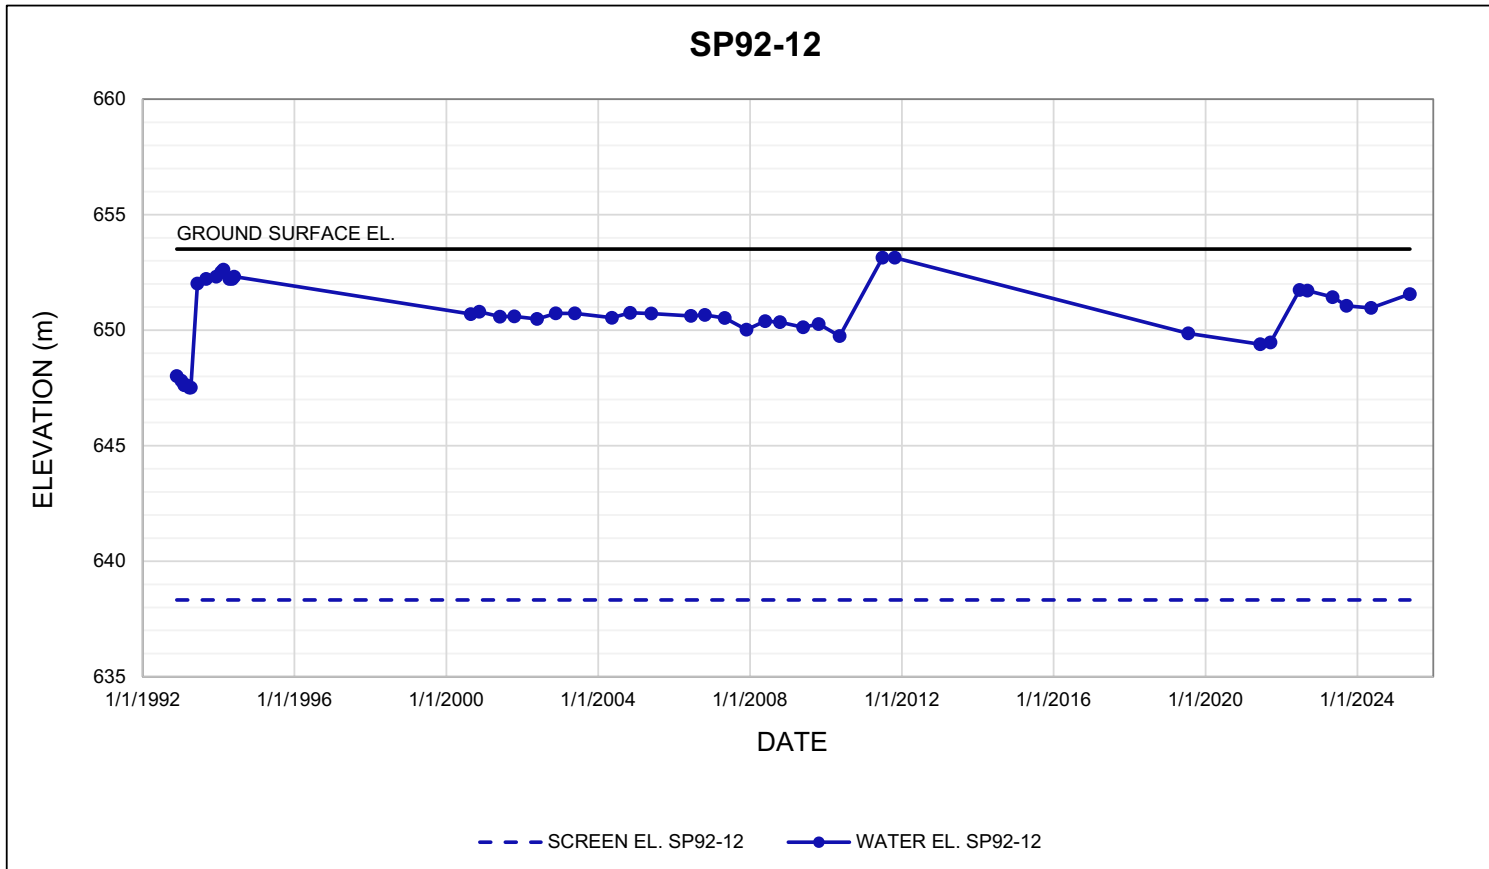
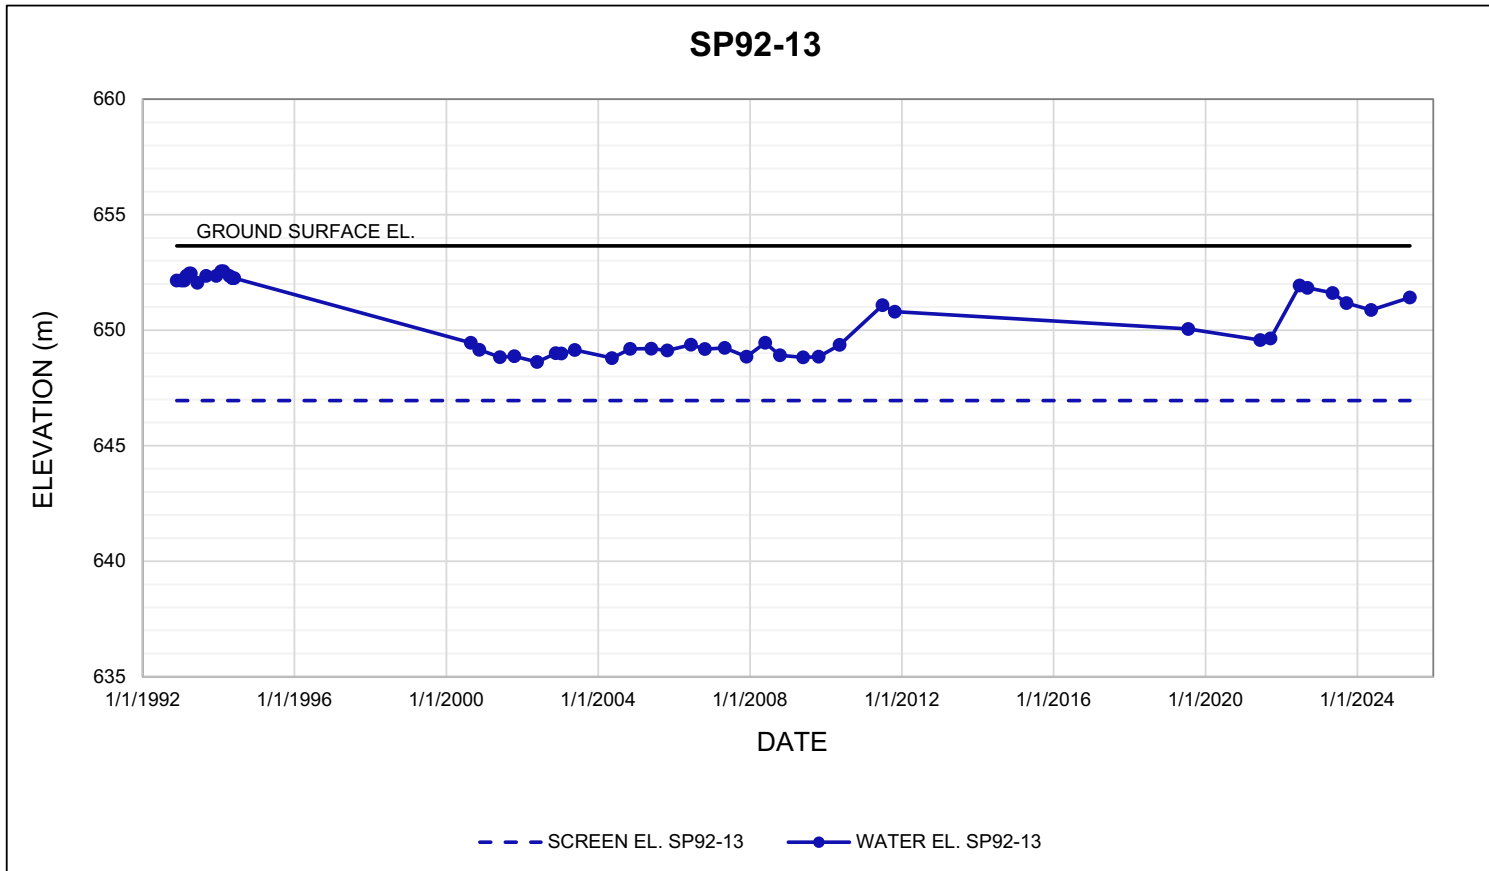
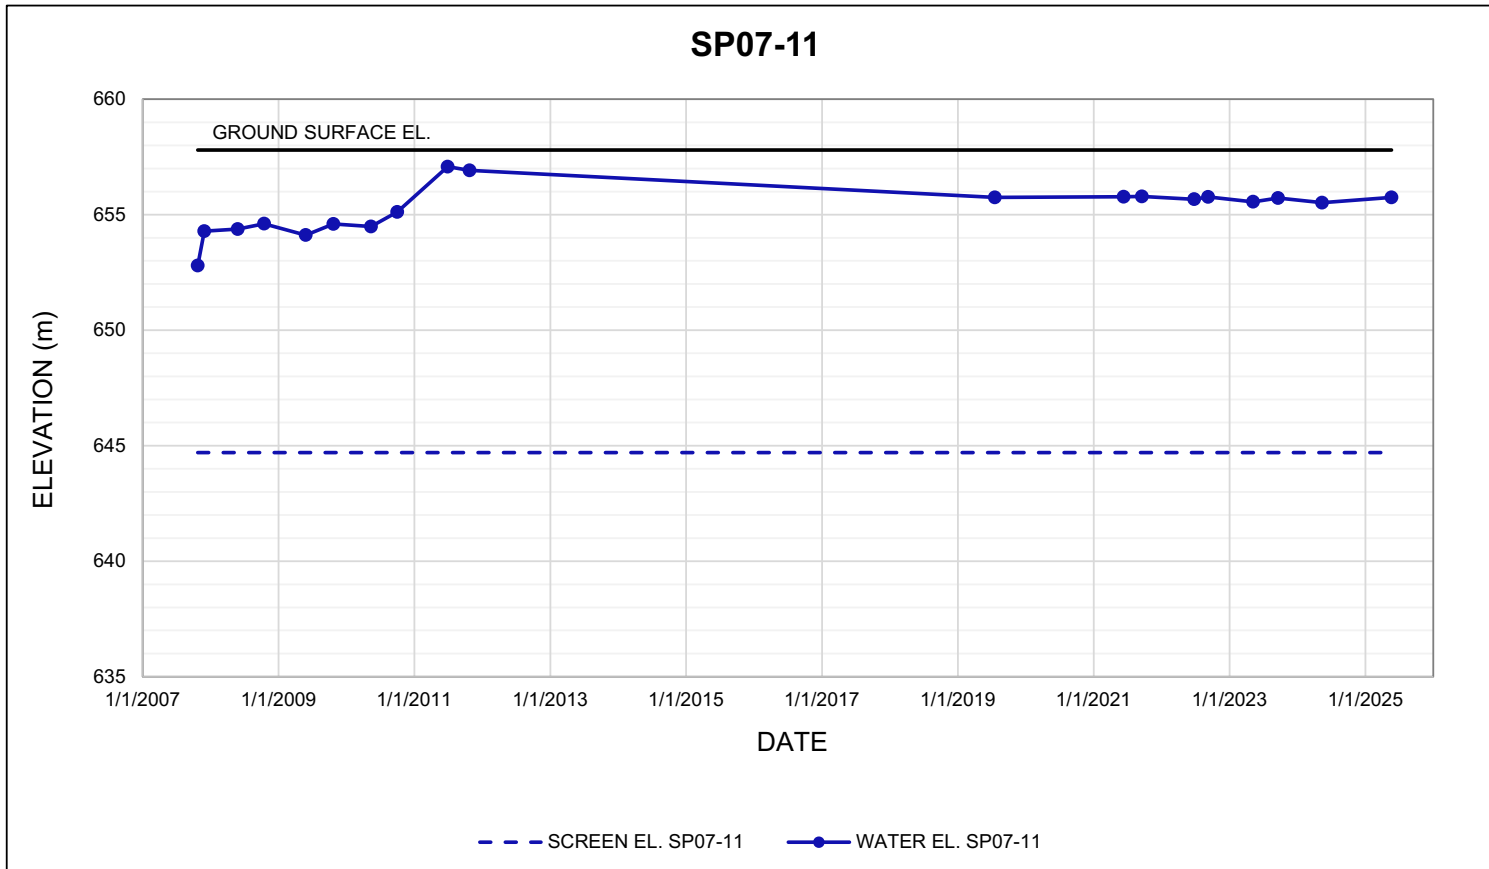
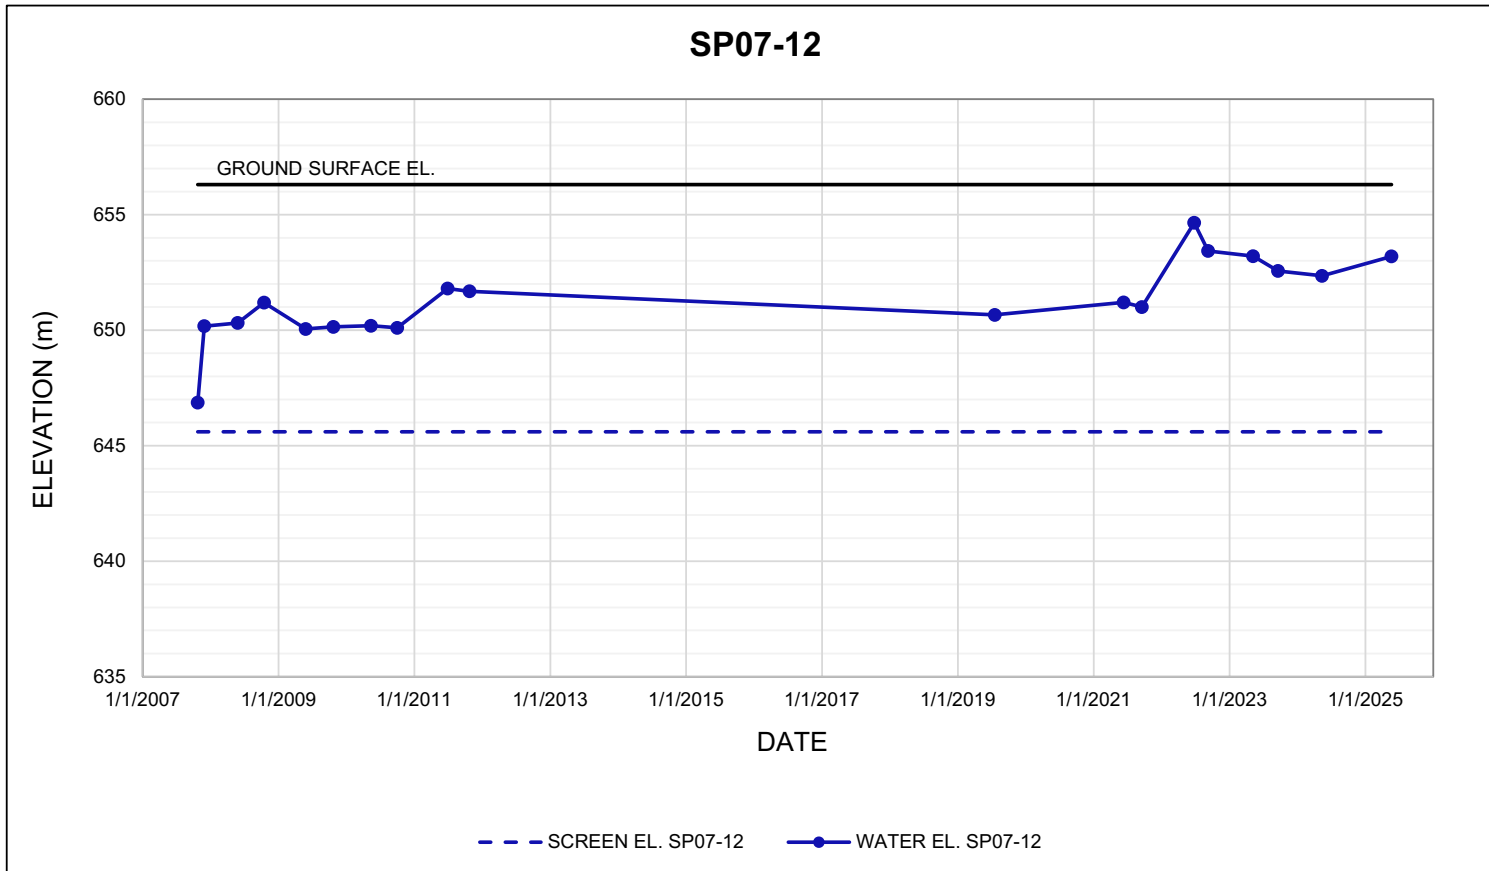
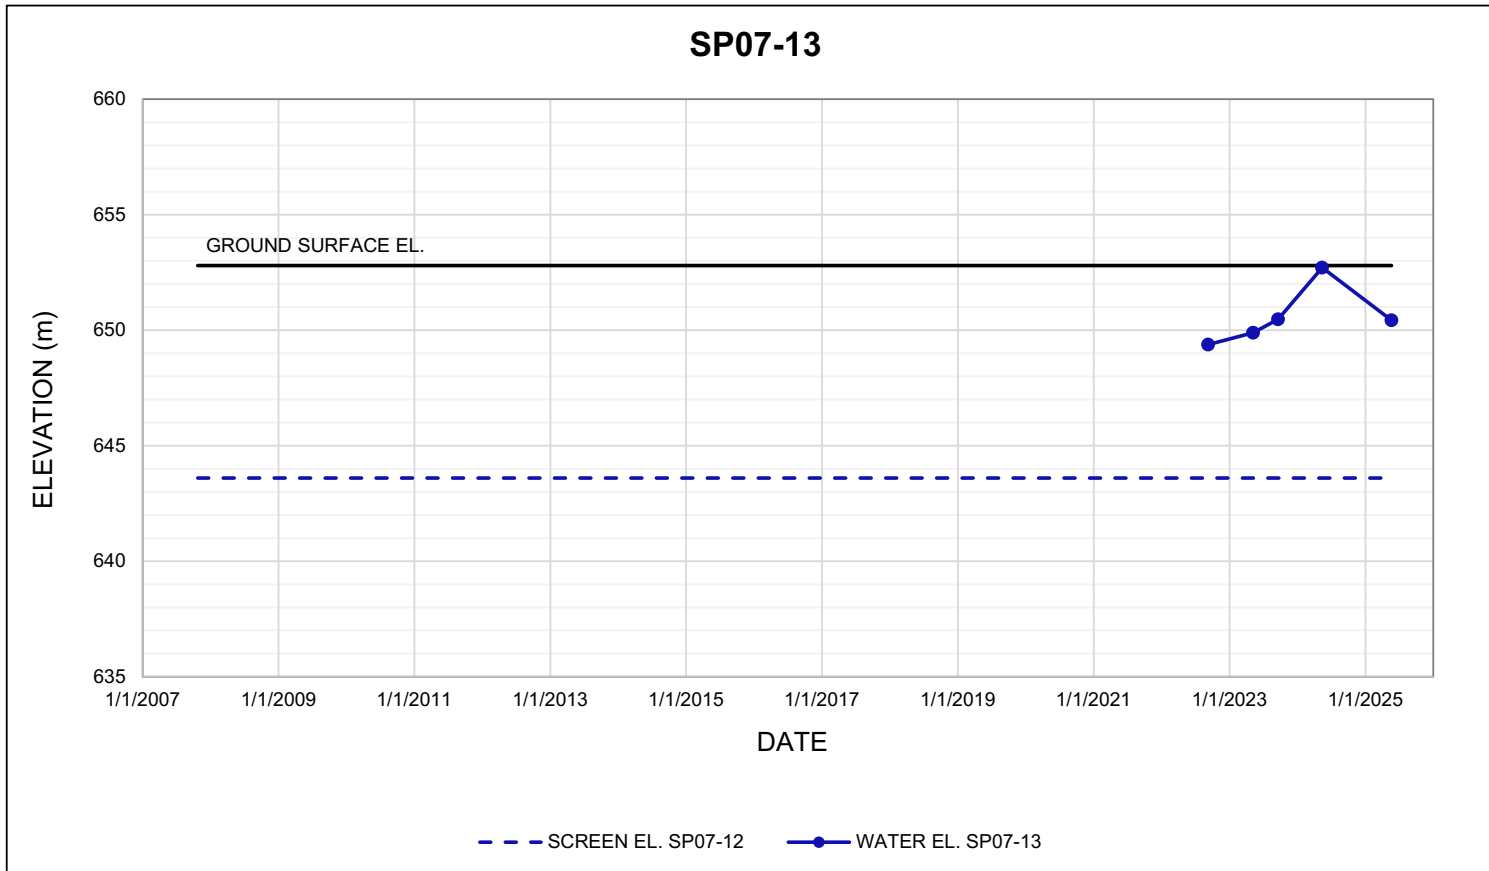
The piezometer data plots are included in Appendix I and a summary of the piezometer data is provided in Table 2.1.

From spring 2022 to spring 2024, the water level recorded in all SPs (except SP07-13) were steady or decreasing (decreases between approximately 0.15 m and 2.30 m). However, from spring 2024 to spring 2025, the water level recorded in all instruments (except for SP07-13) were increasing (increases between approximately 0.2 m to 0.8 m). This increase may be attributed to spring freshet and/or precipitation (heavy or prolonged rainfall).

Based on the piezometer data, it is likely that the movement observed in 2022 (increased pavement cracking, settlement, and guardrail deflection) at the site occurred in response to elevated groundwater levels within the slide mass.

The variation in water level recorded between SI92-12, SP92-13, SP07-11 and SP07-12, and SP07-13, may be due to these instruments being installed on either side of a culvert that receives flows from a wet area upslope and to the east of the instruments. Whereas water levels recorded in the instrument upslope to the north have remained relatively steady or decreasing since the spring of 2021, while the water level recorded in SP07-13 has been increasing (approximately 1.1 m) since spring of 2021, excluding the reading from spring 2024, which may have been attributed to damage to the instrument casing (as discussed below).

Historically, SP07-13 (instrument downslope to the south) has been dry since installation. However, since fall of 2022, steadily increasing water levels from approximately 3.4 m and 2.4 m below ground surface were recorded in this instrument. KCB suspects the water in the instrument may be due to slope movement shearing the SP casing, resulting in groundwater infiltrating the casing. Between the fall 2023 and spring 2024 readings, SP07-13 was broken off at ground surface (likely due to vehicle activities). KCB suspects that surface water may be flowing into the standpipe, resulting in higher-than-actual water levels. Between spring 2024 to spring 2025, a 2.3 m decrease was recorded in SP07-13, potentially attributed to the repairs completed in spring 2024 resulting in groundwater no longer infiltrating the casing and/or surface water flows entering the top of the casing.
