To:	Amy Driessen	From:	Leslie Cho and Lawrence Onwude
	Transportation and Economic Corridors		Stantec Consulting Ltd.
File:	123315222	Date:	October 31, 2025

**Reference: North Central Region, Edson/Stony Plain, Site NC011 – Highway 40:30 5.5 km North of Highway 16 (Near Hinton), Fall 2025 Instrumentation Monitoring Report**

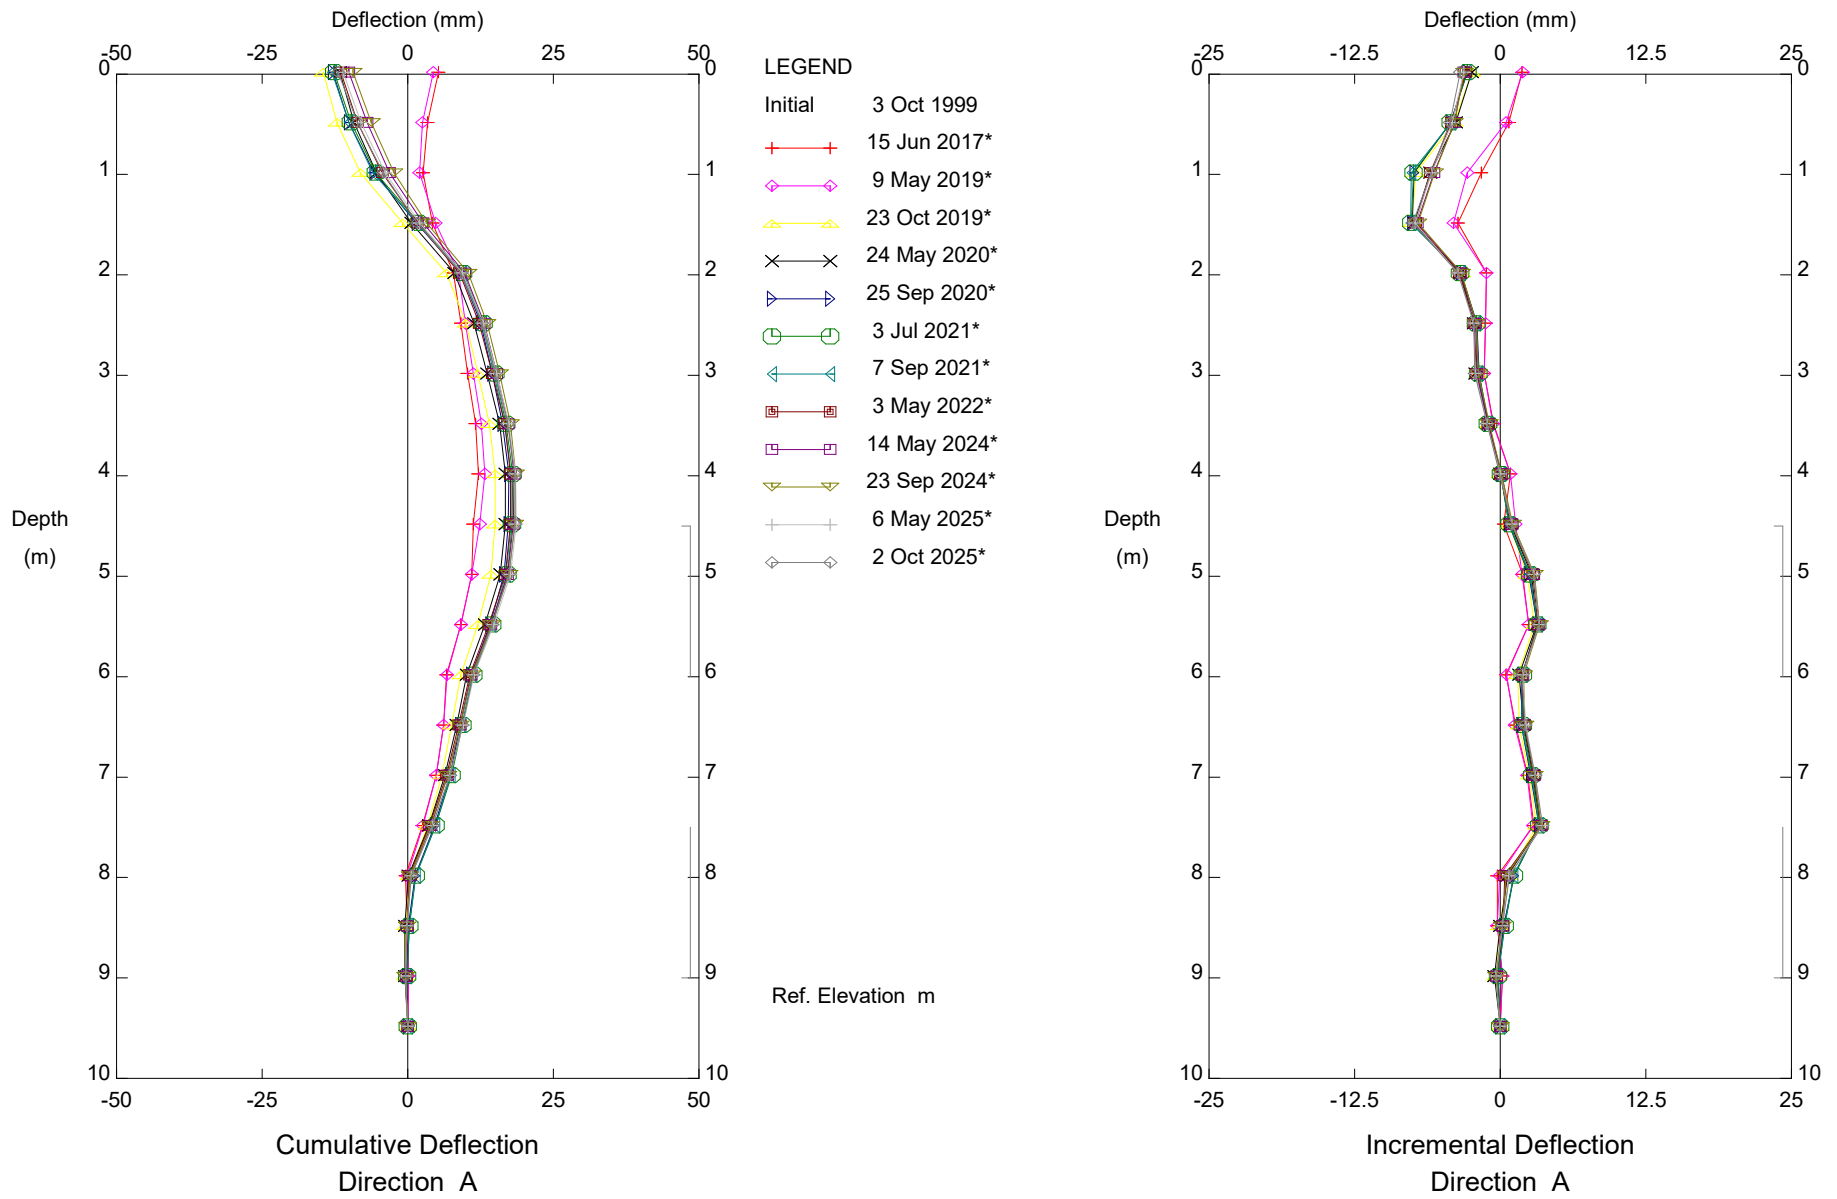
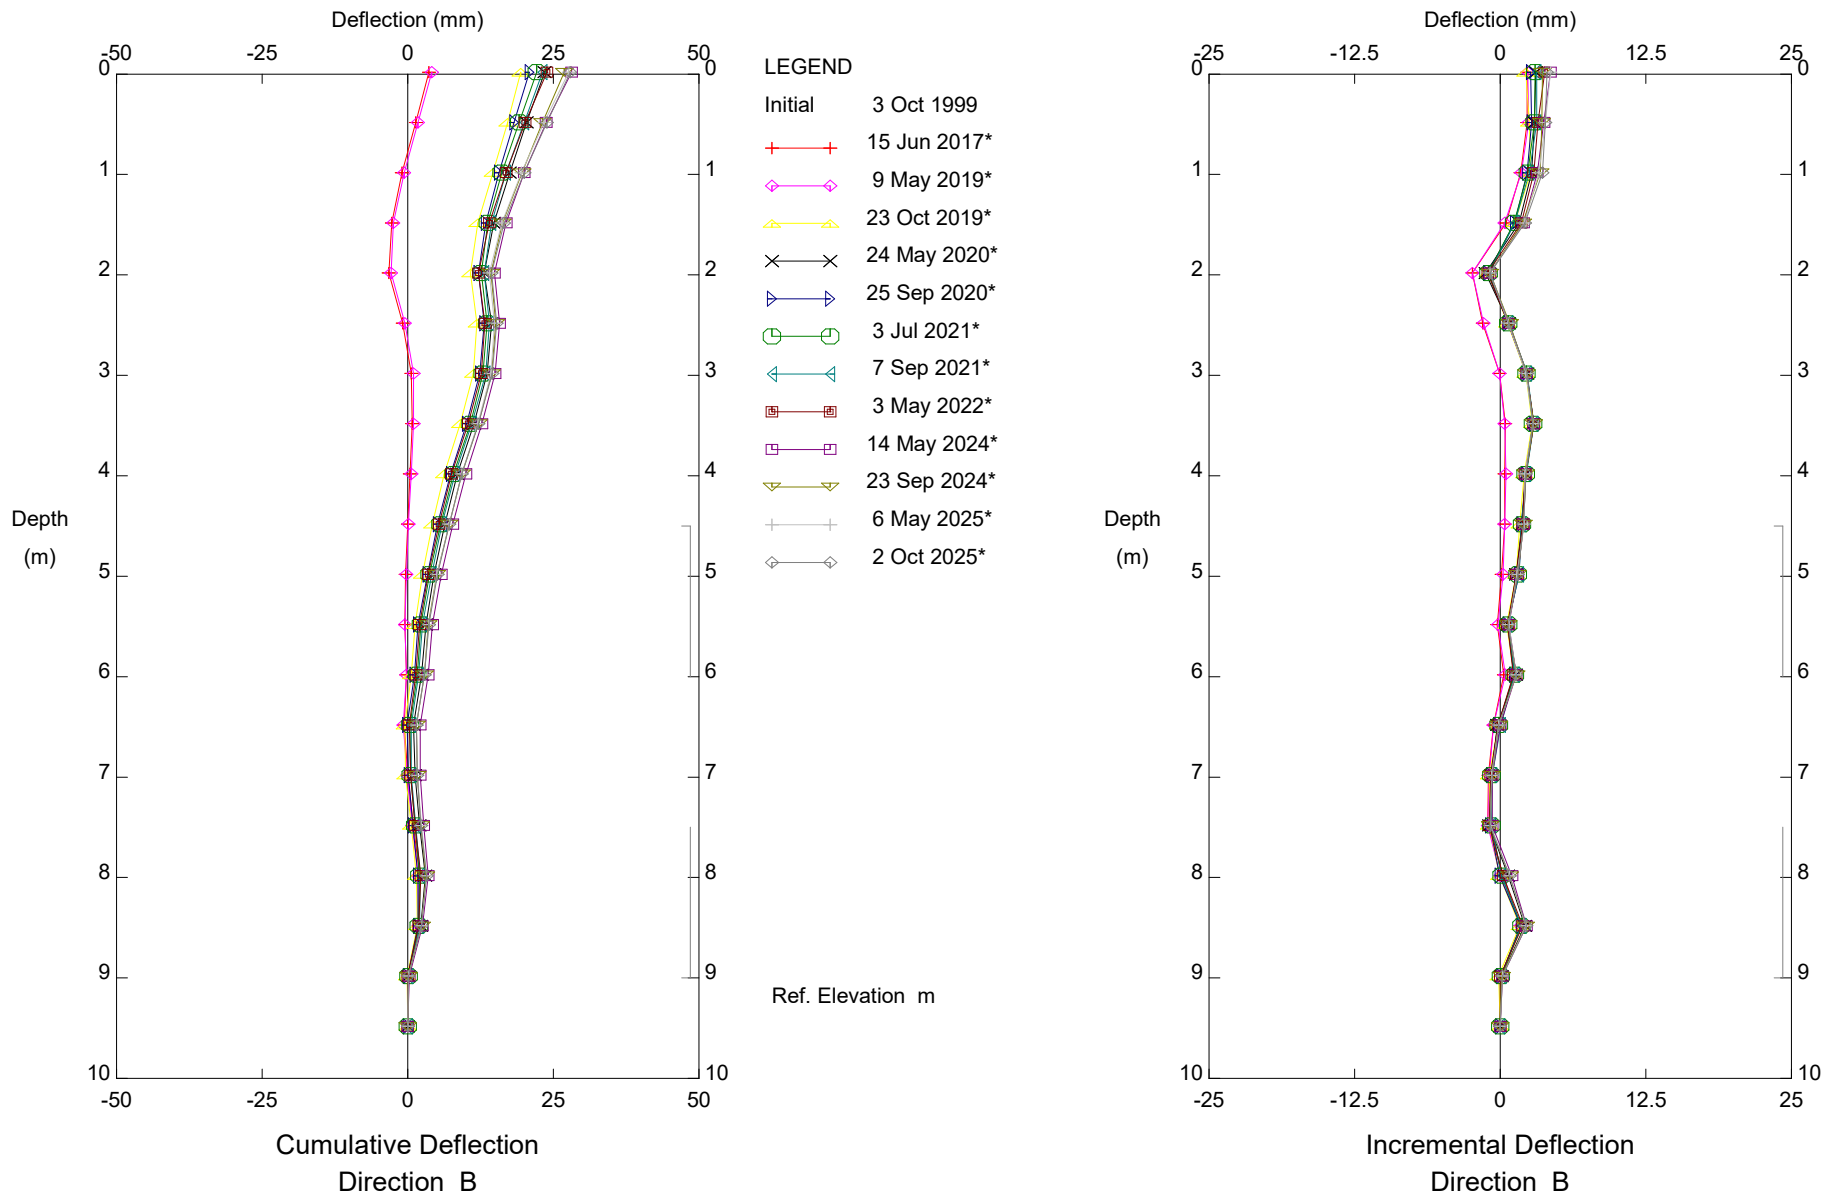
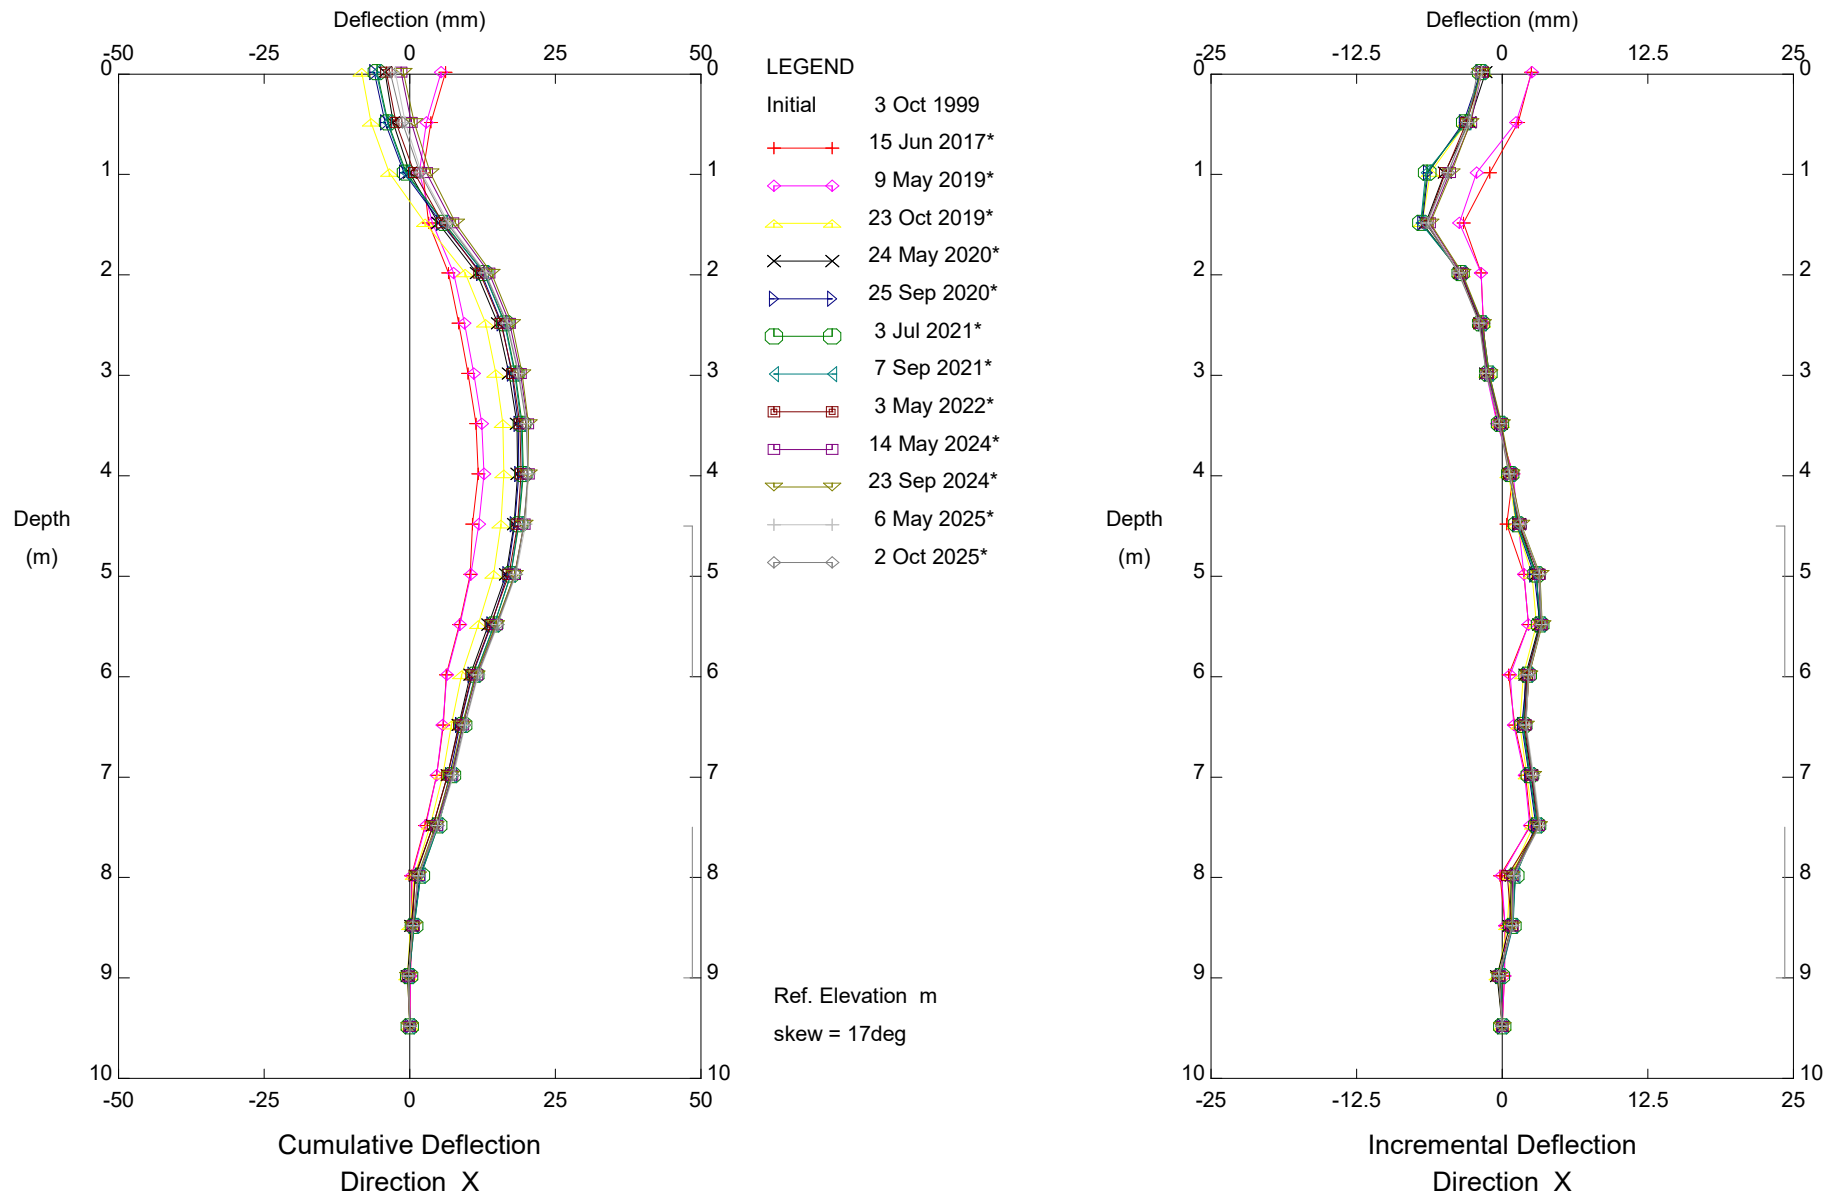
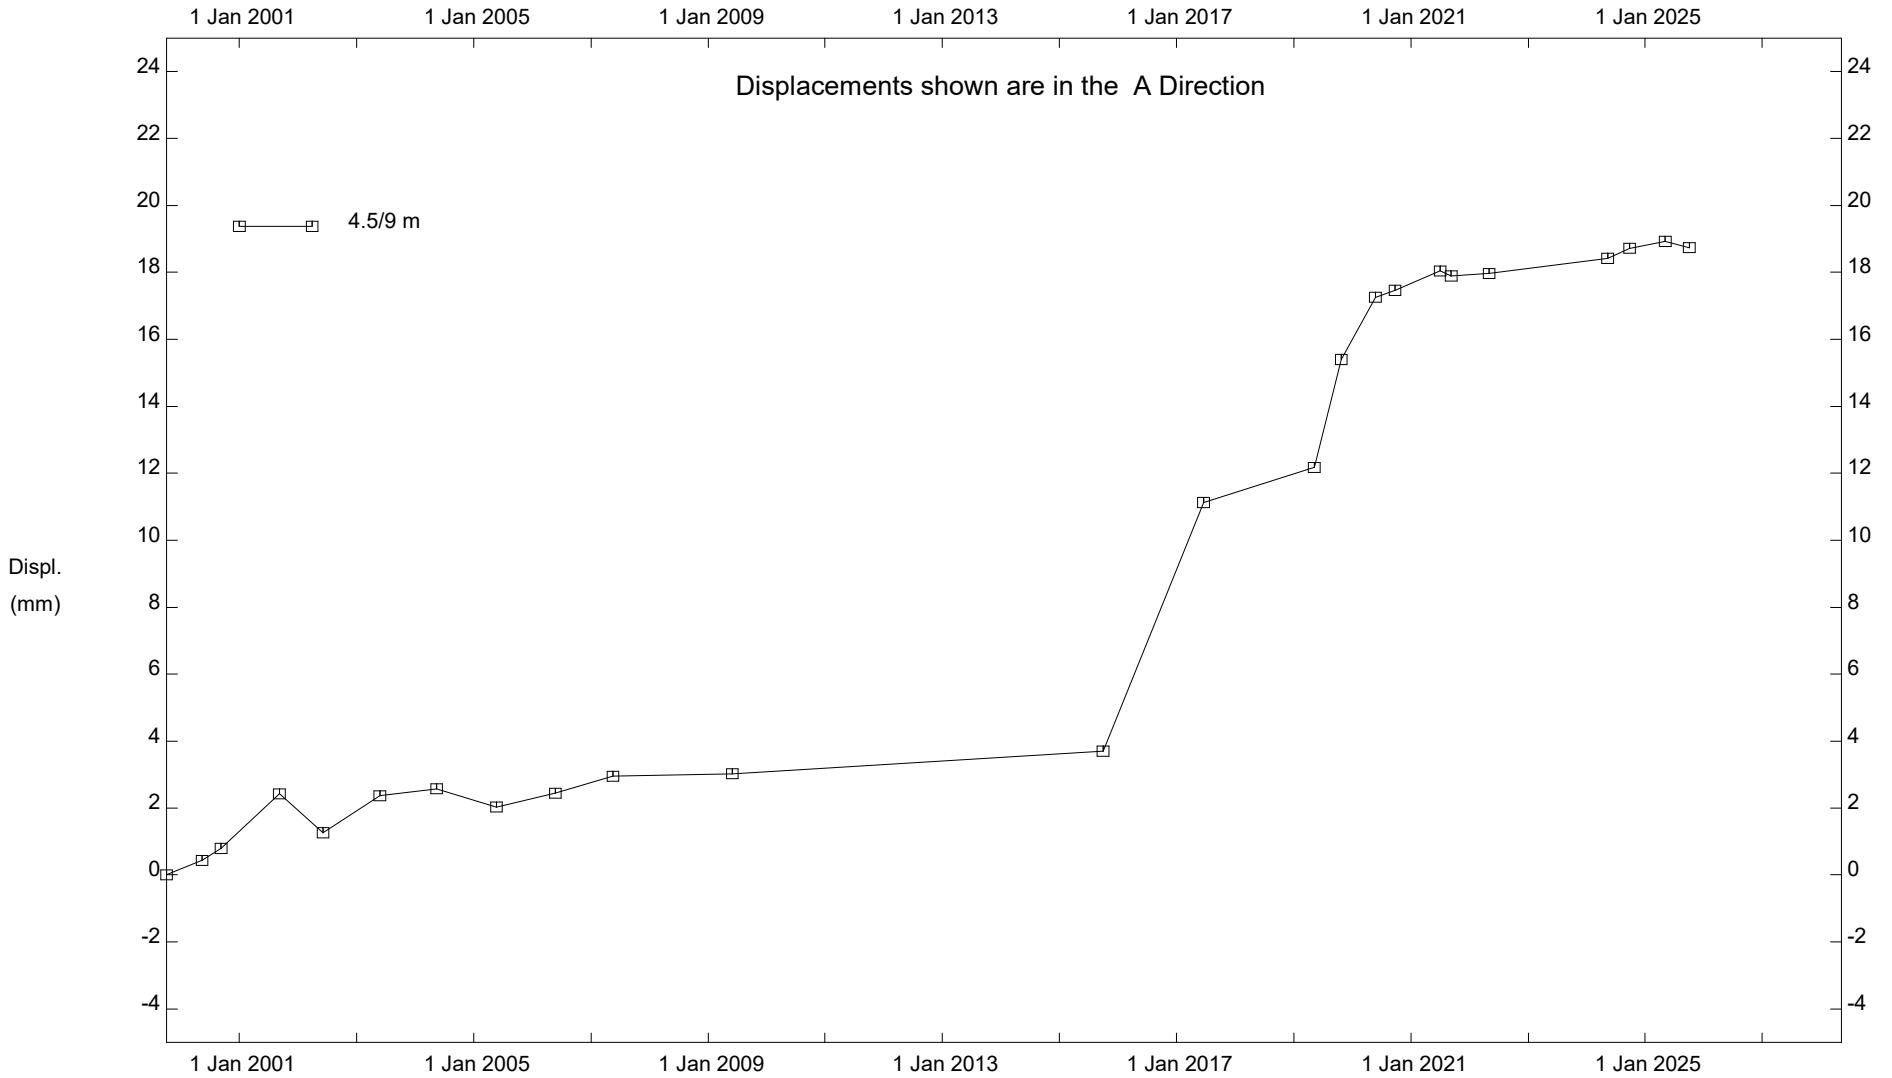
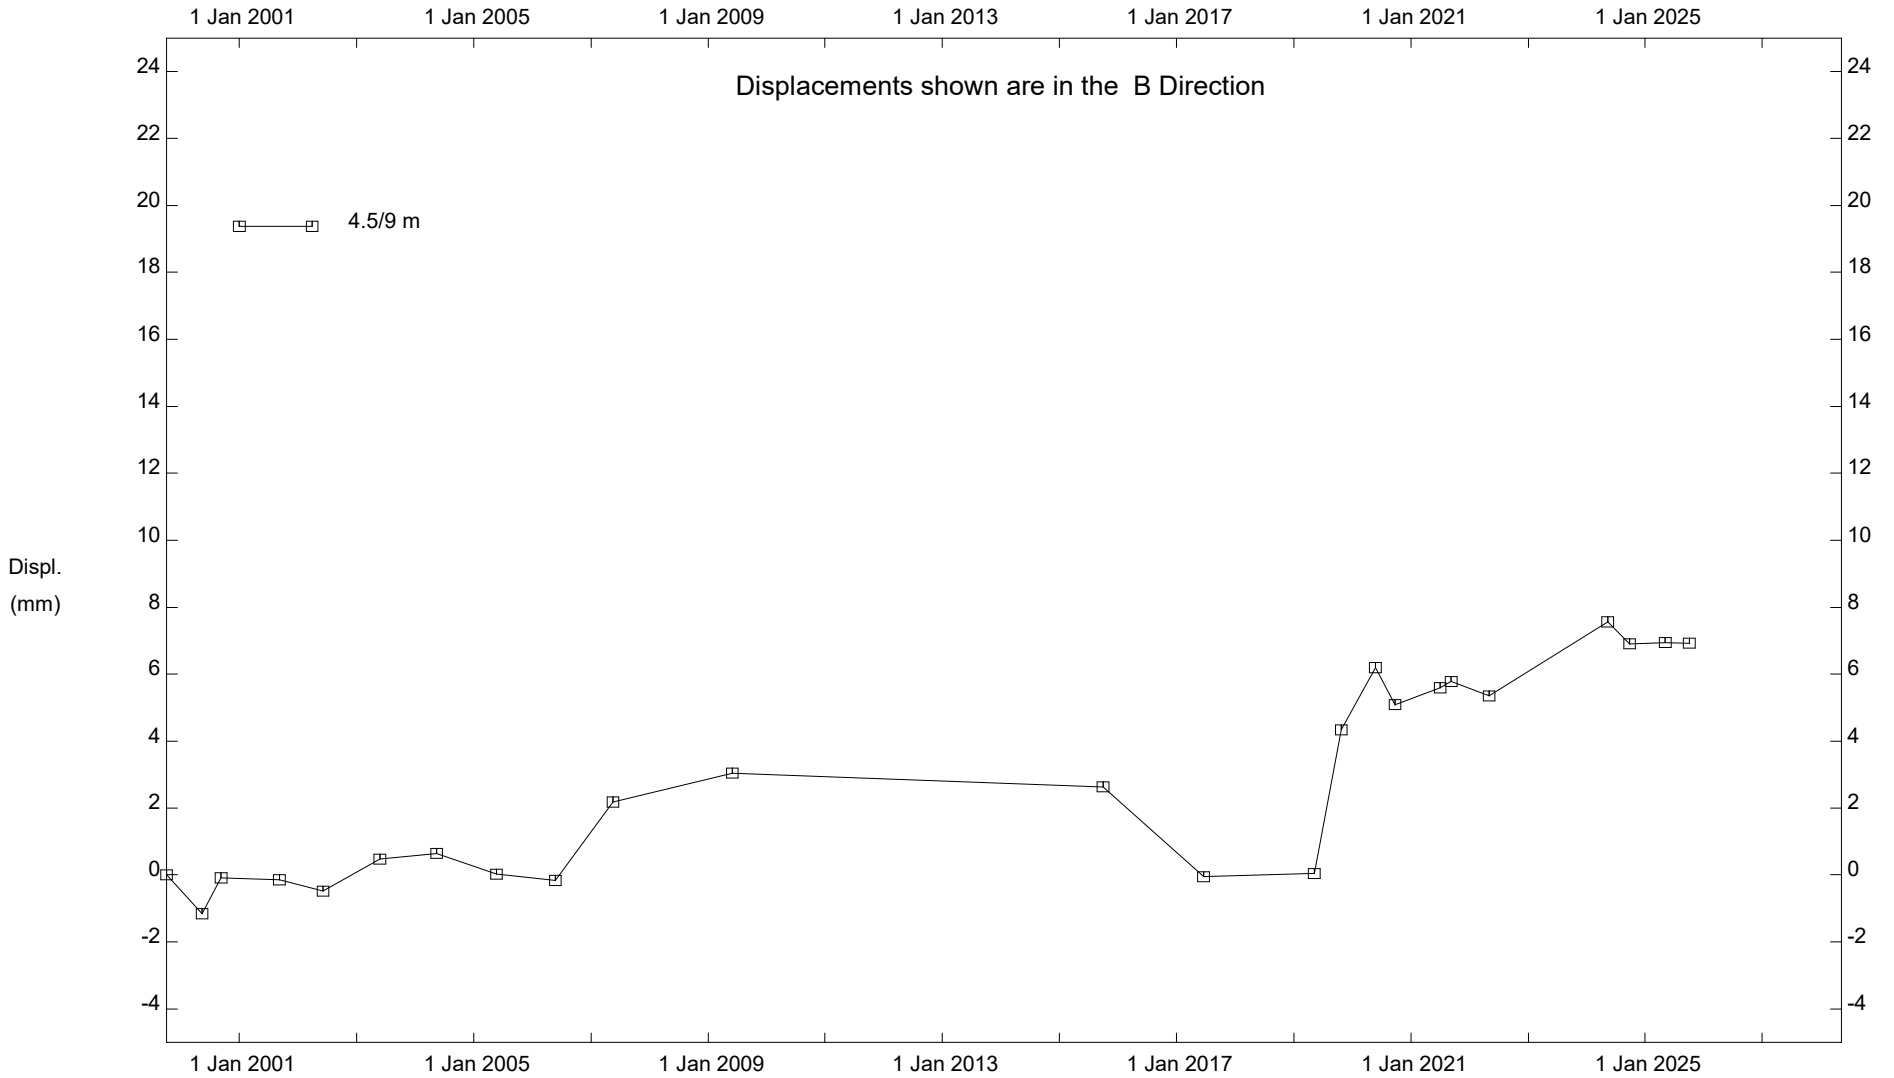
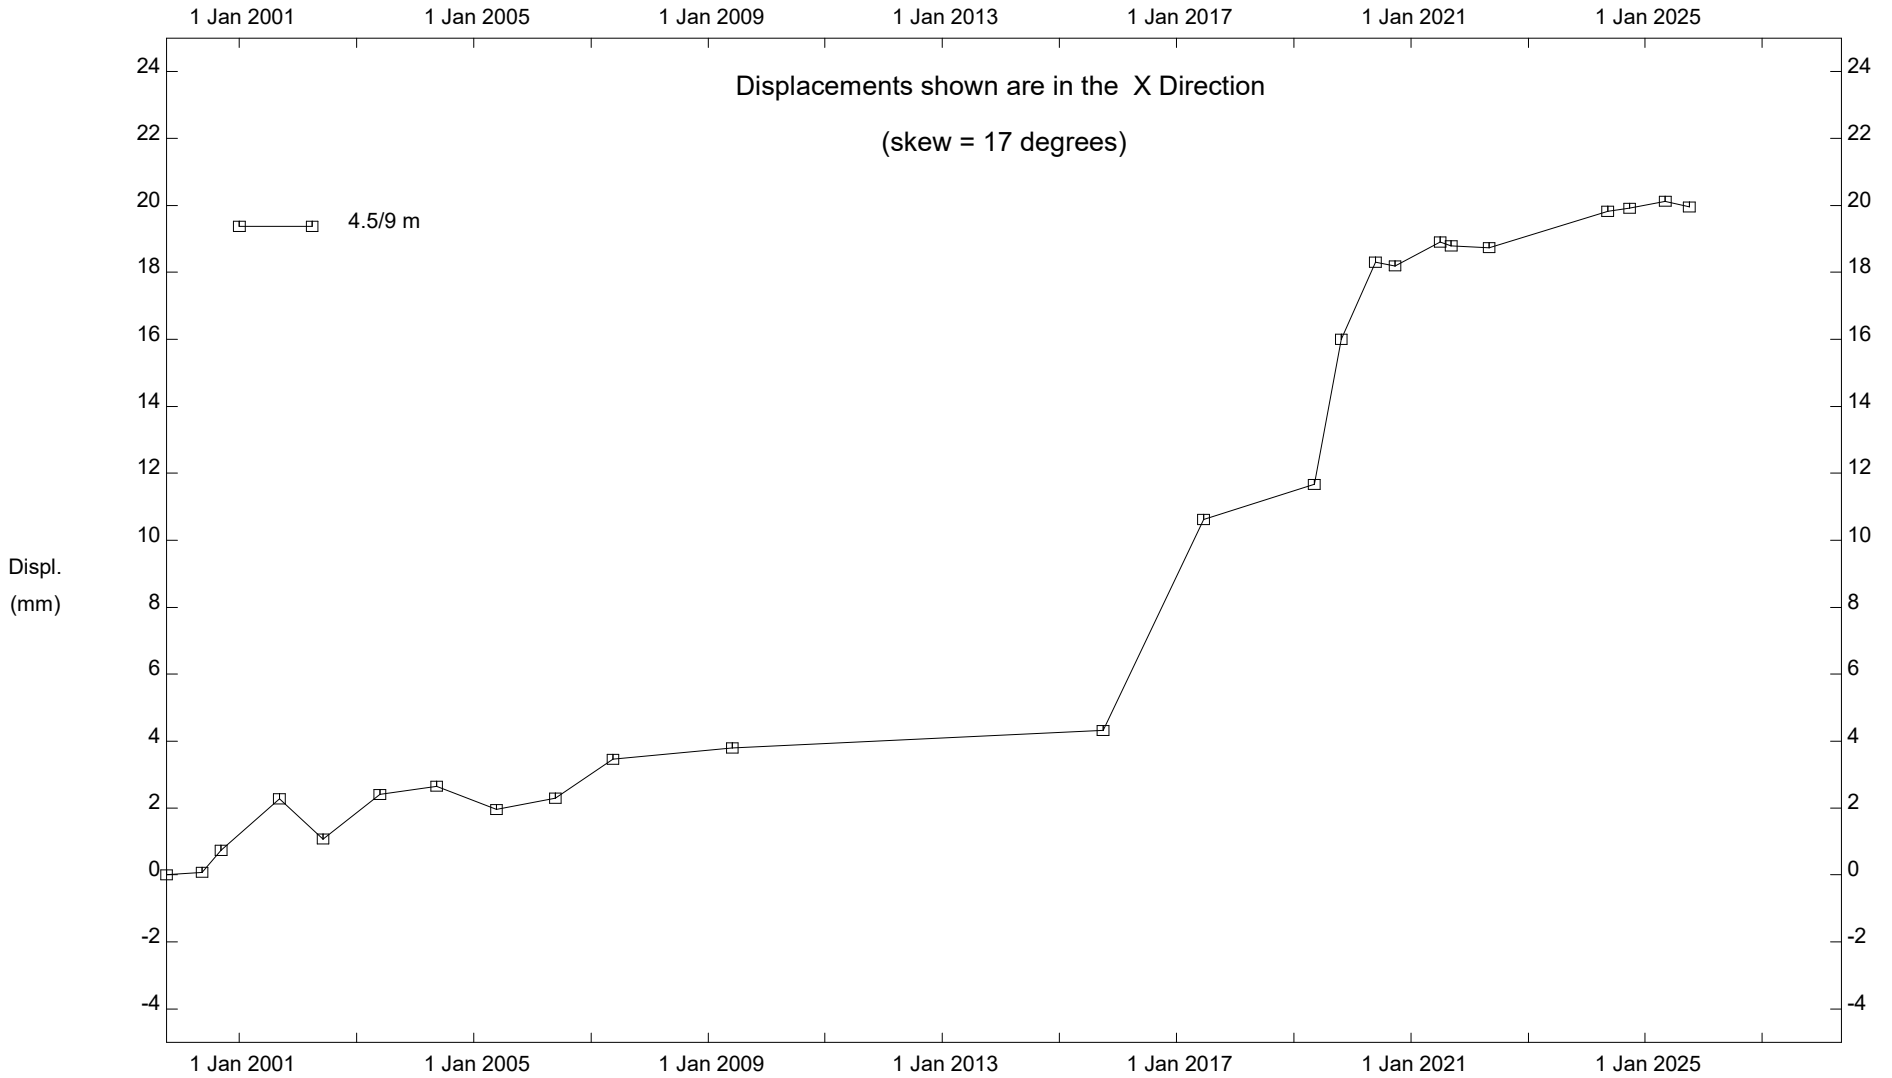
Hwy 40:30, North of Hinton (NC11), Inclinometer SI2  
 Alberta Transportation

SI2 showed little incremental movement ( $< 1$  mm) since the last reading in May 2025. The current movement rate is less than 1 mm/yr.

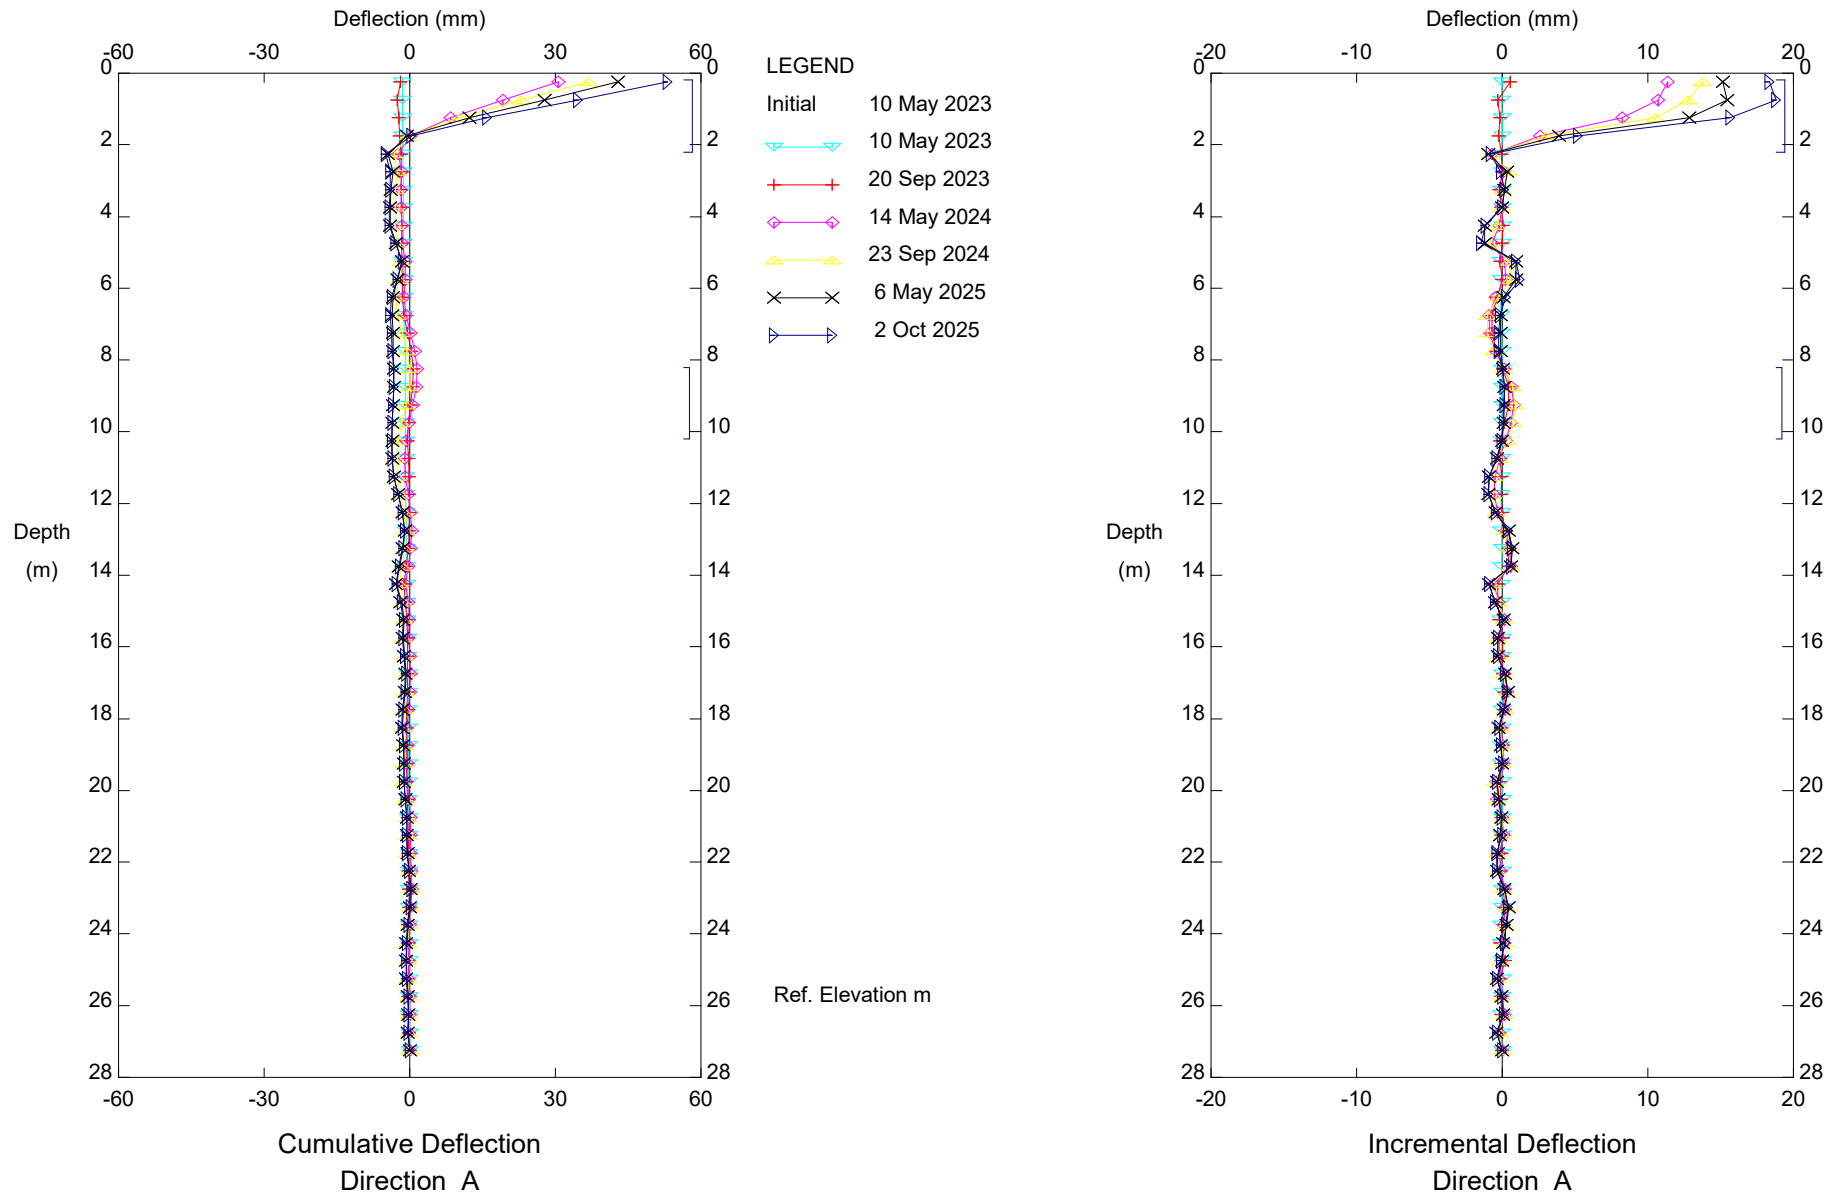
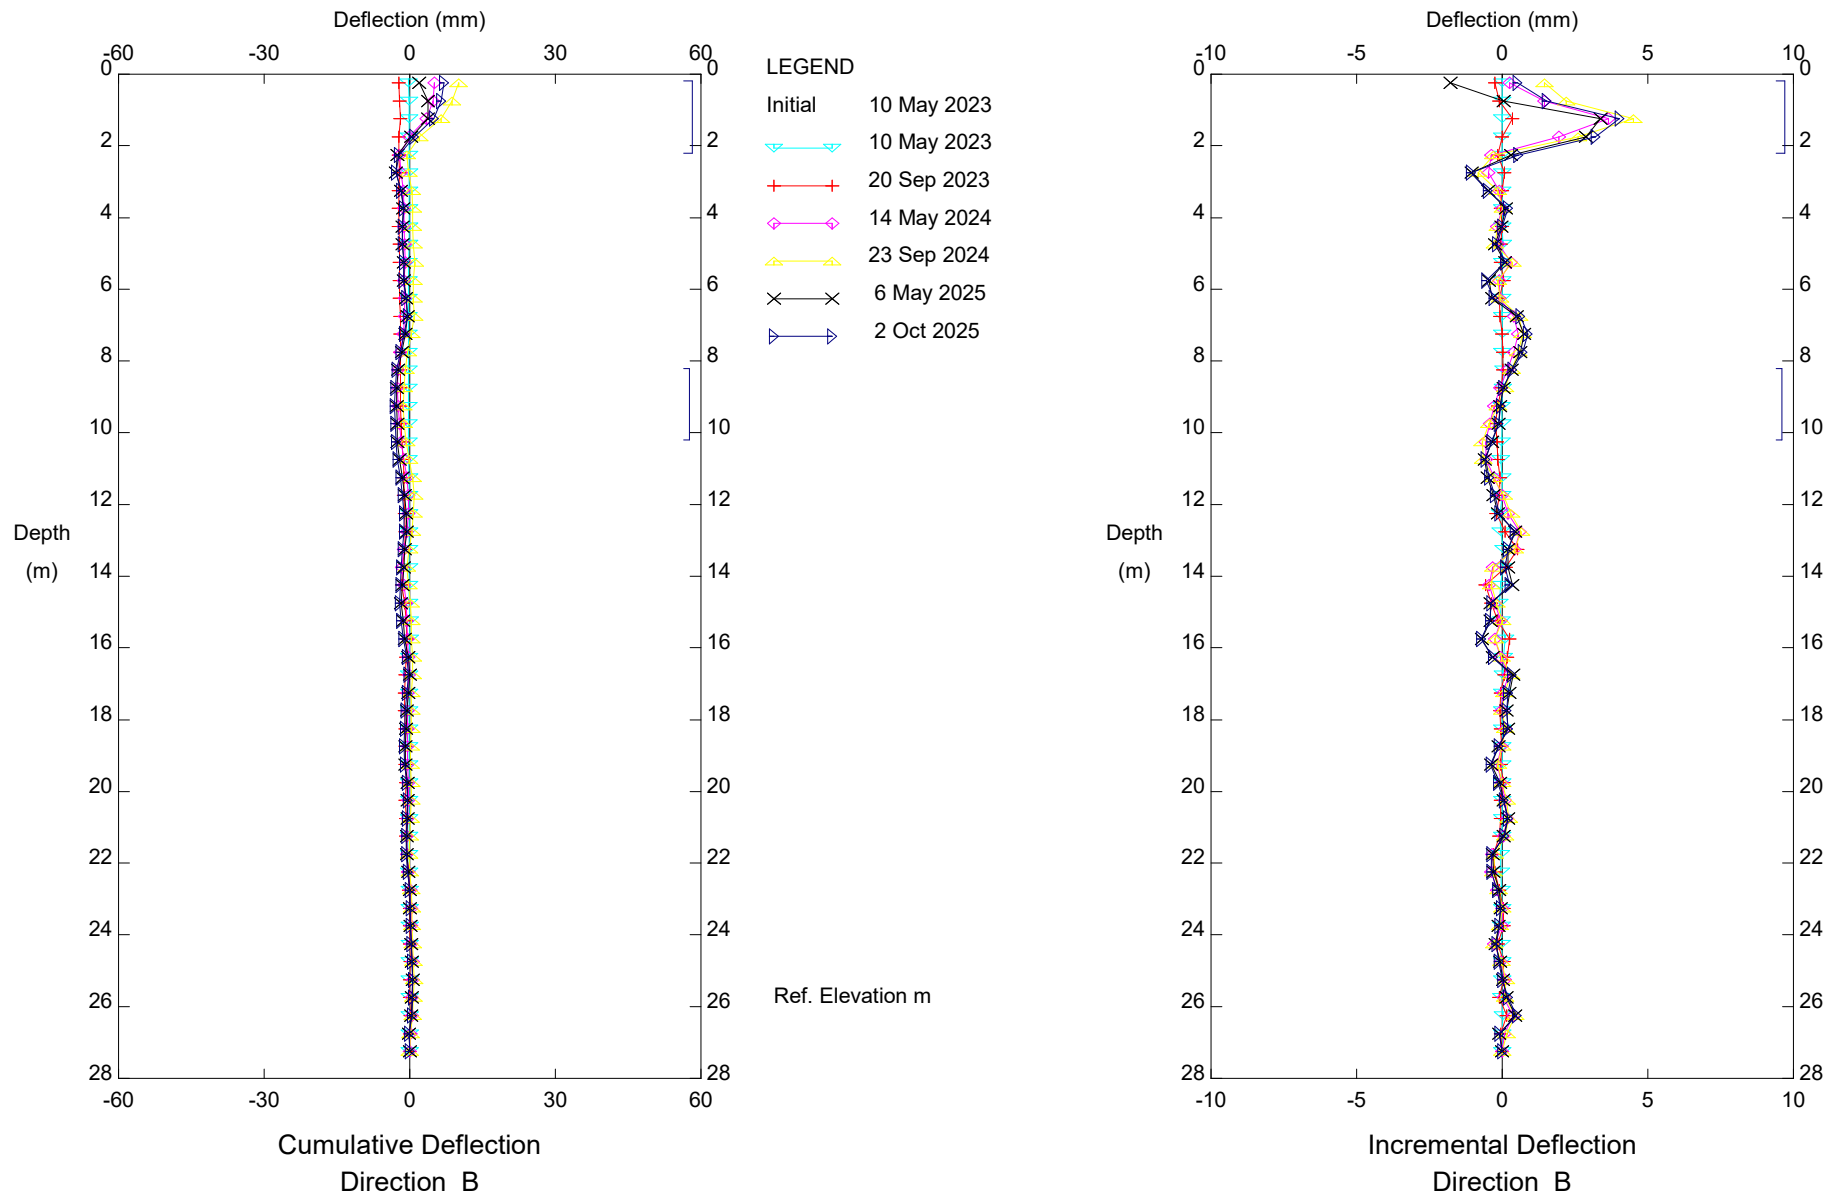
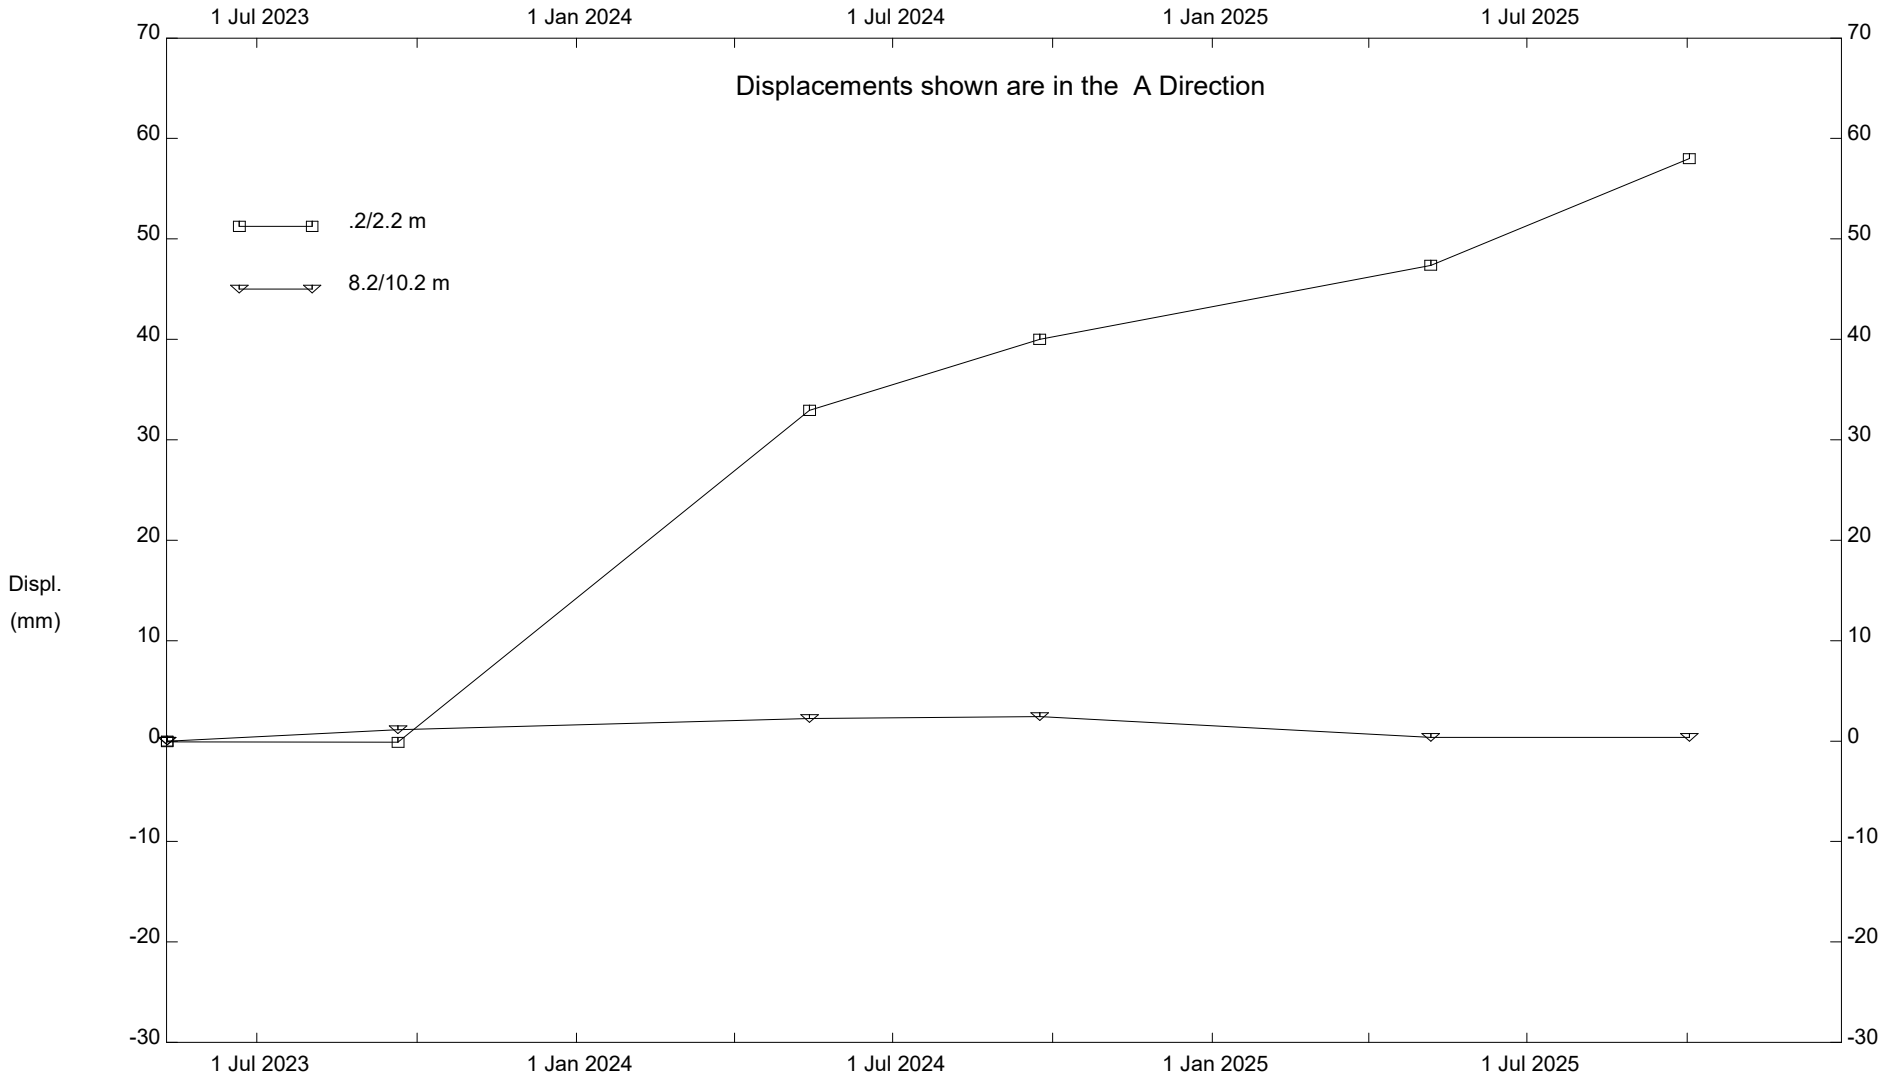
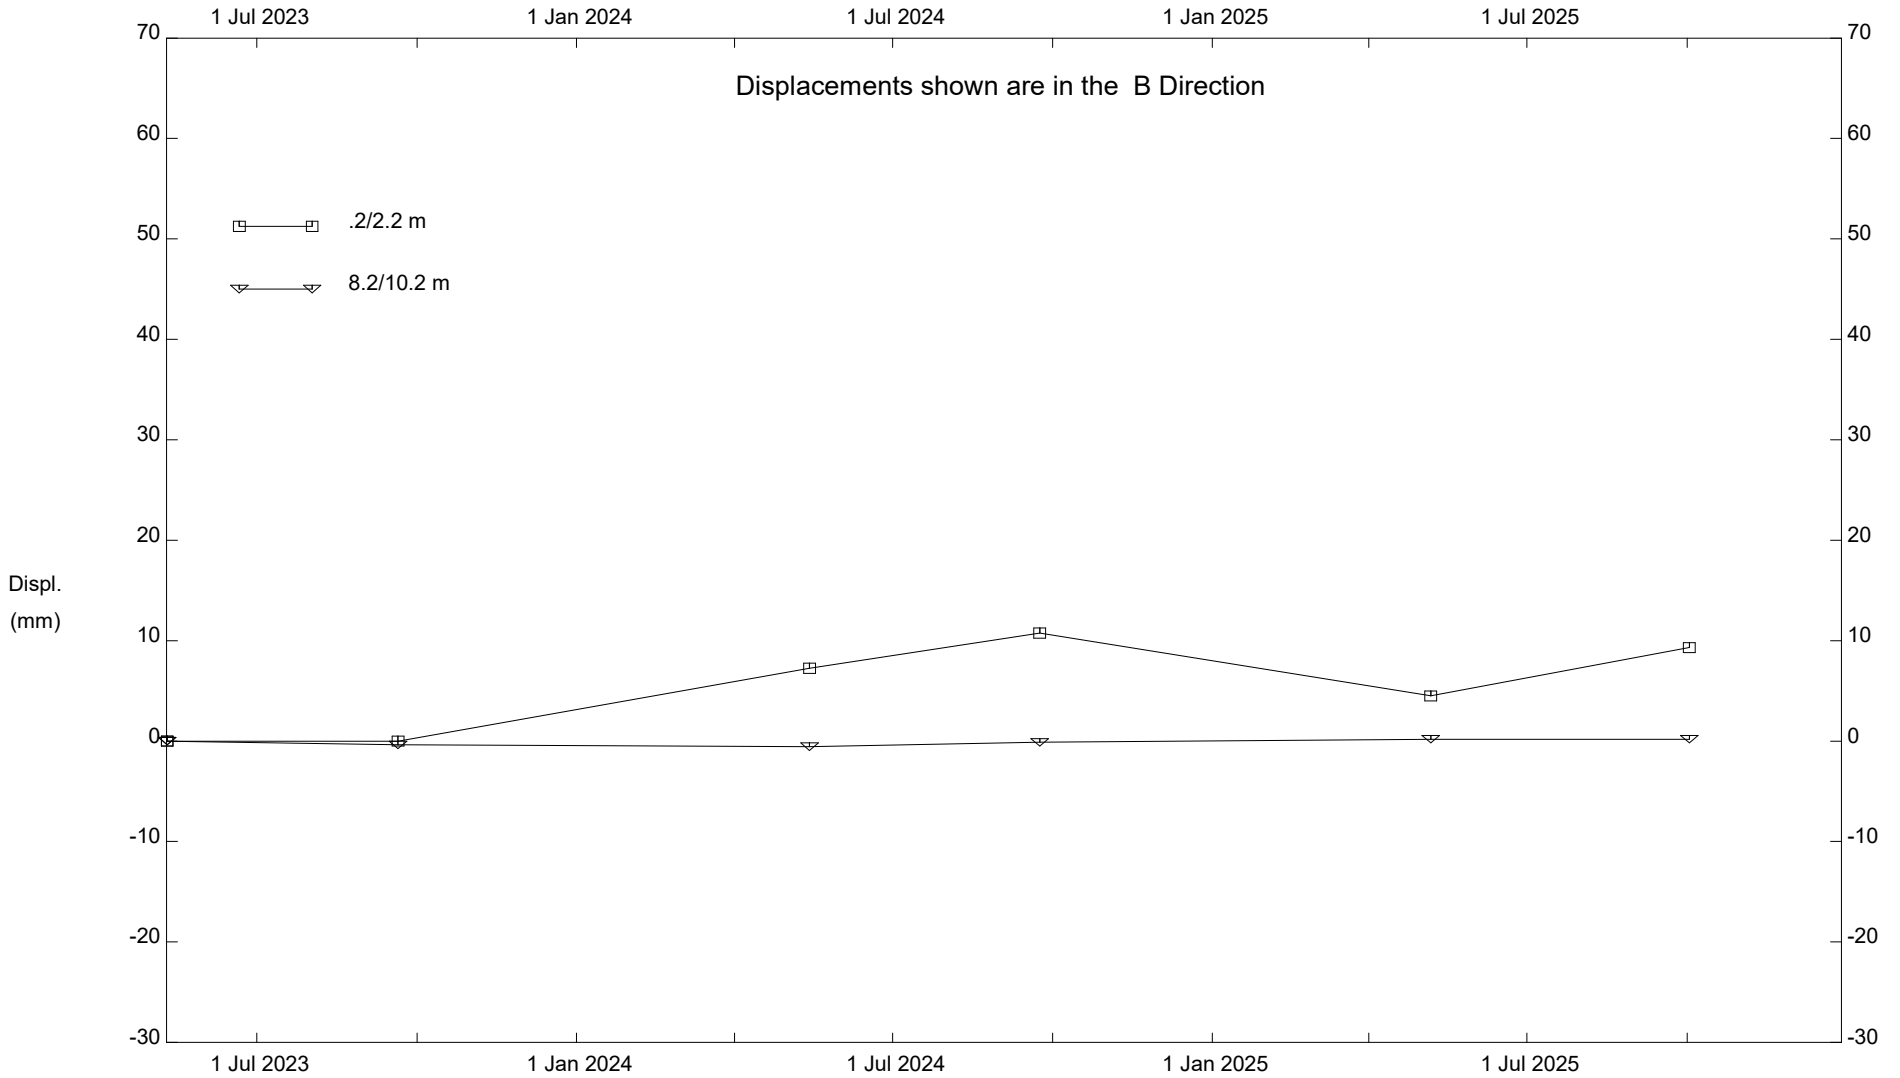
Hwy 40:30, North of Hinton (NC11), Inclinator SI22-01  
 Alberta Transportation

SI22-01 was cut 2 m shorter due to construction for backslope flattening in April 2024. No discernible movement was observed in SI22-01. Some movement was observed in the upper 2 m of the casing and is likely due to ground frost effects and potentially due to ground disturbance from construction activities between 2021 and 2024. Movements observed at depths of about 2 m are likely not related to slope movement.

SI22-01 may require reinitialization upon completion of construction. It is recommended that the next reading cycle take place in Spring 2026.
