**NORTH CENTRAL REGION GRMP
EDSON / STONY PLAIN
SITE INSPECTION FORM**

SITE NUMBER AND NAME: NC011 – 5.5 km North of Highway 16 (Near Hinton)	HIGHWAY AND KM: 40:30, km 5.617	PREVIOUS INSPECTION: July 15, 2021	CURRENT INSPECTION: May 23, 2025
LEGAL DESCRIPTION: NW-01-51-26-W5	NAD83 COORDINATES: UTM11U 5914110N, 452891E		RISK ASSESSMENT: PF: 5 CF: 10 Total: 50
AVERAGE ANNUAL DAILY TRAFFIC (AADT): 1,250 (2024)		CONTRACTOR MAINTENANCE AREA (CMA): 508

SUMMARY OF INSTRUMENTATION: Two slope inclinometers (SI) functional	INSPECTED BY: Stantec: Leslie Cho, Sonja Pharand, and Carrie Murray TEC: Kristen Tappenden
LAST READING DATE: May 6, 2025	
PRIMARY SITE ISSUE: Slope movement of a sidehill cut-fill section downslope of highway. Backslope erosion north of highway.	
APPROXIMATE DIMENSIONS: East scarp along south shoulder of highway: 140 m long x 10 m wide. East midslope slide: 50 m long x 90 m wide. West landslide: 55 m long x 75 m wide. Slope flattening / repair of highway backslope: 650 m long x 95 m wide.	
DATE OF ANY REMEDIAL ACTION: Highway spray patched in 2009. Highway realignment began in 2021 and is ongoing. Riprap placed on backslope north of highway in 2024; additional riprap pl

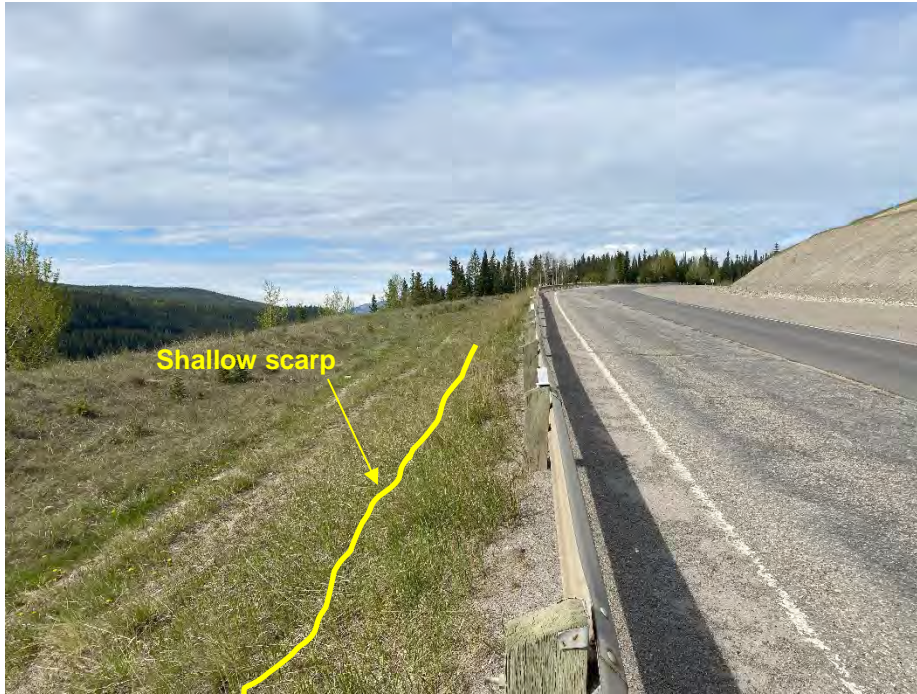
- The WBL was removed in fall 2024 as part of the on-going highway realignment work. Due to delays in construction, the highway was reconstructed in the same alignment to allow for two-way traffic over the winter. No pavement cracking was observed on the WBL (Photos 1, 2, and 4).

- The scarp about 25 m long and 200 mm high on the south side of the highway, observed in 2021, was observed to be in similar condition. The scarp remains approximately 1.9 m south from the guardrail, near the previous pavement cracking observed at the west extent of the site (Photo 1).

Photo 1: Pavement and upper south slope condition at west extent of east landslide scarp. Looking southwest.

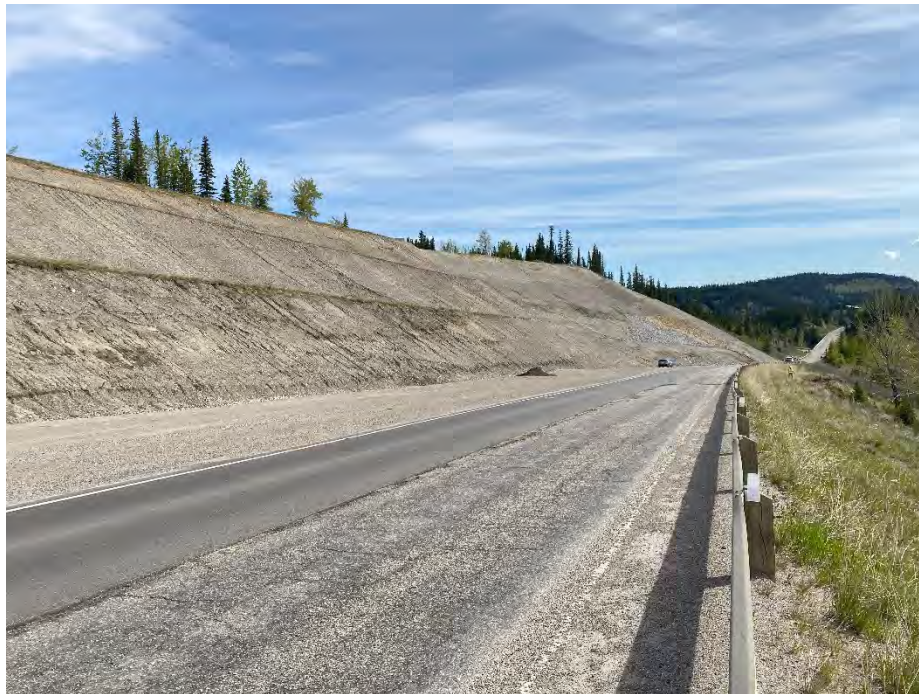
- The majority of the EBL contains map cracking. Additional larger cracks and potholes were observed within the EBL, with cracks up to 75 mm wide and 25 mm deep. The majority of the cracks were partly infilled with sand (Photos 2, 3 and 4).

Photo 2: Pavement condition and benched backslope constructed for highway realignment, above south scarp area near west extent. Looking northeast.

- The backslope repair / highway realignment works have been underway since Summer 2021. As part of construction, the highway backslope was excavated and benched to make room for realigning about 750 m of Highway 40. It is understood that construction of the pavement structure for the realigned highway portion is to take place Summer 2025. No other remedial recommendations are required at this time.

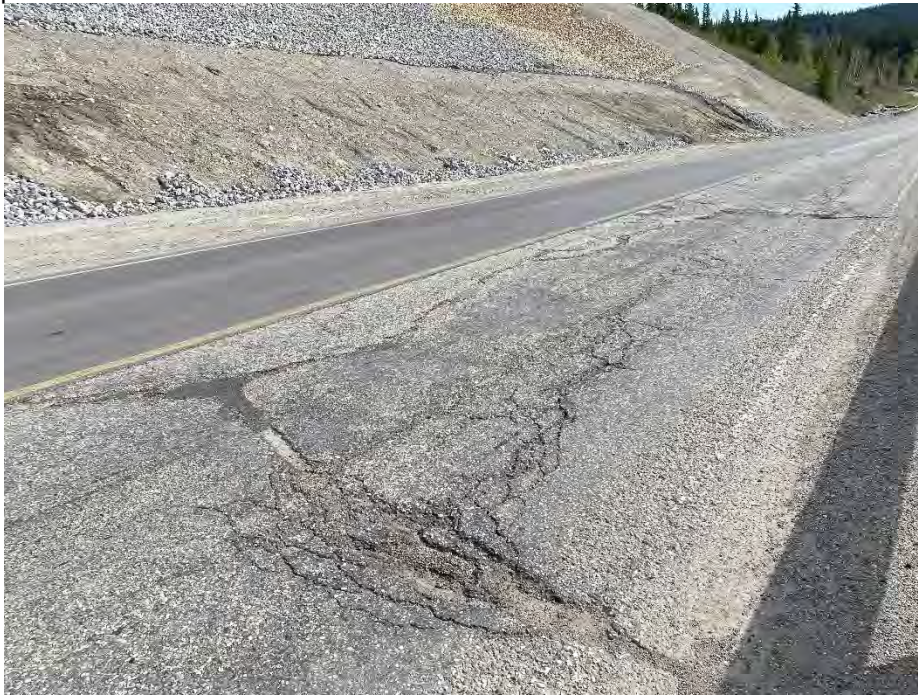
Photo 3: Pavement cracking in EBL north from half-culvert collector drain. Looking northeast.

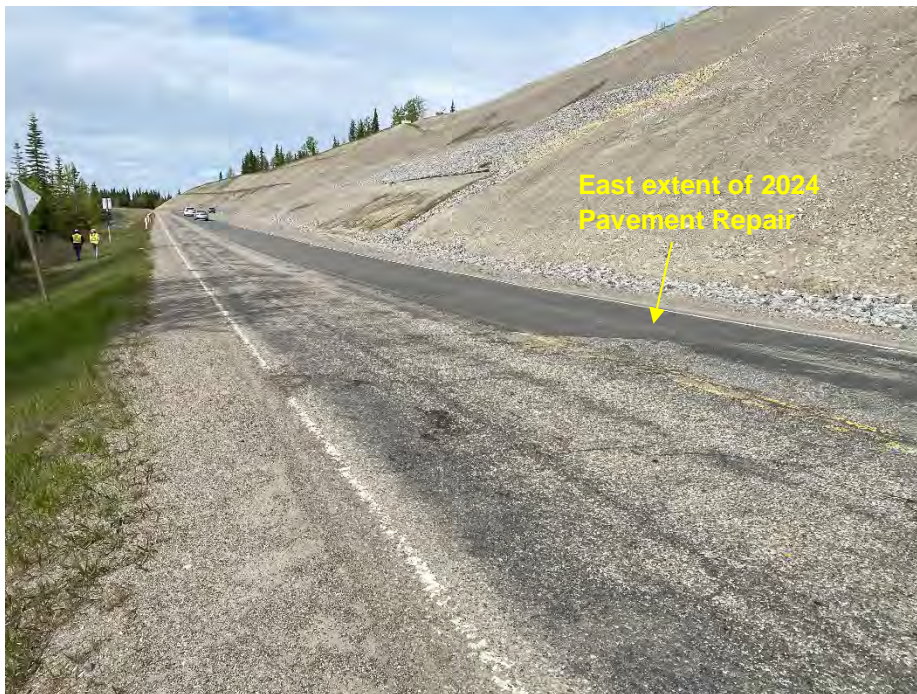
Photo 4: Pavement condition at east extent of site. Looking west.

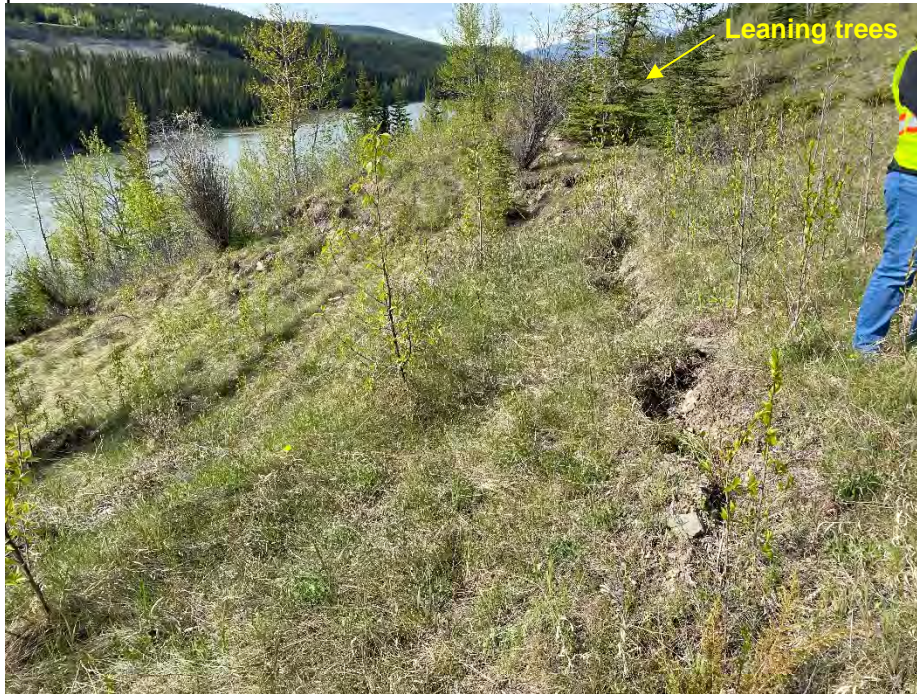
- SI2 near the west landslide remains operational, with a rate of movement of less than 1 mm / year since the previous inspection in 2021.
- The ridge/graben feature about 600 mm high was observed at the west extent of the east mid-slope landslide and appears to have increased from approximately 35 m long in 2021 to 50 m long. At the east extent of this feature, ground cracks about 400 mm wide and 300 mm deep were observed in similar condition to the previous inspection (Photo 5). Some leaning trees were also noted within this area.

Photo 5: Ground crack at ridge location near the centre of the east landslide. Leaning trees in background. Looking southwest.

- Given the lack of instrumentation at the east midslope landslide location, survey control points could be installed to monitor slide retrogression towards the highway. Alternatively, InSAR or LiDAR change detection can be completed to monitor landslide activity.

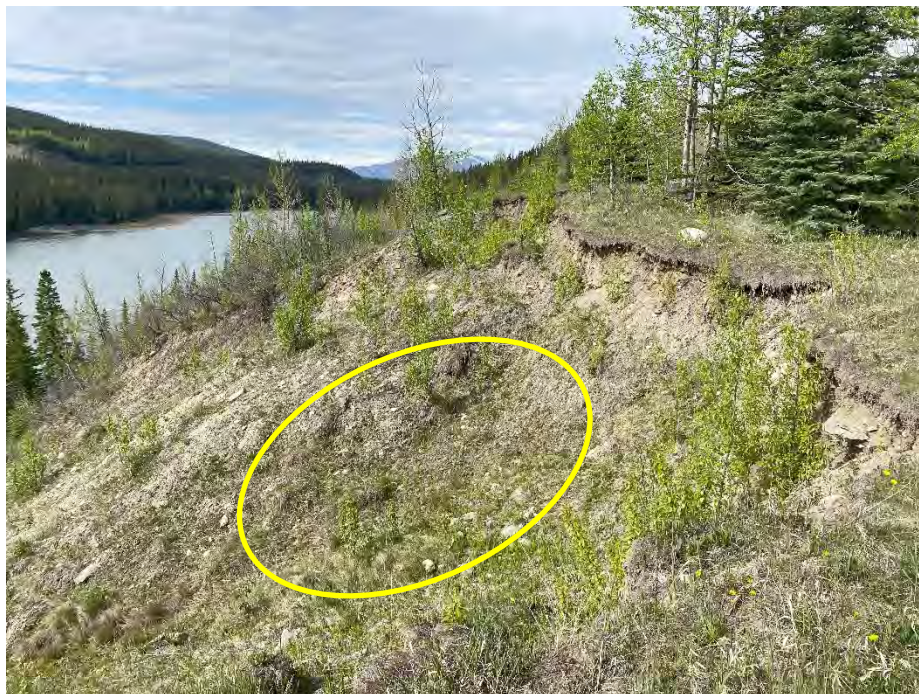
- Seepage was observed within the east landslide near the east and west extents, similar to the 2021 inspection (Photo 6).
- Additional vegetation is present within the east landslide, though continued erosion is visible along the scarp (Photo 6).

Photo 6: Seepage near middle of east landslide. Looking southwest.

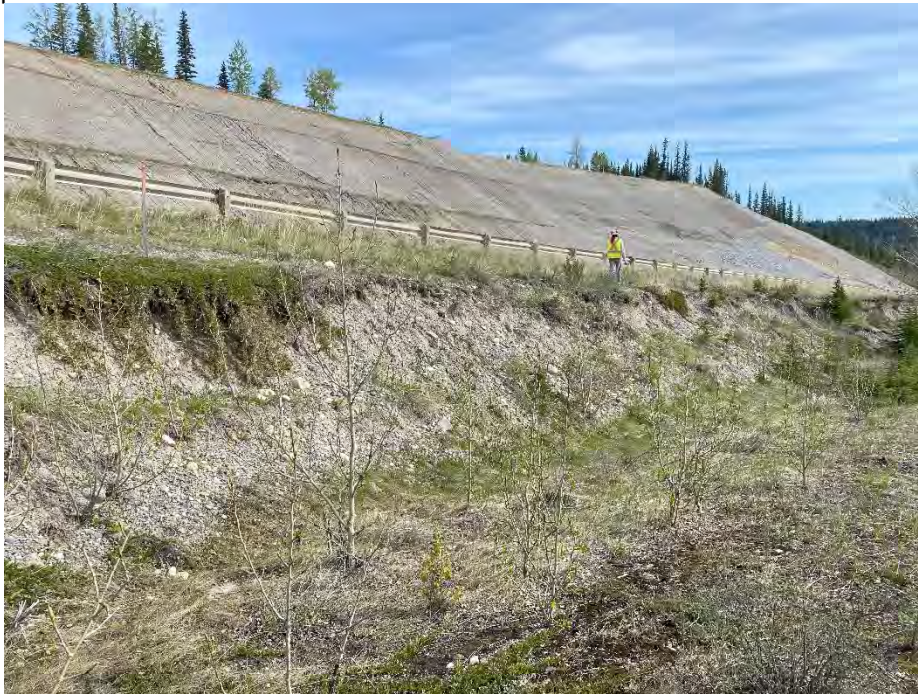
- The south shoulder scarp (Photo 7) is retrogressing towards the highway as indicated by widening of the previously observed tension crack. The crack has extended to about 4 m long, 300 mm deep and 300 mm wide, with a vertical difference of approximately 150 mm between the ground on either side. The crack was about 5.2 m away from the guardrail compared to 5.5 m measured in 2020.

Photo 7: Scarp along highway, near guardrail. Looking northeast.

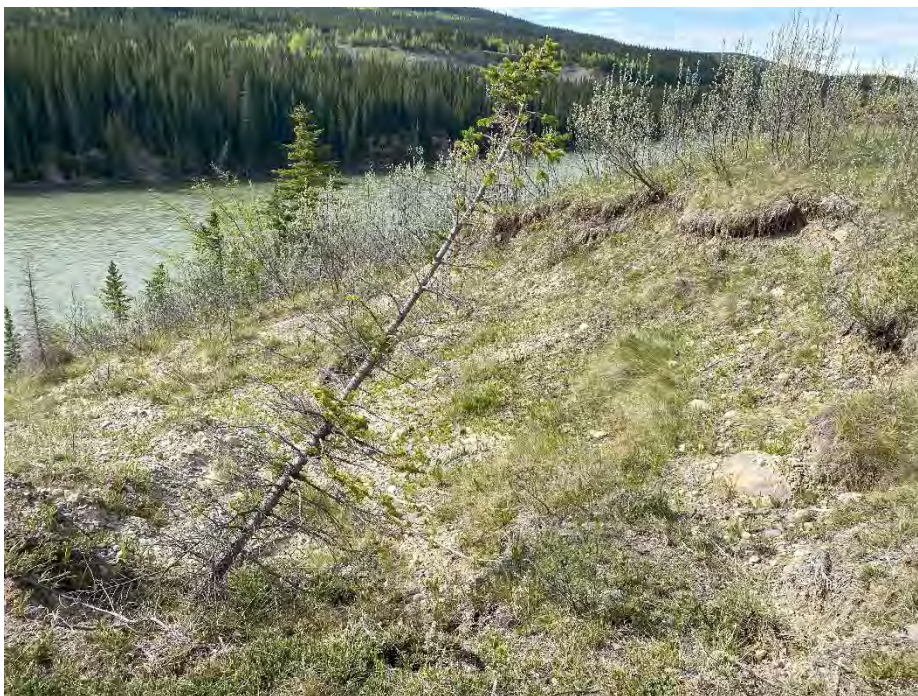
- The scarp at the east extent of the downslope failures of the east landslide was observed to be in a similar state as the previous inspection. Additional vegetation was observed within the landslide (Photo 8).

Photo 8: Scarp at far east extent of eastern slide zone. Looking south.

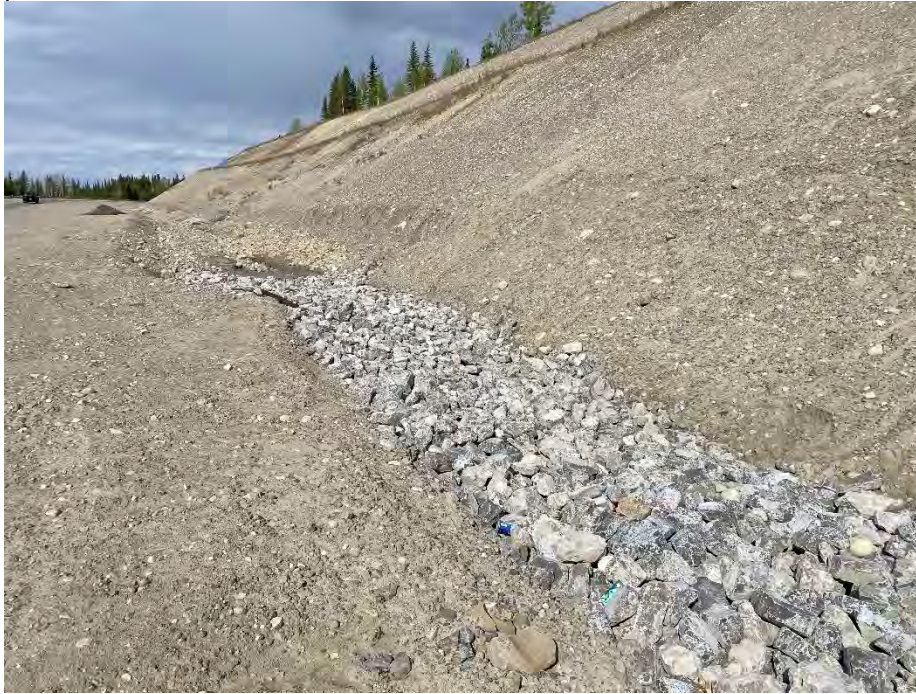
- The north ditch has been relocated further north as part of the backslope cut / highway realignment works. The ditch has been lined with a combination of gabion mattress and angular 1M riprap below the backslope (Photo 9). The gabion mattress transitions into riprap approximately 300 m west of the C/L culvert inlet (Photo 11).

- Sediment was observed within the north ditch, trapped in the gabion mattresses and riprap (Photos 9 and 11). Sediment is also collecting at both the inlet and outlet of the centreline culvert just east of the backslope repair area. The culvert inlet is half filled with sediment (Photo 12) while standing water and sediment were observed at the outlet (Photo 13). The silt fence along the north ditch near the inlet is in disrepair, and the silt fence at the outlet appears to still be letting sediment-heavy water through to flow downslope towards the river.

Photo 9: Transition from gabion mattress to riprap ditch at toe of new backslope. Looking southwest.

- Additional erosion and sedimentation control measures should be considered along the backslope and ditches. This could consist of revegetating the backslope and installing strawbales within the ditch.

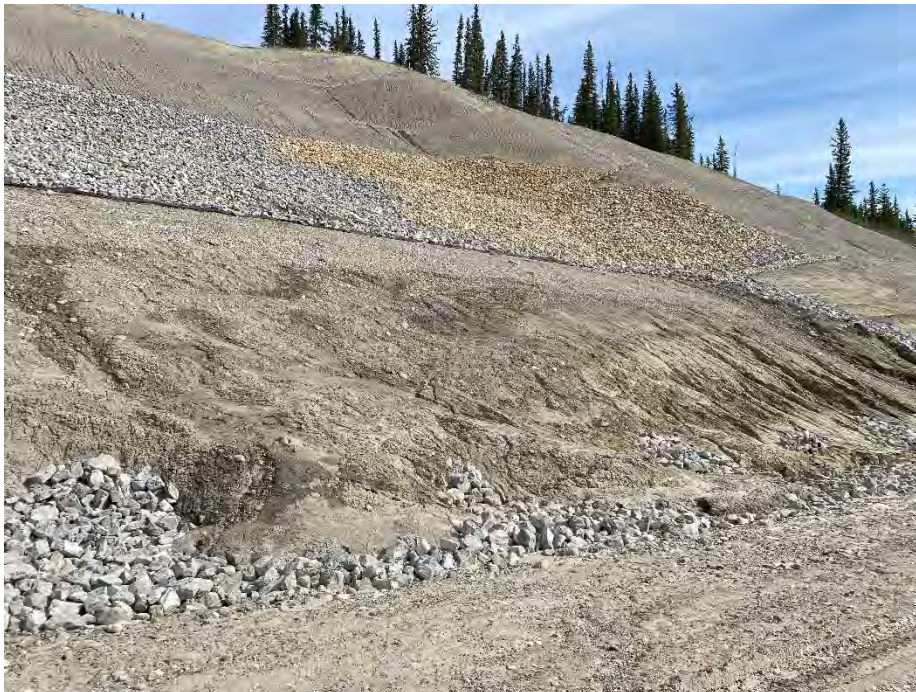
- Erosion rills and areas of severe erosion and seepage are present along the backslope (Photo 10). Minimal vegetation has taken to the slope, and is mainly concentrated along the flatter benches across the slope.

Photo 10: Erosion and seepage on recently completed backslope. Looking northeast.

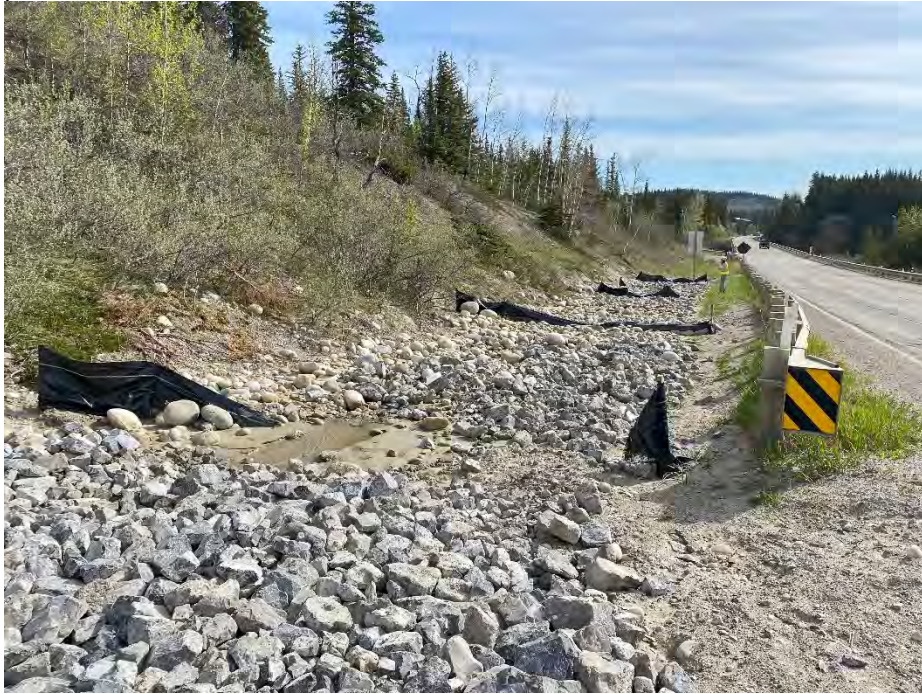
Photo 11: Sedimentation in riprap lined ditch east of slope repair. Silt fence in disrepair. Looking east.

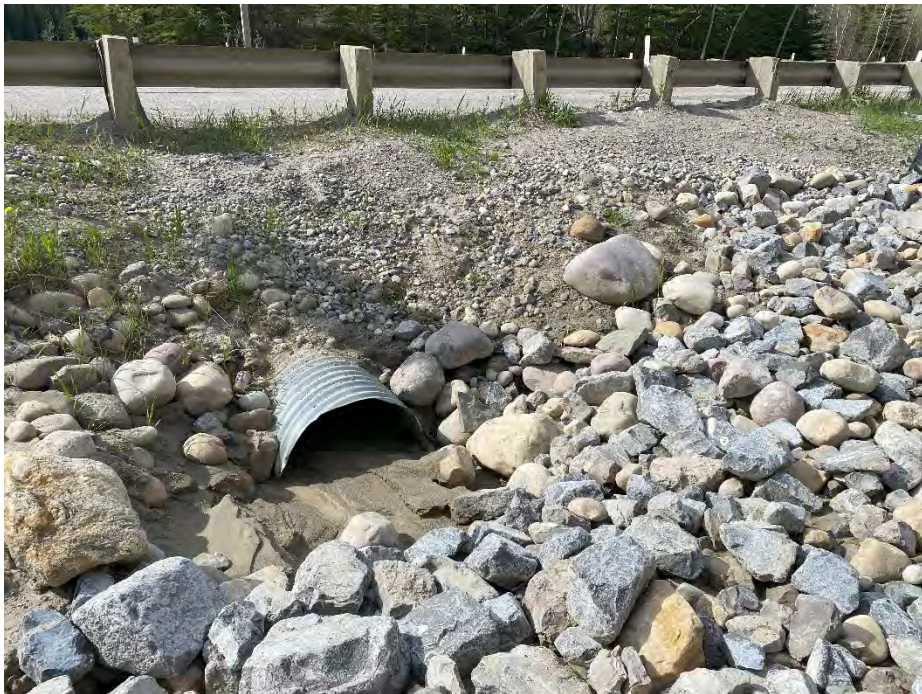
Seepage	X		One confirmed seepage location at midslope landslide below the south shoulder scarp. Multiple areas of seepage on backslope.	X	
Bridge/Culvert Distress	X		Eastern centreline culvert is half-filled with sediment, with ponding water at the outlet.	X

Photo 12: Culvert at east end of site, half filled with sediment. Looking south.

- The centreline culvert at the east end of the site should be cleaned of sediment to allow for proper drainage. The culvert should be regularly monitored and cleaned out by the MCI following completion of construction as it's the only culvert for the north ditch along the entire site.

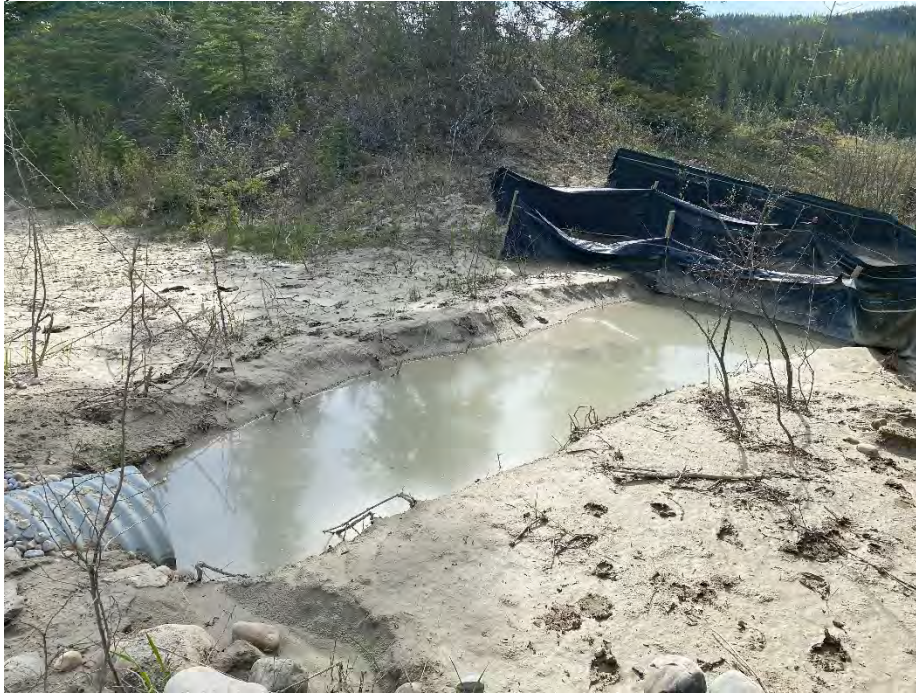
Photo 13: Ponded water and sedimentation at culvert outlet. Looking southeast.
