| | Transportation and Economic Corridors | | Stantec Consulting Ltd. |
| File: | 123315222 | Date: | October 31, 2025 |

Reference: North Central Region, Edson, Site NC013 - Highway 633:02 Cattlepass West, Fall 2025 Instrumentation Monitoring Report

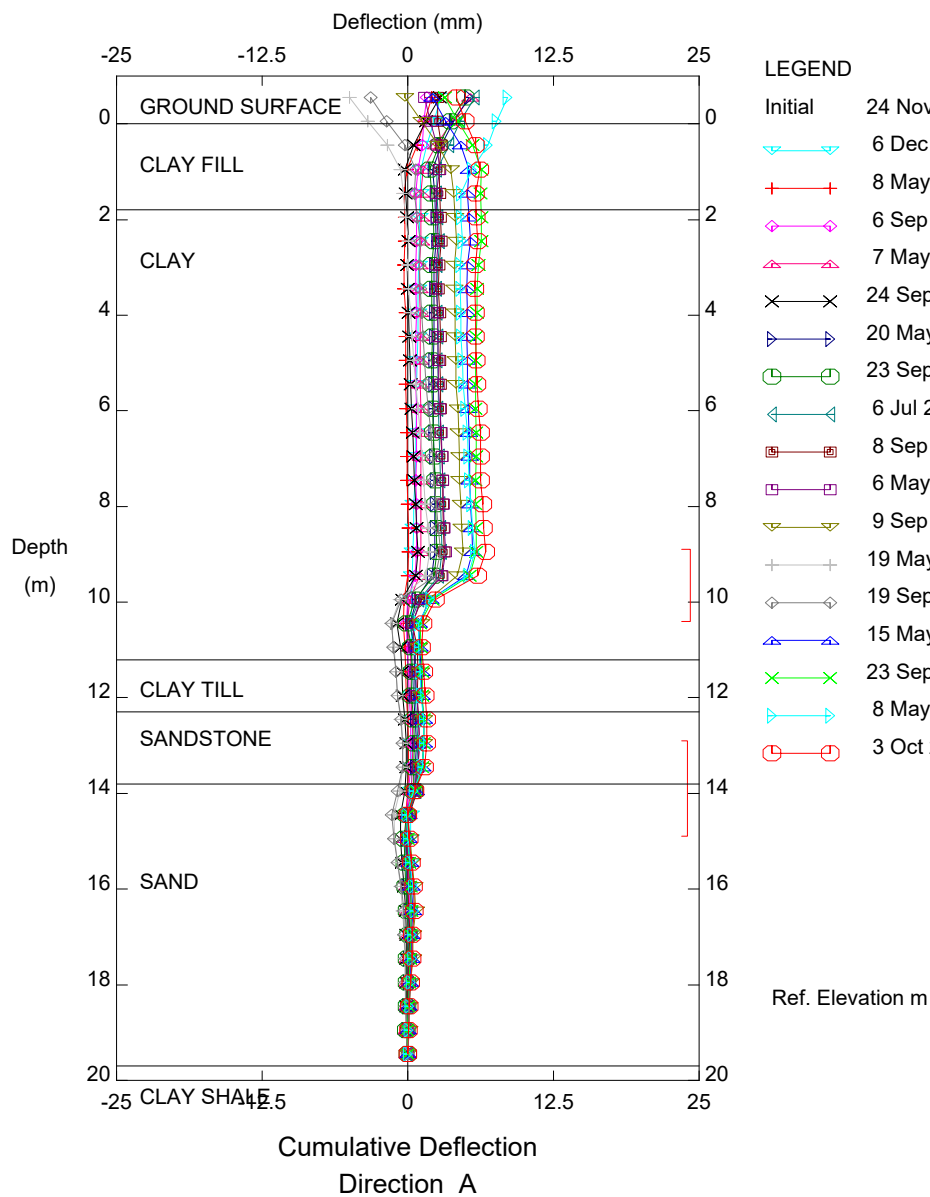
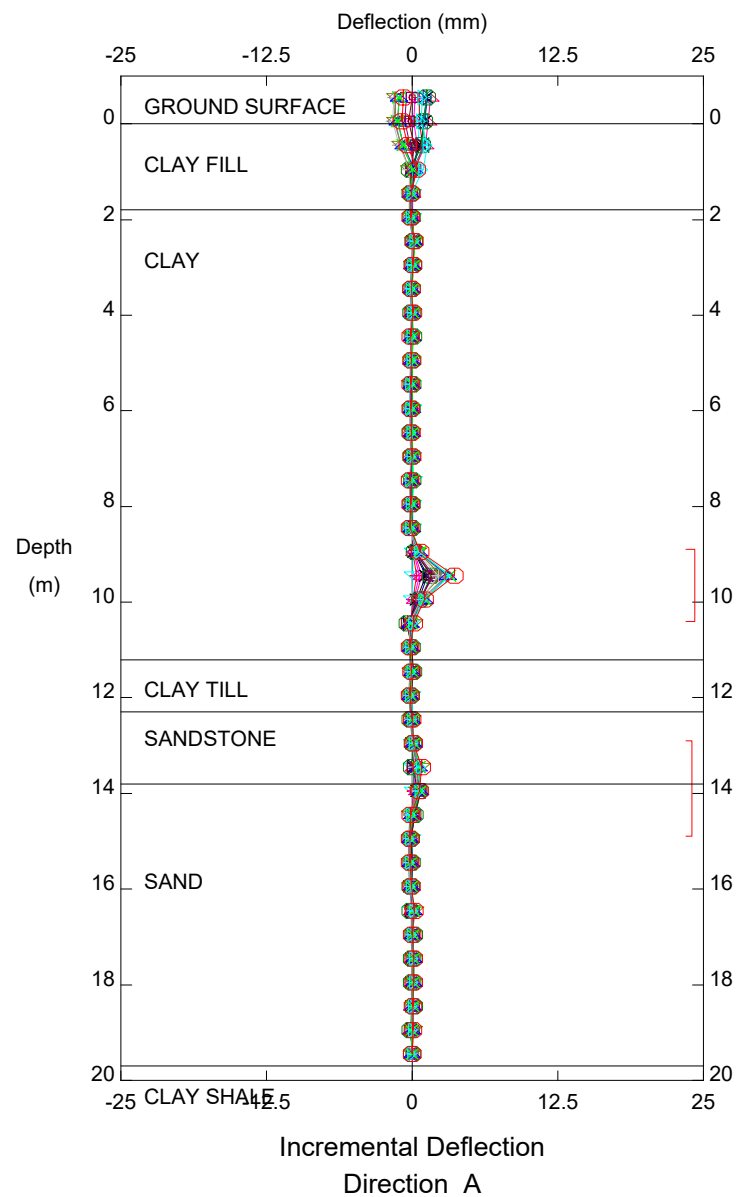
NC13, Inclinometer SI17-02

SI17-02 has two movement zones being monitored, the upper movement zone is at 8.9 m to 10.4 m and the lower movement zone is at 12.9 to 14.9 m. The cumulative movement in each zone is 7 mm and 2 mm,

respectively. The current rate of movement for the upper zone from 8.9 m to 10.4 m is approximately 2 mm/yr and lower zone from 12.9 m to 14.9 m is less than 1 mm/yr.

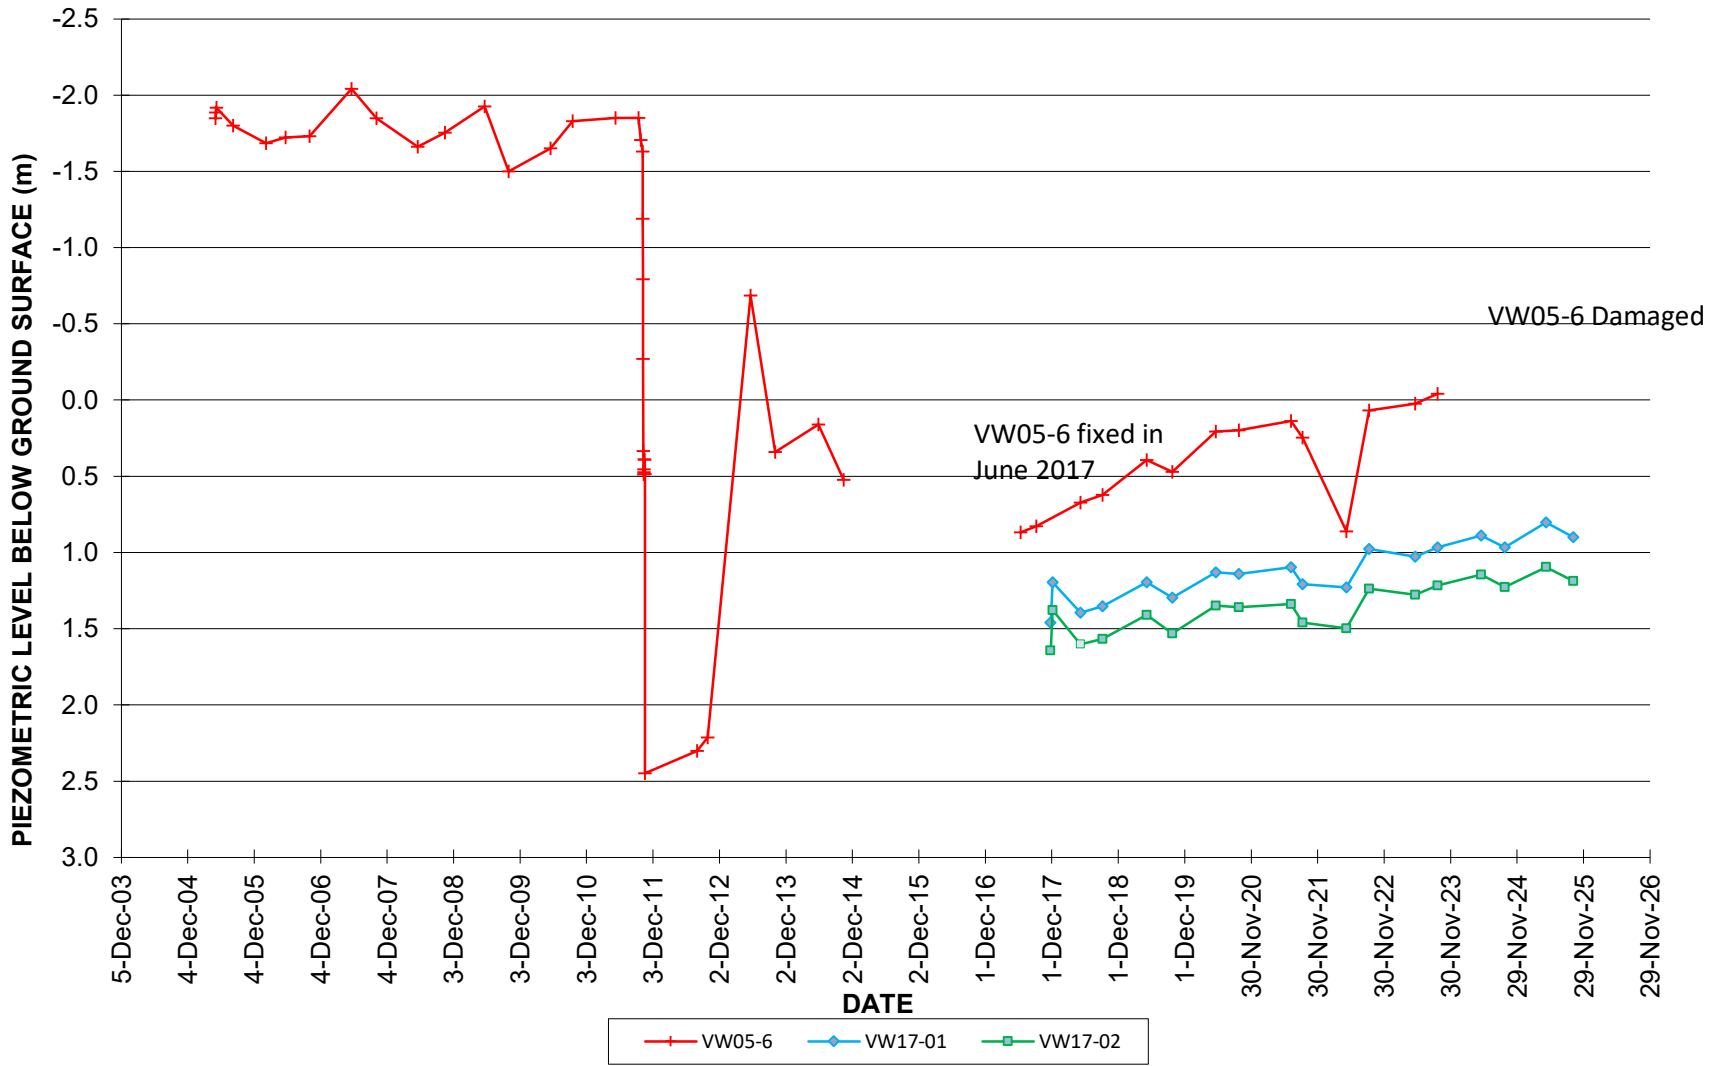
PIEZOMETER DATA NC13: HWY633:02, Cattlepass West

Water levels in VW17-01 and VW17-02 both decreased by about 0.1 m from their historic maximum piezometric elevations. VW17-01 and VW17-02 showed a current piezometric level of 0.9 m and 1.2 m bgs, respectively.
