ALBERTA TRANSPORTATION AND
ECONOMIC CORRIDORS GRMP
PEACE REGION – (PEACE RIVER DISTRICT)
INSTRUMENTATION MONITORING - SPRING 2025

Site Number	Location	Name	Hwy	km
PH045	Hwy 35:08 C1 26.2	Meikle Pile Wall	35:08	Km 26.2
Legal Description:		UTM Co-ordinates		
6-7-94-22 W5		11U E 467580.75	N	6333080.85

Current Monitoring:	11-Jun-2025	Previous Monitoring	23-Sep-2024
Instruments Read By:	Mr. Niraj Regmi, G.I.T., and Mr. Godfred Etiendem, Thurber

SITE PH045: HWY 35:08, MEIKLE RIVER (km 26.2 PILE WALL)

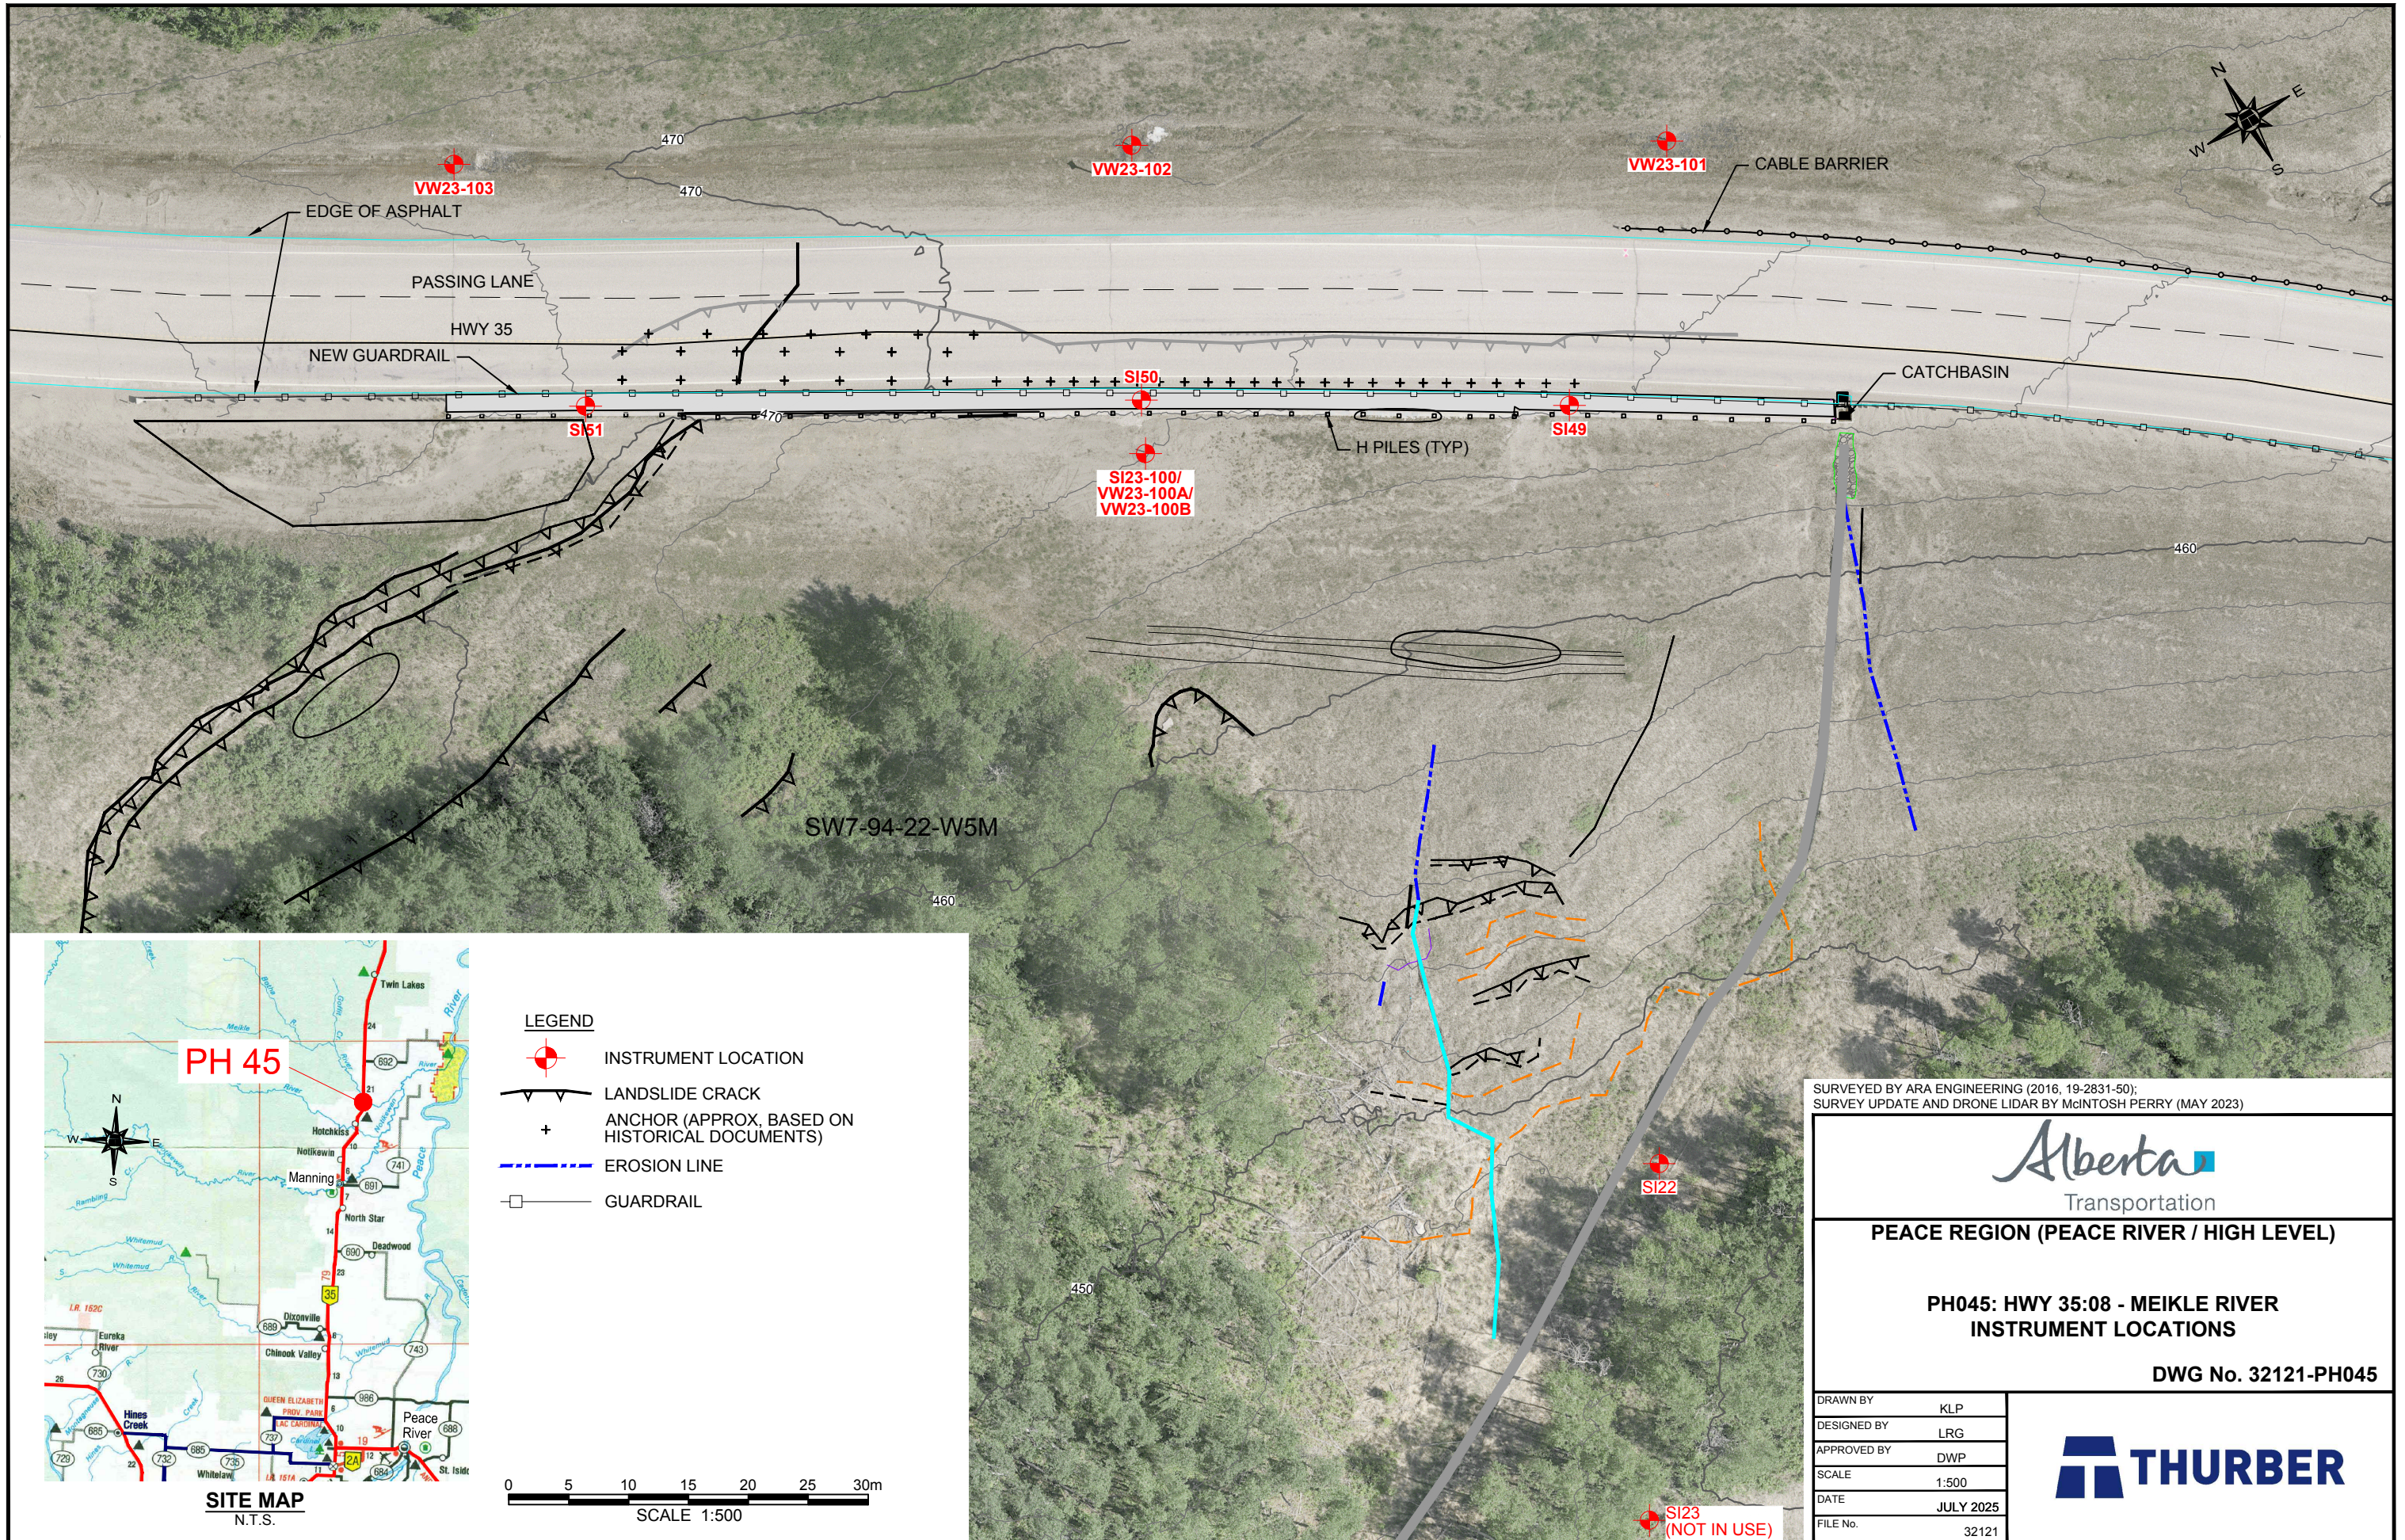
Drawing 32121-PH045 in Appendix A provides a sketch of the approximate location of the monitoring instrumentation for this site.

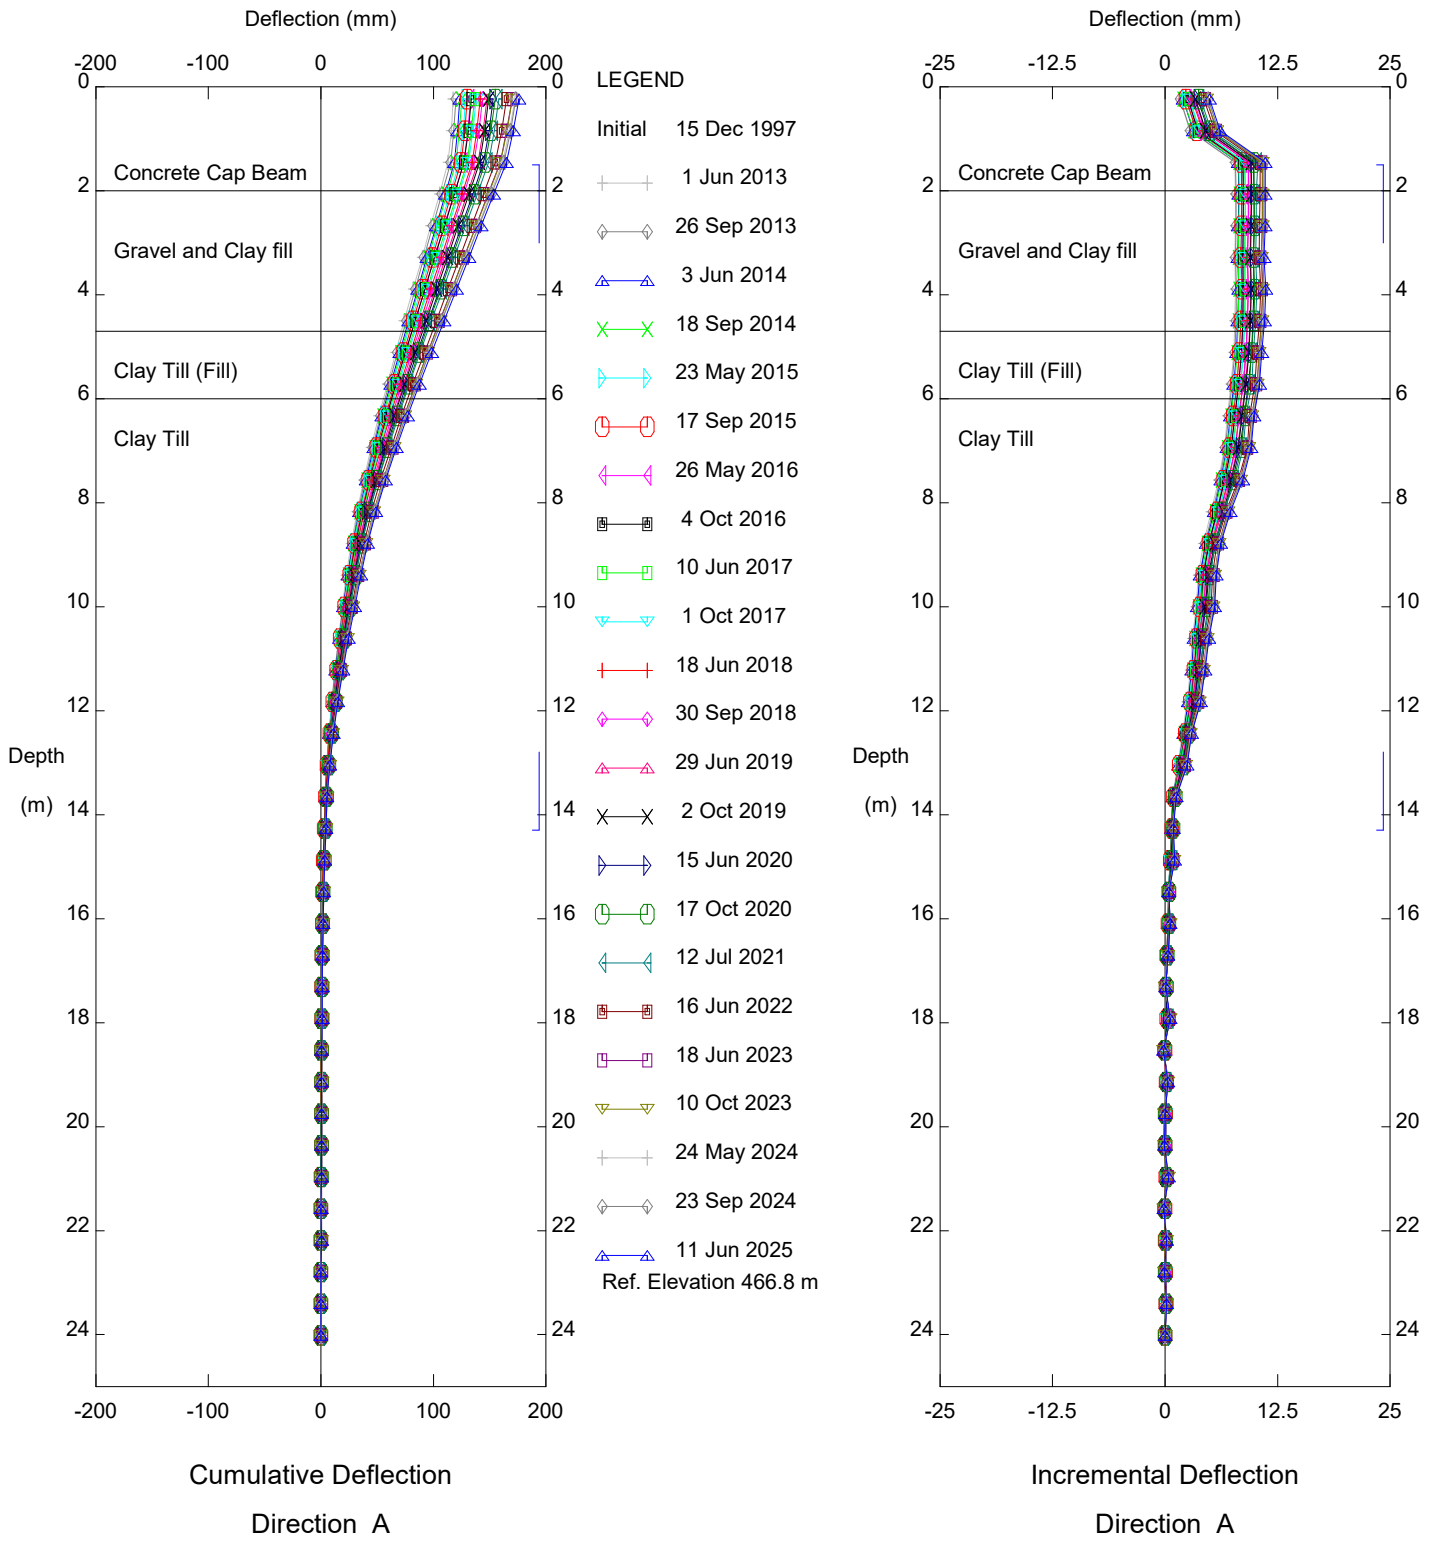
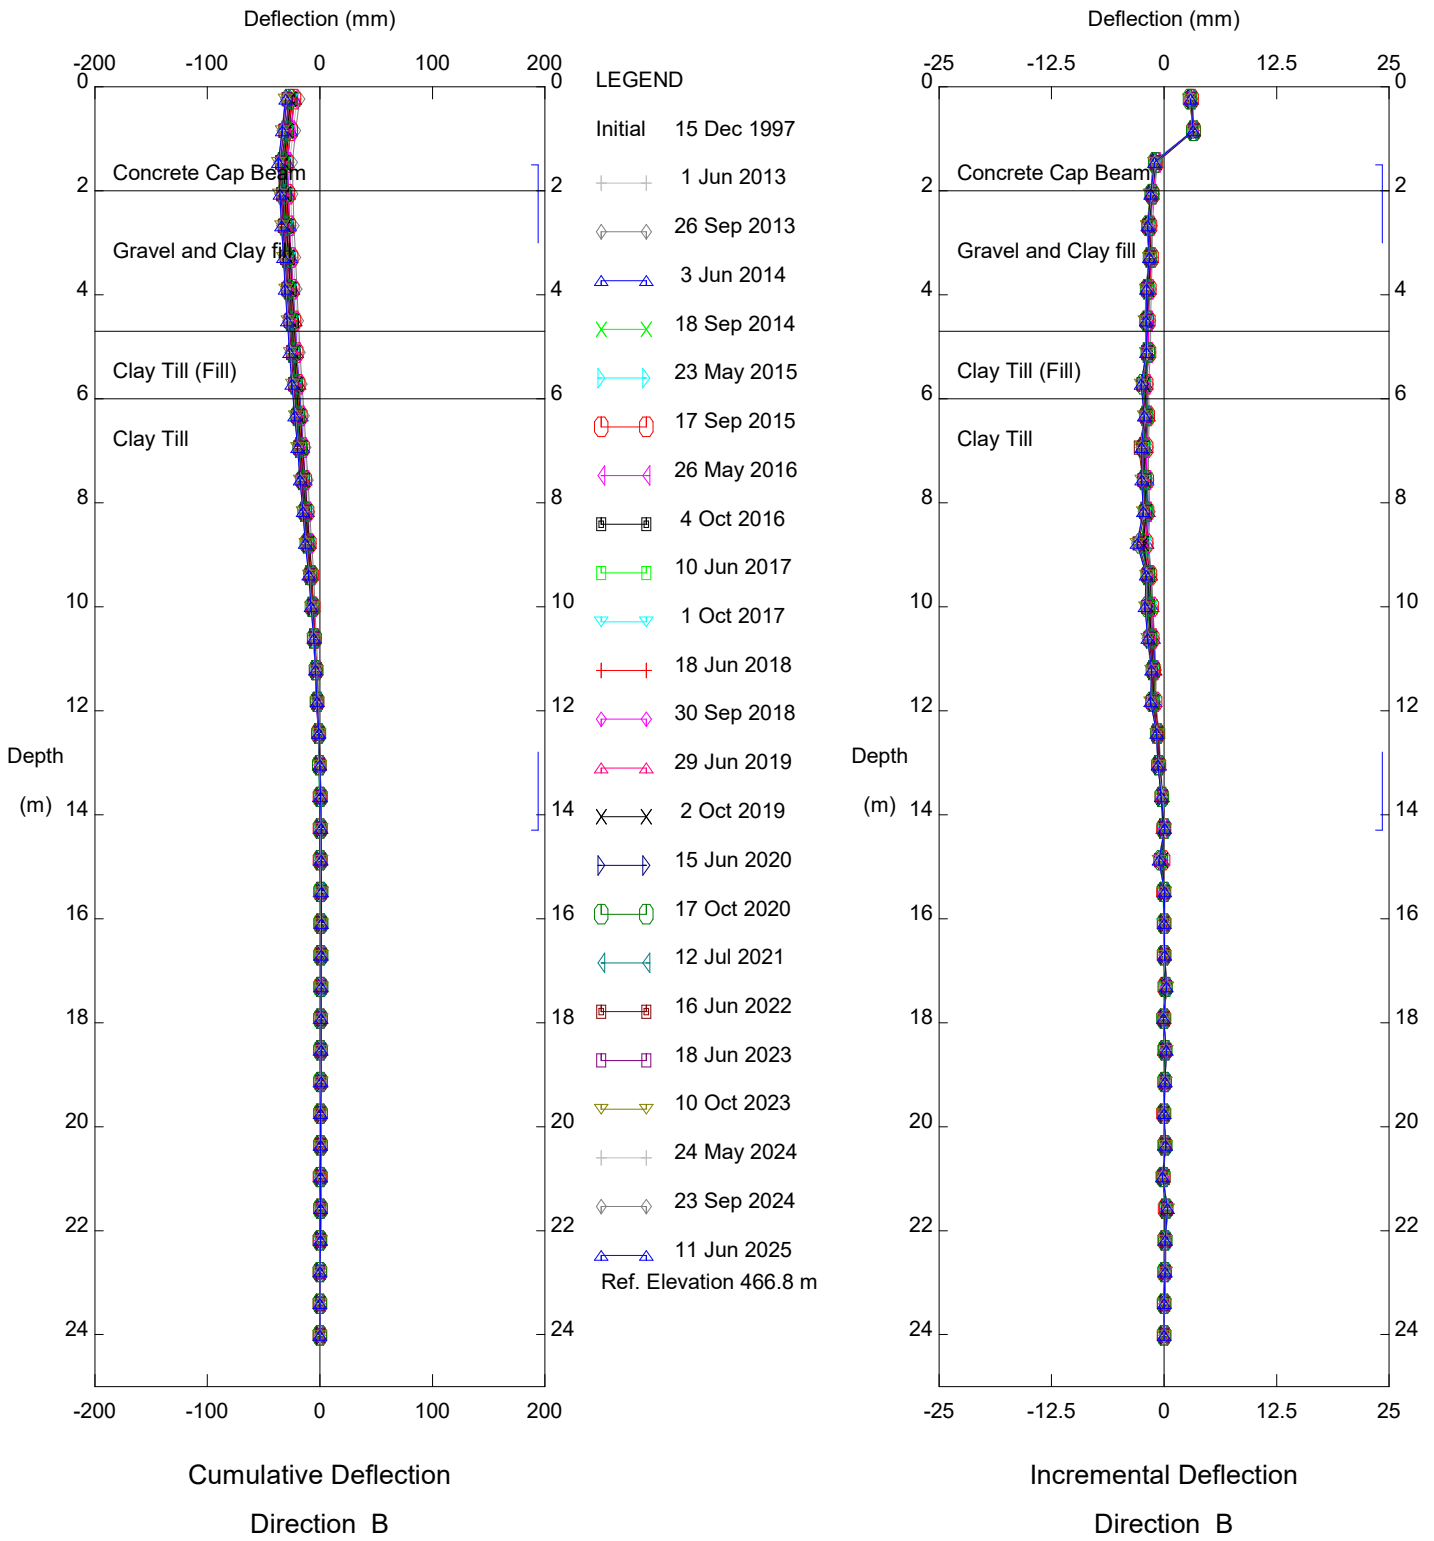
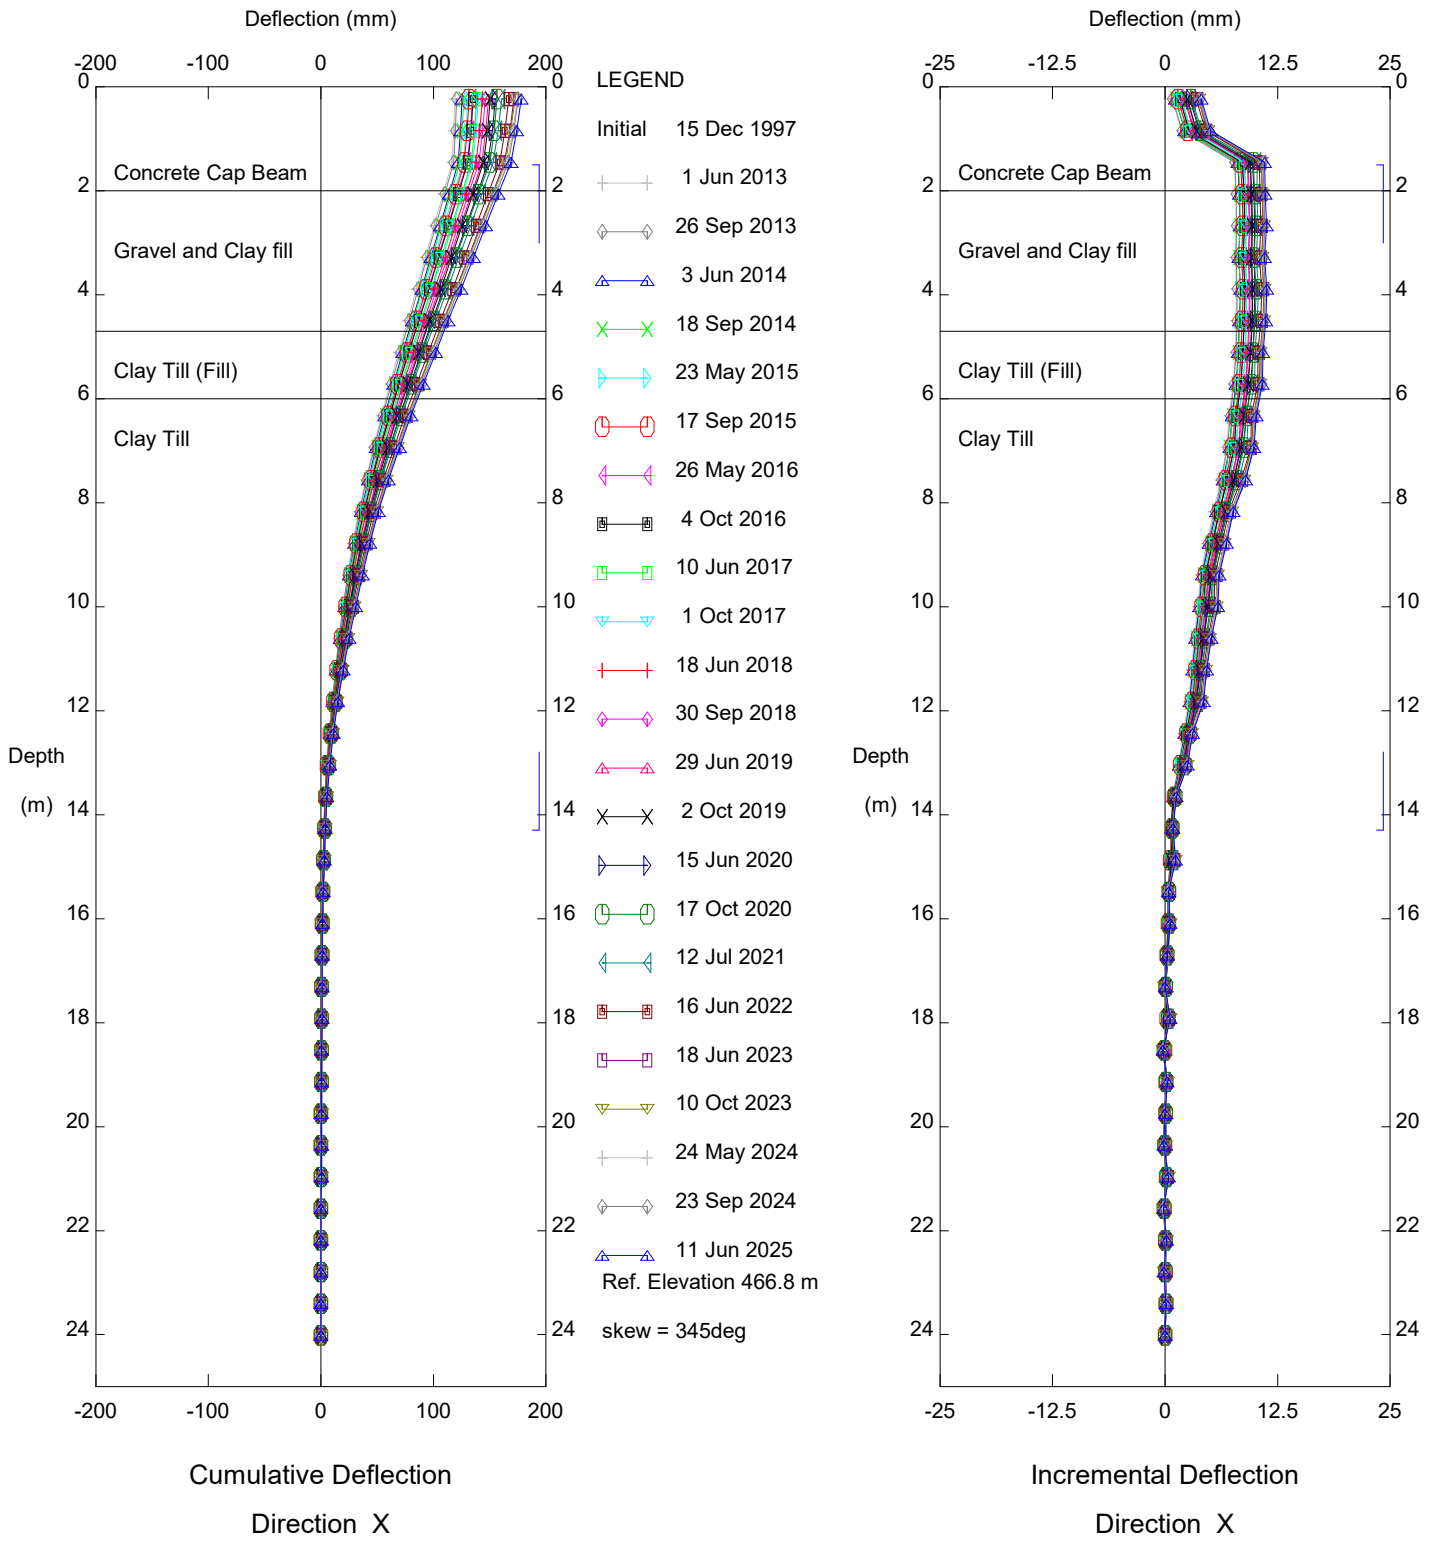
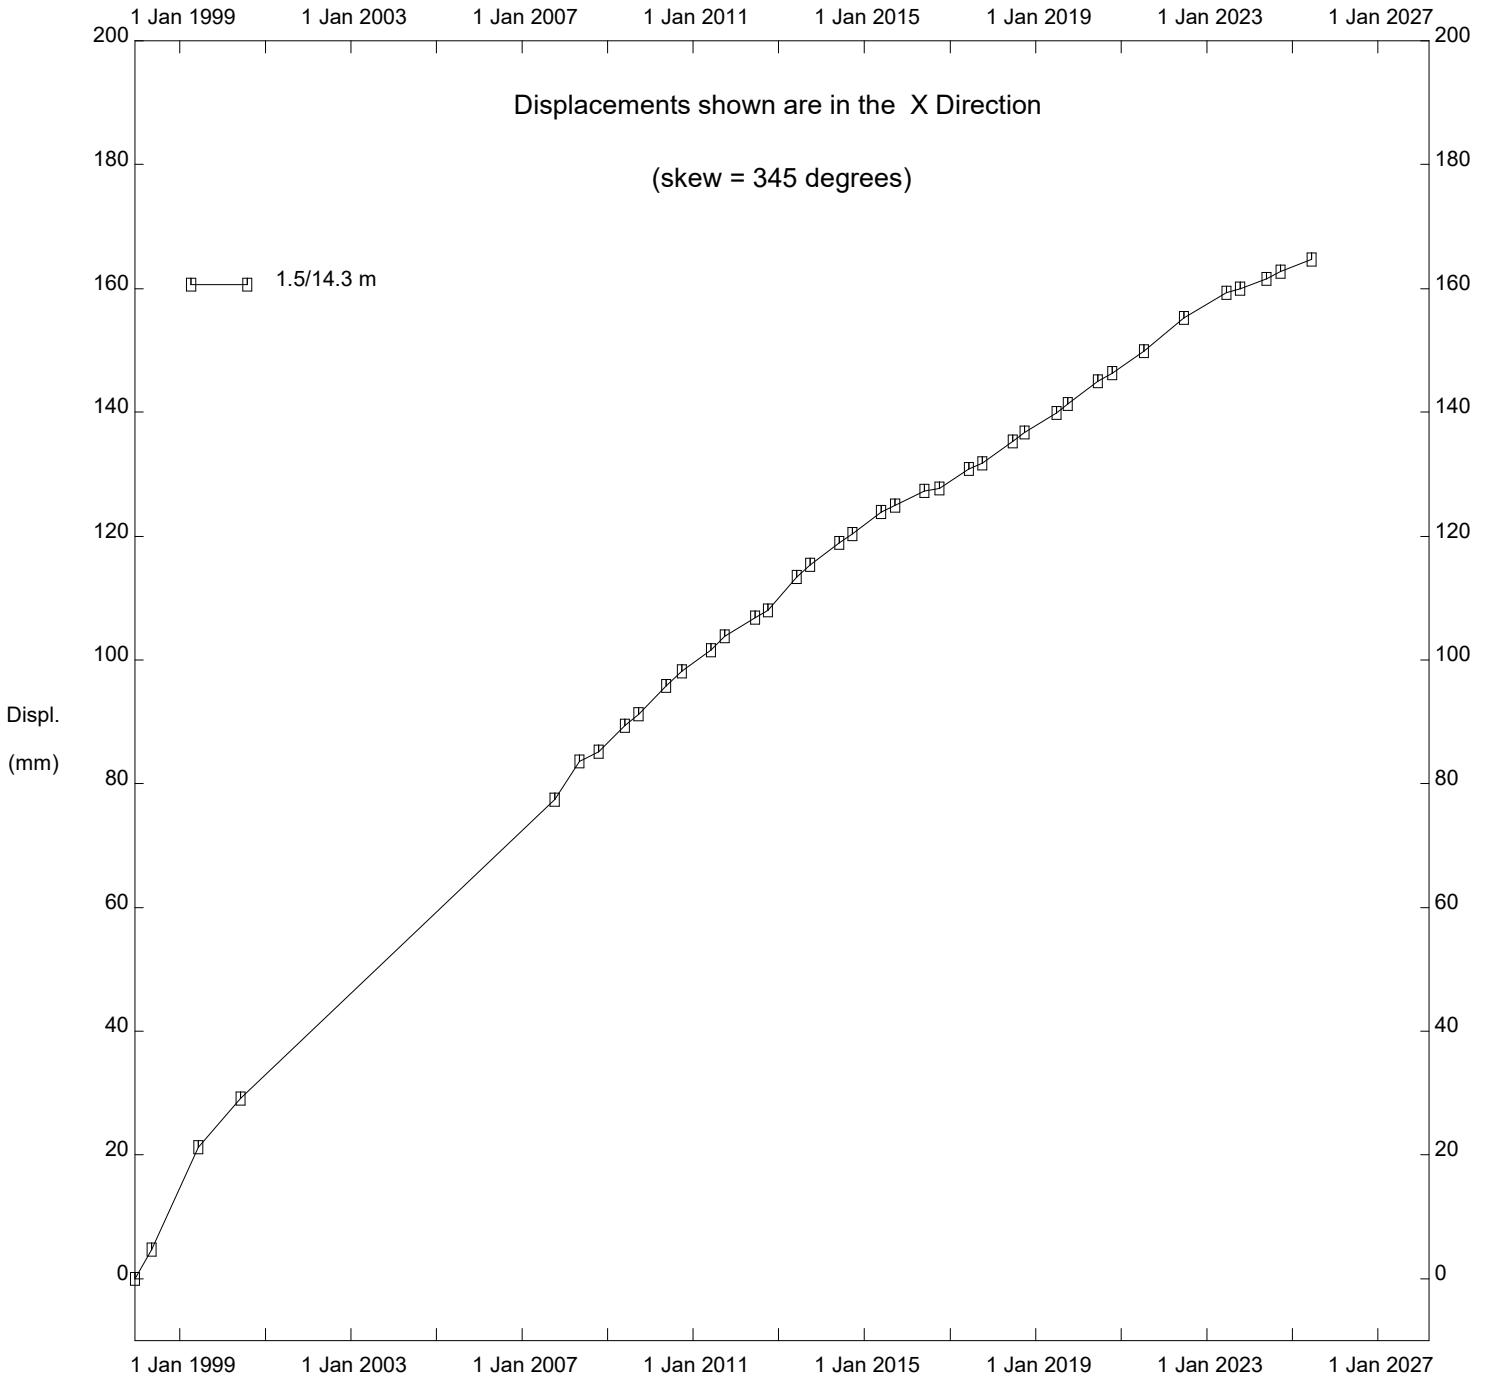
HWY 35:08 (PH045), Inclinator SI-49

Zones of New Movement:	None
Interpretation of Monitoring Results:	<p>Slope inclinometers SI-49, -50, and -51 were installed inside the pile wall along the south shoulder of the highway. The movement zones for the slope inclinometers installed in the piles are defined over the length of the pile and waler.</p> <p>SI-49 is installed near the east end of the wall. Since the fall of 2024 readings, SI-49 showed a rate of movement of 2.7 mm/yr over 1.5 m to 14.3 m depth with a total cumulative deflection of 164.7 mm. The current rate of movement in SI-49 is lower than the overall rate of movement of 6.0 mm/yr measured since initialization. Overall, the movement pattern at SI-49 appears to have been unaffected by the repairs undertaken in 2016.</p> <p>SI-50 is installed in the central portion of the wall and showed a rate of movement of 0.8 mm/yr since the fall of 2024 readings with a total</p>

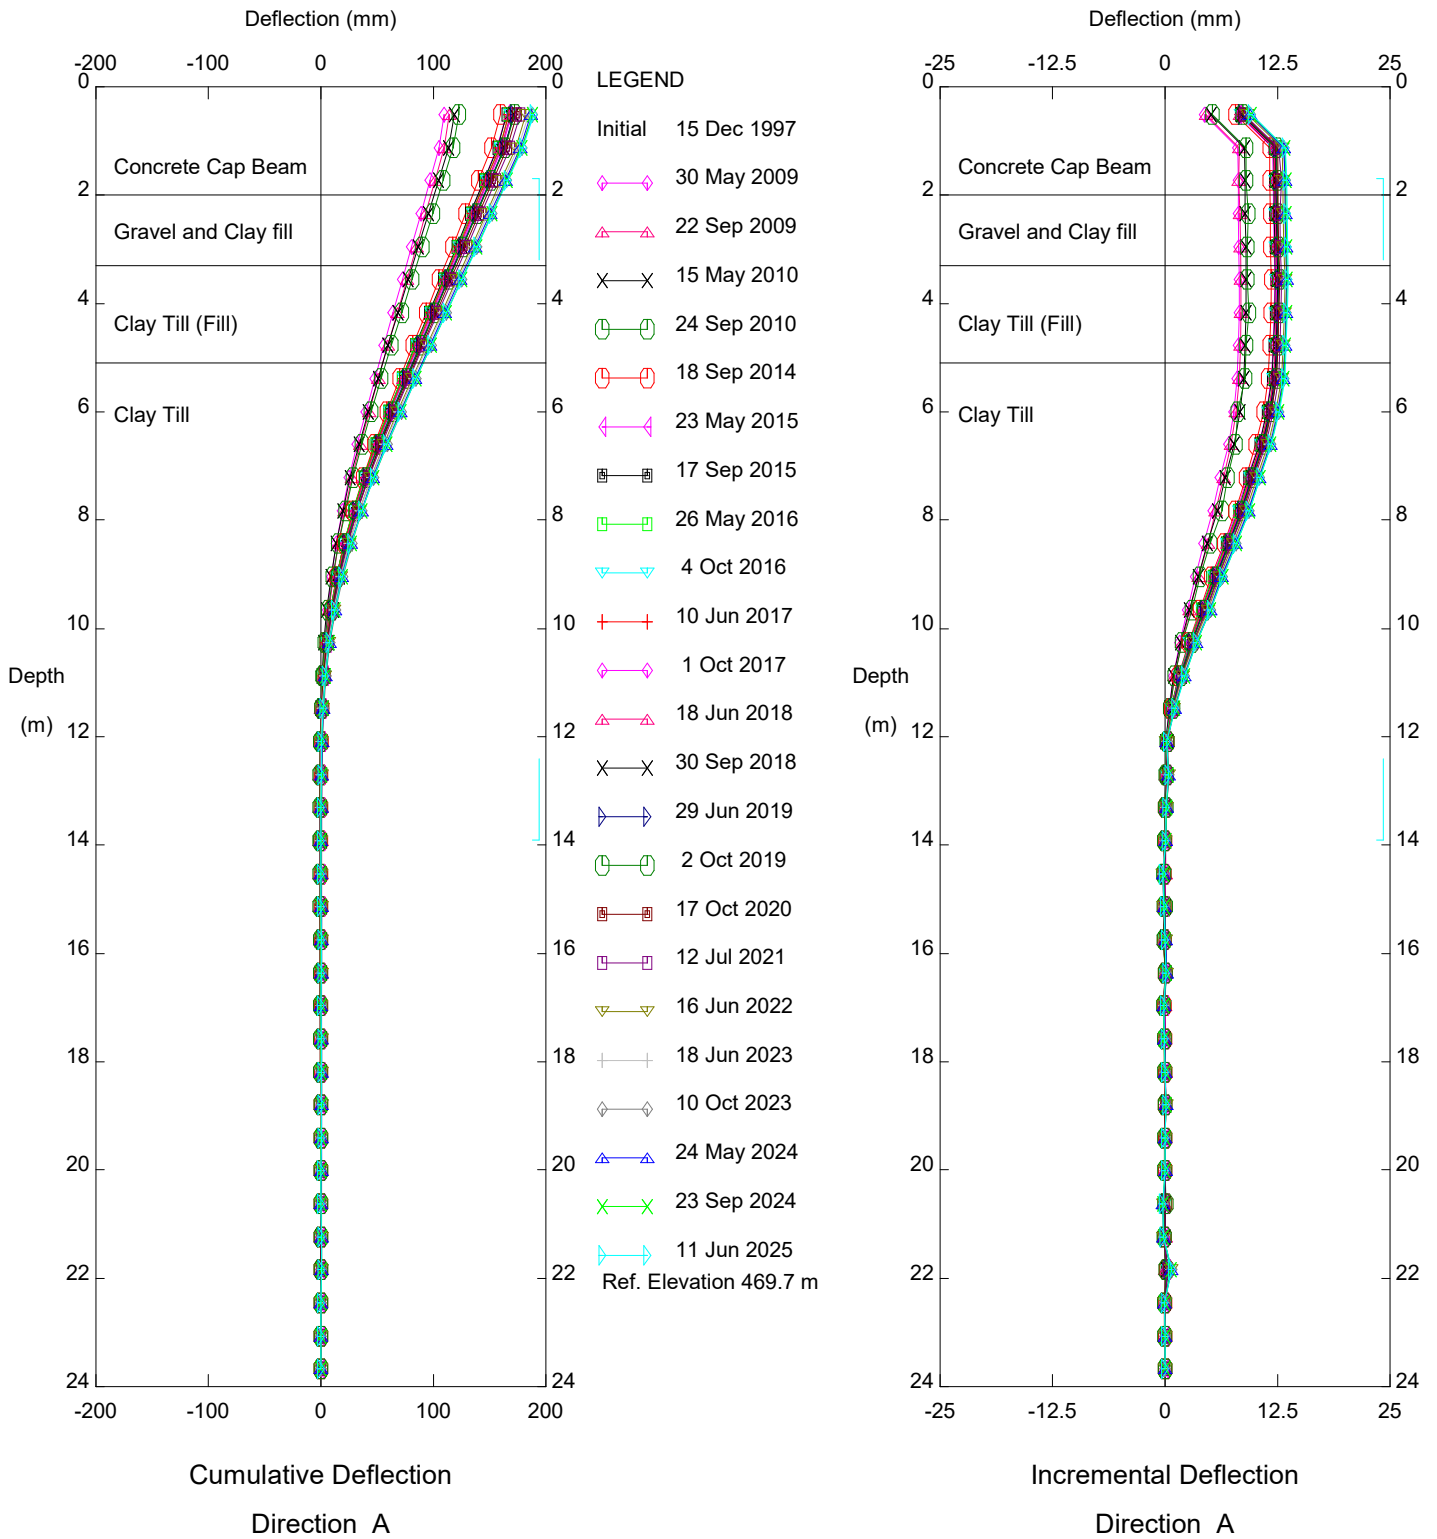
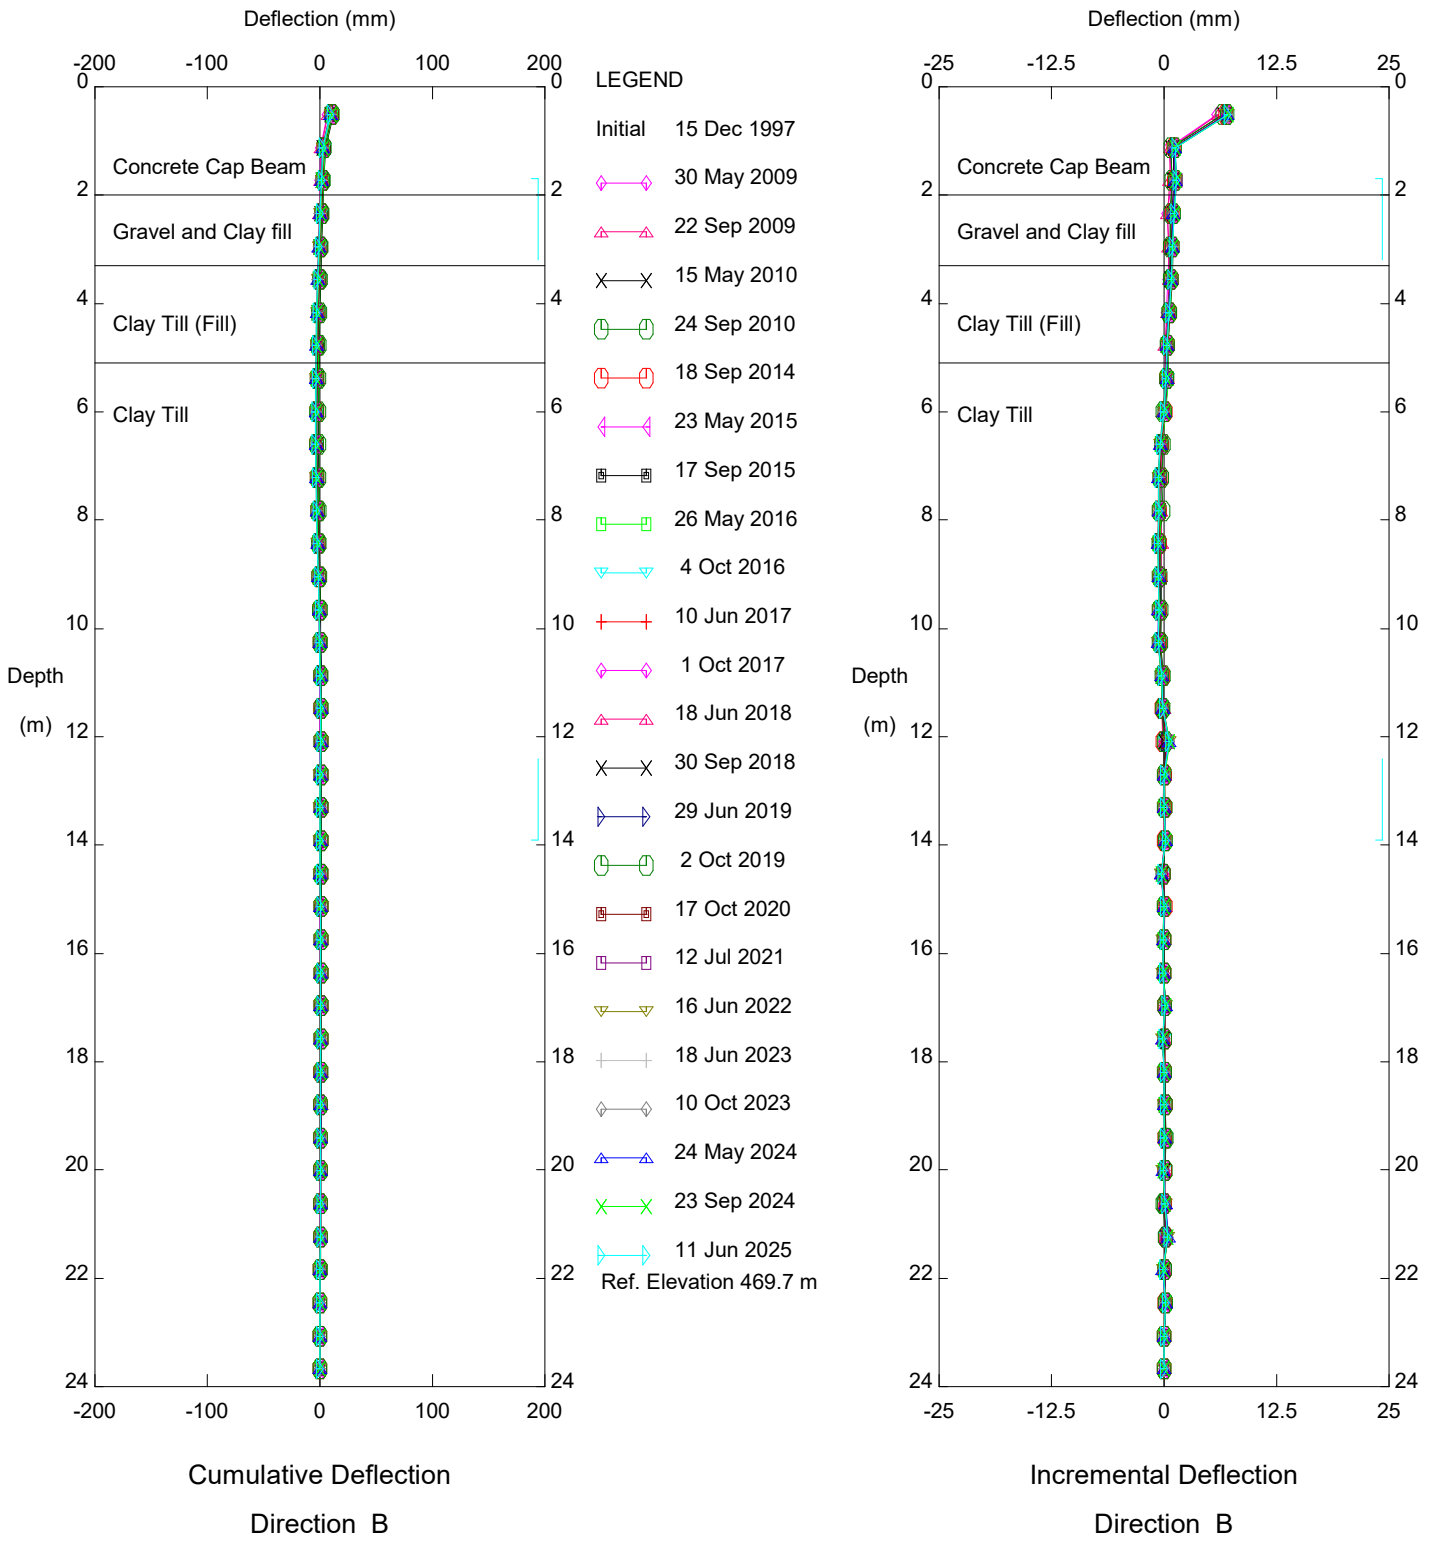
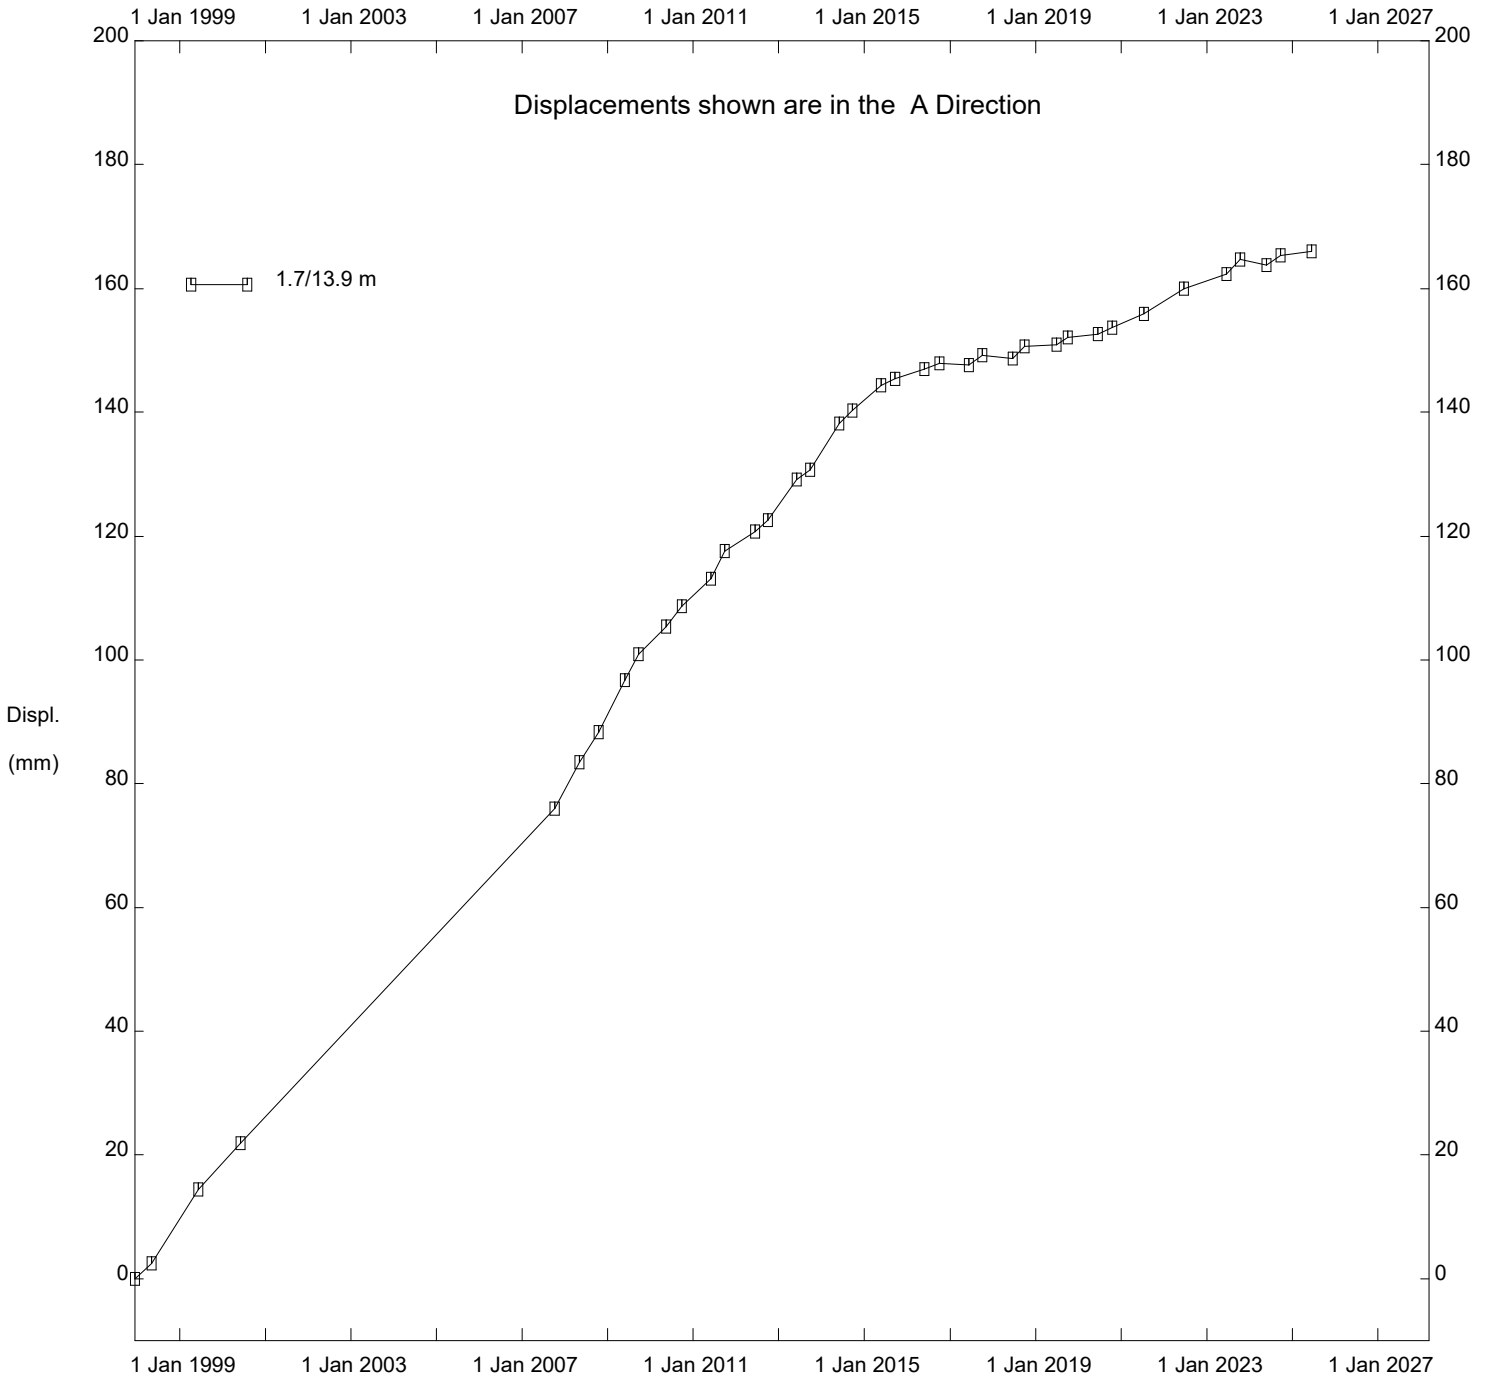
HWY 35:08 (PH045), Inclinometer SI-50

<p>cumulative movement of 166.0 mm. The overall movement rate in this SI since initialization is also 6.0 mm/yr. SI-50 showed a marked reduction in movement rate post-construction but has since increased although at a slower rate than prior to construction.</p> <p>SI-51 is installed in near the west end of the wall and may be outside of the influence of the main slide area. SI-51 showed no discernible movement since the fall of 2024 readings with a total cumulative movement of 79.7 mm. The overall movement rate at SI-51 since initialization is 2.9 mm/yr. The pattern at SI-51 is irregular likely due to the casing damage (at depth and near surface); however, the overall trend indicates that this inclinometer was also unaffected by the 2016 repairs.</p> <p>Slope inclinometer SI23-100 is located immediately downslope of the pile wall and showed a rate of movement of 6.4 mm/yr over 4.8 m to 7.8 m depth, and no discernible movement over 21.9 m to 24.3 m depth since the Fall 2024 readings. This lower zone does not appear to be movement and may have been a grouting issue as the initial displacement has stabilized with no measurable displacement over the last two sets of readings. There is also a potential shallower zone developing at about 3 m which is the contact between the fill and native materials.</p> <p>The vibrating wire piezometers show current groundwater depths ranging from 2.97 m in VW23-100B to 9.13 m below existing ground surface in VW23-103. VW23-100A, VW23-101, and VW23-103 showed decreases in groundwater level of 0.10 m, 0.33 m, and 0.21 m, respectively, since the fall of 2024 readings. VW23-100B and VW23-102 showed increases in groundwater level of 0.01 m and 0.07 m, respectively. The current groundwater level reading in VW23-100B is the highest since the instruments were initialized. The nested piezometers at VW23-100 indicate an upward groundwater flow pattern. The vibrating wire piezometer readings are summarized in Table PH045-2 below and are plotted on Figure PH045-1 in Appendix A.</p>
