ALBERTA TRANSPORTATION AND
ECONOMIC CORRIDORS GRMP
PEACE REGION – (PEACE RIVER DISTRICT)
INSTRUMENTATION MONITORING - SPRING 2025

Site Number	Location	Name	Hwy	km
PH045	Hwy 35:08 C1 26.2	Meikle Pile Wall	35:08	Km 26.2
Legal Description:		UTM Co-ordinates		
6-7-94-22 W5		11U E 467580.75	N	6333080.85

Current Monitoring:	11-Jun-2025	Previous Monitoring	23-Sep-2024
Instruments Read By:	Mr. Niraj Regmi, G.I.T., and Mr. Godfred Etiendem, Thurber

SITE PH045: HWY 35:08, MEIKLE RIVER (km 26.2 PILE WALL)

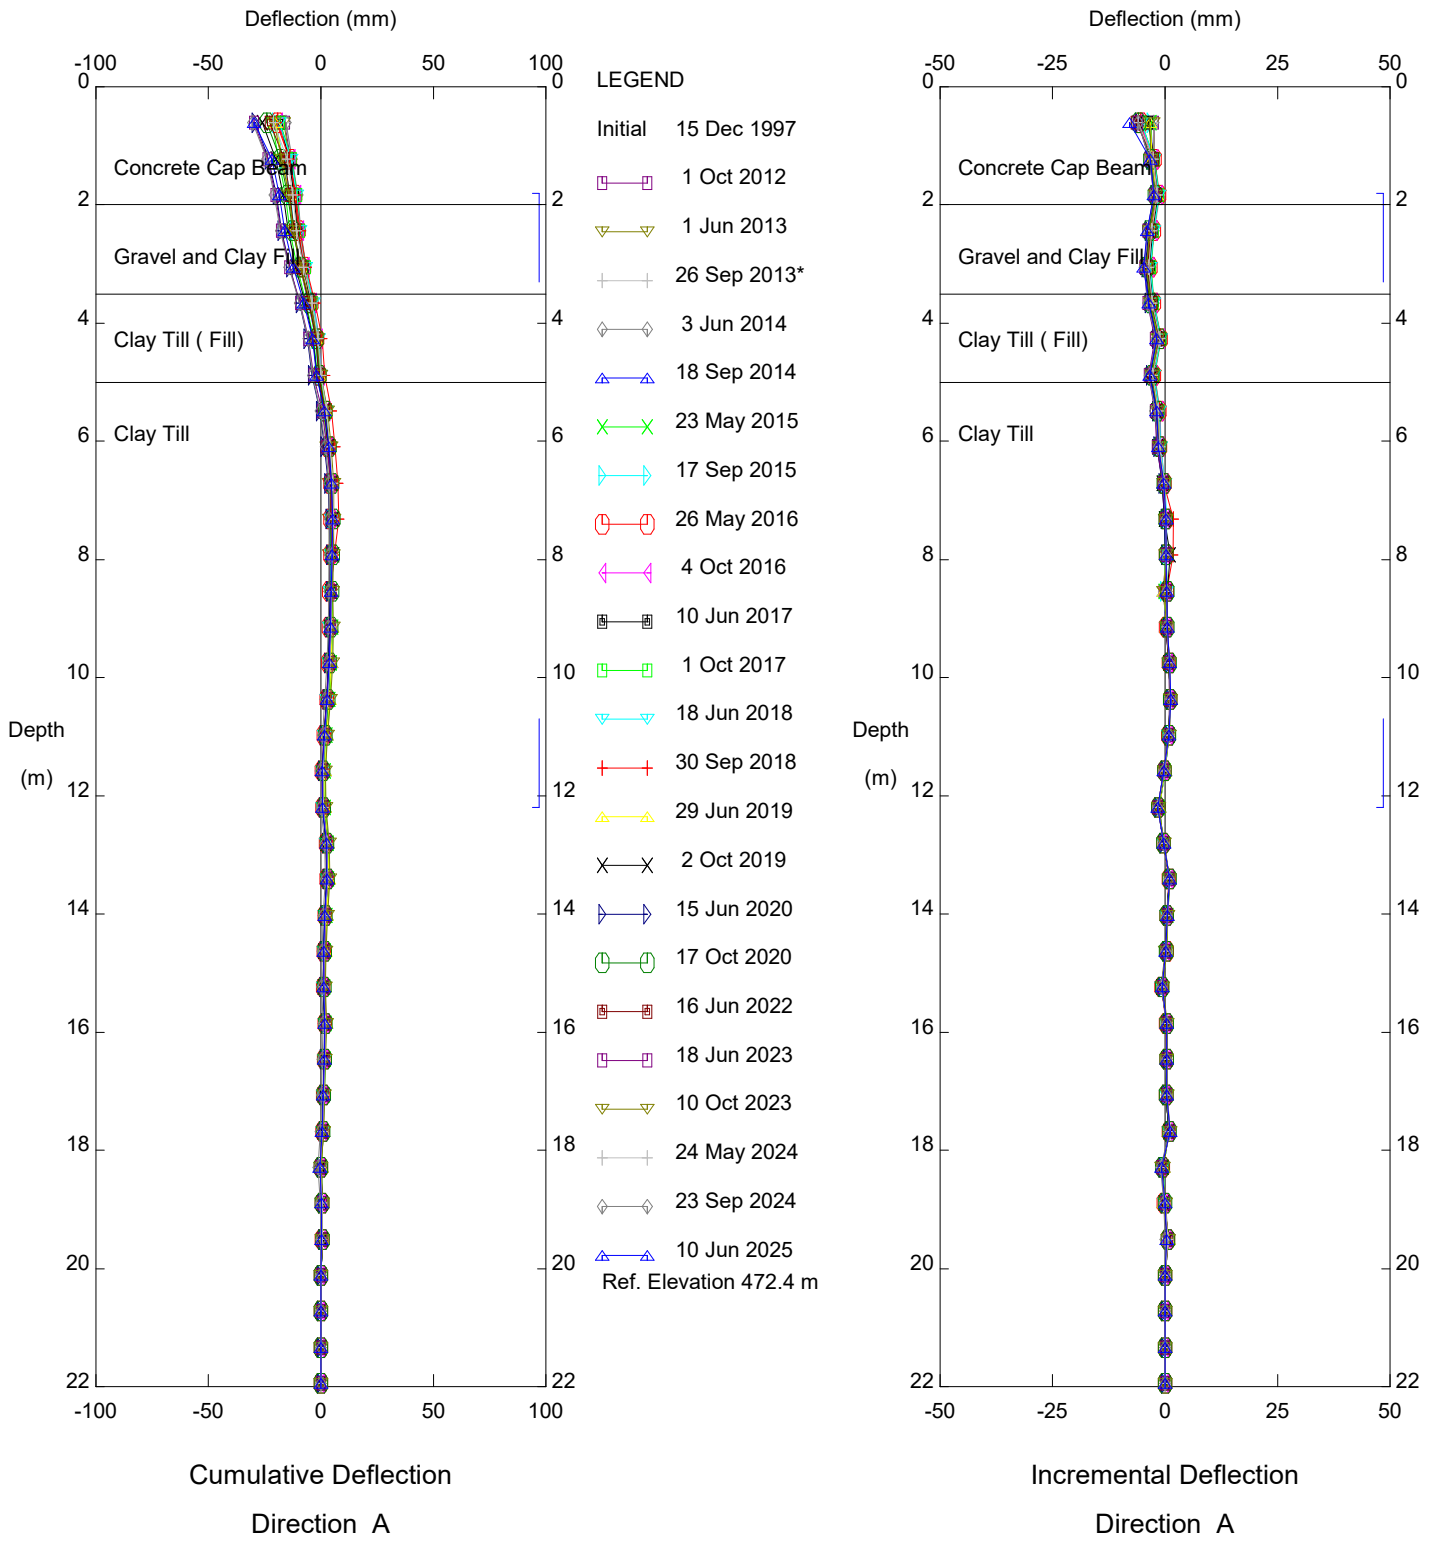
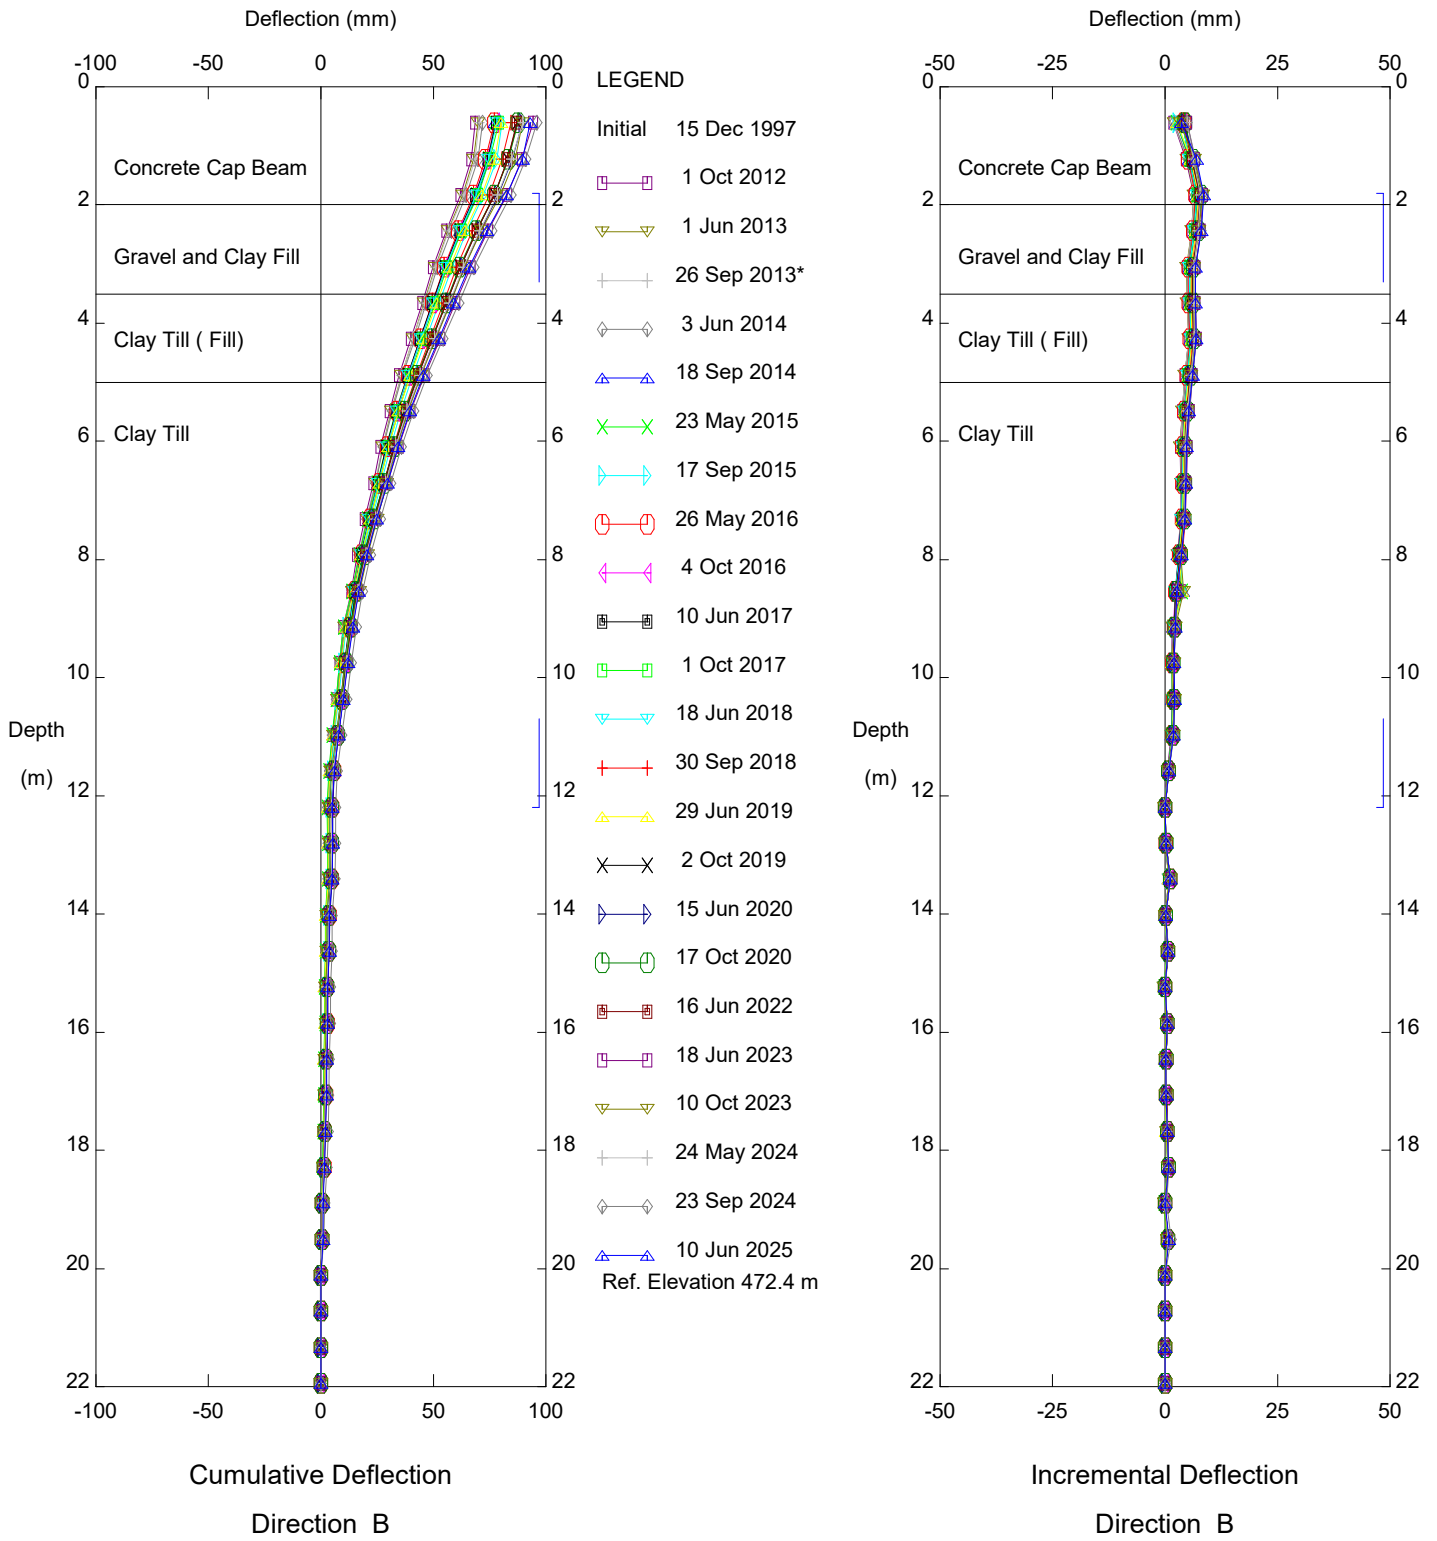
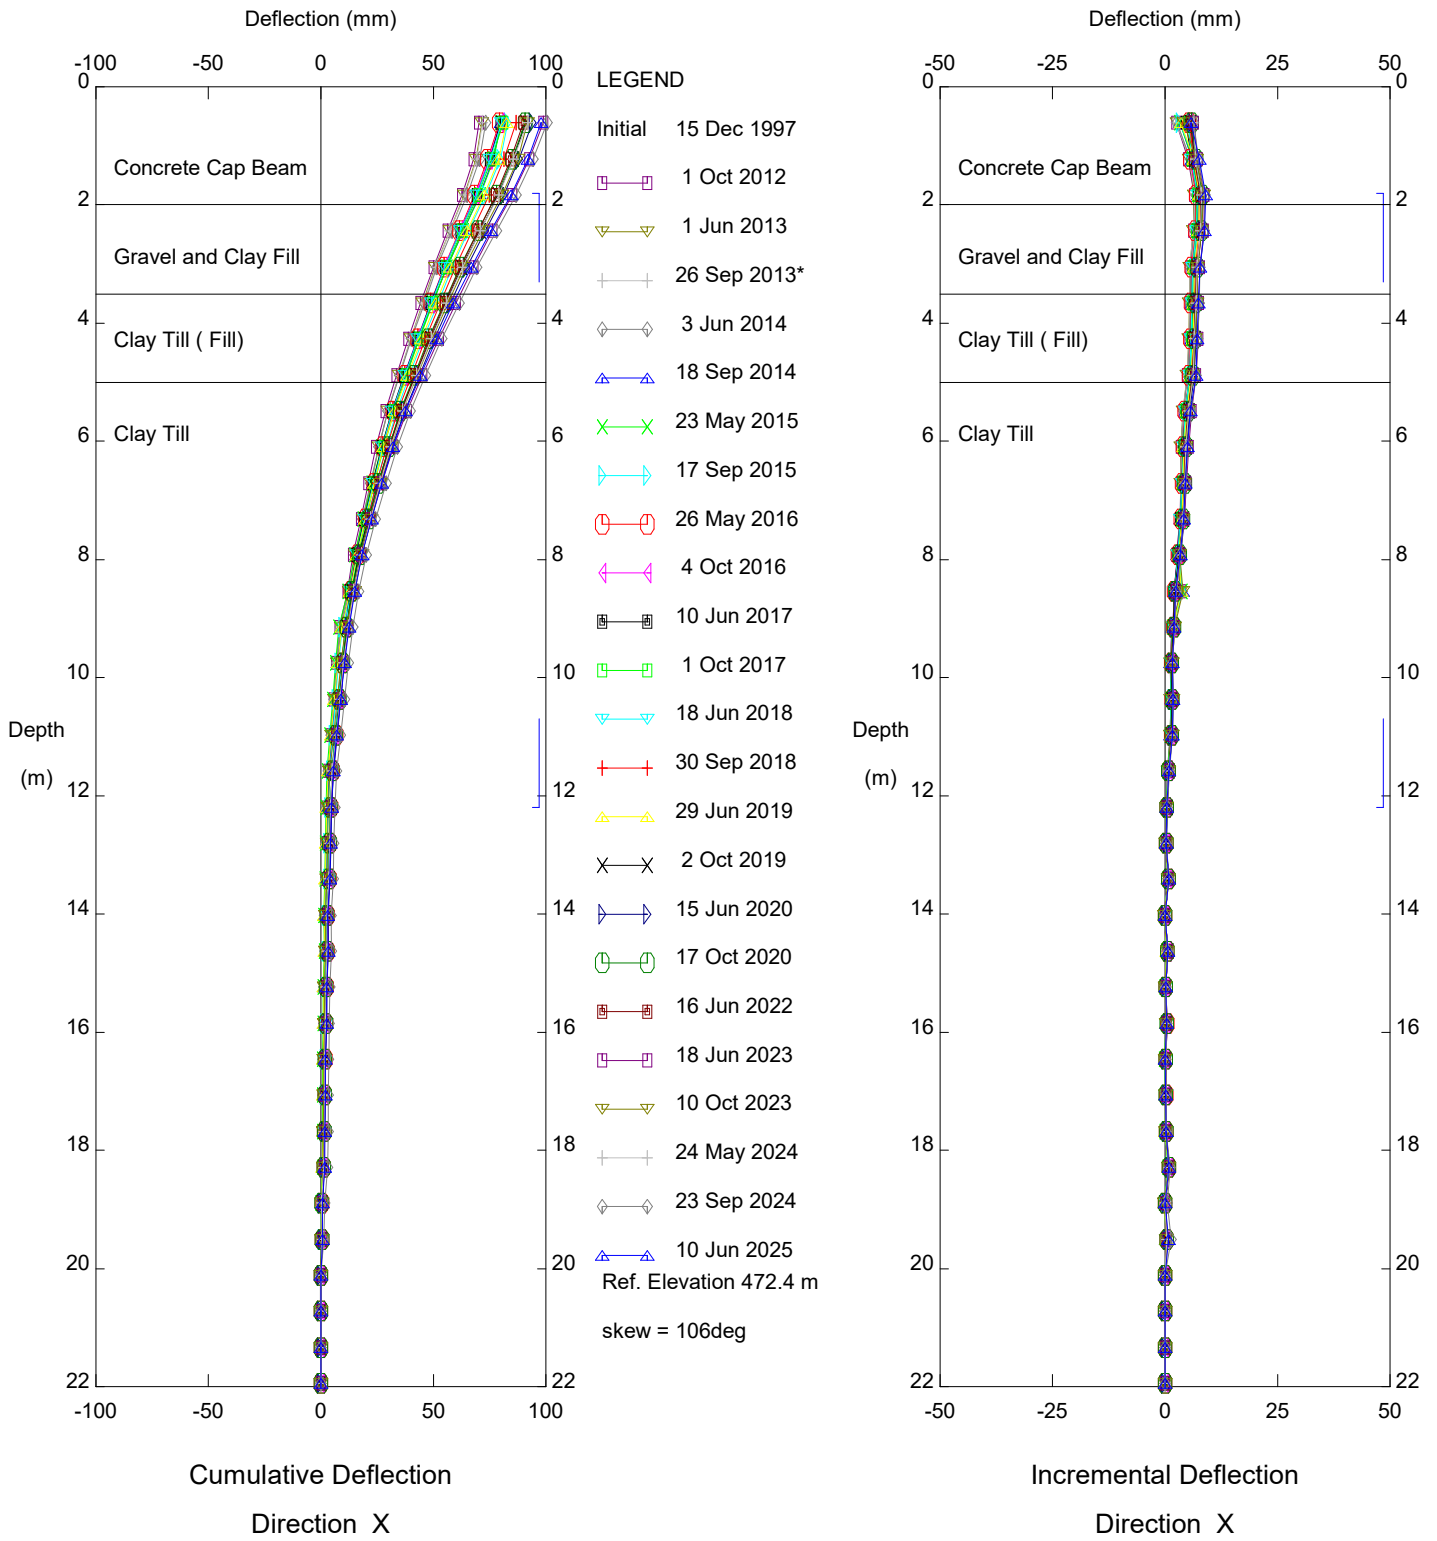
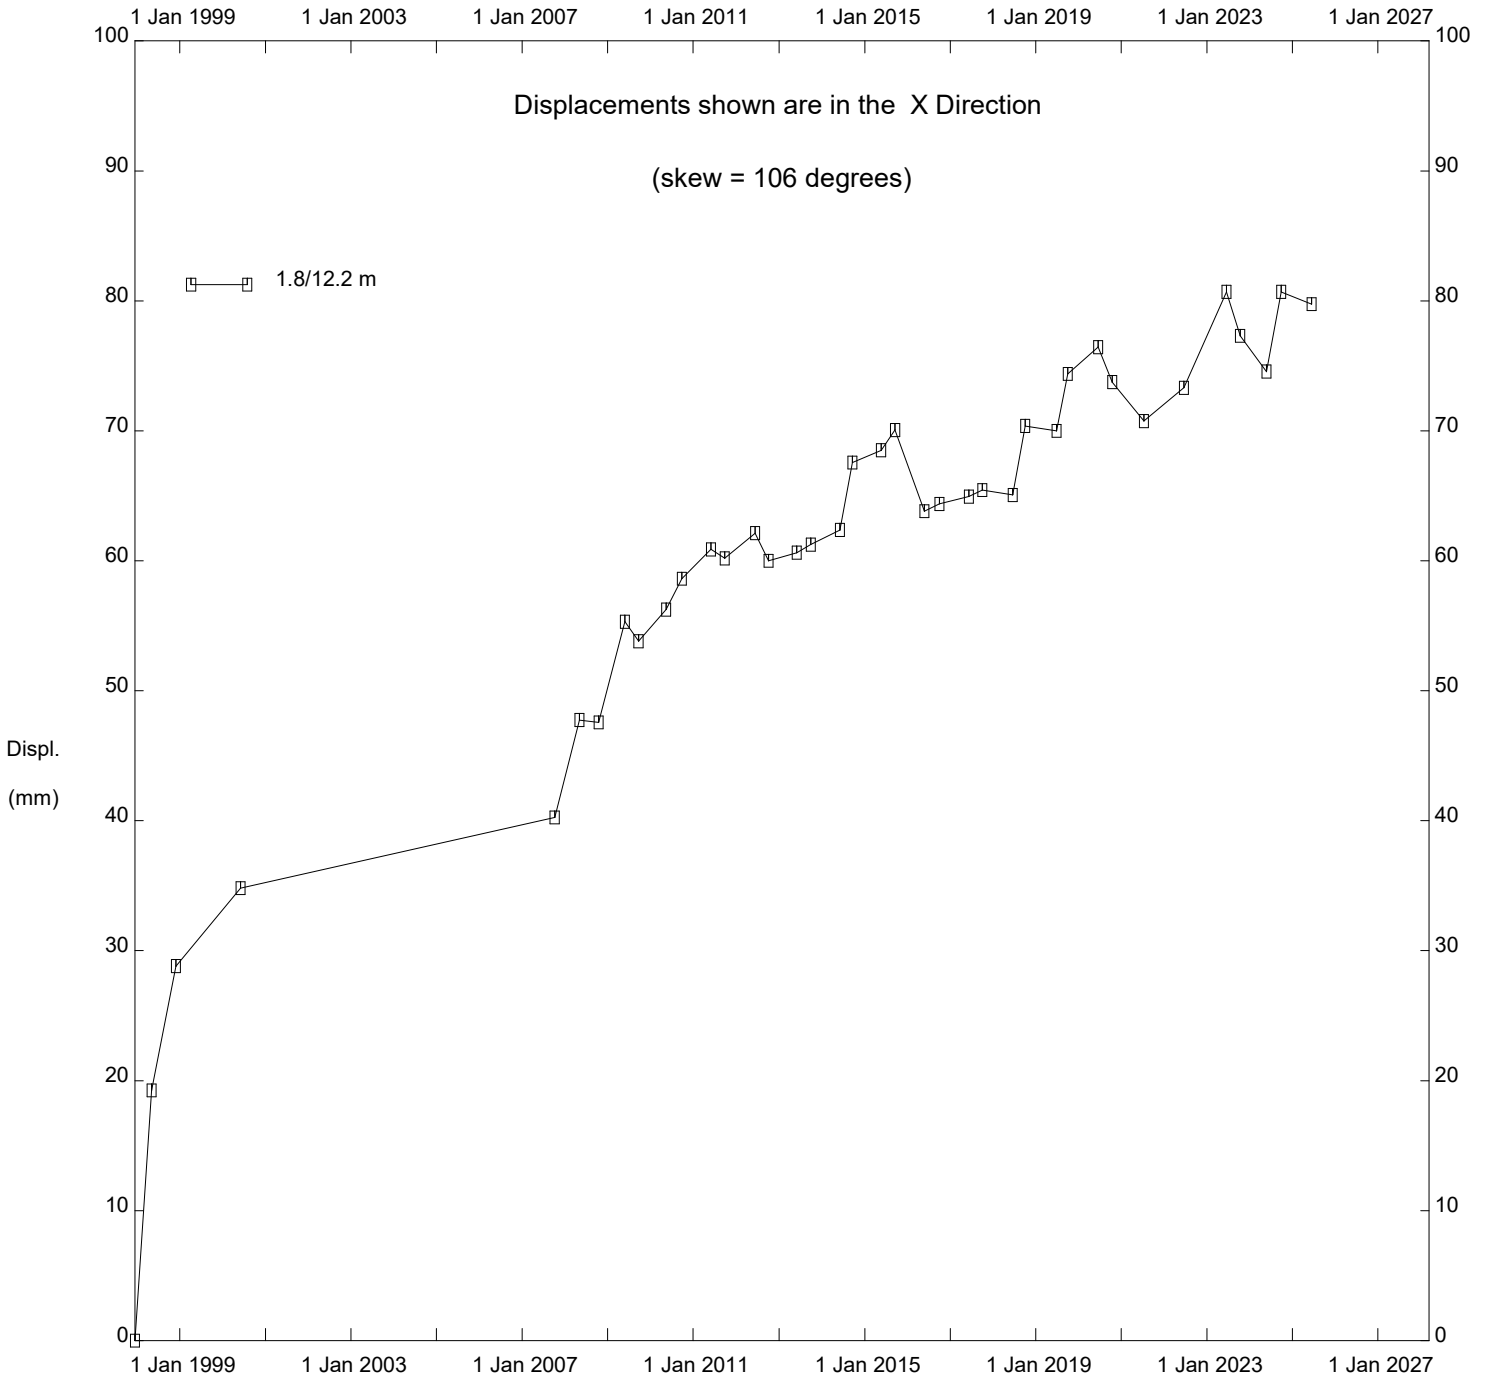
HWY 35:08 (PH045), Inclinometer SI-51

* SI-51 probe comes to surface not in grooves, may be damaged at 2 feet depth. Top of casing damaged
*SI-51 Probe did not go past 65 ft, SI was read from 2 ft to 64 ft
** SI-50 - top of SI slightly damaged
