**ALBERTA TRANSPORTATION AND
ECONOMIC CORRIDORS
GEOHAZARD RISK MANAGEMENT PROGRAM
PEACE REGION (PEACE RIVER DISTRICT)
2025 INSPECTION**

Site Number	Location	Name	Hwy	km
SH016-1	Little Smoky River	West Bridge Abutment	49:12	1.90
Legal Description		UTM Co-ordinates		
NE33-74-21-W5M		11 E 489,573	N 6,145,499

Date	PF	CF	Total
Previous Inspection:	3-Jun-2024	14	4	56
Current Inspection:	26-May-2025	14	4	56
Road AADT:	1460		Year:	2024
Inspected By:	Kristen Tappenden, TEC		Mark Gallego, Thurber Roger Skirrow, Thurber	
Report Attachments:	<input checked="" type="checkbox"/> Photographs		<input checked="" type="checkbox"/> Plans	<input checked="" type="checkbox"/> Maintenance items

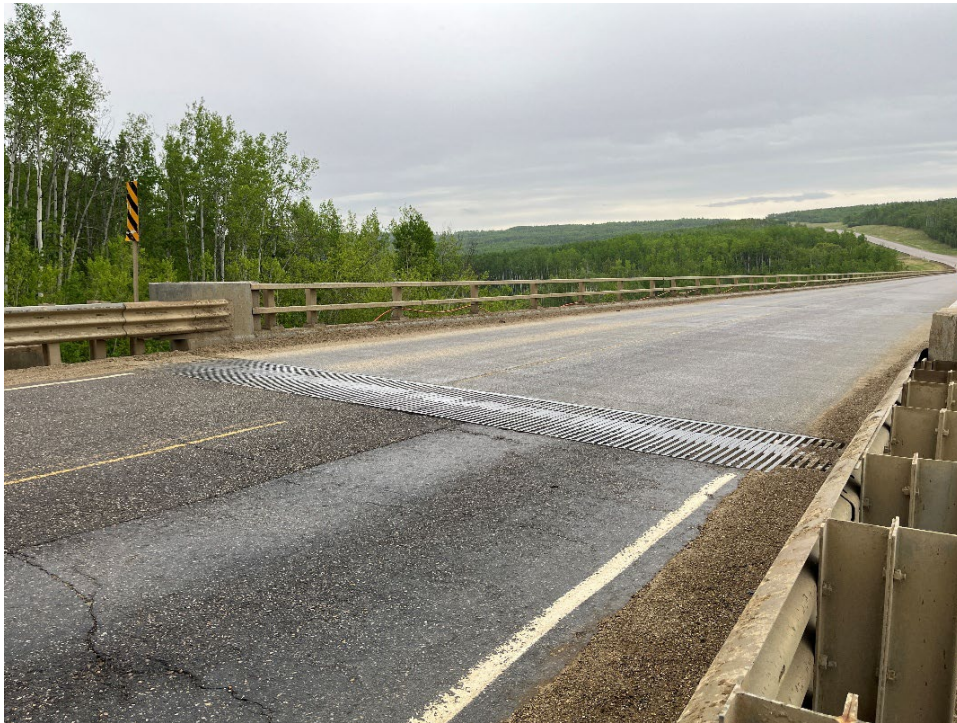
Photo 1 – Looking northeast at new finger joints and repaved approach (done since 2023 inspection).

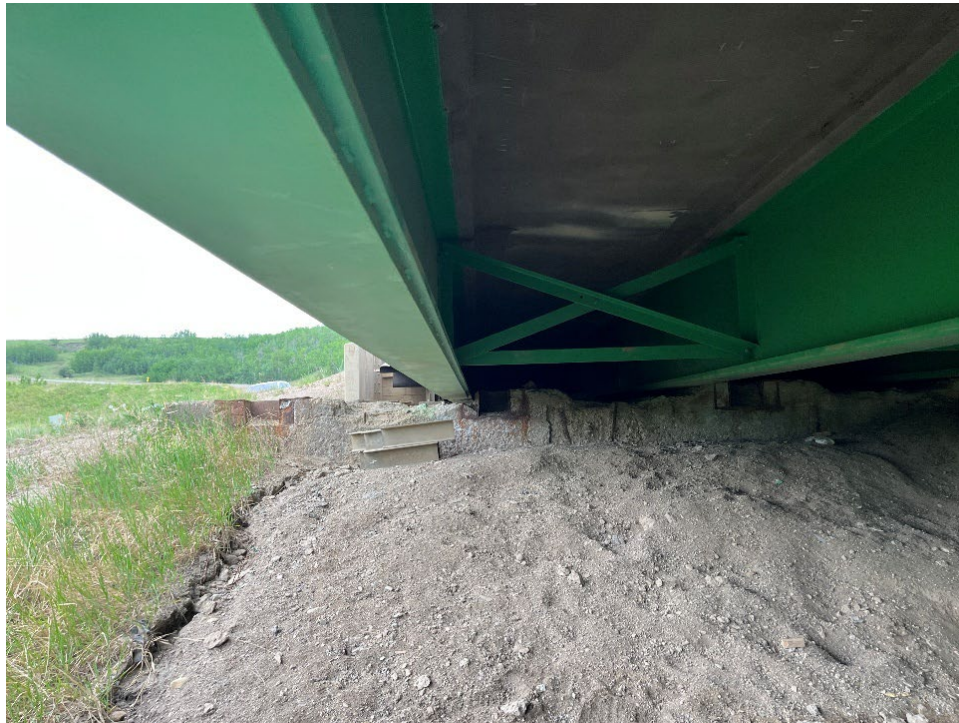
Photo 3 – Looking towards the West Abutment where portions of the old foundation concrete was removed to allow movement of the girders between the West Abutment and Abutment 1.

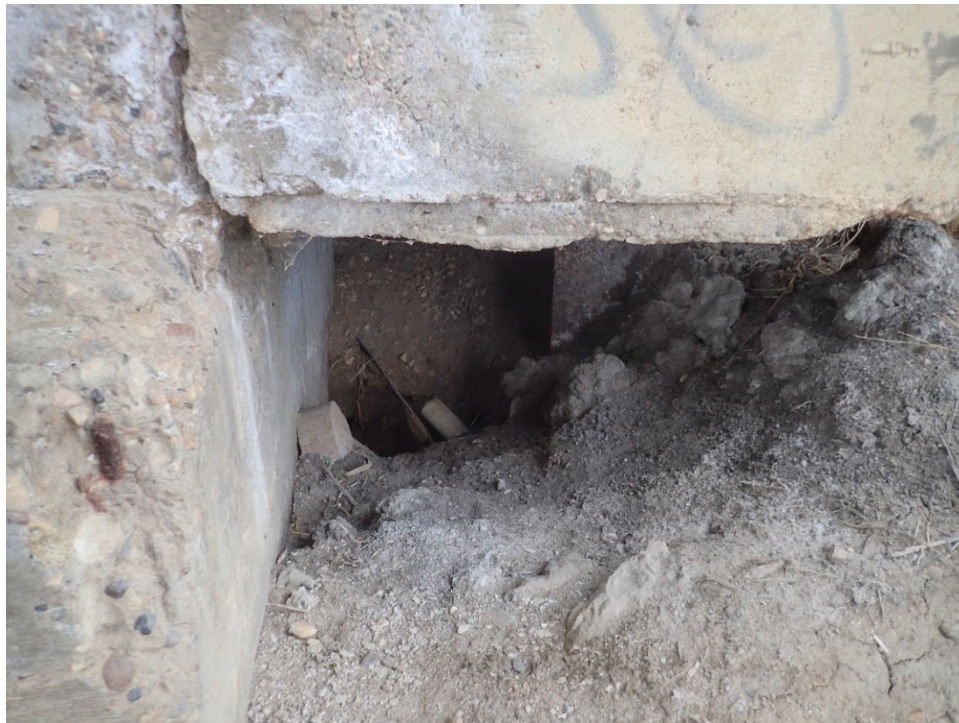
Photo 4 - Void underneath the northeast corner of the old Abutment 1.

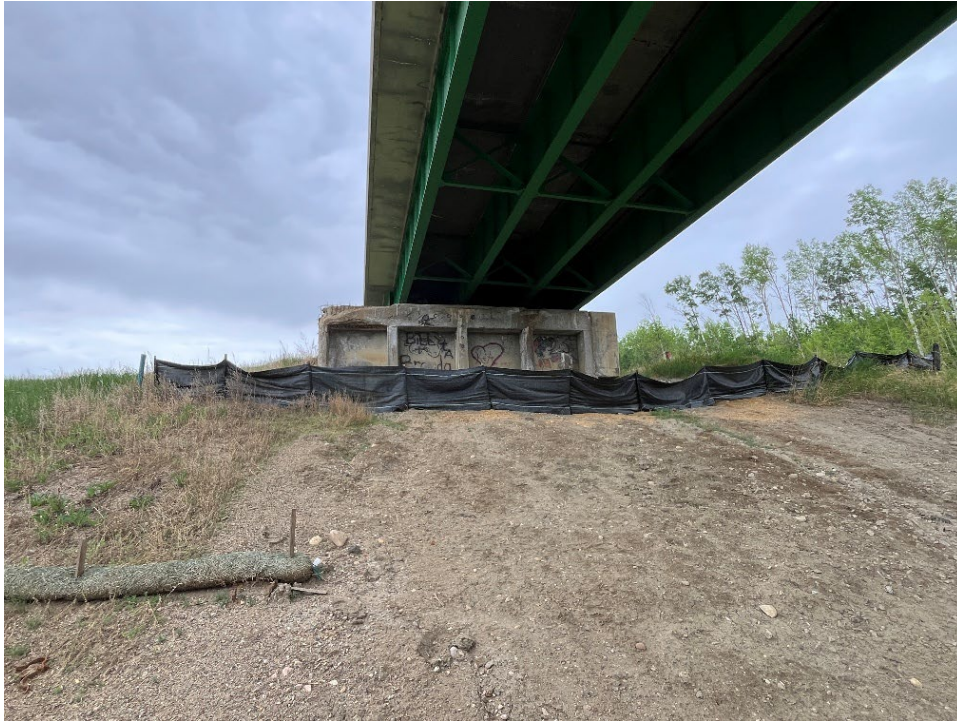
Photo 5 - Looking west at headslope below Abutment 1. Erosion control measures installed in 2023.

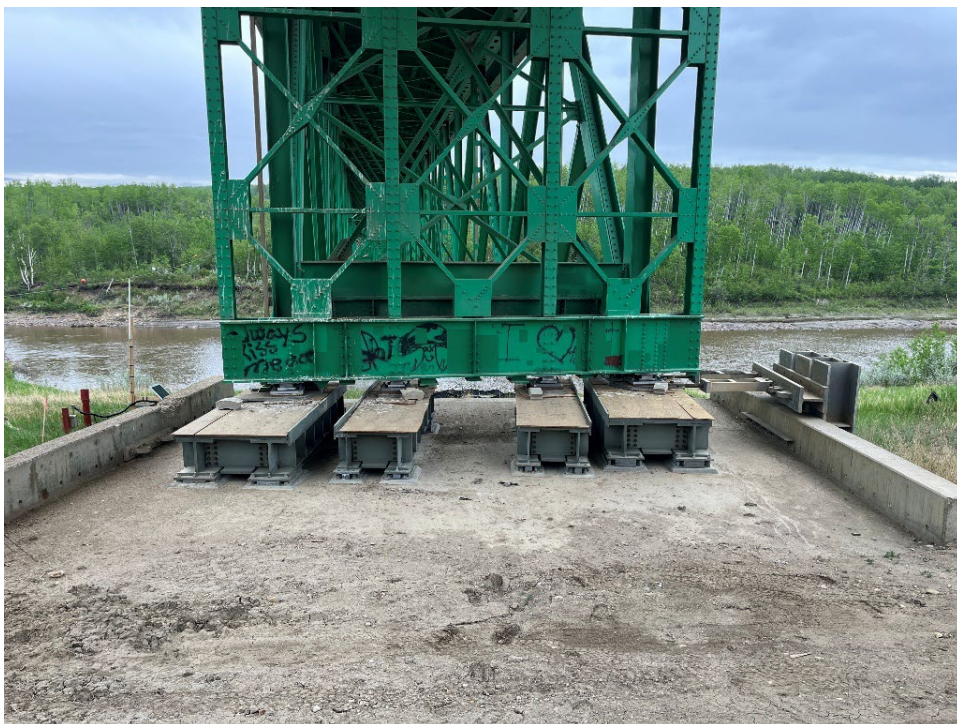
The bearing pad and sliding plate arrangement at Pier 1 was replaced in 2024. Previous measurements were summarized in the 2021 and 2023 Geohazard reports: 2.97 m of vertical settlement (approximately 48 mm/year) since 1957 and 1.18 m horizontal since 2000 (74 mm/year). The new configuration consists of four sets of galvanized steel I-beam pairs bolted to the concrete pier foundation and supporting a stainless-steel plate thus elevating the sliding surface to the bottom of the bent eliminating the tipping risk of the previous configuration. As noted on the Drawings, the outside corners of the slider plates were measured to the outside corners of the stainless-steel plates for future comparison. The lateral restraint has been shifted to vertical steel piles bolted to the exterior of the concrete foundations as the existing bolt holes in the wingwalls were too low. It should be noted that the TEC Bridge Department has been monitoring the movement of the slider plates in Abutment 1 and Pier 1.

Photo 6 – New slide plates installed at Pier 1. TEC Bridge Department has been monitoring the movement of the slider plates.

- It is recommended that the annual Geohazard inspection and twice-annual instrumentation readings should continue as scheduled.
- The TEC Bridge Department has been monitoring the movement of the slider plates in Abutment 1 and Pier 1 which involves an ingenious yet simple movement monitoring system consisting of felt pen markings directly on the sliding pads. This system could be formalized to ensure there is no confusion in the interpretation of movement measurements.

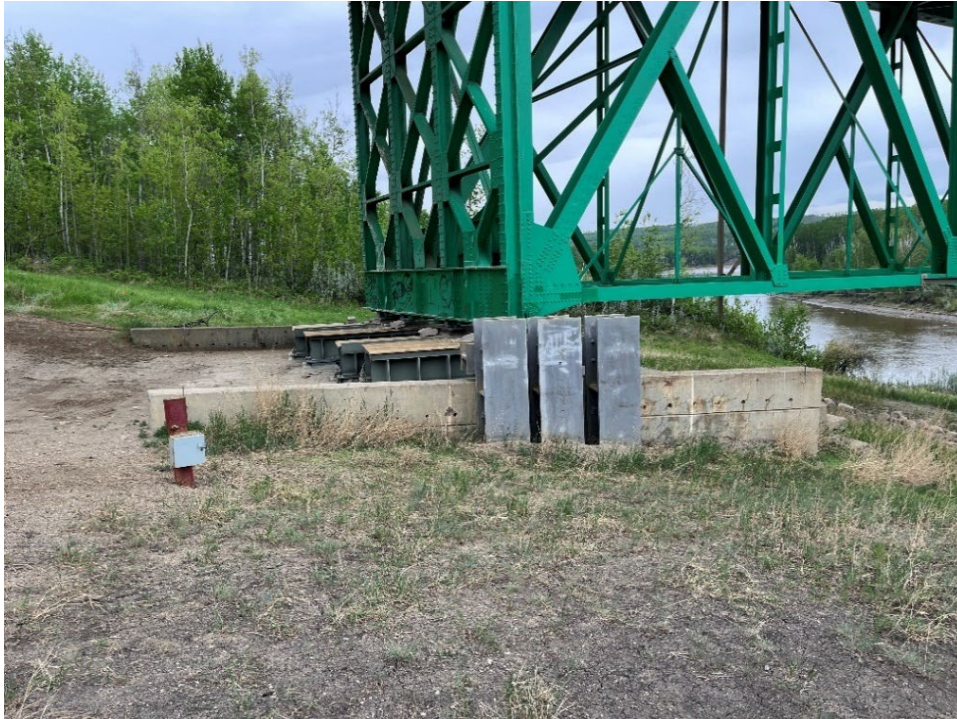
Photo 7 – Looking north at Pier 1 where sliding plates and lateral restraints were installed in 2023.

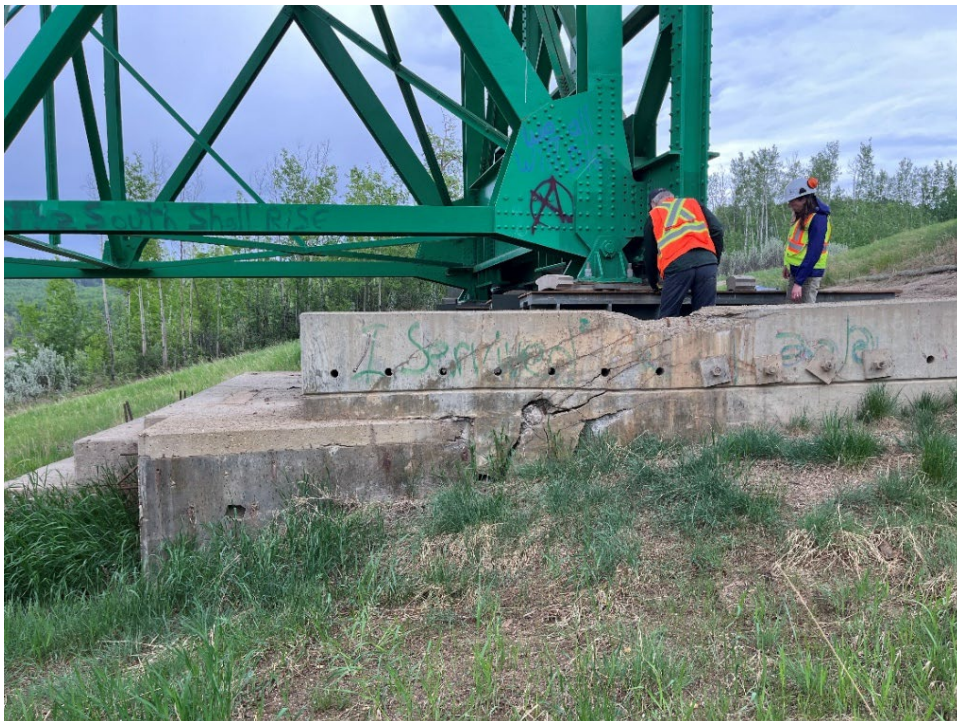
The cracking and accelerating movements and tilting observed in the concrete foundation at Pier 1 might be related to a change in foundation support conditions. The older downstream part of the foundation was supported on deep steel piles; however, the landslide has moved the foundation to the transition point with the south part of the concrete slab which has no piles. The change in loading condition might be causing the slab to tilt and the side walls to crack as noted on the north side of Pier 1.

Photo 8 – Looking south at Pier 1 wingwall at arc-shaped compression crack pattern in foundation. Left-hand portion of foundation is pile supported; right-hand is on-grade.

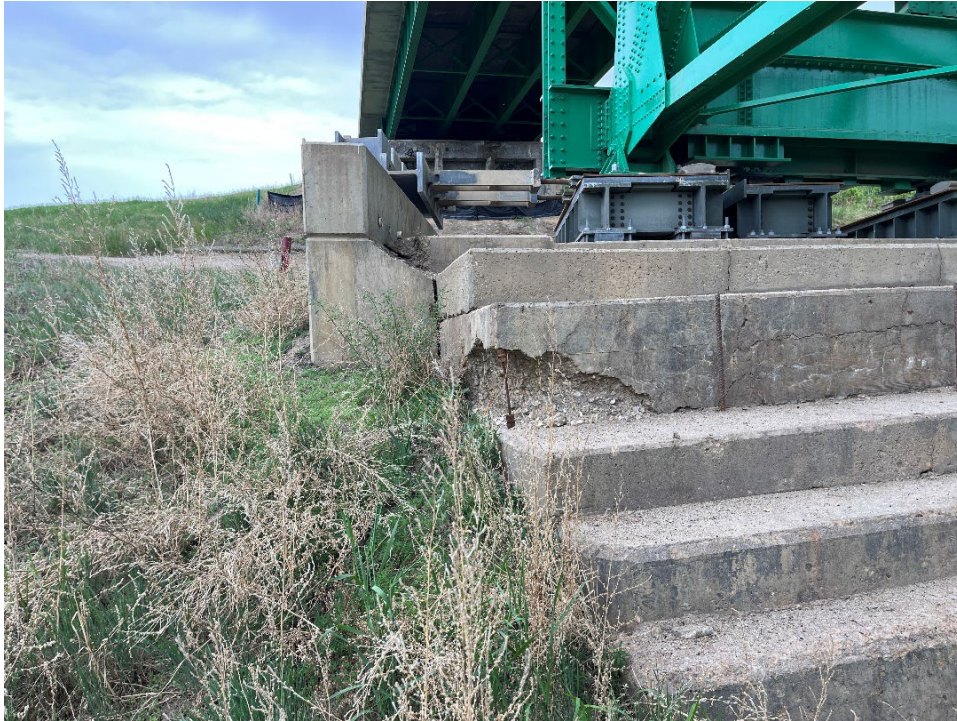
Photo 9 – Looking west at Pier 1 foundation which is tilted downward to the south. The angle from horizontal was 4° at the top and 7° at the bottom stage. Concrete has started to crack and spall.

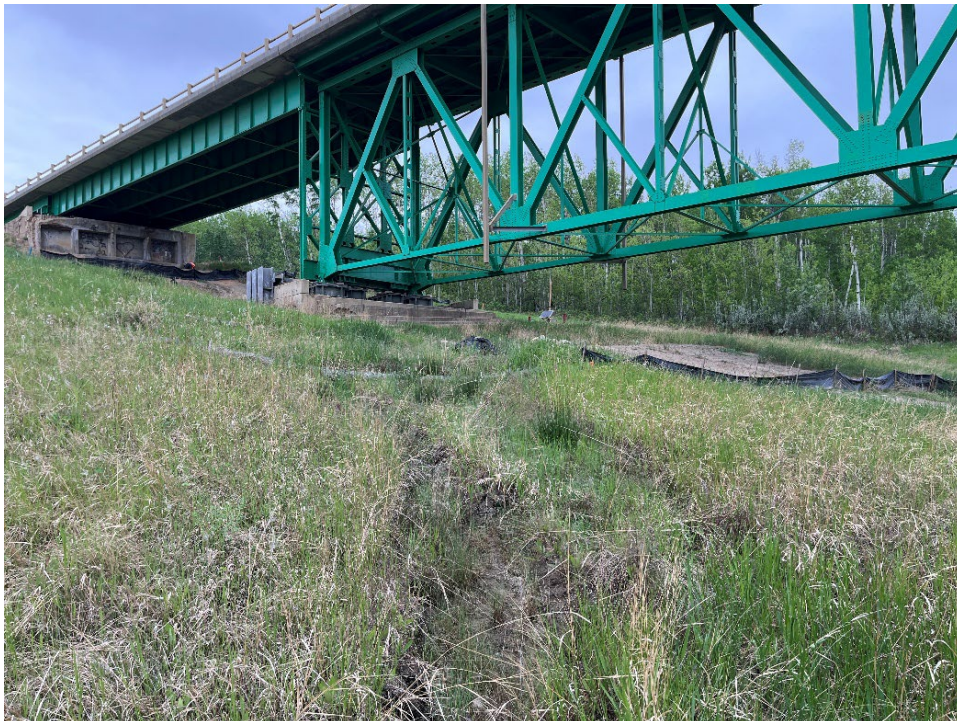
Photo 10 – Looking west toward Pier 1 at rutting and installed erosion control measures. Some of the area has vegetated since.

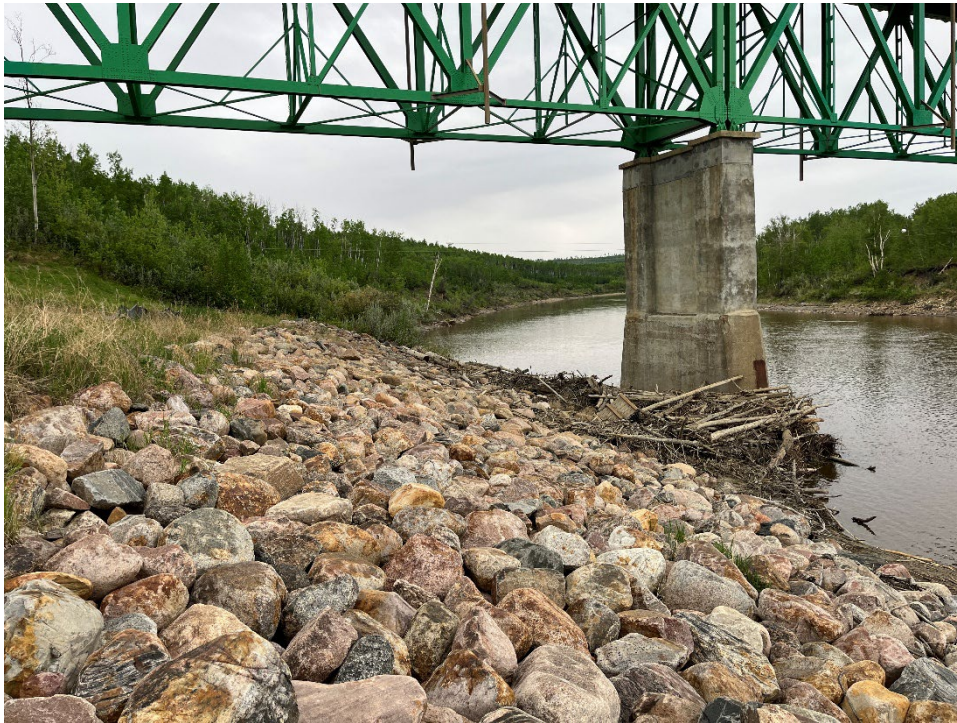
Photo 11 – Looking north at accumulated tree debris against Pier 2.

- Vertical and horizontal adjustment of the bridge superstructure should be undertaken as required. Should cracking form on the highway to the west of the abutment, crack sealing should be undertaken to minimize water infiltration.
- Milling and patching of the pavement surface at the west end of the bridge should be carried out on a periodic basis as required to maintain a safe riding surface (if needed).
- Log jams between the toe of the valley slope and Pier 2 can create eddies in the river flow and otherwise alter the river velocity at the bridge locations. Log jams should be removed as soon as practical to limit the potential for these log jams to erode the toe of the bridge headslope.

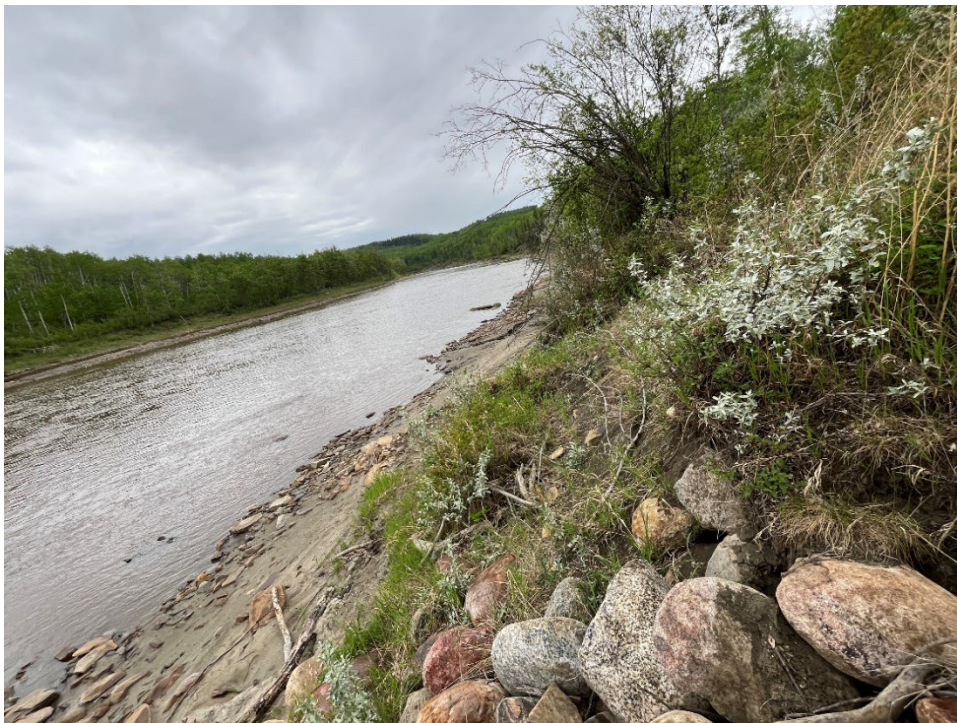
The 2017 repair of the slope below Pier 1 is still effective. This repair has only a limited effect on the overall valley movements. River erosion had over-steepened a portion of the south section of the riprap apron resulting in the loss of some material which worsened in 2020. This was also observed in 2021. At the lower water levels in October 2020, it was also noted that there is some erosion and slumping cutting into the apron north (downstream) of the bridge. The slumping at the river toe, both in and adjacent to the riprap did not appear significantly worse in 2022 and seems to have stabilized since 2023.

Photo 12 – Looking south at erosion along toe of riprap and riverbank.

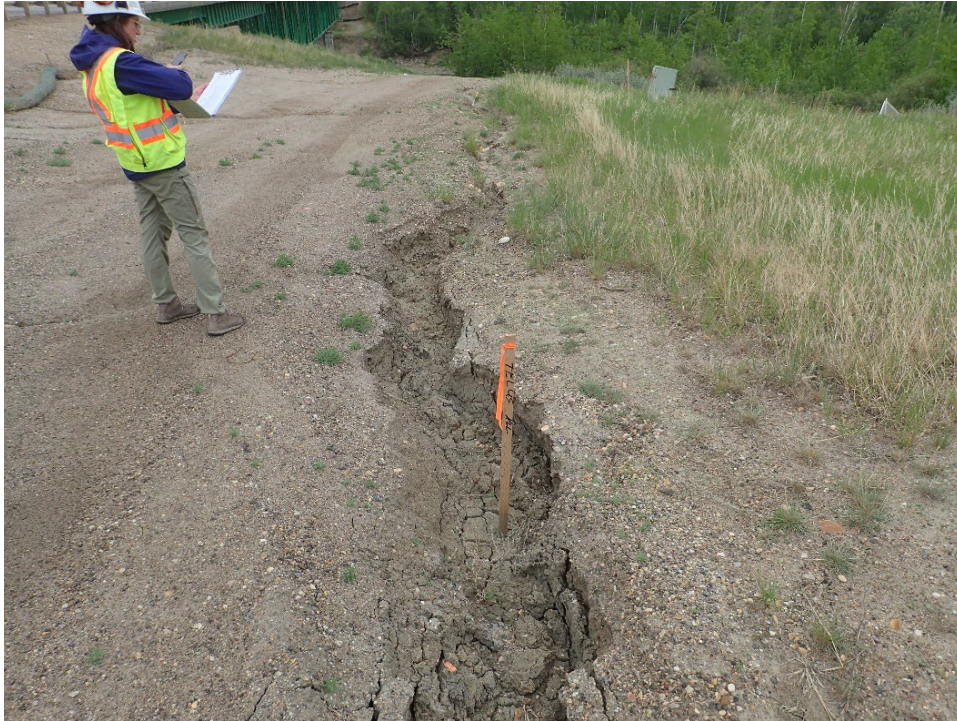
<input checked="" type="checkbox"/> Erosion	Ongoing erosion of valley toe at river's edge (repaired 2017) – south end of riprap over-steepened and north end displaced. Erosion gullies forming on south side of West Abutment, Abutment #1, and Pier #1 repaired in 2024. Erosion gully formed along buried Telus cable trench west of the West Abutment.	<input checked="" type="checkbox"/>
<input type="checkbox"/> Seepage		<input type="checkbox"/>
<input checked="" type="checkbox"/> Bridge/Culvert	The West Abutment, Abutment #1, and Pier 1 are routinely adjusted to compensate for ongoing slope movement.	<input checked="" type="checkbox"/>
<input type="checkbox"/> Other		<input type="checkbox"/>

Photo 13 – Looking east at erosion gully formed along buried Telus cable trench.
