ALBERTA TRANSPORTATION AND
ECONOMIC CORRIDORS GRMP
PEACE REGION – (PEACE RIVER DISTRICT)
INSTRUMENTATION MONITORING - FALL 2025

Site Number	Location	Name	Hwy	km
SH036	HWY 679:06	Prairie Echo	679:06	8.2
Legal Description:		UTM Co-ordinates		
4-26-76-16 W5		11U E 539207	N	6162495

Current Monitoring:	22-Sep-2025 to 25-Oct-2025	Previous Monitoring	5-June-2025
Instruments Read By:	Mr. Niraj Regmi, G.I.T., and Mr. Angelo Castillo, of Thurber

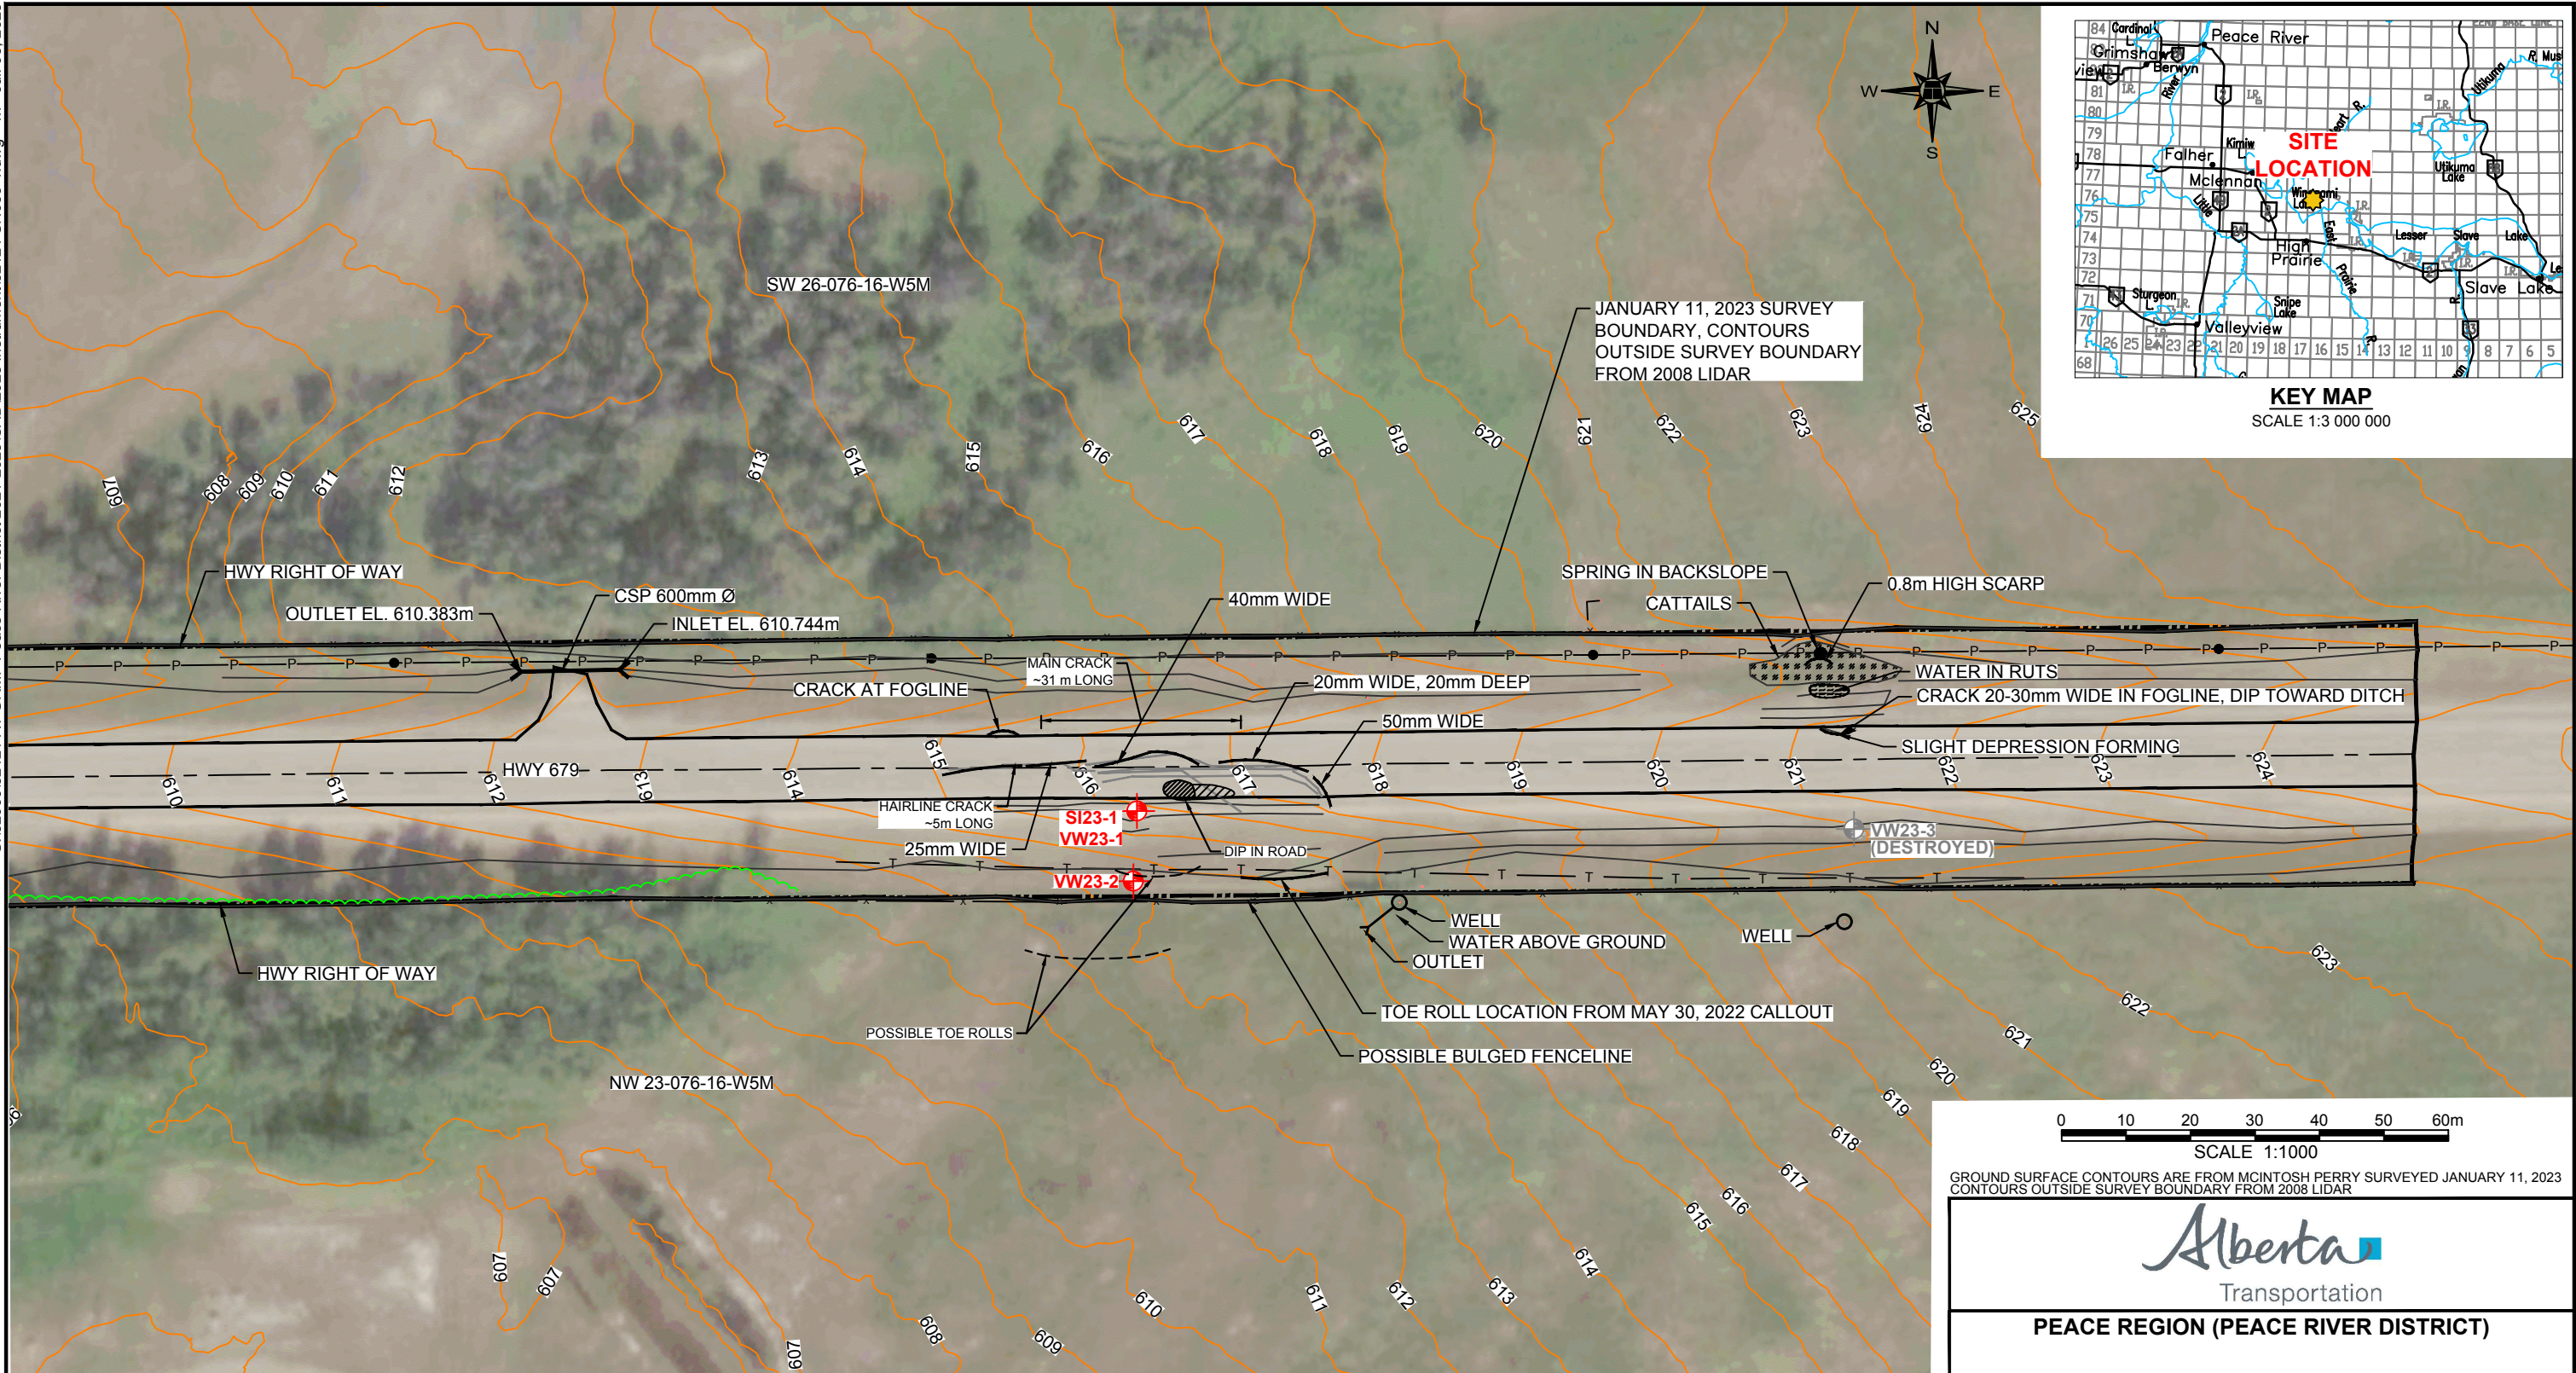
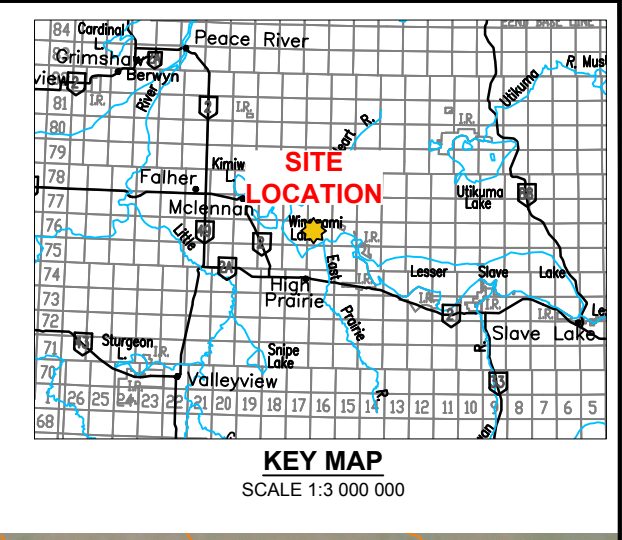
DWG NO. 32121-SH036-1

SH036: HWY 679:06 km 8.18 TO km 8.24 PRAIRIE ECHO
SITE PLAN SHOWING APPROXIMATE
INSTRUMENT LOCATIONS

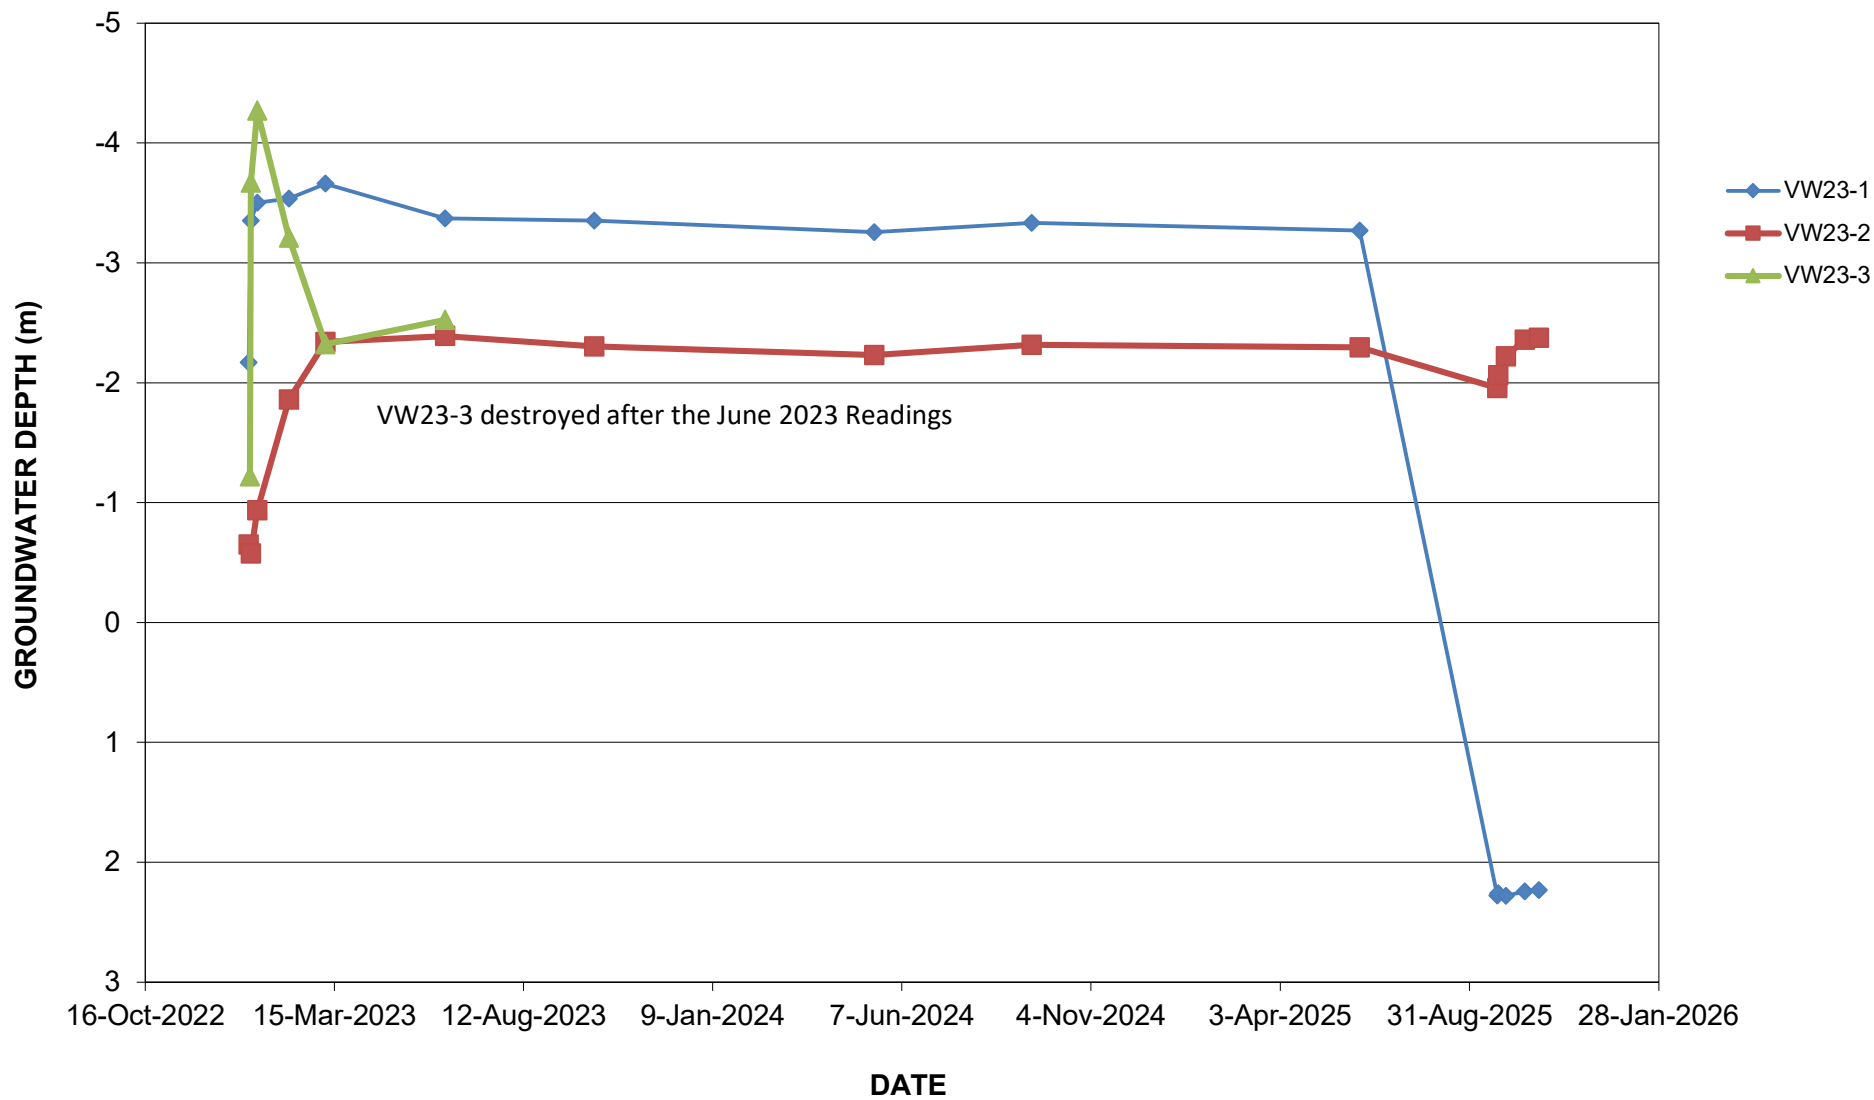
**FIGURE SH036-1
PIEZOMETRIC DEPTHS FOR HWY 679:06 PRAIRIE ECHO**

Discussion	
Zones of New Movement:	None
Interpretation of Monitoring Results:	<p>SI23-1 was damaged during construction</p> <p>Vibrating wire piezometer VW23-1 is located near the shear zone in SI23-1 and shows a groundwater condition of about 2.2 m below the ground surface. VW23-2 shows artesian groundwater conditions of about 2.4 m above ground surface. A number of additional piezometer readings were taken during construction remediation of this landslide project in the summer/fall of 2025, and are also included on the graphs in Appendix A.</p> <p>VW23-1 showed a sustained decrease in groundwater level of about 5.50 m for the readings taken after the wick drains were installed during remediation, compared to all the readings prior to wick drain installation. Over the same period, VW23-2 showed a slight initial decrease of about 0.3 m in groundwater level compared to the prior readings, but then a rebound back to or slightly higher than all the pre-construction readings.</p> <p>It is concluded that the reason the piezometer readings dropped about 5.5 m further in VW23 -1 compared to VW23-2, is because VW23-1 is located about 5 m horizontally inside the south edge of the wick/sand drain zone, while VW23-2 is located about 7 m outside the south edge of this wick/sand drain zone.</p>

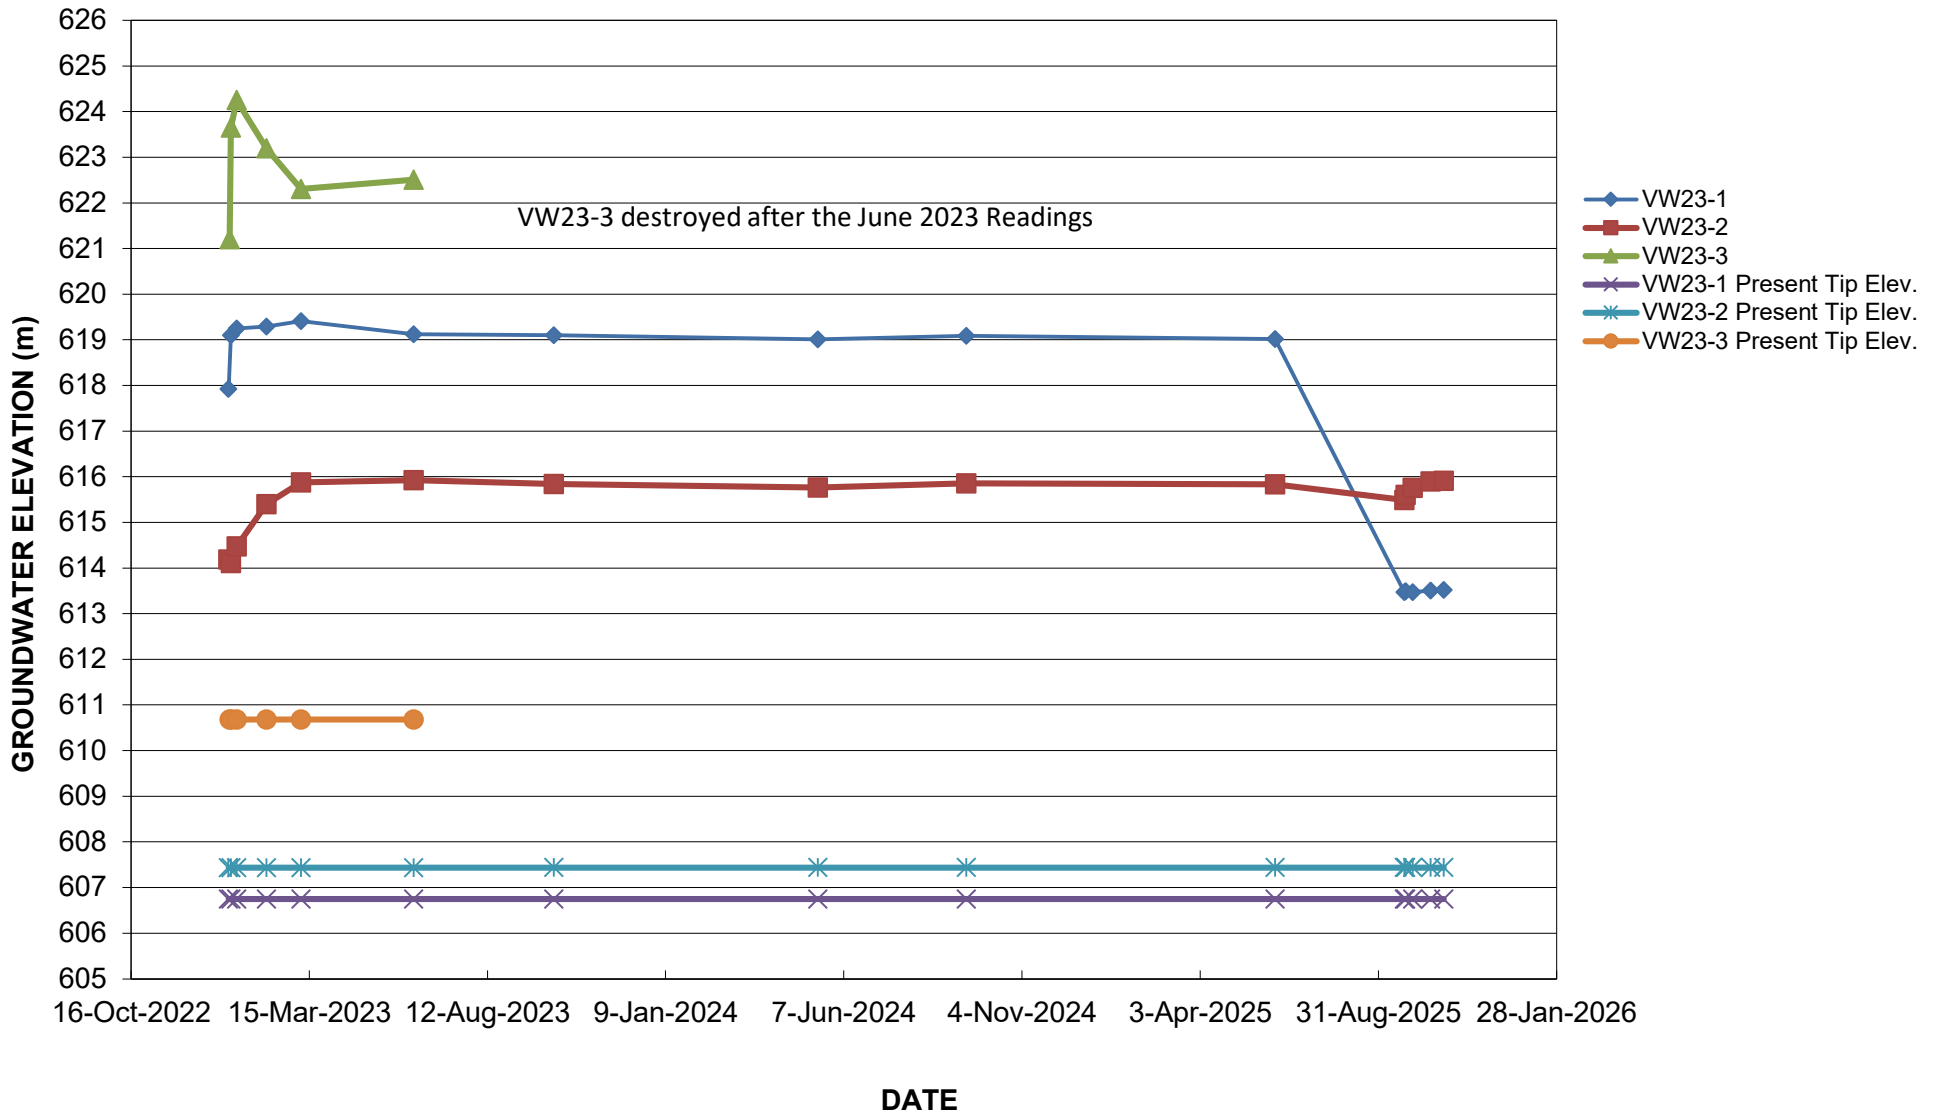
**FIGURE SH036-2
PIEZOMETRIC ELEVATIONS FOR HWY 679:06 PRAIRIE ECHO**

VW23-3 also showed artesian conditions about 2.5 m above ground surface prior to being damaged in 2024.
Future Work:	The instruments should be read again in the spring of 2026.
Instrumentation Repairs:	SI23-1 was damaged during construction. due to all of the surplus grout and bentonite around the hole during initial installation. This SI was considered to be near the end of it's life (a total deflection of 87 mm had already been recorded last spring). Repairs can be attempted but may provide limited data given the SI was nearly pinched off already. A replacement SI may be a better option to meet long-term monitoring objectives. The replacement SI would provide the best indication of repair success as it would be a direct measurement of the slide plane movements.
Additional Comments:	Repairs to the site were undertaken in 2025. The remediation consisted of excavating the highway embankment to 3 m depth, installing a granular filter blanket that collects seepage and drains into a subdrain buried below the north ditch. A system of wick drains, and sand drains were also installed, to about 12 m below the highway across the landslide to dissipate the artesian groundwater pressures and move seepage water to the sand blanket drain and subdrain. The road embankment was reconstructed over the granular filter blanket using light weight cellular concrete capped with clay and the new pavement structure. Inspection of the subdrain outfall, and measurement of the seepage flow rate should be taken during the next instrumentation reading cycle.
