ALBERTA TRANSPORTATION AND  
ECONOMIC CORRIDORS  
GEOHAZARD ASSESSMENT PROGRAM  
PEACE REGION (PEACE RIVER DISTRICT)  
2025 INSPECTION

Site Number	Location	Name	Hwy	km
PH038-1	North of Town of Peace River	Whitemud River (km 45.5)	743:02	45.3
Legal Description		UTM Co-ordinates		
S11-88-21-5		11V N 6,274,373	E 485,755

PH038-1: HWY 743:02 WHITEMUD RIVER, km 45.3  
2025 SITE INSPECTION PLAN

DWG No. 32121-PH038-1

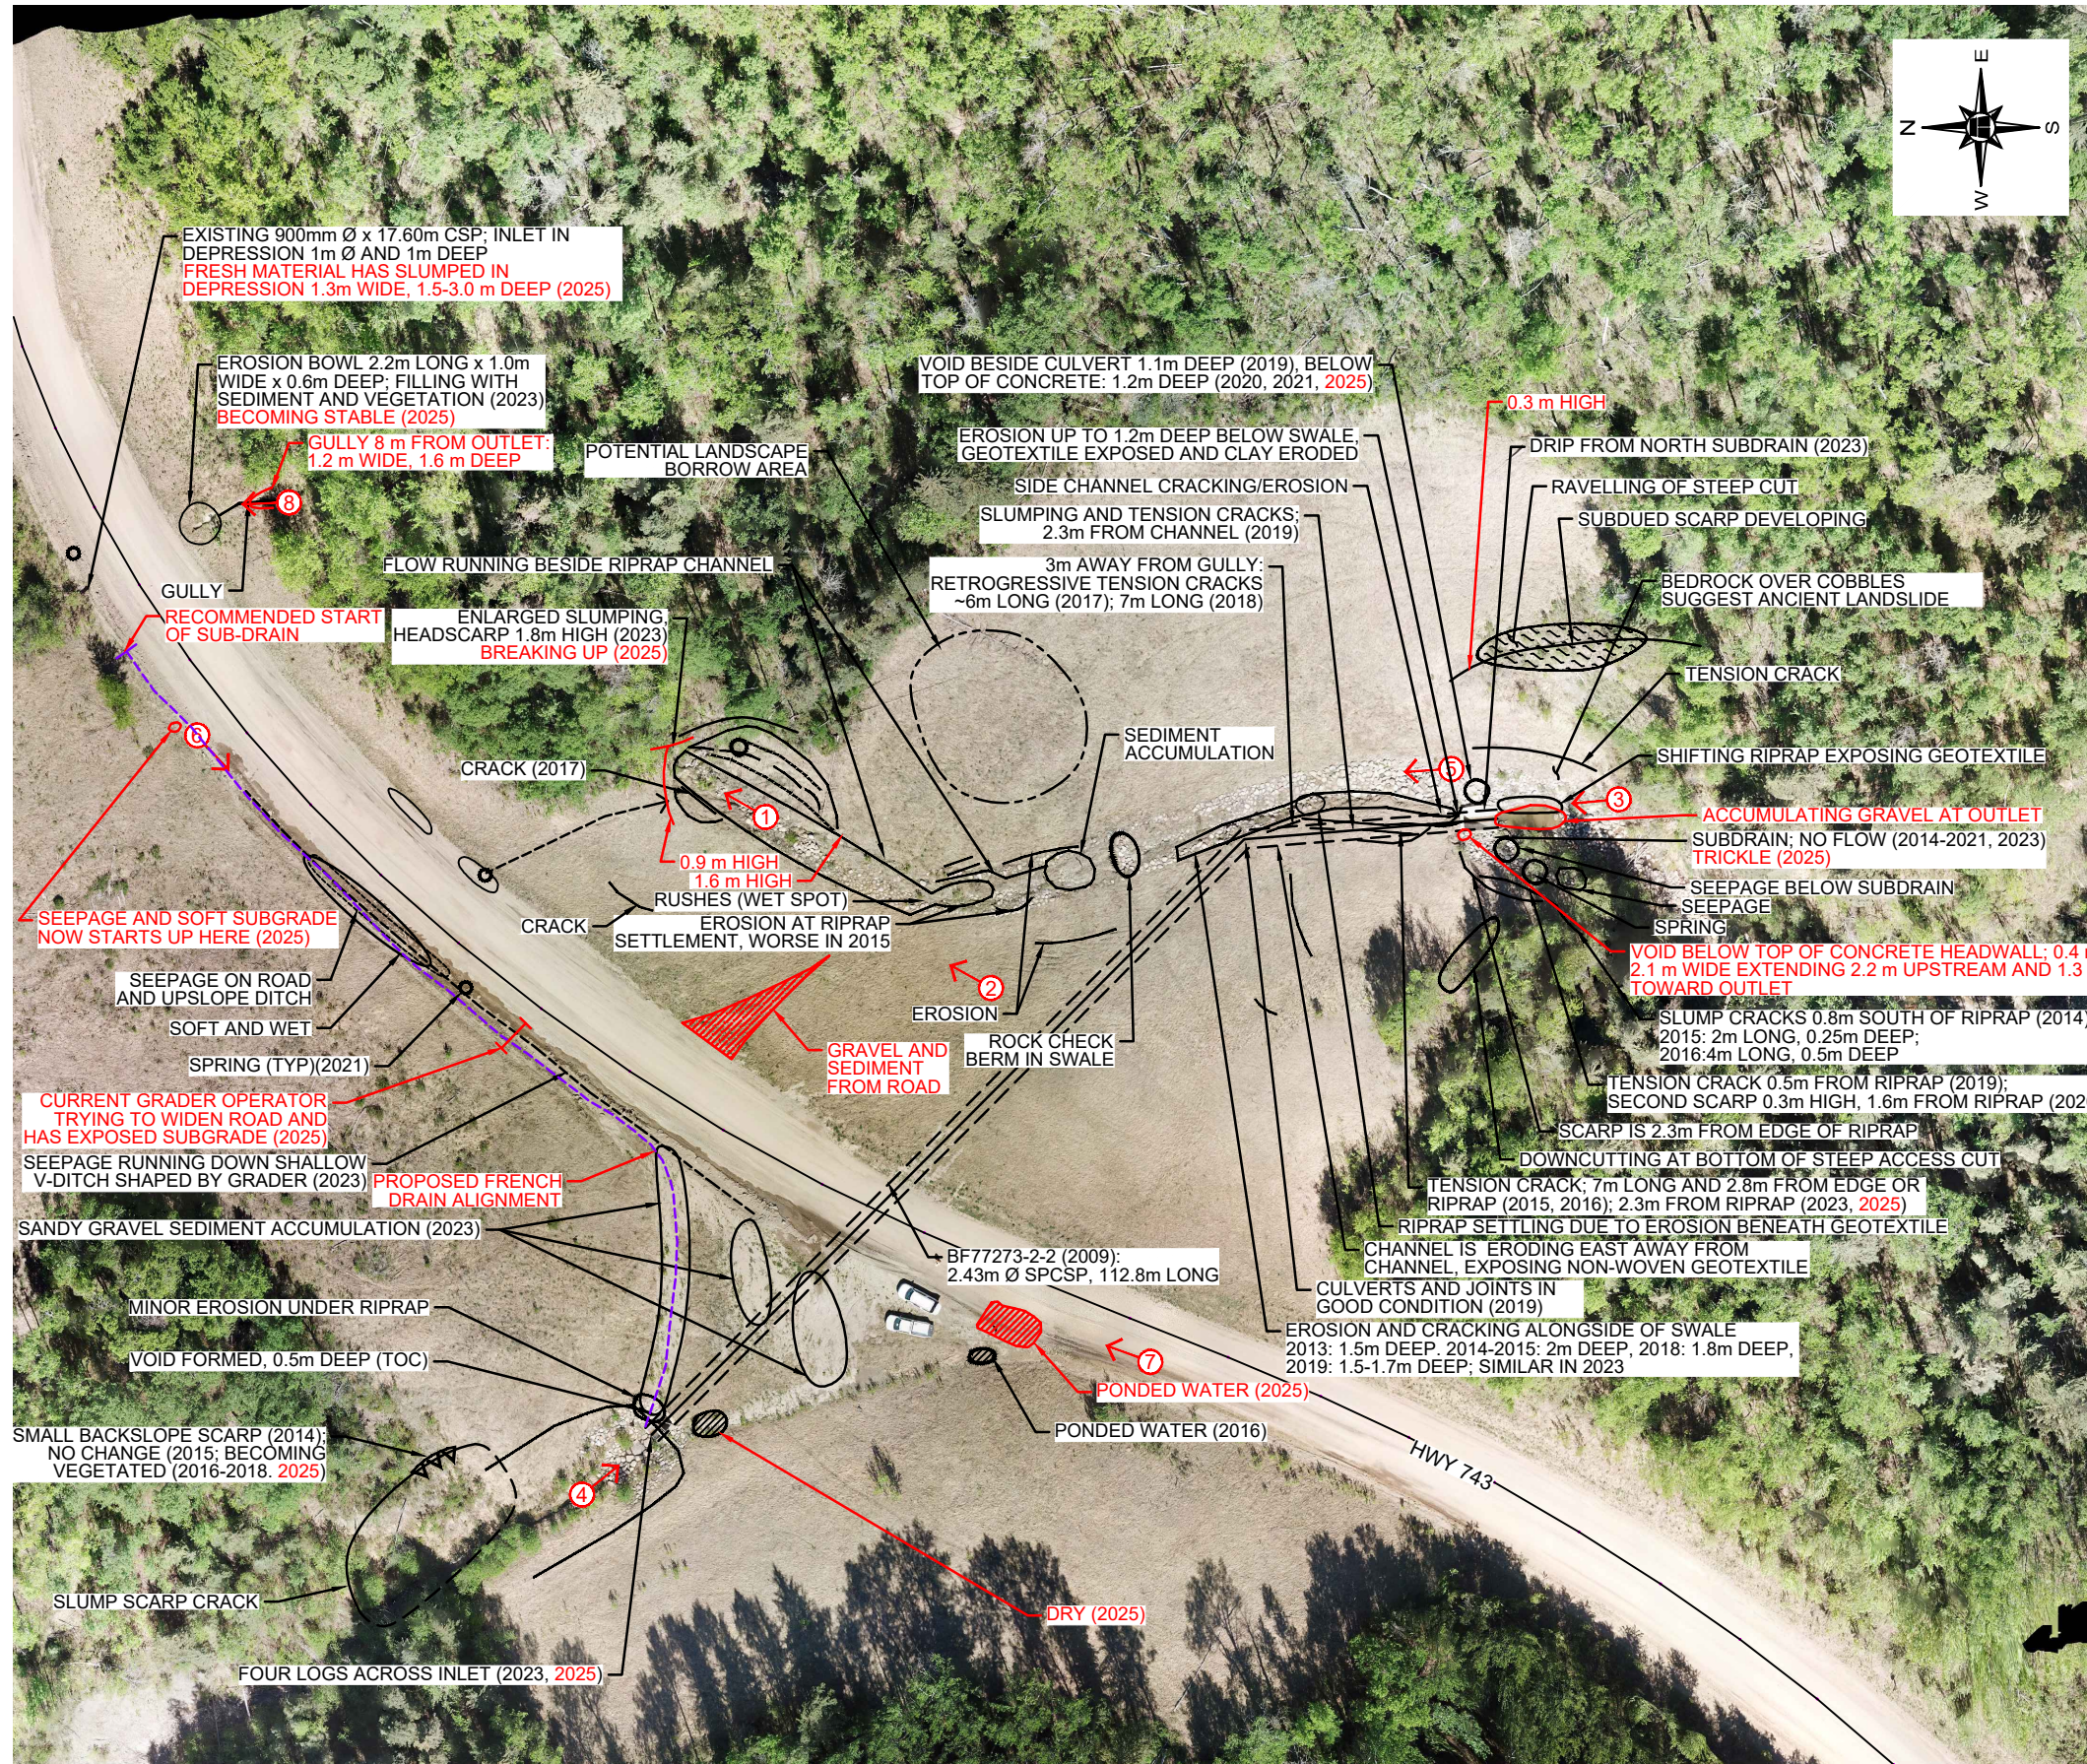
PROPOSED FRENCH DRAIN DETAIL:  
WASHED ROCK IN NON-WOVEN GEOTEXTILE  
0 10 20 30 40 50 60m  
SCALE 1:1000

- A subdrain should be installed at the spring along the west ditch discharging into the riprap apron at the culvert inlet. A proposed alignment and typical French Drain cross-section have been shown on the drawing. A riprap surface on the top of the subdrain should be used to allow infiltration though it will be prone to plugging due to grading and will require routine cleaning or replacement.

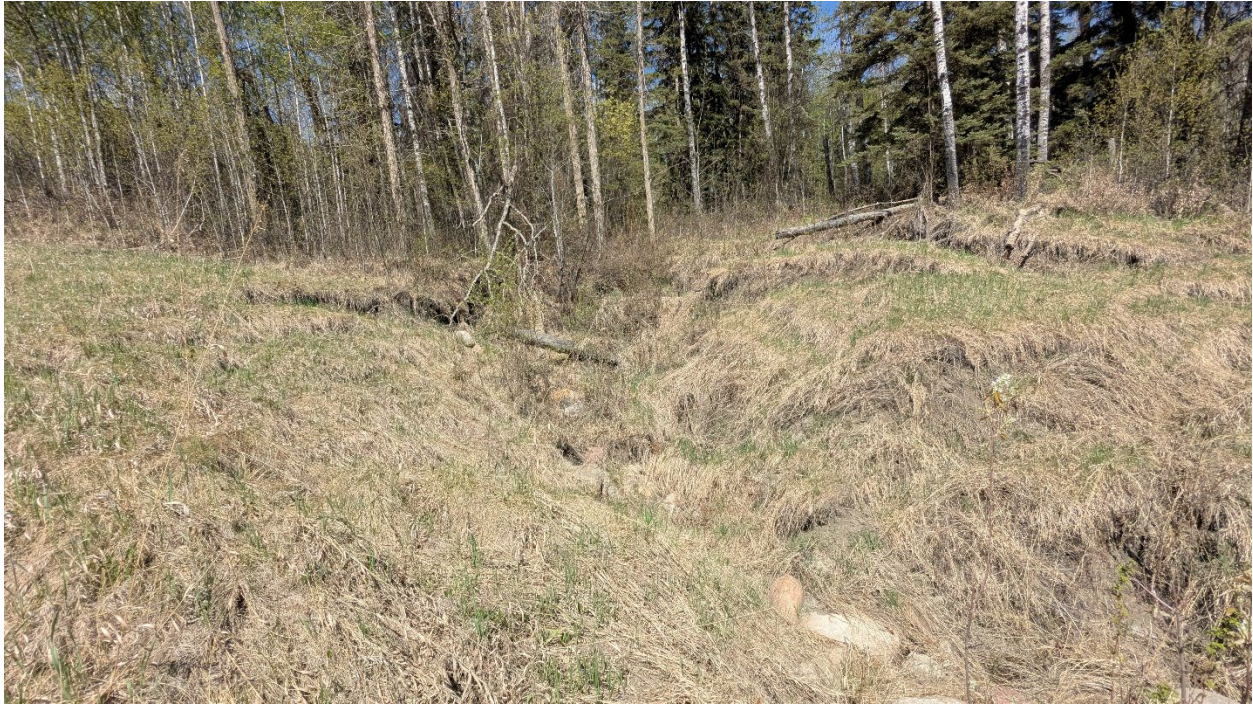
Significant erosion and settlement have developed especially in the upper, steeper, 30 m of the east swale where tension cracks and slumping have formed on both sides of the swale and have continued to deteriorate since 2016. Erosion, settlement, and cracking was also present at several other locations along the swale and have also continued to deteriorate though less aggressively since about 2020. Erosion and settlement along the drainage swale also extends closer to the toe of the bank (near the culvert outlet). The deterioration of this rock swale is likely a result of poor compaction, poor fill quality, and possible gaps in geotextile. Water flow is getting outside of the channel upslope so can erode behind the riprap for the remainder. The overall width of this erosion slumping increased in 2023 and, in 2025, the cracking has begun to extend into the tree line.

**Photo 1 – Looking at the north end of drainage swale.**

- The east swale should be completely reconstructed: remove and salvage the existing riprap, excavate the wet or soft subgrade at the base of the channel to a depth of 1 m over a 10 m width, place and compact borrow material, flatten the sideslopes, install new non-woven geotextile, and replace the rock riprap. The subgrade should be compacted with a sheepsfoot compactor. Borrow material could be taken from the knoll located northeast of the channel.

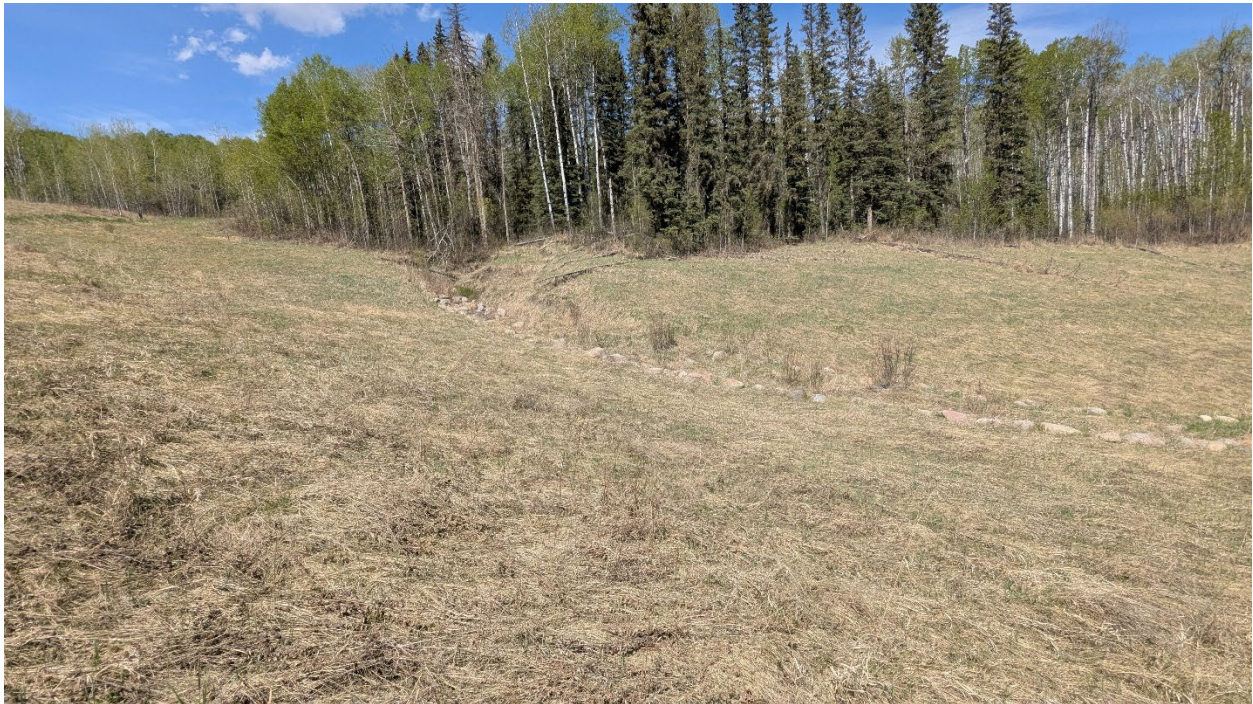
**Photo 2 – Looking northeast at drainage swale.**

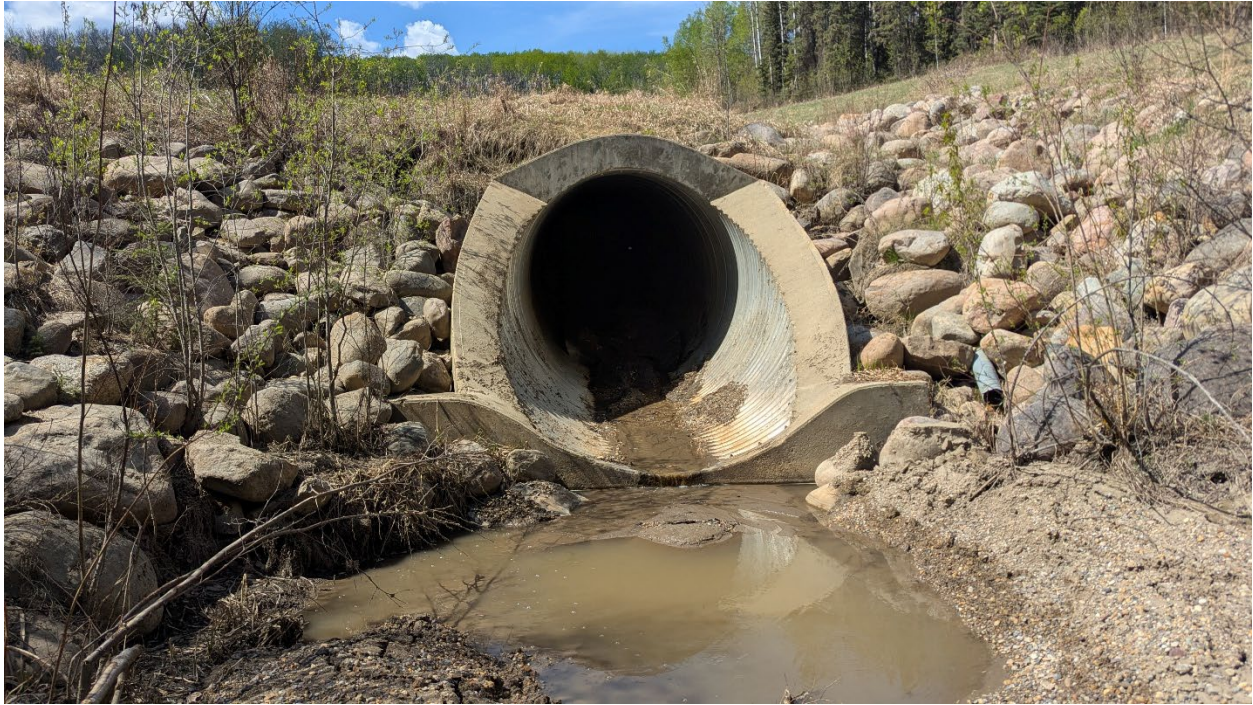
Some erosion and shallow slump cracks are present in the fill at the culvert outlet but have not worsened noticeably since about 2020. The void on the east side of the outlet concrete headwall was unchanged but the one on the west side continues to erode and grow in volume. Accumulated gravel was also noted in the channel just beyond the outlet. In 2020, voids were also documented below the concrete headwall at the inlet as well. No further deterioration was observed in 2021 though minor deterioration was noted in 2023 as ongoing erosion continues to affect the stability of the swale and river valley slopes. Changes in grading practice have meant that the sediment accumulation and ponding water observed in 2023 beyond the ditches haven't recurred though the water is now ponding in the ditch at the SW end of the site.

**Photo 3 – Looking northwest at culvert outlet.**

- The voids forming below the concrete headwalls should be grouted if the other repairs are undertaken at the site.
- Similarly, if other repairs are being done, consideration should be given to adding additional riprap along the creek banks at the outlet to replace that lost to water erosion as well as at both headwalls.

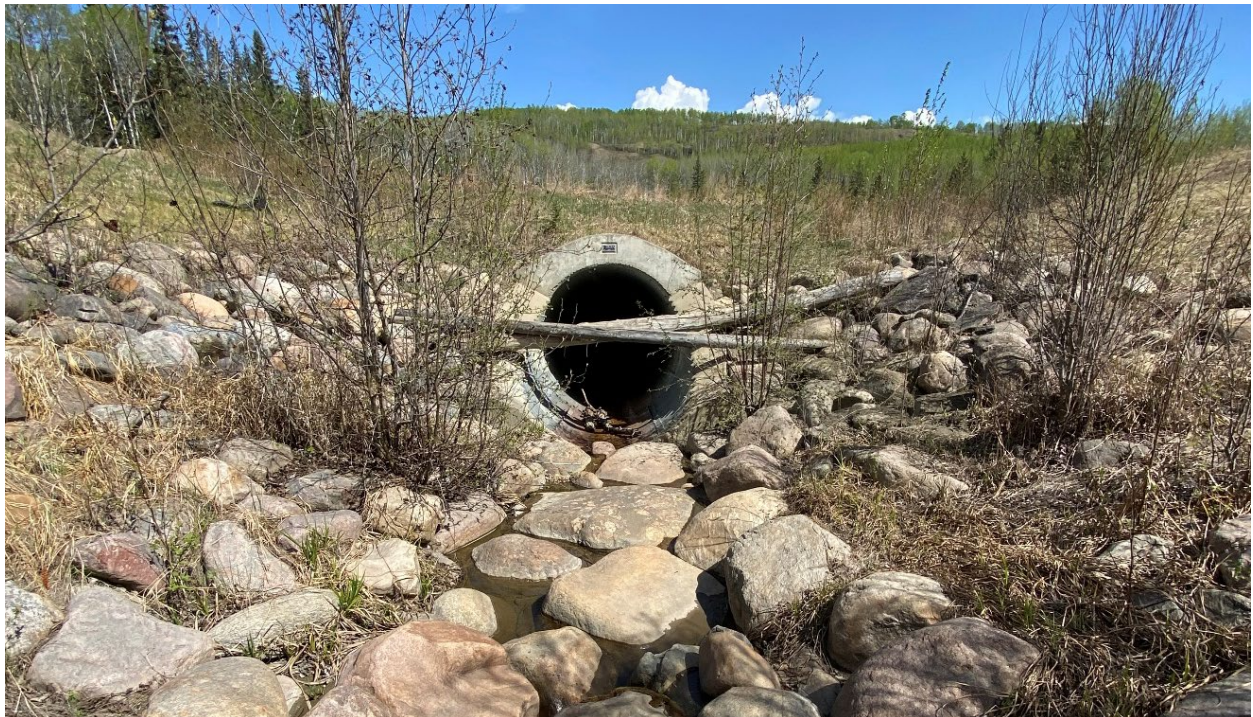
**Photo 4 – Looking southeast at culvert inlet.**

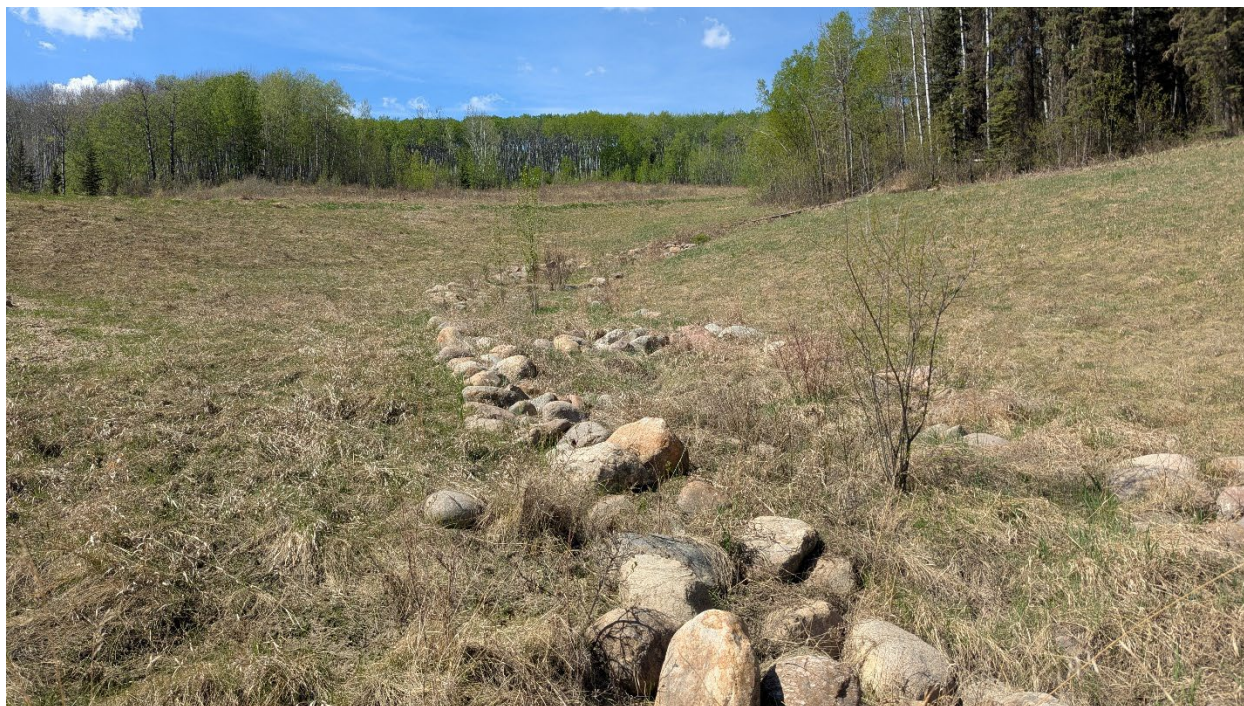
**Photo 5 – Looking north at swale near the culvert outlet.**

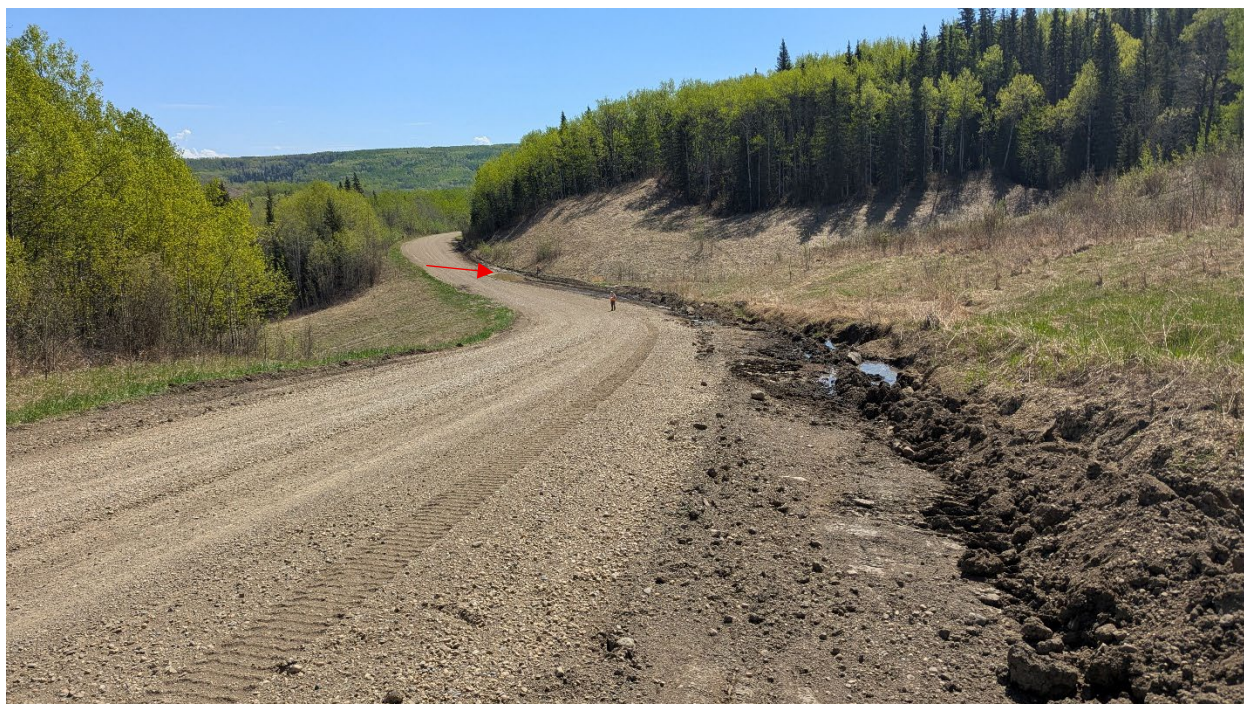
The seepage along the west ditch has continued to become more pronounced at each visit. In 2023, the grader operator had been cutting a shallow v-ditch to control this flow and limiting how much gets out on the roadway surface as it can cause icing in the winter. In 2025, the v-ditch had been graded further west exposing soft subgrade which could be a hazard for vehicles. Water is now also ponding on the roadway.

**Photo 6 – Looking southwest at road and seepage along west ditch. Note exposed subgrade at edge of roadway and ponded water in the distance (red arrow).**

- Periodic visits by the AT Maintenance Contractor are recommended to ensure that the erosion at the west end of the swale is not adversely affecting the highway.
- Grading practices should be adjusted to limit the attempts to widen the roadway top width at this location as pushing into the soft subgrade is somewhat counter-productive.
- The silt fences installed on both sides of the embankment are no longer required and should be removed to minimize the potential for channelized flow.

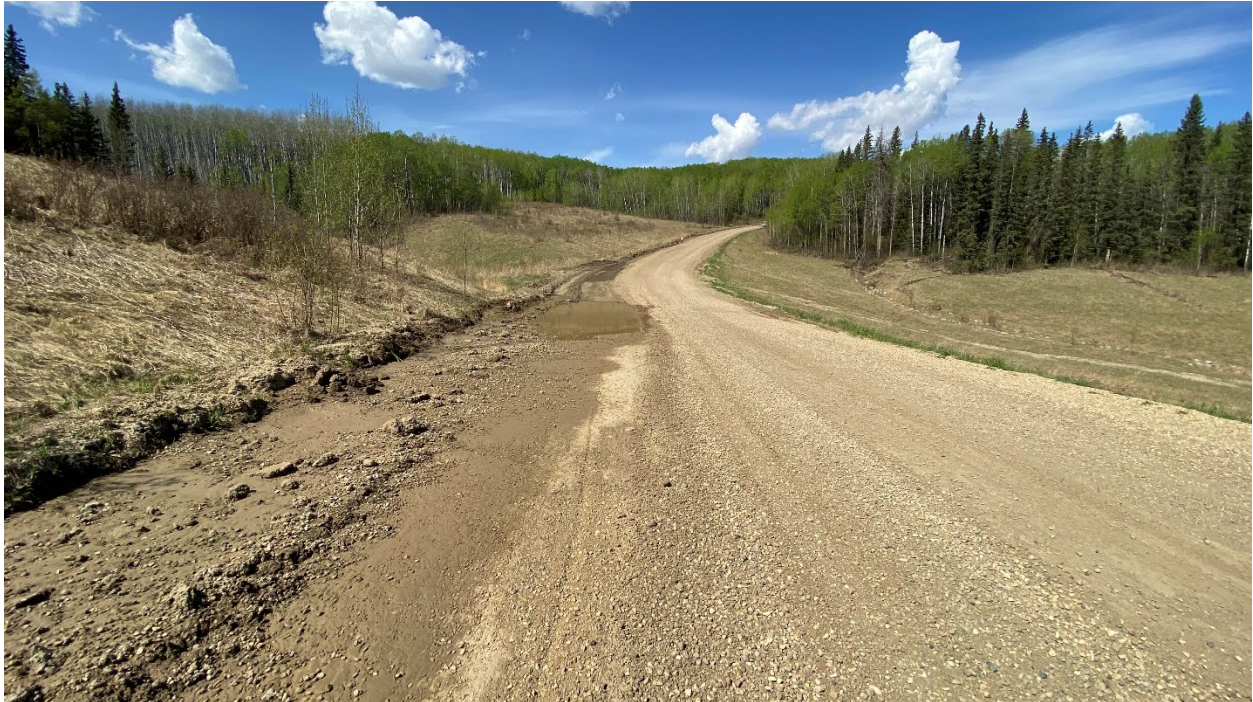
**Photo 7 – Looking at seepage along west side of road near the south end of the site.**

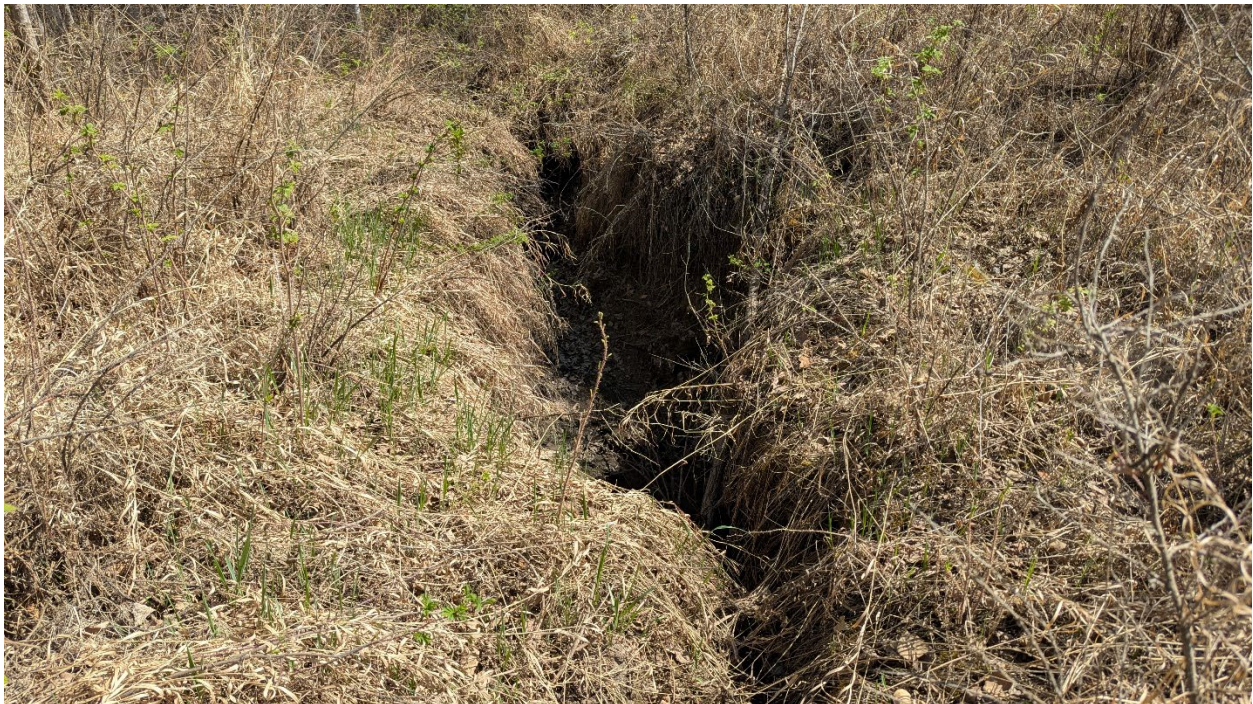
**Photo 8 – 900 mm-dia. culvert outlet and gully at the north end of the site.**

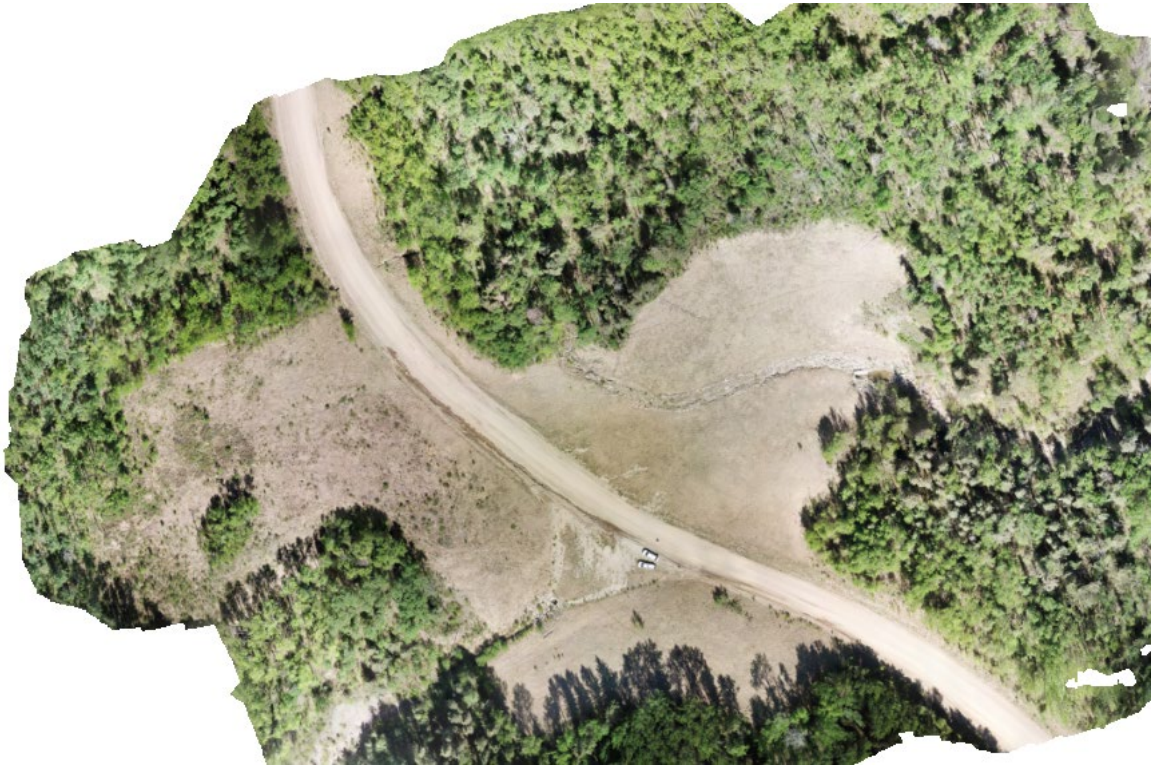
**UAV 2023 Orthomosaic: Seepage can be seen along the left side of the highway; the eroding and slumping channel is to the right of the highway.**

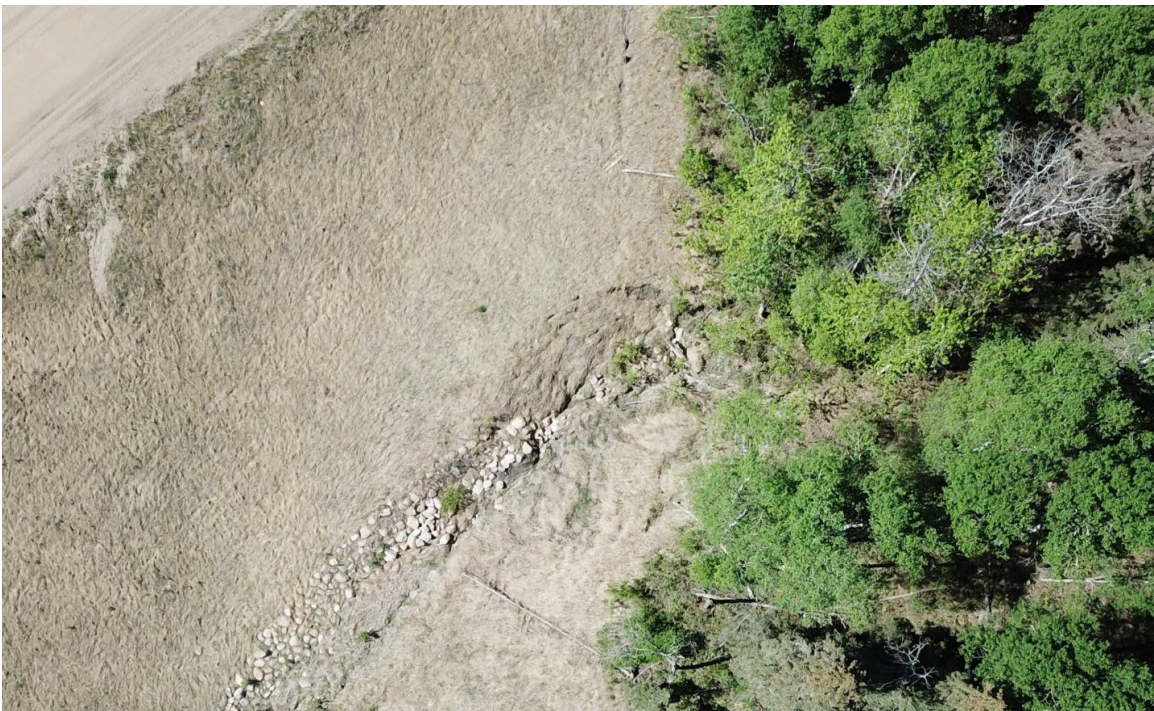
**UAV 2023 UAV Image – Slumping at the north end of the of the riprap-lined channel on the east embankment.**
