ALBERTA TRANSPORTATION AND
ECONOMIC CORRIDORS
GEOHAZARD ASSESSMENT PROGRAM
PEACE REGION (PEACE RIVER DISTRICT)
2025 INSPECTION

Site Number	Location	Name	Hwy	km
PH075-1	North of Peace River	Whitemud River (km 44.4)	743:02	44.4
PH075-2		Whitemud River (km 44.8)		44.8
Legal Description		UTM Co-ordinates		
NE2-88-21-W5M		11U E 486,395 486,112	N	6,273,737 6273,982

Date	PF	CF	Total
Previous Inspection:	16-May-2023	PH075-1: 13	4	52
		PH075-2: 8	6	48
Current Inspection:	13-May-2025	PH075-1: 13	4	52
		PH075-2: 8	6	48
Road AADT:	180		Year:	2025
Inspected By:	Rocky Wang, TEC		Don Proudfoot, Thurber Ken Froese, Thurber	
Report Attachments:	<input checked="" type="checkbox"/> Photographs		<input checked="" type="checkbox"/> Plans	<input type="checkbox"/> Maintenance Items

Primary Site Issue:	PH075-1: Creek bank erosion and slumping of over-steepened slope above culvert inlet. PH075-2: Retrogressive landslide scarp through both lanes	
Dimensions:	PH075-1: 40 m of creek bank erosion PH075-2: 55 m wide along the shoulder, approx. 275 m wide at the creek and 160 m long from the highway to the creek.	
Date of Remediation:	2009: Culvert replaced and sideslopes rebuilt.	
Maintenance:	Highway closed

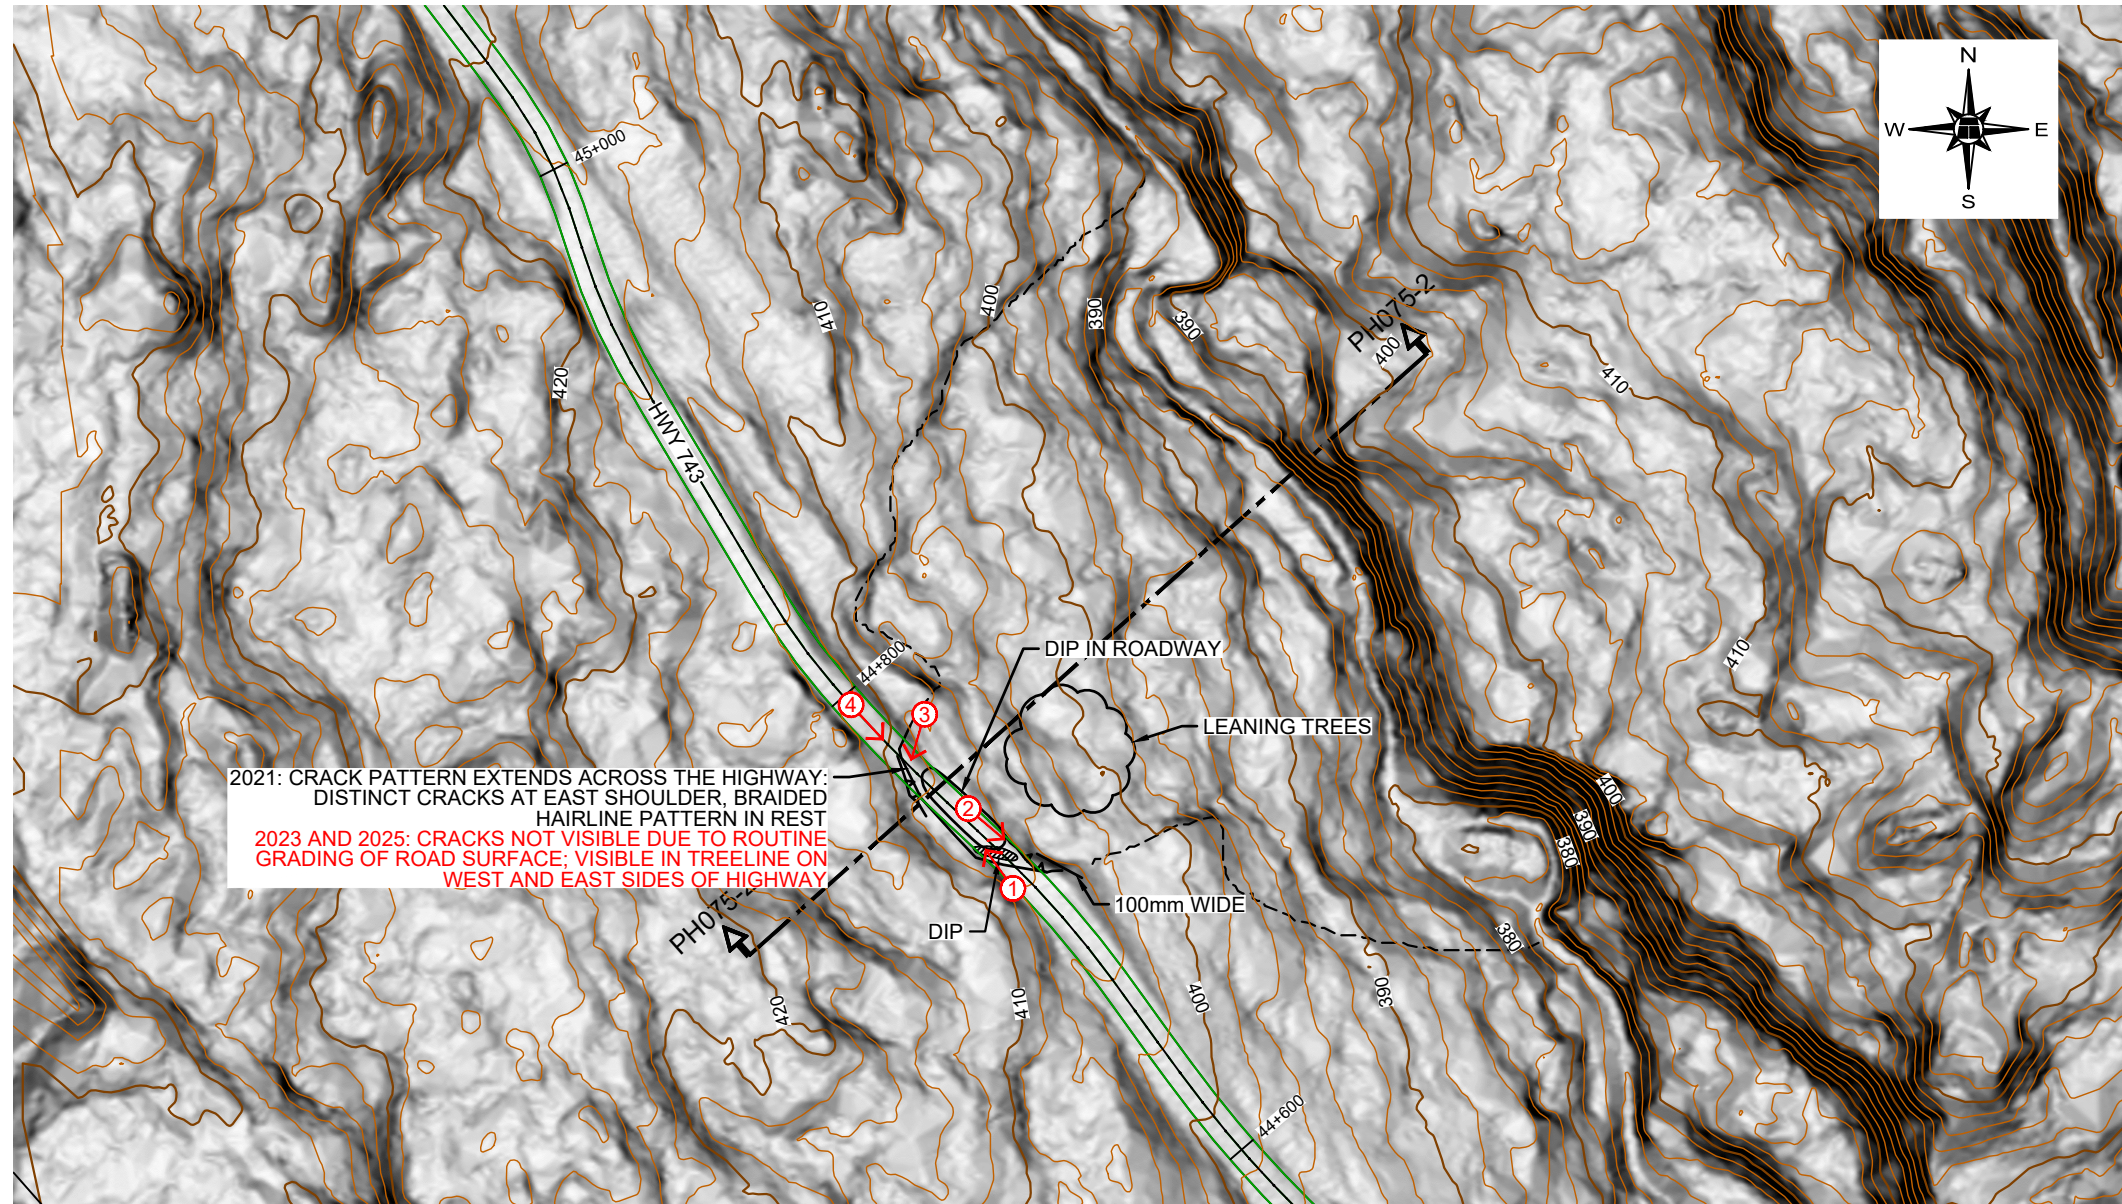
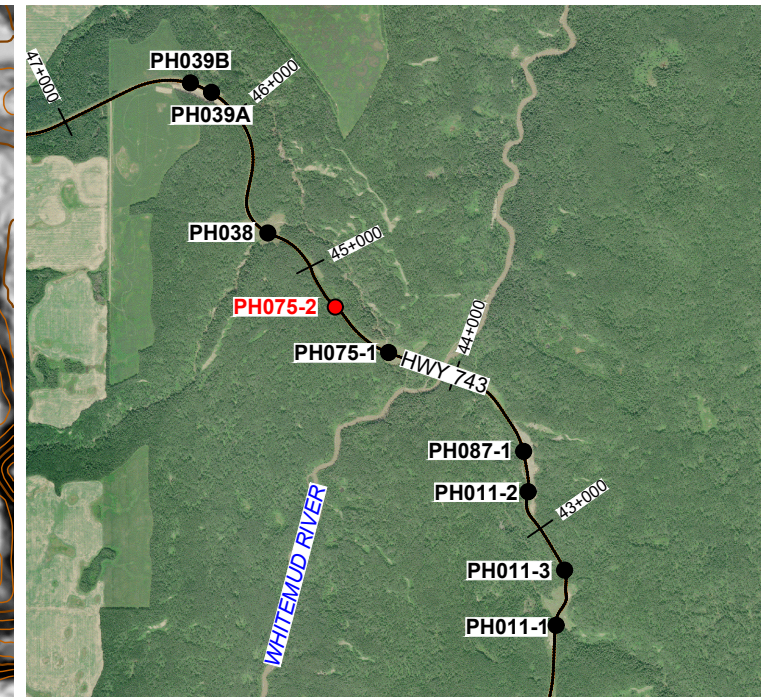
DWG No. 32121-PH075-2

The slide at PH075-2 was first noticed during a callout inspection of other sites on Hwy 743 on August 4, 2020, shortly after significant slope movements elsewhere in the valley closed the highway. The site is located on a sidehill alignment ascending the valley slope of a tributary to the Whitemud River. LiDAR provided by TEC shows that the valley slope has been affected by historic landslide movements. Similar to the other sites along this highway that moved during the summer of 2020, it was likely that higher groundwater levels re-activated a large slide block which affected about 55 m of the road surface. The highway is located about 25 m vertically above the creek. The valley slope surface, as shown by the cross-section on Dwg. No.13351-PH075-2, is hummocky, indicating the presence of several retrogressive slide blocks between the creek and the road. The dip encompasses the entire roadway surface at this location and trees at the toe of the embankment are being to tilt. Similar to 2023, ongoing grading has obscured the cracks in the highway although the main scarp is still visible beyond the roadway on both sides of the highway.

- Site 2: A localized realignment to the west of the roadway around the slide could be carried out if the slide accelerates and the road condition becomes unsafe.

- Site 2: A driven steel pile or sheet pile wall might also be considered to provide temporary support to the road but might become distorted over time if the larger slide blocks move again.

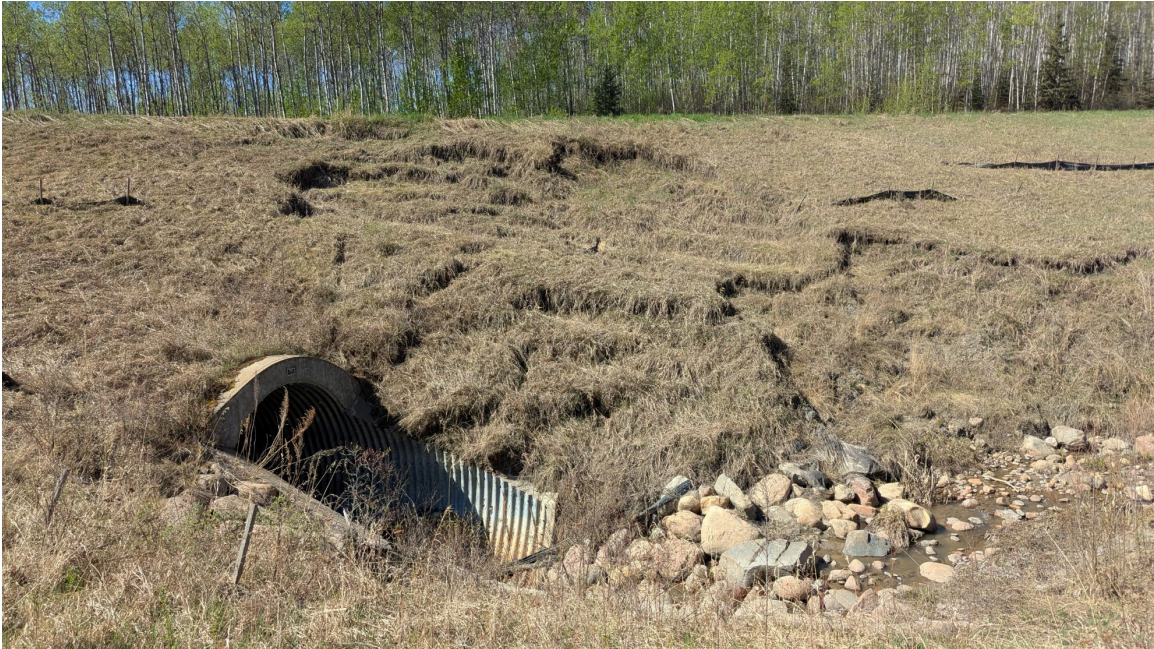
Site 1, Photo 1 – Looking west at north sideslope.

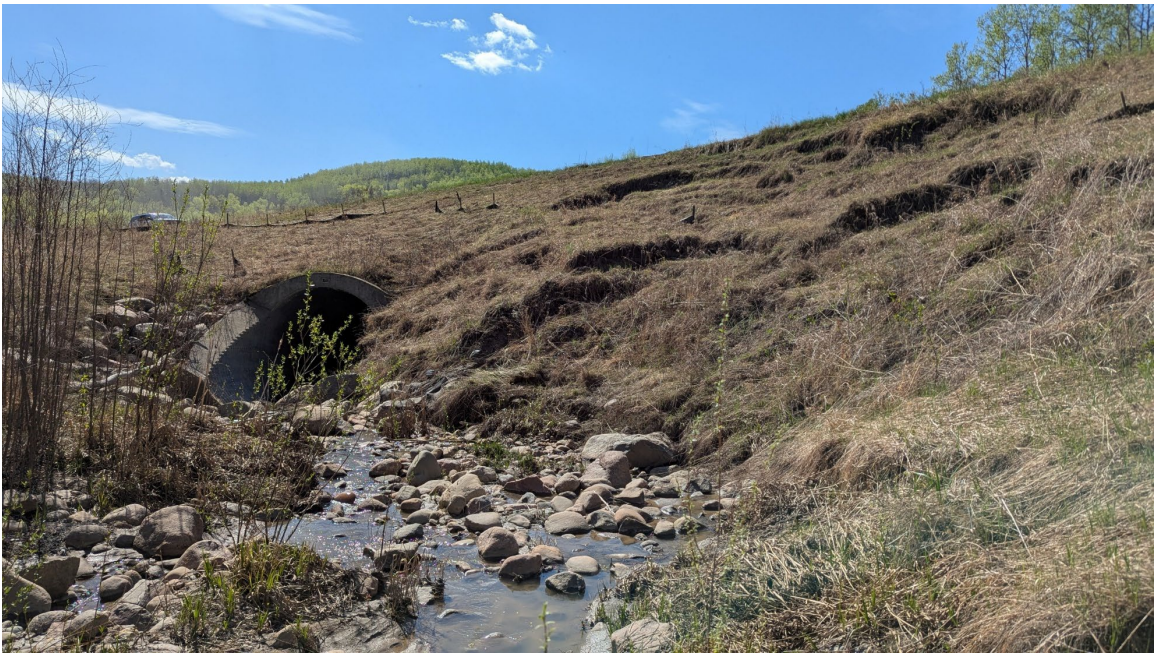
The creek bank at the culvert inlet began to regress significantly due to heavy runoff in Spring 2018. The spring of 2020 also had significant runoff and there was an ice jam at this site that year (reported by MCI). The scarps above the culvert have formed into numerous slump blocks and have continued to retrogress from 8.85 m away in 2018 to 2.2 m in 2023. In 2025, the offset was reduced to 0.7 m; however, recent grading practices appear to have pushed the edge of the roadway closer to the slope edge as well. Slumping continues to worsen along the west bank of the creek moving further into the slope since first mapped in 2017. The slumping of the riverbank is undermining the embankment and is causing instability which will impact the highway and has started to impact the culvert obstructing the inlet slightly.

Site 1, Photo 2 – Looking southeast at creek bank slumping upstream of the culvert inlet.

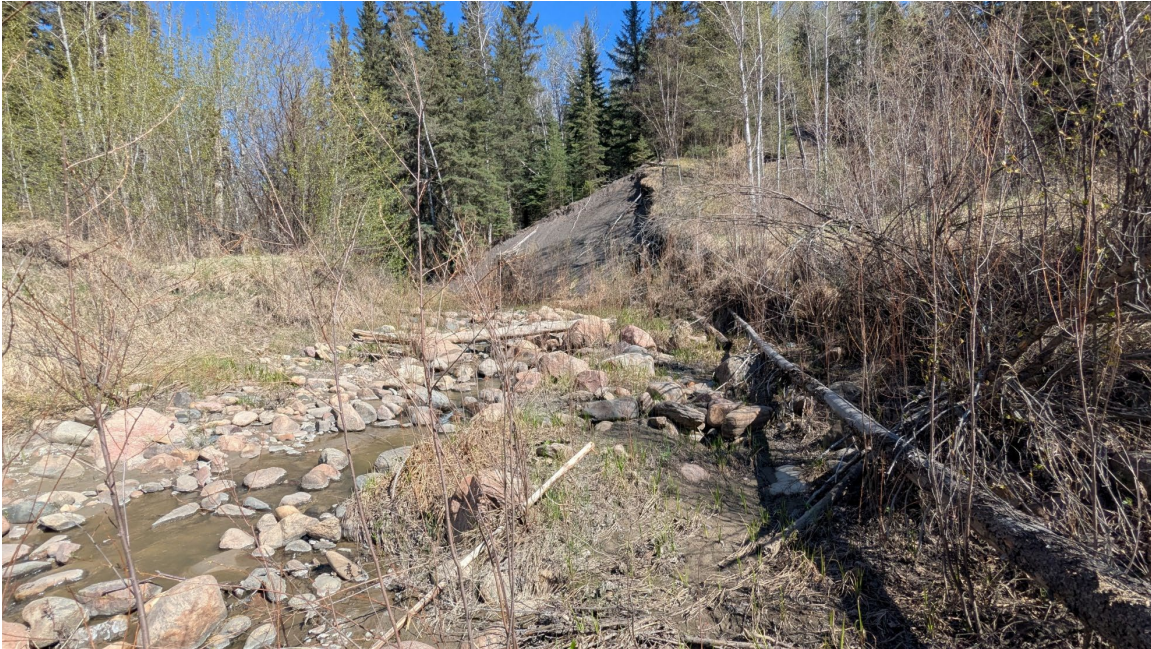
Site 1, Photo 3 – Looking north at creek bank slumping upstream of the culvert inlet.

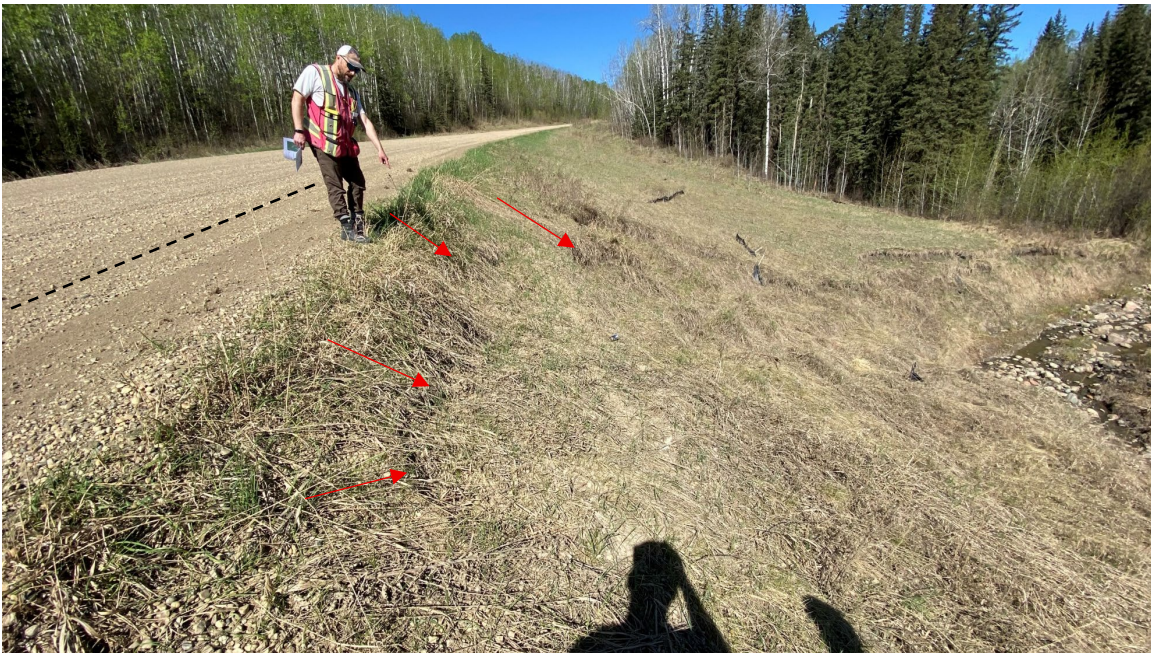
Site 1, Photo 4 – Looking west at the tension crack (red arrows) proximity to the shifted gravel edge (the dashed line is the approximate previous roadway edge).

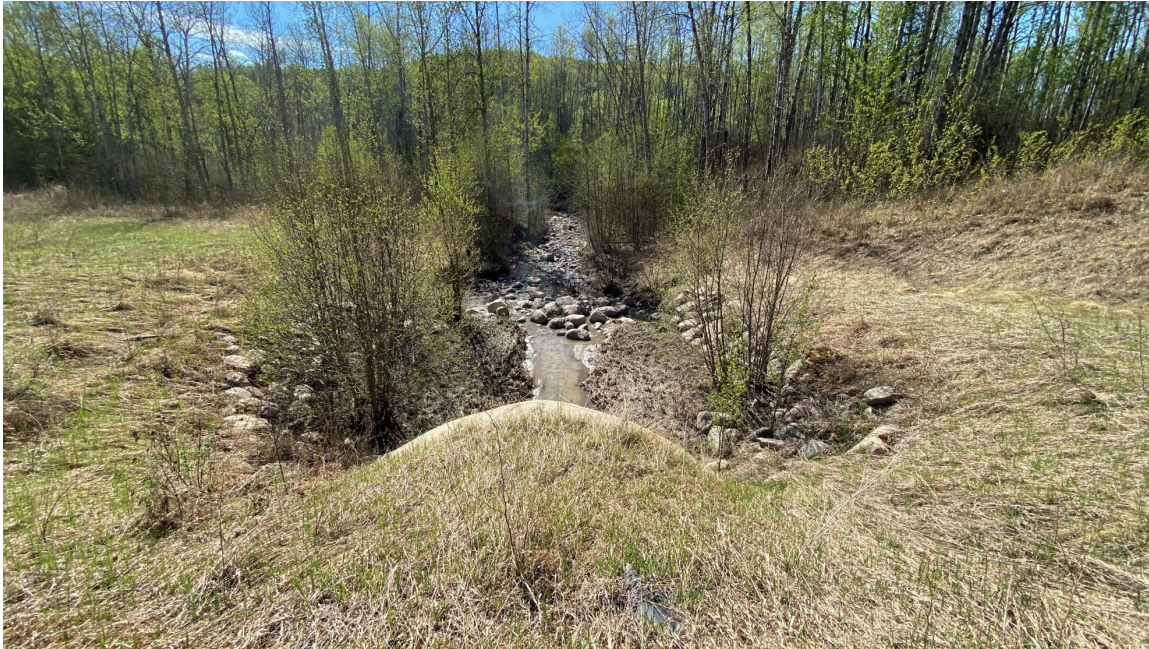
The shallow gully that formed at the west side of the top of the outlet riprap has vegetated and did not appear to have increased in size since 2017. This gully has likely formed due to surface runoff short-cutting out of the ditch channel. It was also observed that the displaced riprap from the culvert outlet apron is mounded in the centre of the channel forcing flow around causing the increasing undercut on the east bank. The length of affected bank was slightly longer in 2020 but unchanged in 2021 and 2023.

Site 1, Photo 5 – Looking south at culvert outlet. Much of the riprap has been displaced downstream and the accumulated sediment noted in 2023 at the outlet of the culvert has been washed away.

- Site 1: Riprap along the west bank at the inlet could be used to reconstruct the channel and force it back to the original alignment.
- Site 1: The mound of riprap downstream of the outlet should be redistributed to create a flow path down the centre of the channel rather than the unprotected sides.

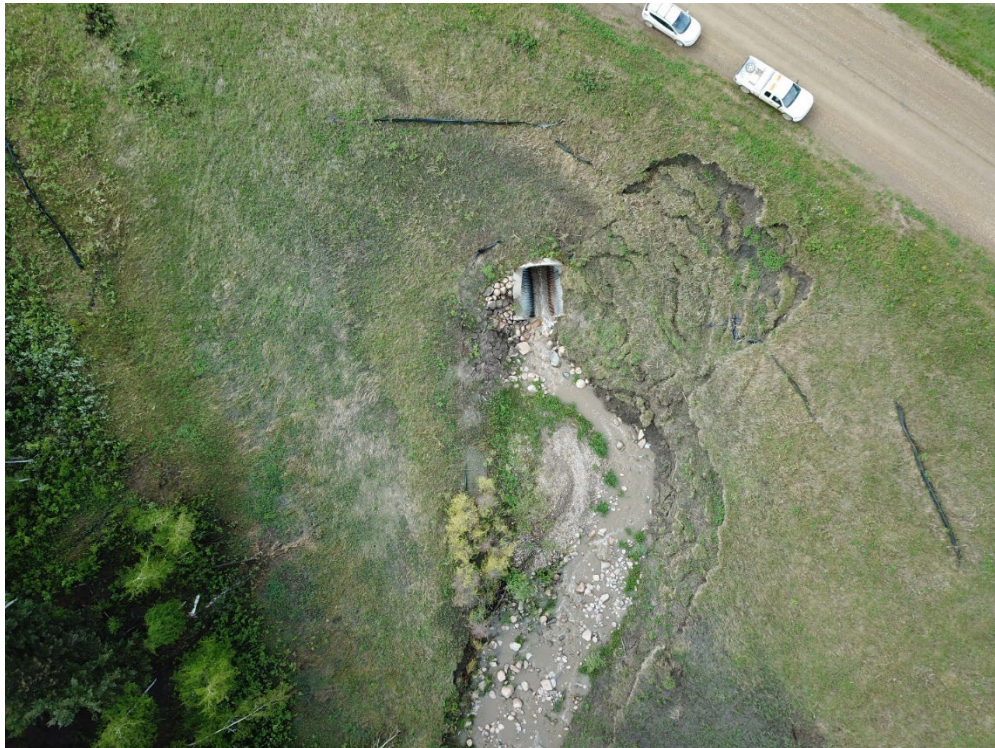
2020 UAV Image of slumping around Site 1 culvert inlet.

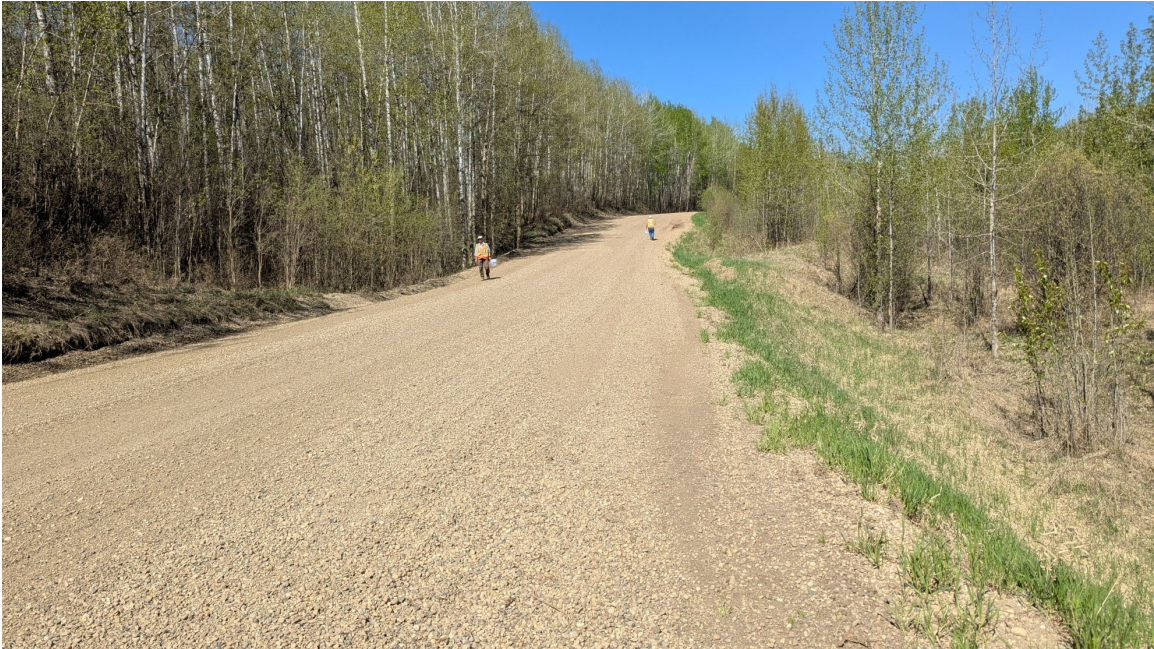
Site 2, Photo 1 – Looking northeast along highway where scarp cracks had previously been visible (since graded over).

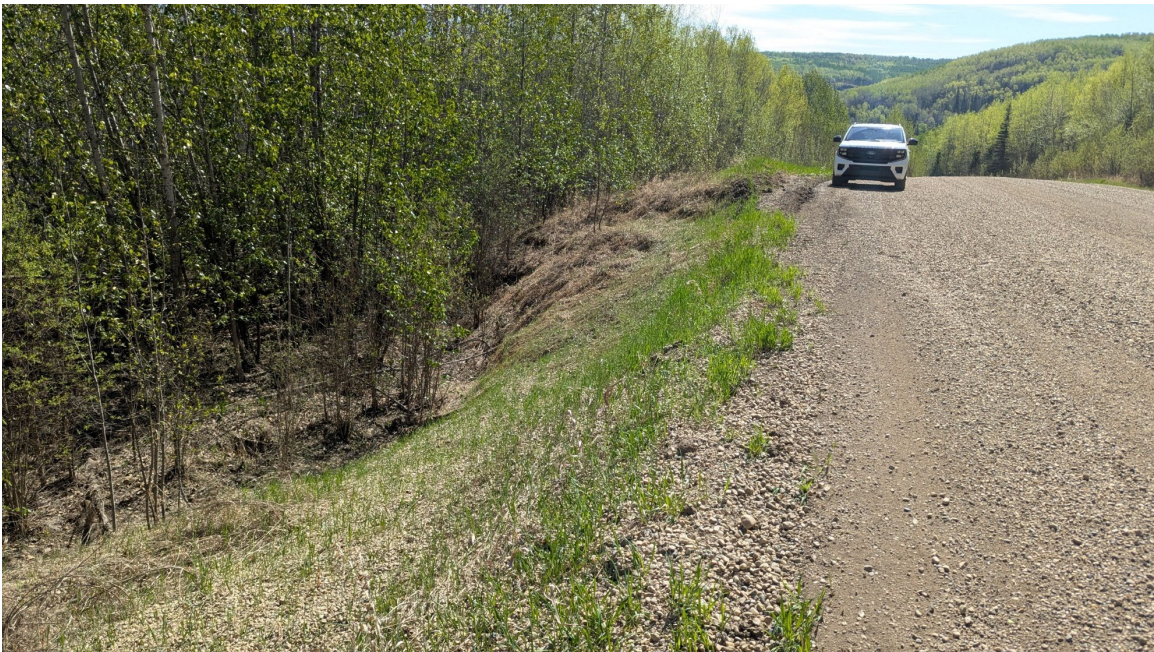
Site 2, Photo 2 – Looking southeast where scarp crack is visible on the east side of the highway.

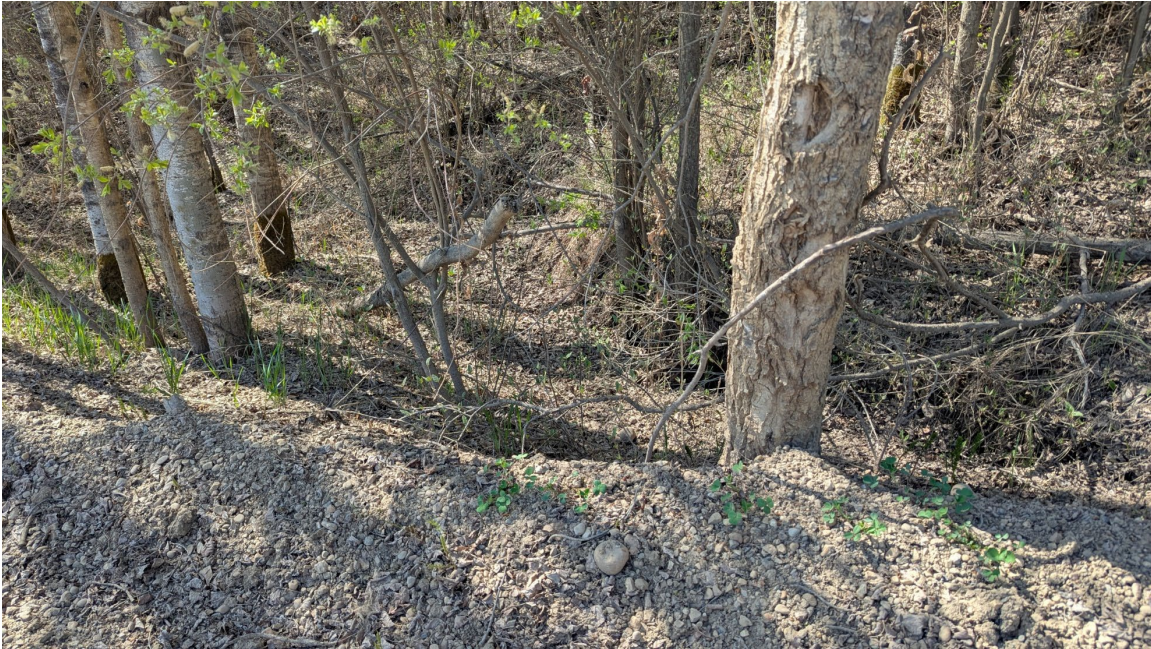
Site 2, Photo 3 – Looking south where scarp continues on the west side of the highway.

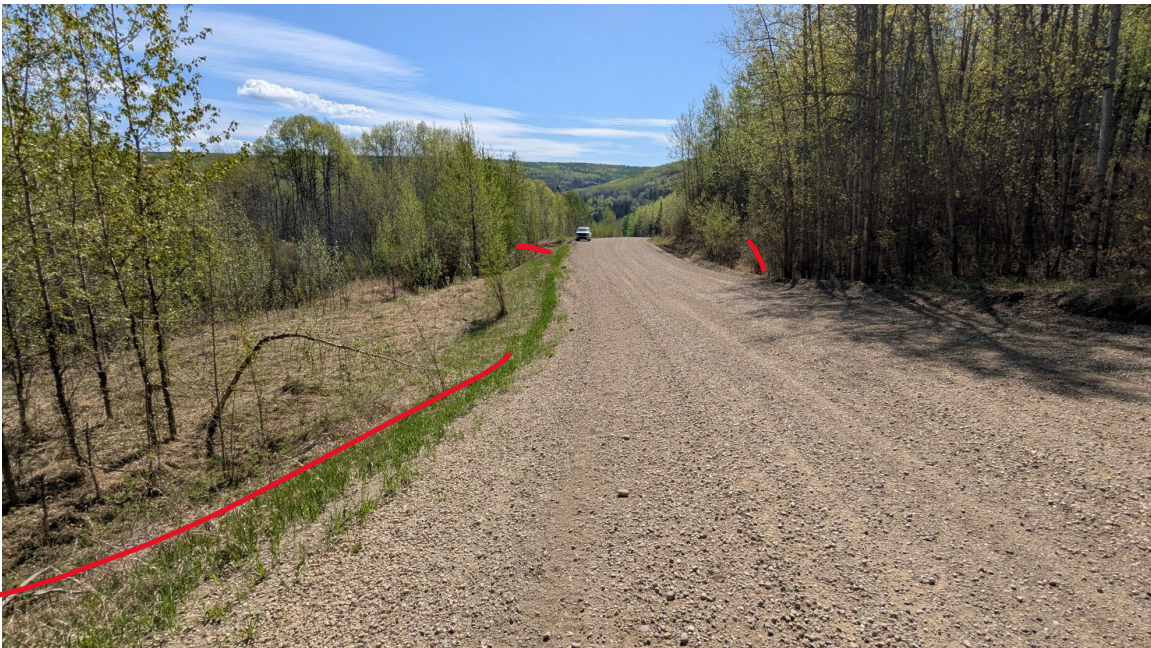
Site 2, Photo 4 – Looking southeast from north end of the site at the sag in the highway where it crosses the slide mass. The visible scarps are shown with red lines.
