**ALBERTA TRANSPORTATION AND
ECONOMIC CORRIDORS
GEOHAZARD RISK MANAGEMENT PROGRAM
PEACE REGION (PEACE RIVER DISTRICT)
2025 INSPECTION**

Site Number	Location	Name	Hwy	km
SH010-1	Little Smoky River West Valley Slope	Little Smoky River Valley, South Hill – Site #1	744:02	14.4-14.7
Legal Description		UTM Co-ordinates		
NE-13-76-23-W5		11U E 473,759	N	6,160,016

SH010: HWY 744:02 LITTLE SMOKY RIVER VALLEY (SITE #1)

2025 SITE INSPECTION PLAN

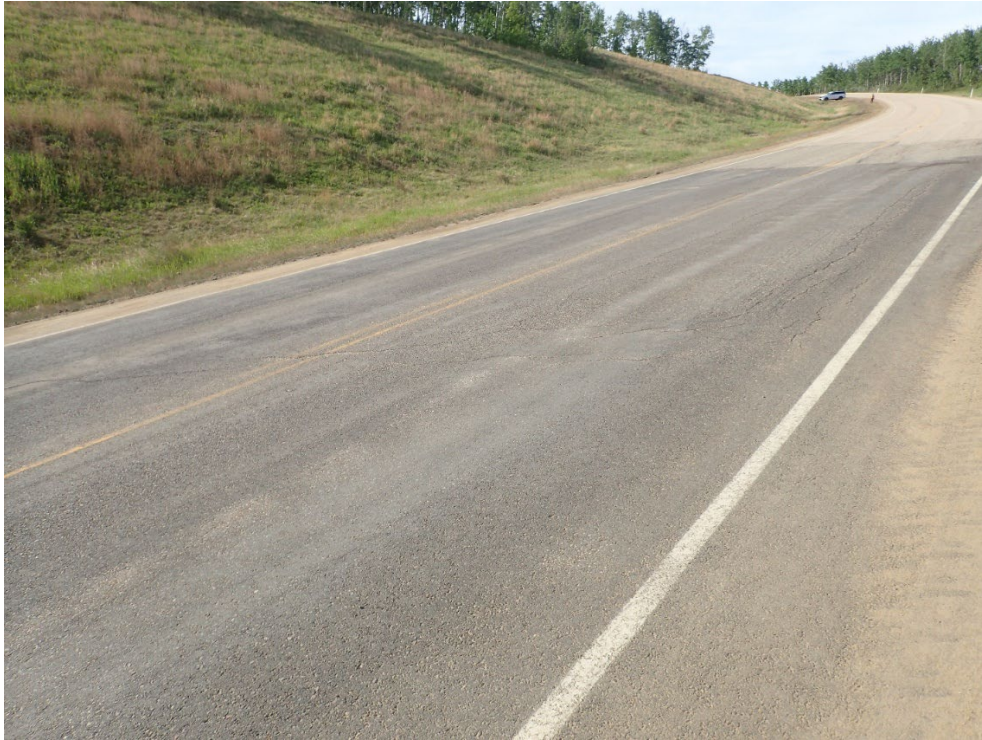
Photo 1 – Looking southeast at crack pattern on highway patch.

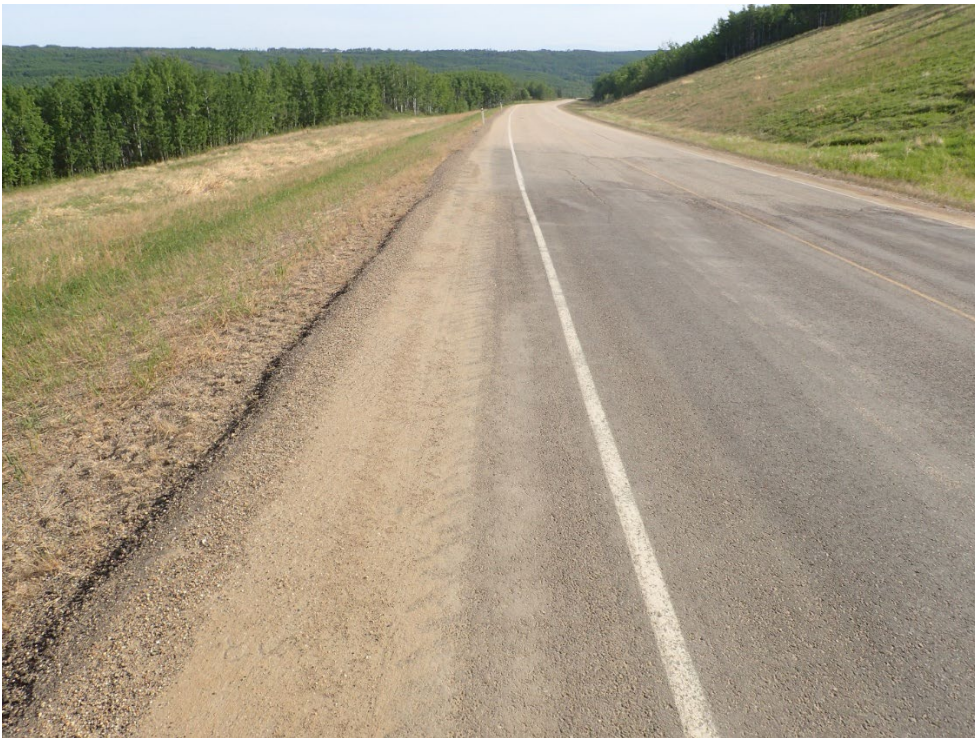
Photo 2 – Looking north at extended cracks along fog line and outside highway patch.

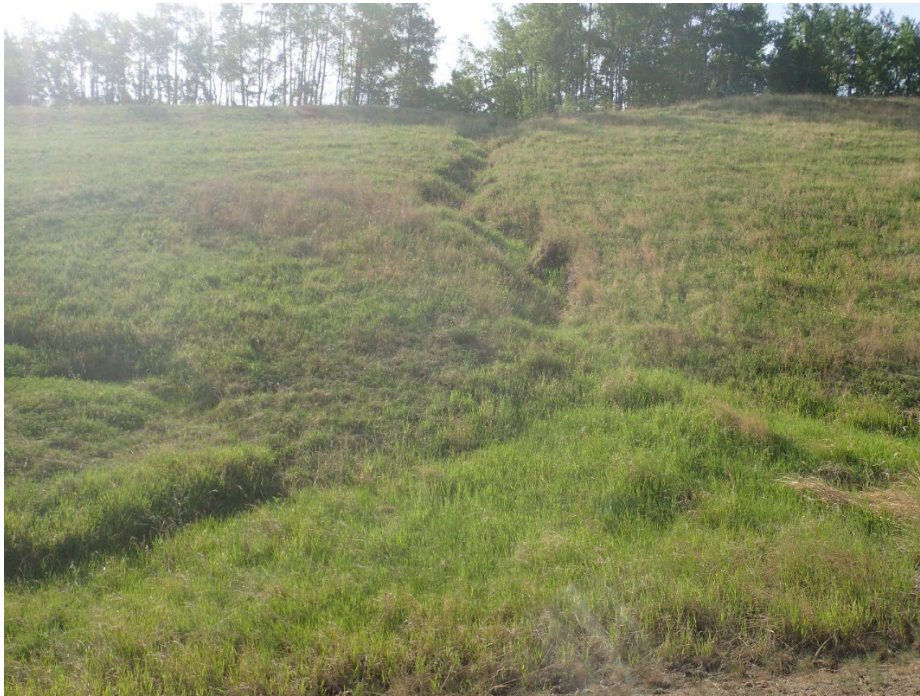
Photo 3 – Looking east at north gully.

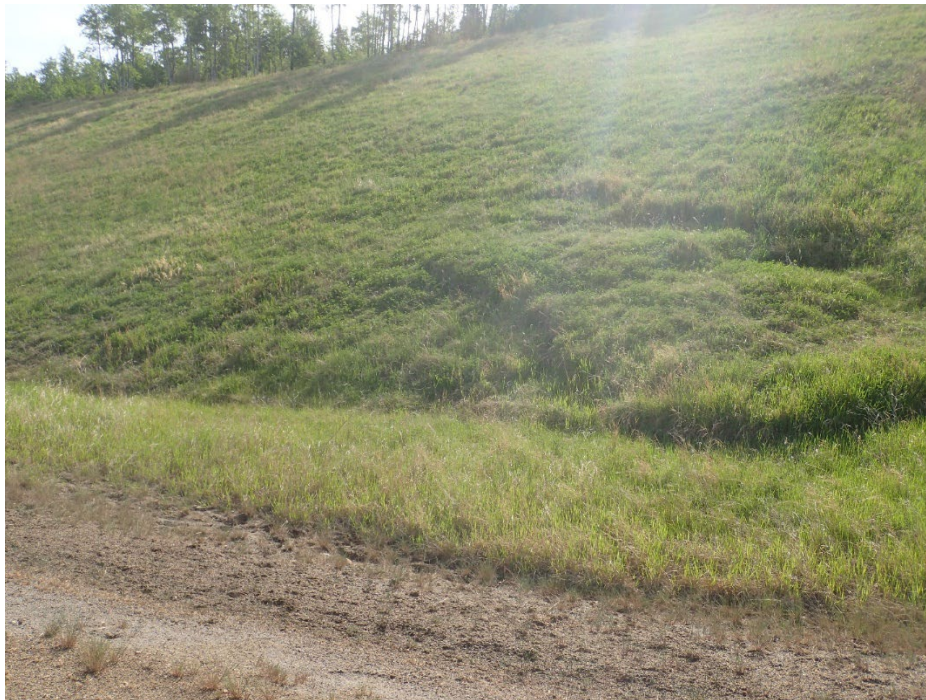
Photo 4 – Looking northeast at slump adjacent to the north gully on the lower part of the slope.

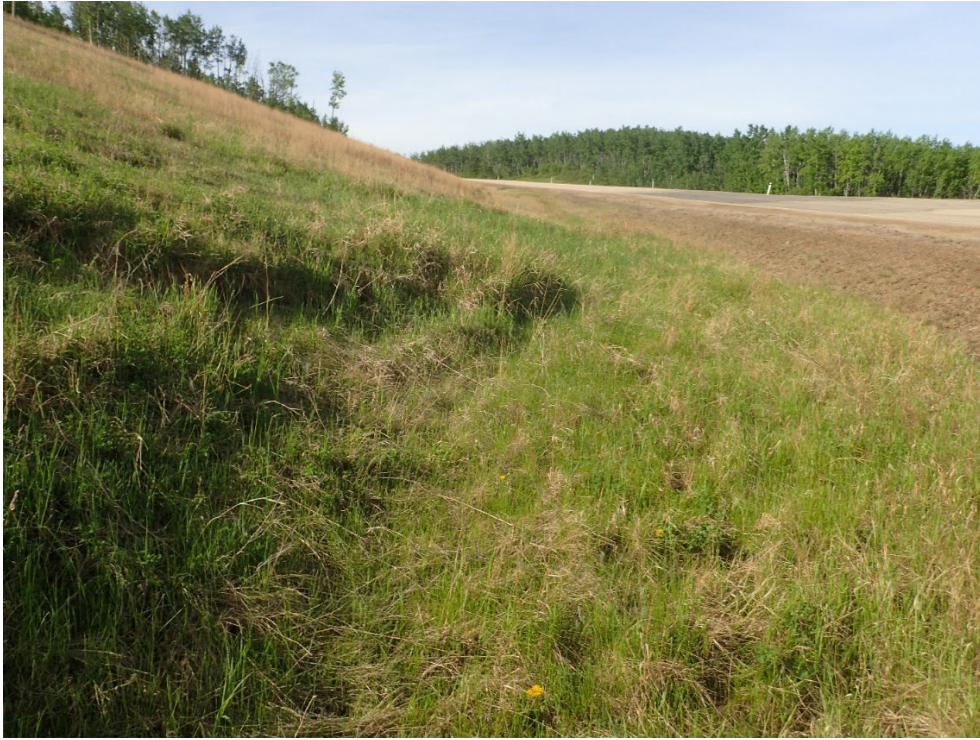
Photo 5 – Looking south at lower slump where vegetative growth was noted.

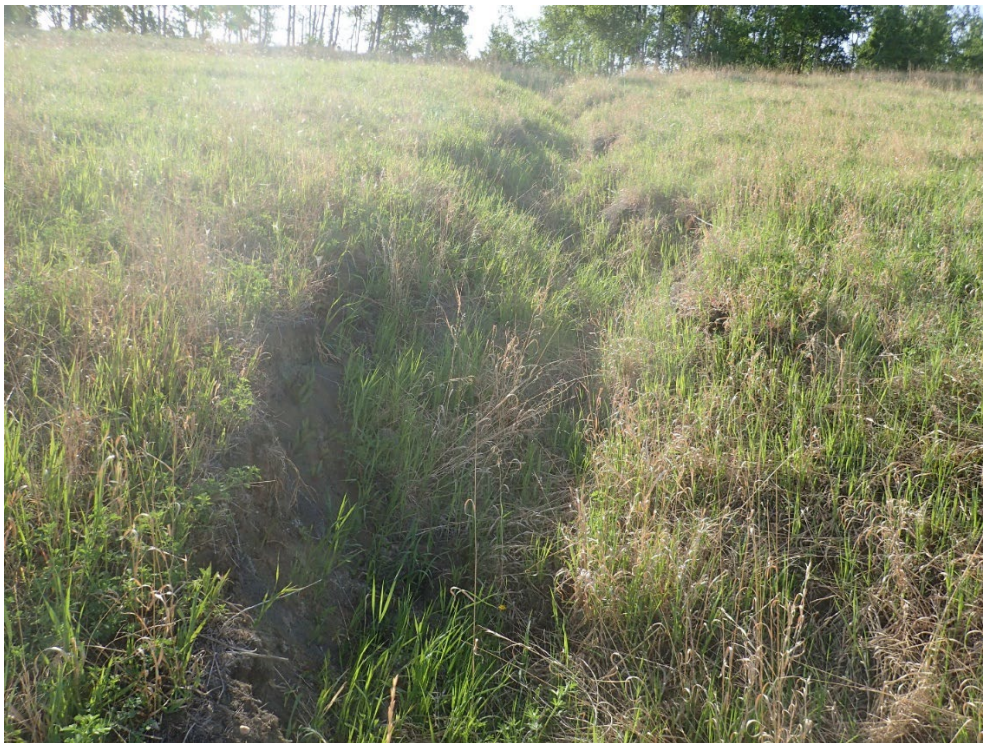
Photo 6 – Looking east at upslope portion of north gully.

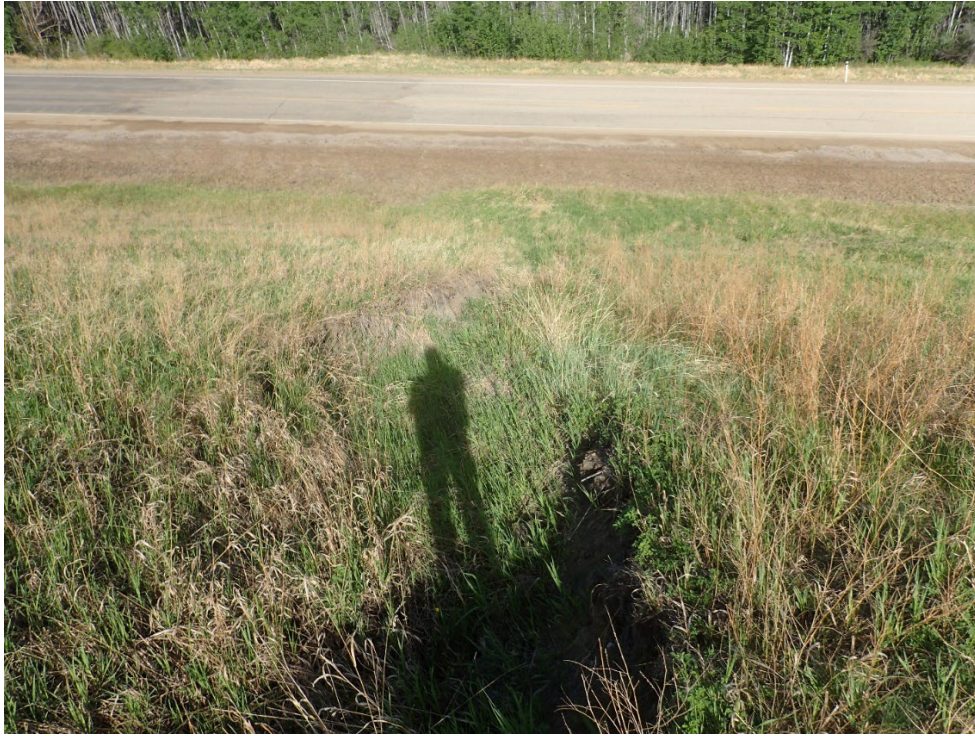
Photo 7 – Looking west and downslope of north gully where vegetative growth was observed.

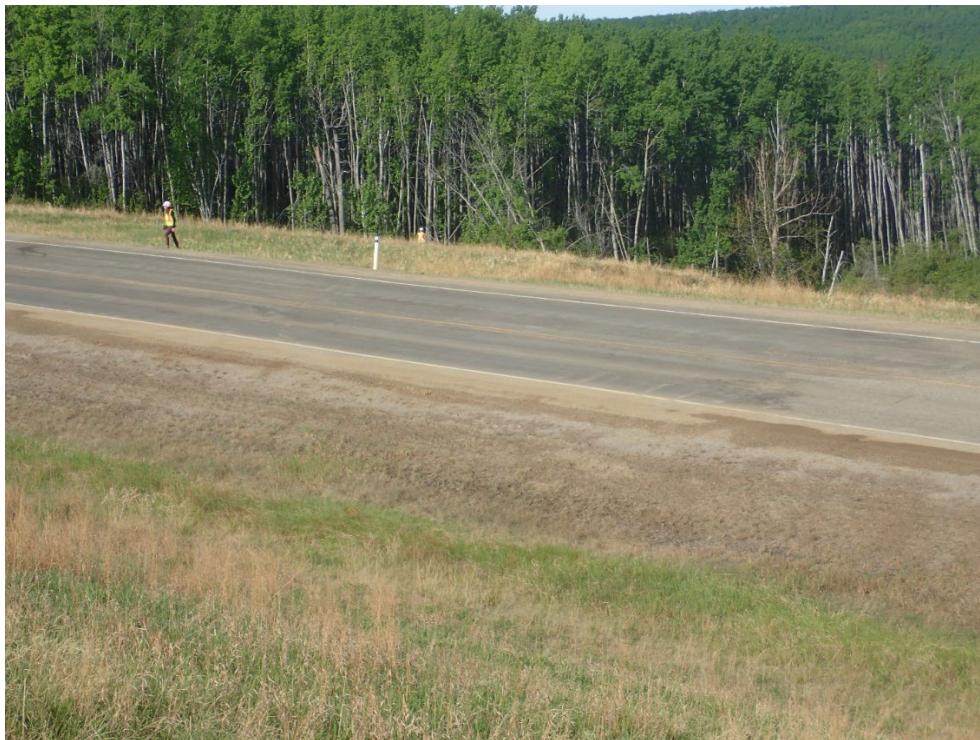
Photo 8 – Looking southwest at highway patch.

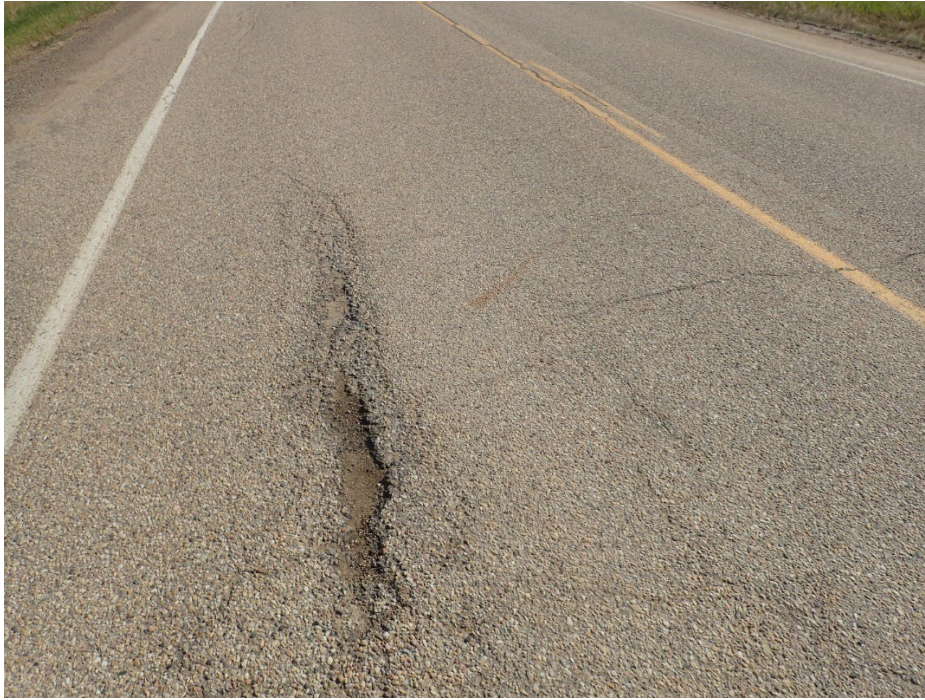
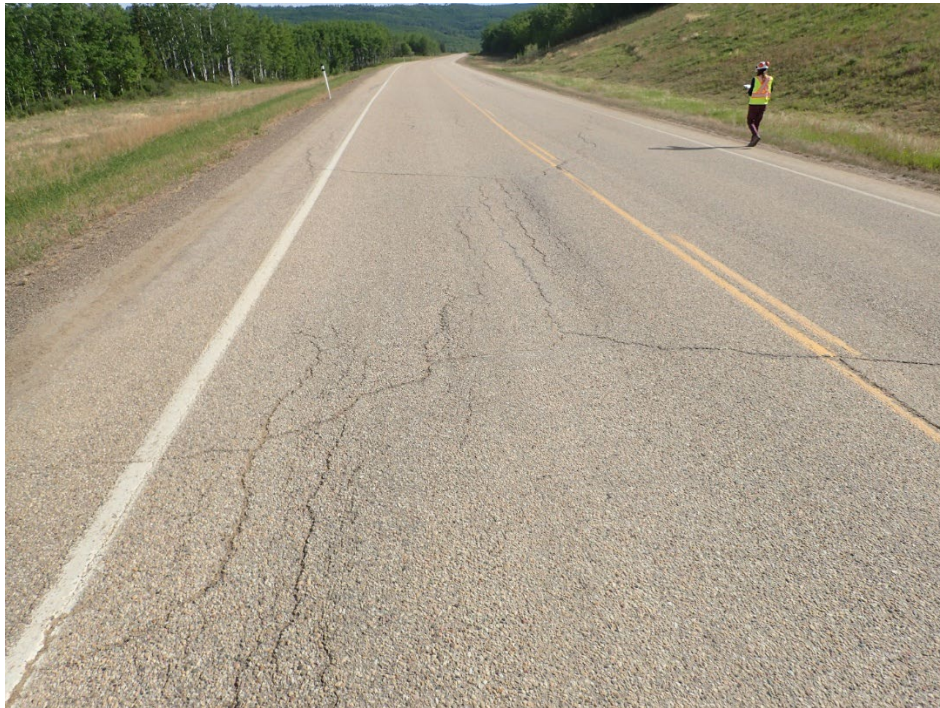
Photos 9 and 10 – Looking north at crack patterns along SBL.

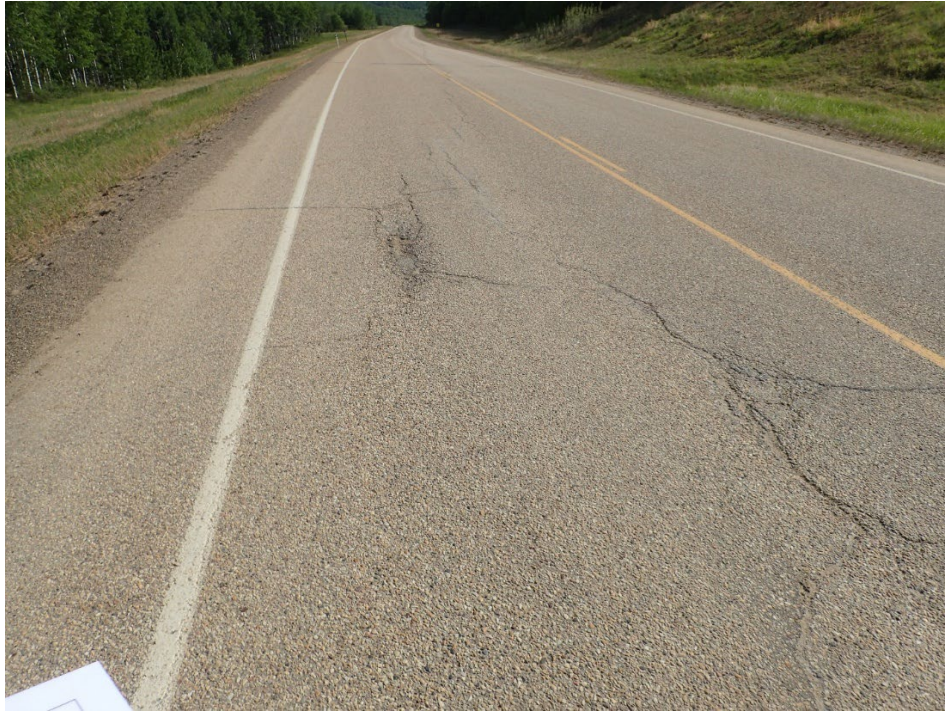
Photo 11 – Looking north at crack pattern and dip along SBL.

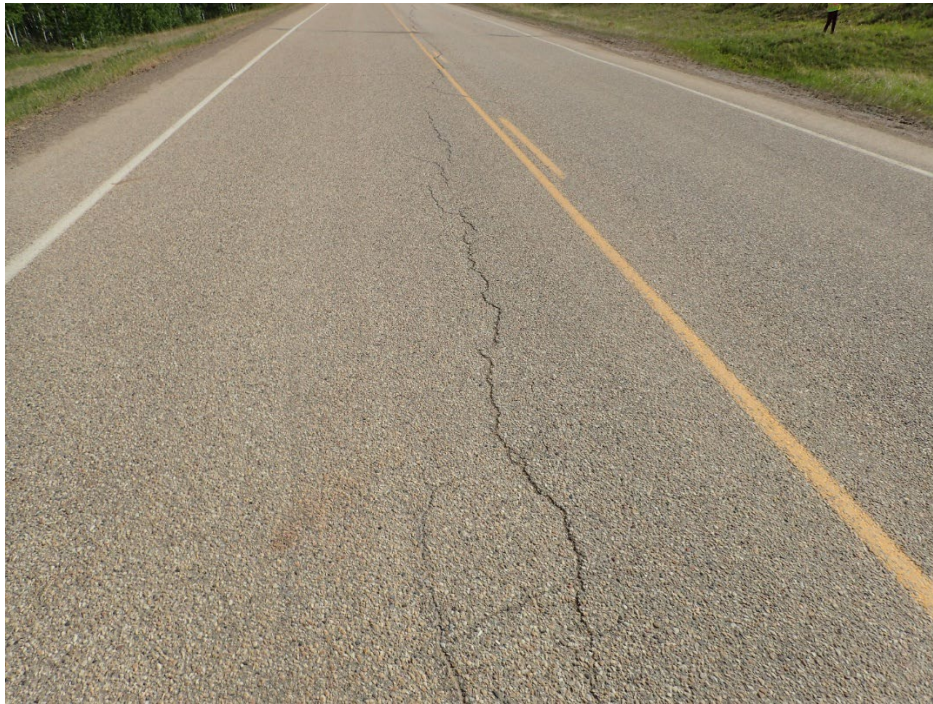
Photo 12 – Looking north at crack pattern along SBL at north end of site.

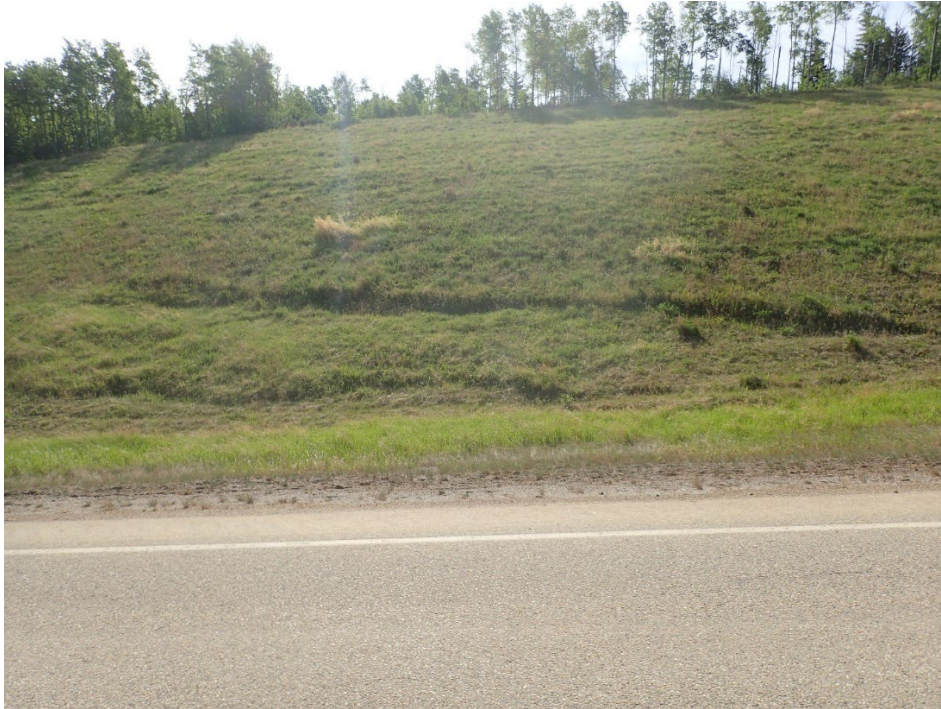
Photo 13 – Looking east at scarp crack at north end of site on east backslope.

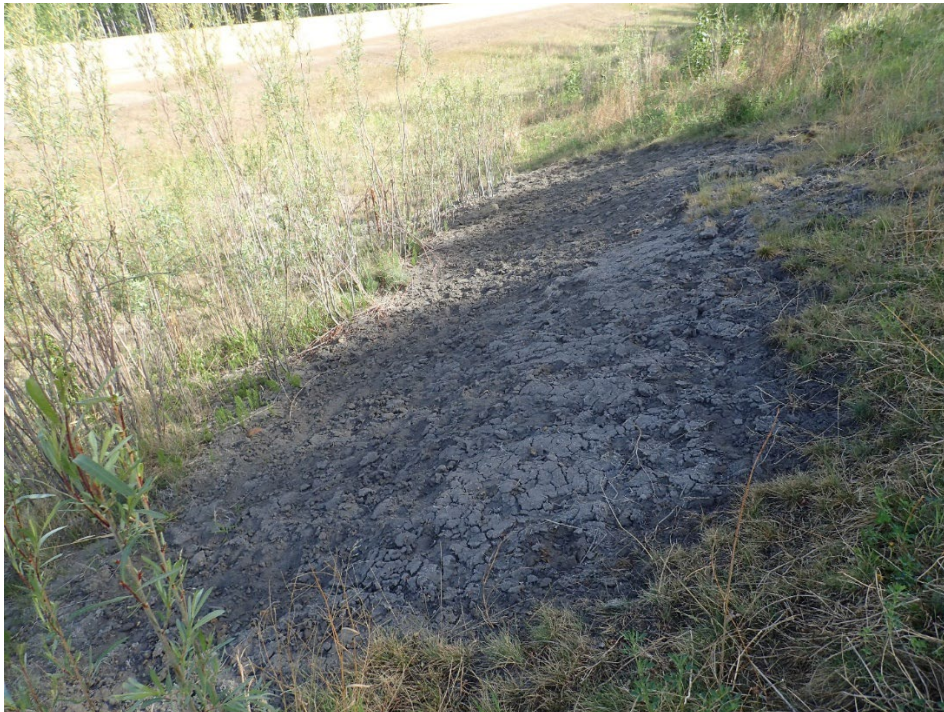
Photo 14 – Looking north at dry bare patch on east backslope. Willows were observed downslope of bare patch.

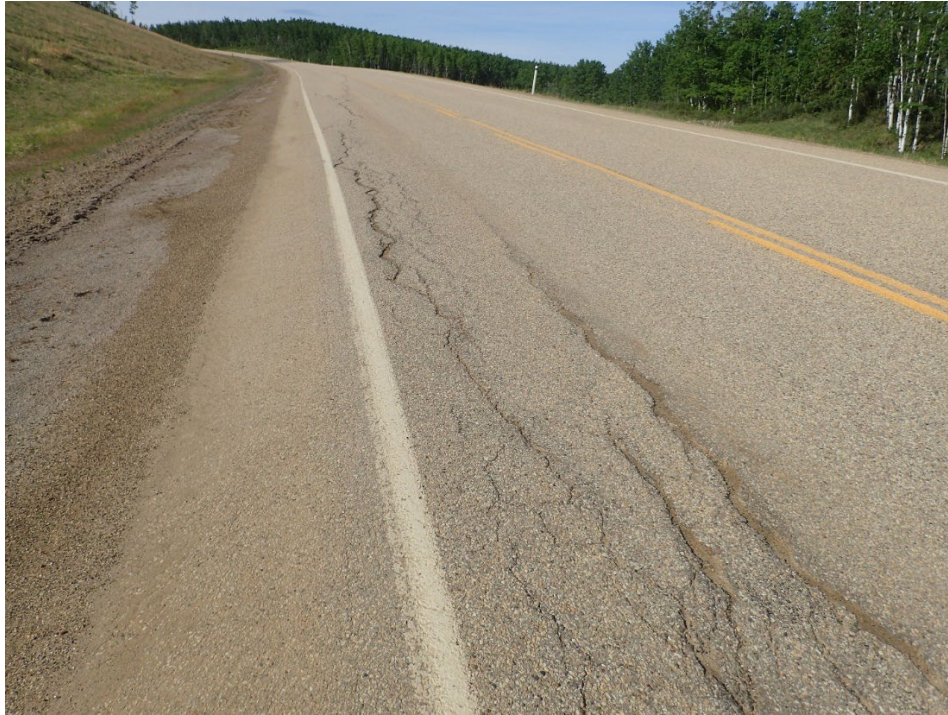
Photo 15 – Looking south at crack pattern along NBL at north end of site.

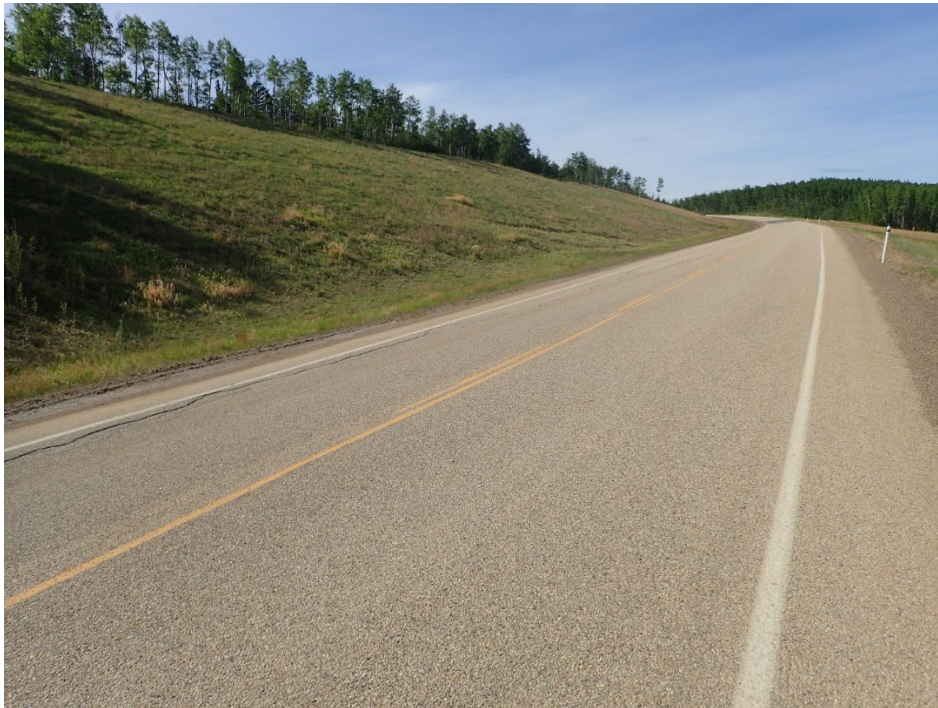
Photo 16 – Looking southeast at crack pattern along NBL at north end of site with backslope scarp in the background.

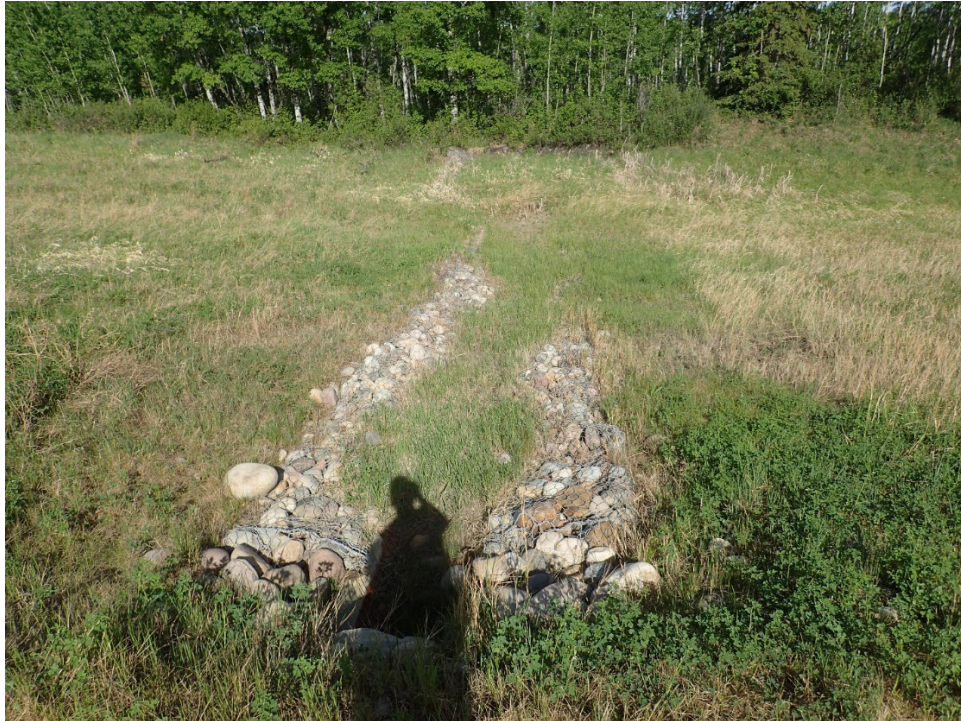
Photo 17 – Looking west downslope of CSP culvert outlet at north end of site.

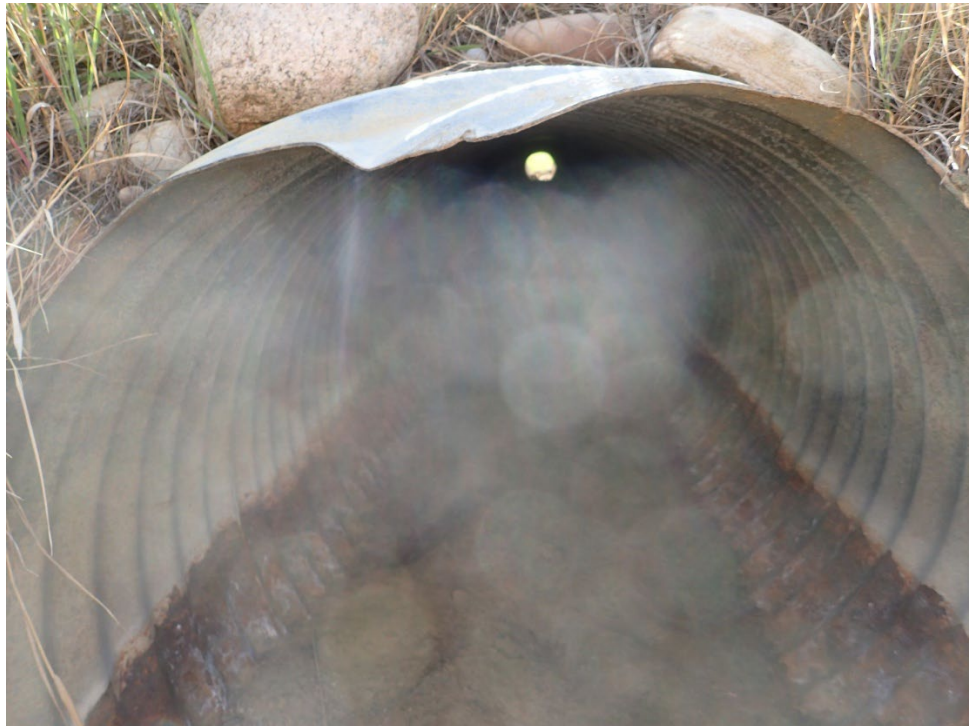
<input checked="" type="checkbox"/> Bridge/Culvert Distress	Downstream apron of 800 mm centreline CSP culvert at km 14.45 damaged by slope movement. The CSP was 1/3 full and corroding. The 800 mm centreline CSP culvert at km 14.69 was in good condition.	<input type="checkbox"/>
<input checked="" type="checkbox"/> Other	Sediment from gullies accumulating over ditch gabion check baskets	<input type="checkbox"/>
Instrumentation: None.

Photo 18 – Looking east at culvert outlet.

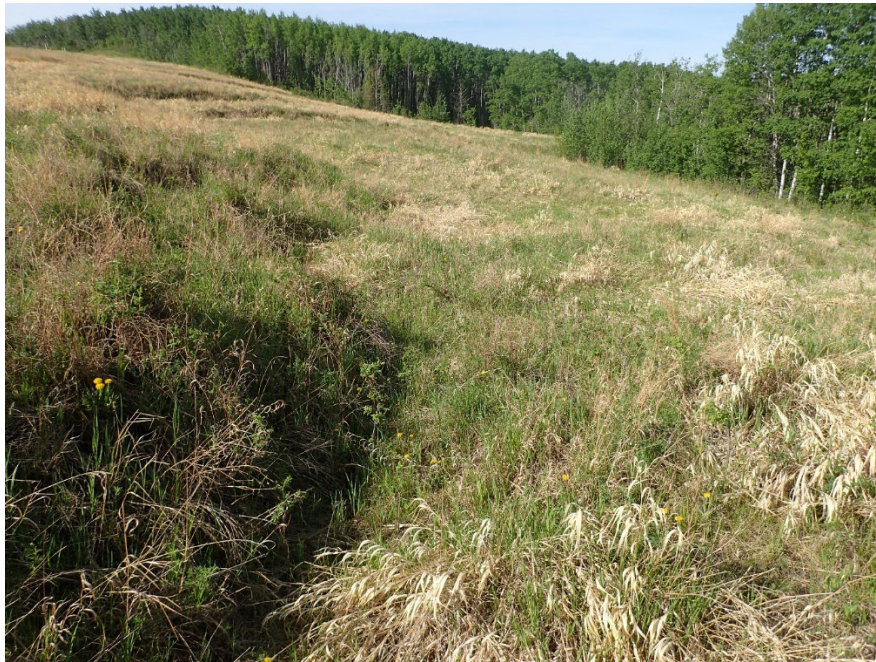
Photo 19 – Looking south at scarps downslope of highway at north end of site.

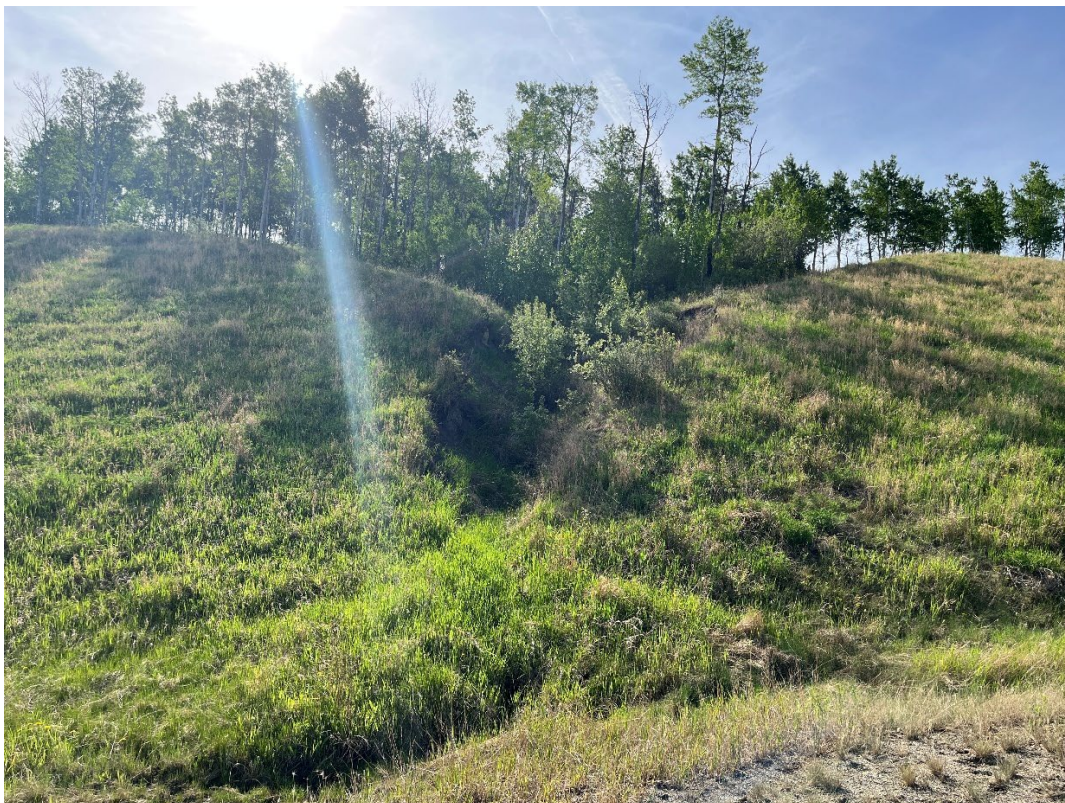
Photo 20 – Looking east at south gully.

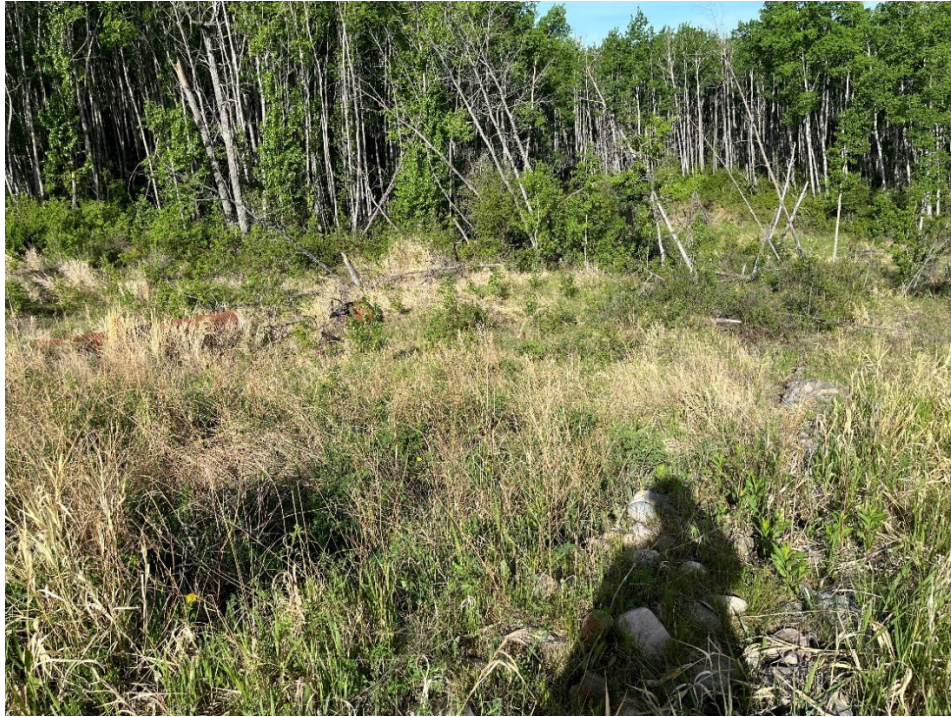
Photo 21 – Looking west where slide at km 14.45 cuts into the gabion basket swale. There has been a lot of vegetative growth in this area.

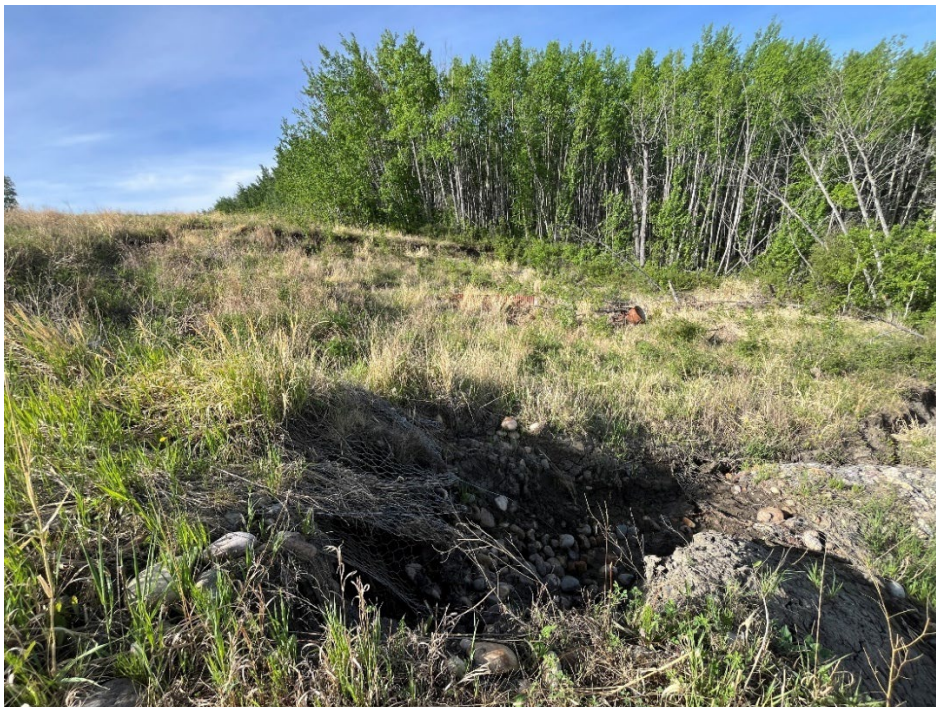
Photo 22 – Looking south at slide at km 14.45 located adjacent to south gabion basket swale.
