**ALBERTA TRANSPORTATION AND
ECONOMIC CORRIDORS
GEOHAZARD ASSESSMENT PROGRAM
PEACE REGION (PEACE RIVER DISTRICT)
2025 INSPECTION**

Site Number	Location	Name	Hwy	km
PH030	Judah Hill	Lookout Slides	744:04	57.43
Legal Description		UTM Co-ordinates (NAD 83)		
SE¼ 20-083-21 W5M		11V E 483194	N 6229425

**PH030 LOOKOUT SLIDES
2025 SITE INSPECTION PLAN**

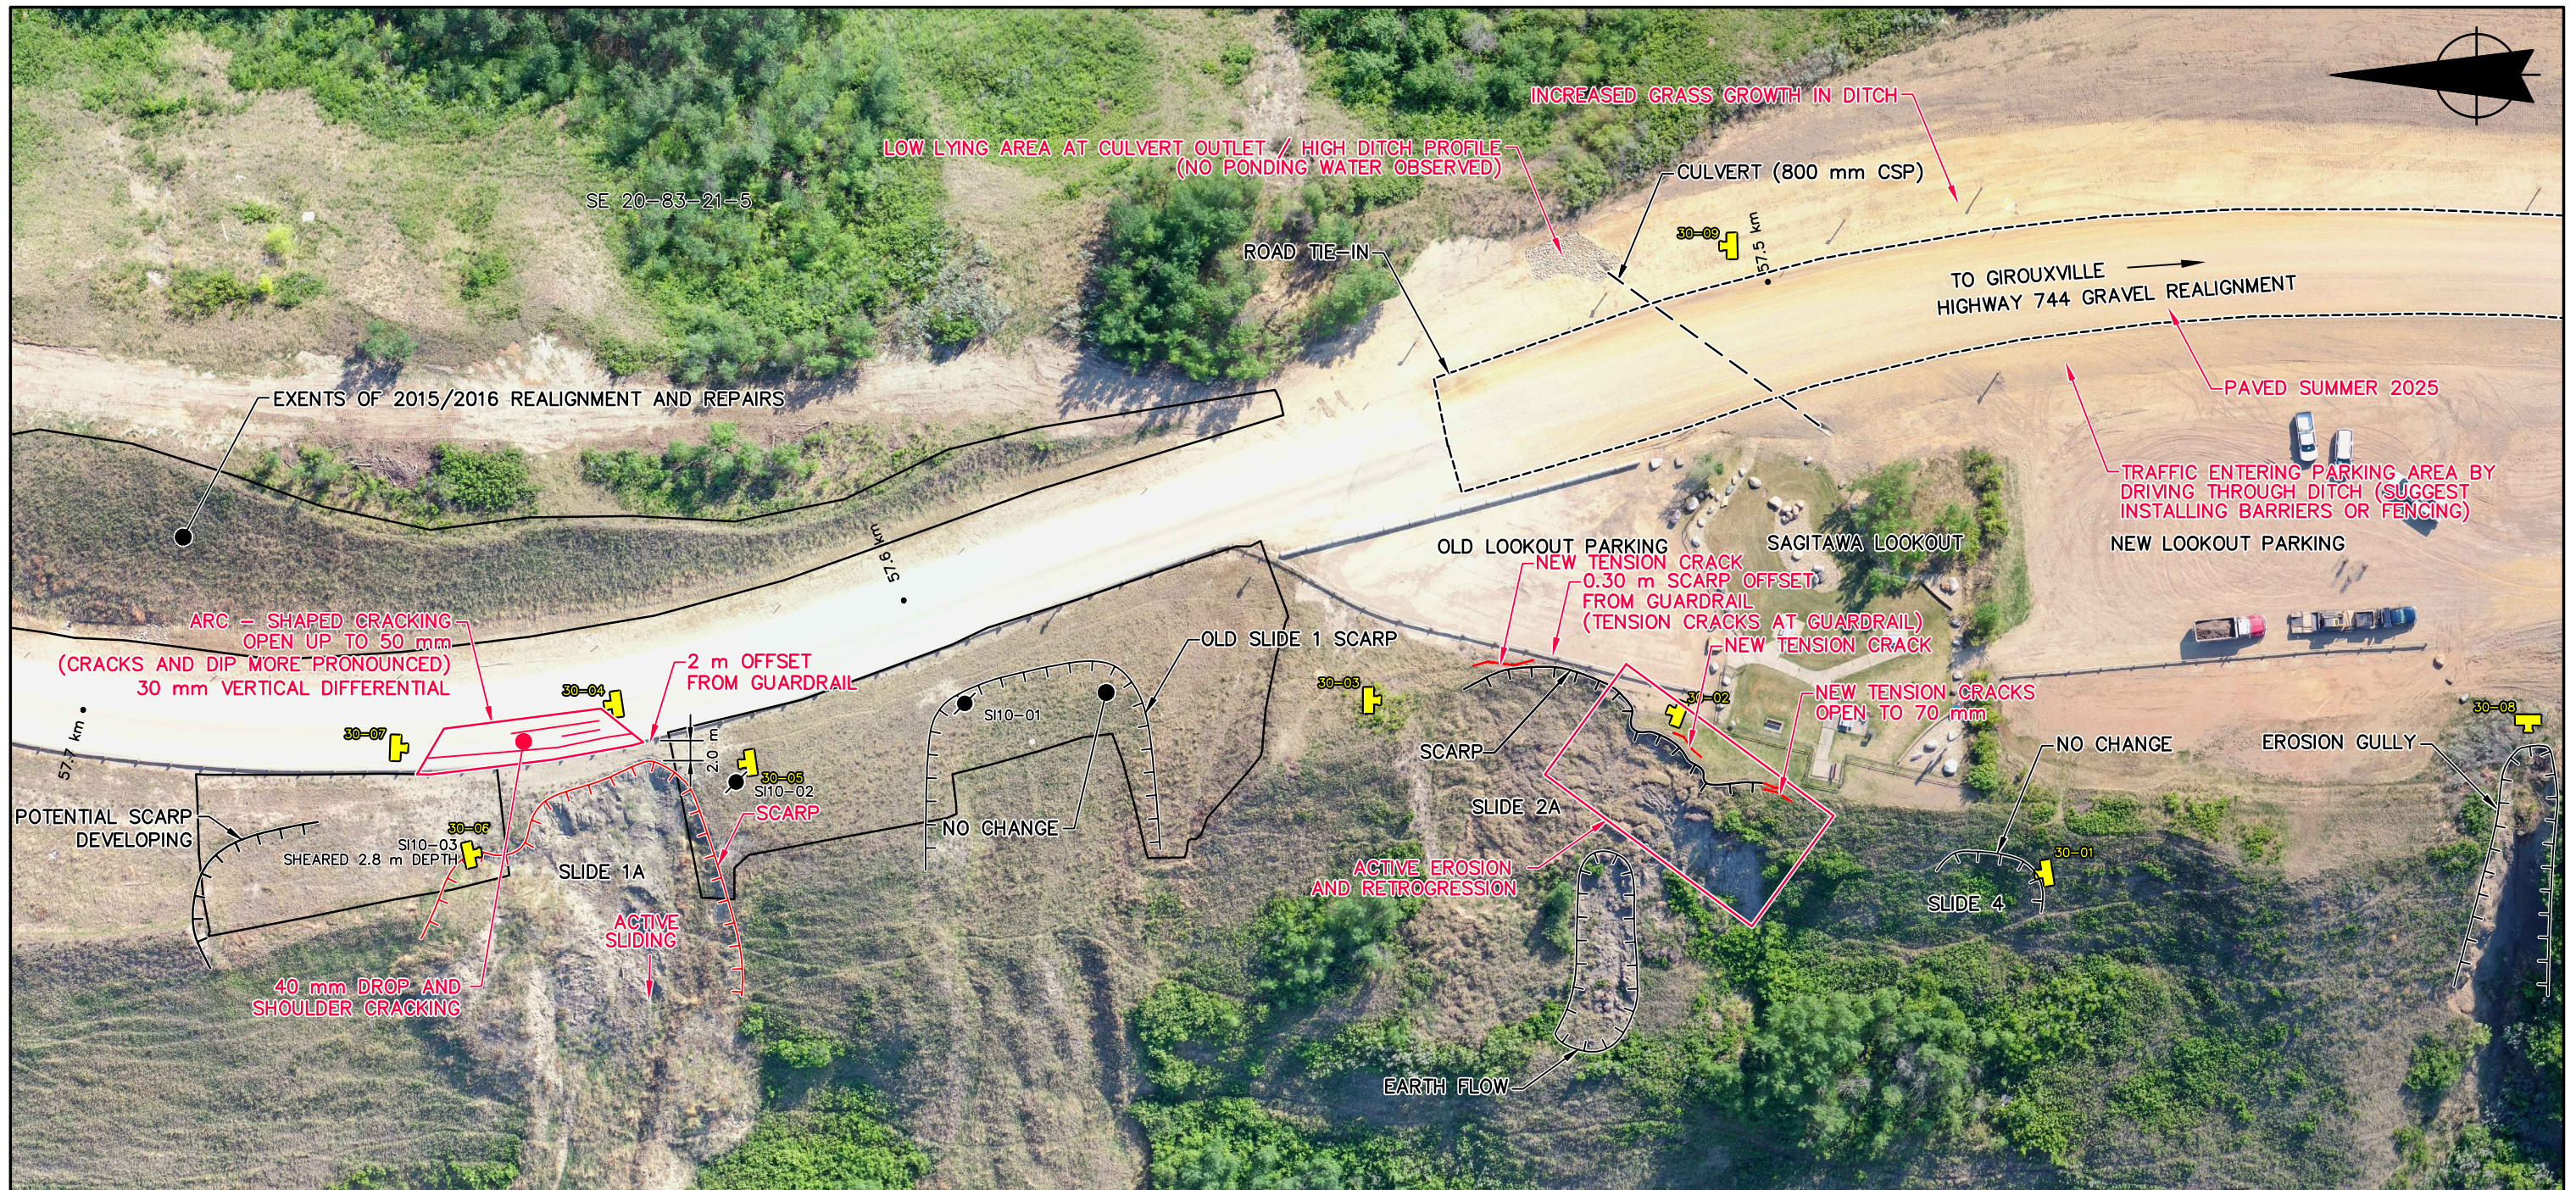
FIGURE PH030-1

Assessment (Refer to Drawing PH030-1-1):

The existing slides occurred on steep slopes (36° to 38°) and are similar in appearance to the Heart River slides. The previous repairs at Slide 1 (shredded tire fill wedge) appear to be effective, although there may be some ongoing movement in the backscarp causing minor pavement distress.

The October 2015 landslide at SI10-3 was addressed as part of Contract CON0015153 with a realignment of the affected highway section into the backslope further to the east. The extent of the realignment was limited by the presence of the ATCO natural gas pipeline right-of-way which flanked the highway alignment along the NBL. The ATCO pipeline has since been abandoned within this section which could provide some additional space for future realignments, if required.

There is continuing slide activity in Slide 2A (formerly Slides 2 and 3) and in Slide 1A located in the newly regraded highway sideslope below the SBL at km 57.65. This movement could be in response to natural groundwater drainage and seepage locations. Retrogression of the main scarps at these slides has generally been slow with larger increments that could be linked to seasonal affects.

At Slide 1A (km 57.65), the visible main scarp continues to retrogress towards the SBL and is only offset 2 m from the guardrail. Based on the arc-shaped cracking pattern within the pavement upslope from this slide area, a slide plane appears to have developed beneath the highway, and it encompasses the SBL and an increasing part of the NBL. Although the movements within the road have been relatively small to date, a large increment of movement within this slide block could negatively impact both lanes of the driving surface. The operating SI near this area (SI10-2) appears to be outside of the main movement zone; however, a trend of accelerating movement rates has been observed at approximately 6 m depth. The largest movement rate (~12 mm/yr) was recorded at SI10-2 since initialization during the Fall 2024 readings This could reflect progressive loss of toe support below the highway at km 57.65, resulting in the observed pavement damage.

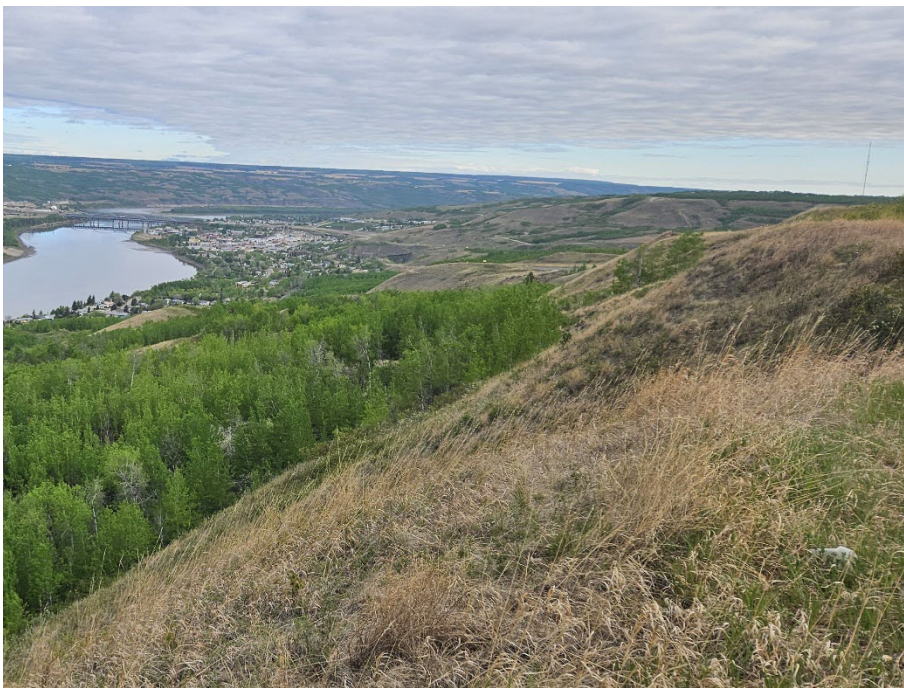
**Photo 30-01.**

Looking north towards the Slide 4 area from the south end of the site. No change to the slide in this area has been observed over the last several years and it is well vegetated.

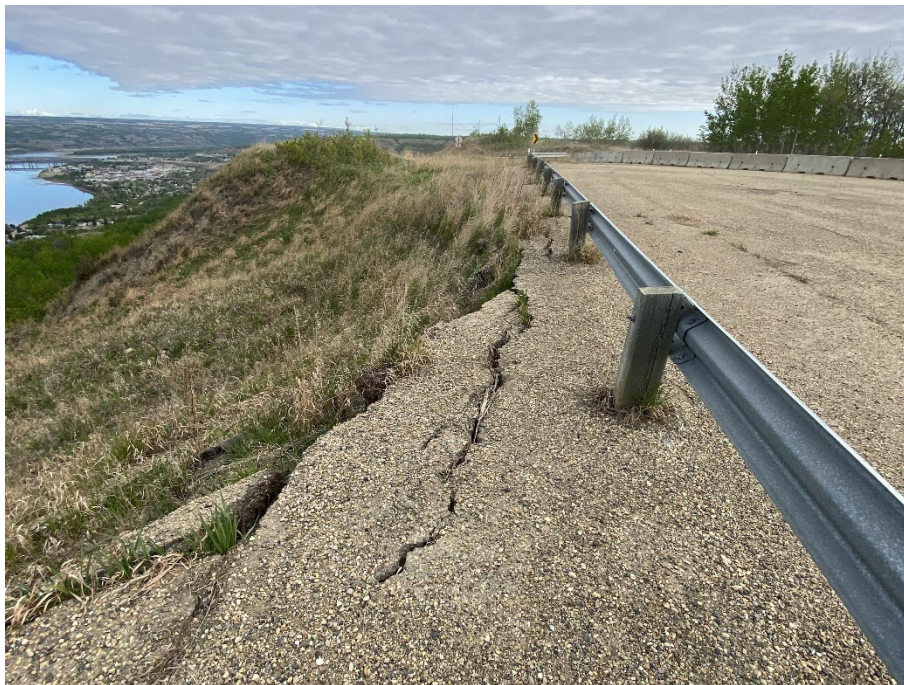
**Photo 30-02.**

<p>Increased retrogression and flank expansion within the southern end of Slide 2A. Slide 2A main scarp offset 0.30 m from the guardrail and upper slide area was well vegetated. Tension cracks behind the main scarp now extend below the guardrail. (Photos 30-2 and 30-3)</p> <p>The main scarp of Slide 1A (km 57.65) appears to be actively moving with increased dropdown, and erosion along the exposed scarp faces but no significant retrogression since 2024. Main scarp is offset a minimum of 2.0 m from the guardrail, unchanged from the 2024 condition. (Photos 30-5 and 30-6)</p>		
<input checked="" type="checkbox"/> Erosion	<p>Erosion gully approximately 50 m south of Slide 4 showed no change compared to 2024 inspection (Photo 30-8).</p> <p>Traffic is entering the new lookout parking area (km 57.45) by driving through the ditch on the west side of the new alignment which could limit grass growth and exacerbate any development of future ditch erosion.</p>	<input type="checkbox"/>	<input checked="" type="checkbox"/>

Looking north along backscarp of Slide 2A (previously Slides 2 and 3) which has a minimum offset of 0.30 m from the old parking lot guardrail. Some localized main scarp retrogression at south end, flank erosion and additional pavement cracking since 2024. Tension cracks are now at the guardrail.

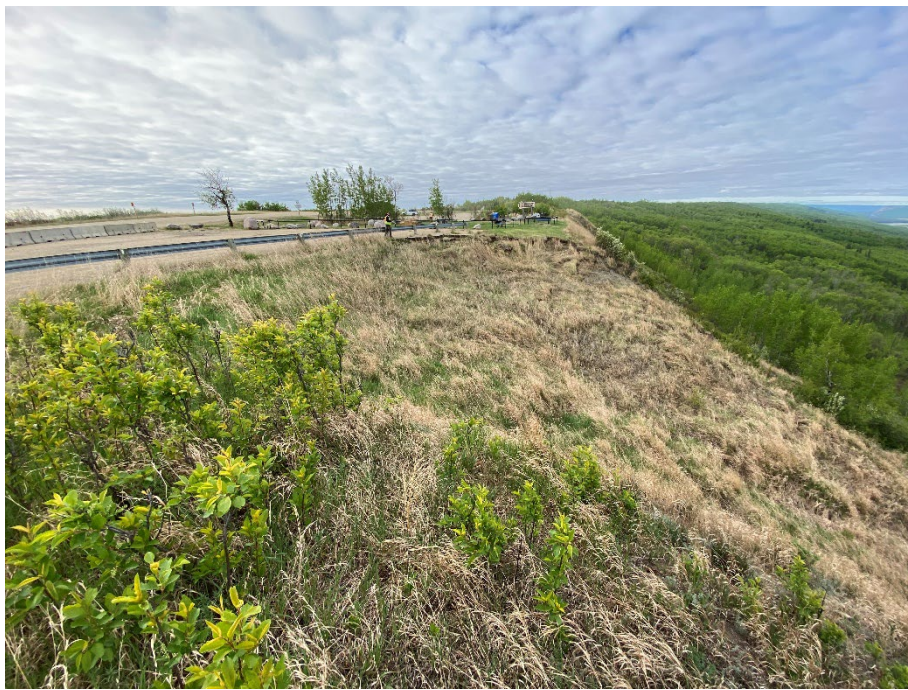
Photo 30-03.

Looking south towards the upper part of Slide 2A. South flank had most activity since 2024 with increased erosion and minor retrogression. Ongoing movements occurring further downslope, primarily involving shallow earth flows.

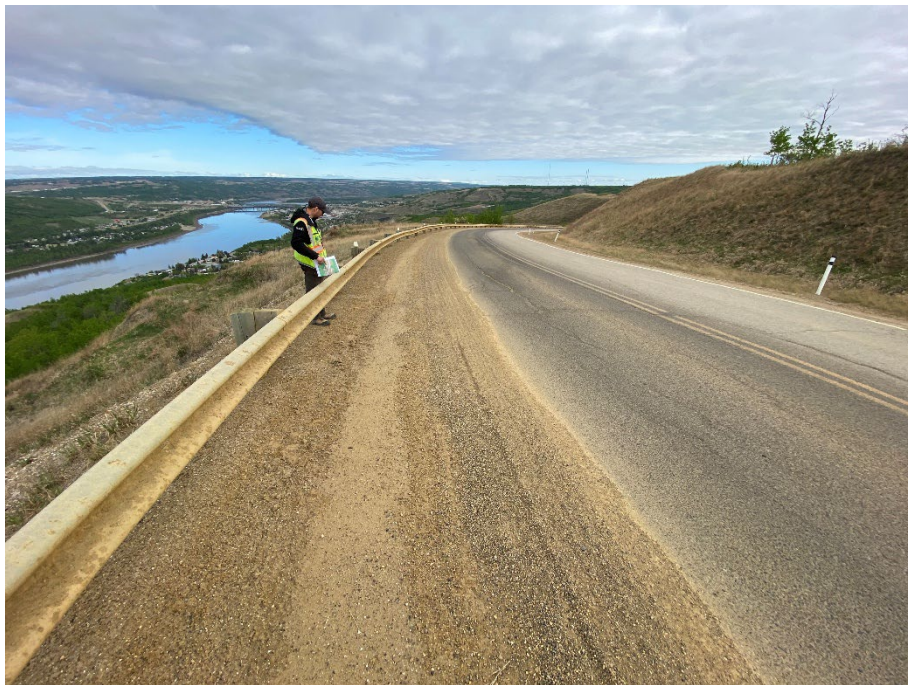
Photo 30-04.

Looking north along the SBL of Hwy 744:04 near km 57.65 at south end of 2015 realignment. Transverse cracks have formed joining the previous longitudinal crack in the NBL to form arch-shaped crack within the downslope extents of Slide 1A. Cracks have extended into the NBL.

- Movement at Slide 1A (57.65) is expected to continue and retrogress toward the new highway alignment. In the short-term, if the southbound lane was lost an emergency repair would likely involve a realignment into the hillside and conversion to gravel. (\$350k – \$500k)
- Sub-excavation of the Slide 1A mass and replacement with light weight fill could be considered as a shorter-term, cost-effective solution. (\$500k - \$750k)

- Long-term option for Slide 1A would likely involve a tied-back pile wall. The wall will need to be in the order of 35 m to 40 m wide with two rows of tie-back anchors. (\$1.5M - \$3M)

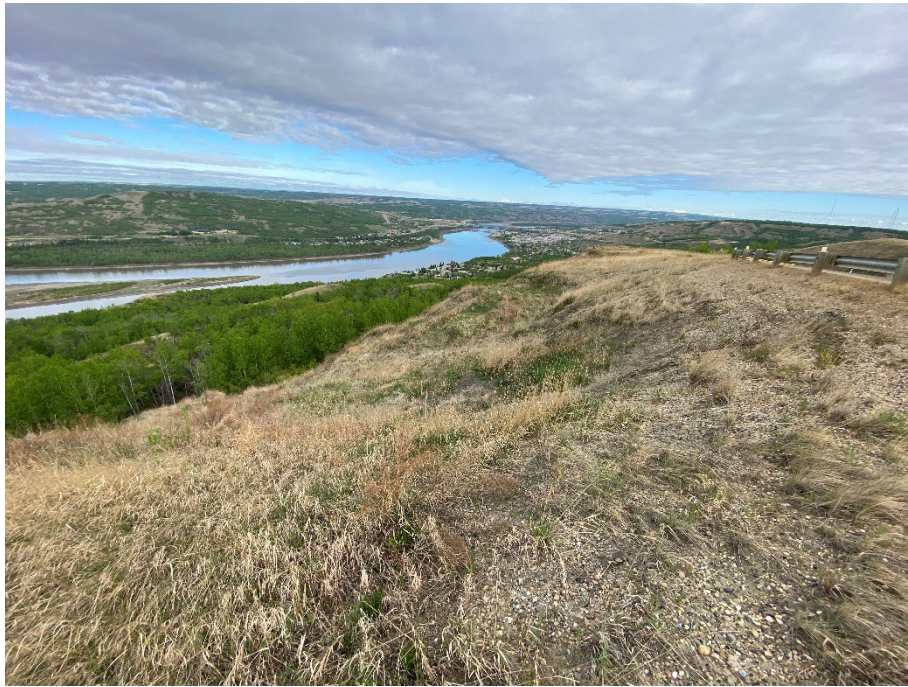
**Photo 30-05.**

Looking north from downslope of the SBL of Hwy 744:04 near km 57.63. Increased down drop within the disturbed slide mass of Slide 1A. Main scarp is offset a minimum of 2.0 m from the guardrail (unchanged from 2024).

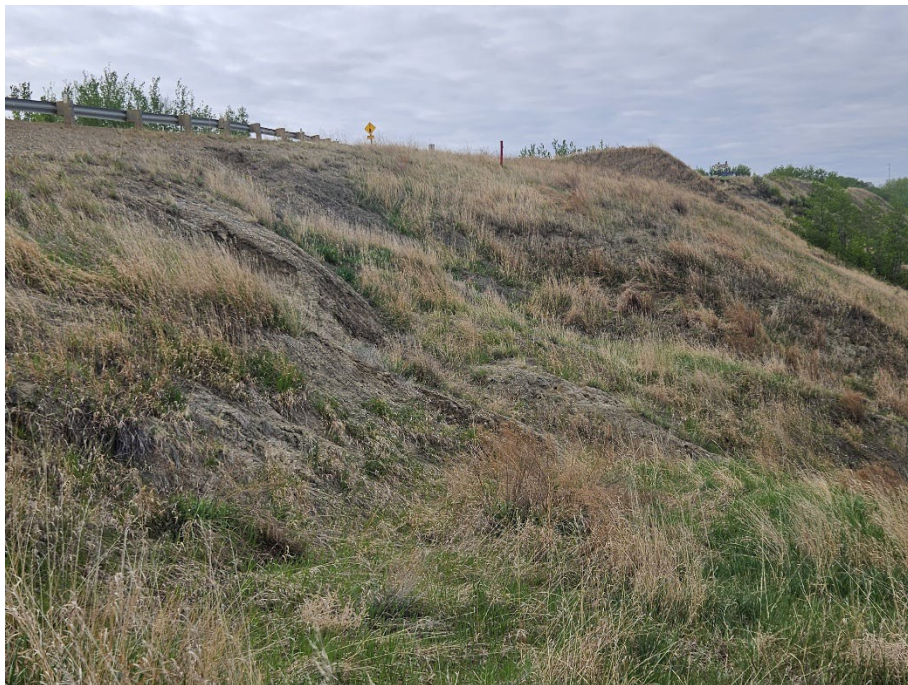
**Photo 30-06.**

Looking south at Slide1A (near KM 57.65). Ongoing downslope movement and erosion at the main scarp and south flank; however, no major change from the 2024 condition.

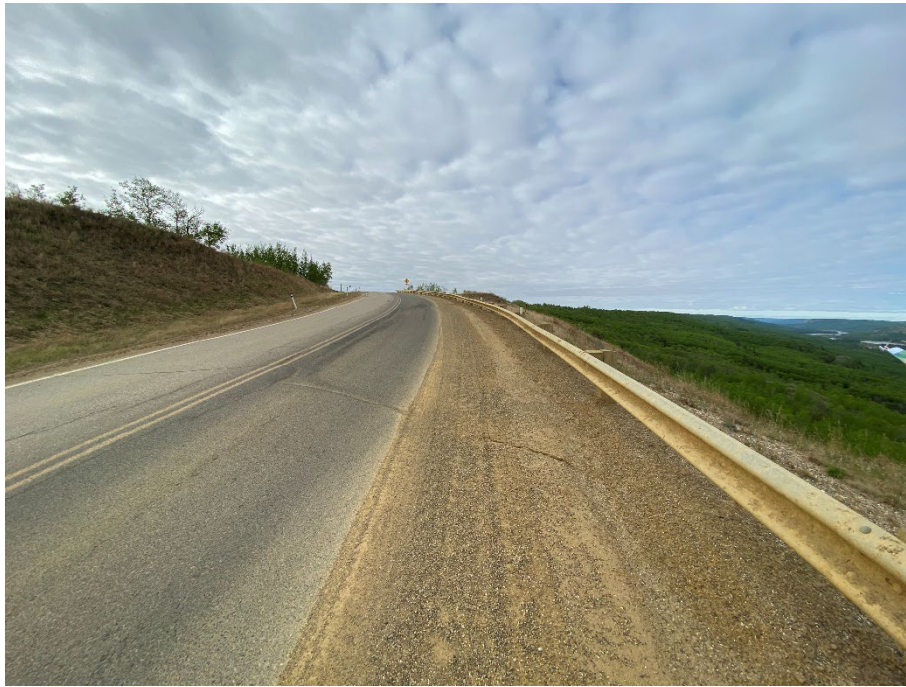
**Photo 30-07.**

Looking south along SBL of Hwy 744:04 at km 57.67. Arc-shaped cracking more prominent in SBL within the downslope extents of Slide 1A. Dip was more pronounced relative to the 2024 condition (up to 30 mm) and cracks have started to extend into NBL.

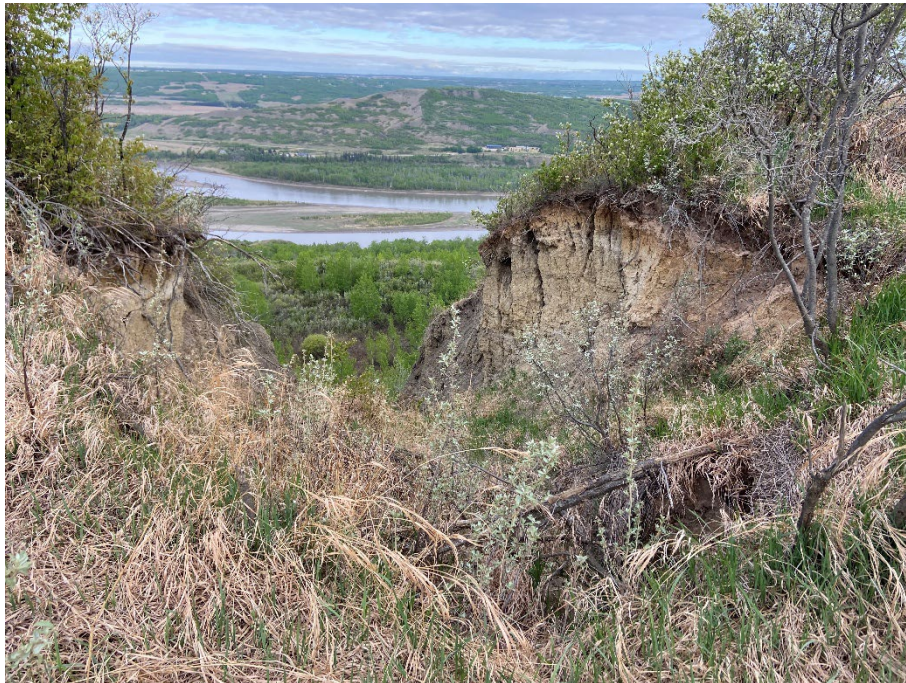
**Photo 30-08.**

Looking at the top of an erosion gully located at the southern edge of the site, approximately 50 m south of the Slide 4 area. Gully is offset approximately 50 m west of the new highway realignment. No headwall retrogression since 2024.
