Site Number	Location	Name	Hwy	km
PH031	HWY 744:04 C1 57.7	Michelin Slide- Judah Hill	744:04	Km 57.7
<b>Legal Description:</b>		<b>UTM Co-ordinates</b>		
9-20-83-21 W5		11U E 483125.92	N	6229725.01

<b>Current Monitoring:</b>	25 to 28-Sep-2025	<b>Previous Monitoring</b>	9-Jun-2025
<b>Instruments Read By:</b>	Mr. Niraj Regmi, G.I.T and Mr. Angelo Castillo, of Thurber

**ALBERTA TRANSPORTATION AND ECONOMIC CORRIDORS GRMP (CON0022164)  
PEACE REGION (PEACE RIVER DISTRICT)  
INSTRUMENTATION MONITORING RESULTS**

**SITE PH031: HWY 744:04, JUDAH HILL (MICHELIN SLIDE)**

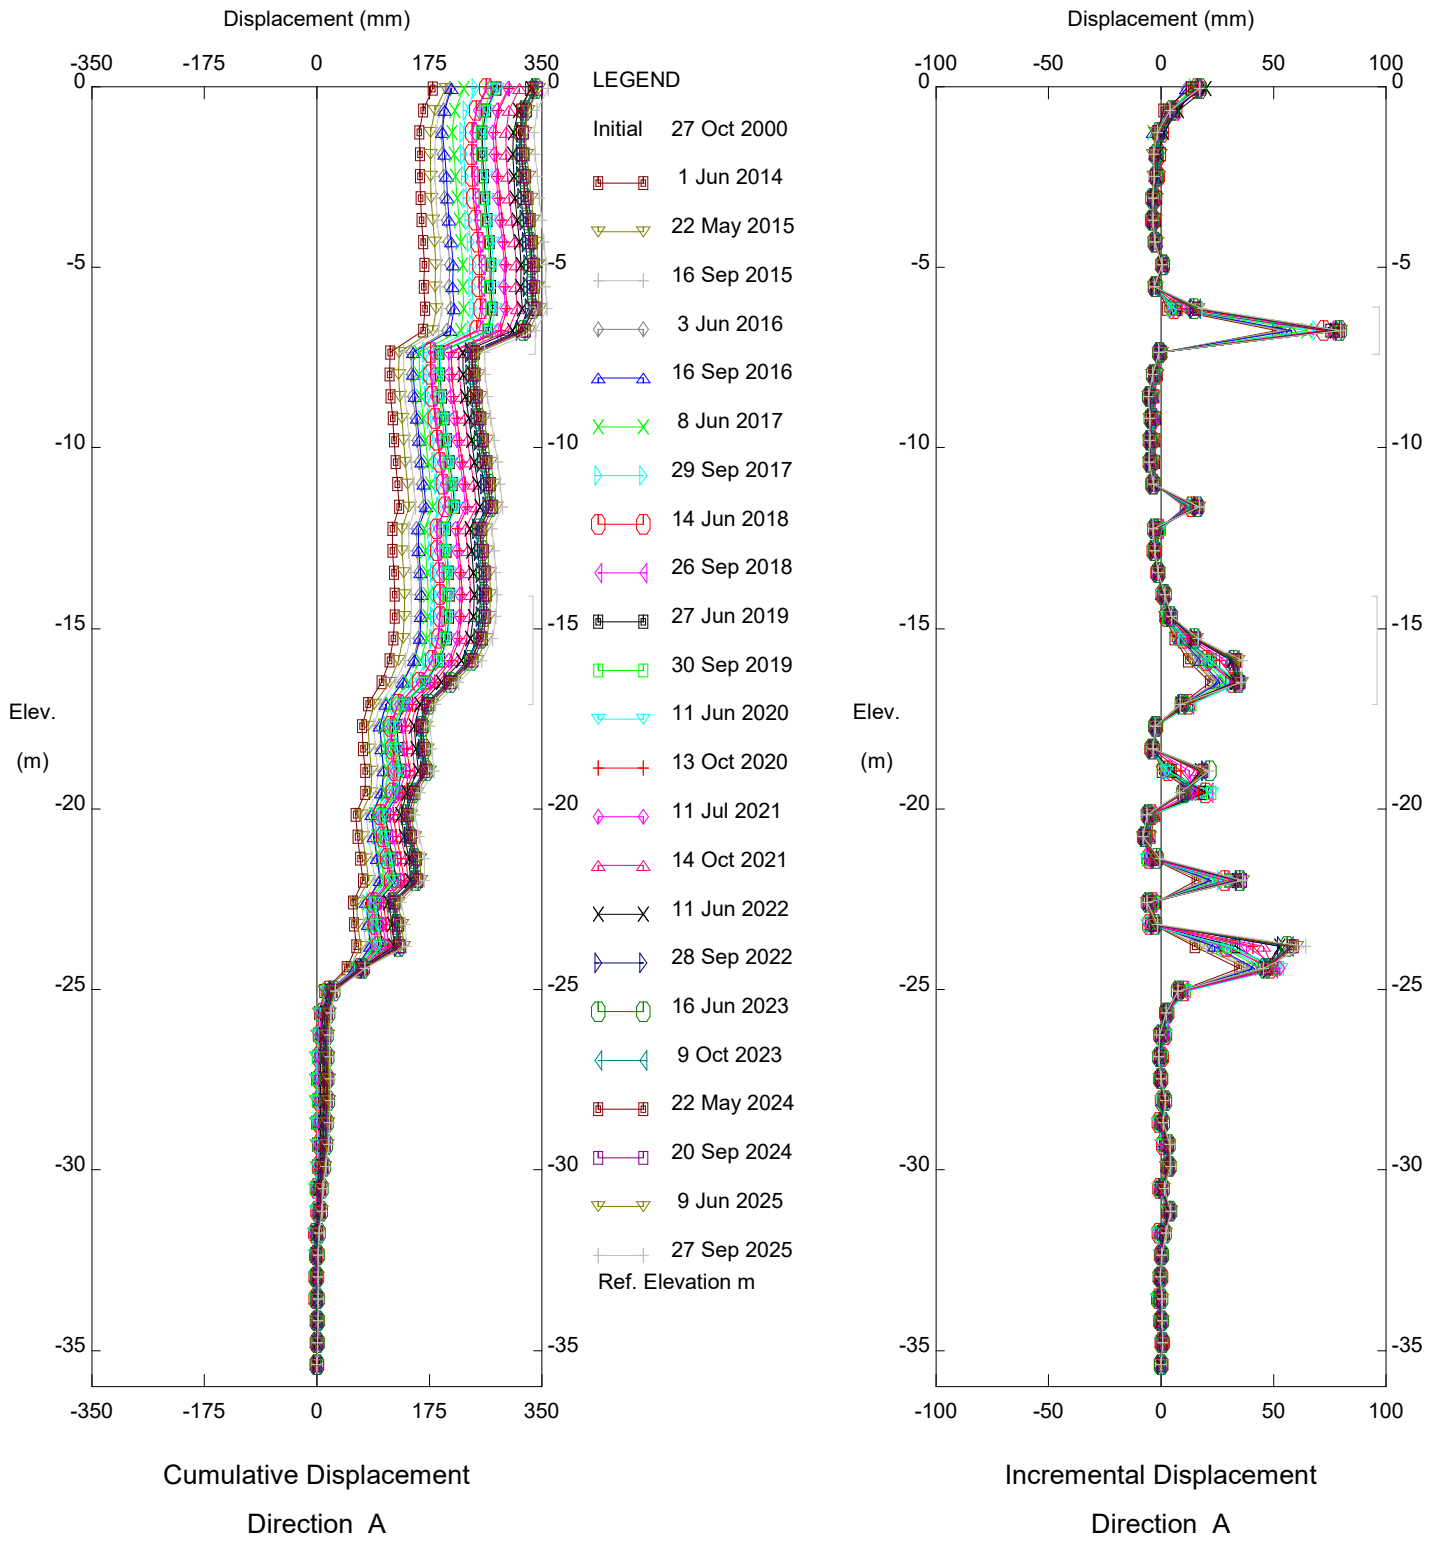
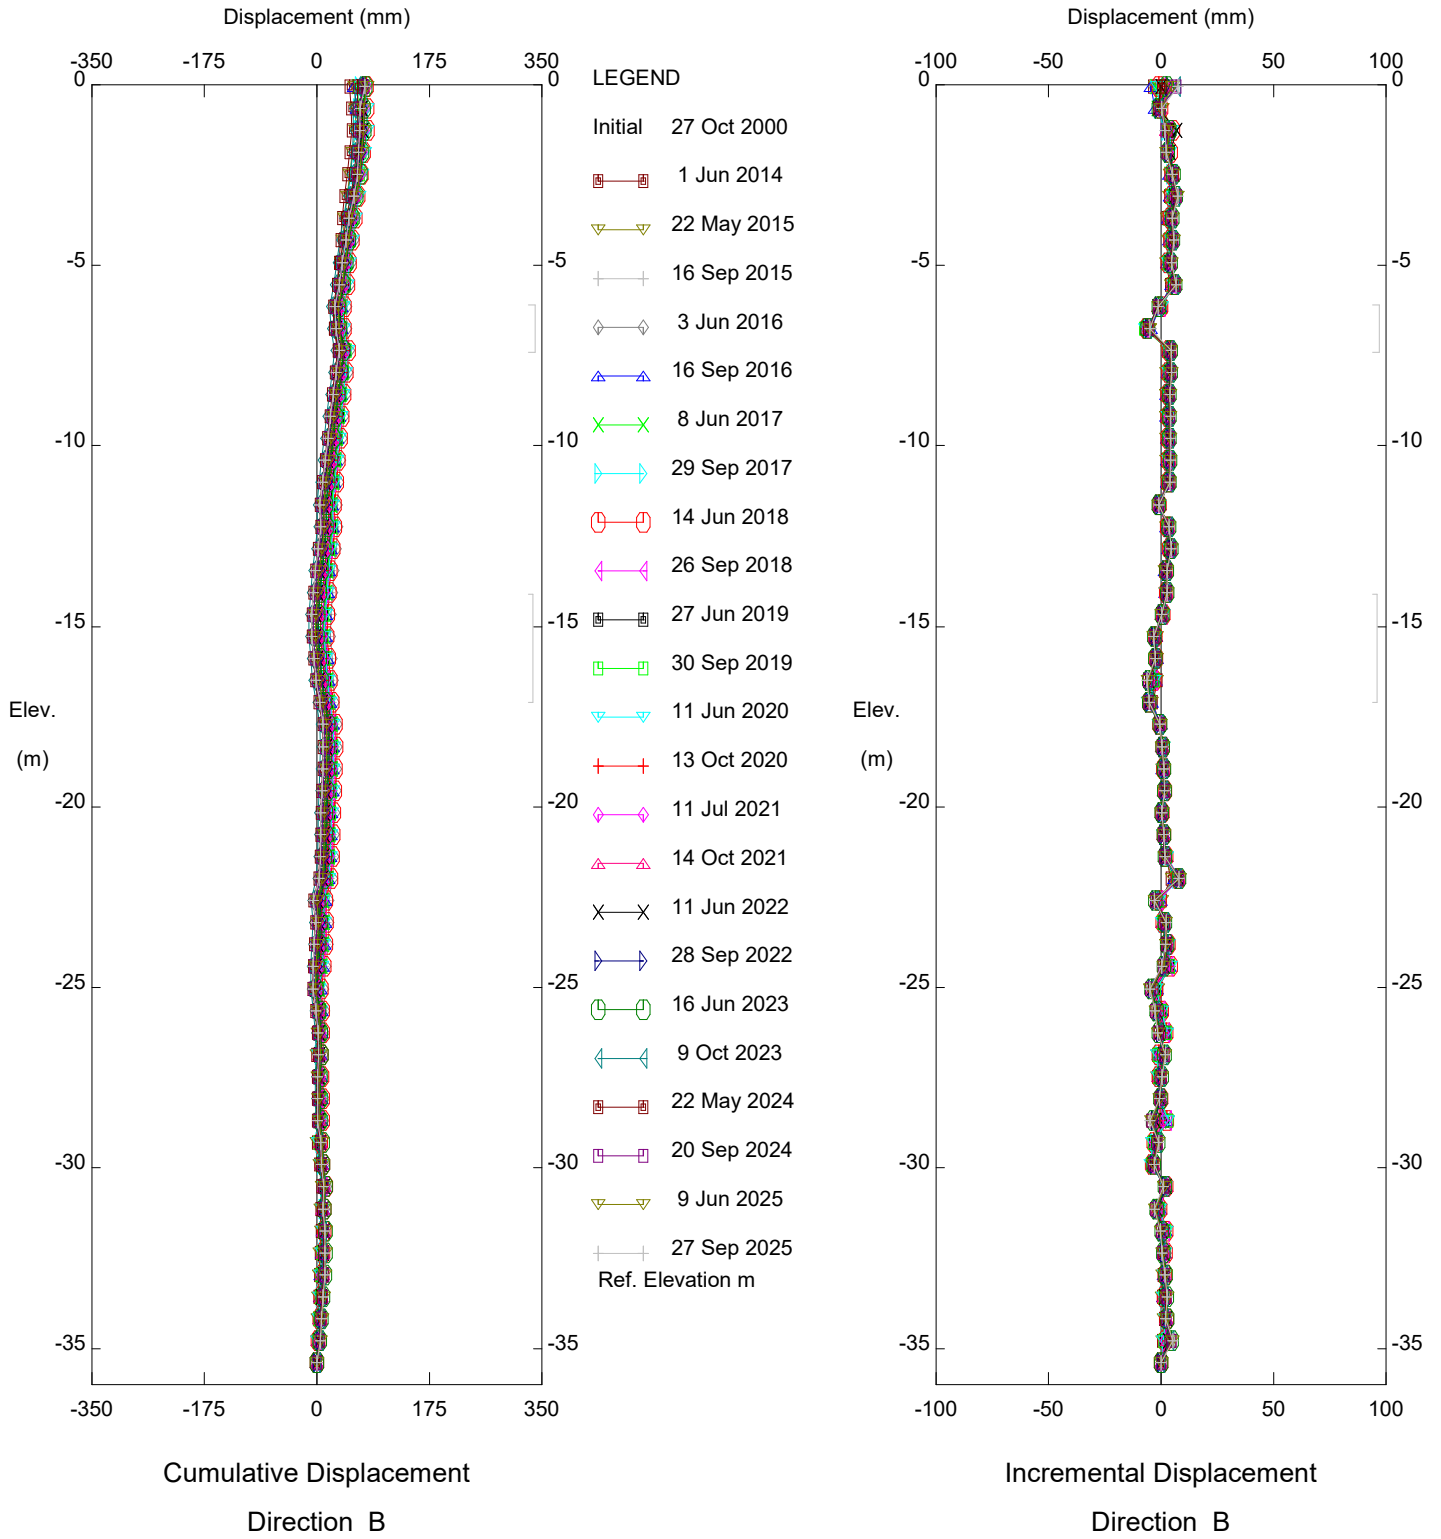
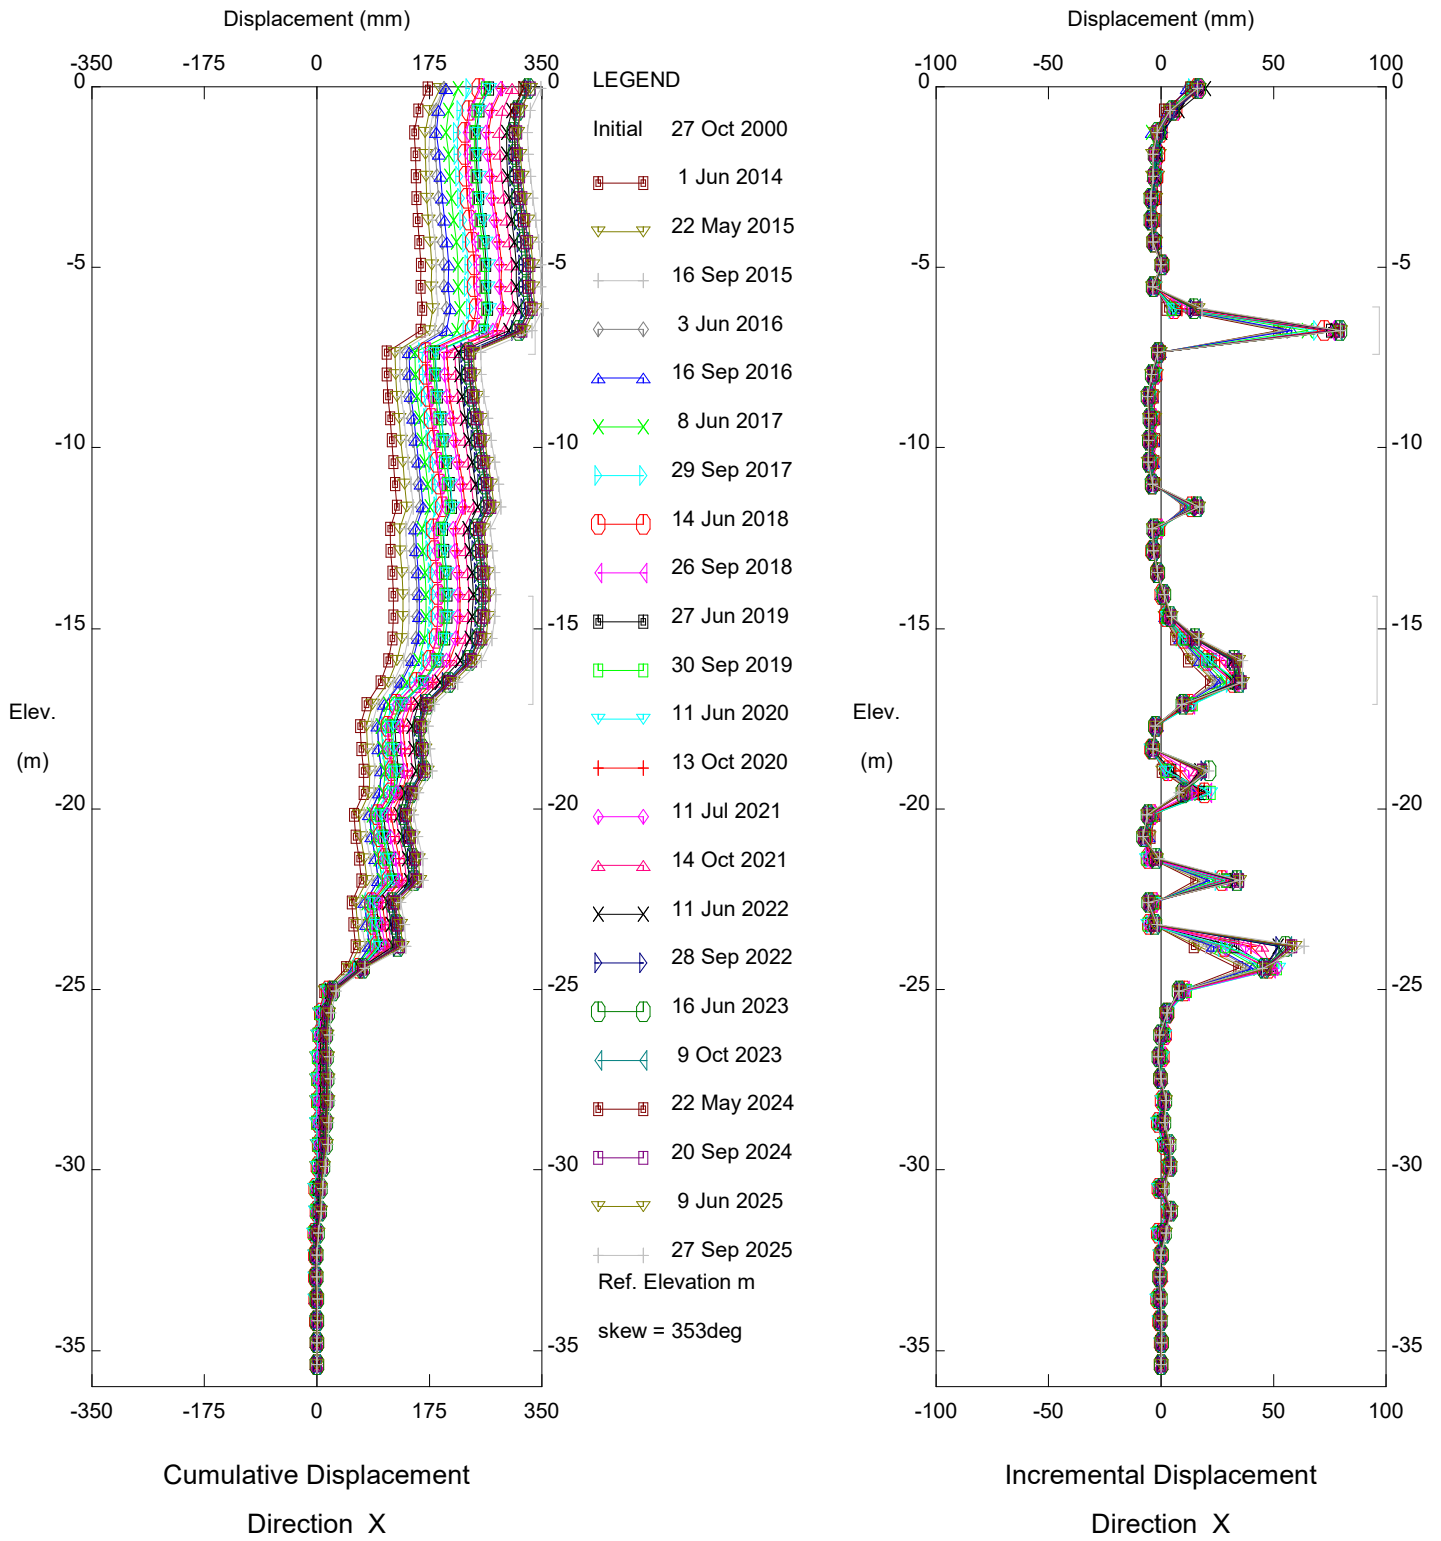
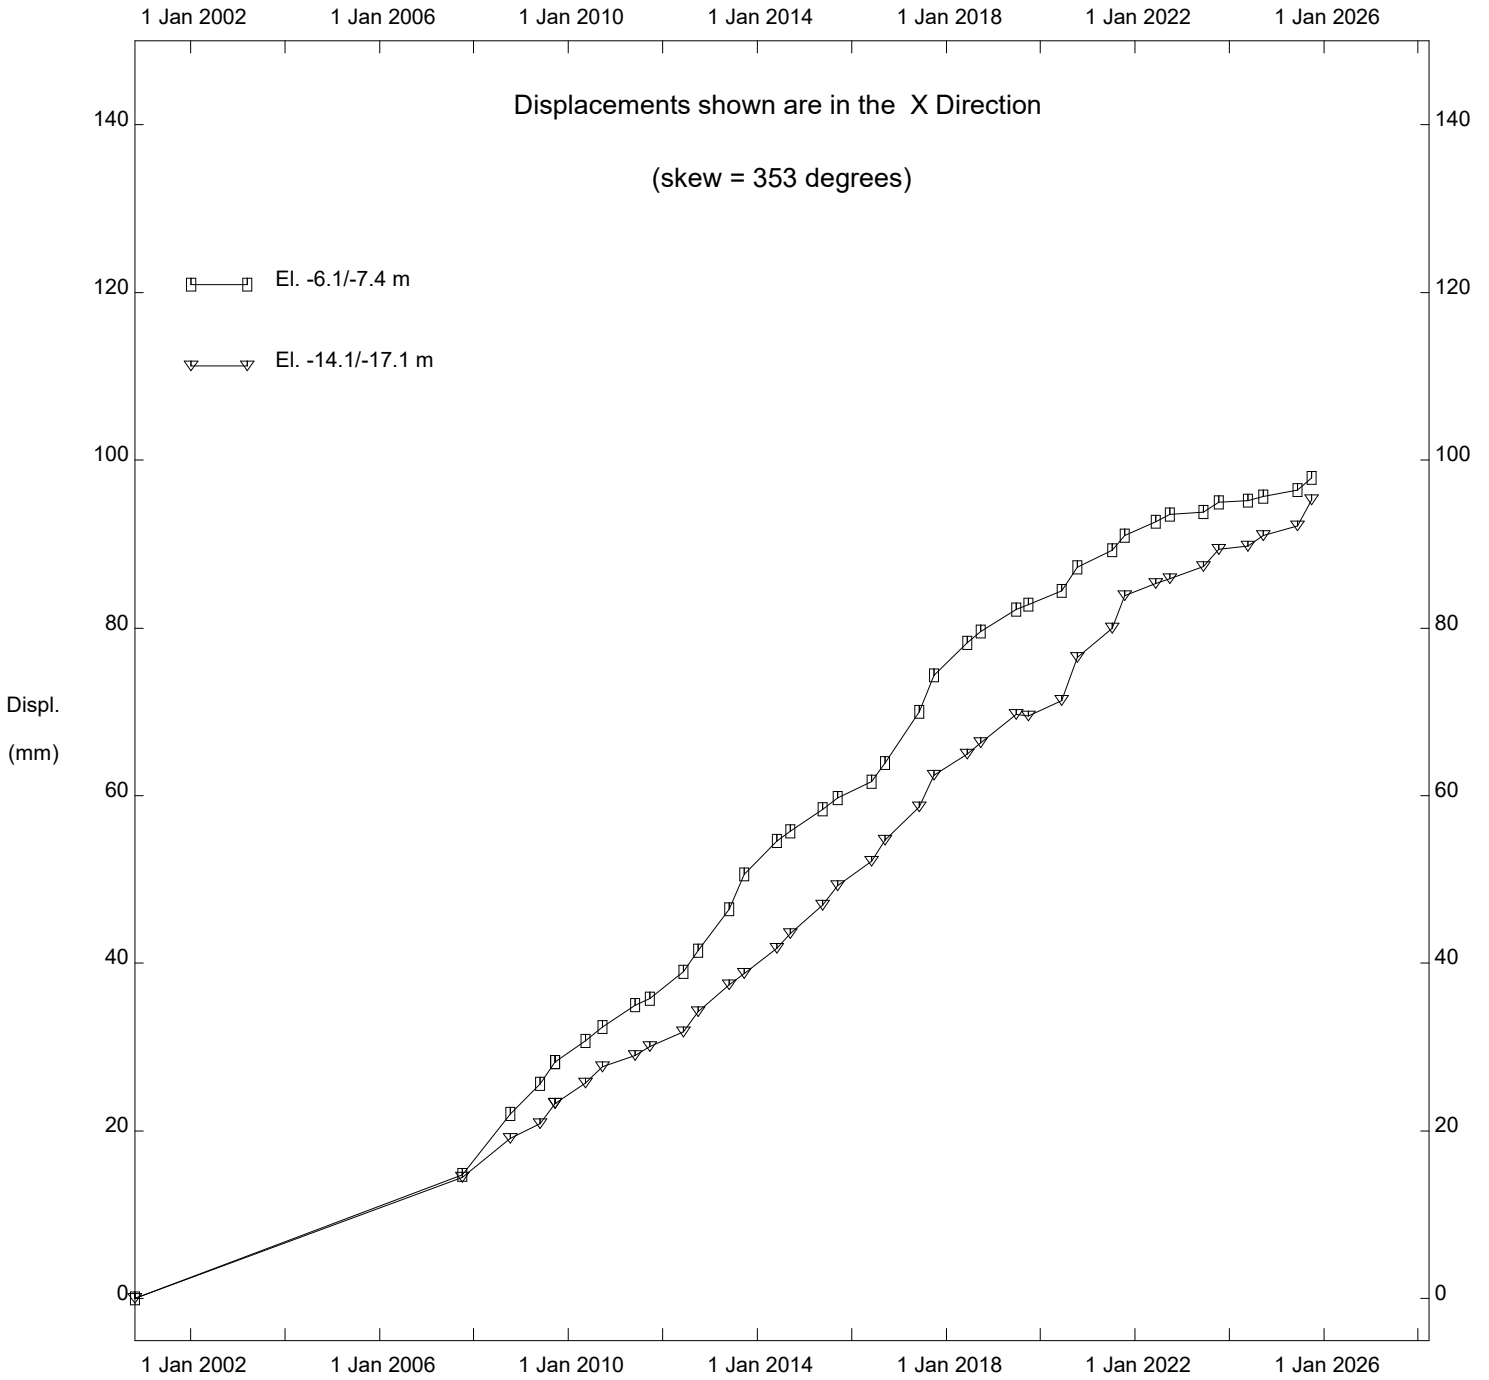
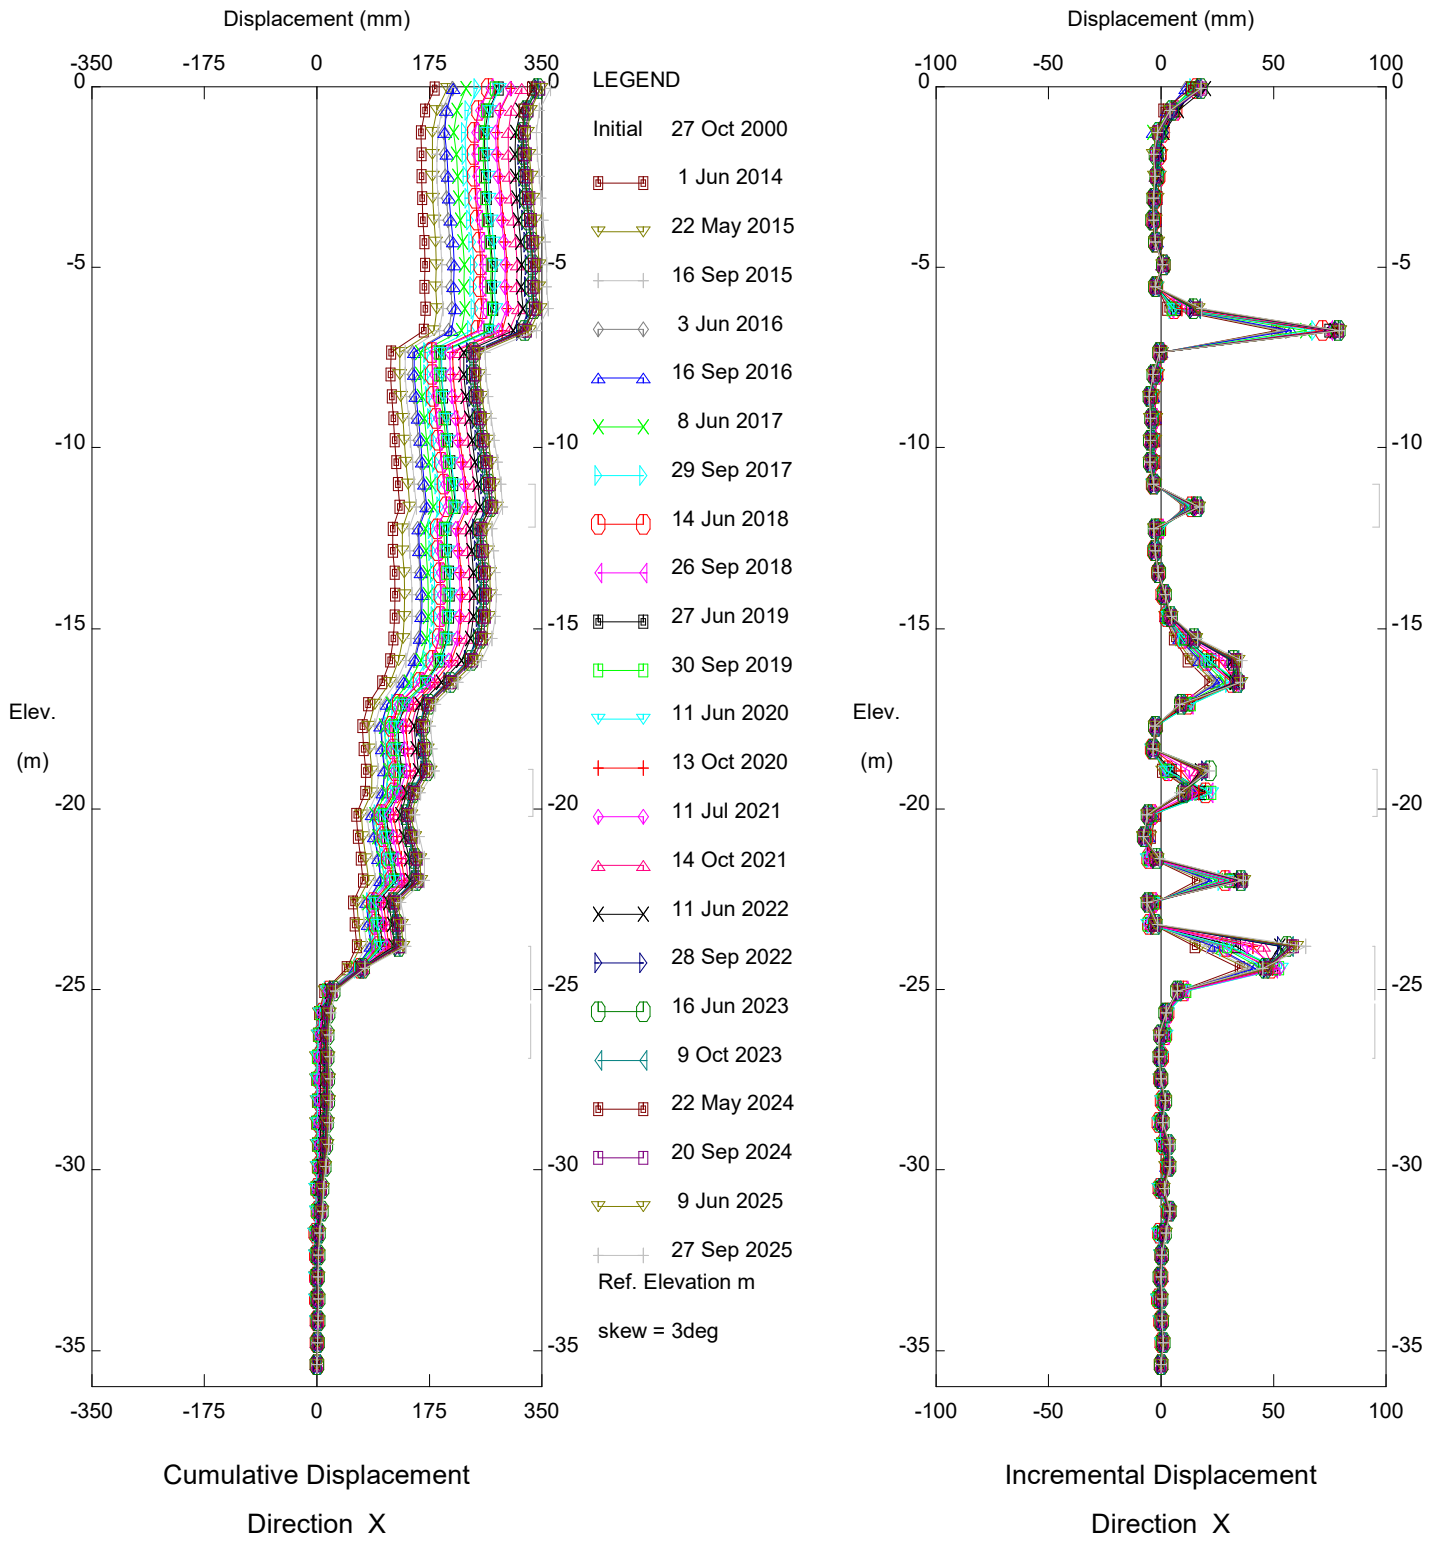
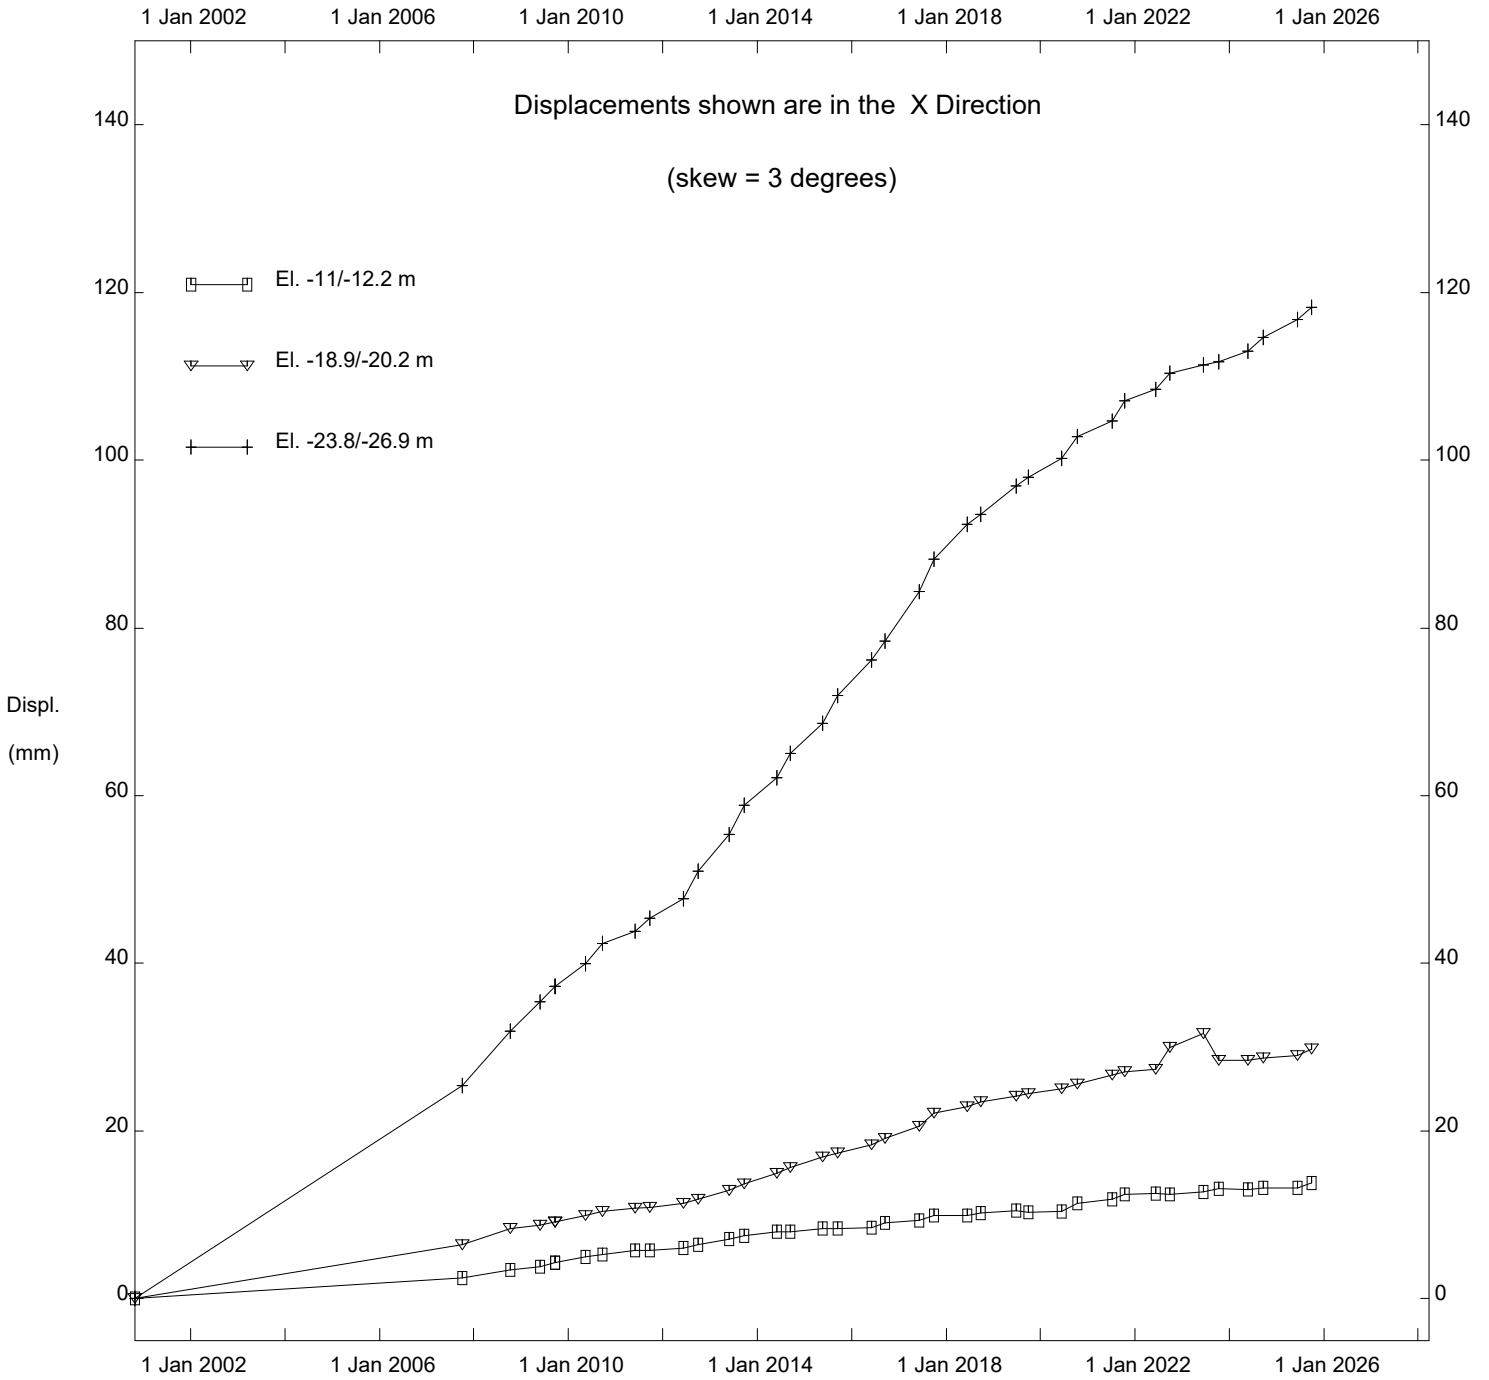
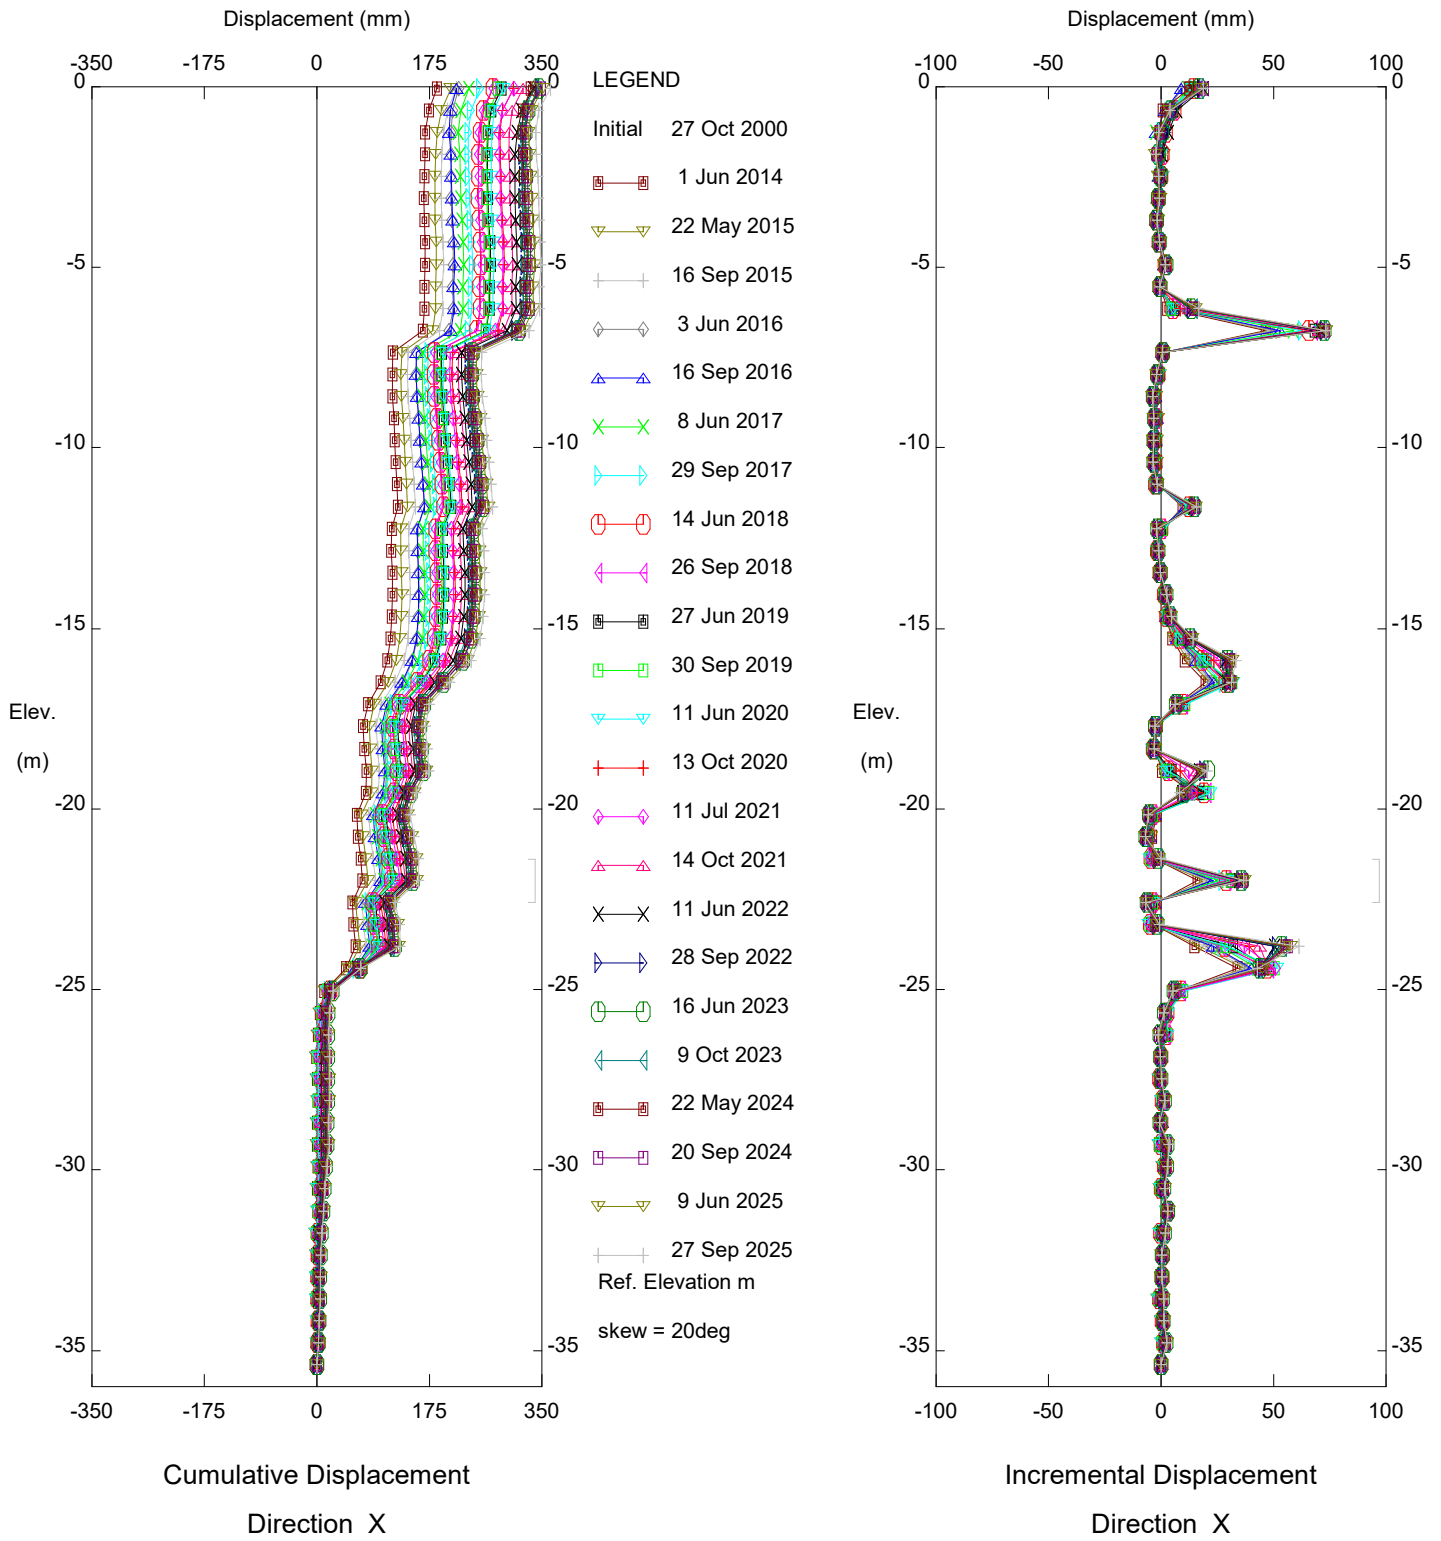
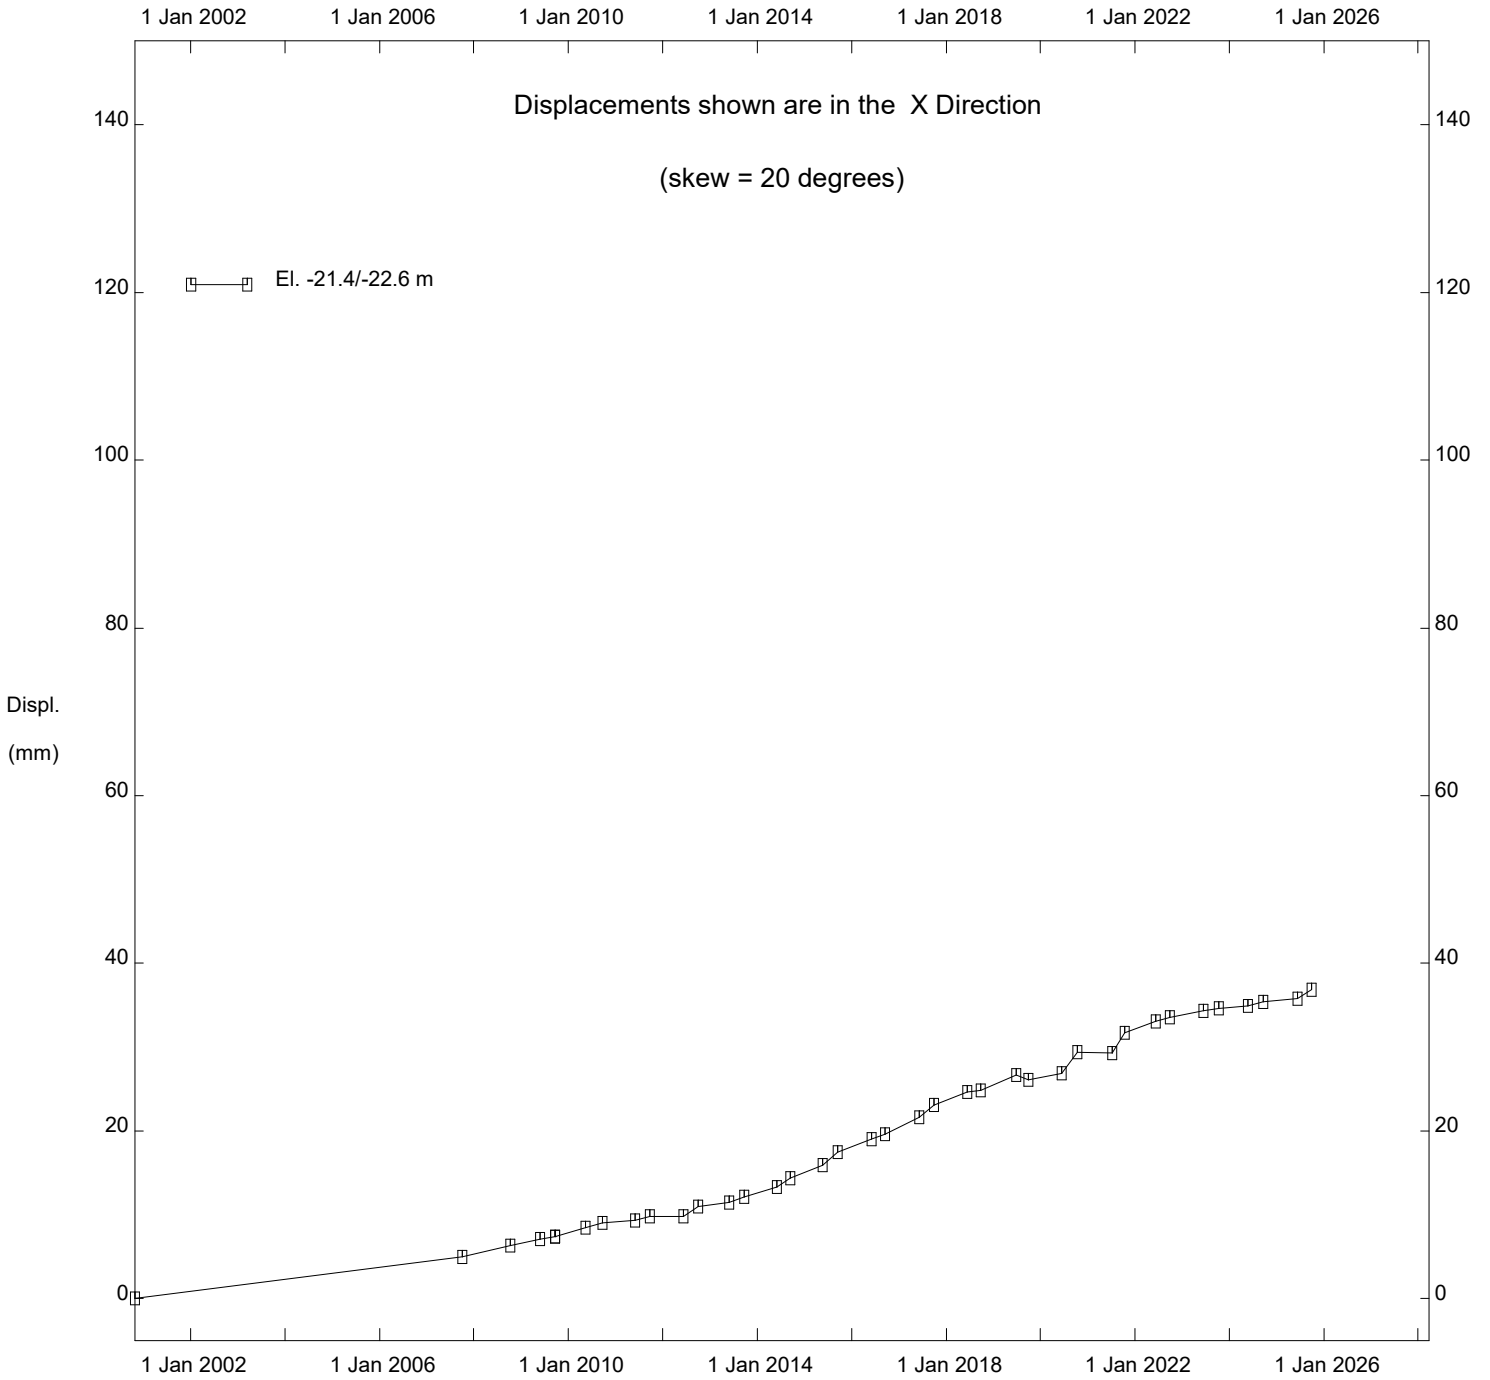
HWY 744:04 - STA. 57+700 to 58+000, Inclinometer SI98-10i

<b>Zones of New Movement:</b>	None
<b>Interpretation of Monitoring Results:</b>	<p><b>Slope Inclonometers</b></p> <p>Slope inclinometer SI98-10i, located about 100 m downslope of the highway showed small incremental movements along six distinct shear planes, since the spring of 2025 readings. The multitude of distinct movement zones speaks to the complexity of ongoing valley wall deformations along Judah Hill. Since the slope indicator was installed in October 2000 the sum of the movements over all these zones is 391.8 mm. The movement rates in these zones has typically ranged between 2.0 mm/yr and 10.4 mm/yr with median rate of 4.7 mm/yr. The movement rates showed increases of 4.1 mm/yr over 6.1 m to 7.4 m depth, 8.8 mm/yr over 14.1 m to 17.1 m depth, 2.0 mm/yr over 11 m to 12.2 m depth, 2.2 mm/yr over 18.9 m to 20.2 m depth, 1.5 mm/yr over 23.8 m to 26.9 m depth, and 2.8 mm/yr over 21.4 m to 22.6 m depth since the previous readings in the spring of 2025.</p> <p>Slope inclinometer SI10-4 is located east of the highway and has one well defined movement zone at 6 m depth in a clay strata, and several subtle movement zones at greater depths in clay and clay till layers. A rate of movement of 1.1 mm/yr was measured over 5.7 m to 6.9 m depth and no discernable movement over 11.8 m to 17.9 m depth since</p>

<p>the spring of 2025 readings. Average movement rates in both zones has typically been below 1.5 mm/yr and the cumulative movement measured is less than 15 mm. The movement is in the direction of the active landslide in the Heart River valley slope, directly opposite from the Michelin Slide direction.</p> <p>SI10-7, located just west of the highway, showed three zones of movement. In the upper clay fill a movement rate of 3.4 mm/yr was measured over 1.9 m to 6.8 m depth; near a sand/clay transition no discernable movement was measured over 8.6 m to 9.8 m depth, and; in a lower clay layer 0.3 mm/yr was measured over 14.1 m to 15.9 m depth, since the spring of 2025 readings. These movement rates are generally consistent with measured rates since 2010.</p> <p>SI10-9, also located just west of the highway, showed one distinct zone of movement and several more subtle movement zones. In the upper clay a movement rate of 1.0 mm/yr was measured over 6.5 m to 7.7 m. The more distinct movement zone was between 11.9 and 14.4 m in a sand layer, where a movement rate of 1.1 mm/yr was measured since the spring of 2025 readings.</p> <p><b>SAA</b></p> <p>SAA10-8 was installed in the casing of SI10-8, and has shown a movement rate of 3.2 mm/yr since the spring of 2025 readings. The movement rate plot for SAA 10-8 shows a consistent annual pattern of movement with accelerating movements in late summer to early winter and decelerating movements in late winter to early summer.</p> <p><b>Piezometers</b></p> <p>Pneumatic piezometers PN10-7 and PN10-8 showed increases in groundwater level of 0.20 m and 1.18 m since the spring of 2025 readings. PN10-4, PN10-6, and PN10-9 showed decreases in groundwater levels of 0.59 m, 0.14 m, and 0.16 m, respectively, since the spring of 2025 readings.</p> <p>VW17-1 showed a decrease in ground water level of 0.09 m since the fall of 2025 readings. VW17-2 has been dry since initialization.</p>
