**ALBERTA TRANSPORTATION AND
ECONOMIC CORRIDORS
GEOHAZARD ASSESSMENT PROGRAM
PEACE REGION (PEACE RIVER DISTRICT)
2025 INSPECTION**

Site Number	Location	Name	Hwy	km
PH032	Judah Hill	Makeout Landslide	744:04	57.924
Legal Description		UTM Co-ordinates (NAD 83)		
SE¼ 20-083-21 W5M		11U E 483171	N 6229947

PH032-1 HWY 744:04 JUDAH HILL - MAKEOUT SLIDE
2025 SITE INSPECTION PLAN

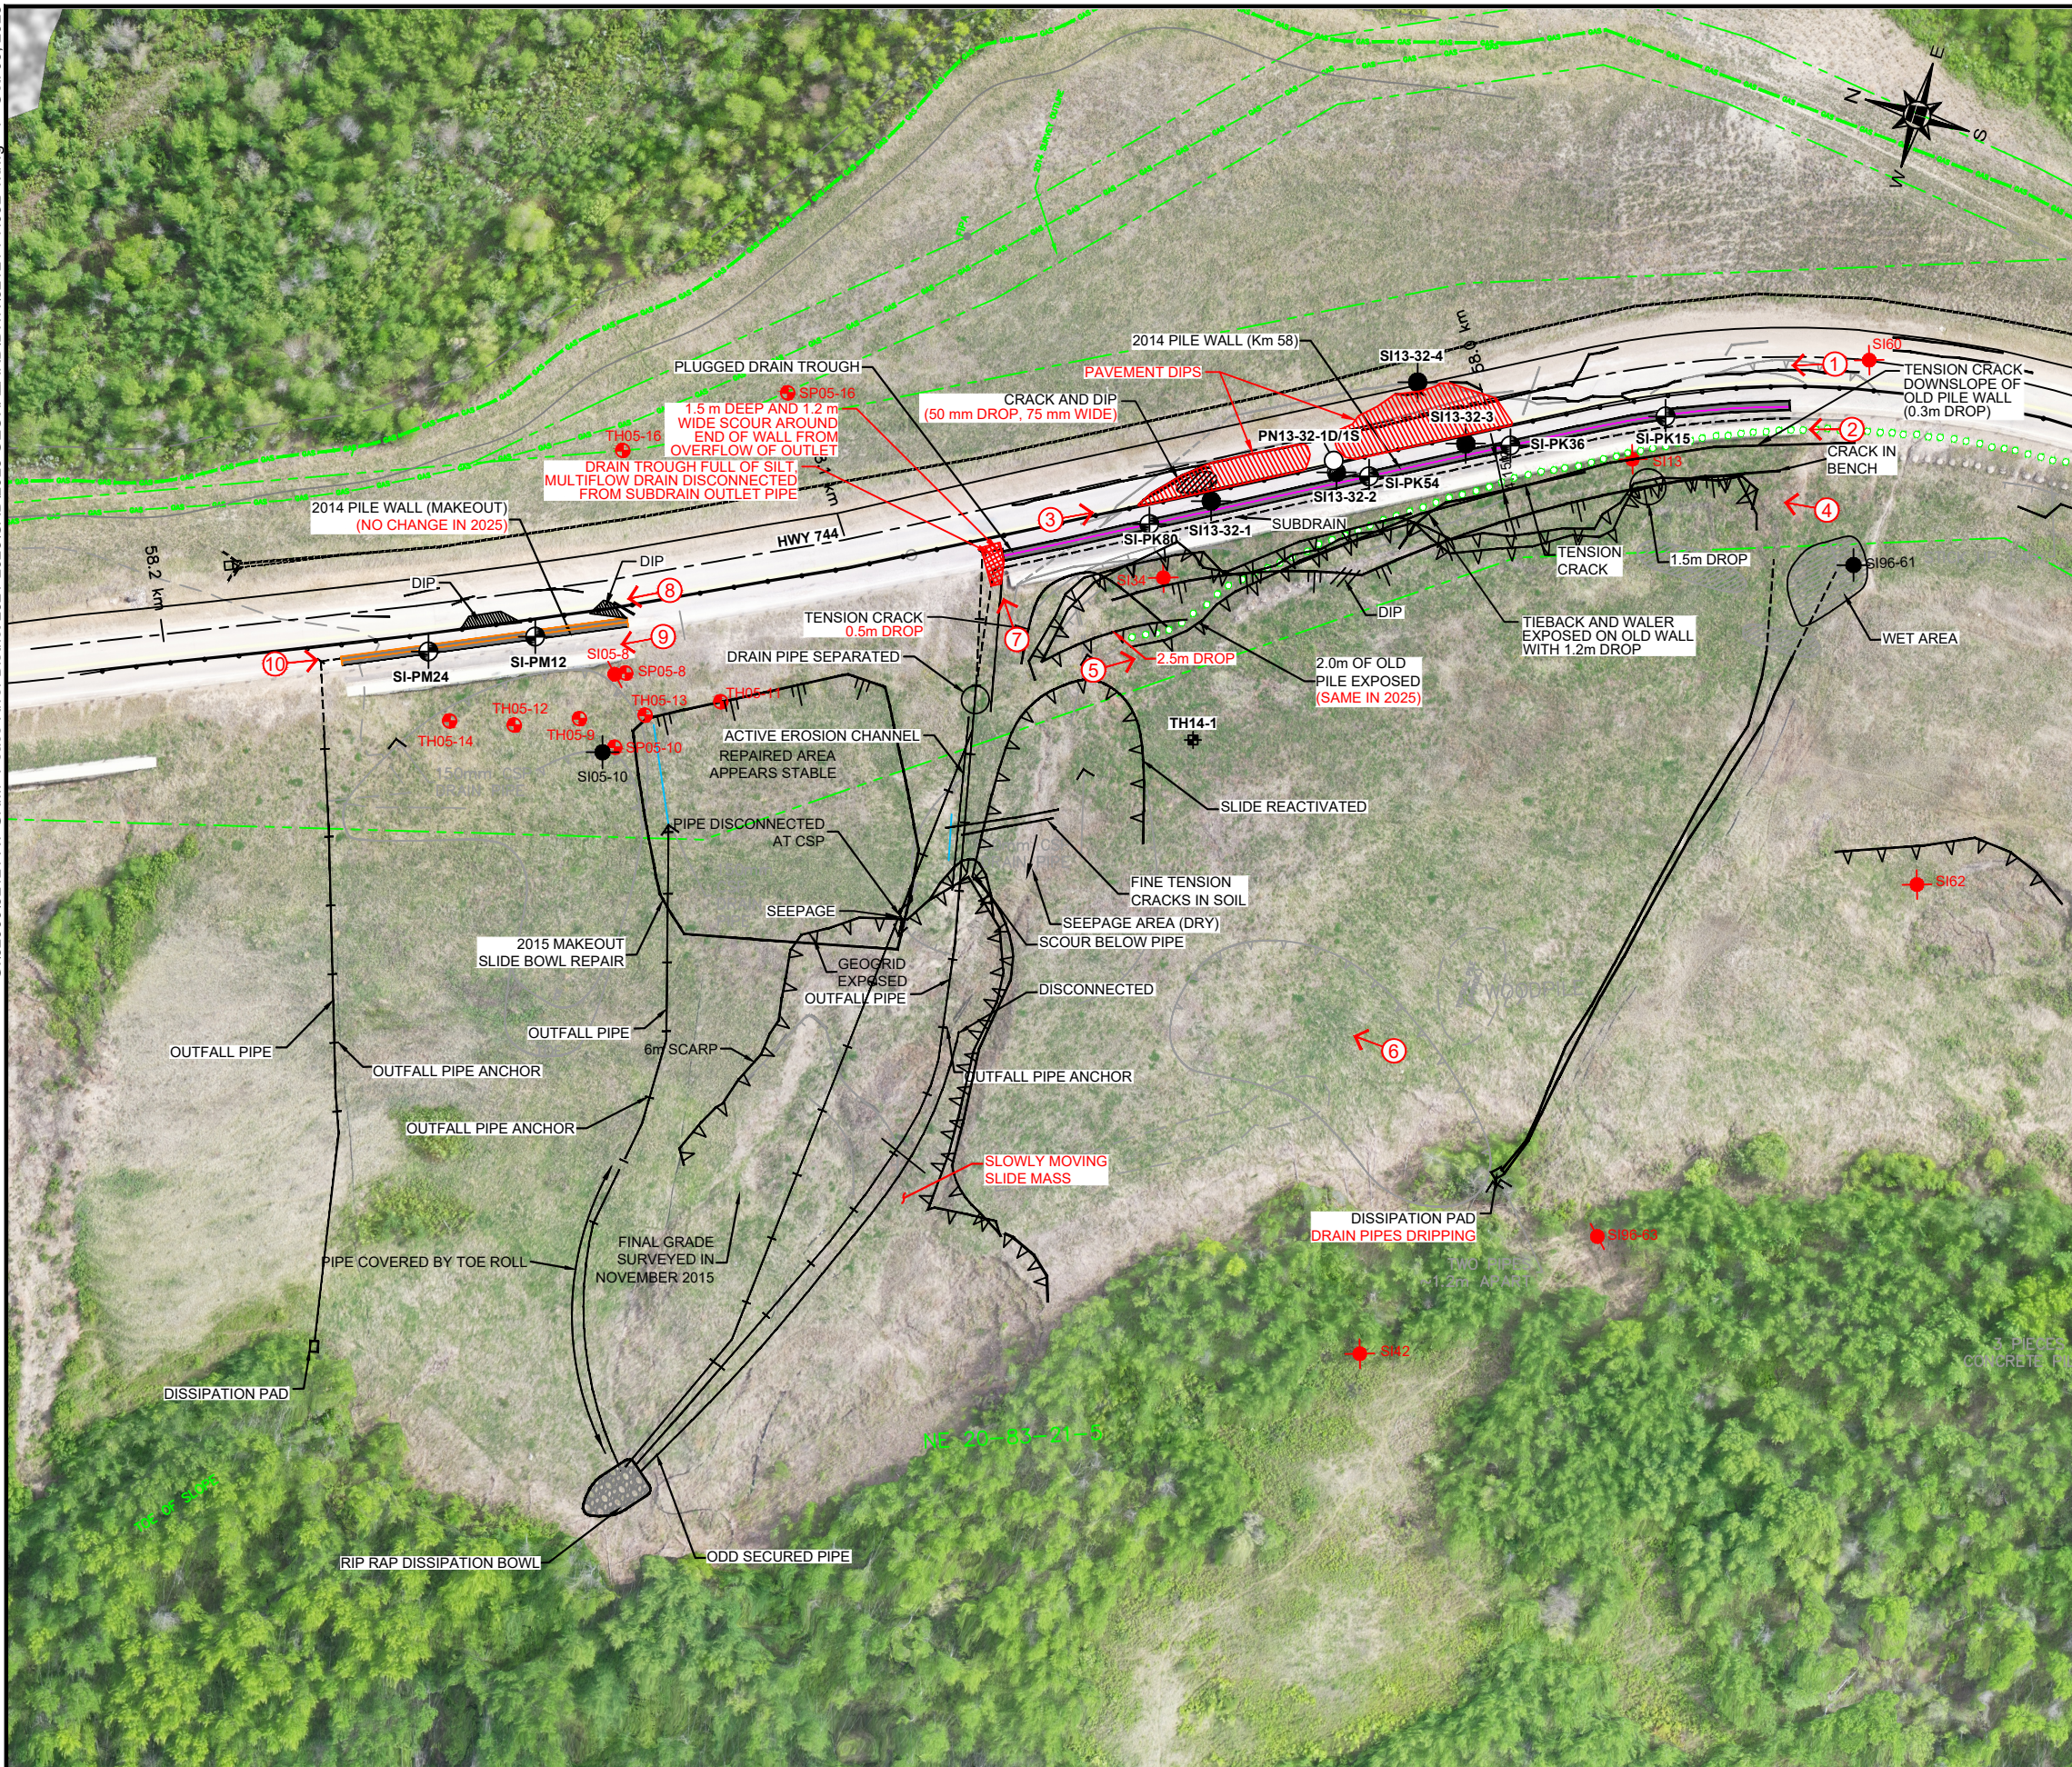
DWG No. 32121-PH032-1

The newly reconstructed slide bowl repair and pile walls appear to be performing well. Recent movement observed in the passive soil bench below the km 58 wall was anticipated and accounted for in the design.

The progressing of the scour below the disconnected drainpipe at the base of the clay backfilled slide bowl will need to be monitored. This slide could grow rapidly in size and retrogress toward the highway if the water leakage is not remediated.

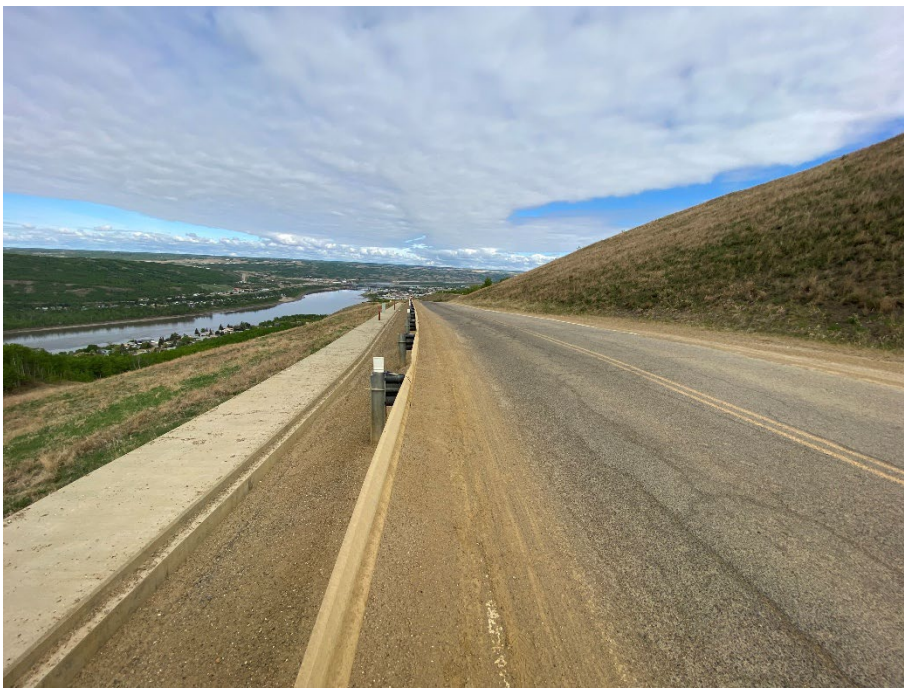
**Photo 1.**

Looking northwest from the SBL shoulder of Hwy 744:04 at km 57.98 along the guardrail above the km 58 pile wall. There have been no major changes in the cracks in the ACP within the southern half of the wall since 2023.

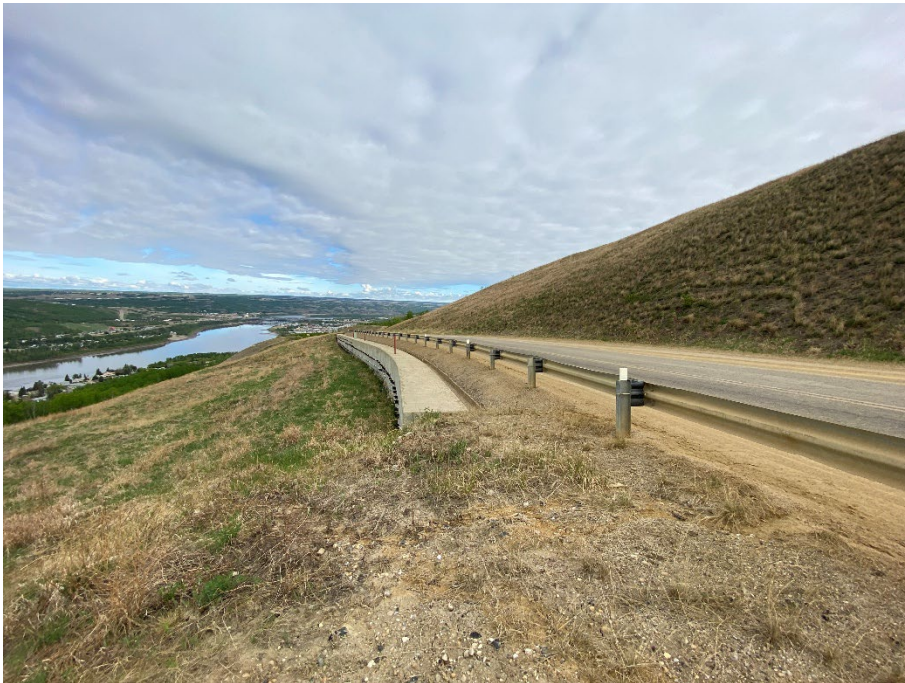
**Photo 2.**

<input type="checkbox"/> Bridge/Culvert		<input type="checkbox"/>	<input type="checkbox"/>
<input checked="" type="checkbox"/> Other	No change observed in the ACP shoulder protective cover at either pile walls (Photos 2, 8 and 10).	<input type="checkbox"/>	<input checked="" type="checkbox"/>

Looking northwest from the south end of the km 58 pile wall. The ACP shoulder protective cover was in good condition. No significant changes were noted downslope of the wall at this site relative to the 2023 condition.

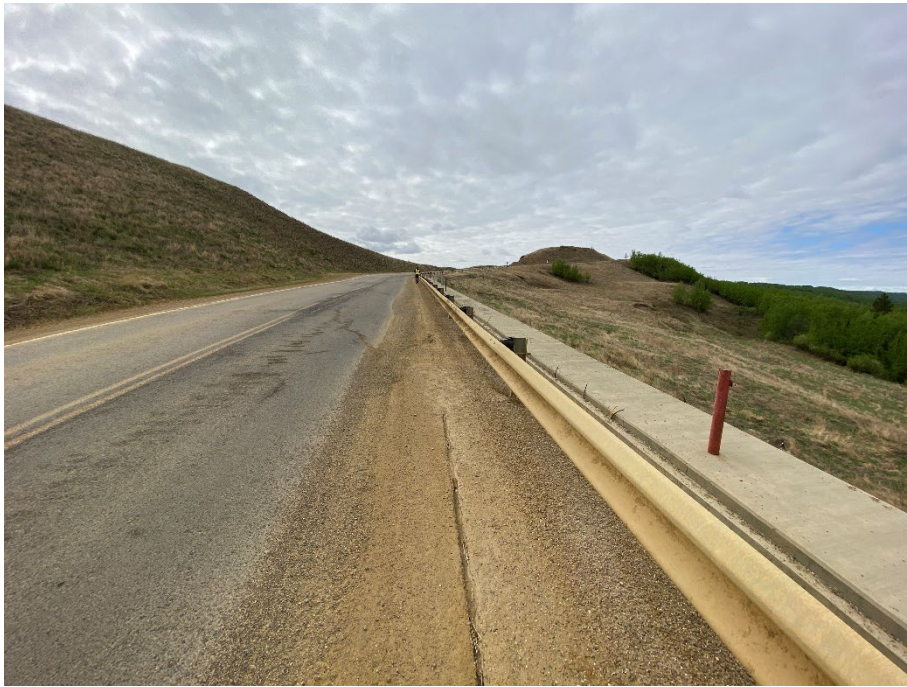
**Photo 3.**

Looking south from the north end of the km 58 pile wall. Overall road condition appeared similar to 2023 condition; tension crack in center of photo had a 50 mm drop with a width of 75 mm.

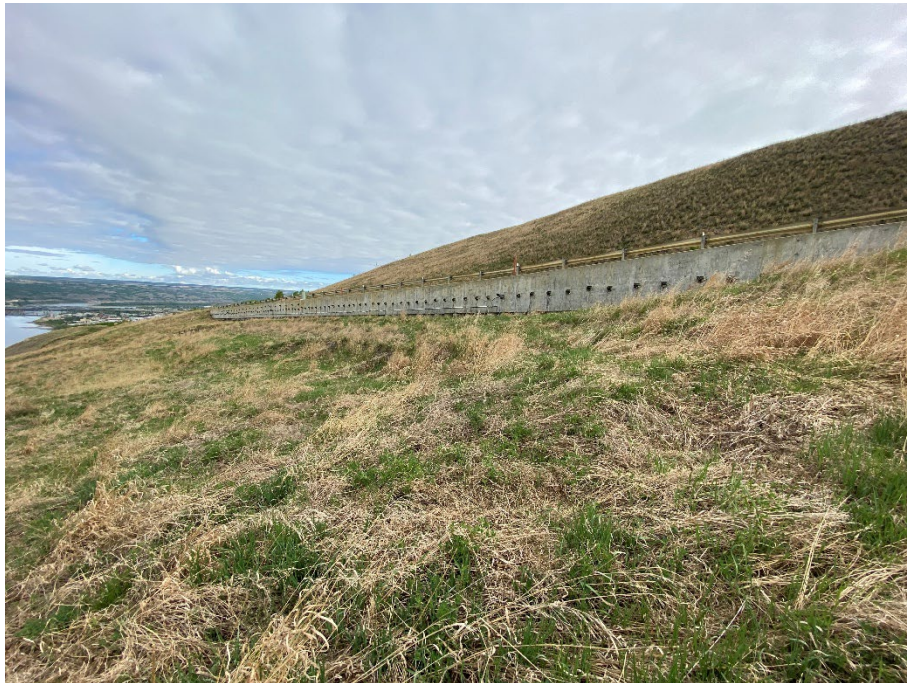
**Photo 4.**

Looking northeast from below the south end of the km 58 pile wall. The old landslide scarps below the pile wall that were regraded in 2015 have ongoing movement with a drop of up to 1.5 m at the south end of the wall.

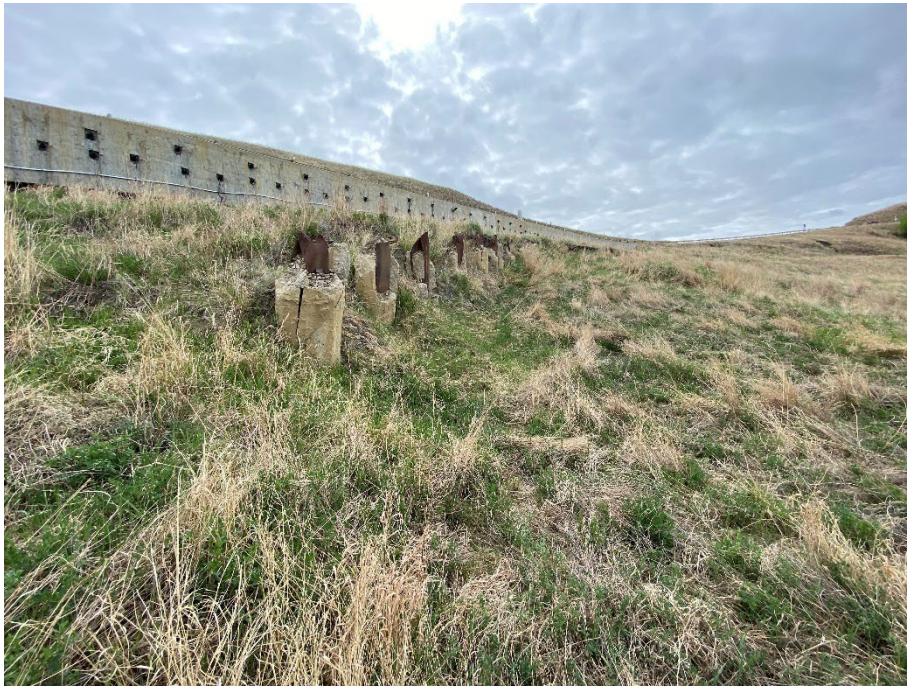
**Photo 5.**

Looking southeast at the landslide scarps downslope from the km 58 pile wall (km 58.07). A tension crack in this area first observed in 2023 had a 0.5 m drop. The old piles are exposed up to 2.0 m in height. Overall drop of 2.5 m at backscarp at south end of old pile wall.

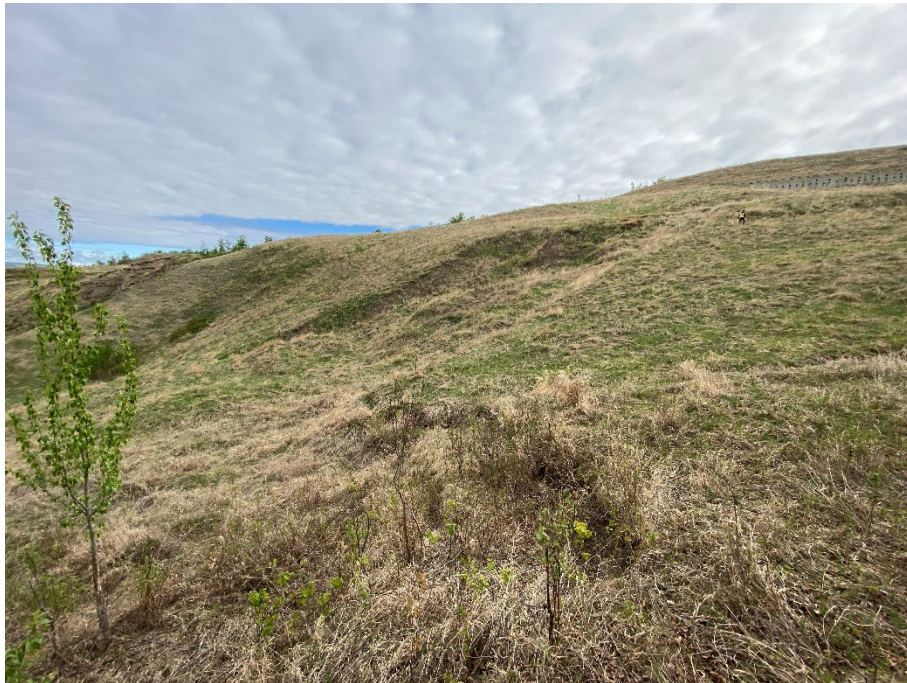
**Photo 6.**

<input checked="" type="checkbox"/> Erosion	<p>Both ends of the km 58 pile wall have become eroded by runoff water and water overtopping the outlet of the pile wall due to blockage of the drain trough with sediment buildup. Scour at the north end of the wall has become worse (up to 1.5 m deep and 1.2 m wide) exposing the gutter and subdrain outlet pipes. Multi-flow subdrain has become disconnected from drainpipe (Photo 7).</p> <p>The solid HDPE outlet drainpipe for the clay backfilled area became disconnected from the perforated CSP drainpipe at the base in 2018 and erosion damage is ongoing.</p>	<input checked="" type="checkbox"/>	<input type="checkbox"/>
<input checked="" type="checkbox"/> Seepage	No major changes observed at previous seepage area in the lower slope area between the pile walls near the active erosion gully (Photo 6).	<input type="checkbox"/>	<input checked="" type="checkbox"/>

Looking at the north flank of the slowly moving lower slide area between the pile walls. Seepage from a disconnected drainage pipe is causing erosion and exacerbating slide movement. No major changes from the 2023 condition.

- The pile wall surface drainage gutters will require to be regularly cleaned to continue to provide erosion protection for the partially buried pile wall and avoid clogging of its solid down drain pipes. The void at the north end of the km 58 pile wall should be backfilled with granular fill and topped with Class 1 riprap to prevent further expansion of the erosion damage. The multi-flow subdrain will also need to be reconnected to the down drain pipe at the km 58 pile wall.
- Some further drainage efforts might be required at the wet area near the south end of the km 58 wall as a future maintenance item as history has shown that persistent seepage can lead to slide movements. The disconnected drainpipe below the north end of the km 58 pile wall should be reconnected to help prevent further retrogression of the landslide scarp that has formed below it.

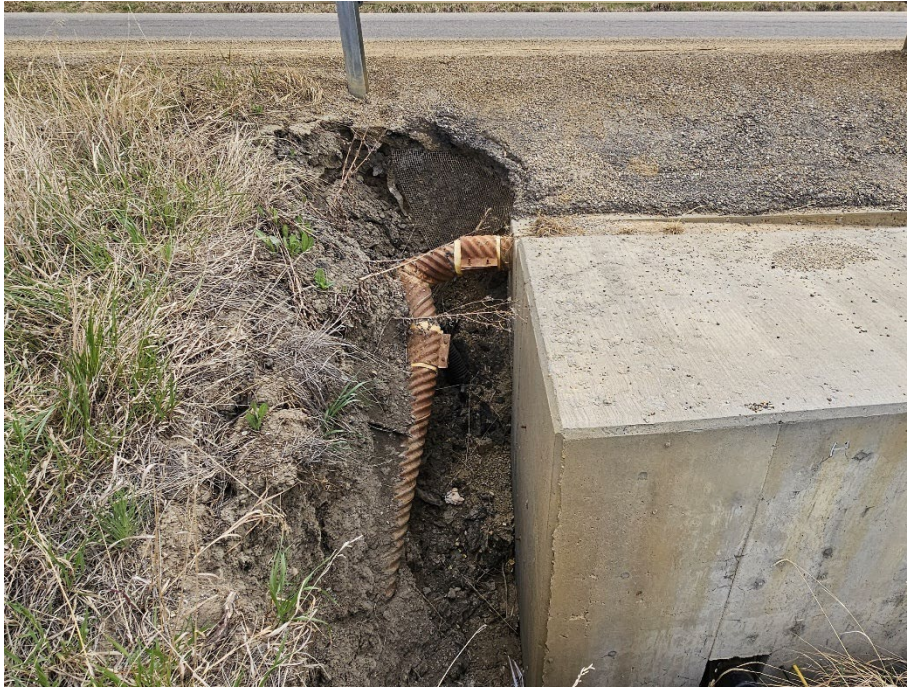
**Photo 7.**

Looking at the north end of the km 58 pile wall where the drain outlet has become blocked and caused water overflow and scour exposing the subdrain and gutter pipes. Multiflow subdrain has become disconnected from the outlet pipe.

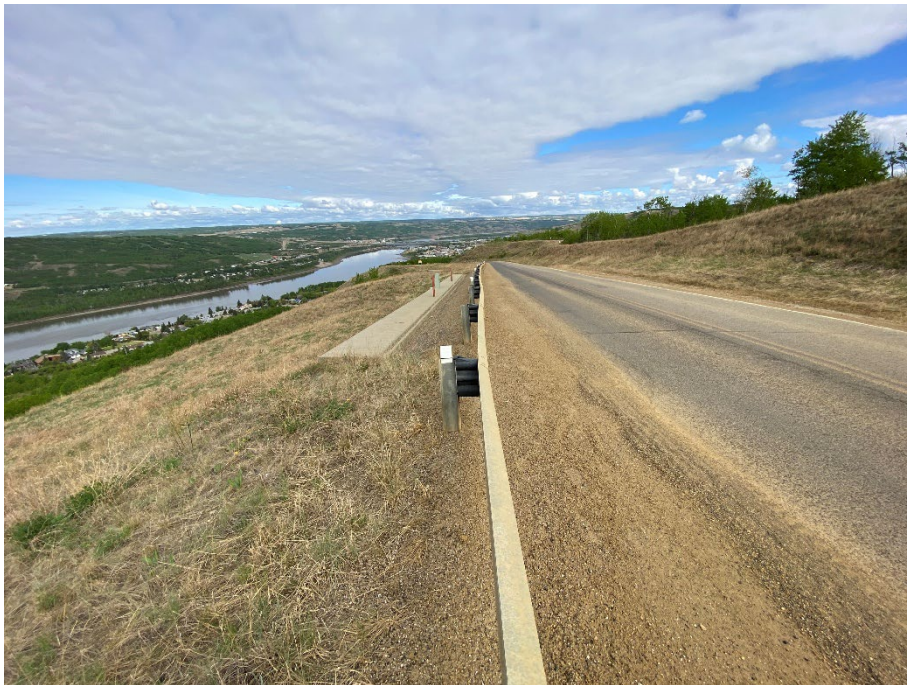
**Photo 8.**

Looking northwest at the highway above the "Makeout" pile wall. Overall condition appeared similar to 2023 inspection.

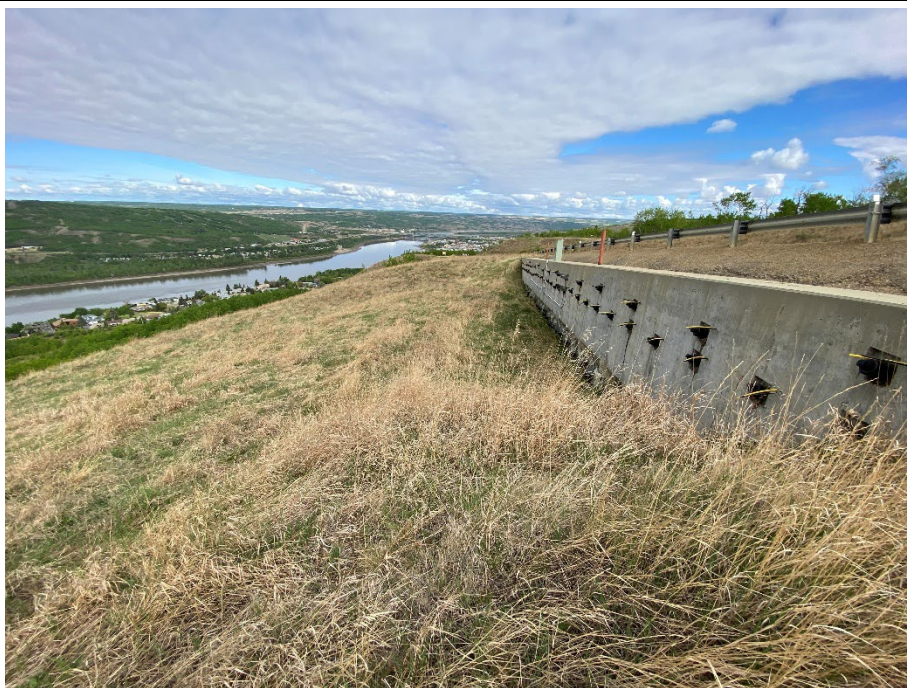
**Photo 9.**

Looking north at the bench and graded area below the “Makeout” pile wall. Area appeared in good condition and had no observable changes from 2023.

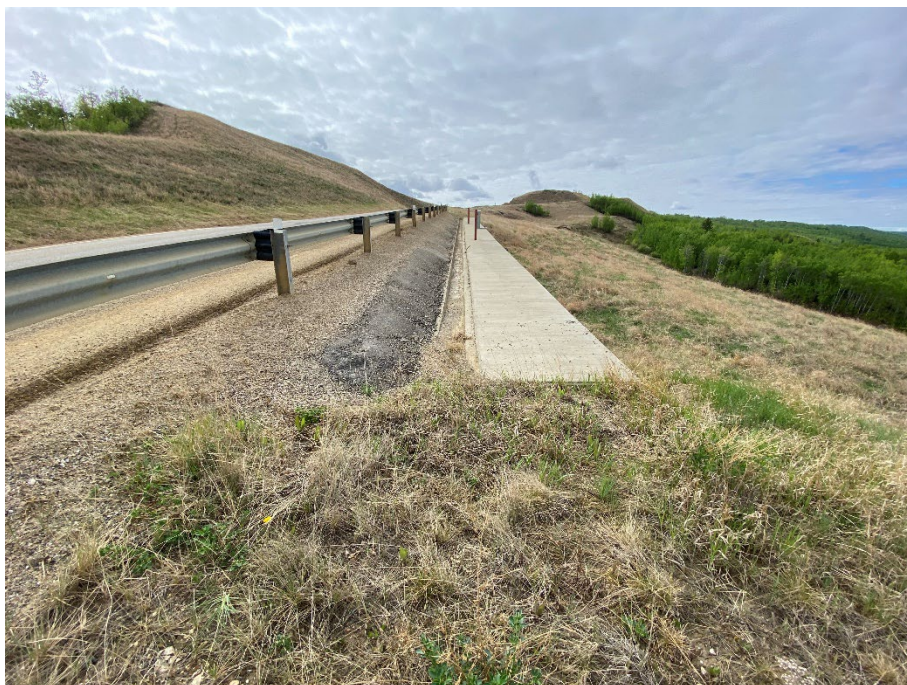
**Photo 10.**

Looking at the north end of the top of the “Makeout” pile wall. Drainage trough inlet was relatively clear and functioning.
