ALBERTA TRANSPORTATION AND
ECONOMIC CORRIDORS
GEOHAZARD ASSESSMENT PROGRAM
PEACE REGION (PEACE RIVER DISTRICT)
2025 INSPECTION

Site Number	Location	Name	Hwy	km
PH041	Daishowa East Hill	Daishowa Ditch Erosion (formerly referenced as Site 5 km31.6 to km32)	986:01	31.916
Legal Description		UTM Co-ordinates		
NE12-85-21 W5M		11V E 489875	N	6246293

Date	PF	CF	Total
Previous Inspection:	18-July-2024	9	4	36
Current Inspection:	14-May-2025	9	4	36
Road AADT:	1020		Year:	2024
Inspected By:	Rocky Wang, TEC		Tyler Clay, Thurber Don Proudfoot, Thurber	
Report Attachments:	<input checked="" type="checkbox"/> Photographs		<input checked="" type="checkbox"/> Plans	<input type="checkbox"/> Maintenance Items

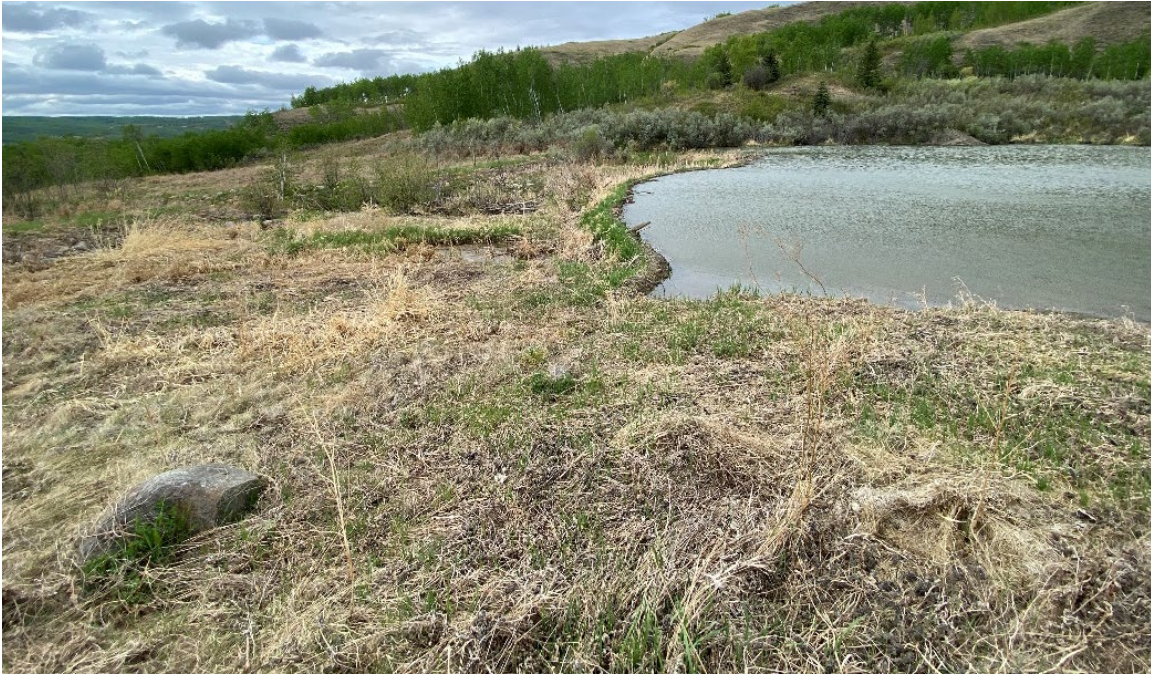
Photo 41-01.: Standing by the beaver dam near km 31.95 looking north at the upstream pond. Dam was intact and previous 2024 breach areas had been infilled from beaver activity.

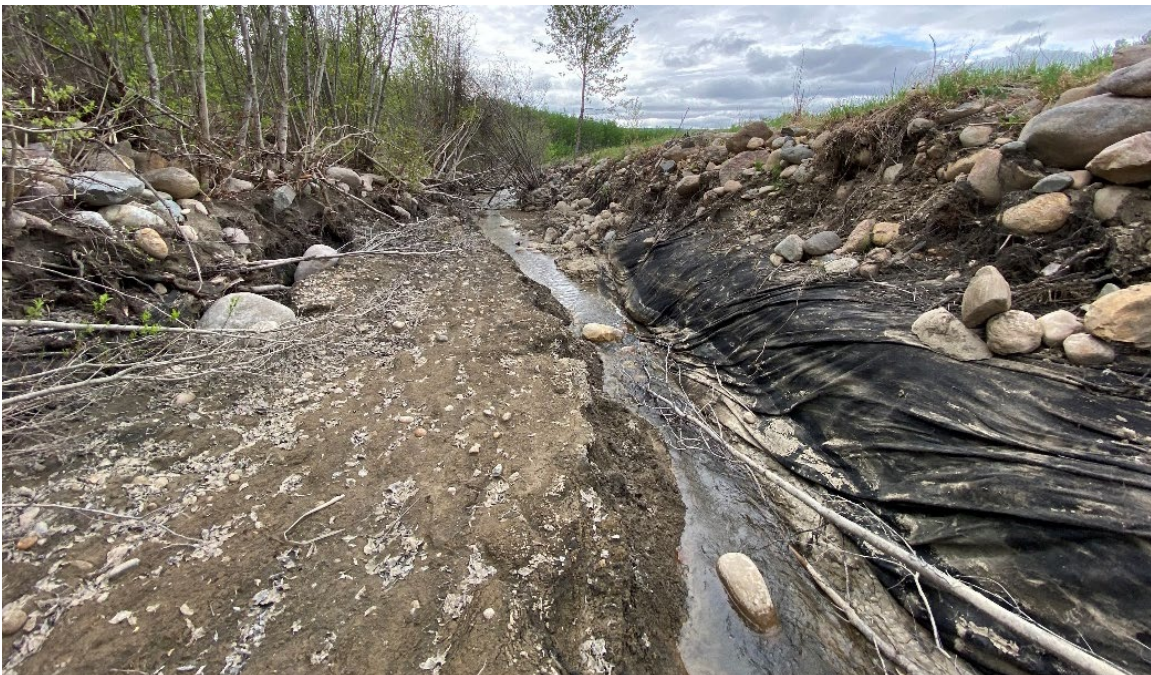
Photo 41-02.: Looking west (downstream) at the downcutting erosion within the channel near km 31.75 from the 2024 high flow event that washed out the riprap and exposed the geotextile. Erosion was slightly deeper within the thalweg relative to the 2024 condition.

- Salvage and redistribute washed-out riprap to upstream areas with significant scour/soil exposure placed over non-woven geotextile. Redistribute some of the washed out rock to protect the more vulnerable exposed bank areas on the drop structure.

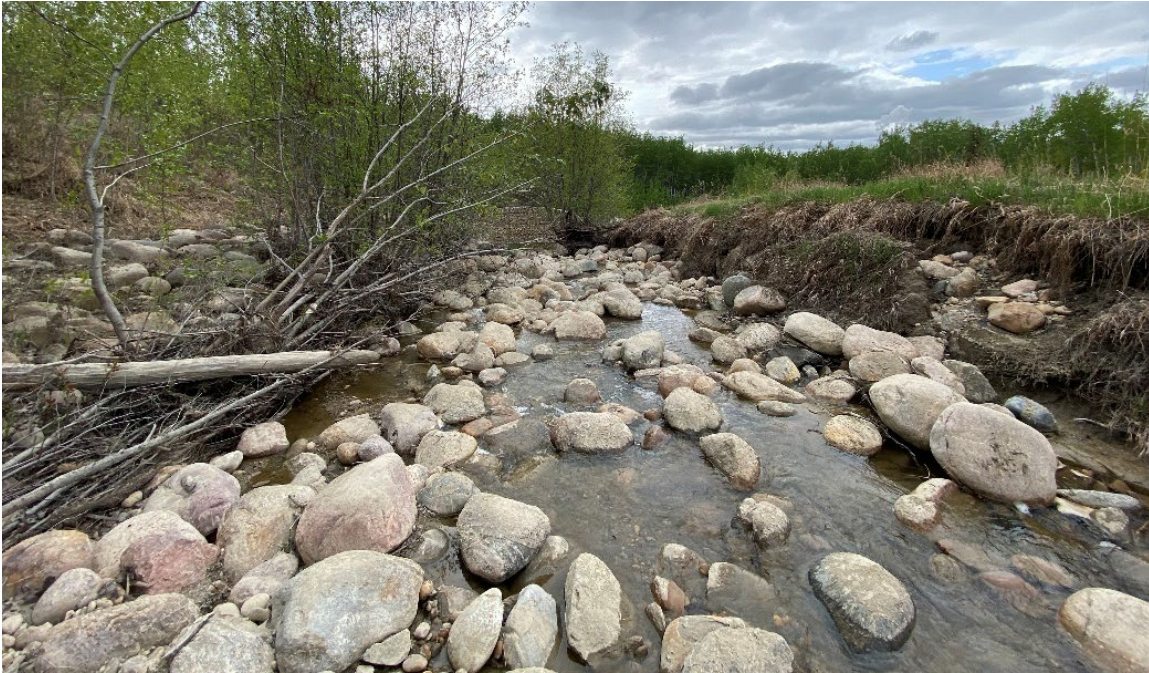
Photo 41-03.: View downstream (west) of the riprap displacement and north bank undermining near km 31.825. Some additional bank slumping relative to the 2024 condition.

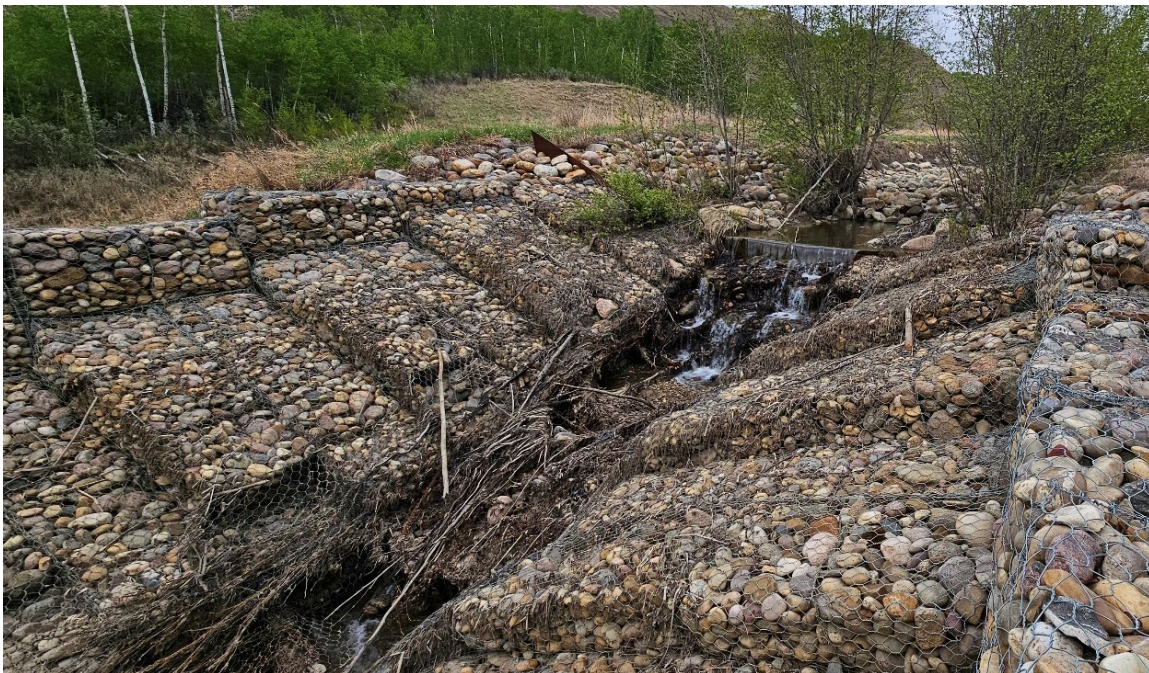
Photo 41-04.: View from the top/inlet of the curved gabion drop structure looking towards the northeast near km 31.79. Within the centre of the structure there was major basket deformation, broken basket wires and loss of rock due to downcutting within the thalweg. Scour below the baskets has resulted in an approximately 1 m drop in channel elevation. No major change from 2024.

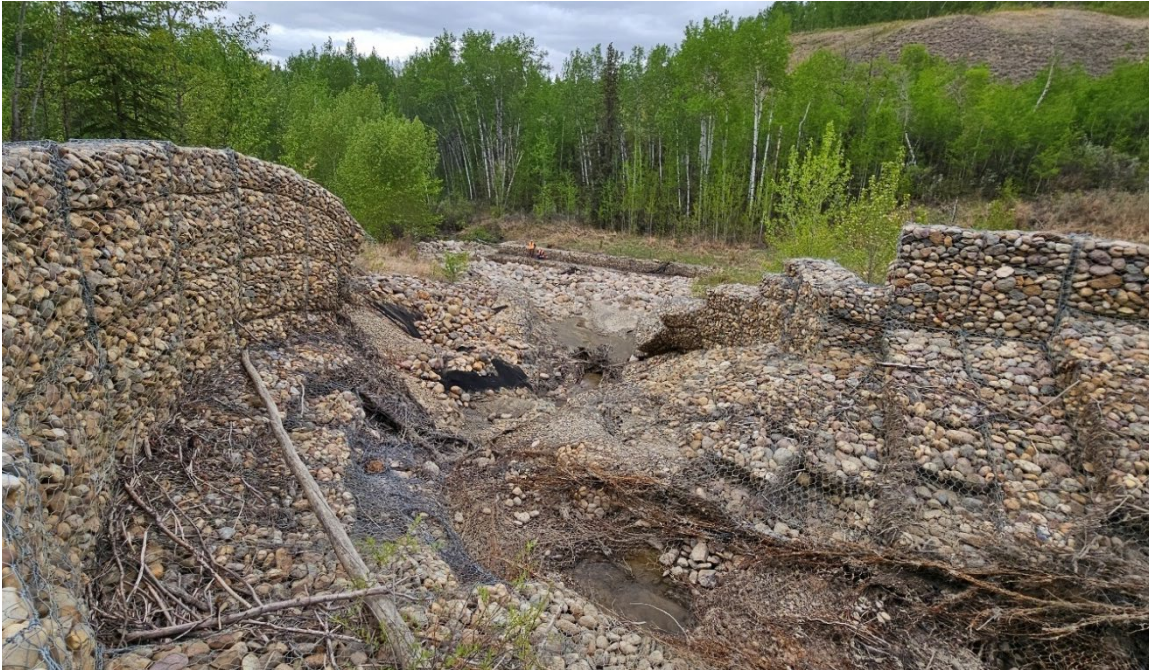
Photo 41-05.: View downstream (north) at the corner of the drop structure with extensive damage to the gabion baskets and wood debris buildup. Condition appeared slightly worse relative to the 2024 condition.

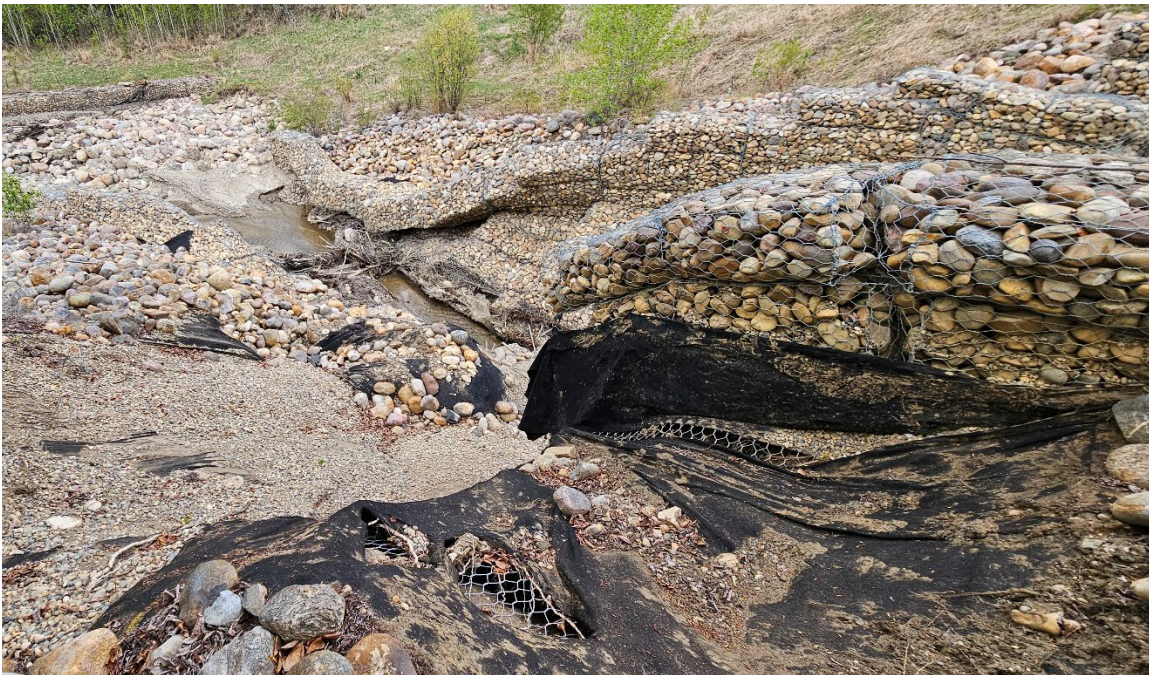
Photo 41-06.: View towards the northeast at the top of the gabion sidewall section that pulled apart and collapsed due to deep scour that undermined the base of the structure within the lower section. Some additional basket deformation and rock loss relative to the 2024 condition.

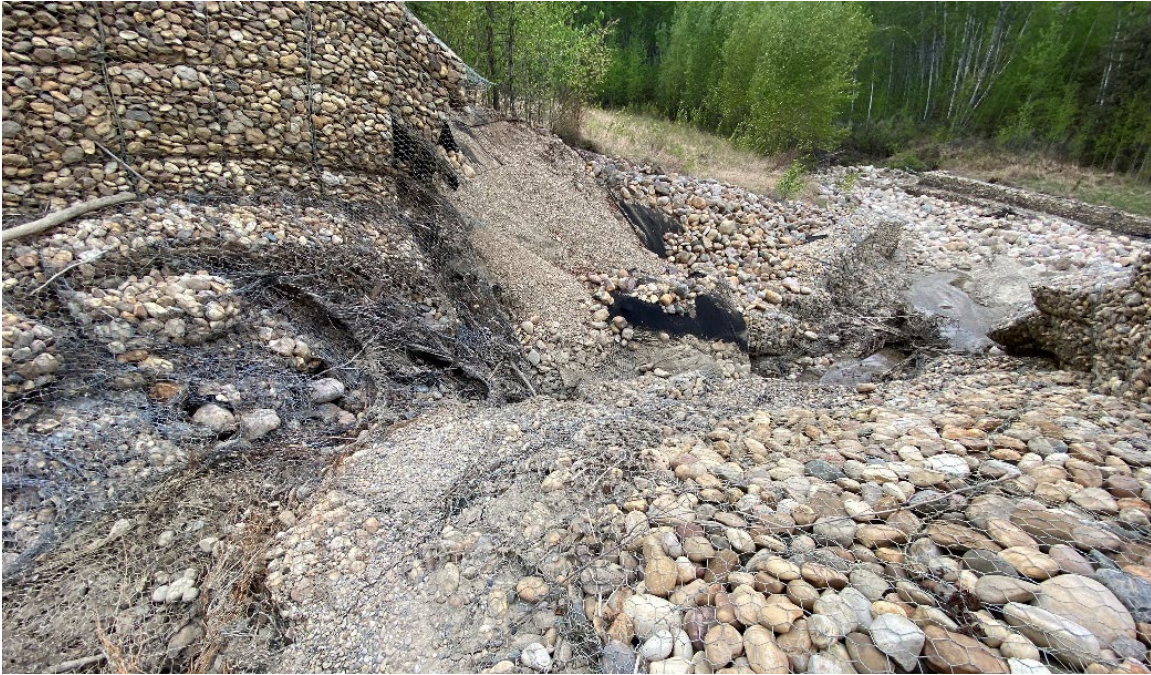
Photo 41-07.: View northwest towards the top of the gabion sidewall section that pulled apart and collapsed due to deep scour that undermined the base of the structure within the lower section. Slightly more visible damage relative to the 2024 condition.

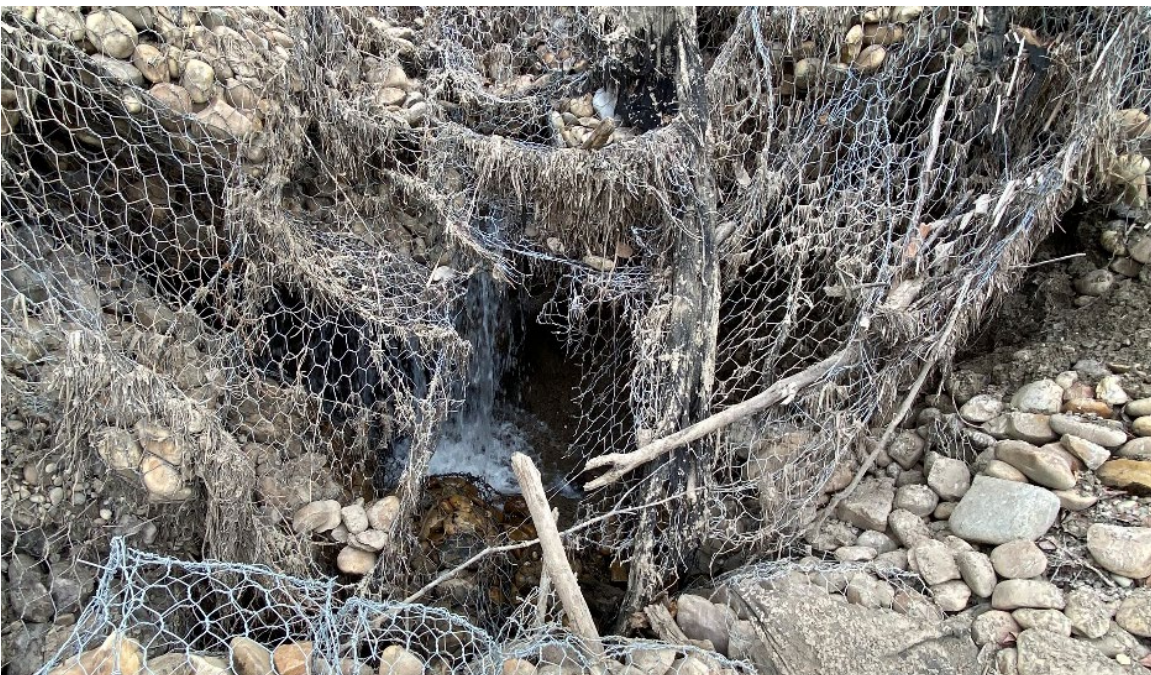
Photo 41-08.: Close-up of scour plunge hole at least 2 m deep that has formed within the thalweg downstream of the drop structure corner.

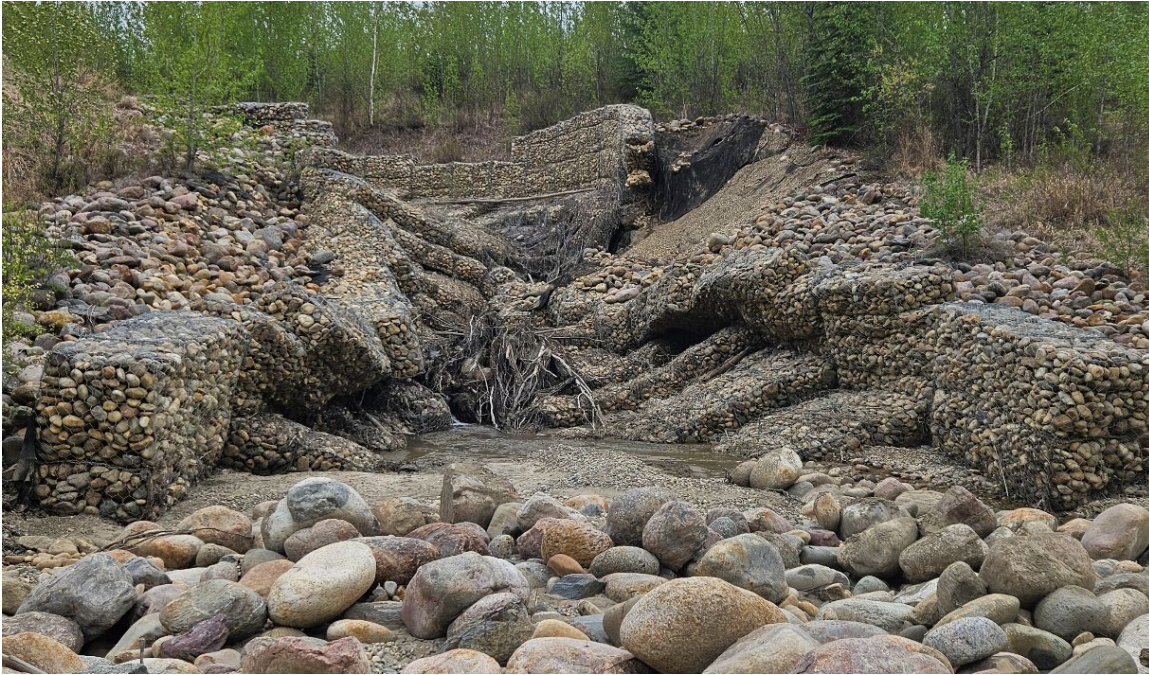
Photo 41-09.: View upstream (south) from the bottom of the drop structure. Extensive deformation and collapse of the structure due to scour and undermining below the baskets within the channel centreline. Minor downwards movement of the baskets towards the channel thalweg within the downstream section of the structure since 2024.

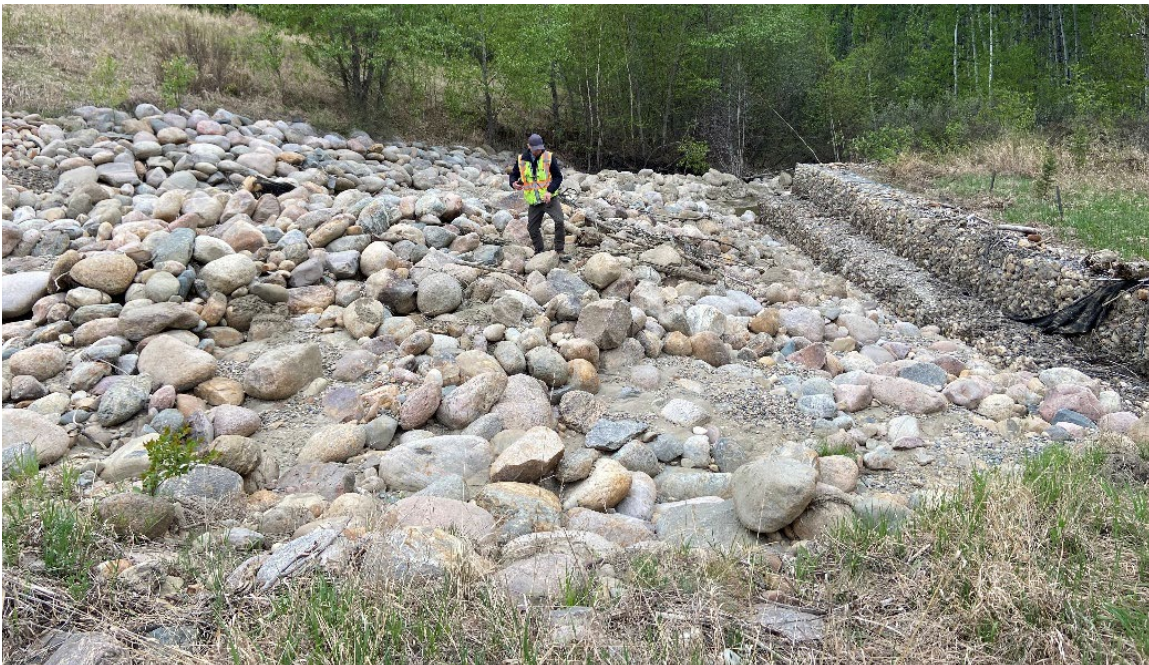
Observations:	Description	Worsened?
<input type="checkbox"/> Pavement Distress		<input type="checkbox"/>
<input type="checkbox"/> Slope Movement		<input type="checkbox"/>
<input checked="" type="checkbox"/> Erosion	<p>The beaver dam and pond were intact at the east end of the site, with no visible damage to the dam structure. Previous overflow channel areas identified in 2024 were rebuilt by the beavers where water overtopped the dam during high flow conditions. (Photo 41-1).</p> <p>The armoured channel between the beaver dam and gabion drop structure had minor riprap displacement in the upstream 40 m length of the channel. The remaining downstream length of the armored channel had significant scour, channel bed degradation and washout of the rock riprap that exposed and damaged the underlying geotextile. The most extensive damage occurred within a 30 m length between approximately km 31.85 and km 31.88 where most of the channel bottom was washed out below the geotextile fabric and scour had left near vertical banks up to 2 m in height. There was slightly increased scour and bank sloughing since 2024. (Photos 41-02 and 41-03).</p> <p>Extensive damage occurred to the gabion drop structure due to the July 2024 high flow event. Within the upper portion of the drop structure damage was primarily localized to the flow centreline within a 15 m long and 3 m wide segment. There was major gabion basket deformation, wood debris buildup, broken wire and washout of the rock from damage baskets. Due to scour below the baskets the channel bed elevation had dropped by up approximately 1 m resulting in a sunken U-shaped channel profile along the centreline of the structure. (Photos 41-04 and 41-05).</p> <p>The lower downstream section of the drop structure below the curve towards the north had the most extensive damage due to erosion scour resulting in a 2 m vertical drop causing undermining and collapse of the gabion sidewalls for an approximately 15 m length section. The eastern lower gabion sidewall was still intact but had fallen inwards towards the channel centreline scour area. Most of the centreline gabion baskets were sunken, heavily deformed and had wire pulled apart resulting in loss of rock. Basket deformation and scour were slightly rose from the 2024 condition. (Photos 41-06 to 41-09)</p> <p>At the bottom of the drop structure, riprap had been displaced downstream and there was silt and sand buildup (Photo 41-10).</p>	<input checked="" type="checkbox"/>

Photo 41-10.: Downstream view towards the west of the buildup of washed out riprap below the gabion drop structure within the natural channel.
