SITE NUMBER AND NAME: S070-II and -III Eyrie Gap and Fir Creek Geohazard Sites		HIGHWAY & KM: 541:02, km 4.488 to km 4.794	PREVIOUS INSPECTION DATE: May 17, 2022	INSPECTION DATE: May 9, 2023
LEGAL DESCRIPTION:	NAD 83 COORDINATES: UTM Northing Easting		RISK ASSESMENT:	
S070-II: NW-35-16-05 M5	11	5585241 671123	PF: 10	CF: 1 TOTAL: 10
S070-III: NW-35-16-05 M5	11	5585007 671335	PF: 11	CF: 1 TOTAL: 11
AVERAGE ANNUAL DAILY TRAFFIC: 153 (west) & 158 (east) (Reference No. 55410220)			CONTRACTOR MAINTENANCE AREA (CMA): 27

PROJECT SOUTHERN REGION GEOHAZARD RISK MANAGEMENT PROGRAM		
TITLE Site Plan S070-2, -3 - Eyrie Gap and Fir Creek Geohazard Sites Hwy 541:02, km 4.794-4.488		
SCALE 1:5,000	PROJECT No. A05116A03	FIG No. 1

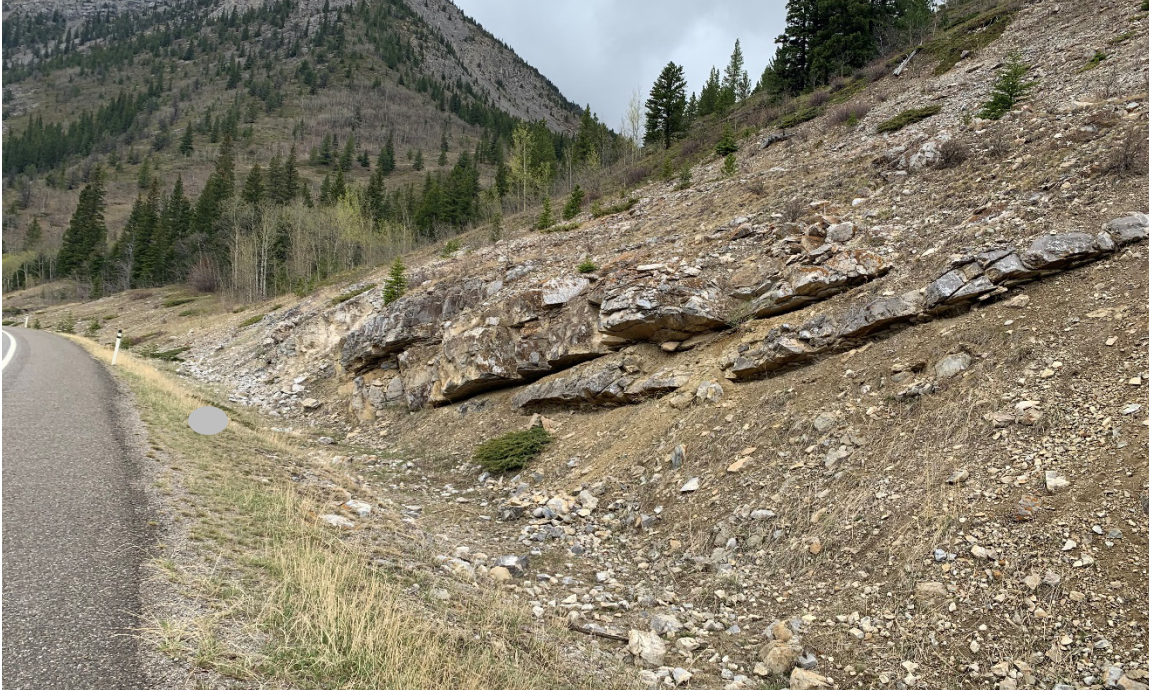
Photo 1 **S070-II: Northern portion of back slope adjacent to the highway. Photo taken facing west on May 9, 2023.**

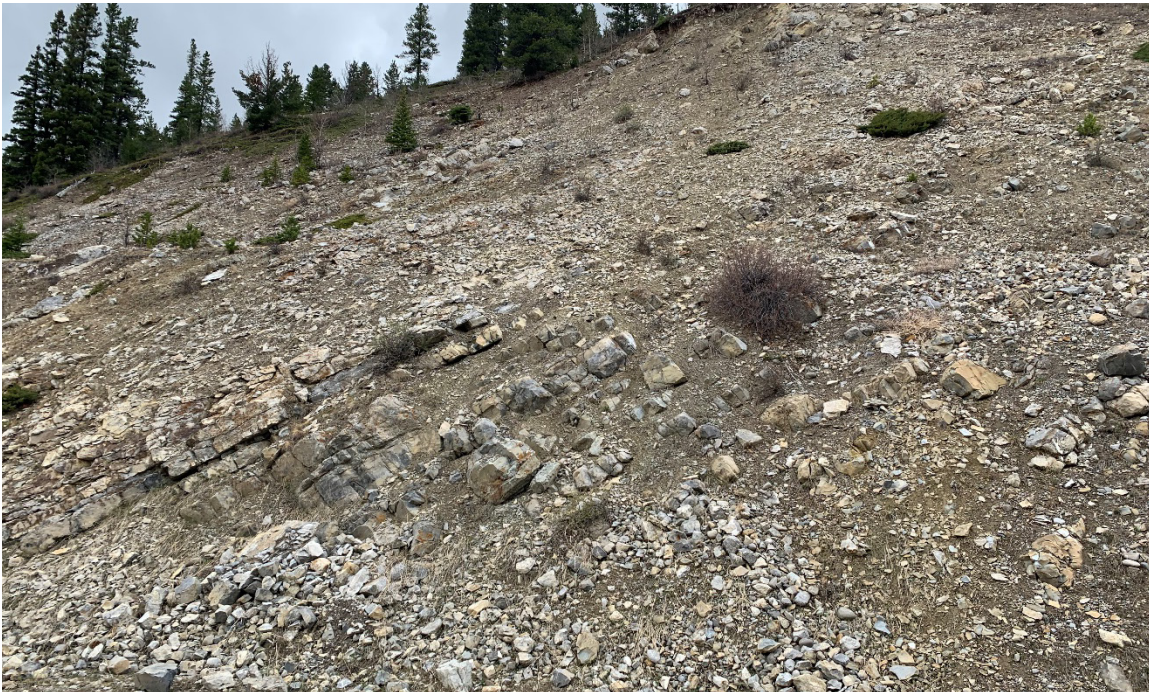
Photo 2 **S070-II: Central portion of back slope adjacent to the highway. Photo was taken facing north on May 9, 2023.**

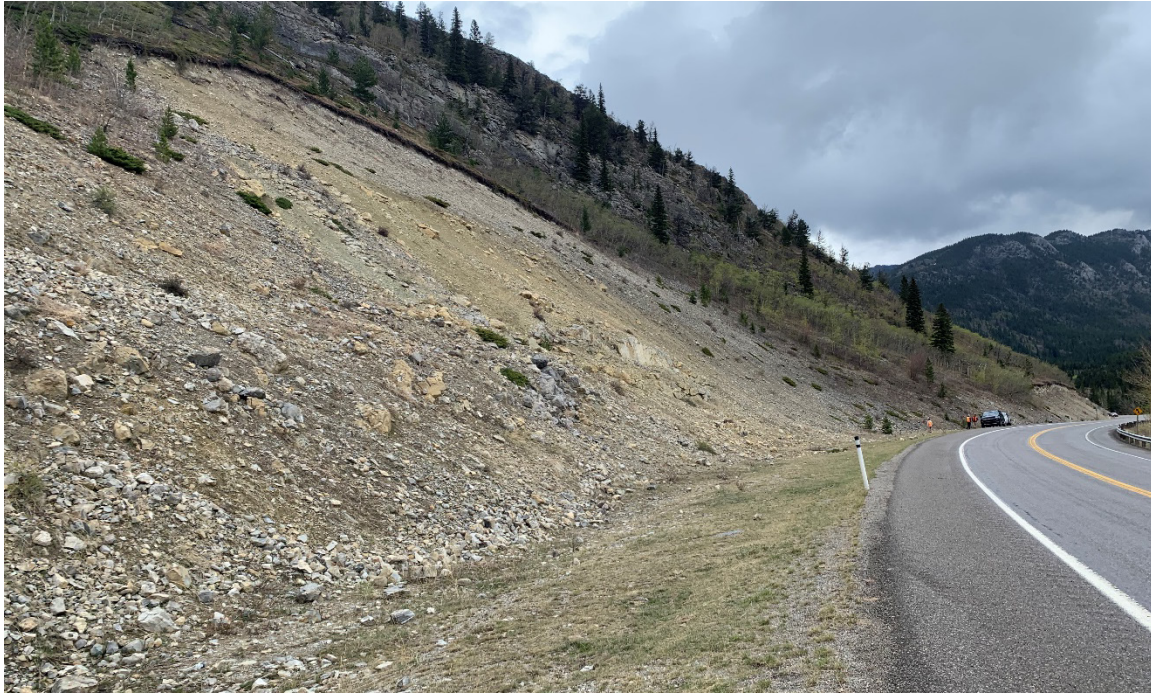
Photo 3 S070-II: Southern portion of back slope adjacent to the highway. Photo was taken facing southeast on May 9, 2023.

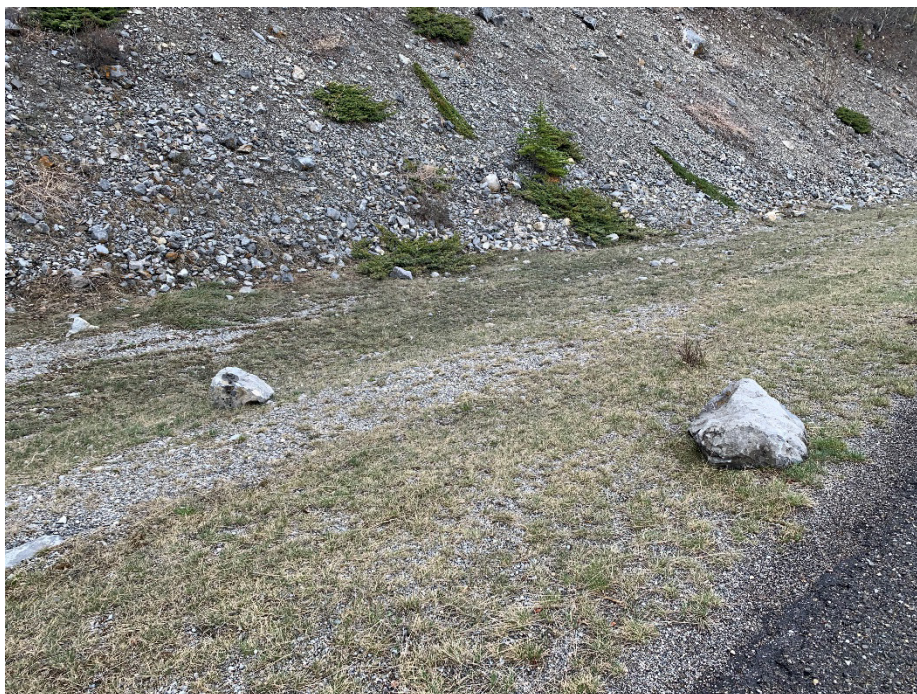
Photo 4 S070-II: Rockfall debris close to the road. Photo taken facing southeast on May 9, 2023.

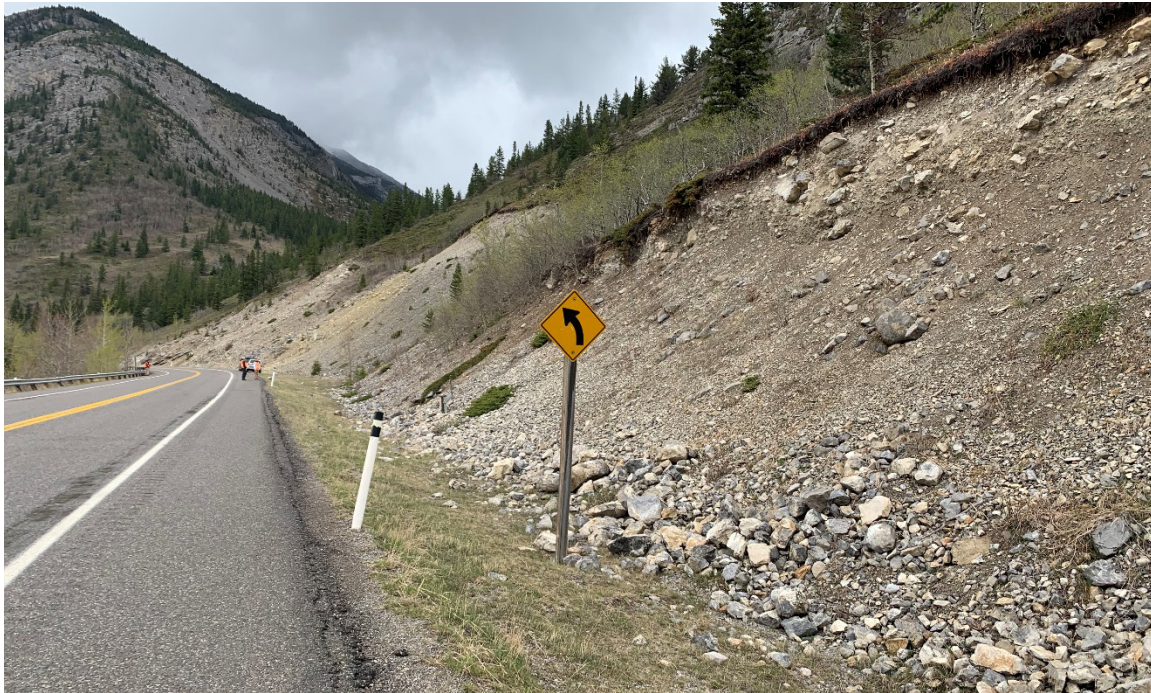
- Rockfalls are active and fresh rockfall debris up to 1.45 m x 0.65 m x 0.70 m was observed in the ditch during the 2023 inspection. The large debris noted was at the same location as what was observed during the 2022 inspection, indicating that the debris has not been cleared out of the ditch. Rockfall debris is primarily subrounded to angular. Material that has accumulated in the ditch and should be cleared out.

Photo 5 S070-III: Rockfall debris at the toe of the slope in northbound ditch. Photo taken facing northwest on May 9, 2023.

- The sites should be regularly inspected by AT's MCI and inspected as part of the Southern Region GRMP Section B inspections.
- The ditches at S070-II and -III should be regularly cleaned out to maintain rockfall capacity.
- This site was included in the K-Country Rockfall Hazard Assessment completed by KCB in 2023. A draft report was submitted on September 18, 2023. One of the recommendations in the report included that the risk rating should be re-assessed during the next Section B inspection based on the results of the rockfall hazard assessment.

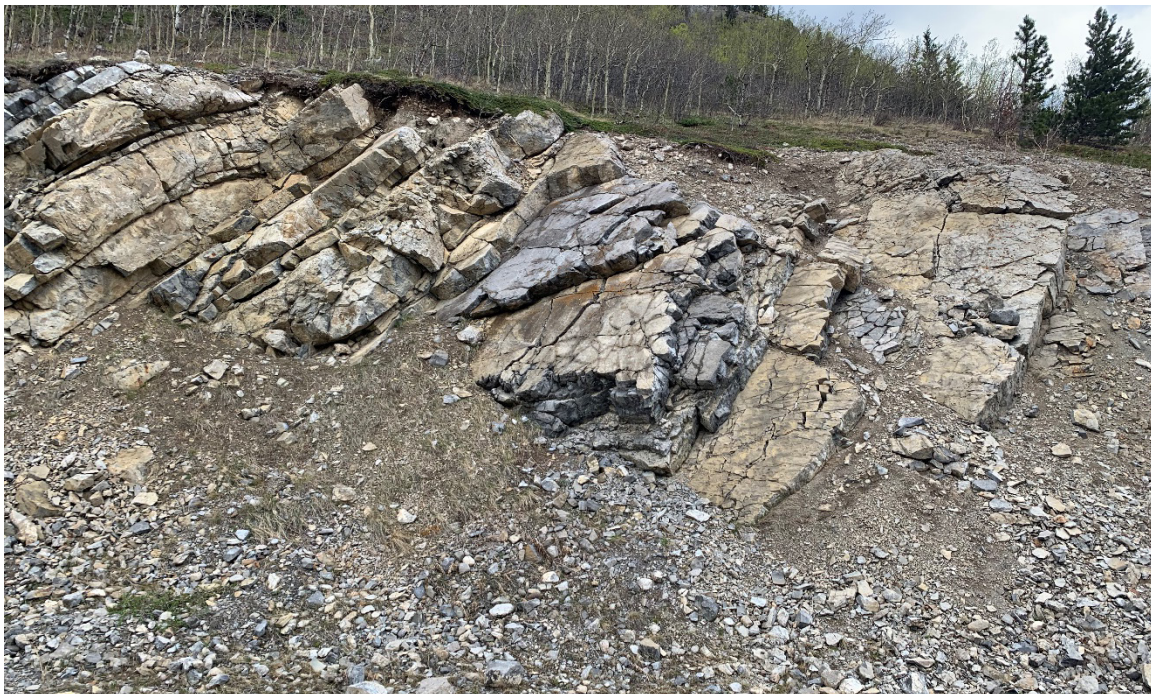
- The ditch is approximately 0.7 m deep and provides good catchment for rockfall debris.
- The site is located on the right-hand side of a pullout where a creek was realigned due to a previous washout.

Photo 6 S070-III: Northbound ditch and bedrock fracturing. Photo taken facing east on May 9, 2023.

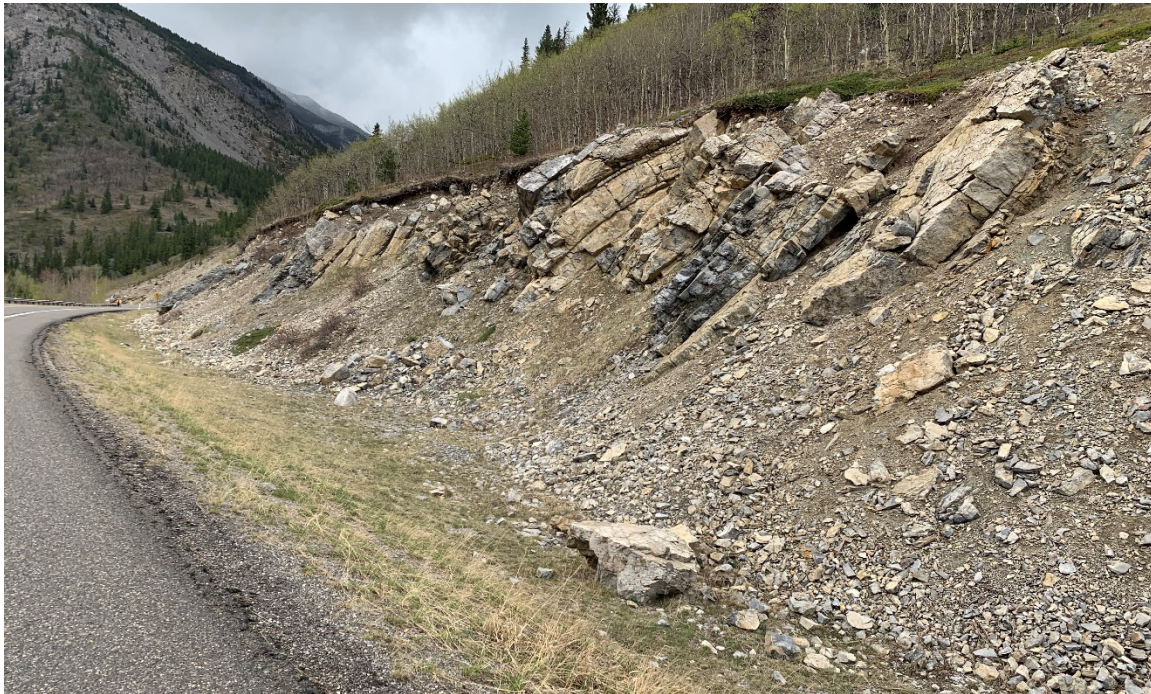
Photo 7 **S070-III: Bedrock fracturing leading to future rockfall blocks. Large rock noted in ditch was there during the 2022 inspection. Photo taken facing north on May 9, 2023.**
