Degradation Concerns related to Bridge Structures in Alberta

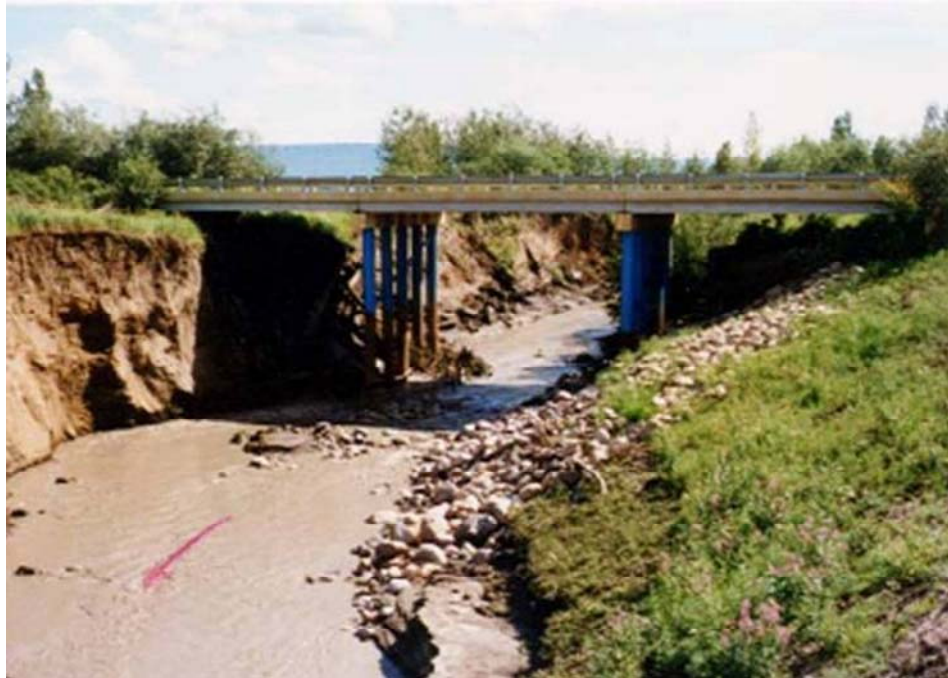
BF74852 – Local Road over Bear River

1987 Photo: note paint elevation and vertical banks

- steepening and shortening of the channel in 1969 resulted in degradation (about 2.1m in almost 20 years) until drop structures were constructed. The channel was attempting to achieve a new equilibrium (Figure 6). Since streambed surveys were not obtained over the years, we do not know the timing and progression of the degradation. The majority of degradation could have occurred initially with minimal progression in the later years, it could have occurred at an average rate per year, or as a scenario in between.
- installation of the drop structures resulted in aggradation at the bridge site (about 0.6m over 5 years).

- Do nothing. The existing drop structures are minimizing streambed elevation changes and threat is no threat of foundation undermining at the current bridge structure

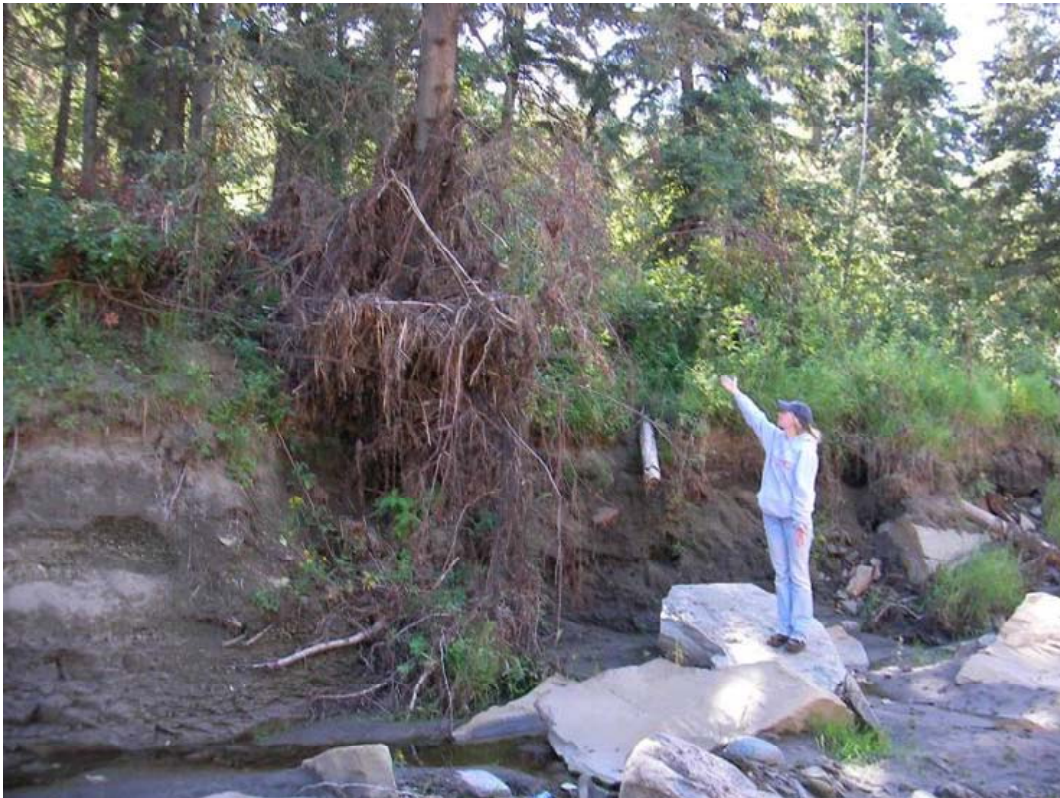
2007 Photo – note vegetation elevation, near vertical banks

- there is a lack in historical information from 1966 to 2006 to assess if the straightening undertaken in 1966 had an impact on the channel (aggradation/degradation). The lack of information may suggest that major issues were not observed.
- from the local streambed survey and DTM extracted survey, it is evident that the channel downstream of the culvert has degraded (by 2.5m +/-) and that the culvert is acting as a control structure preventing the progression of this degradation upstream.
- the break in slope seen in the DTM slope, with a steeper portion closer to the receiving stream, is evidence of the stream downcutting to meet a receiving channel. Cucumber Creek is degrading to match the elevation of the receiving North Saskatchewan River

- if the structure integrity is not comprised, remediation may include preventing future structure issues, namely undermining. This may involve the design of a cut off wall to hold up the outlet and/or installation of protection works (rip rap) to prevent loss of backfill material and to dissipate high outlet velocities.
- for a new structure design, considerations could involve allowing the degradation to progress upstream (cost, potential liabilities), installing a structure to act as a control (maintain status quo), or somewhere in between (allow for a certain amount of degradation). For each option, there should be consideration given to cost (both capital and future maintenance) and potential risks or liabilities (known vs. potential concerns, legal consequences).

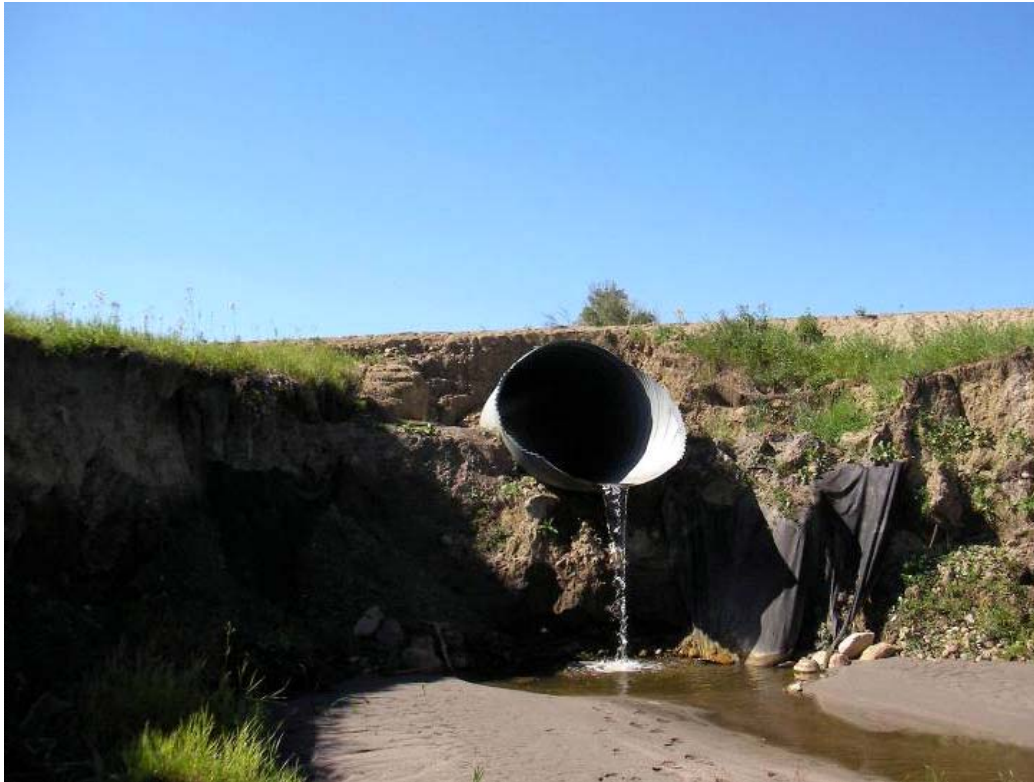
BF73235 – Cucumber Ck

2007 Photo – note hanging outlet, vertical banks

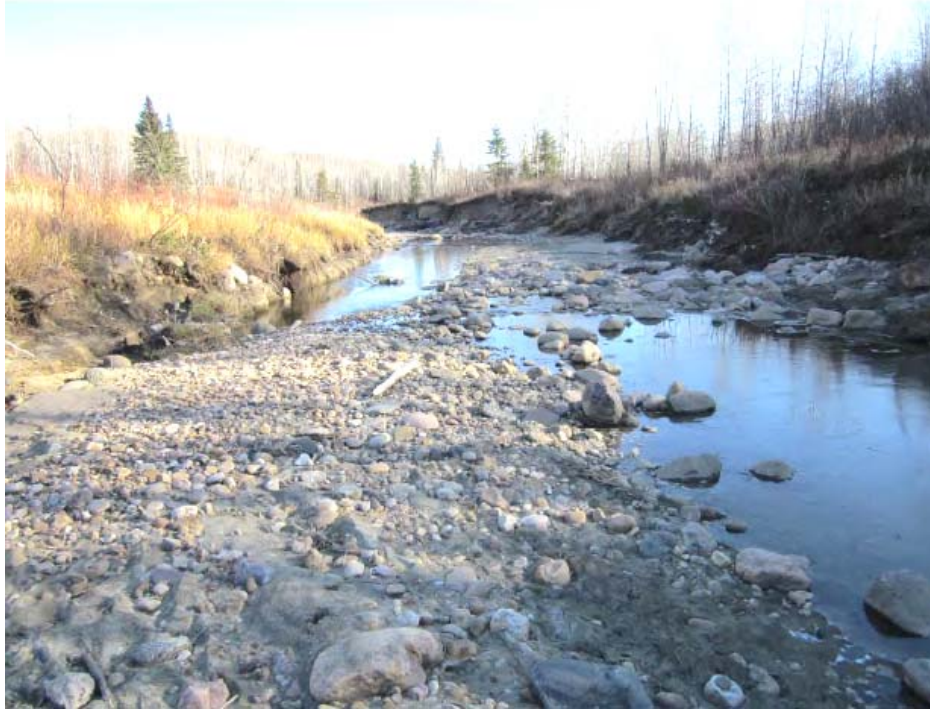
Looking at Downstream (note banks slumping/vertical banks)

- from site photos, a large scour hole downstream of the outlet can be seen. This local scour hole is also seen on the survey. Site photos also show slumping, vertical banks in the downstream channel which could be indicative of degradation (if occurring along an entire section) and/or lateral stream instability (if occurring locally; outside of meander bends).

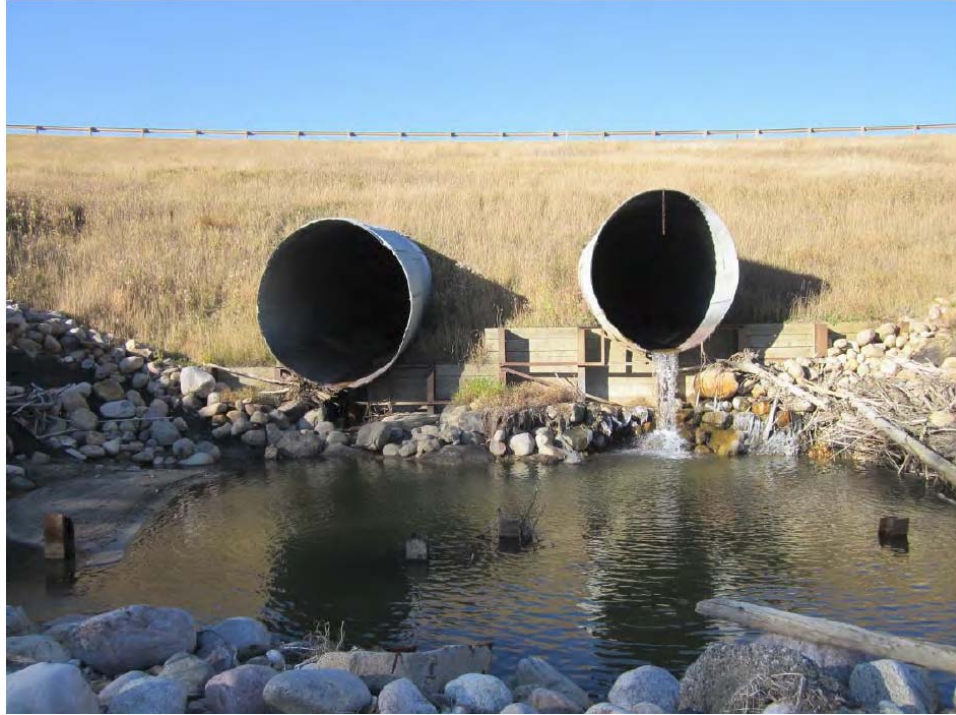
Looking at outlets from Downstream (note ~2m drop, scour hole)

- since the structure condition warrants replacement, remediation was not considered. In the past, a cutoff wall was installed to support the culvert structures and riprap was placed in the scour hole to dissipate outlet velocities and prevent structure undermining.

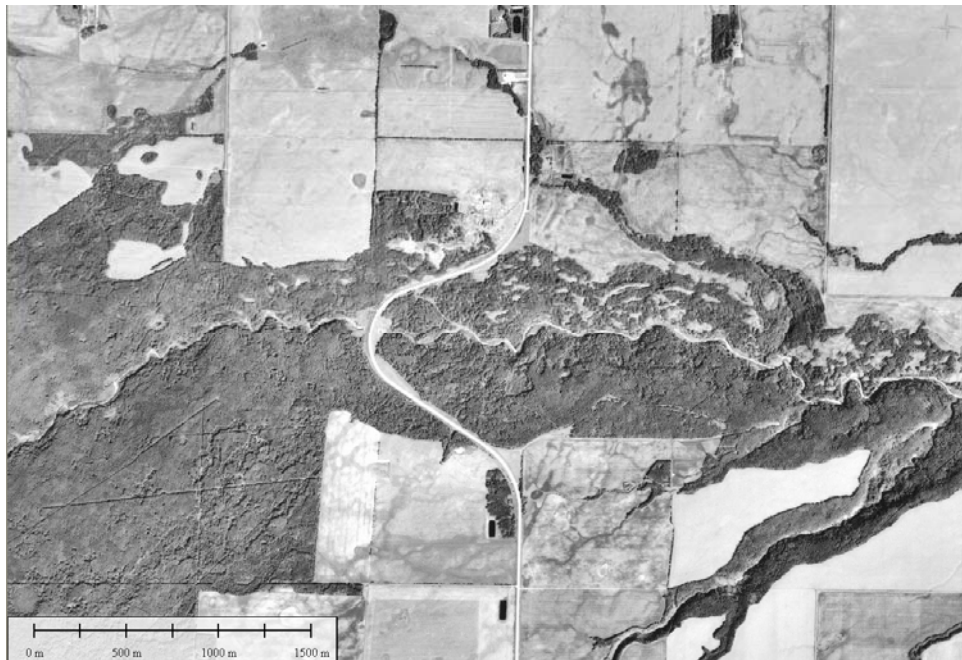
2007 Airphoto (note number of slides d/s compared to u/s)

- the air photo shows a much greater number of landslides downstream of the structure than upstream. This could be from degradation (toe slope undermining). A review of historical air photos may help to determine if this was a continual process over time or occurred as a result of a specific event(s).

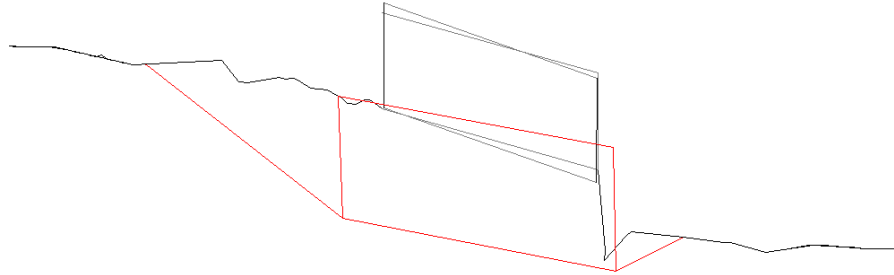
Schematic for Option 1

Cons: greater depth of fill (potential settlement concerns), greater depth of excavation (potential constructability, geotechnical concerns), greater culvert length, greater length of channel impacted, more RoW required, greater risk (uncertainty associated with progression of degradation upstream).

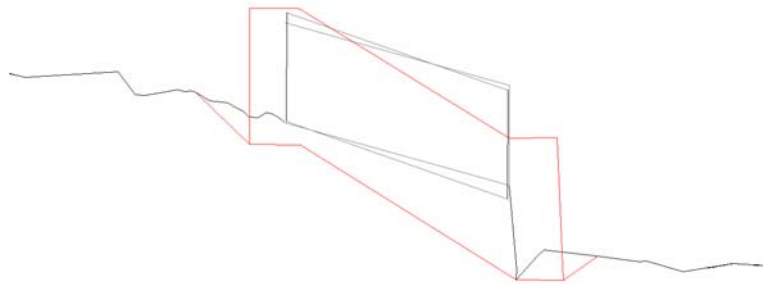
Schematic for Option 2

Cons: worse for fish passage, worse for watercraft navigability, high velocities within the structure requiring energy dissipation design.

Option 2 was recommended as the replacement structure.
