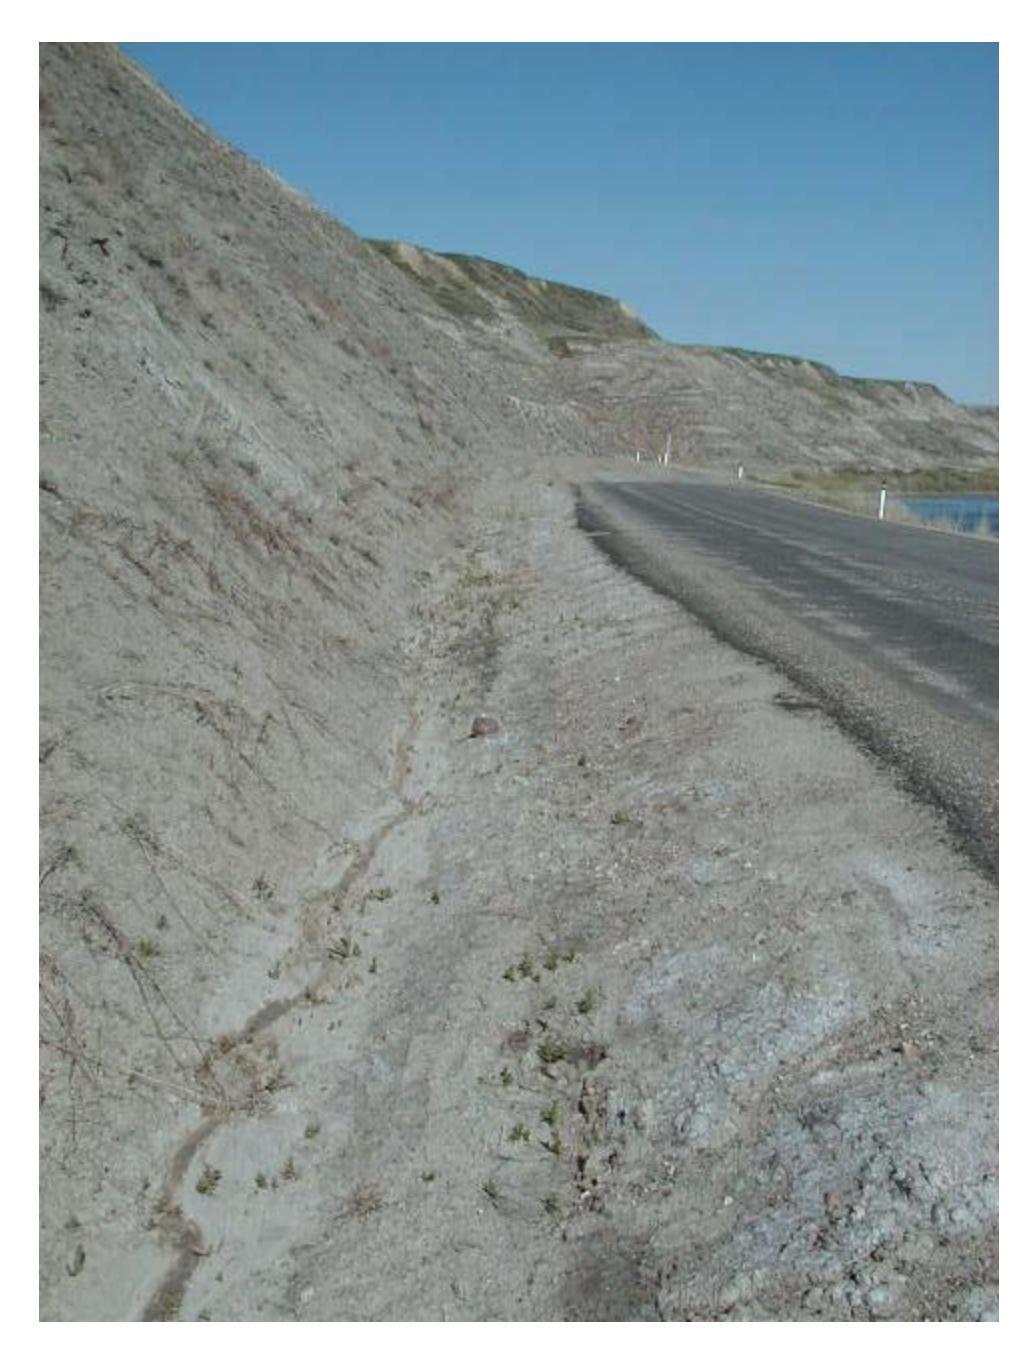
Well defined ditch on backslope side of highway

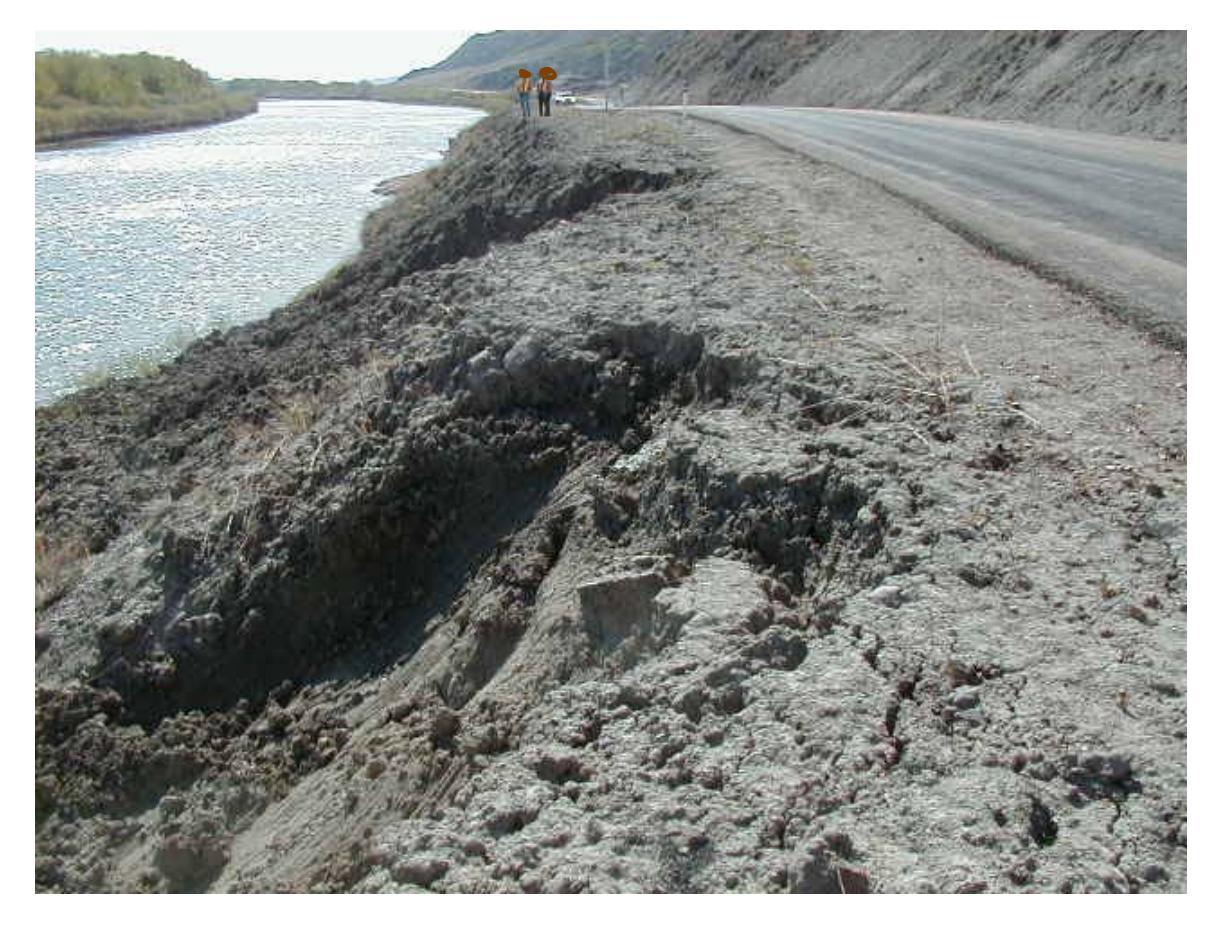
Two new unstable areas have appeared with scarps regressing towards the pavement
