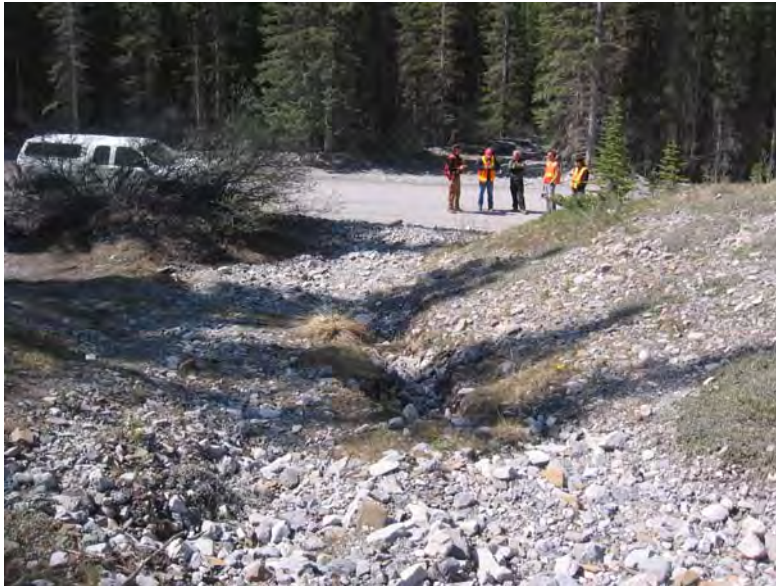
Photo 1 – June 2009 (top)
Facing downstream along the creek channel towards the highway crossing. Note the lack of surface flow in the channel.

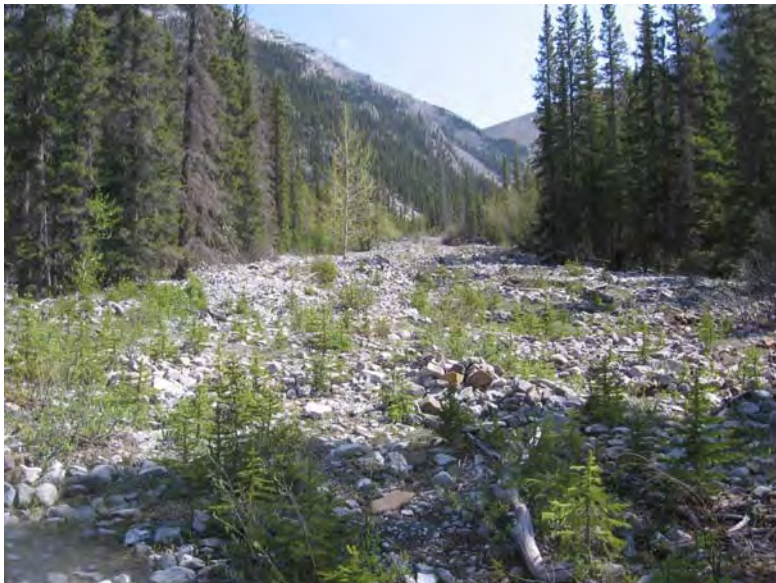
Photo 2 – June 2009 (bottom)
Facing upstream along the creek channel from the same location that Photo 1 was taken from.
