SITE NUMBER AND NAME: C062 Back Slope Failure North of Vermillion Dam		HIGHWAY & KM: 41:20, 2.889	PREVIOUS INSPECTION DATE: July 12, 2019	INSPECTION DATE: June 24, 2020
LEGAL DESCRIPTION: 16-31-050-06 W4M	NAD 83 COORDINATES: UTM Northing Easting 12 5912662 509163		RISK ASSESSMENT: PF: 15 CF: 4 TOTAL: 60	
Average Annual Daily Traffic (AADT): 3770 (north) (Ref No. 997074)			CONTRACTOR MAINTENANCE AREA (CMA): 512

PROJECT	CENTRAL REGION GEOHAZARD RISK MANAGEMENT PROGRAM	
TITLE	Site Plan C062 - Back Slope Failure North of Vermilion Dam Hwy 41:02, km 2.889	
SCALE	PROJECT No.	FIG No.
1:1,500	A05115A02	1

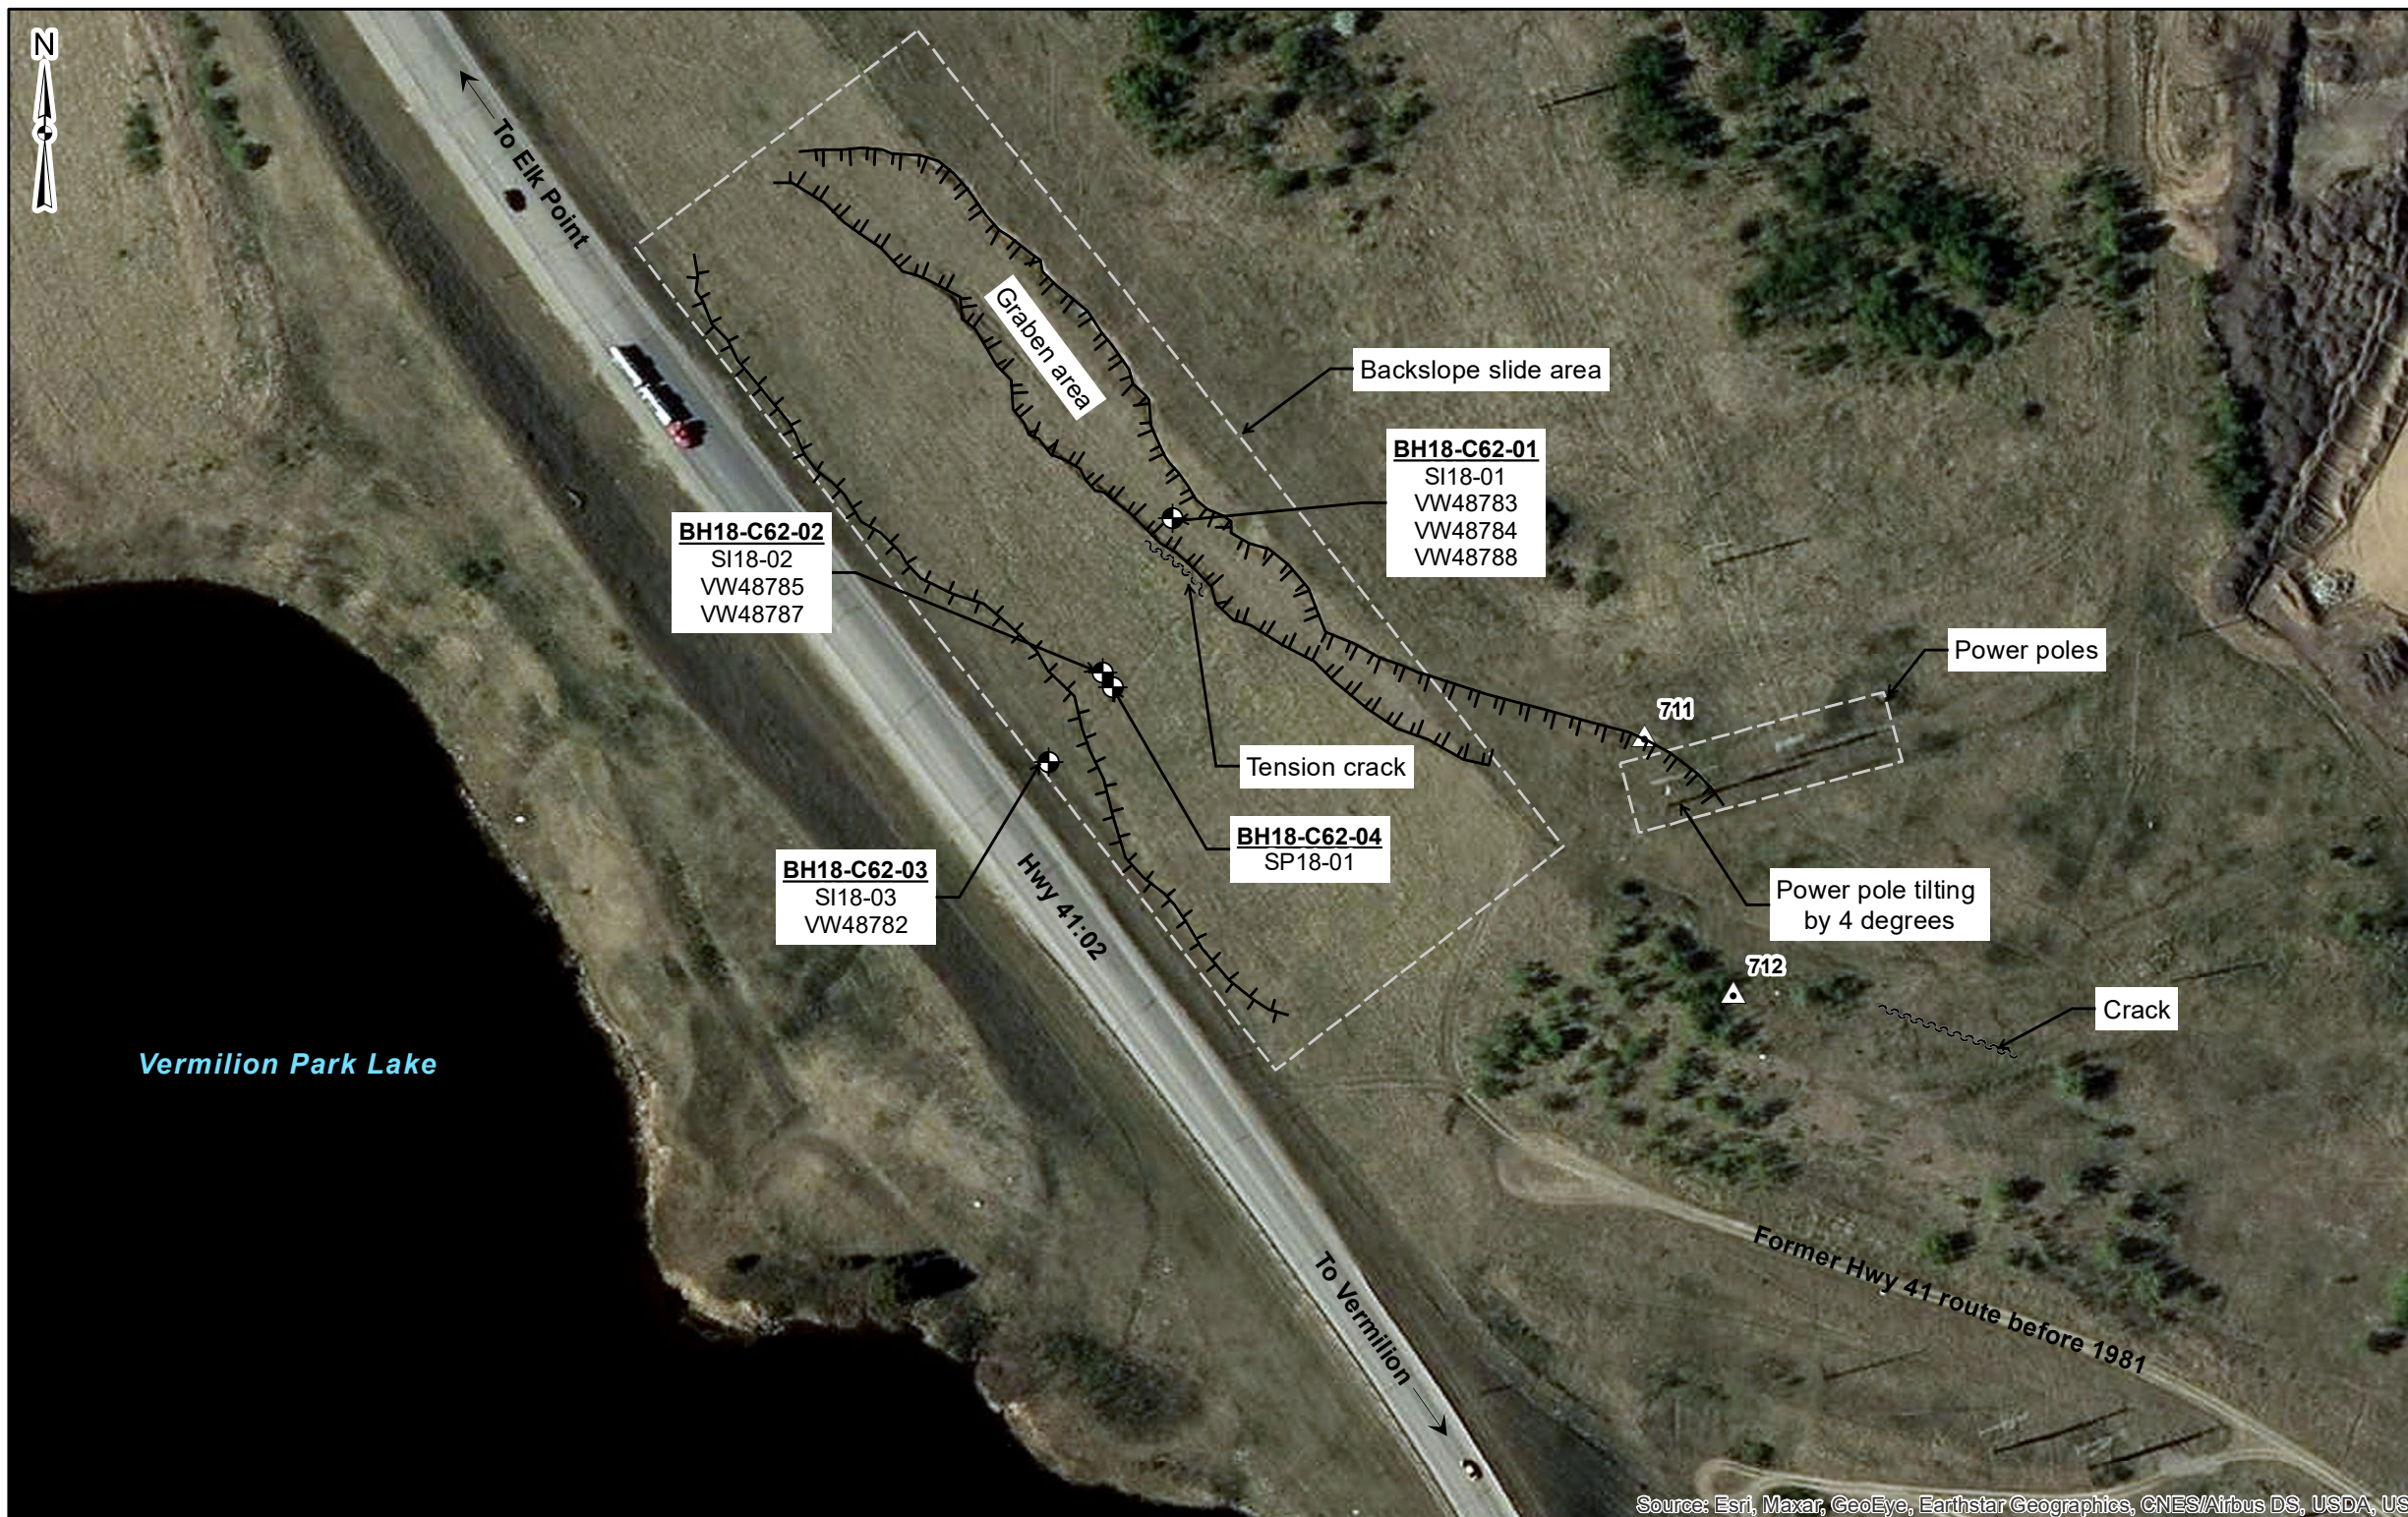
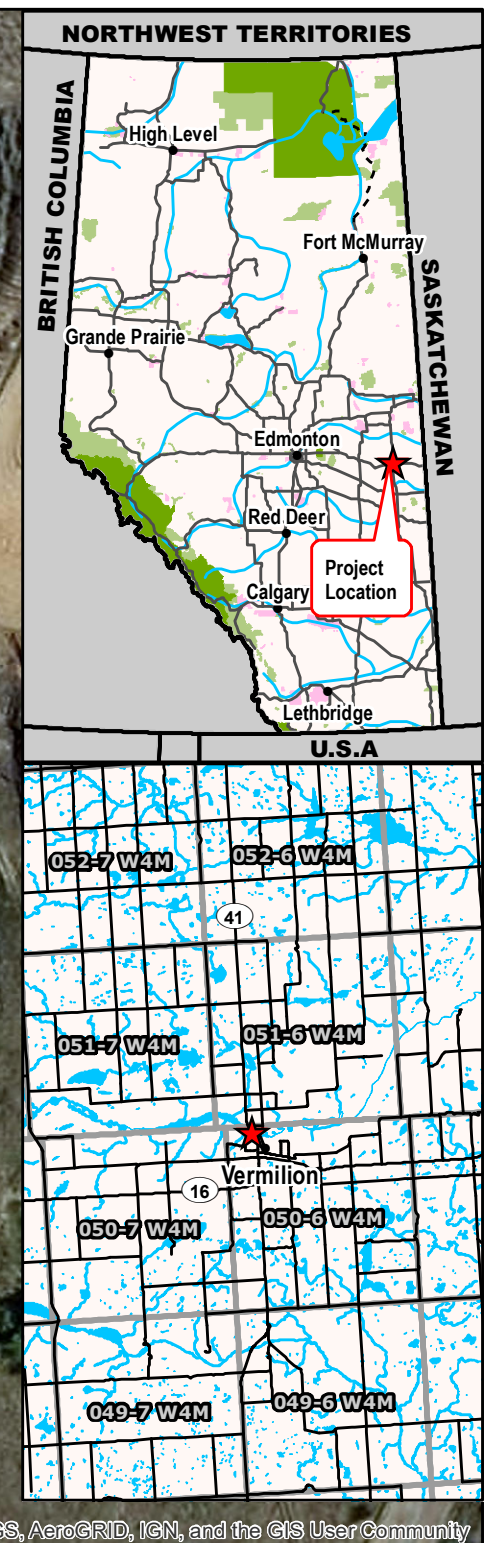
COMMENTS
Slide area extends along the crest of the back slope to the river valley slope south of the power poles. Bench on river valley slope is located at the previous Hwy 41 alignment, before it was realigned across Vermillion Dam in 1981.
Since the 2019 inspection, the toe roll of the slide appears to have deformed further into the ditch. However, due to the height of the vegetation, the amount of movement was difficult to determine.
Cracking was observed in 2019 on the river valley slope (southeast of waypoint 712) and directly north of the outlet channel from the Vermillion Dam spillway. The grass on the backslope and river valley slope is approximately 2 ft high (0.6 m) and may be obscuring other slide features. An old bench possibly associated with slope movement on the river valley slope is located at waypoint 712.

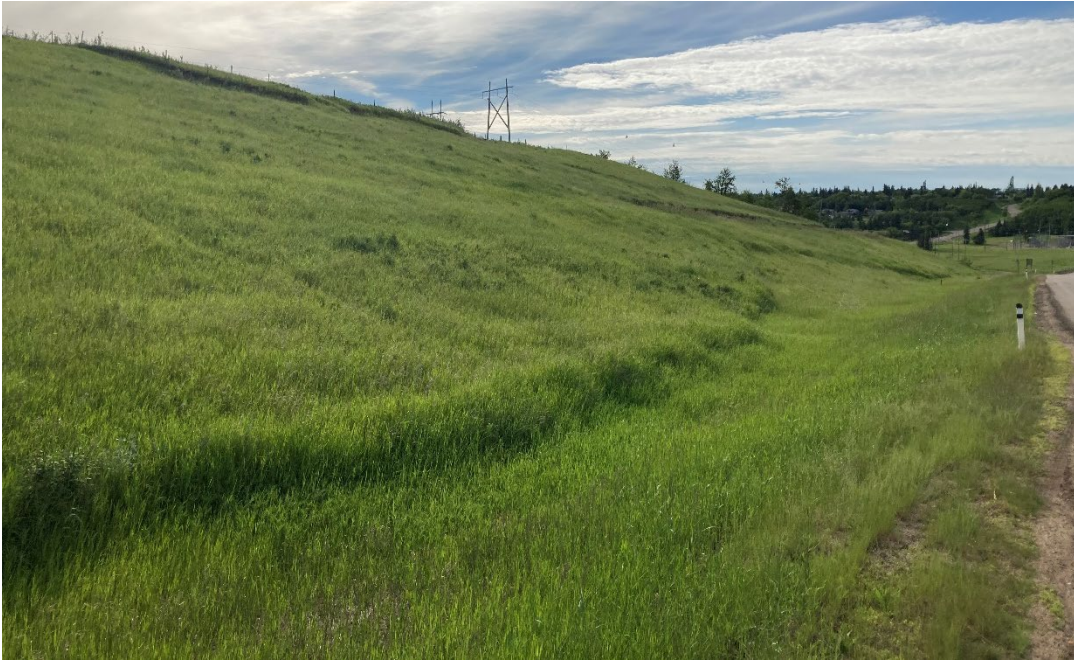
Photo 1 Backscarp and toe roll of slide. Photo taken June 24, 2020 looking southeast.

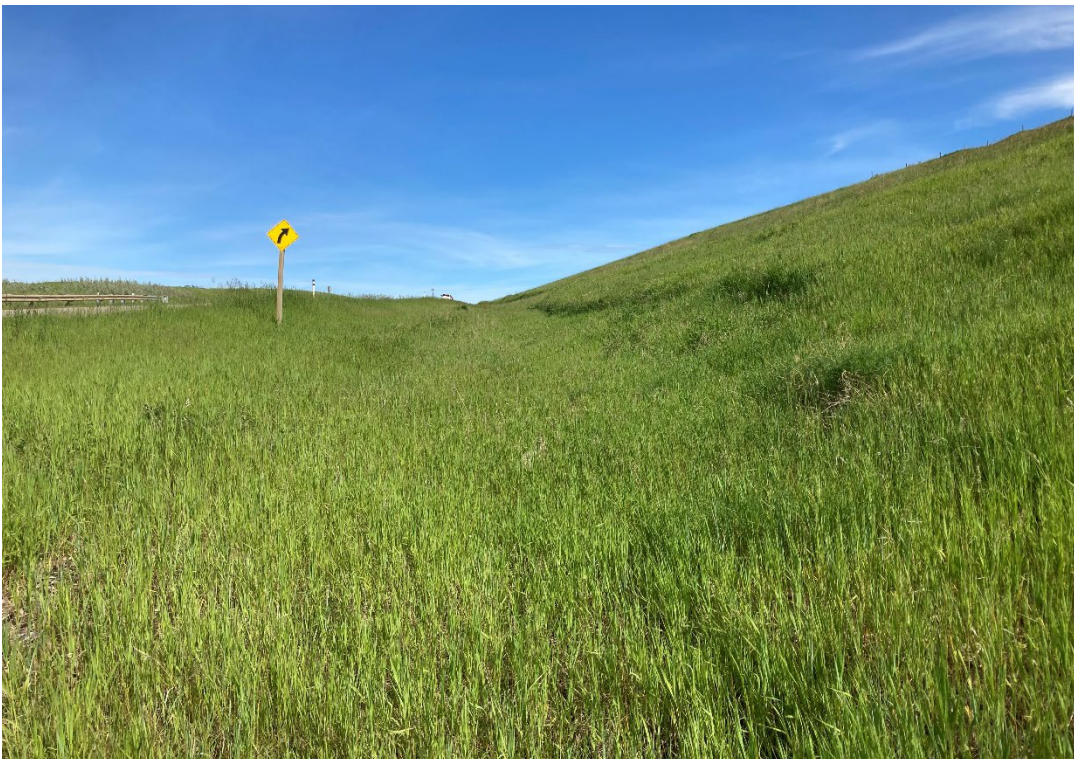
Photo 2 Ditch bottom and toe roll of the slope east of Hwy 41:02. Recent movement difficult to determine due to height of the vegetation on the slope. Photos taken June 24, 2020 looking northwest.

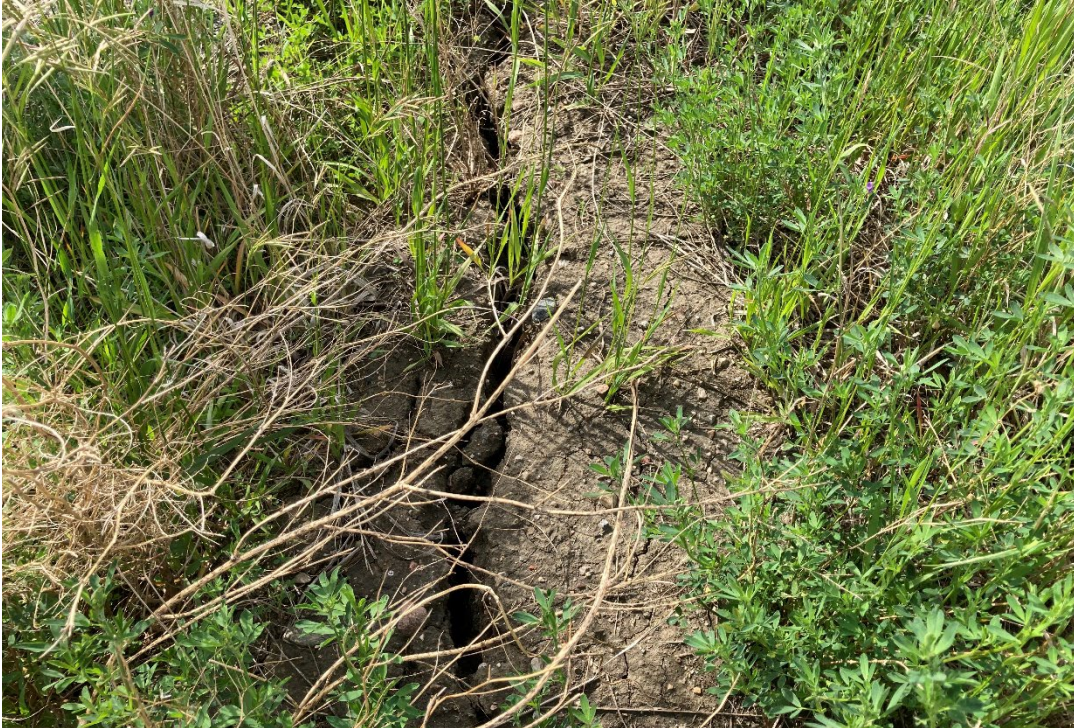
A tension crack was observed on the downslope bench created during the geotechnical investigation completed in April 2018 (bench constructed in March 2018). The tension crack was approximately 25 mm wide during our June 2020 site inspection (Photo 3).

Photo 3 Longitudinal tension crack on the downslope edge of the bench built in 2018 as part of the April 2018 geotechnical investigation. Photo taken June 24, 2020 facing northwest.

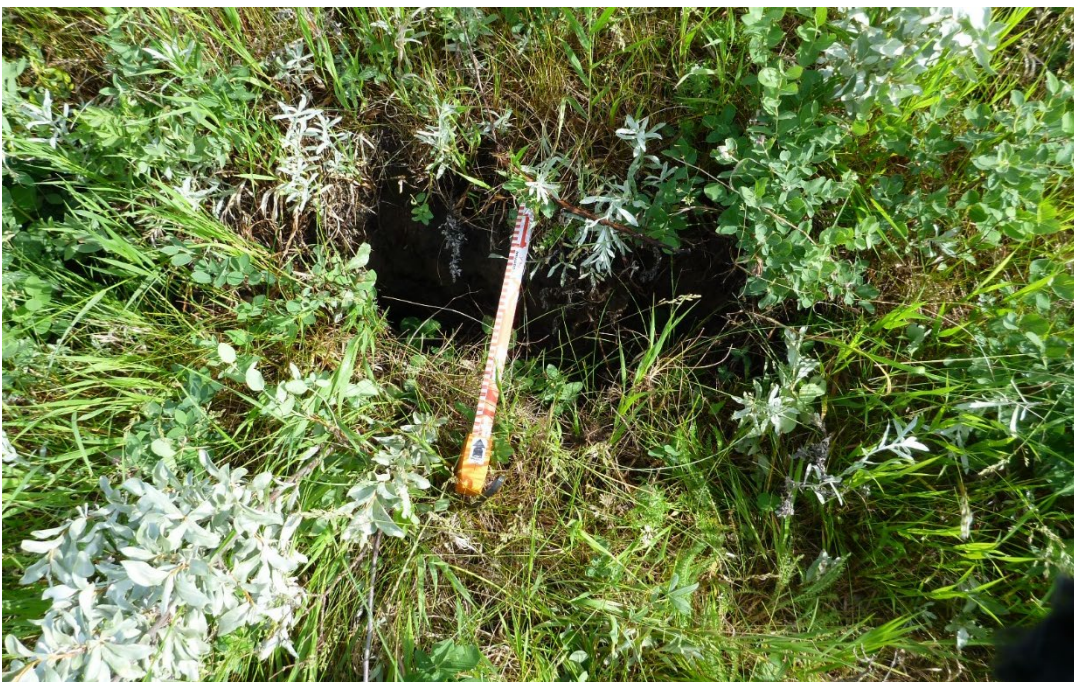
The backscarp has extended further to the southwest (past waypoint 711) as further settlement was observed near the power poles and on the slope below the power poles. The settlement/cracking observed was approximately 0.3 m wide by 0.5 m deep.

Photo 4 Location of ground cracking observed southwest of Waypoint 711 near the power poles at the top of the slope. Photo taken June 24, 2020 facing north.
