November 19, 2021

CON0022166 Peace Region (Grande Prairie District – South) GRMP Instrumentation Monitoring Site GP042; H40:36, km 37.524 Slide 9 km North of Wanyandie Road Section C – 2021 Fall Readings

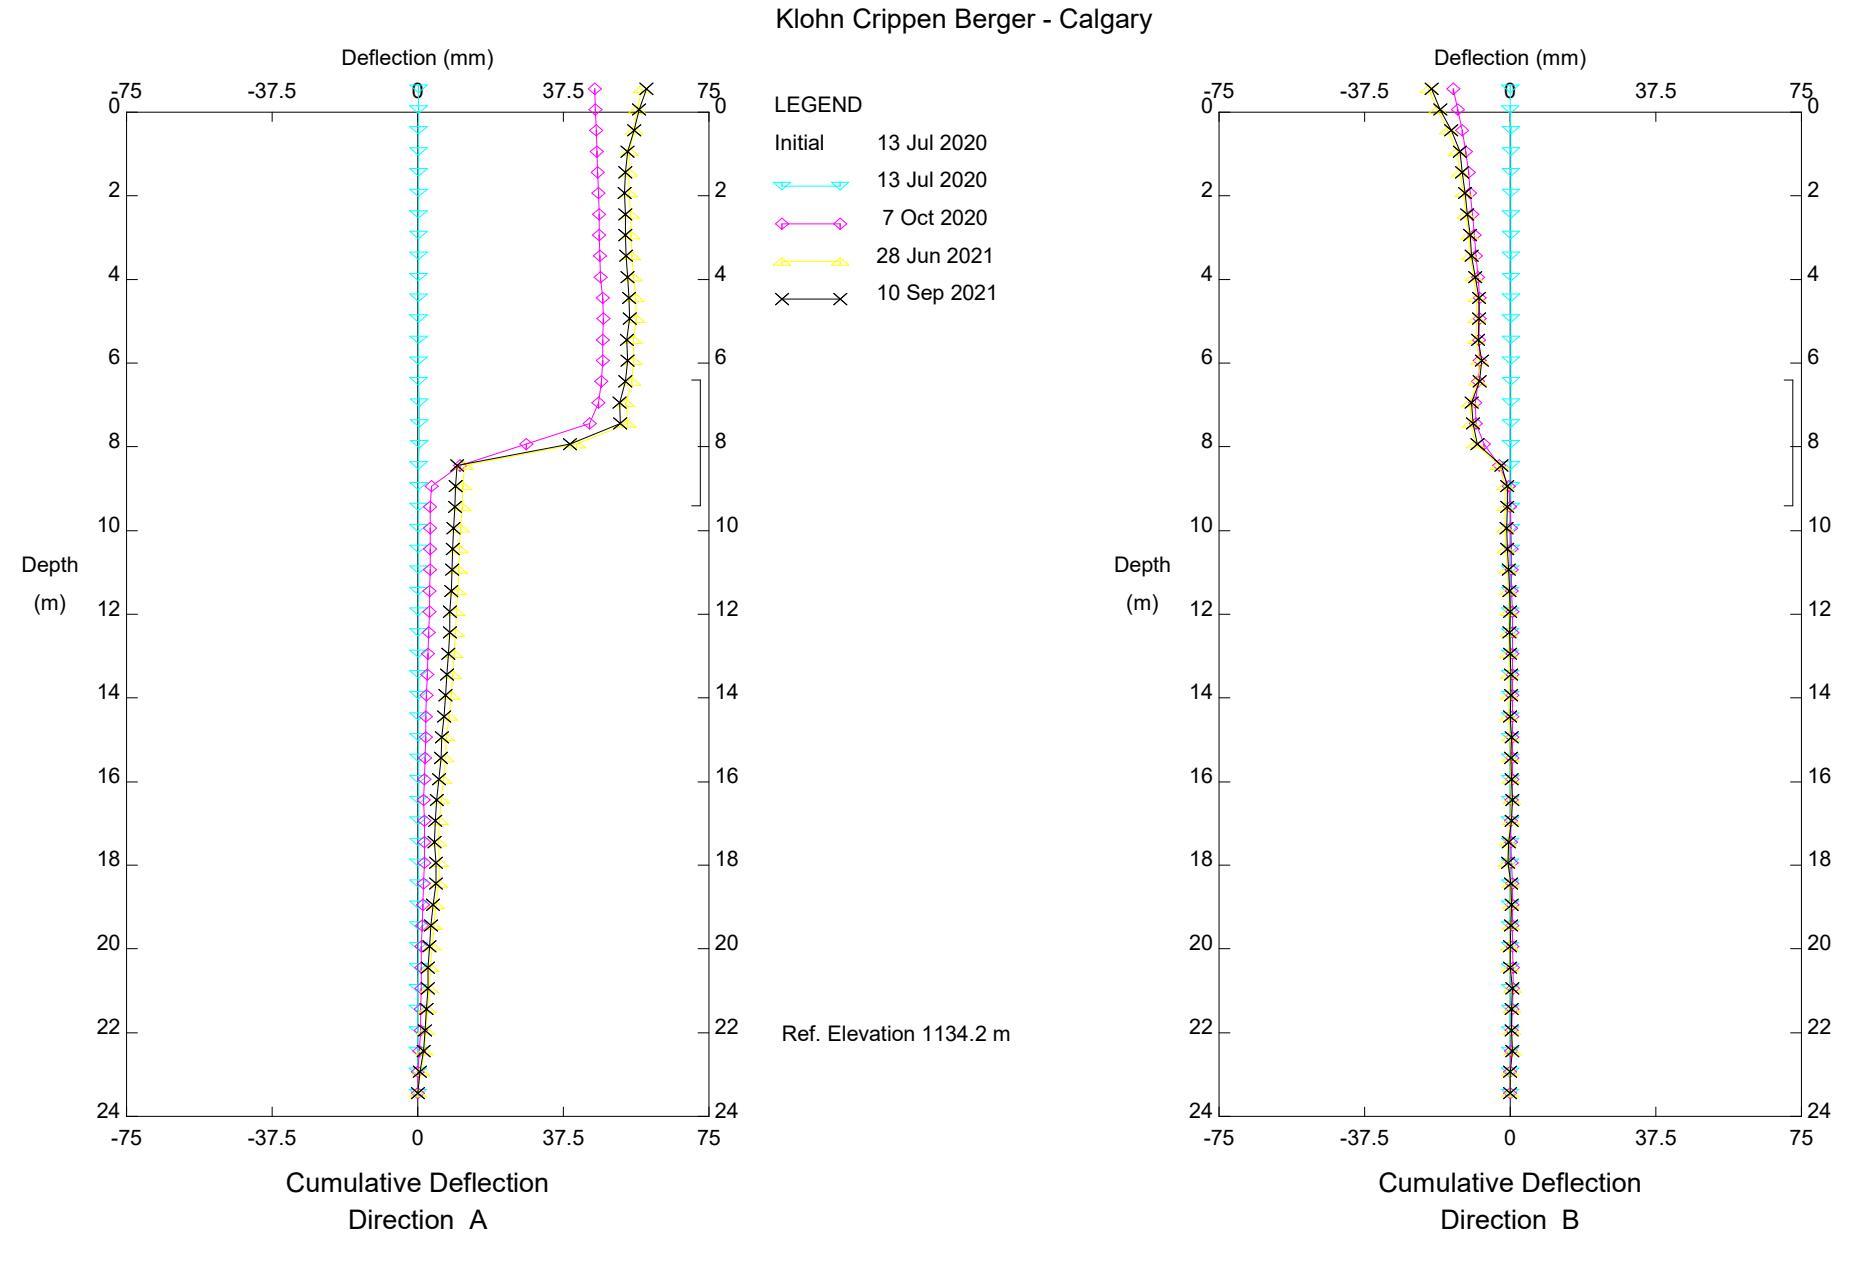
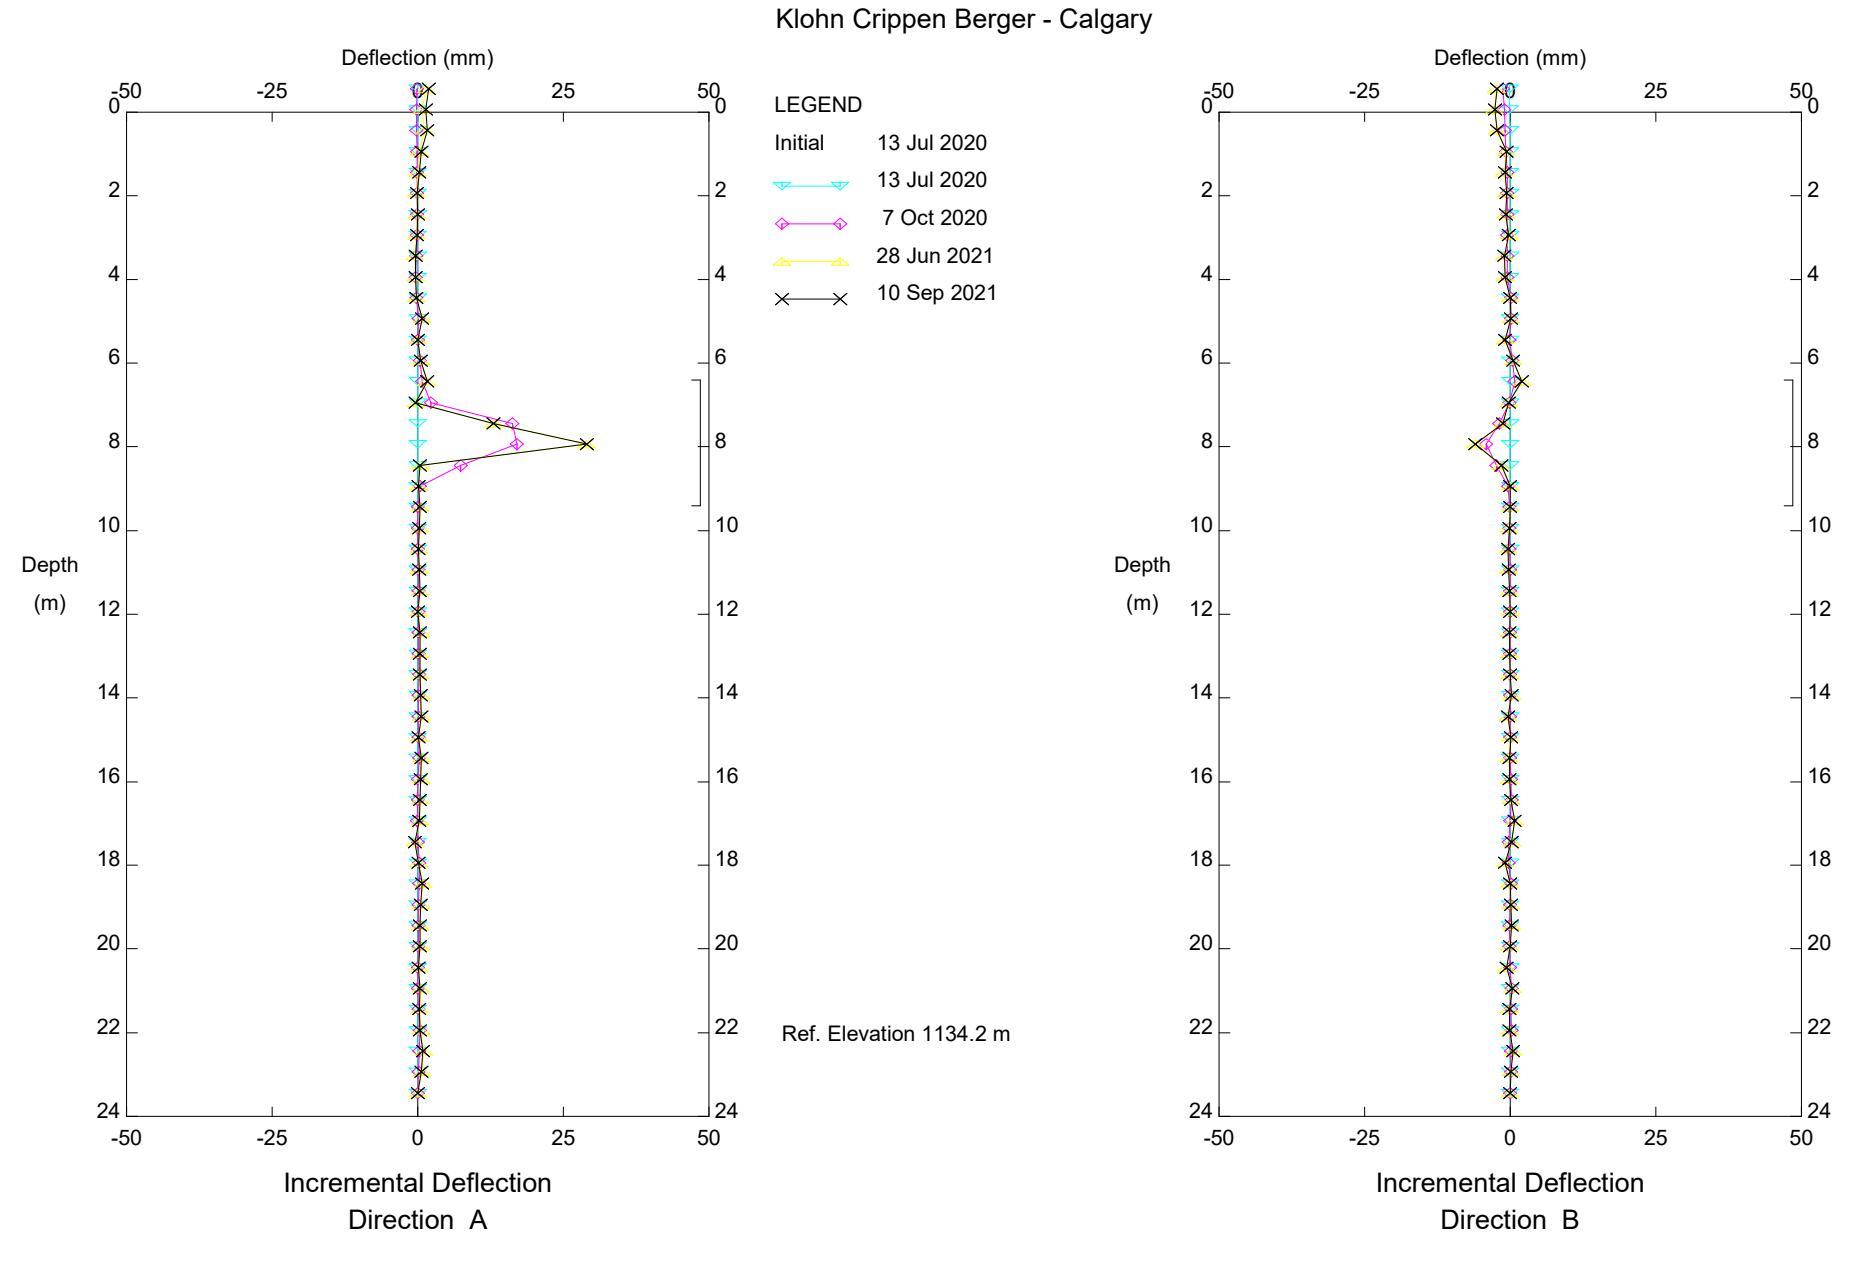
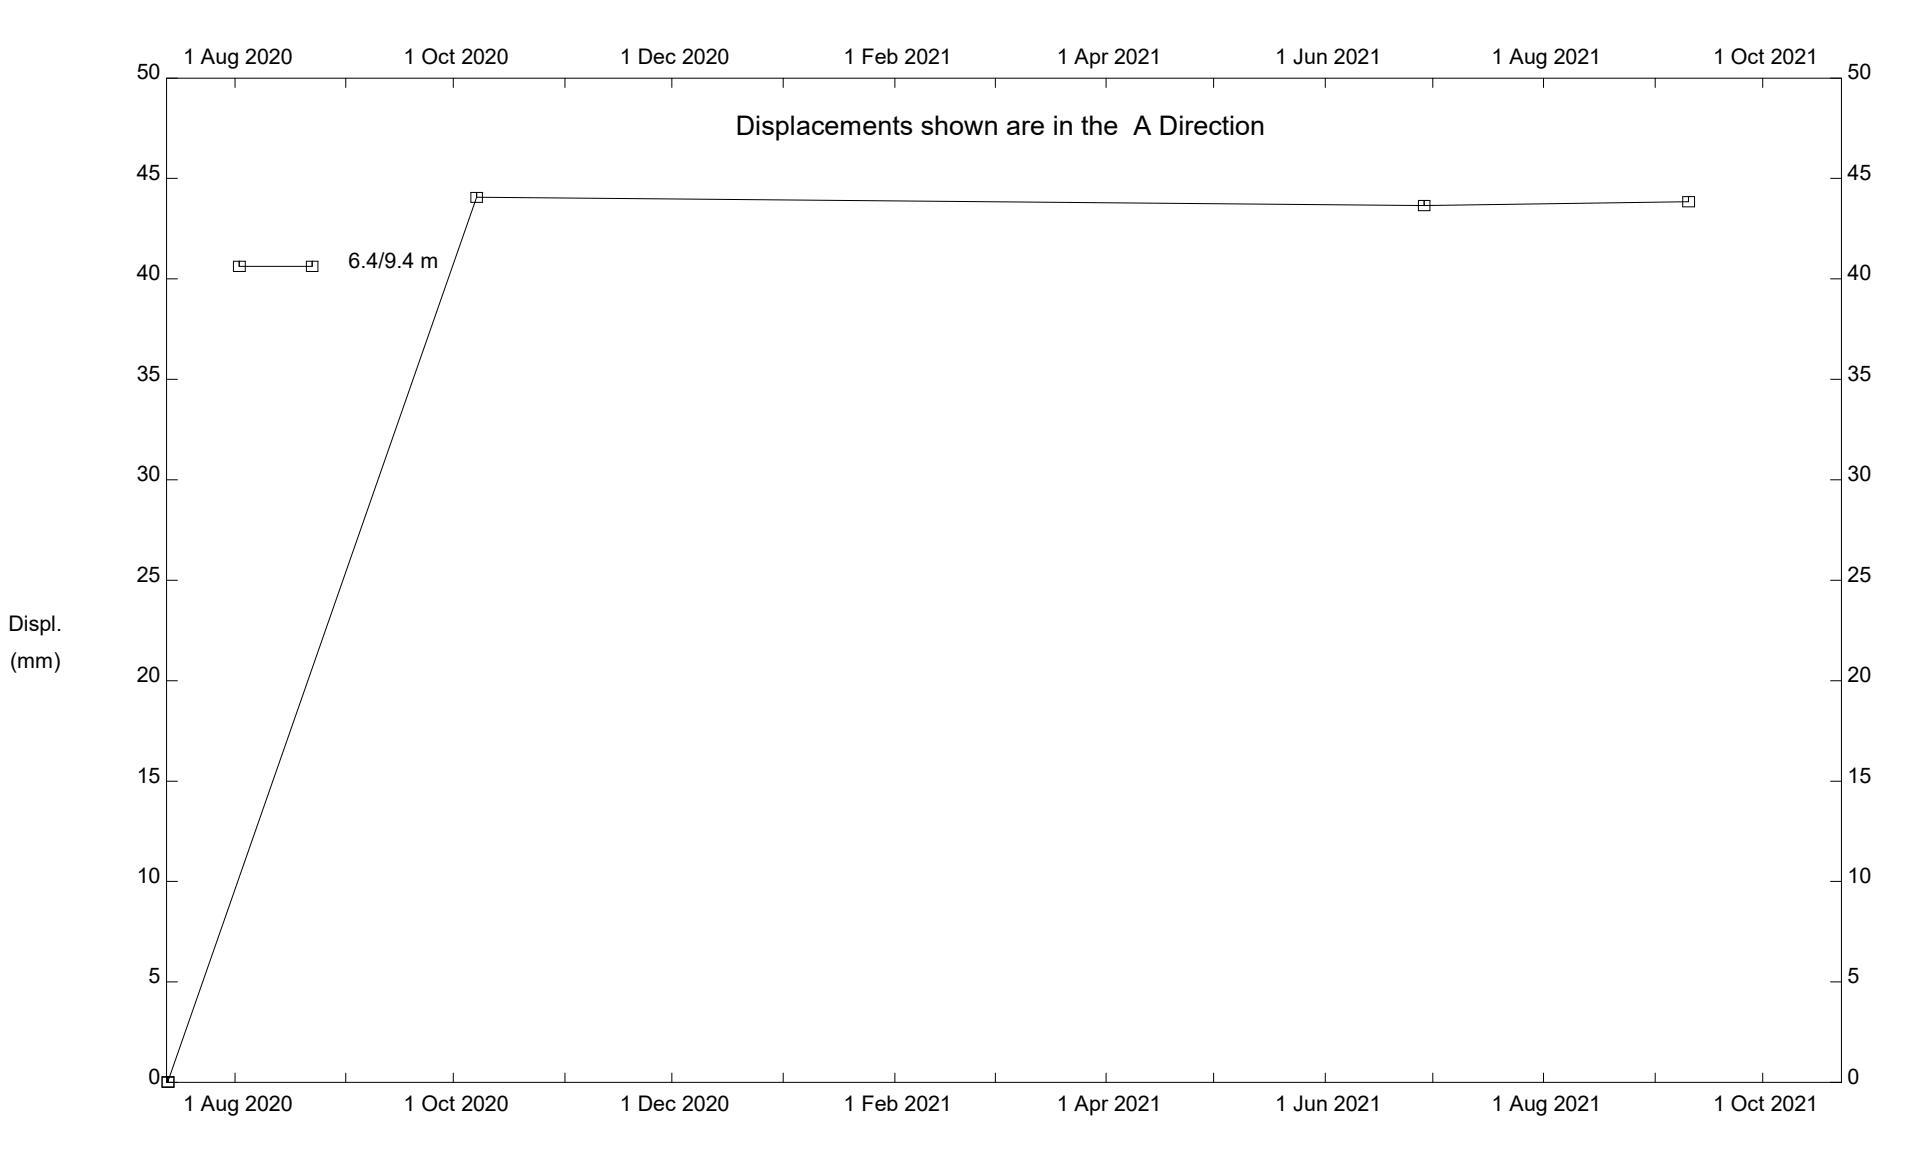
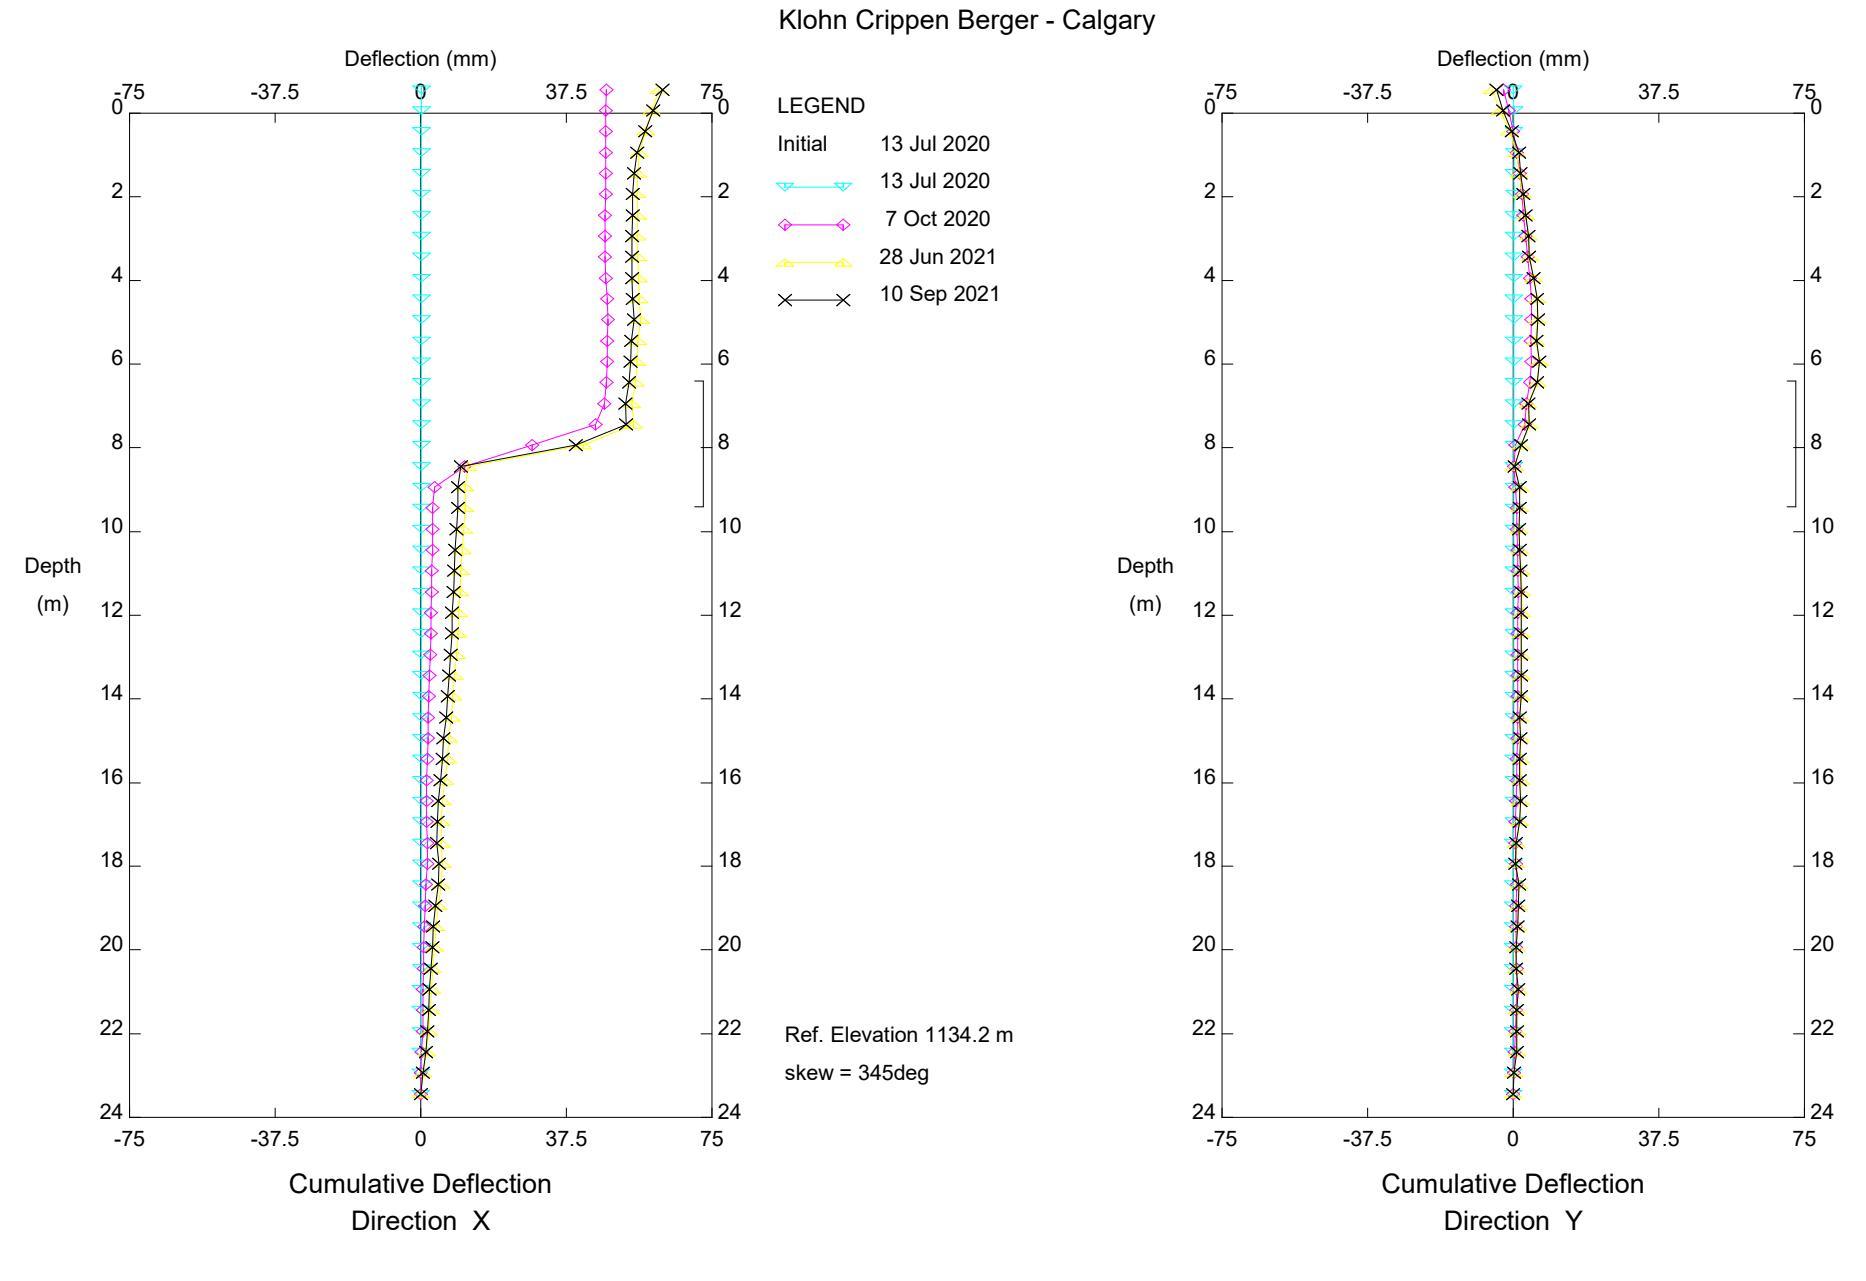
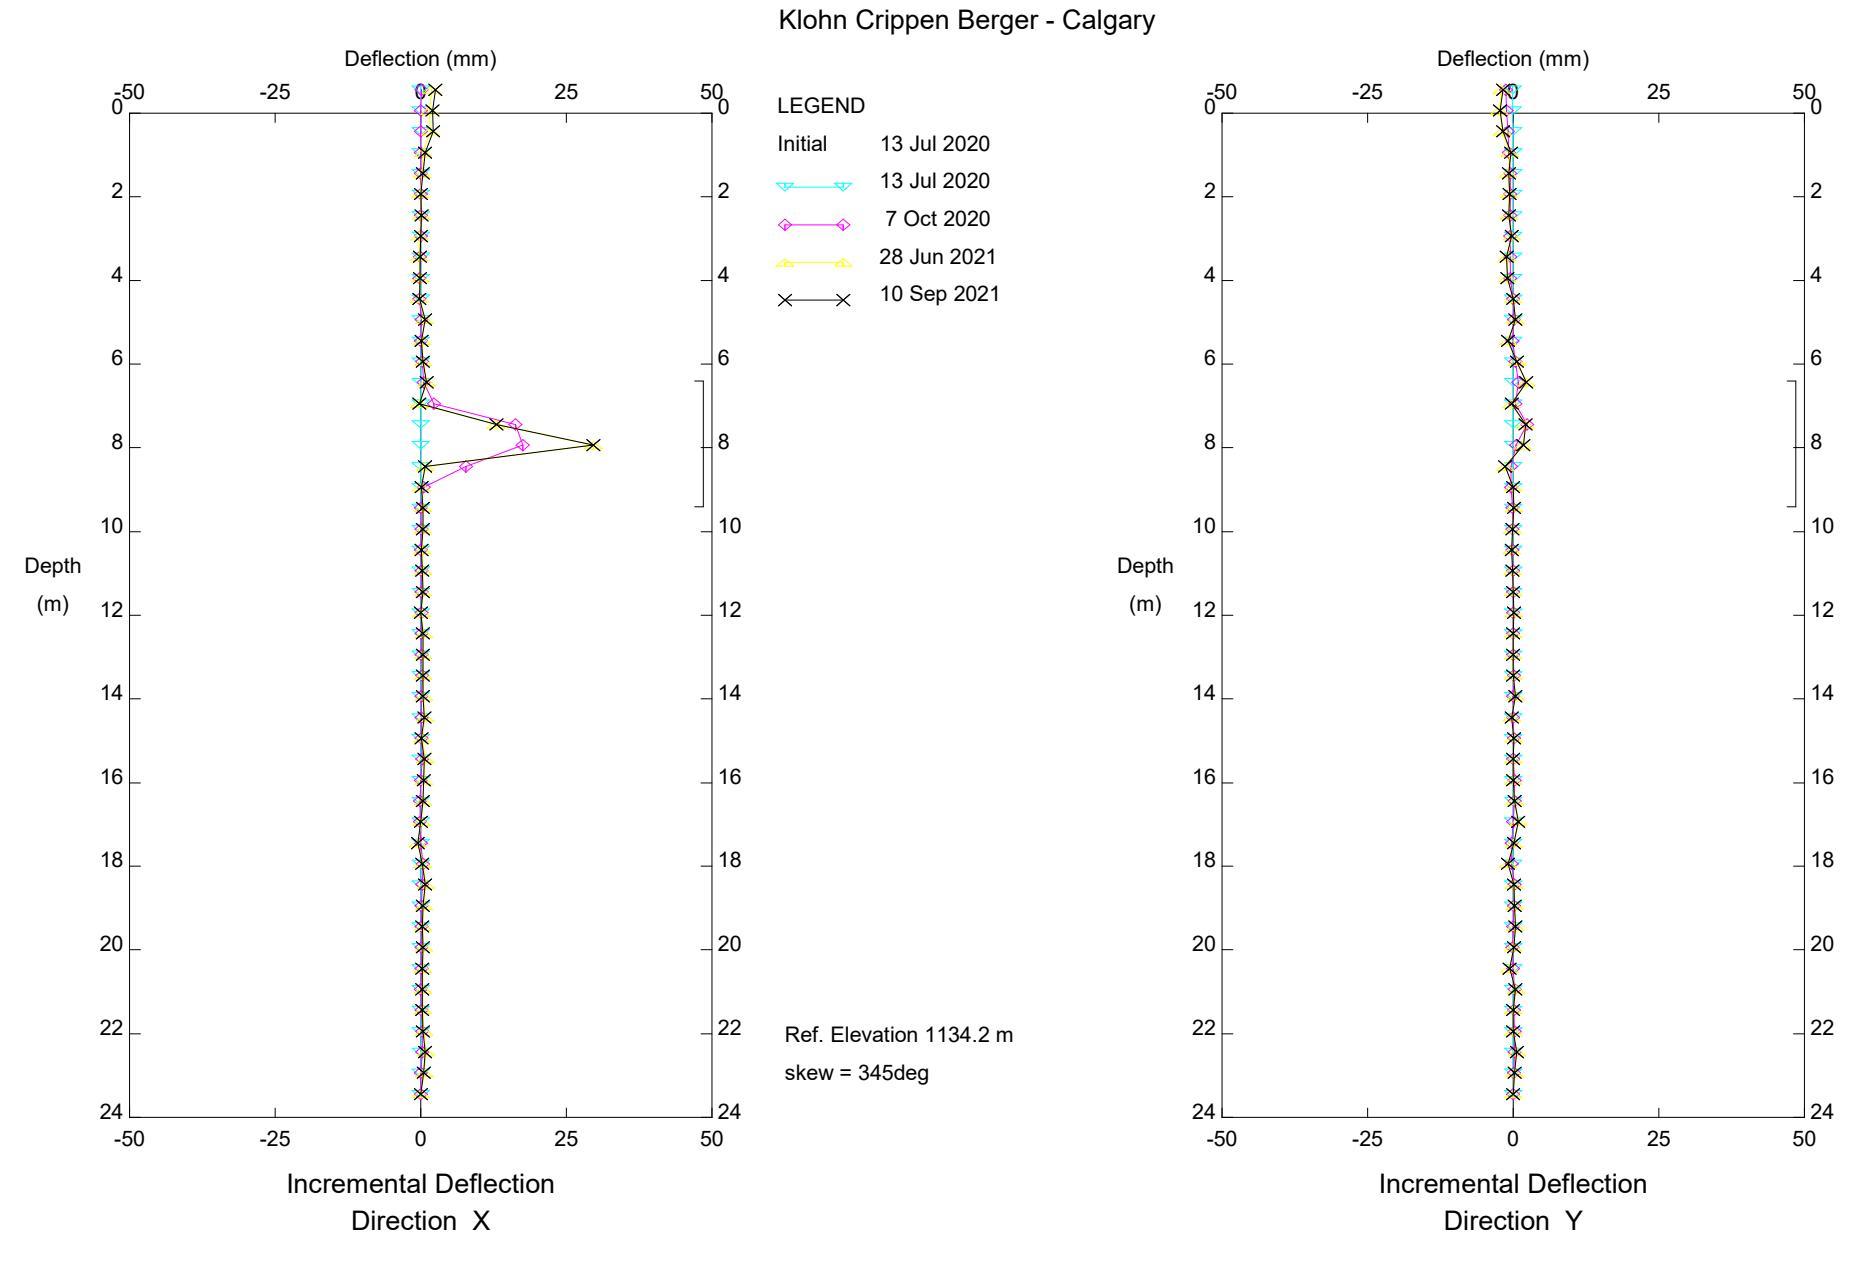
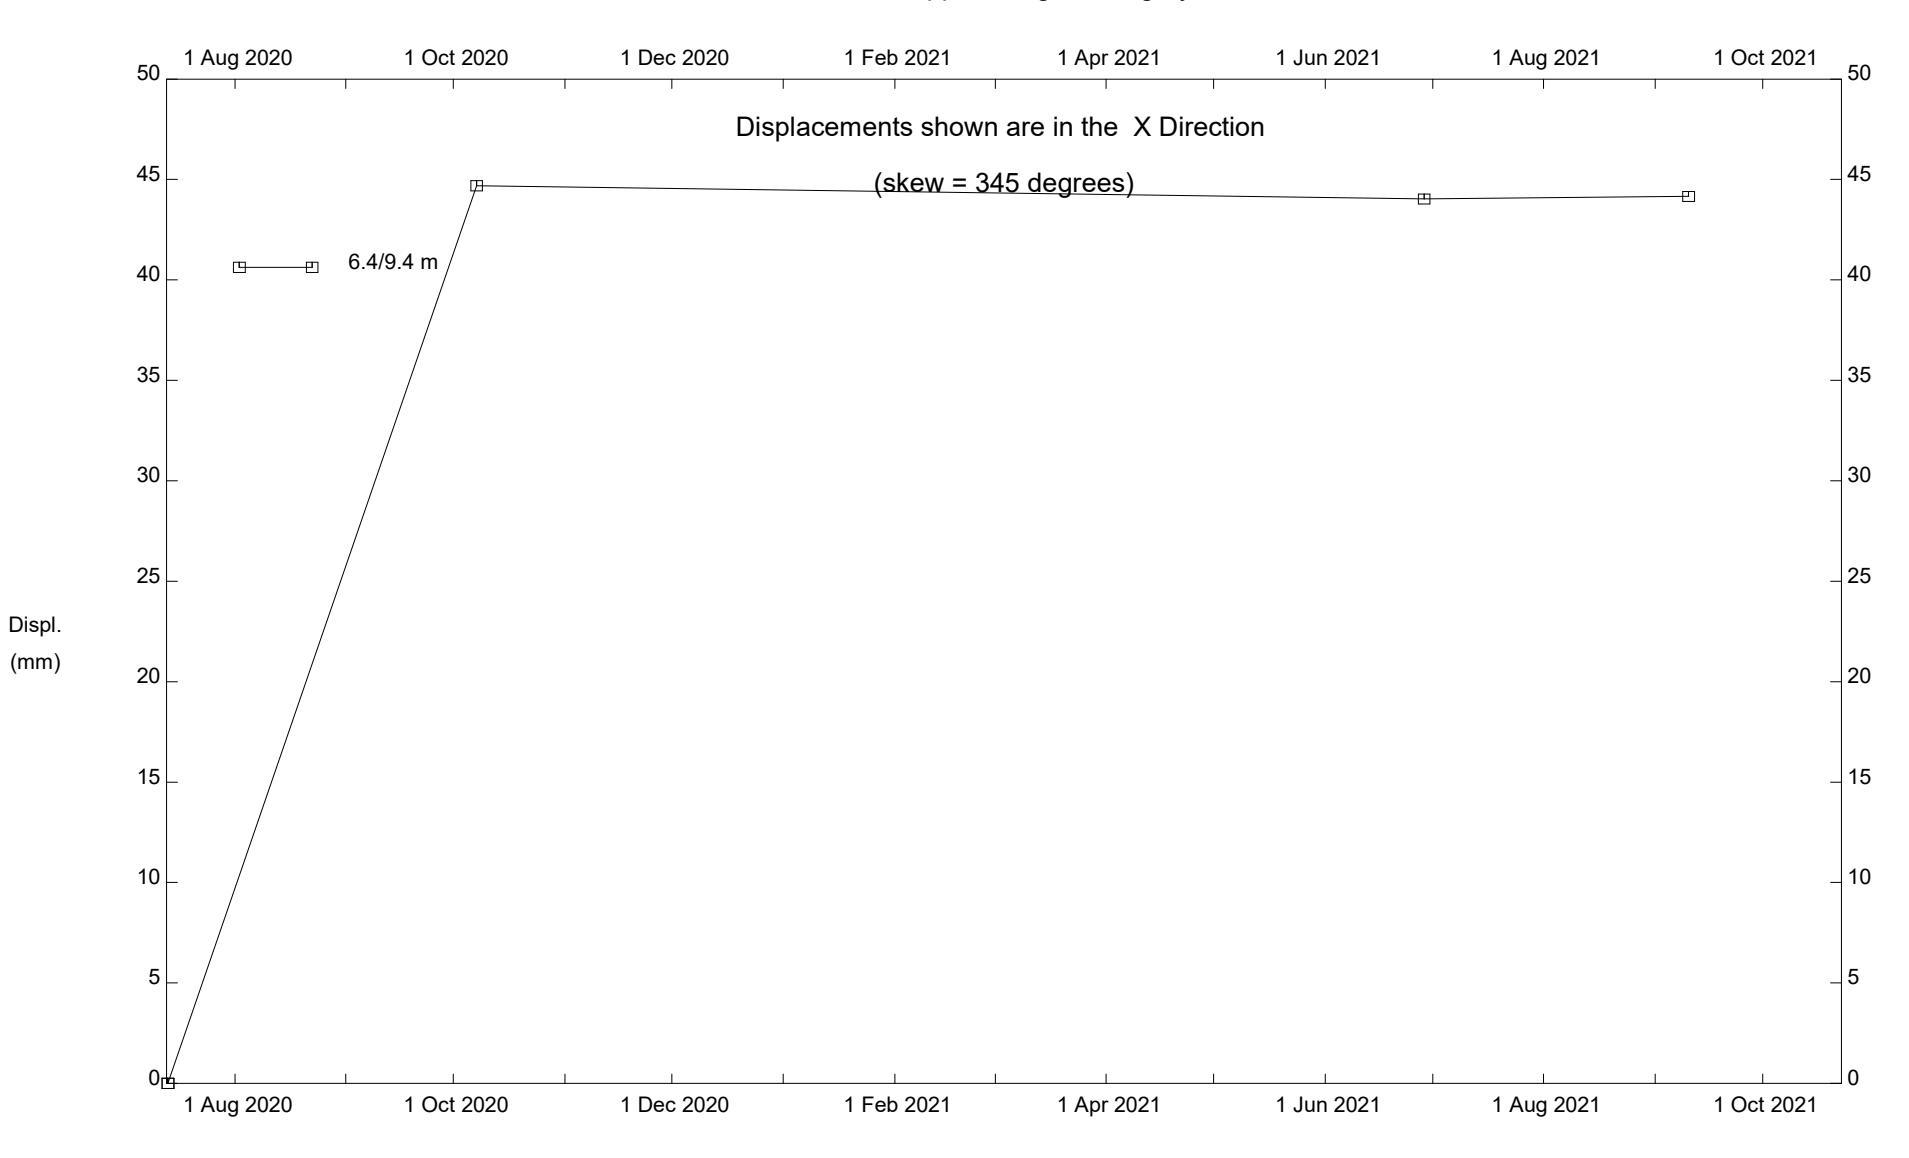
GP042; H40:36, Inclinometer TH20-DS2 Slide 9 km North of Wanyandie Road Alberta Transportation

- TH20-DS2 between an approximate depth of 7.4 m and 8.9 m below ground surface; and
- TH20-DS5 between an approximate depth of 3.3 m and 4.3 m below ground surface.

Since installation in 2020, approximately 45 mm and 26 mm of discrete movement has been recorded in TH20-DS2 and TH20-DS5, respectively, with most of the movement occurring before October 2020. Since October 2020, the rate of movement being recorded in TH20-DS5 and TH20-DS5 has either halted or decreased to less than 10 mm/year. However, the rate of movement may increase in response to periods of heavy or prolonged rainfall, and/or elevated groundwater levels. Construction activity could result in increased rate of movement, or lateral expansion of zones of movement. More data is needed to assess trend for the instruments installed in 2020.

KCB to assess reinitializing the SIs in the spring of 2022 after construction is complete.
