November 19, 2021

CON0022166 Peace Region (Grande Prairie District – South) GRMP Instrumentation Monitoring Site GP042; H40:36, km 37.524 Slide 9 km North of Wanyandie Road Section C – 2021 Fall Readings

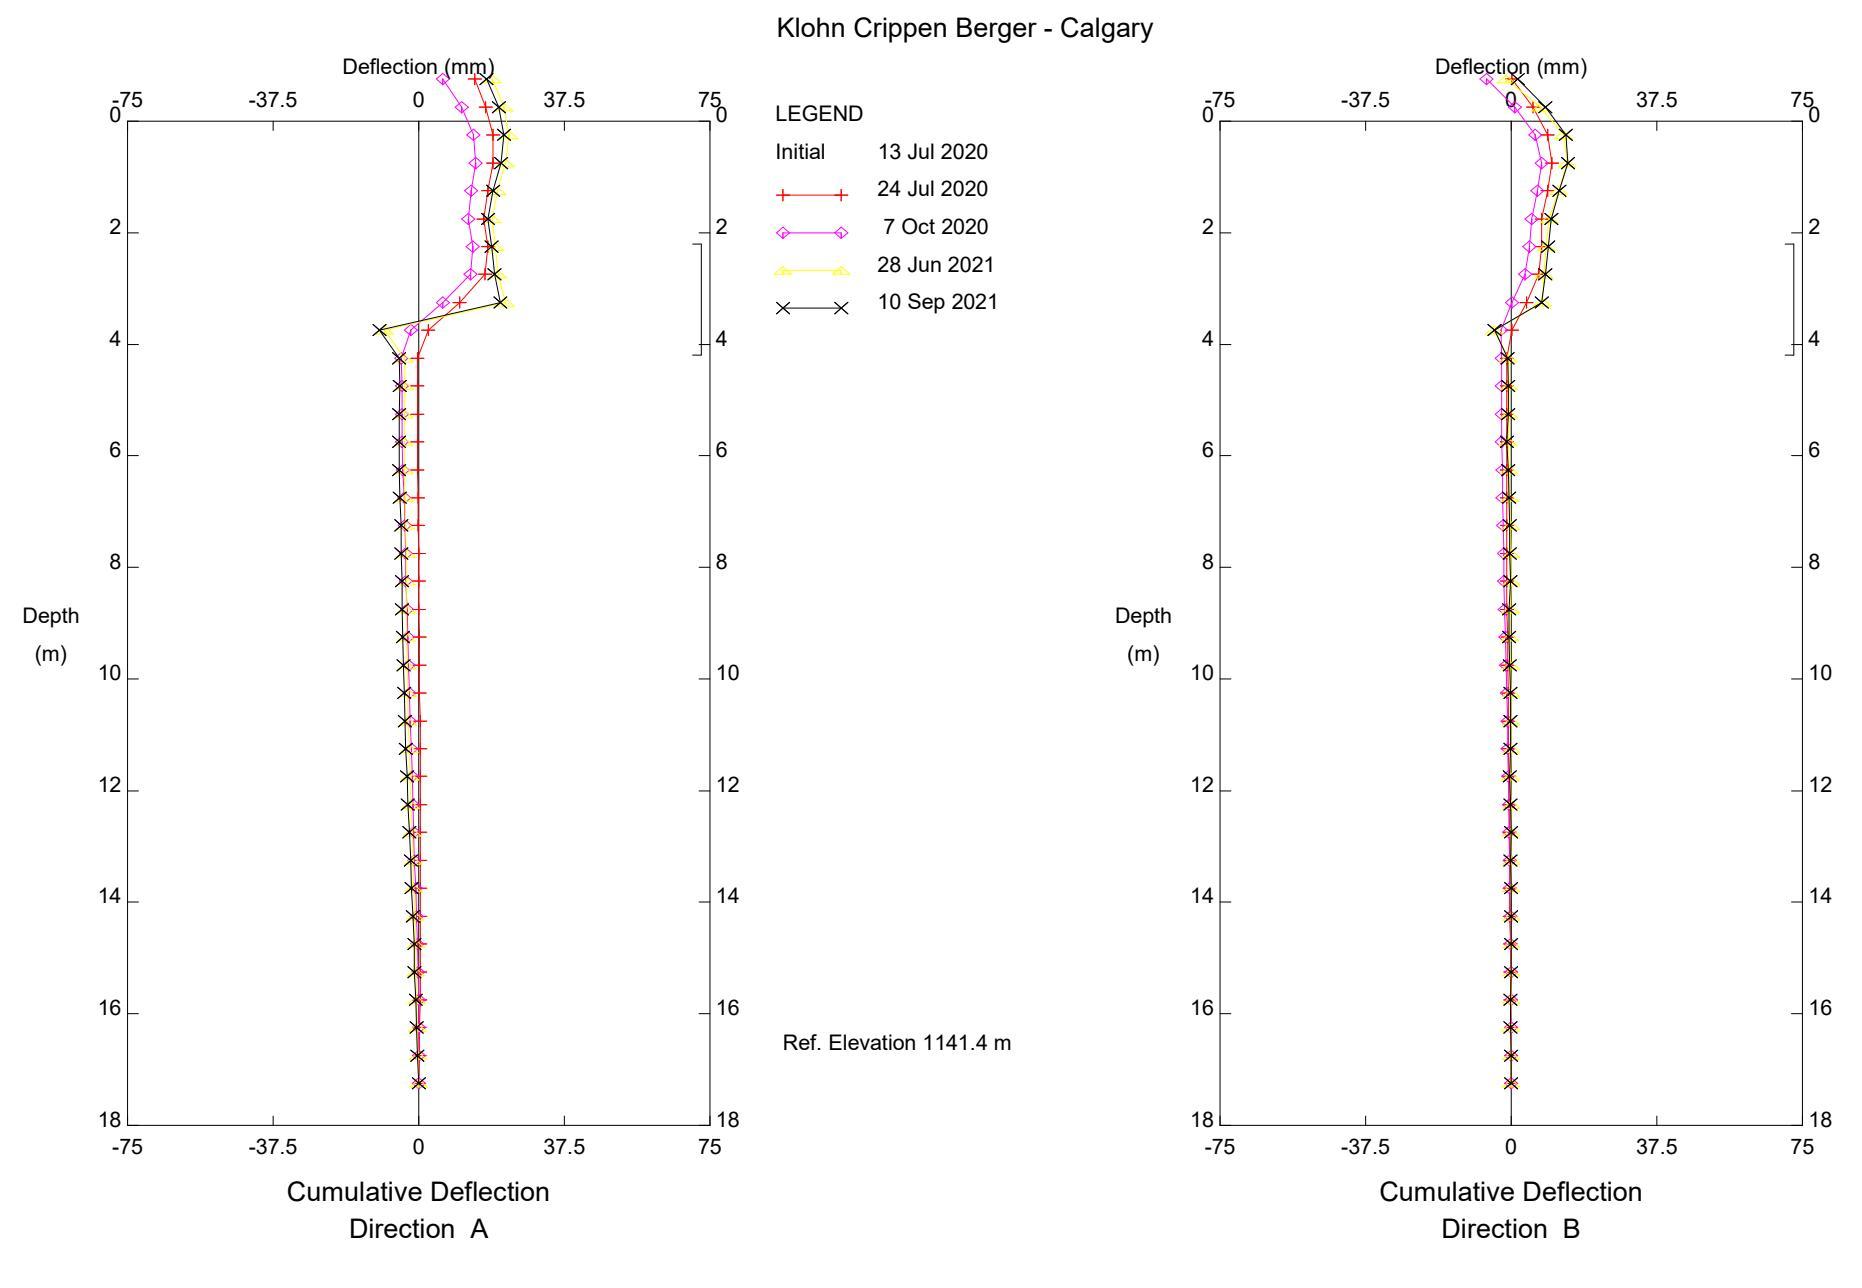
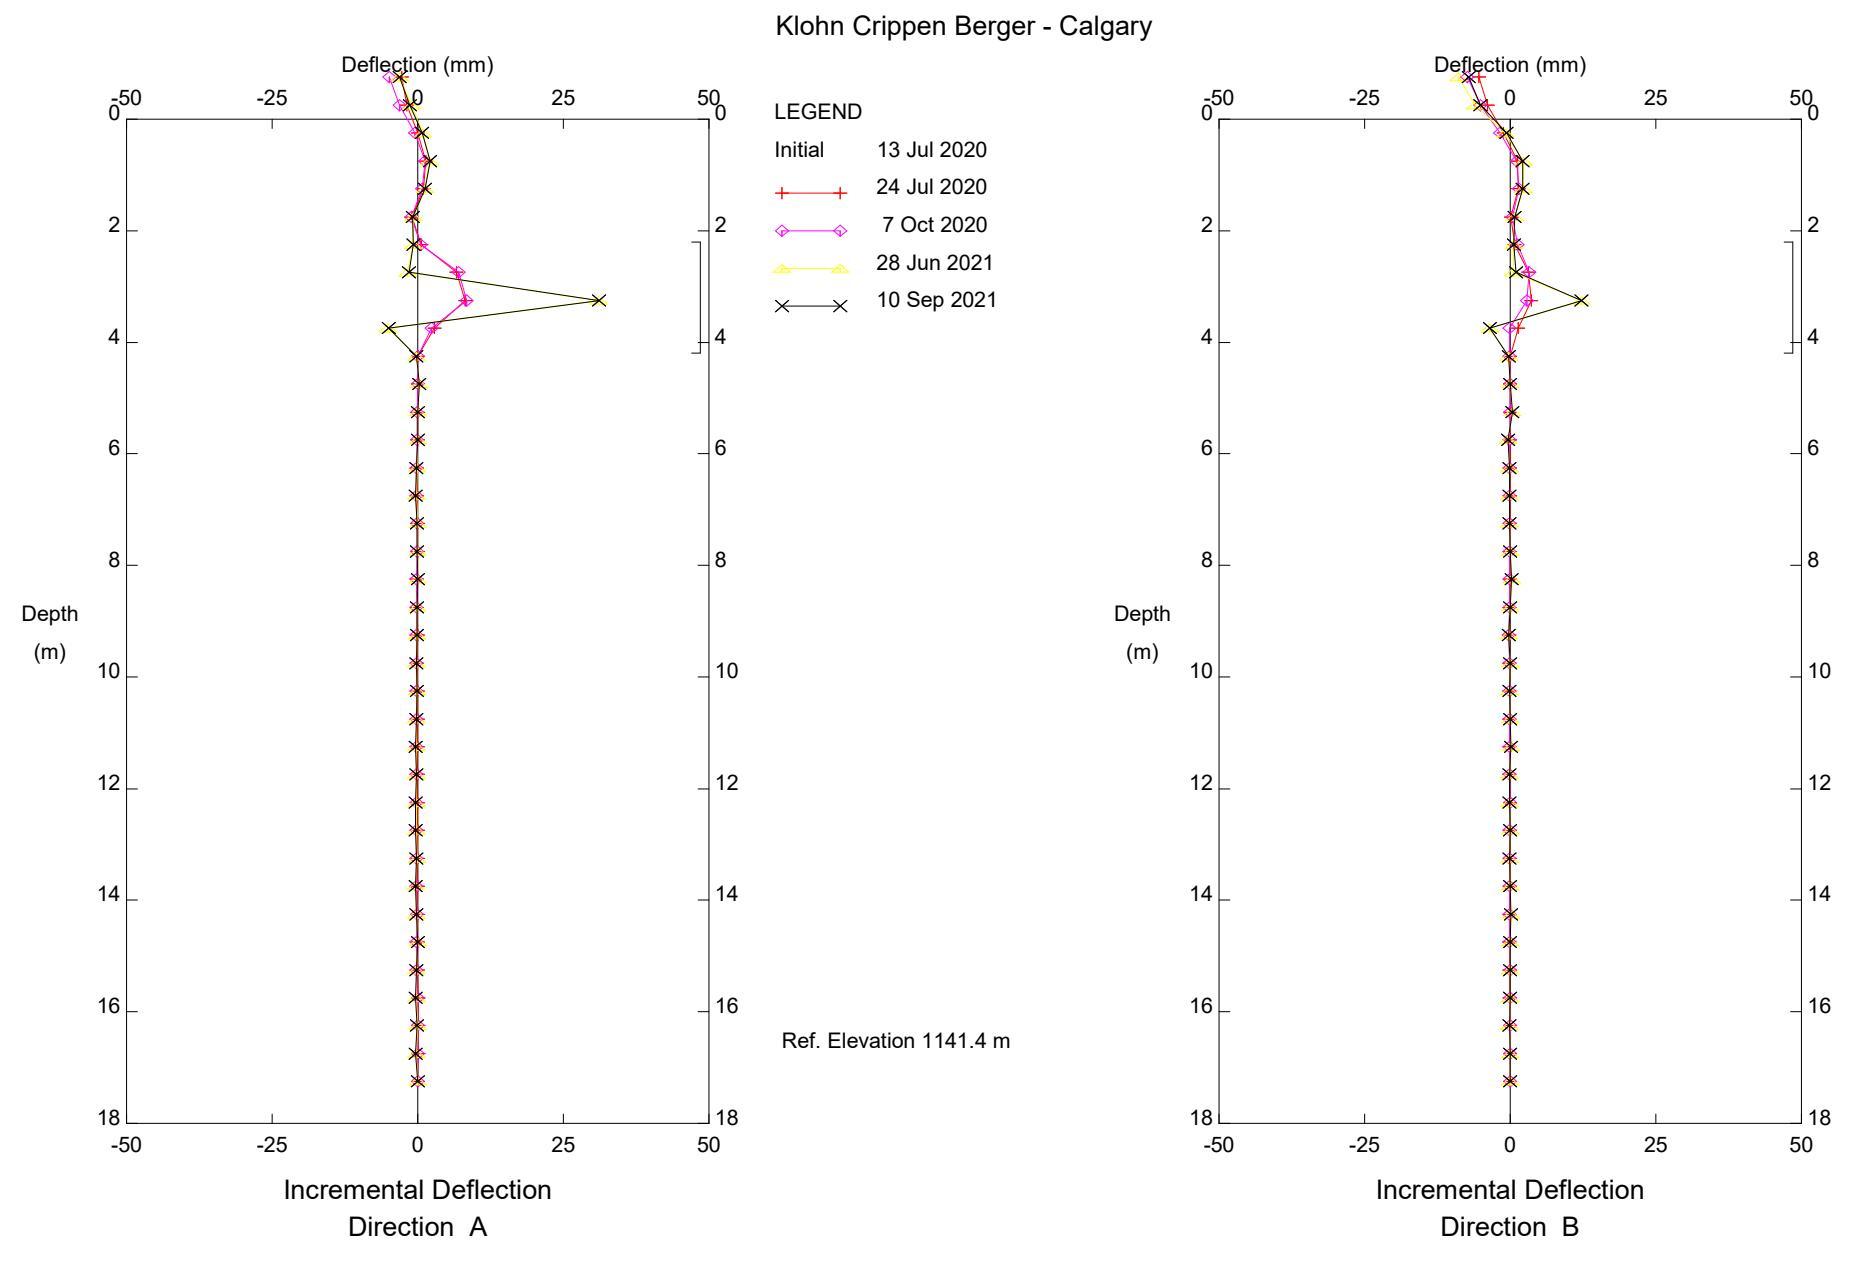
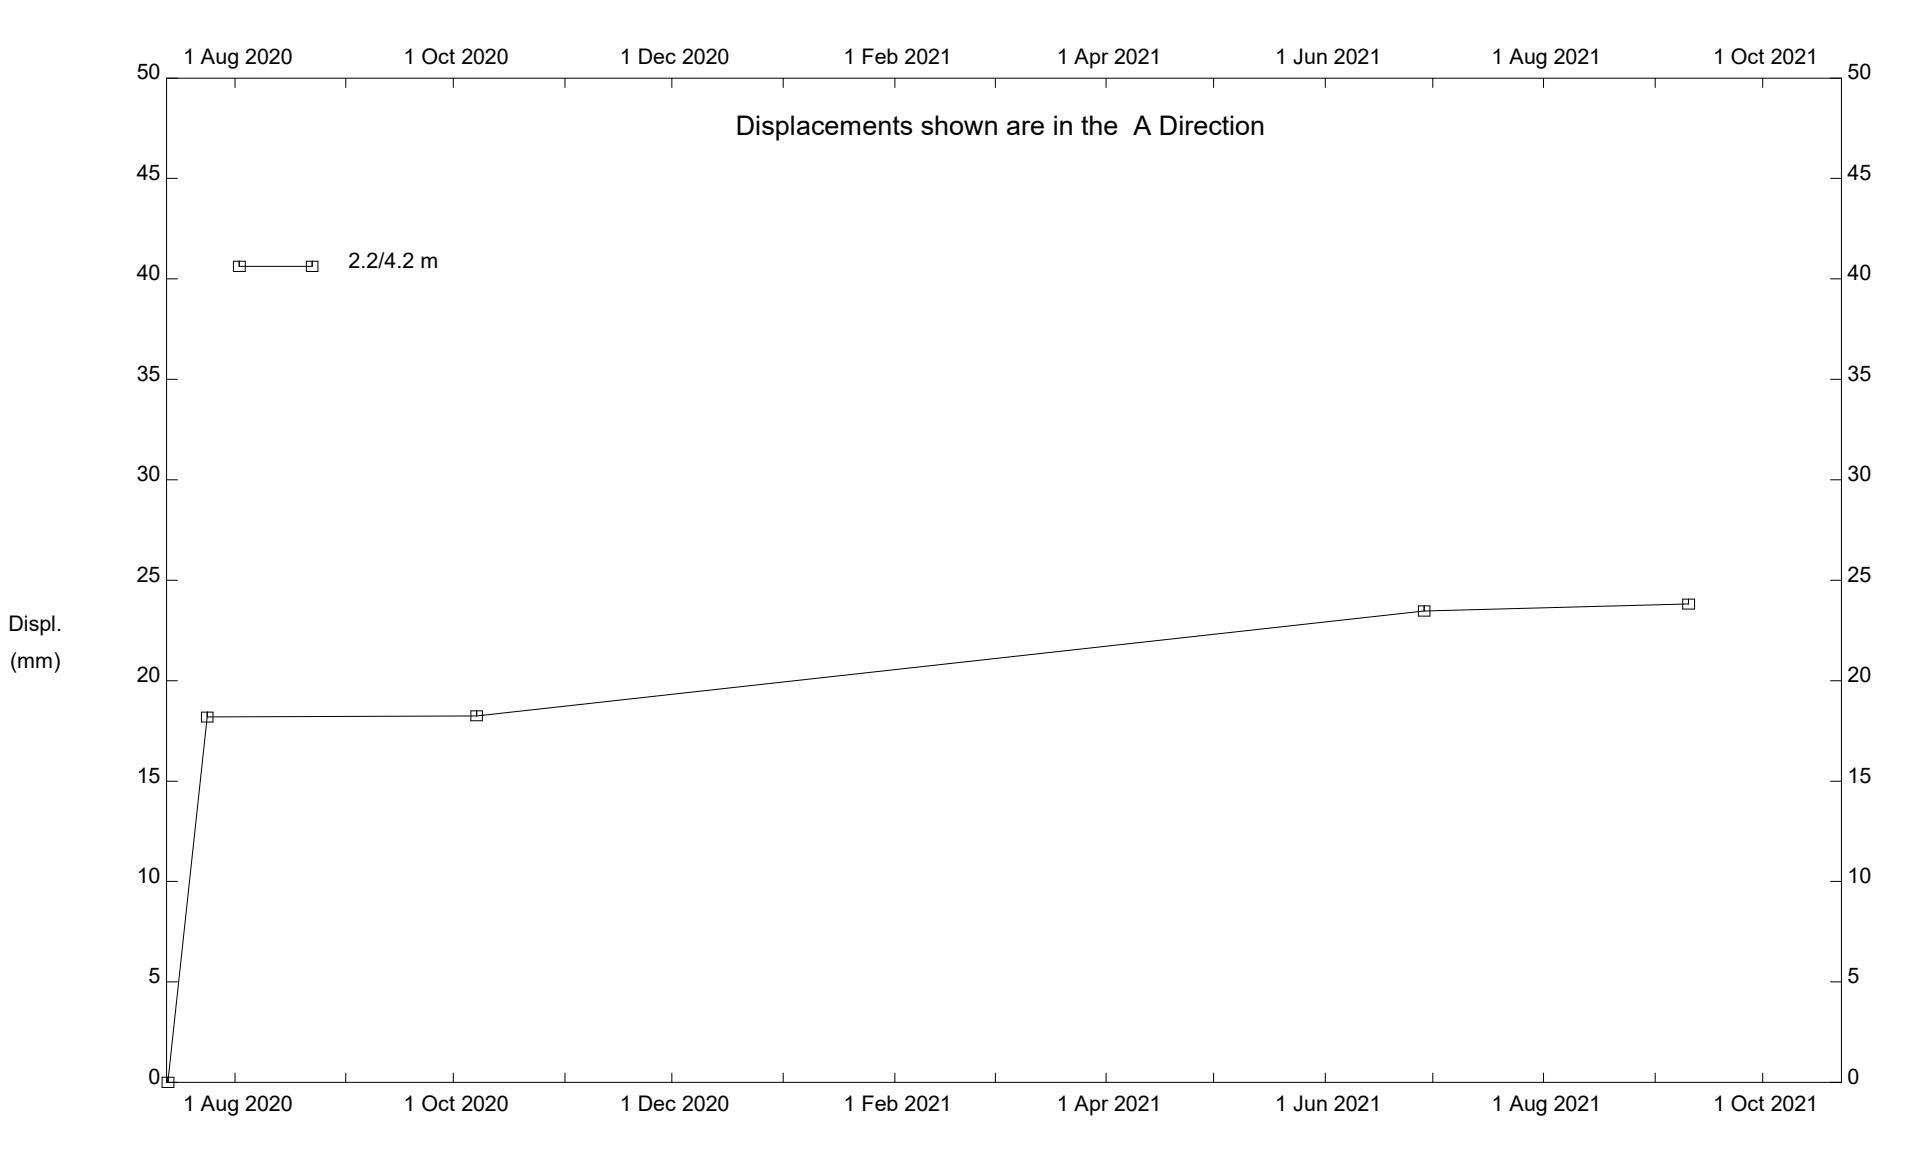
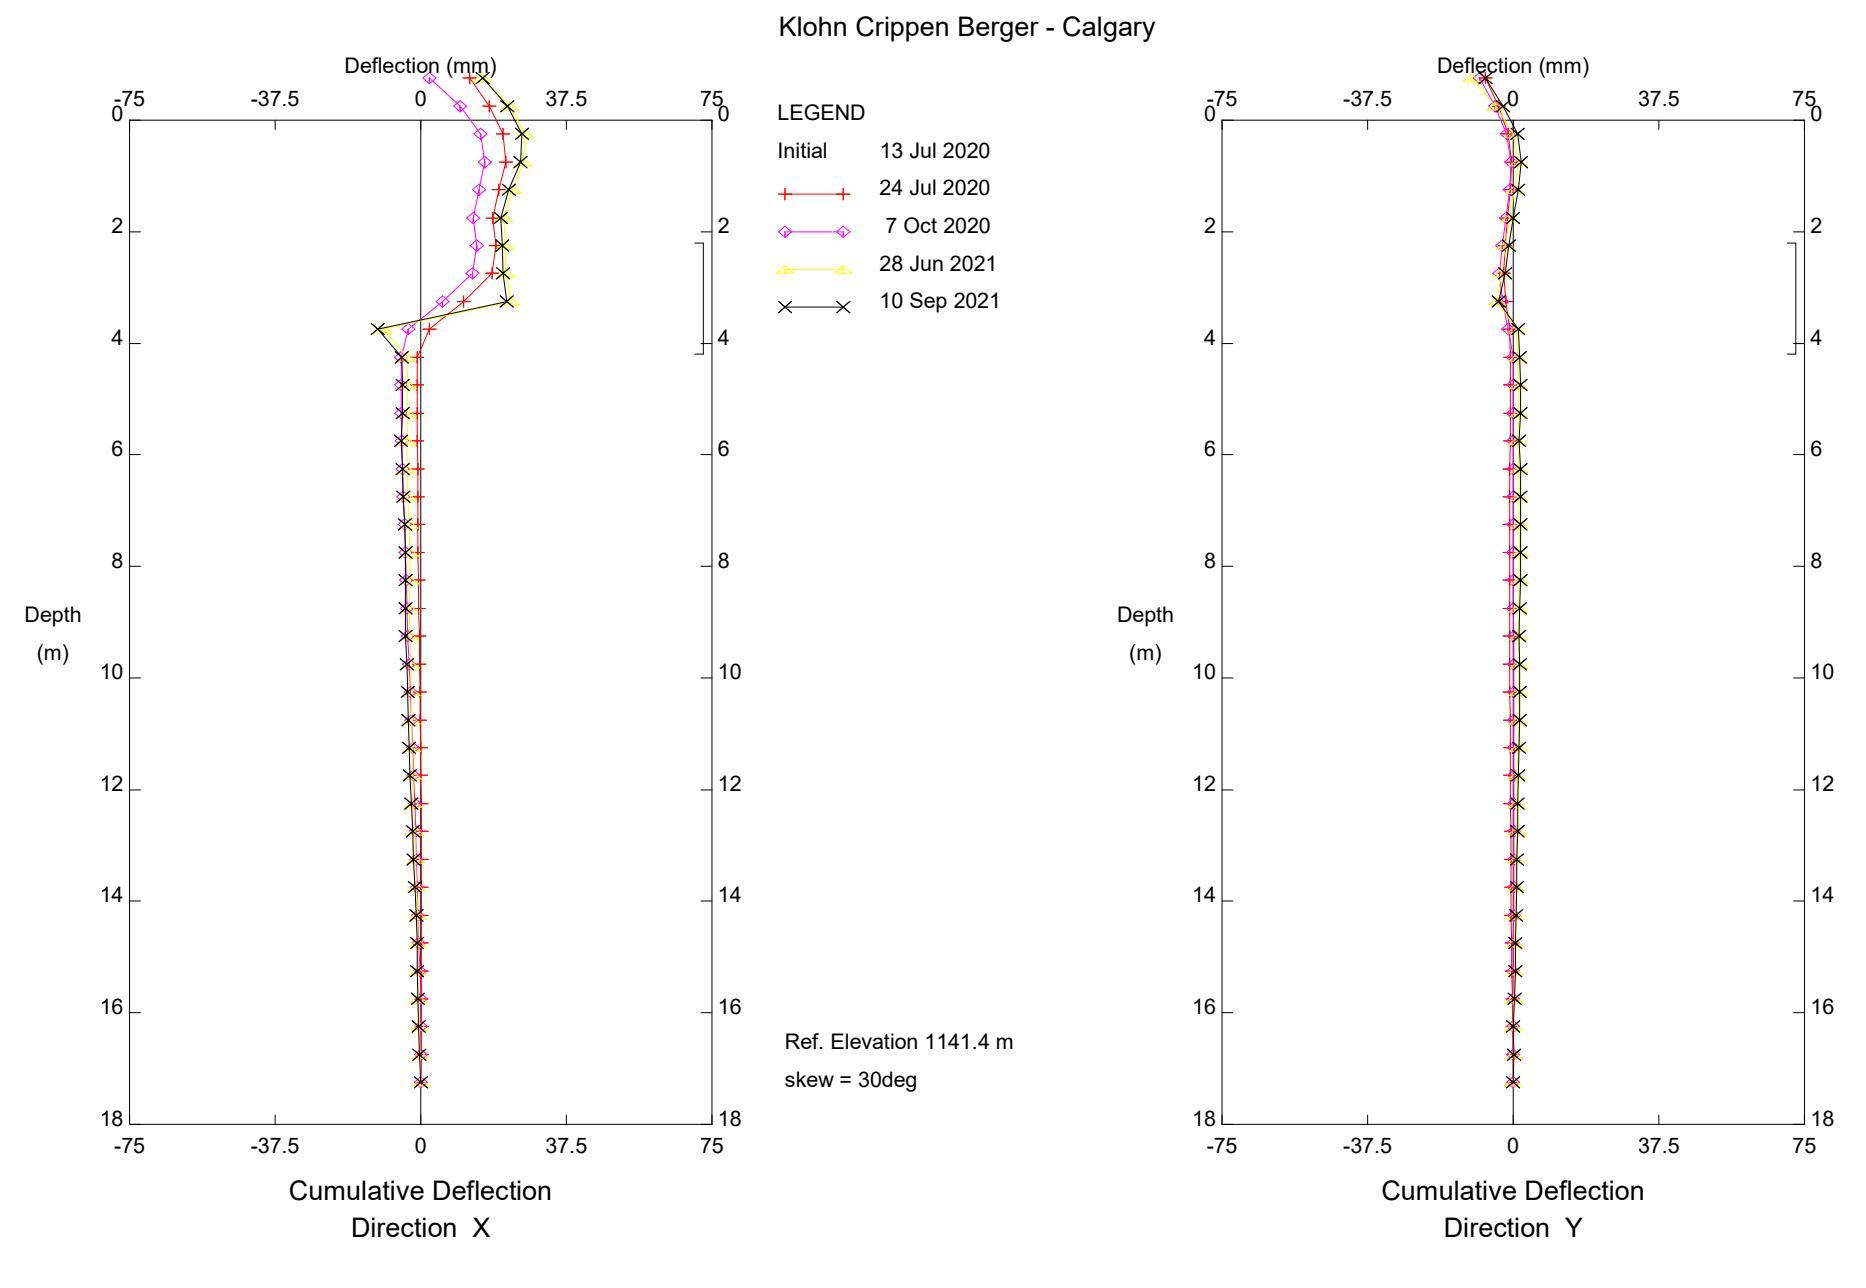
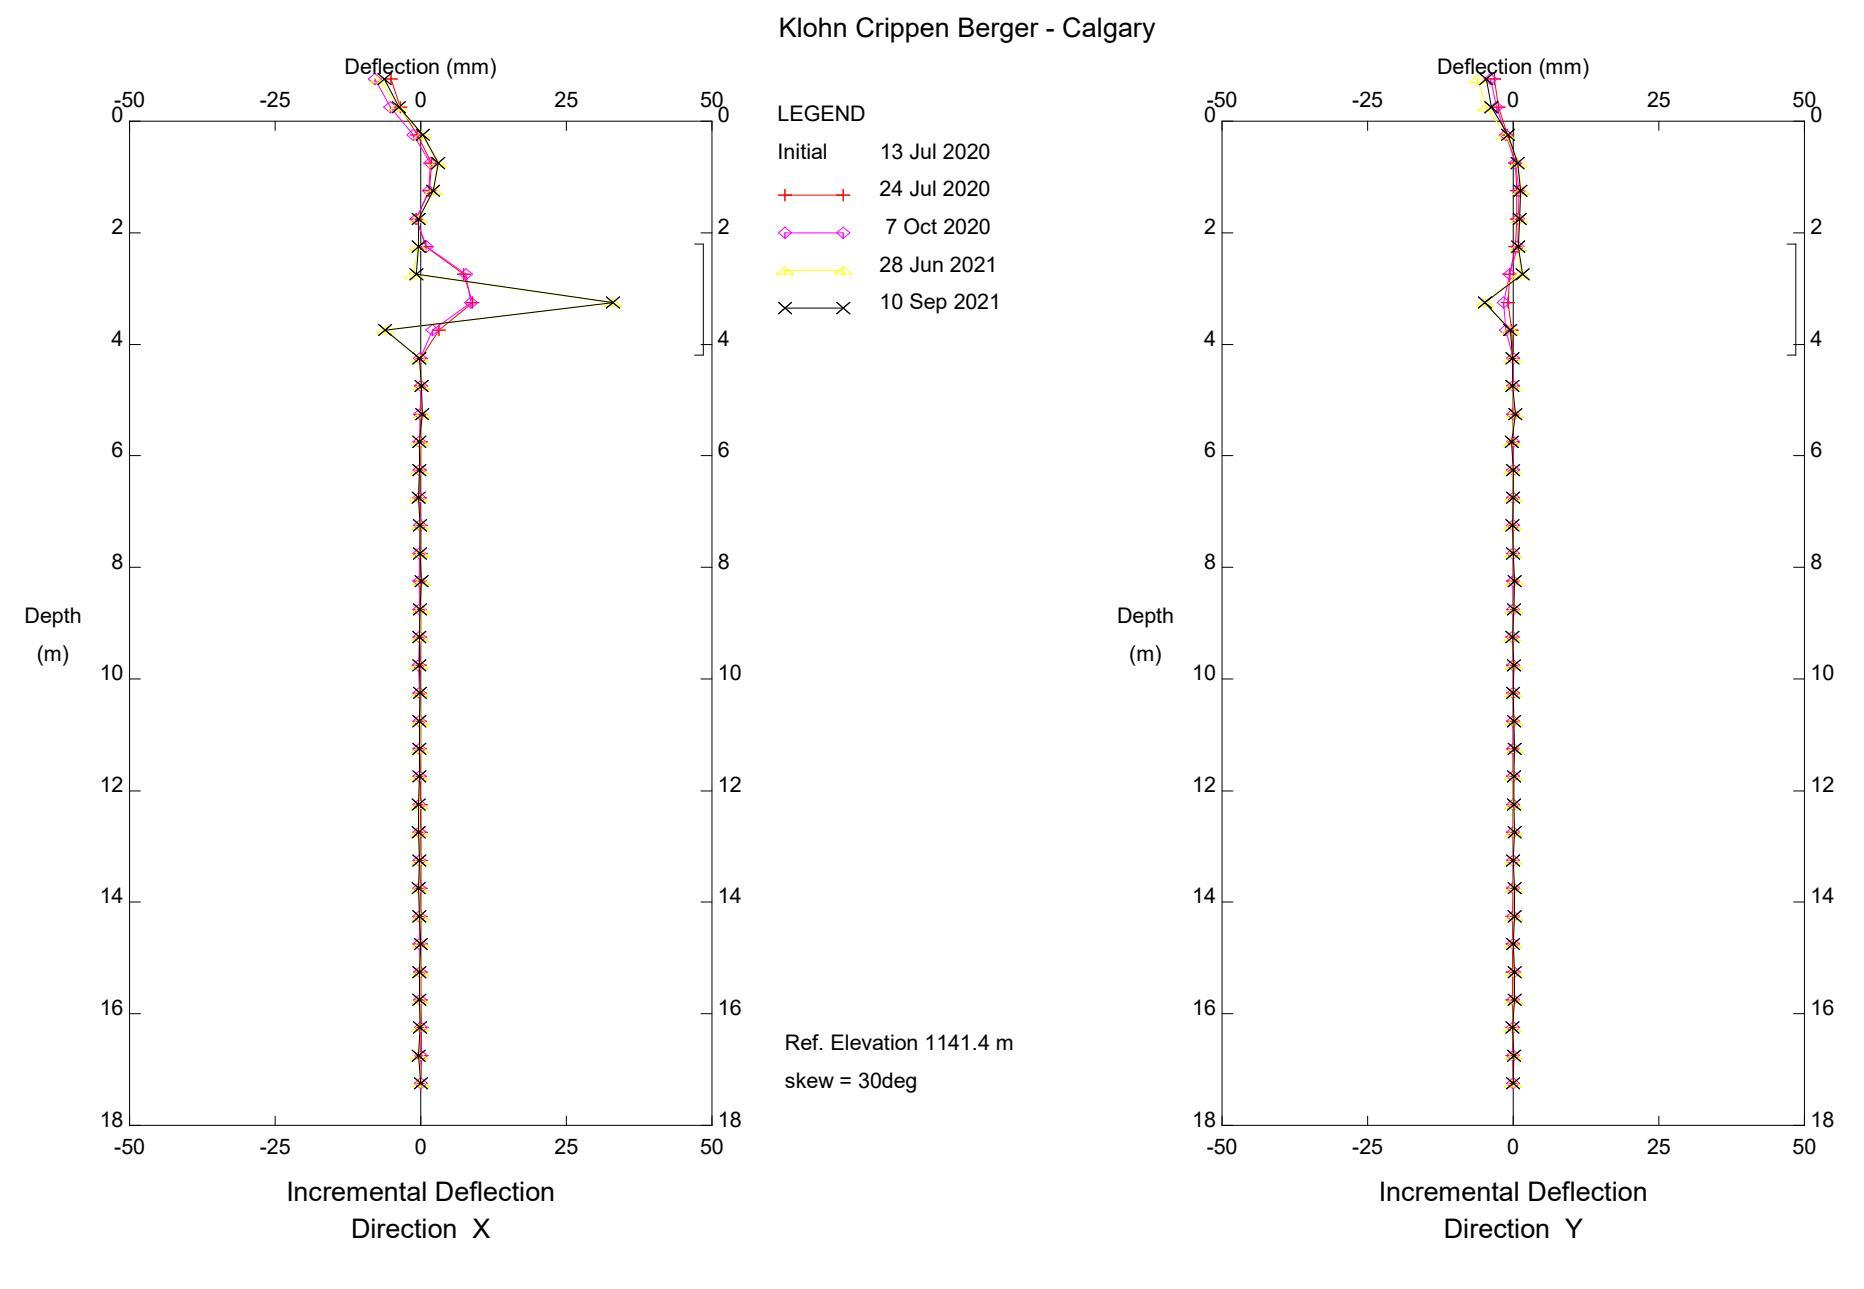
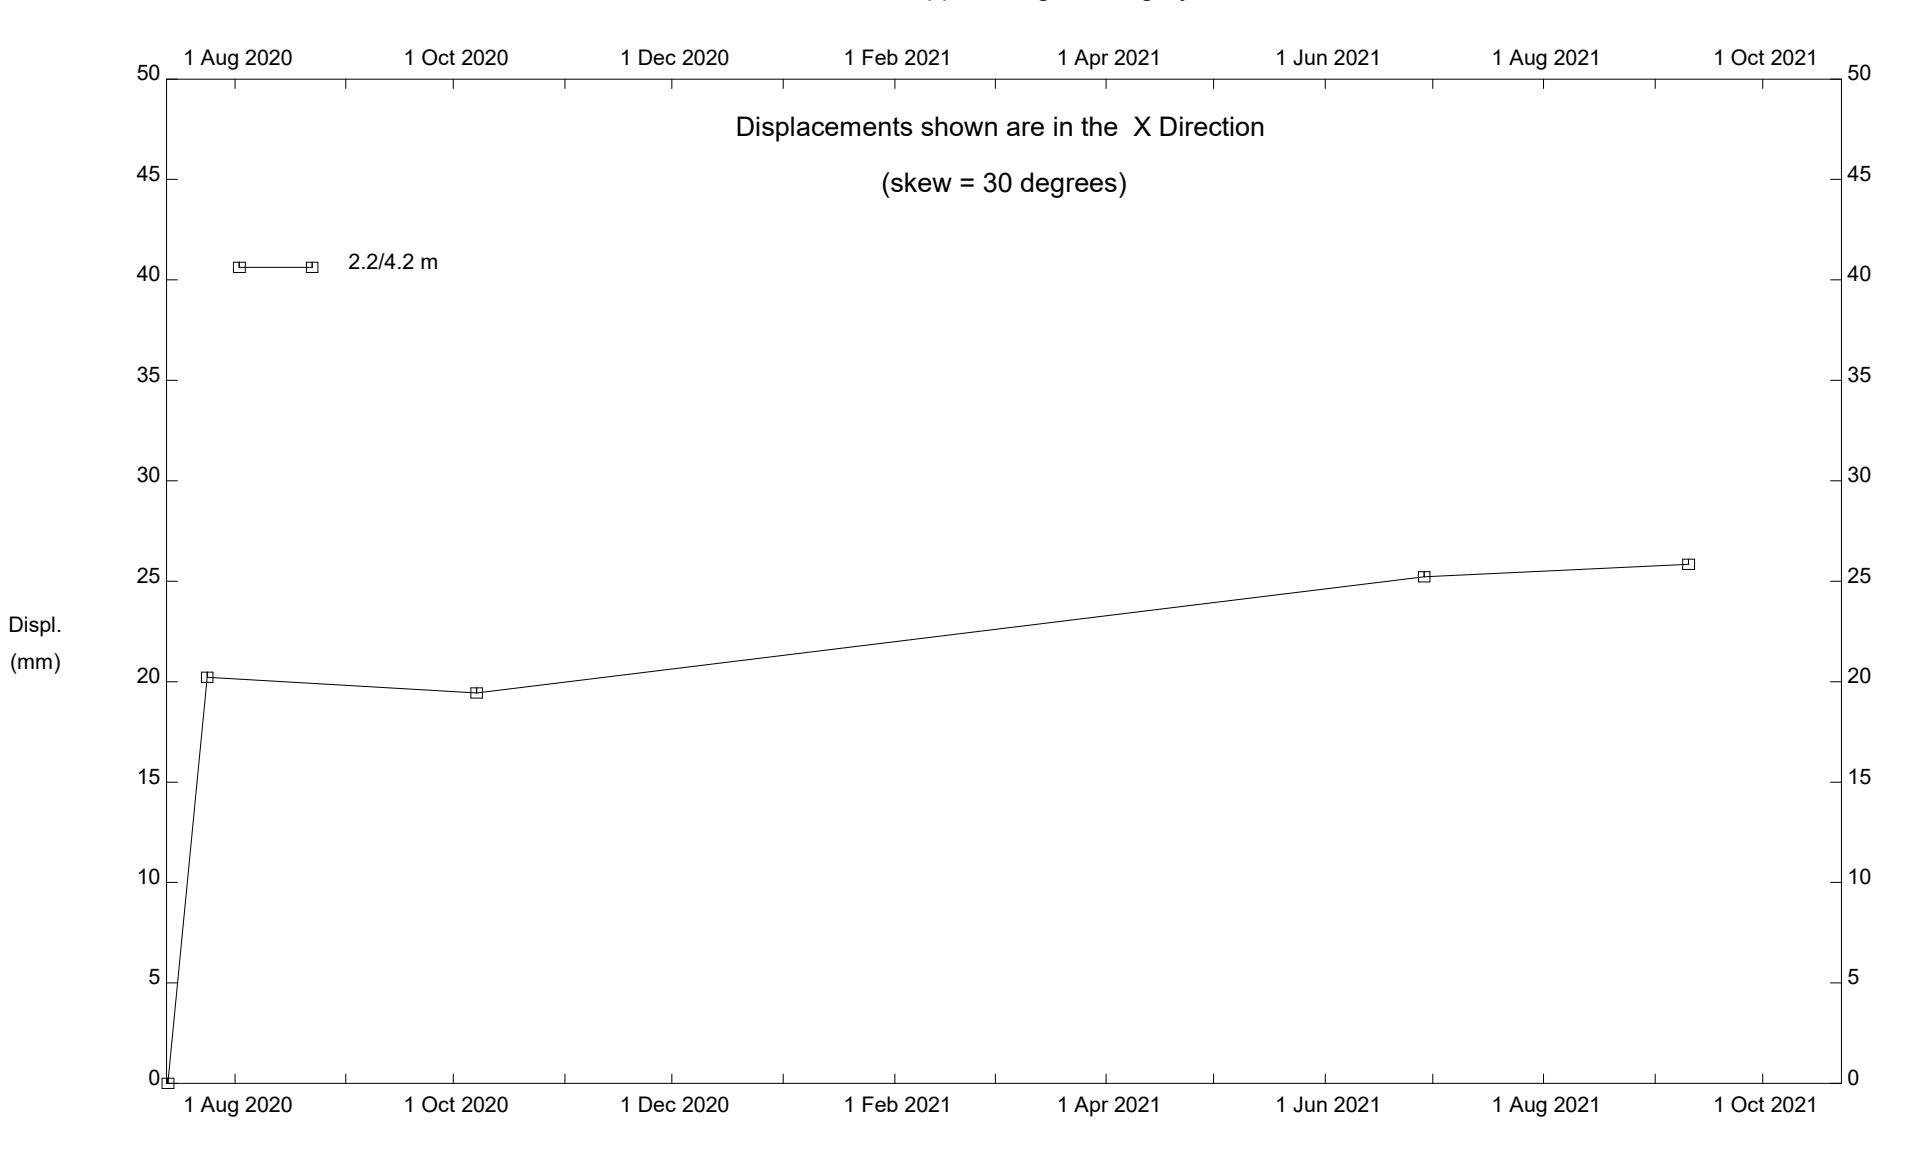
GP042; H40:36, Inclinometer TH20-DS5 Slide 9 km North of Wanyandie Road Alberta Transportation

The instrumentation data obtained by KCB is relatively consistent with the data obtained by the previous consultant, except for some reading "noise" (i.e., data with high checksums) that was recorded in TH20-DS5 between an approximate depth of 3.3 m and 4.3 m below ground surface. It is unclear if the noise being recorded in TH20-DS5 is due to changing the SI equipment or continued slide movements damaging the casing. These instruments were only read twice before KCB took over the readings in June 2021. More data is needed to assess trends for these instruments. KCB will assess if reinitialization of the SIs is needed in the spring of 2022 after construction is complete. The SI data plots presented herein include data for readings taken with both the previous consultants' and KCB's equipment.

- TH20-DS2 between an approximate depth of 7.4 m and 8.9 m below ground surface; and
- TH20-DS5 between an approximate depth of 3.3 m and 4.3 m below ground surface.

Since installation in 2020, approximately 45 mm and 26 mm of discrete movement has been recorded in TH20-DS2 and TH20-DS5, respectively, with most of the movement occurring before October 2020. Since October 2020, the rate of movement being recorded in TH20-DS5 and TH20-DS5 has either halted or decreased to less than 10 mm/year. However, the rate of movement may increase in response to periods of heavy or prolonged rainfall, and/or elevated groundwater levels. Construction activity could result in increased rate of movement, or lateral expansion of zones of movement. More data is needed to assess trend for the instruments installed in 2020.

KCB to assess reinitializing the SIs in the spring of 2022 after construction is complete.
