ALBERTA TRANSPORTATION GEOHAZARD ASSESSMENT PROGRAM PEACE REGION – HIGH LEVEL 2020 CALLOUT

Site Number	Location		Name			ŀ	lwy	km	
PH011-3 North of T River		own of Peace Whitemuc		hitemud Riv	River (km 42.8)		743:02	42.8	
Legal Description		UTM Co-ordinates							
SW01-88-21-W5	11V N 6272586			72586	E 487326				
		Date PF CF		CF	Total RISK LEVEL				
Previous Inspection:									
Current Inspection:		4-August-2020)	10	6	60			
Road AADI:		110 Year:					2019)	
Inspected By:		Ed Szmata, TRANS Don Proudfoot, Thurbe					irber		
Report Attachments:		Photographs Plans Daintena					enance l	tems	
Primary Site Issue:		A landslide scarp has developed in the surface of a two laned gravelled road.							
Dimensions:		170 m long from the highway to the creek.							
Date of any remediation:									
Maintenance:		Highway officially closed on July 13, 2020 due to landslide movements at other sites.					Wor	Worsened?	
Observations:		Description					Yes	s No	
Pavement Distress		Cracks crossing both lanes and dip in gravel road surface.					ad 🔽

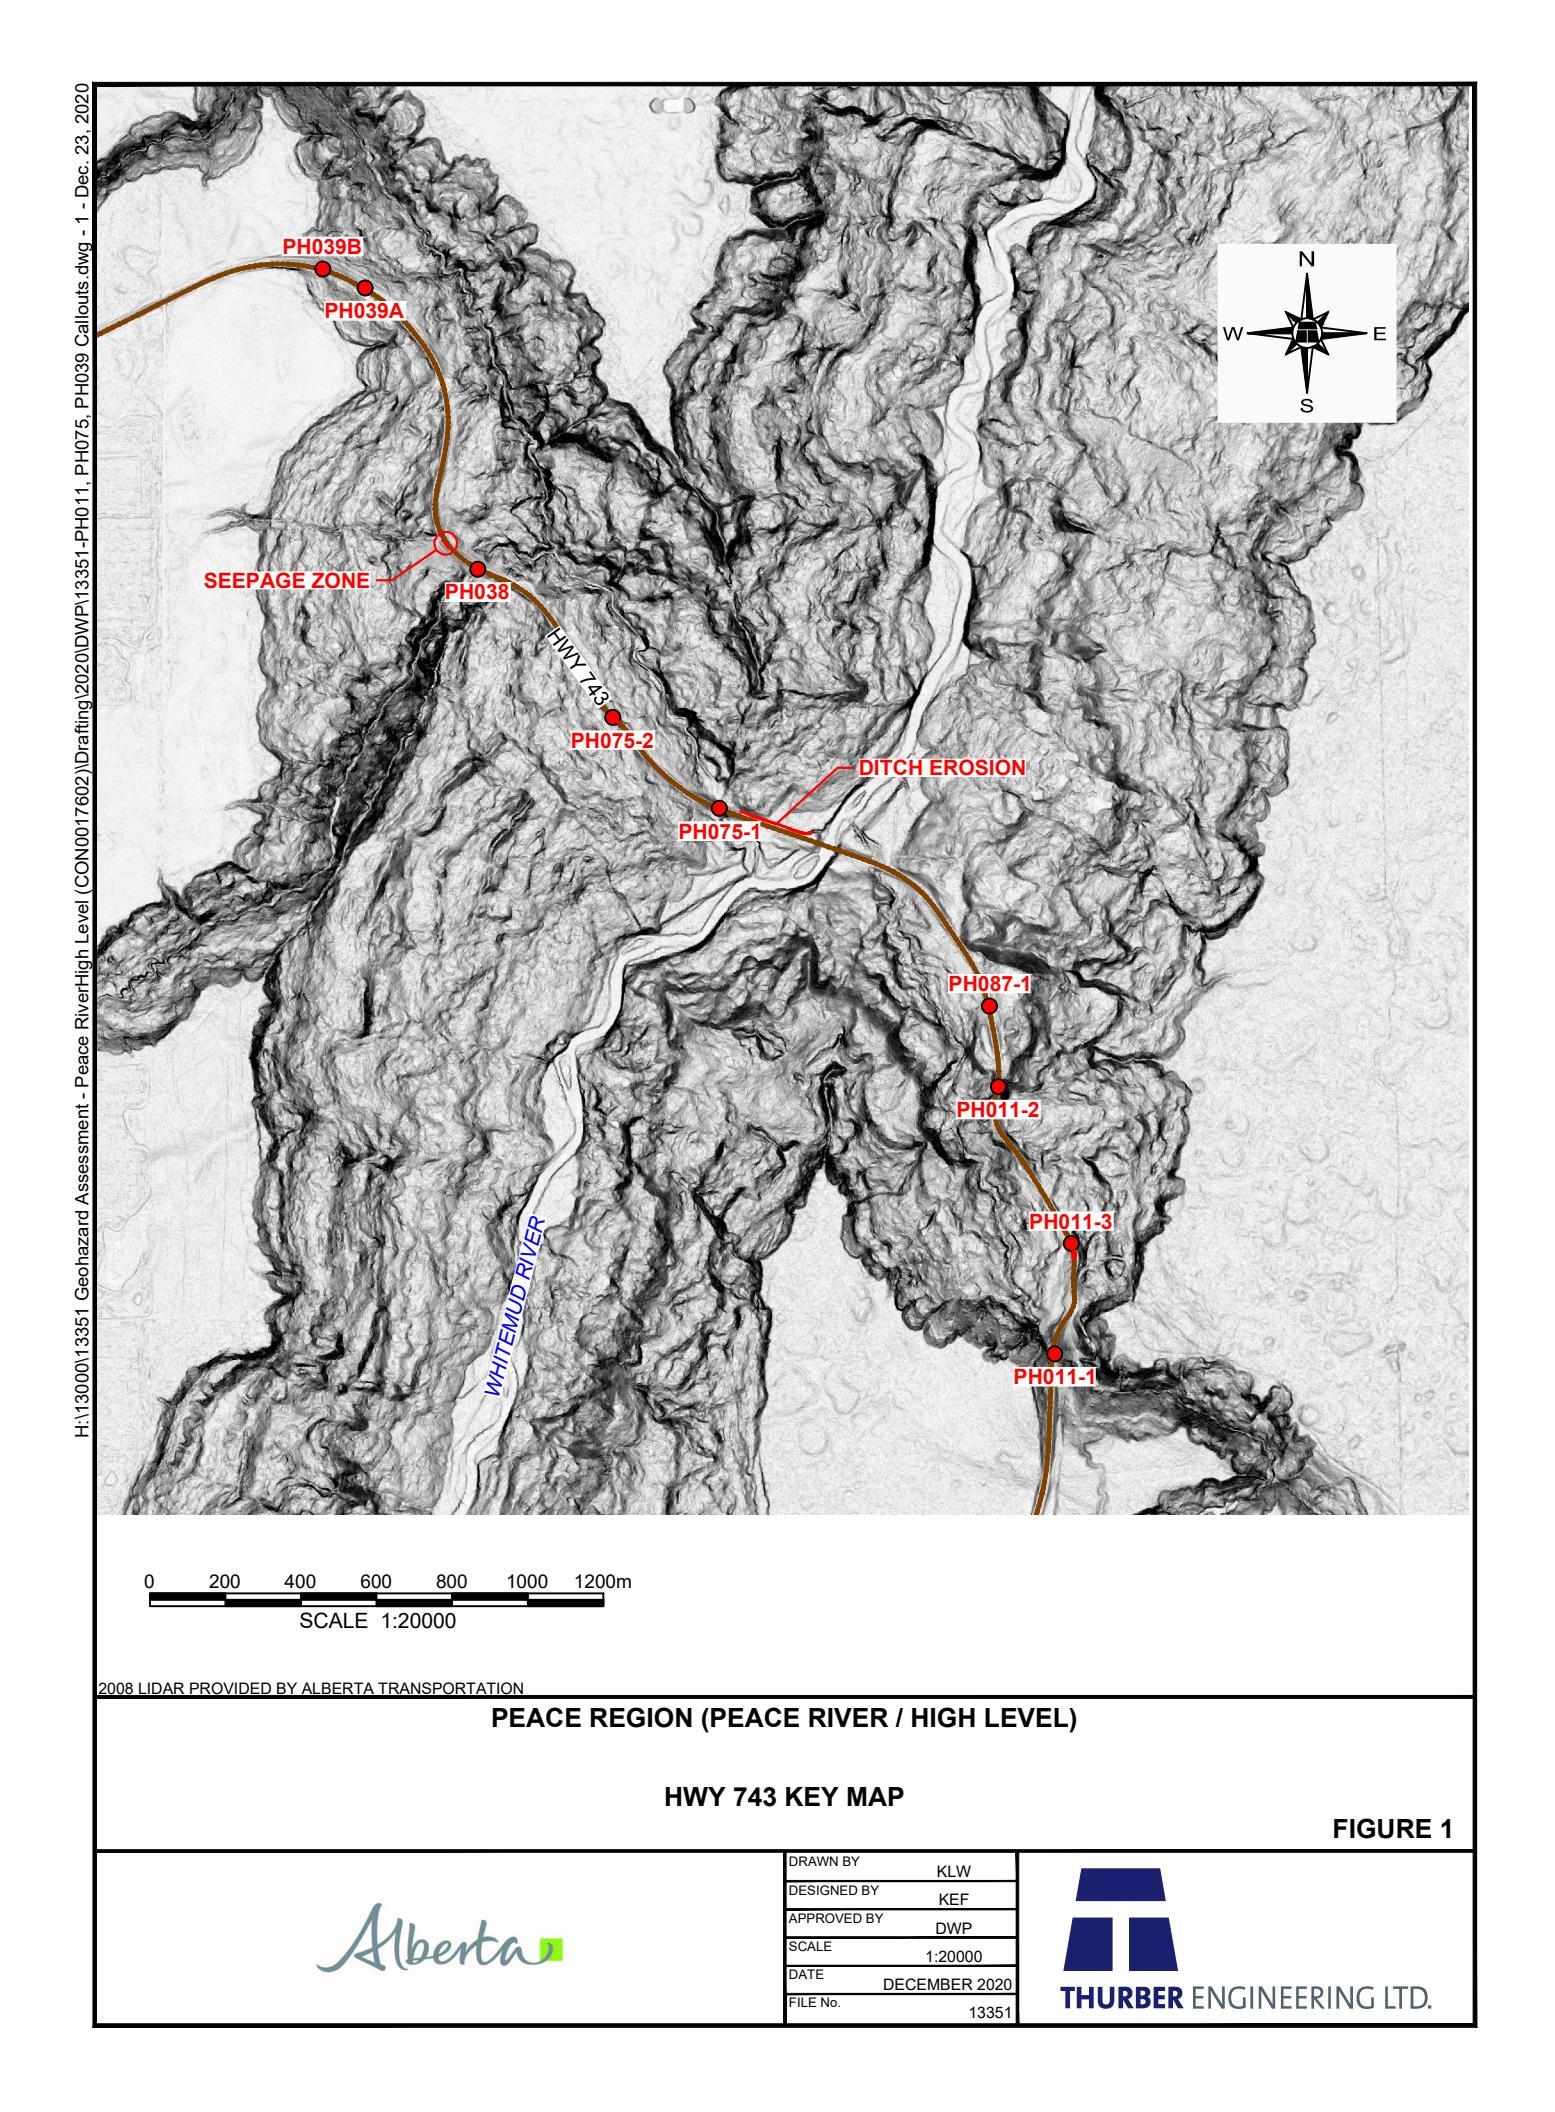
The site is located on Highway 743:02 on a sidehill alignment ascending the valley slope of a tributary to the Whitemud River. LiDAR provided by Alberta Transportation (Figure 1) shows that the valley slope has been affected by historic landslide movements. It is considered that recent higher groundwater levels have re-activated a large slide block which is now affecting about 100 m of the road surface. At the centre of the disturbance the highway is located about 25 m above the creek. The valley slope surface, as shown by the cross-section on Dwg. No.13351-PH011-3, is hummocky, indicating the presence of several retrogressive slide blocks between the creek and the road.

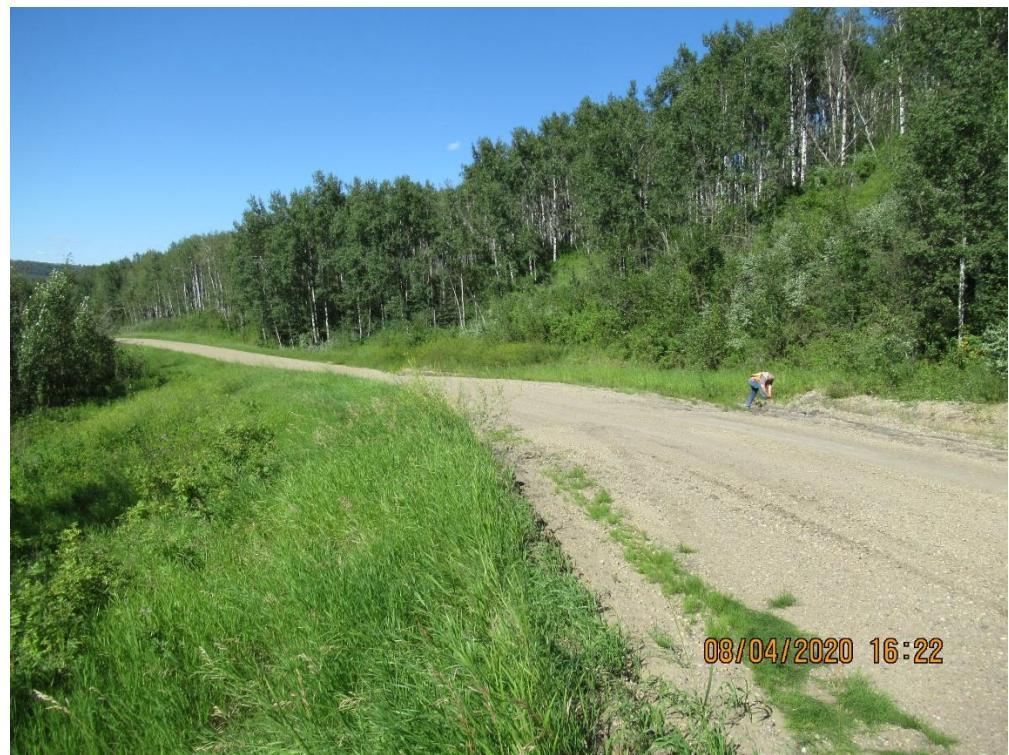
Photo 1 – Looking north at landslide site.

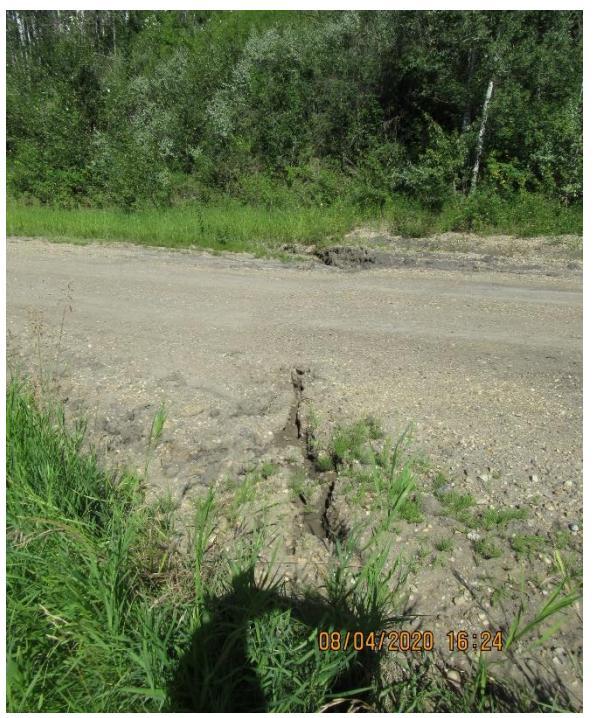
Photo 2 – Scarp crack crossing road

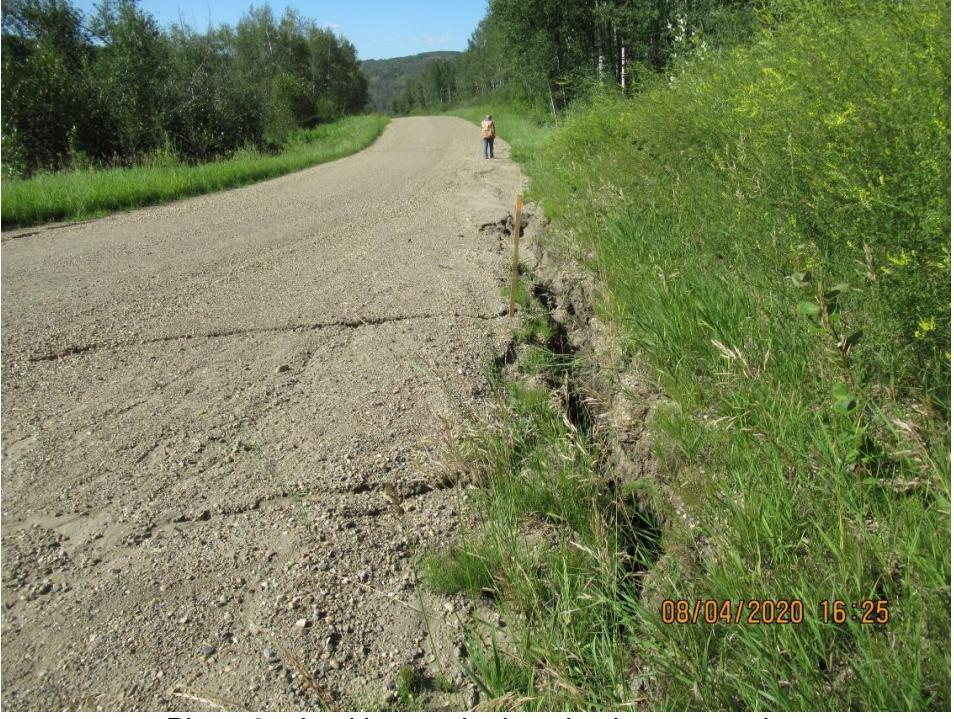
Photo 3 – Looking north along backscarp crack.

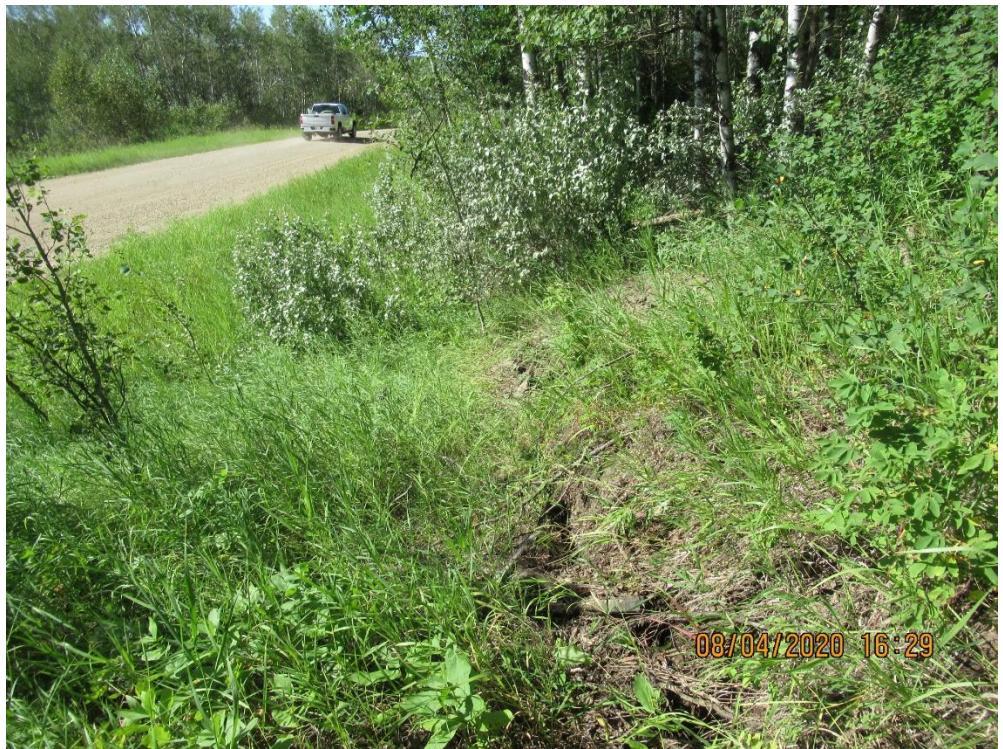
Photo 4 – Backscarp of slide

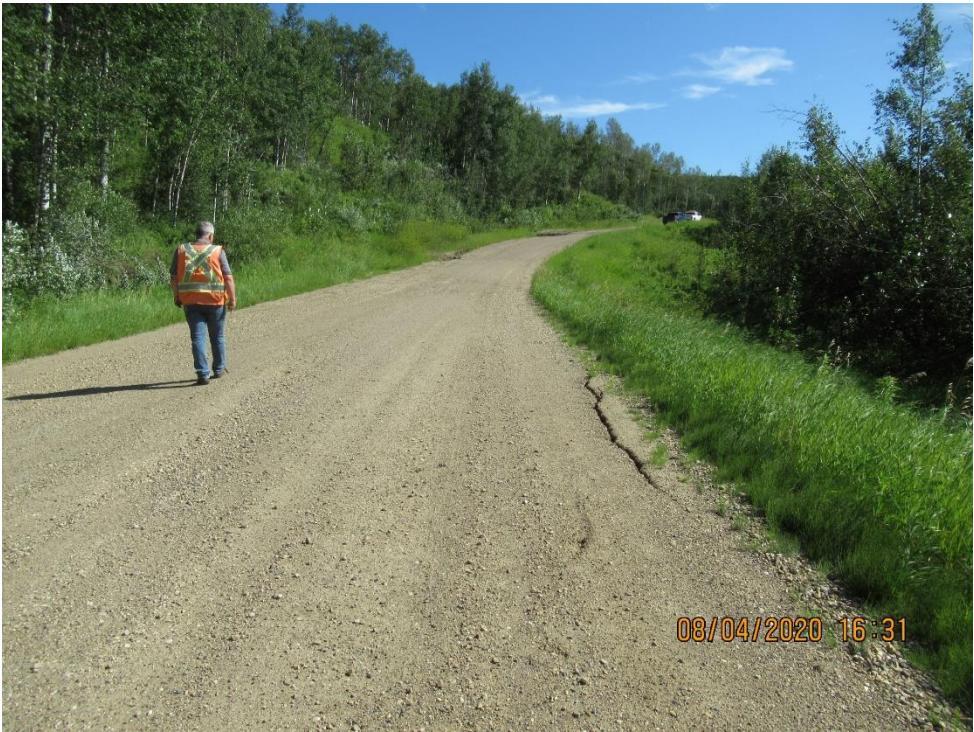
Photo 5 – Looking south toward the landslide.

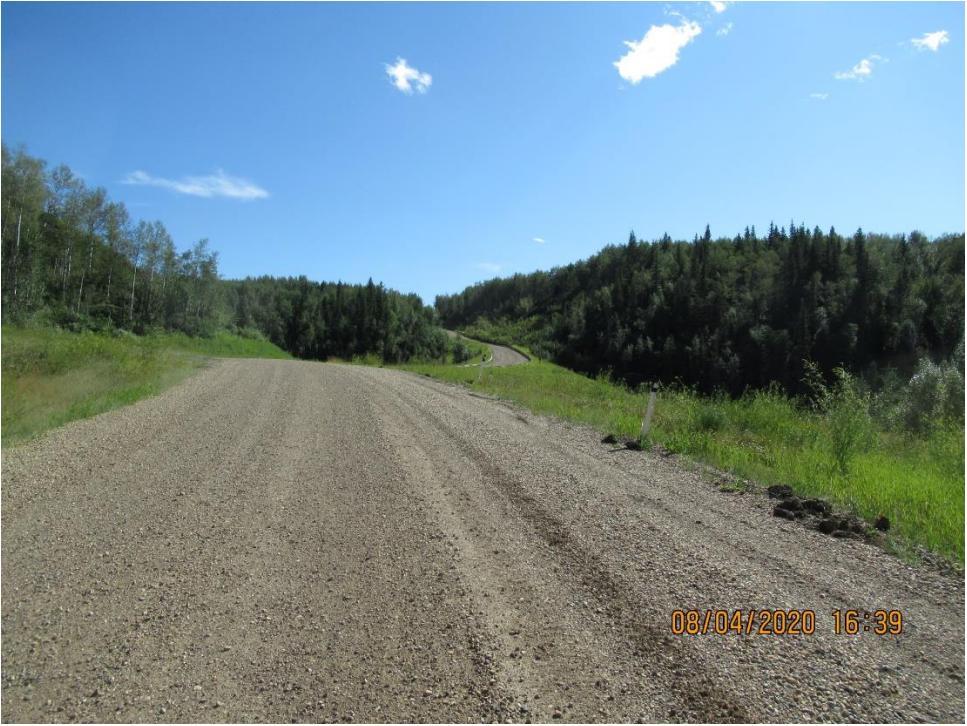
Photo 6 – Looking south at hump in road profile south of the site.

A vertical realignment of the roadway through the slide could be carried out if the road condition worsens. The reprofiling could lower the road a few meters through the slide zone by taking out the hump in the road profile starting from south of the site. The slide area itself could be further unloaded by subexcavating some of the soil and replacing it with EPS light weight fill. A subdrain could also be installed along the upslope side of the road to locally lower the groundwater and the shoulder of the road in the slide zone could be cut down to take a bit of the weight of the slide block.
