**ALBERTA TRANSPORTATION
GEOHAZARD ASSESSMENT PROGRAM
PEACE REGION – SWAN HILLS
2022 INSPECTION**

Site Number	Location	Name	Hwy	km
SH023-11	Little Smoky River	Little Smoky River Valley, North Hill – Site #11	744:02	20.46-20.79
Legal Description		UTM Co-ordinates		
NE21-76-22-W5M		11U E 478,317	N	6,162,188

PEACE REGION (SWAN HILLS)	
SH023-11: HWY 744:02 LITTLE SMOKY RIVER VALLEY 2022 SITE INSPECTION PLAN	
DWG No. 32121-SH023-11	
DRAWN BY	ML
DESIGNED BY	MG
APPROVED BY	DWP
SCALE	AS SHOWN
DATE	OCTOBER 2022
FILE No.	32121

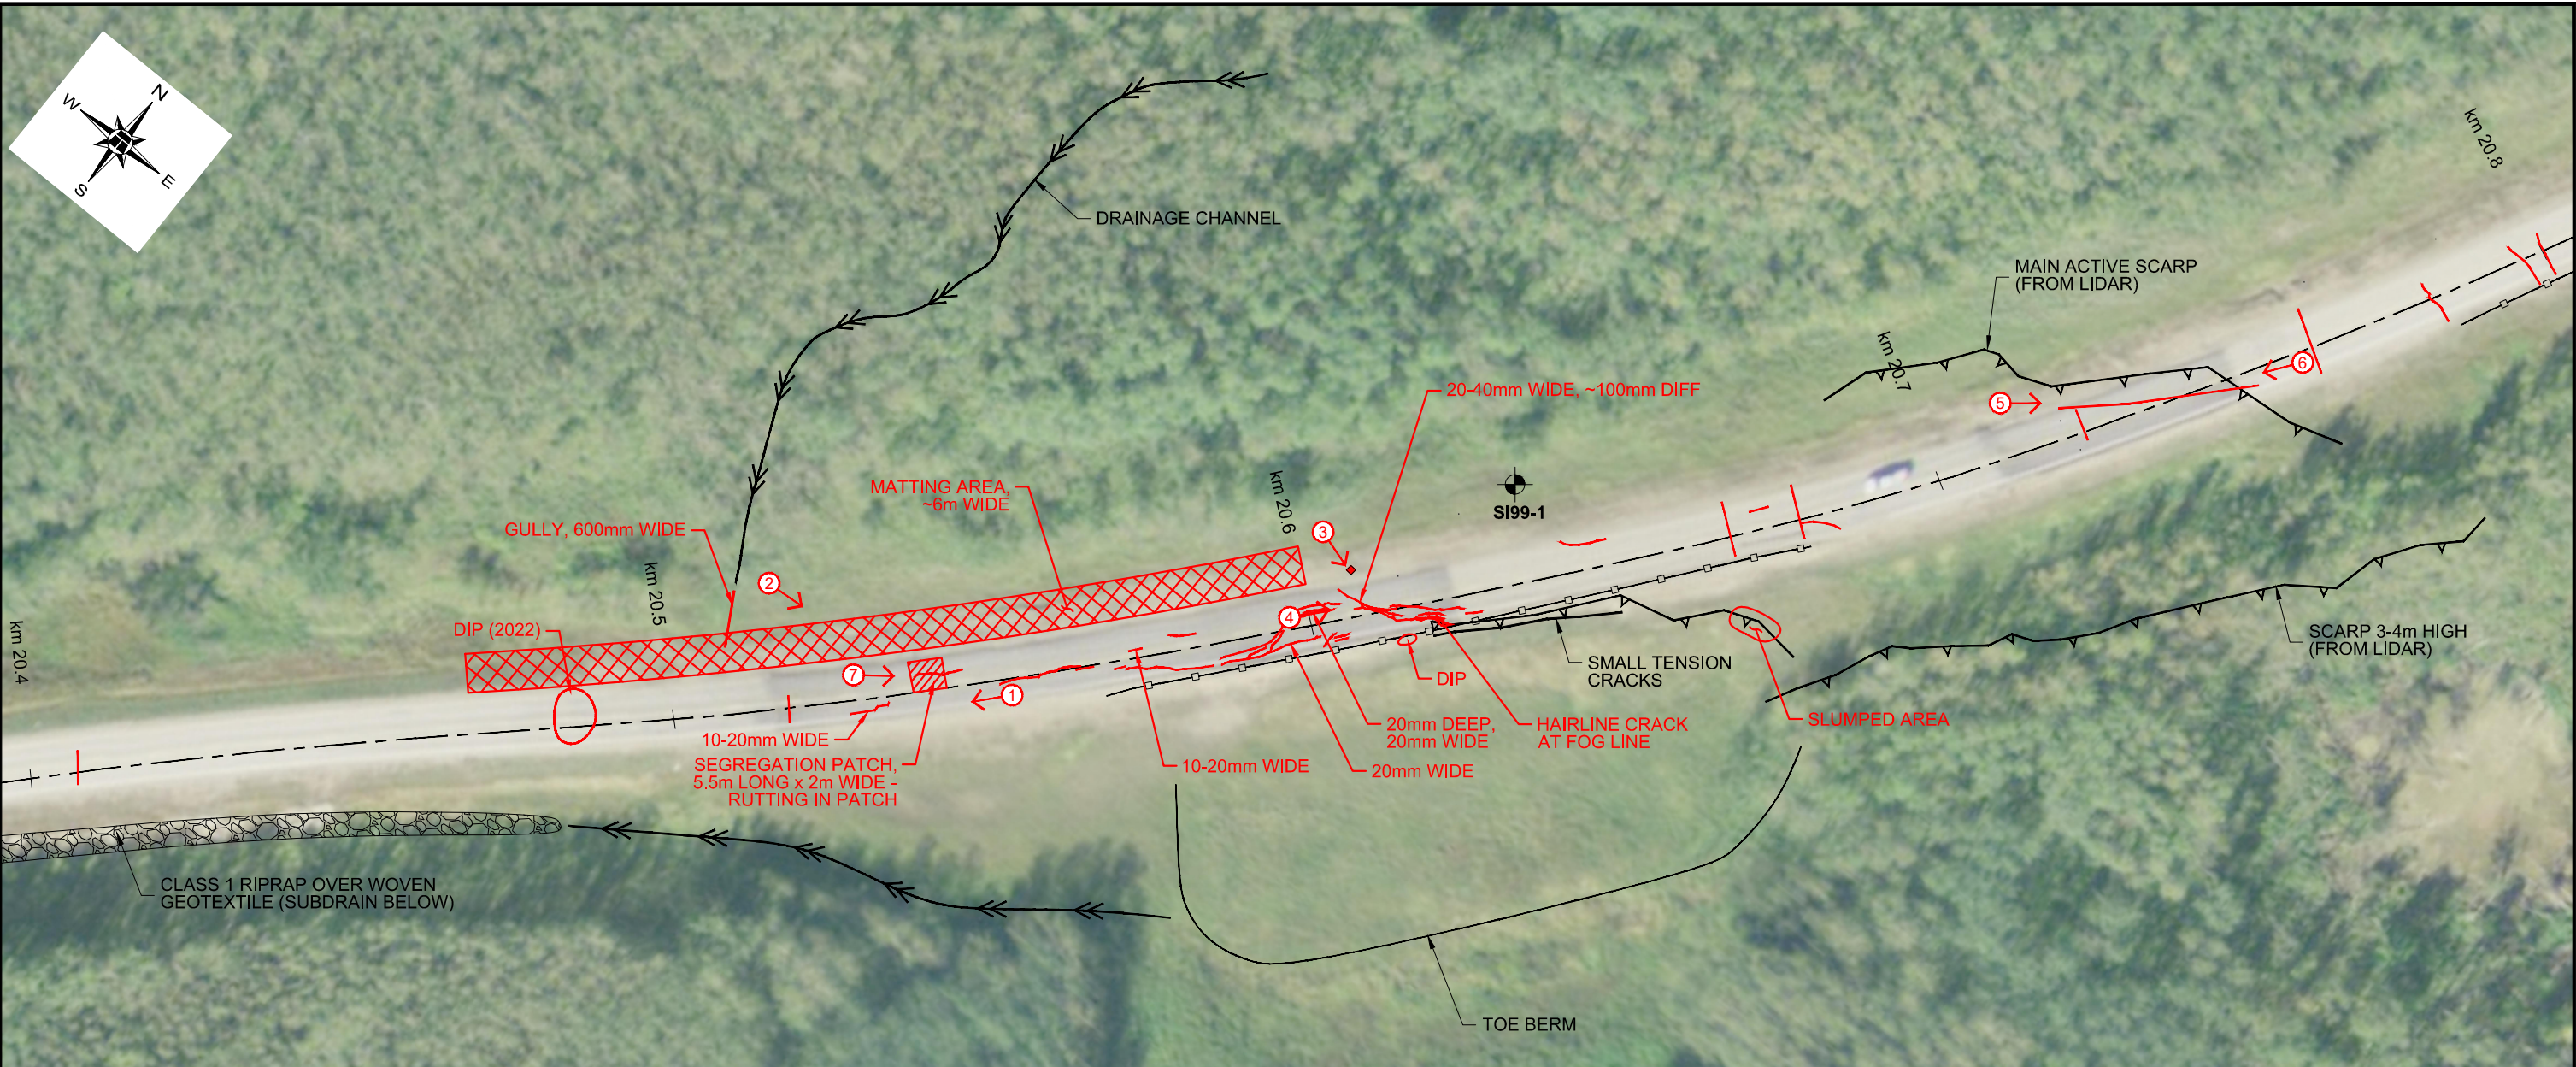
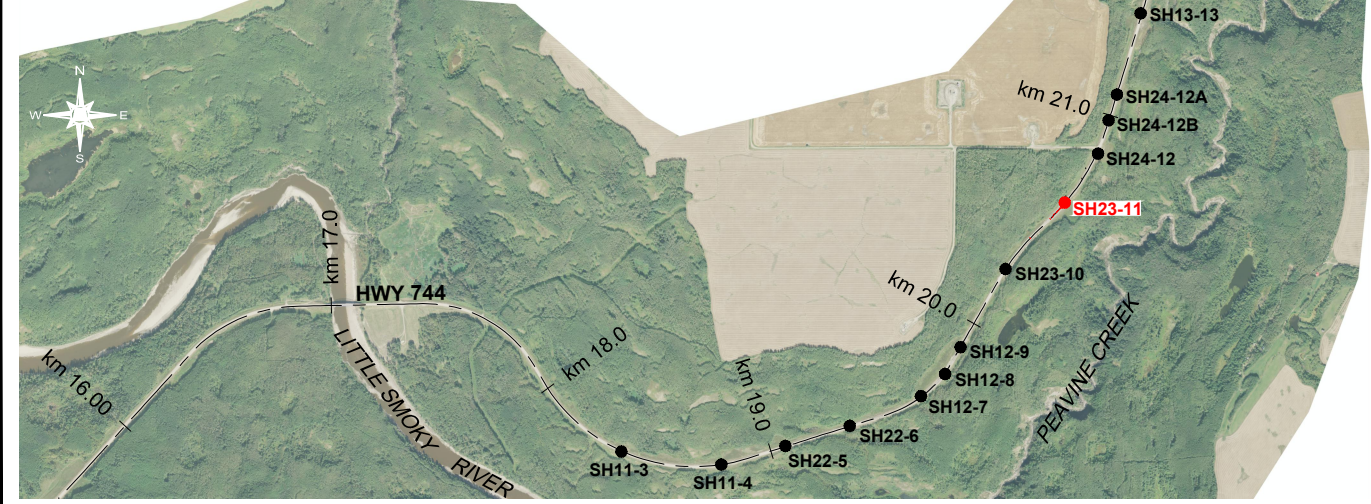
1. FEATURE LOCATIONS ARE APPROXIMATE.
2. JUNE 2022 OBSERVATIONS SHOWN IN RED.
3. CRACK AND PATCH PATTERNS RESET AS HWY 744 WAS OVERLAID IN SUMMER 2021.
4. GUARDRAIL AND CULVERT LOCATIONS TAKEN FROM MCINTOSH PERRY AS-BUILT DRONE SURVEY (JULY 2021).

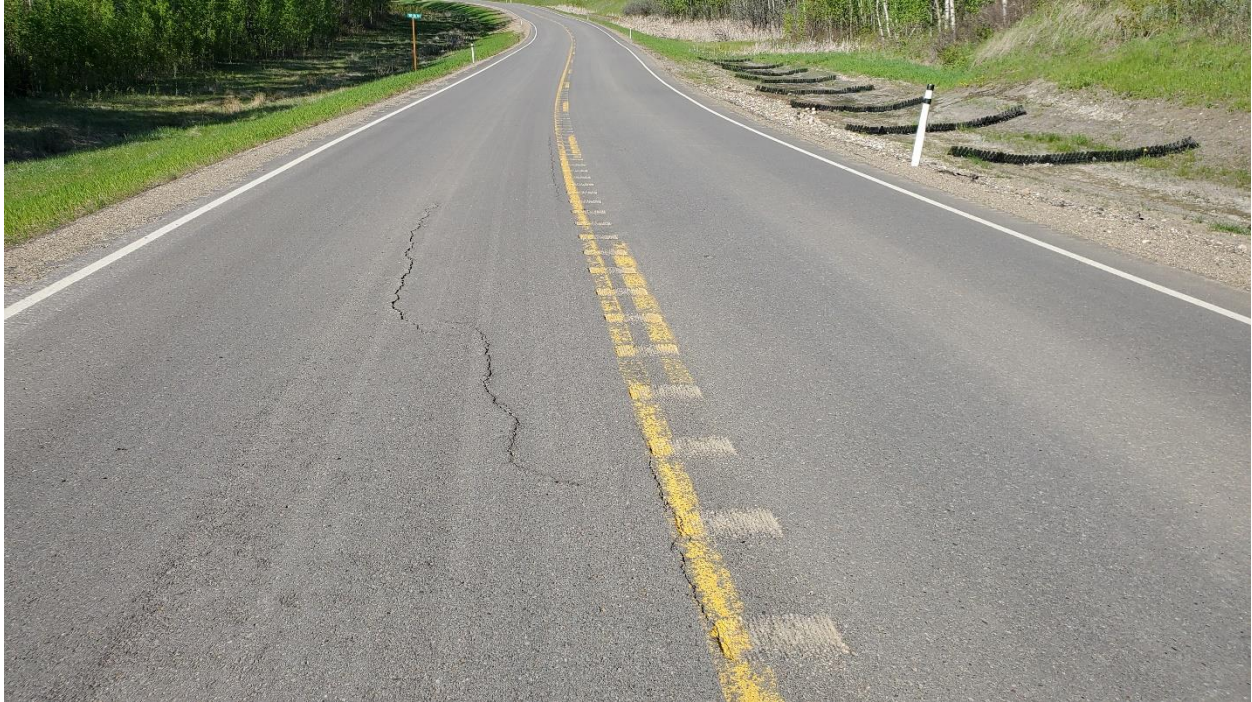
Photo 1 – Looking southwest at the southwest end of Site 11.

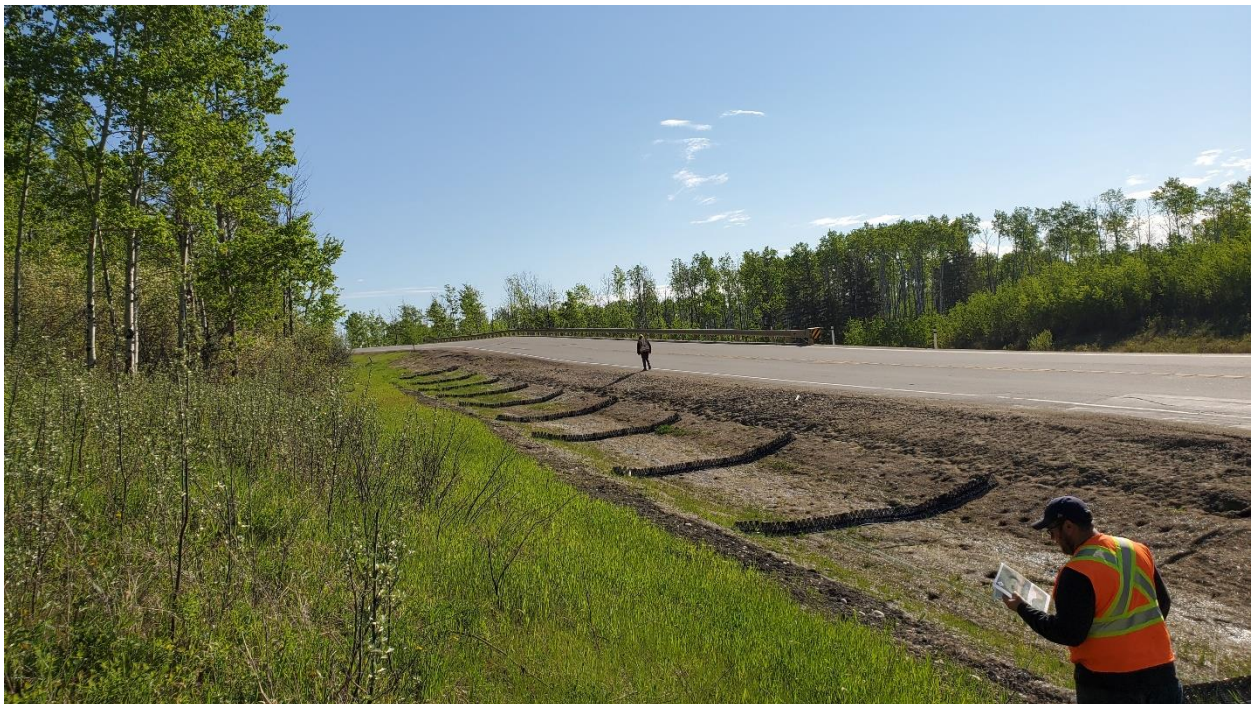
Photo 2 – Looking east highway at south end of site where previous significant gully was regraded and erosion control measures (matting and GeoRidges) were installed.

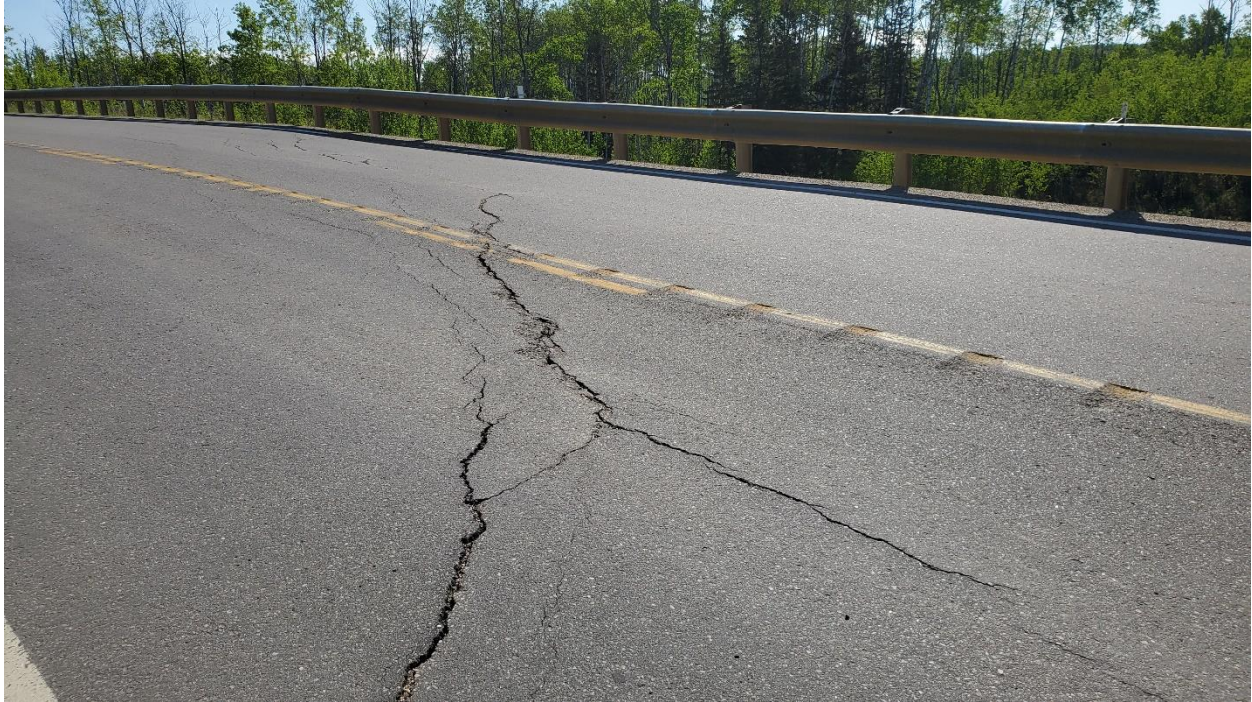
Photo 3 – Looking east at main scarp crack crossing highway (see Photo #4).

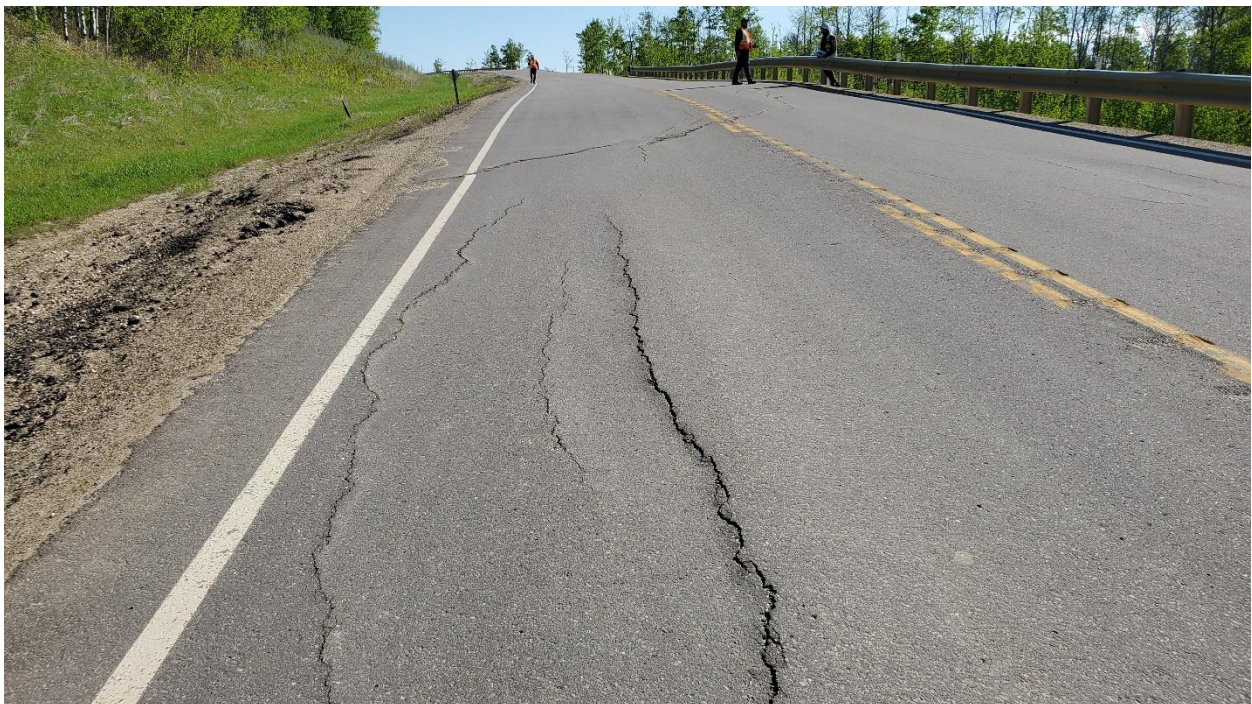
Photo 4: Looking northeast where main scarp crack crosses the highway at the central portion of Site 11.

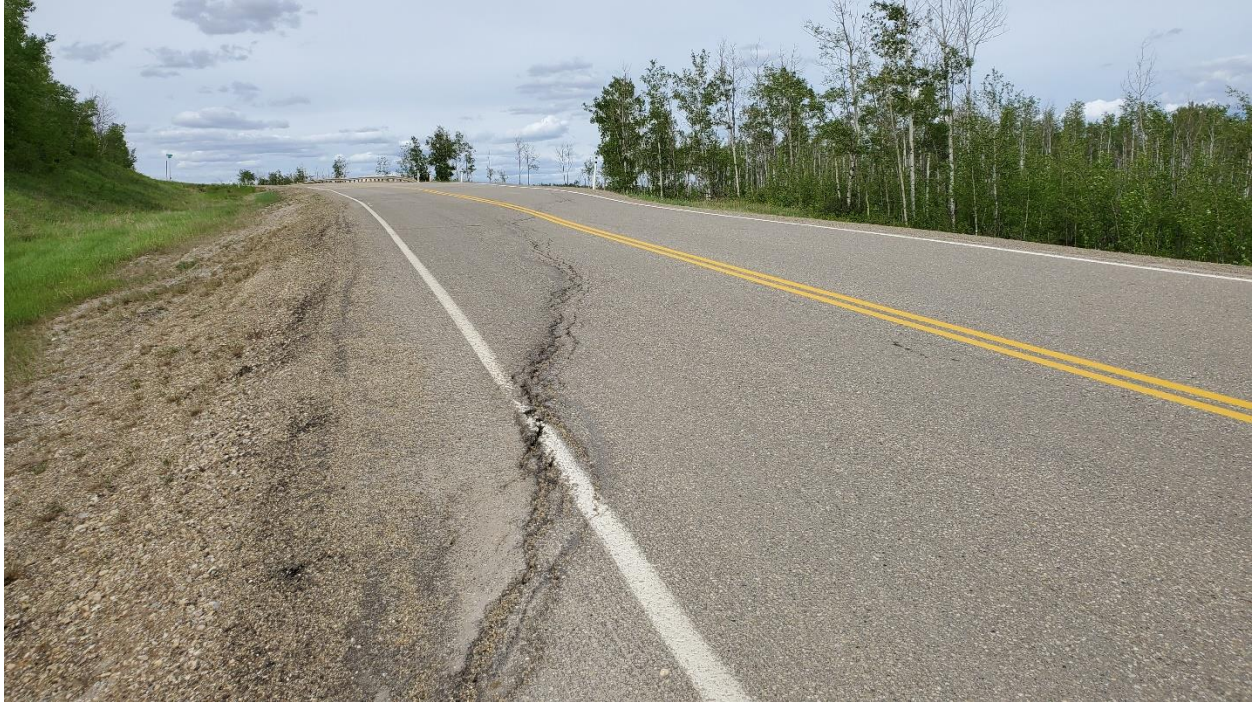
Photo 5 – Looking northeast at north scarp crack.

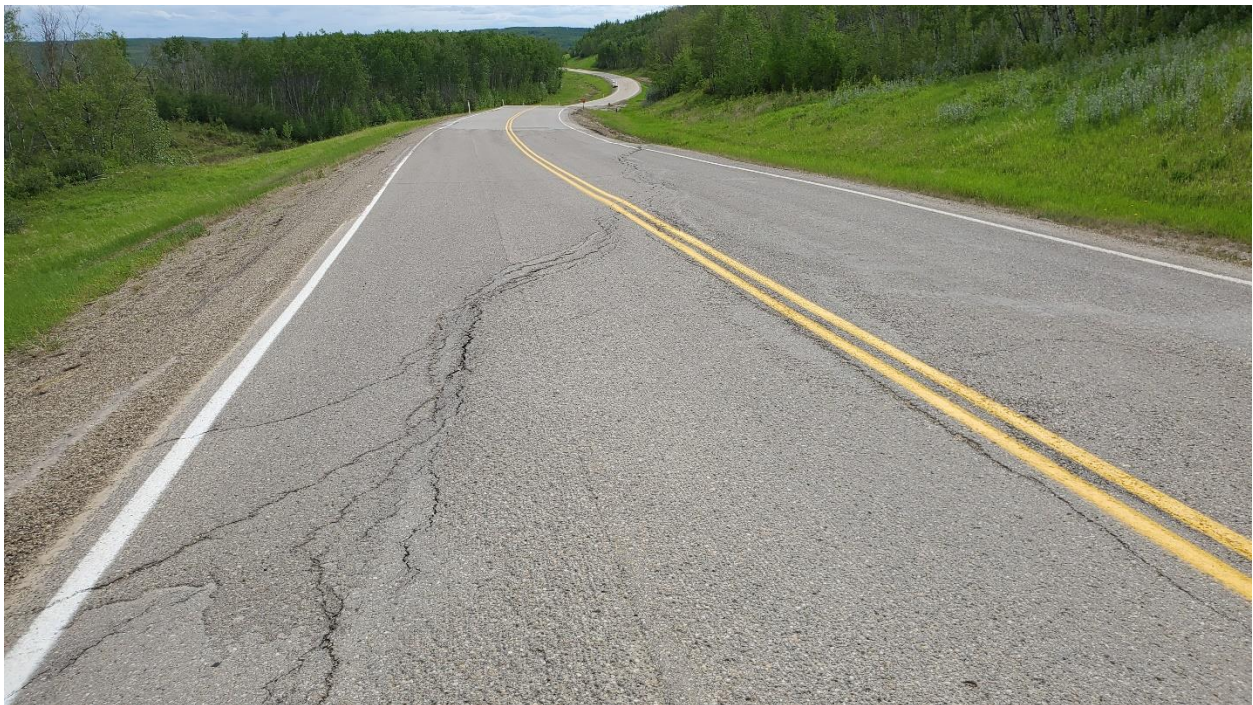
Photo 6 – Looking southwest at north scarp crack.

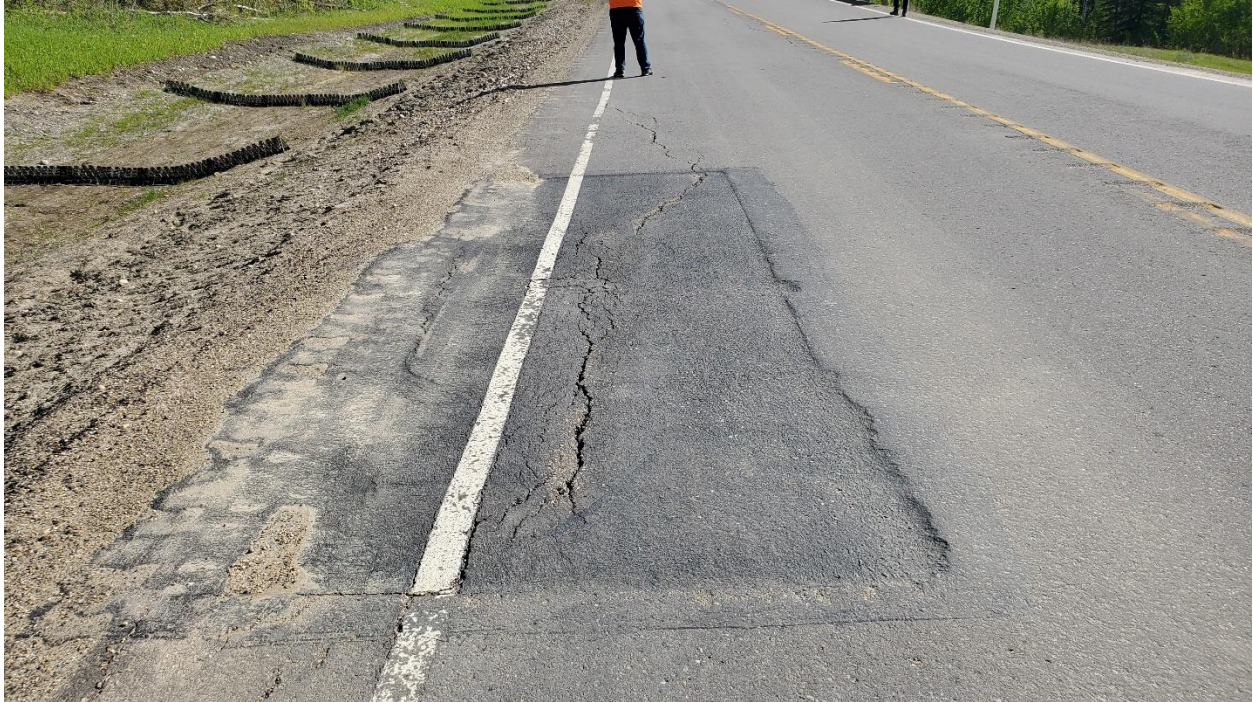
Observations:	Description	Worsened?
<input checked="" type="checkbox"/> Pavement Distress	Site was recently overlaid. Some of the previous longitudinal and traverse cracks have reflected through. Rutting was observed in a patch located in the outer wheel path of the SBL.	<input checked="" type="checkbox"/>
<input checked="" type="checkbox"/> Slope Movement	Site is located on an active deep-seated landslide moving toward the Peavine Creek. There is significant vertical deformation of the pavement.	<input checked="" type="checkbox"/>
<input checked="" type="checkbox"/> Erosion	Upslope ditch was regraded and erosion control measures installed.	<input type="checkbox"/>
<input type="checkbox"/> Seepage		<input type="checkbox"/>
<input type="checkbox"/> Bridge/Culvert Distress		<input type="checkbox"/>

Photo 7: Scarp crack and rutting in a patch located in the SBL.

Recommendations:		
Short-Term:		
<ul style="list-style-type: none"> ▪ Road maintenance should continue as necessary to maintain as safe roadway surface and may consist of milling, patching, and crack sealing of the ACP. 		
Long-Term:		
<ul style="list-style-type: none"> ▪ It is understood that, at this time, the only long-term remediation option under consideration is realignment of the entire north hill section of Highway 744. However, given the high cost of this option and as it is a low volume highway, it is unlikely that a full realignment will be undertaken in the near-future. Consideration is also being given to a shorter realignment which would include both of the SH023 sites as they currently require frequent maintenance. ▪ However, given the significant vertical distortion, vertical realignment of the highway at this Site #11 should be considered. Lowering of the highway grade, or subcut and replacement with light-weight fill, would reduce the driving weight at the top of this slide block and might decrease the rate of maintenance. Alternatively, a horizontal shift of at least 20 m into the slope could be considered to move the highway off this active slide block. The Maintenance Contractor Inspector estimates a \$2M cost to realign the highway around the current Sites #10 and #11.
