September 6, 2016

Alberta Transportation 2nd Floor, 803 Manning Road NE Calgary, Alberta T2E 7M8

CON0017609 Southern Region GRMP - Call-Out Reports S050 - Hwy 549:02-01 Embankment Earth Slide (km 4.831) DRAFT

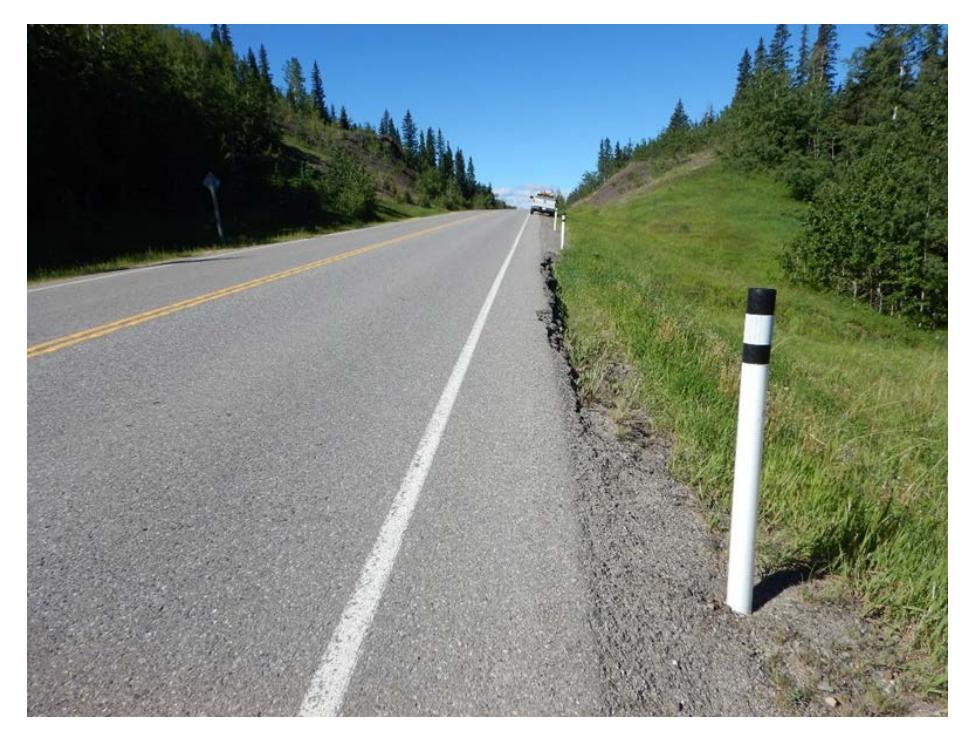
Photo 1 North side of Hwy 549:02-01 at km 3.8. Note through-cut in bedrock in the background. Photo westward taken June 15, 2016.

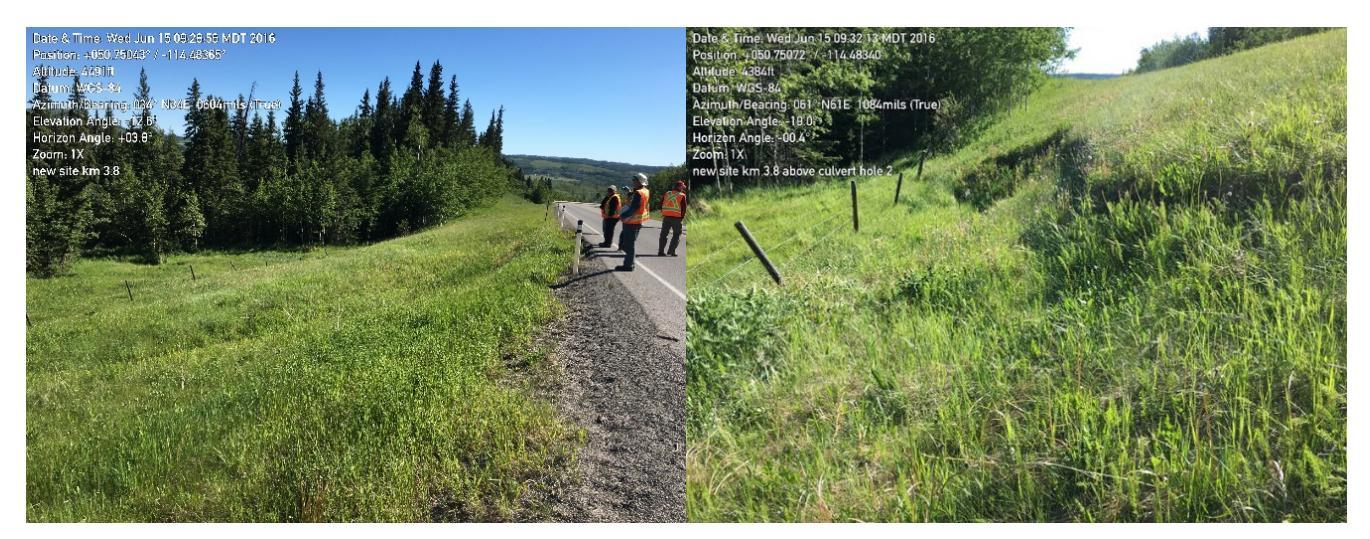
Photo 2 Road embankment sloughing on the north side of Hwy 549:02-01 at km 3.8. Photos eastward taken June 15, 2016.

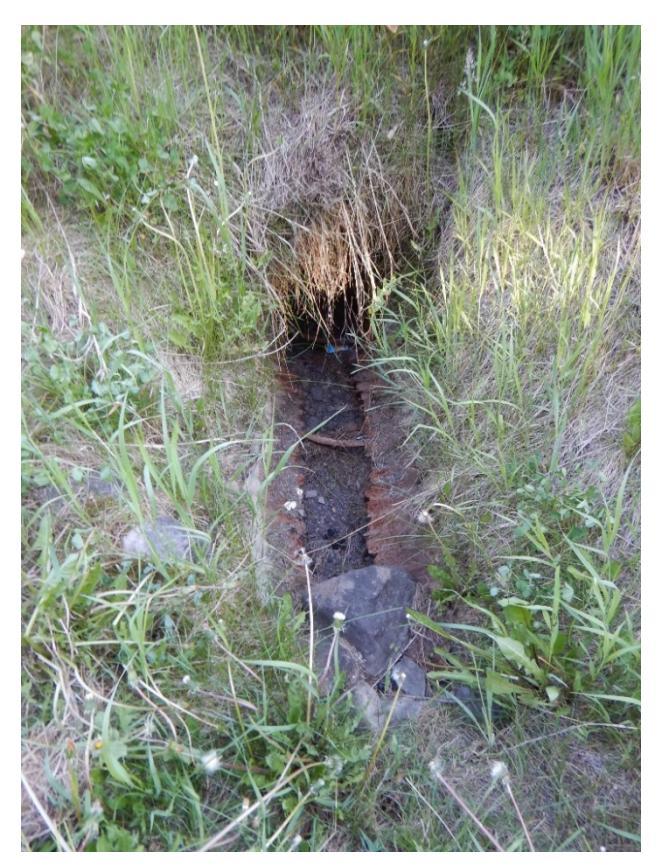
- As shown in Photos 3 and 4, the invert of the galvanized CMP culvert has apparently corroded out and has not conveyed water through to the outlet in some time. Although Photo 4 shows the bottom has been corroded out some distance upstream, it is unclear how far this extends upstream under the embankment. The open bottom of the culvert infers that most or all of the water entering the culvert inlet escapes from the culvert and flows on the outside of the culvert saturating and eroding the embankment fill and foundation deposits. This has obviously been occurring for some time and likely explains the observation of springs and ponding water outside the toe of the embankment slope. Water flowing outside the culvert is also the likely cause of internal erosion and the formation of the collapse structures (sink holes). Influx of water into the foundation deposits is also the likely cause of the embankment earth slide.

- This type of internal corrosion of galvanized pipe is most often associated with acidic water. The corrosion of copper, galvanized steel, and lead pipes can increase considerably by acidification of the water flowing through them, and the concomitant drop in pH and hydrogen carbonate concentrations and rise in sulfate concentrations. This is particularly manifest if the pH falls below about 7.0 (Kucera, 1988).

Photo 3 Damaged culvert at Hwy 549:02-01 at km 3.8. Photo taken southward June 15, 2016.

Given the very poor and worsening condition of the culvert due to continued flow of presumably acidic water through the culvert and the realization that all three failure modes are driven by water flowing through the compromised culvert, the short term action should involve stopping flow through the culvert. This can be accomplished by blocking the existing culvert inlet and removing the ditch block, just east of the inlet, which will route the ditch flows eastward down the south ditch. The downstream impact of doing this should be assessed and mitigated as required. This should be followed by installation of a new culvert, as soon as practicable, and, finally, abandonment by either removal or filling of the compromised culvert.

Initial thoughts are that the new culvert should be installed outside the slide mass, bored in place, and be a smooth wall steel or corrugated plastic culvert. Given the condition of the existing culvert and the voids that have formed around the culvert, it seems more practical to remove the culvert

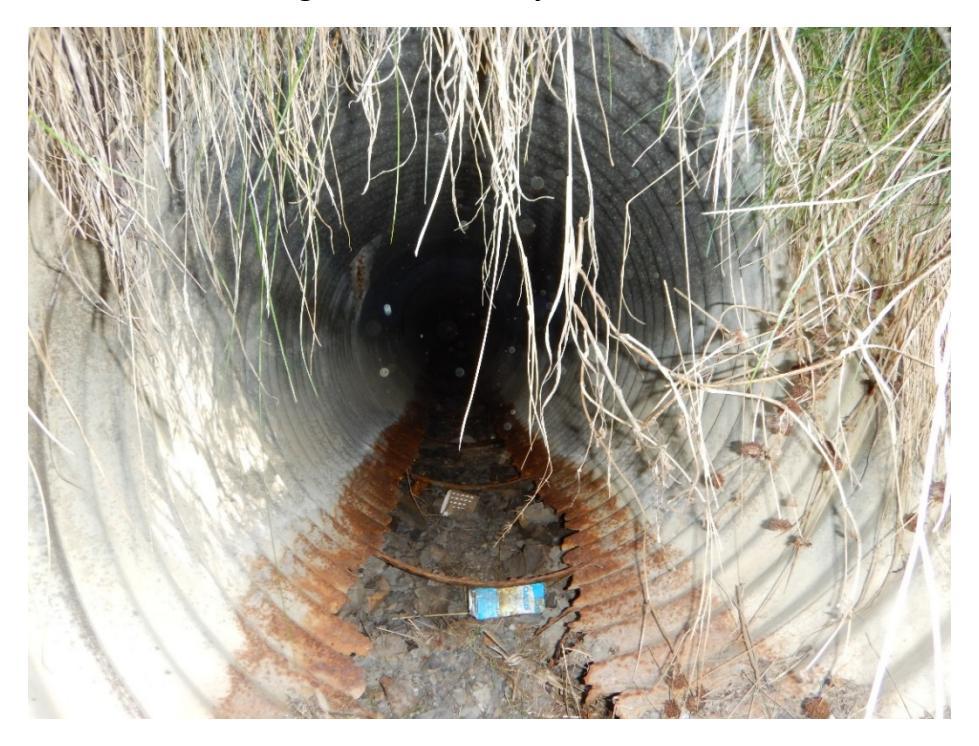
Photo 4 Damaged culvert at Hwy 549:02-01 at km 3.8. Photo taken southward June 15, 2016

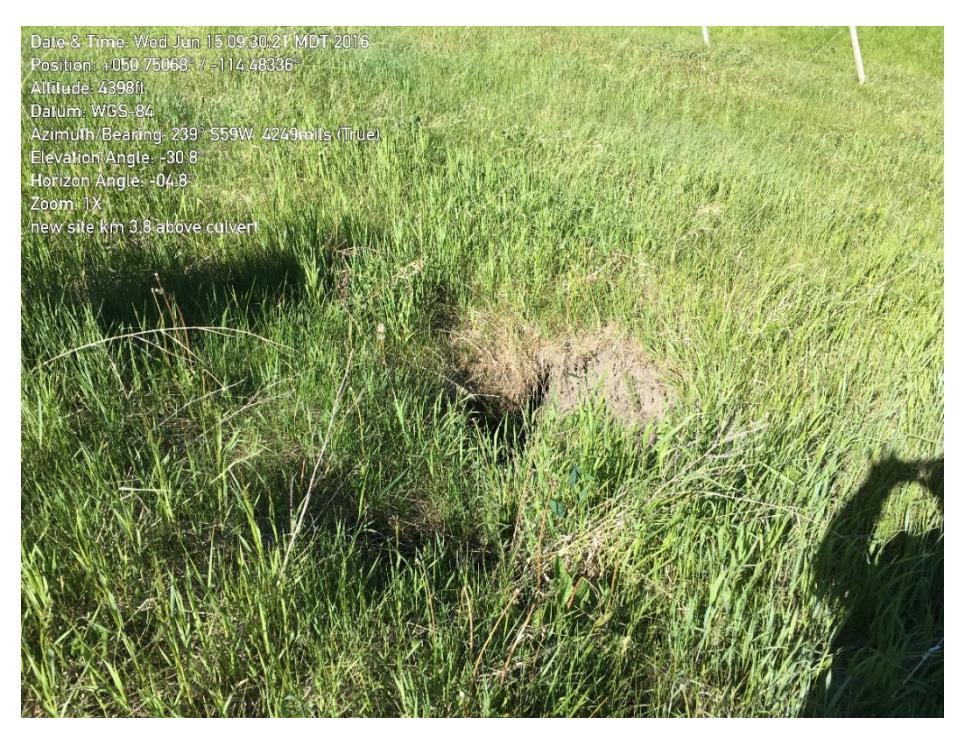
- The active earth embankment slide is centered on the approximate 600 mm dia. CMP culvert. Two sink holes or collapse structures have formed above the culvert at two locations on the north facing slope as shown in Figure 2. These are inferred to have been caused by damage and/or collapse of the culvert, causing loss of overlying soil into the culvert.

Photo 5 Upper sinkhole on above culvert on the north side of Hwy 549:02-01 at km 3.8. Photo taken north-westward June 15, 2016.

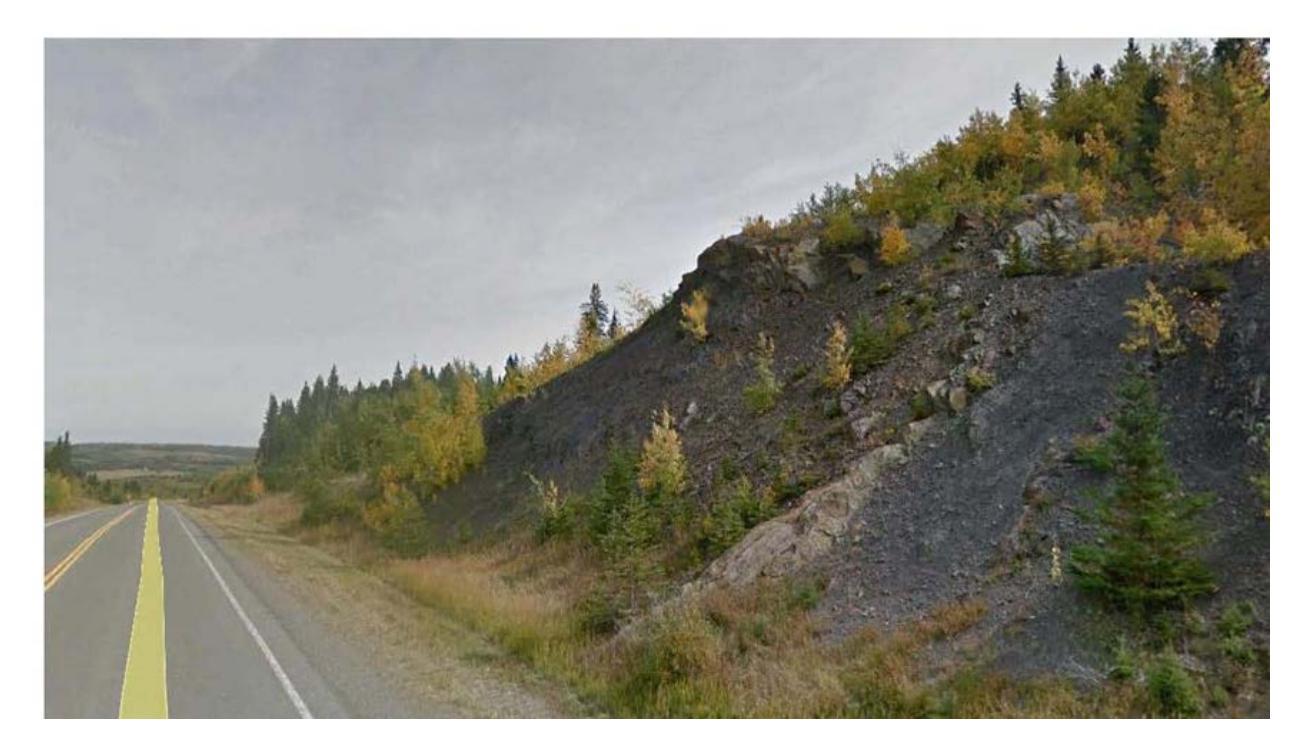
Photo 6 Eastward at south side of Hwy 549:02-01 showing bedrock exposed in the south cut slope of the through cut. Imagery from Google Earth Street View: September 2012.

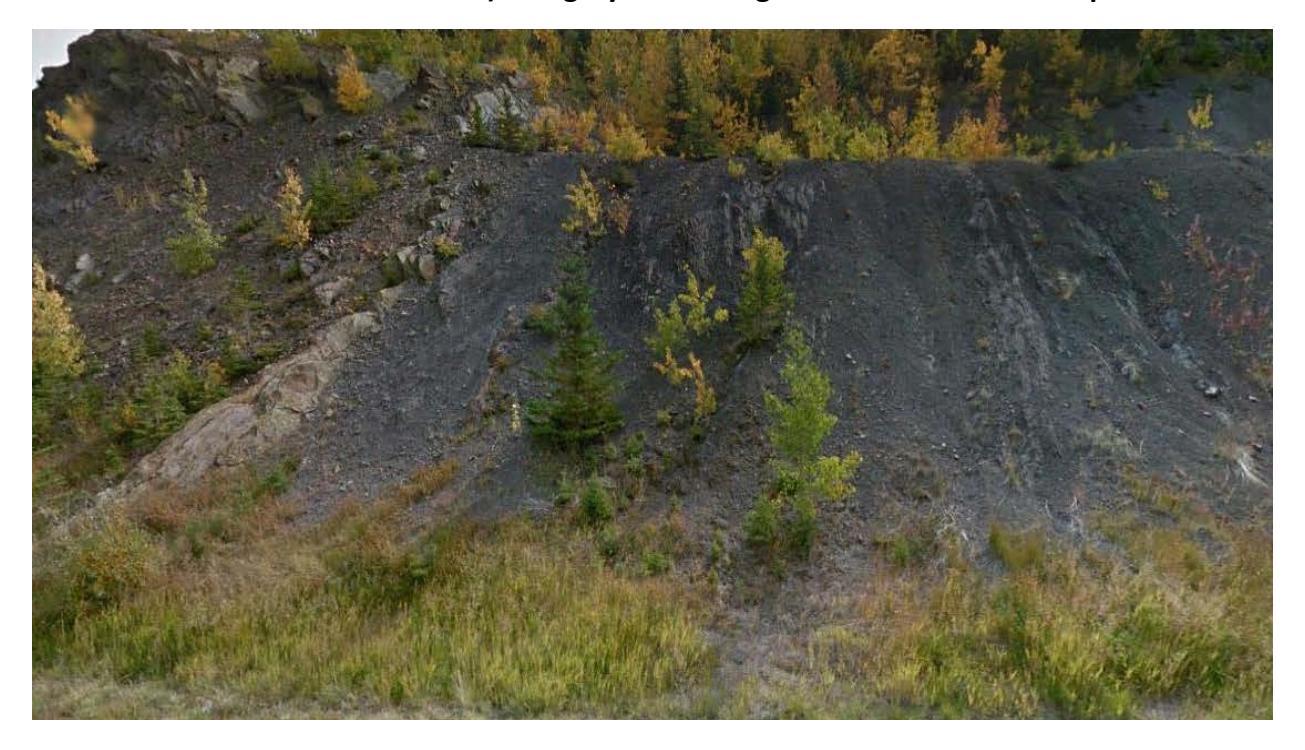
Photo 7 South at the south cut slope of the through-cut west of the site. Sub vertical sedimentary beds (Bedrock is likely part of the Belly River/St. Mary River Succession (bedded chloritic & feldspathic sandstone and blocky grey sandstone with some tuff and thin coal seams). Imagery from Google Earth Street View: September 2012.
