Investigation and Design of Coal-Mine Mitigation below a Highway Chris Grapel, M.Eng., P.Eng. Tri-Party 2018

S012 – Spray Lakes Road site

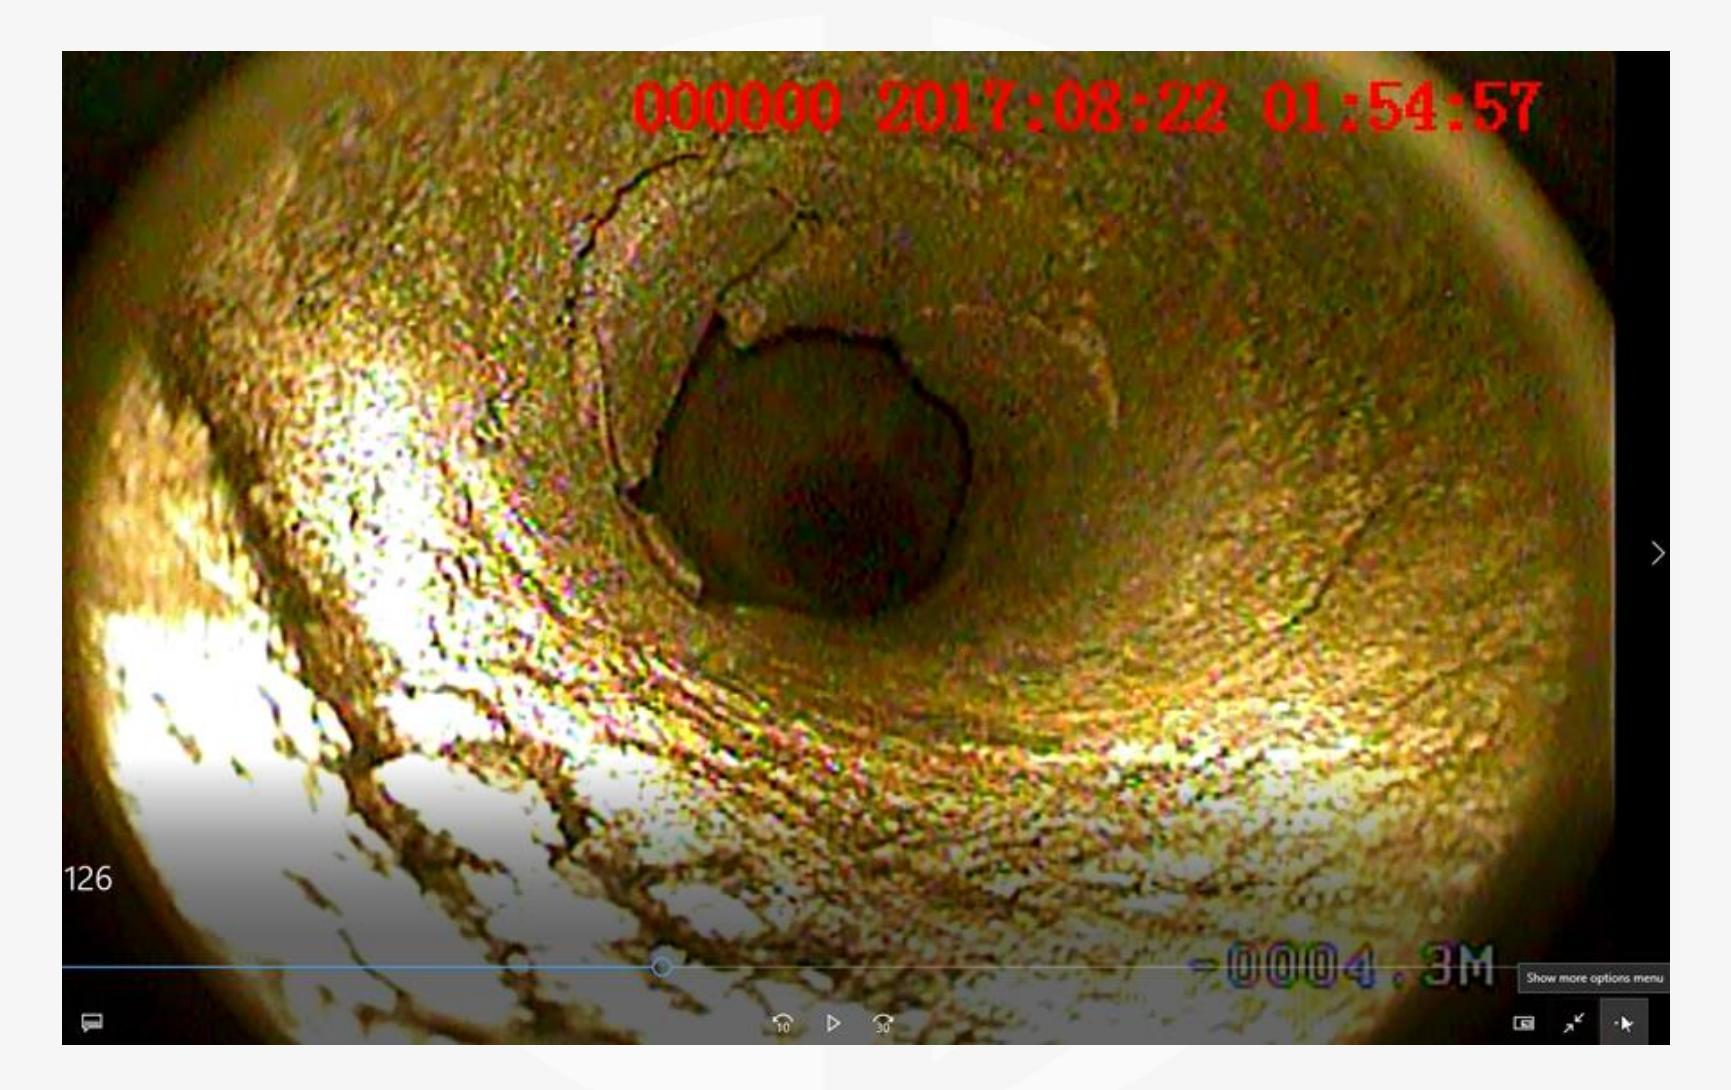
Downhole-Video Camera

- No evidence of pavement movement noted in InSAR data or pavement LiDAR data
- Some previous observations of new pavement cracks
- Downhole video camera survey noted cracking in the bedrock exposed in the borehole walls above the open void
- ERT data indicates higher resistivity above void, below highway, which could indicate dilating (i.e. opening) bedrock joints
- Continued monitoring of S012 site without repair not recommended
