SOUTHERN REGION GRMP SITE INSPECTION FORM

PRIMARY SITE ISSUE: Monitoring landslide repairs on outside of bend of Belly River.

PROJECT
SOUTHERN REGION GEOHAZARD RISK MANAGEMENT PROGRAM
TITI F
Site Plan
Olle Fian
S036 - Belly River
Hun 900.02 km 0.05
TWY OUU.UZ, KIII 9.00

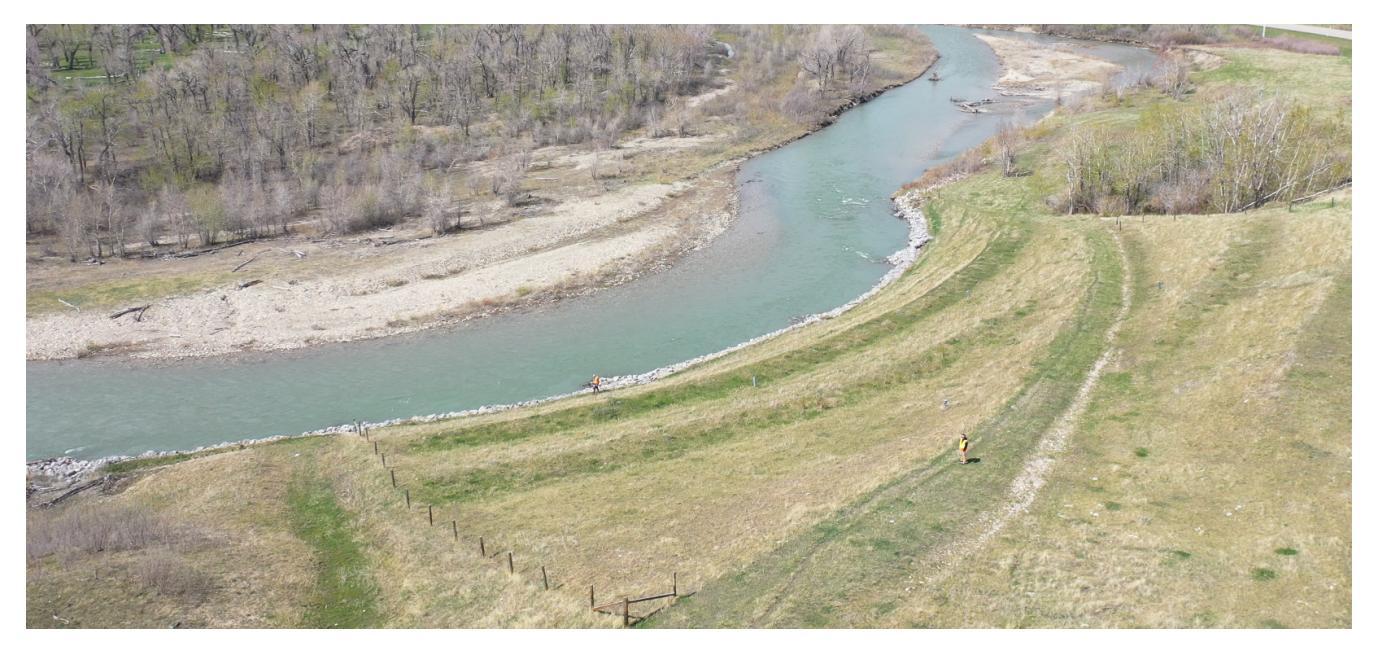
Photo 1 Repair area. Photo taken facing north on May 10, 2023.

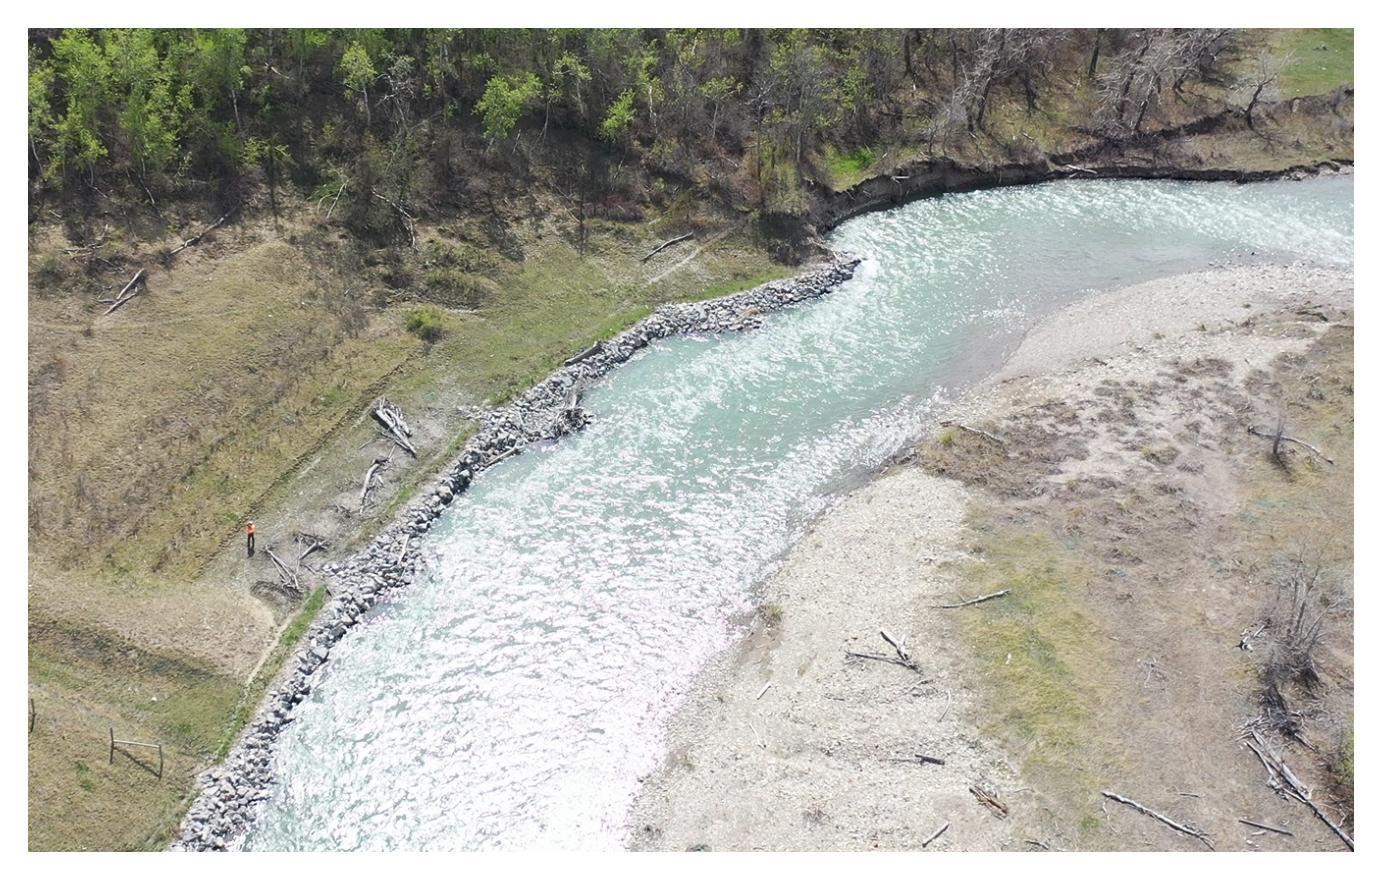
ITEM	CONDITION EXISTS		DESCRIPTION AND LOCATION	NOTICABLE CHANGE FROM LAST INSPECTION		
	YES	NO		YES	NO	
Pavement Distress		Х			Х	
Slope Movement		Х			Х	
Erosion	x		High water events have displaced some of the riprap redirective vanes. Erosion of the bank at the west end of the site, directly upstream of the riprap, is getting worse.	×		
Seepage	X	I'	Wet zones at outlet of drains near toe of slope.		Х	
Culvert Distress	<u> </u>	Х			X	
COMMENTS						
Repaired slope in good condition with generally well-established vegetation.						
Erosion noted on the bank upstream of northwestern end of riprap. The bank erosion has the potential to wash out erode the slope behind the riprap causing the riprap to collapse at the upstream edge of the riprap repair. Once the riprap is compromised, further erosion of the riprap could occur quickly. Failure of the riprap could eventually cause toe erosion and reactivation of the slide. Additional erosion noted since the previous inspection in 2019.

Photo 2 Bank erosion behind riprap at upstream end. Photo taken facing south on May 10, 2023.

Inspection frequency should be increased from once per contract to every second year to monitor erosion. AT should design a repair at the upstream end of the riprap to halt erosion and redirect water away from the eroding bank.

• A design should be completed to halt erosion and redirect water away from the eroding bank. Work would include civil/hydrotechnical design and environmental/regulatory permitting.

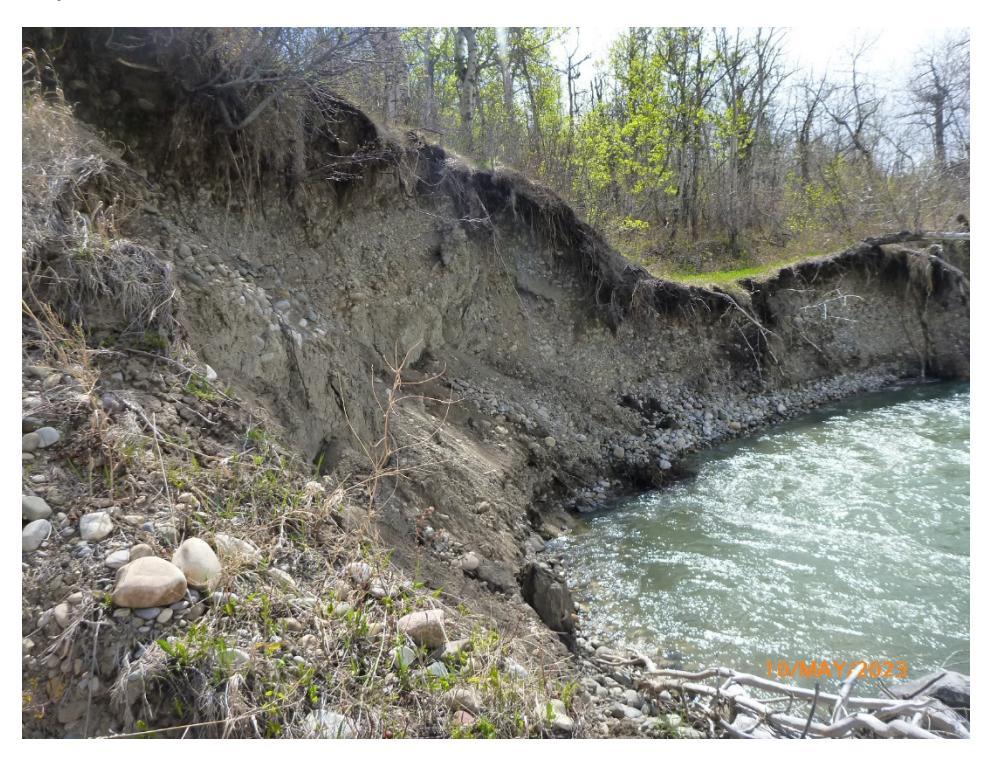
Photo 3 Bank erosion behind riprap at upstream end. Photo taken facing southwest on May 10, 2023.

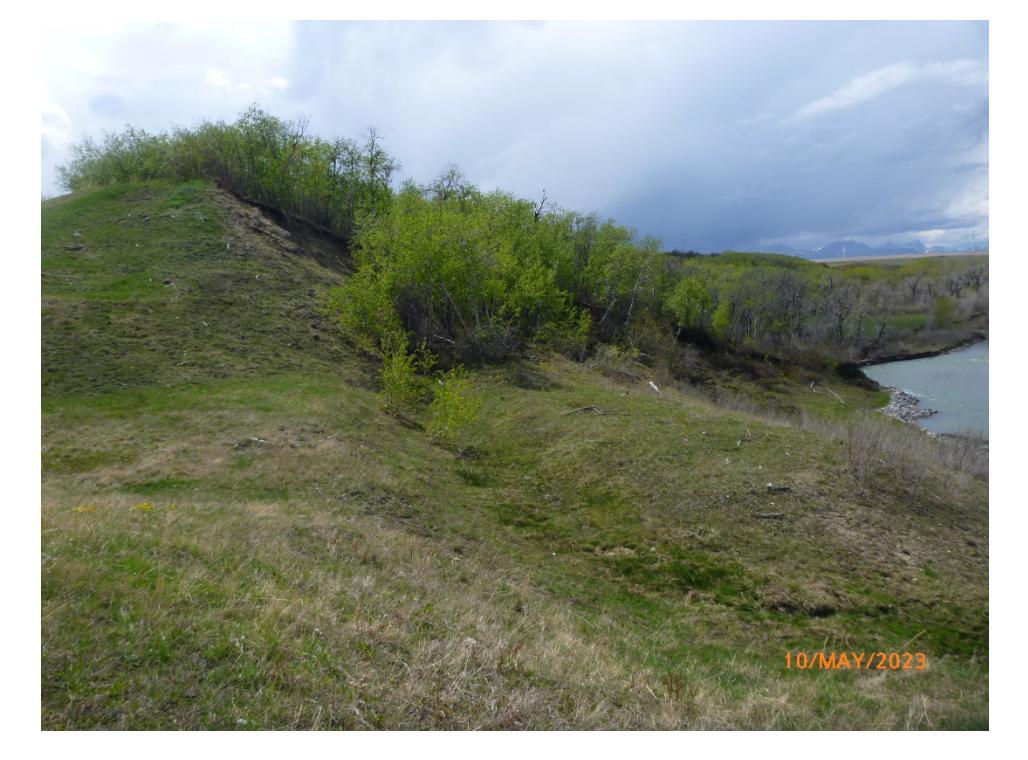
Lower bench is damp where drain outlets are present. Logs and stumps/roots were deposited on the lower bench by high-water event in 2017/2018. Some erosion at the toe of the slope near the south end of the site.

Photo 4 South end of repair area. Photo taken facing southwest on May 10, 2023.

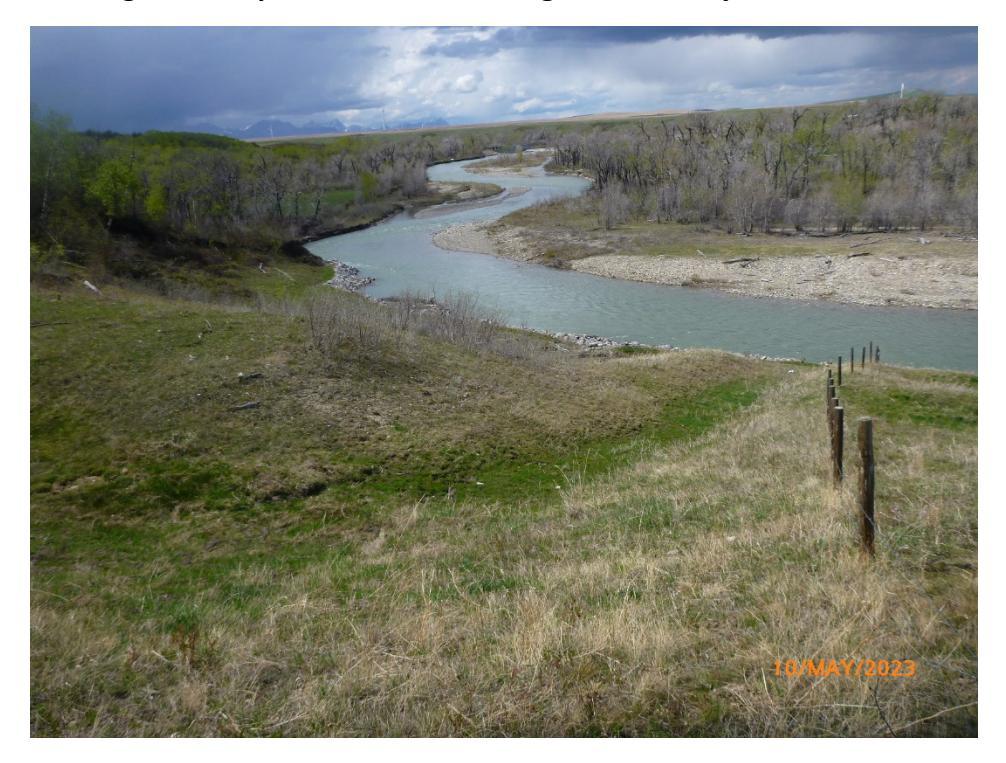
Photo 5 Looking downslope. Photo taken facing west on May 10, 2023.

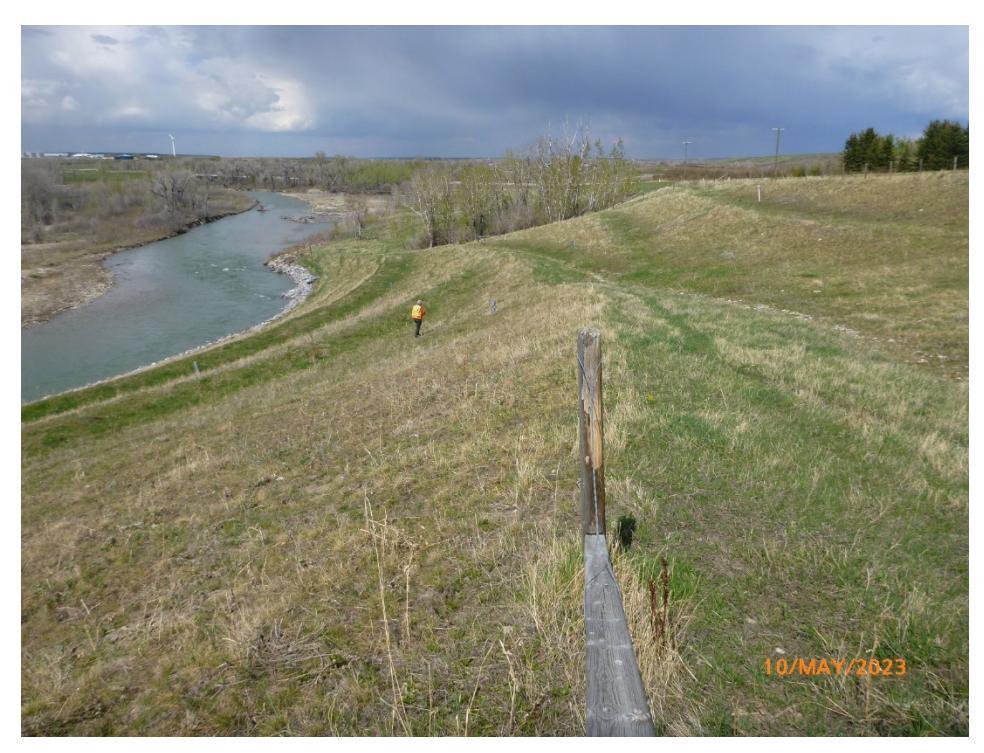
Photo 6 Repair area midslope. Photo taken facing north on May 10, 2023.
