July 14, 2023

CON0022161 Southern Region GRMP Instrumentation Monitoring Site S036; H800:02, km 9.05 Belly River Section C – 2023 Spring Readings

ATTACHMENTS Figure Appendix I Instrumentation Plots

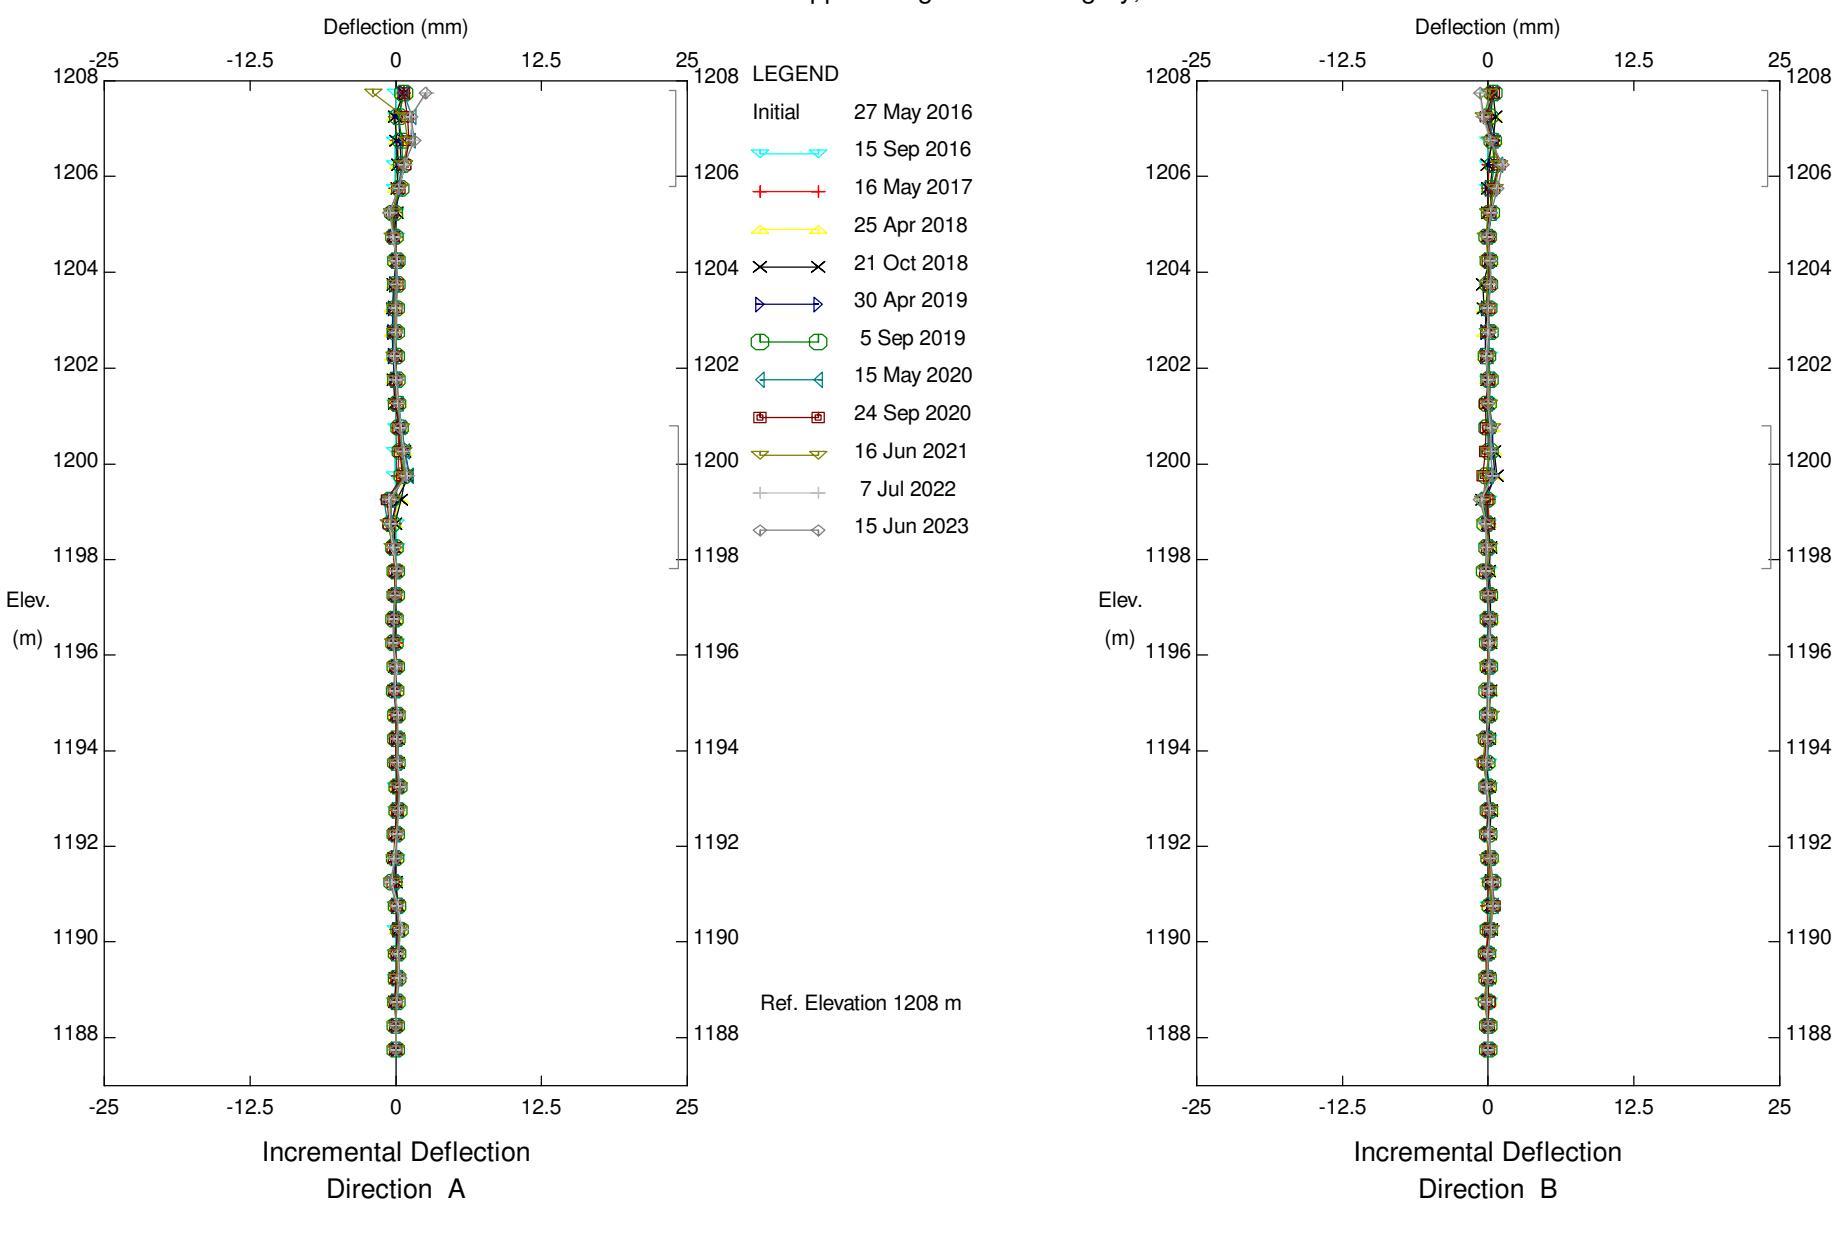
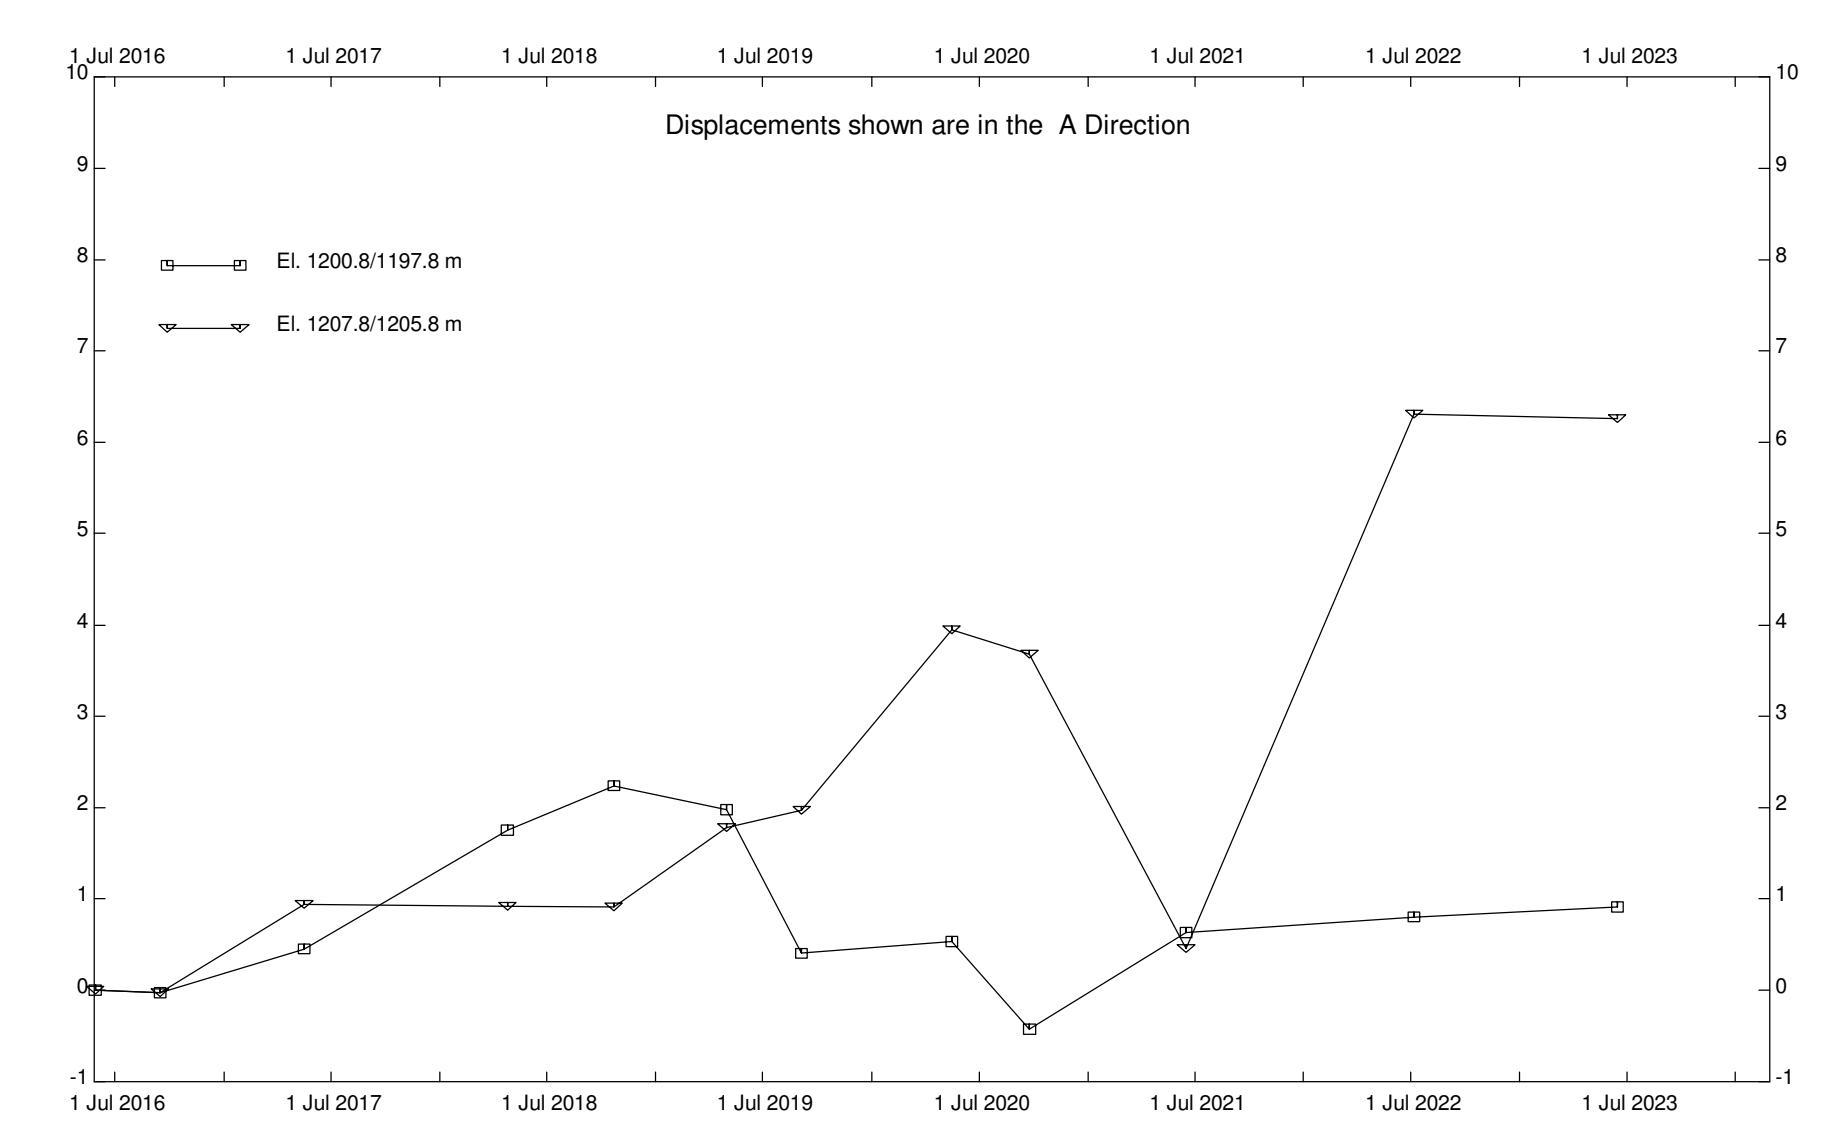
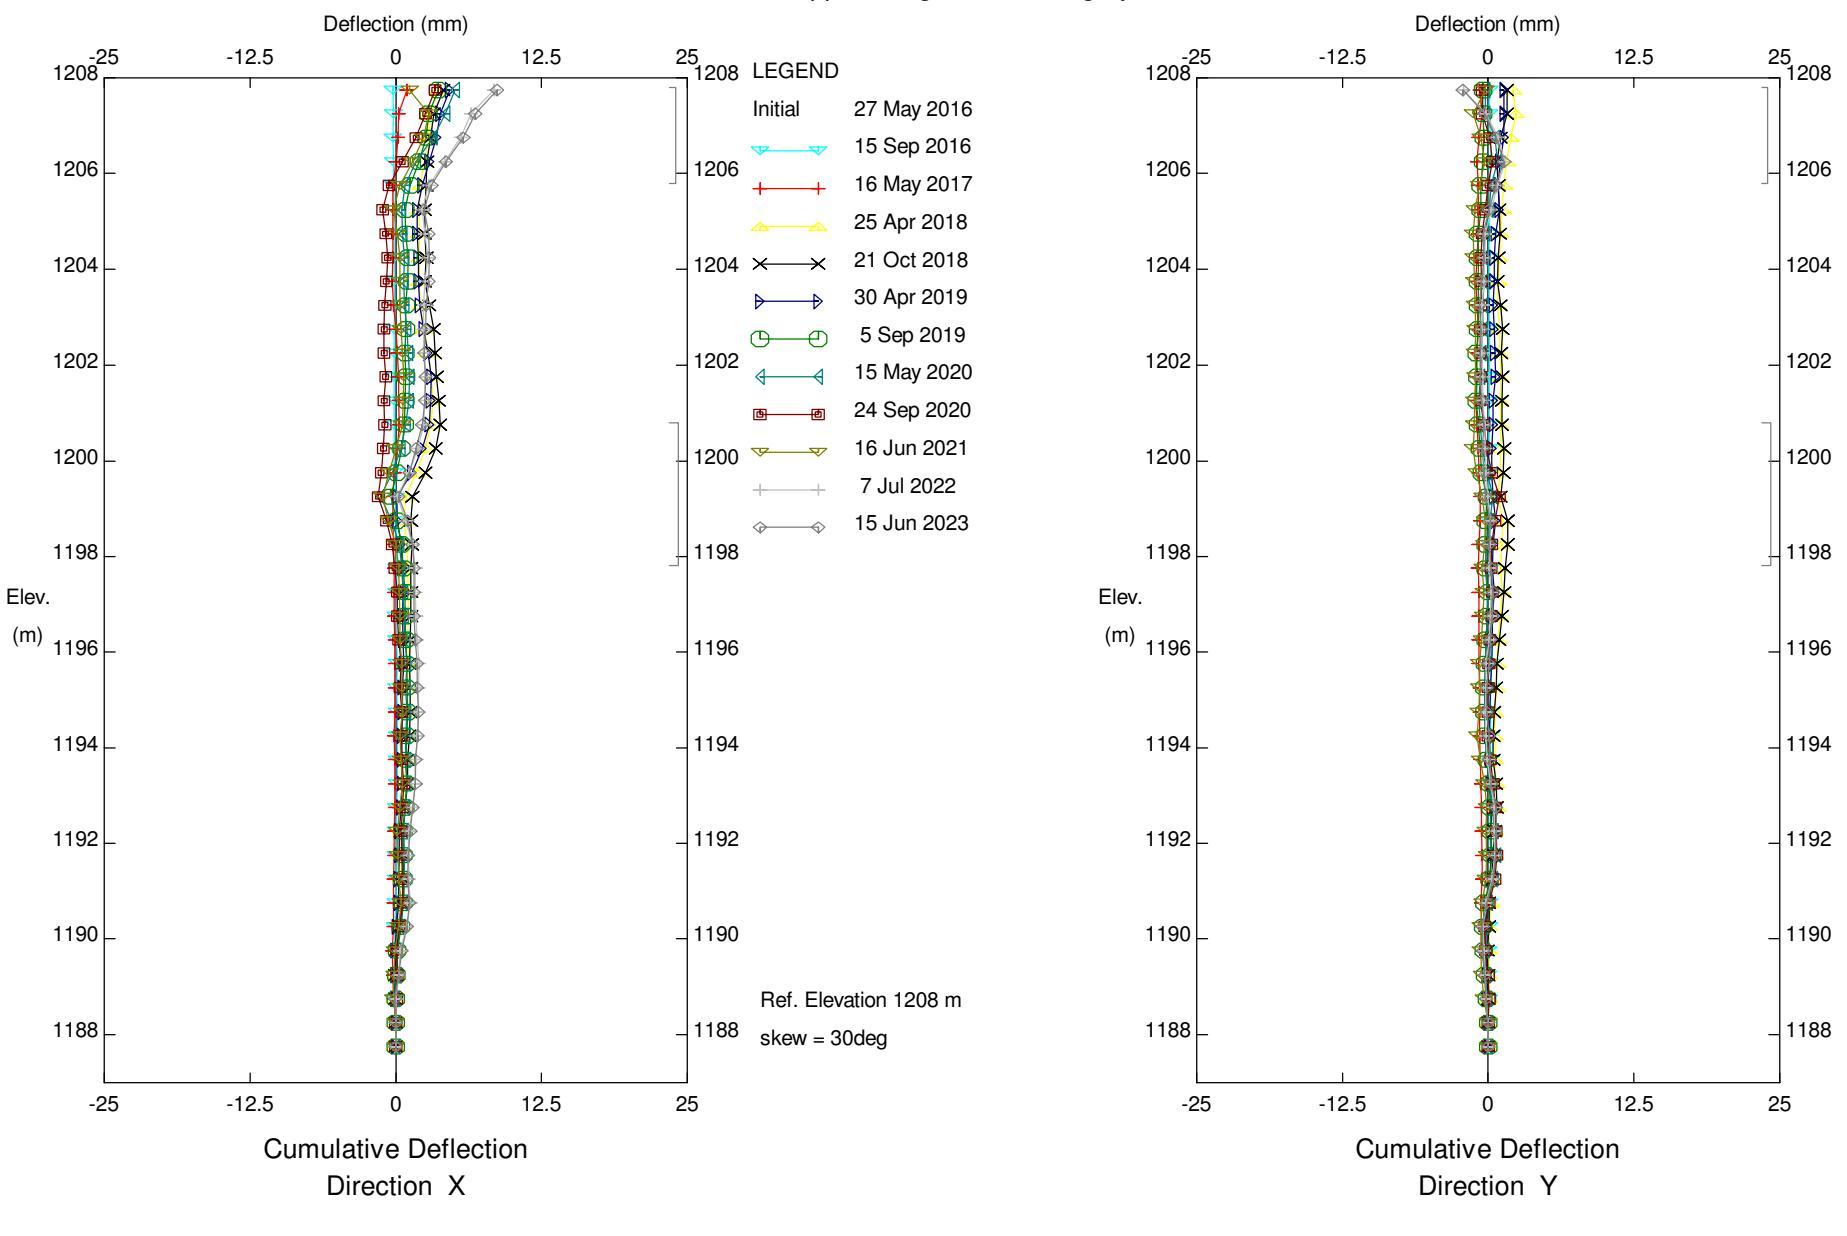
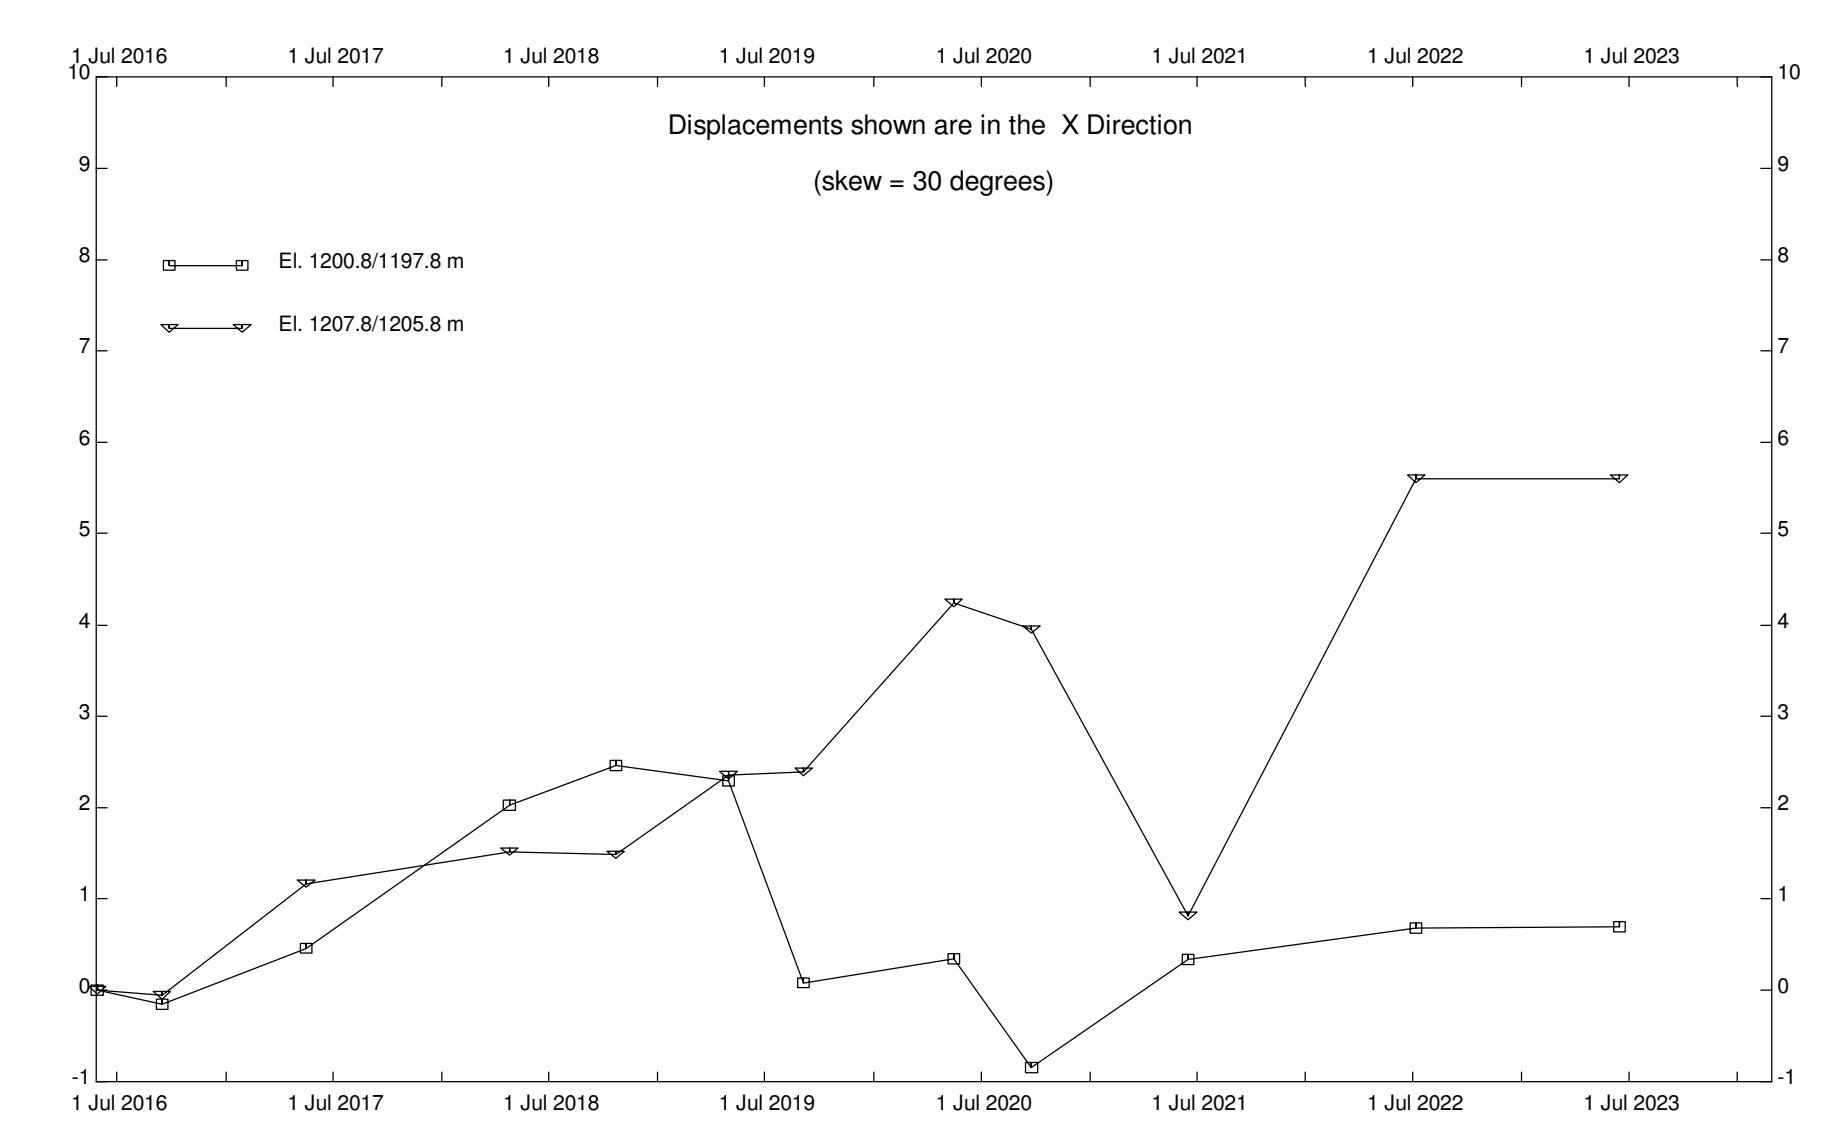
S036; H800:02, Belly River, Inclinometer SI11-01

Movement has been recorded in SI11-01 from an approximate depth of 7 m to 10 m below ground surface (approximately El. 1198 m to El. 1201 m). Shallow movement from ground surface to approximately 2 m below ground surface (El. 1206 m) was also recorded between June 2021 and July 2022.

The July 2022 data indicated a small amount of movement (less than 6 mm) had occurred in the upper 2 m of SI11-01 between fall 2021 and spring 2022; however, no additional movement was measured in the zone during the spring 2023 reading. This movement could be due to instrument noise or reading error, or an indication that the slide is retrogressing towards the highway. More data is needed to assess. Tightness and difficulty passing the SI probe at approximately 8 m has been noted over the past several years; during the spring 2023 readings it was noted again.

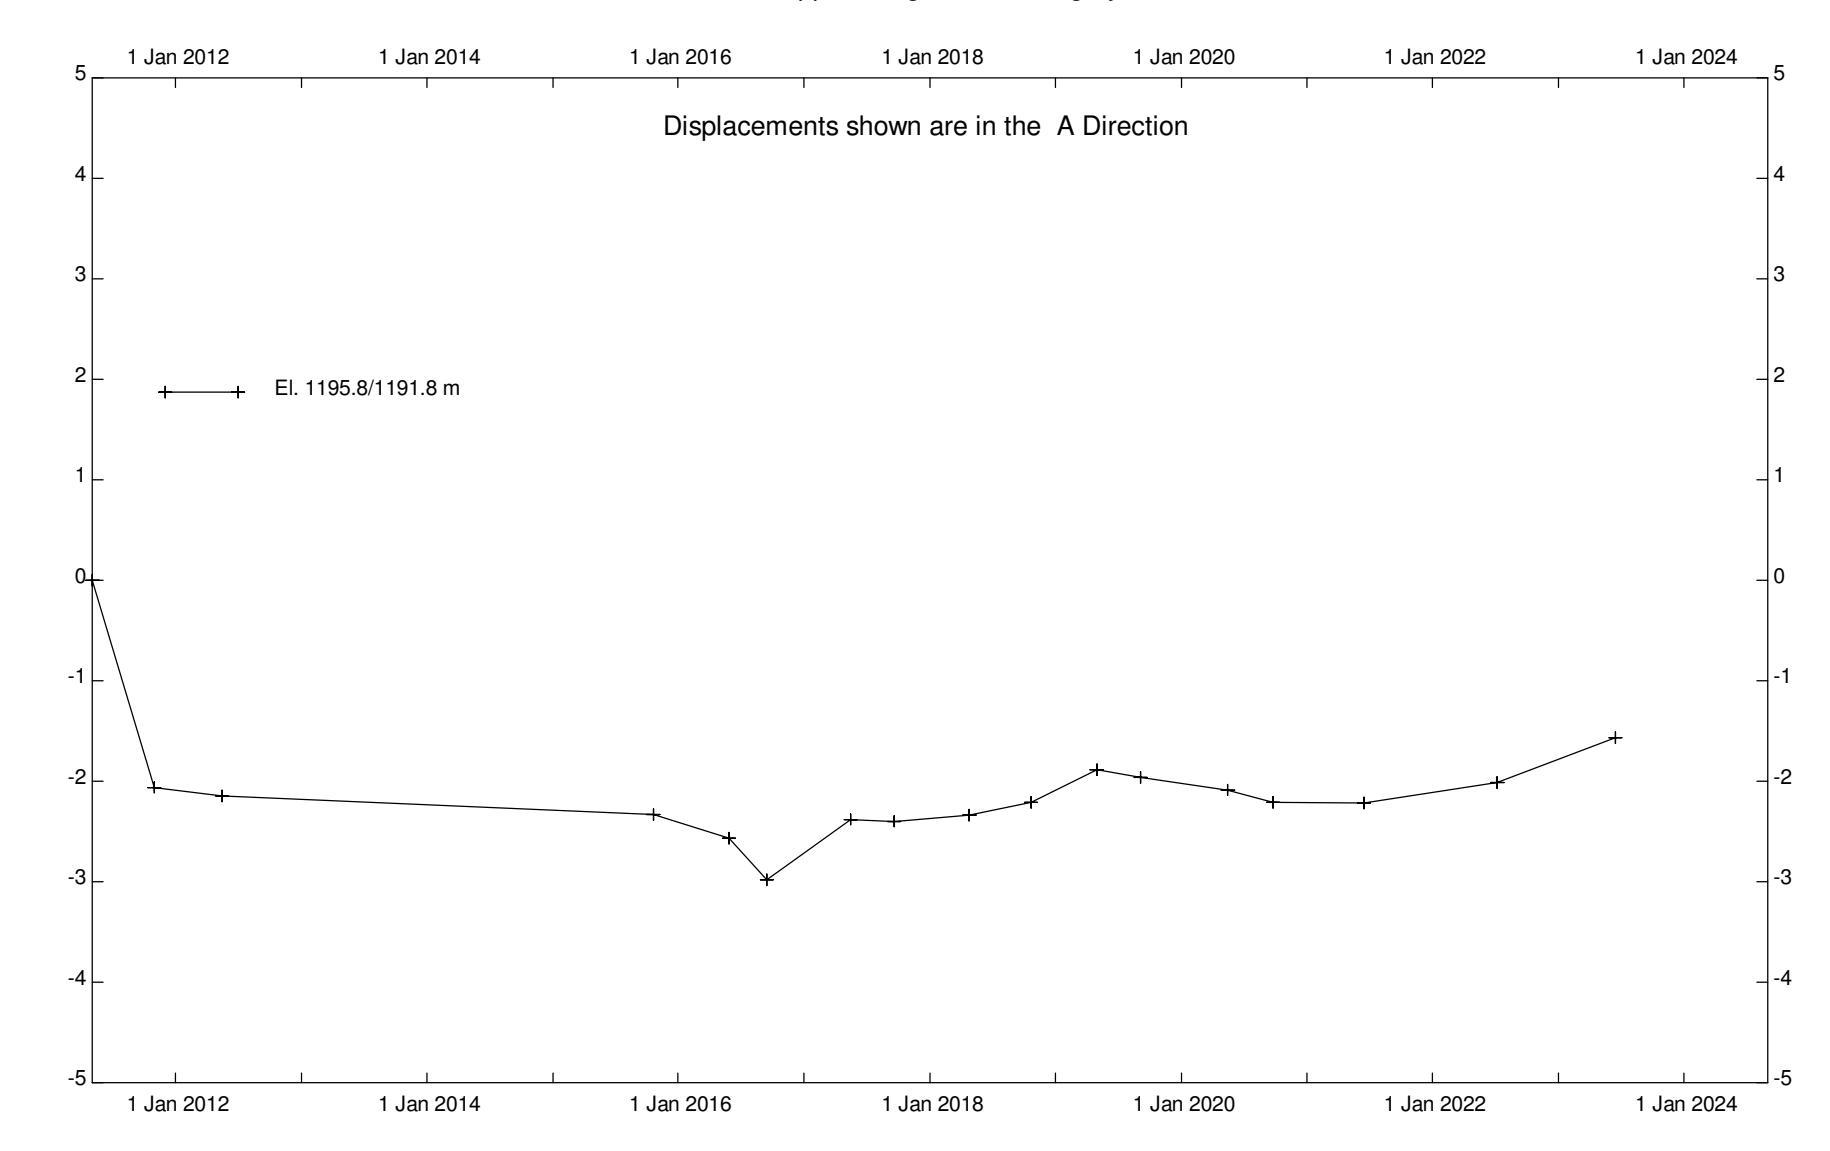
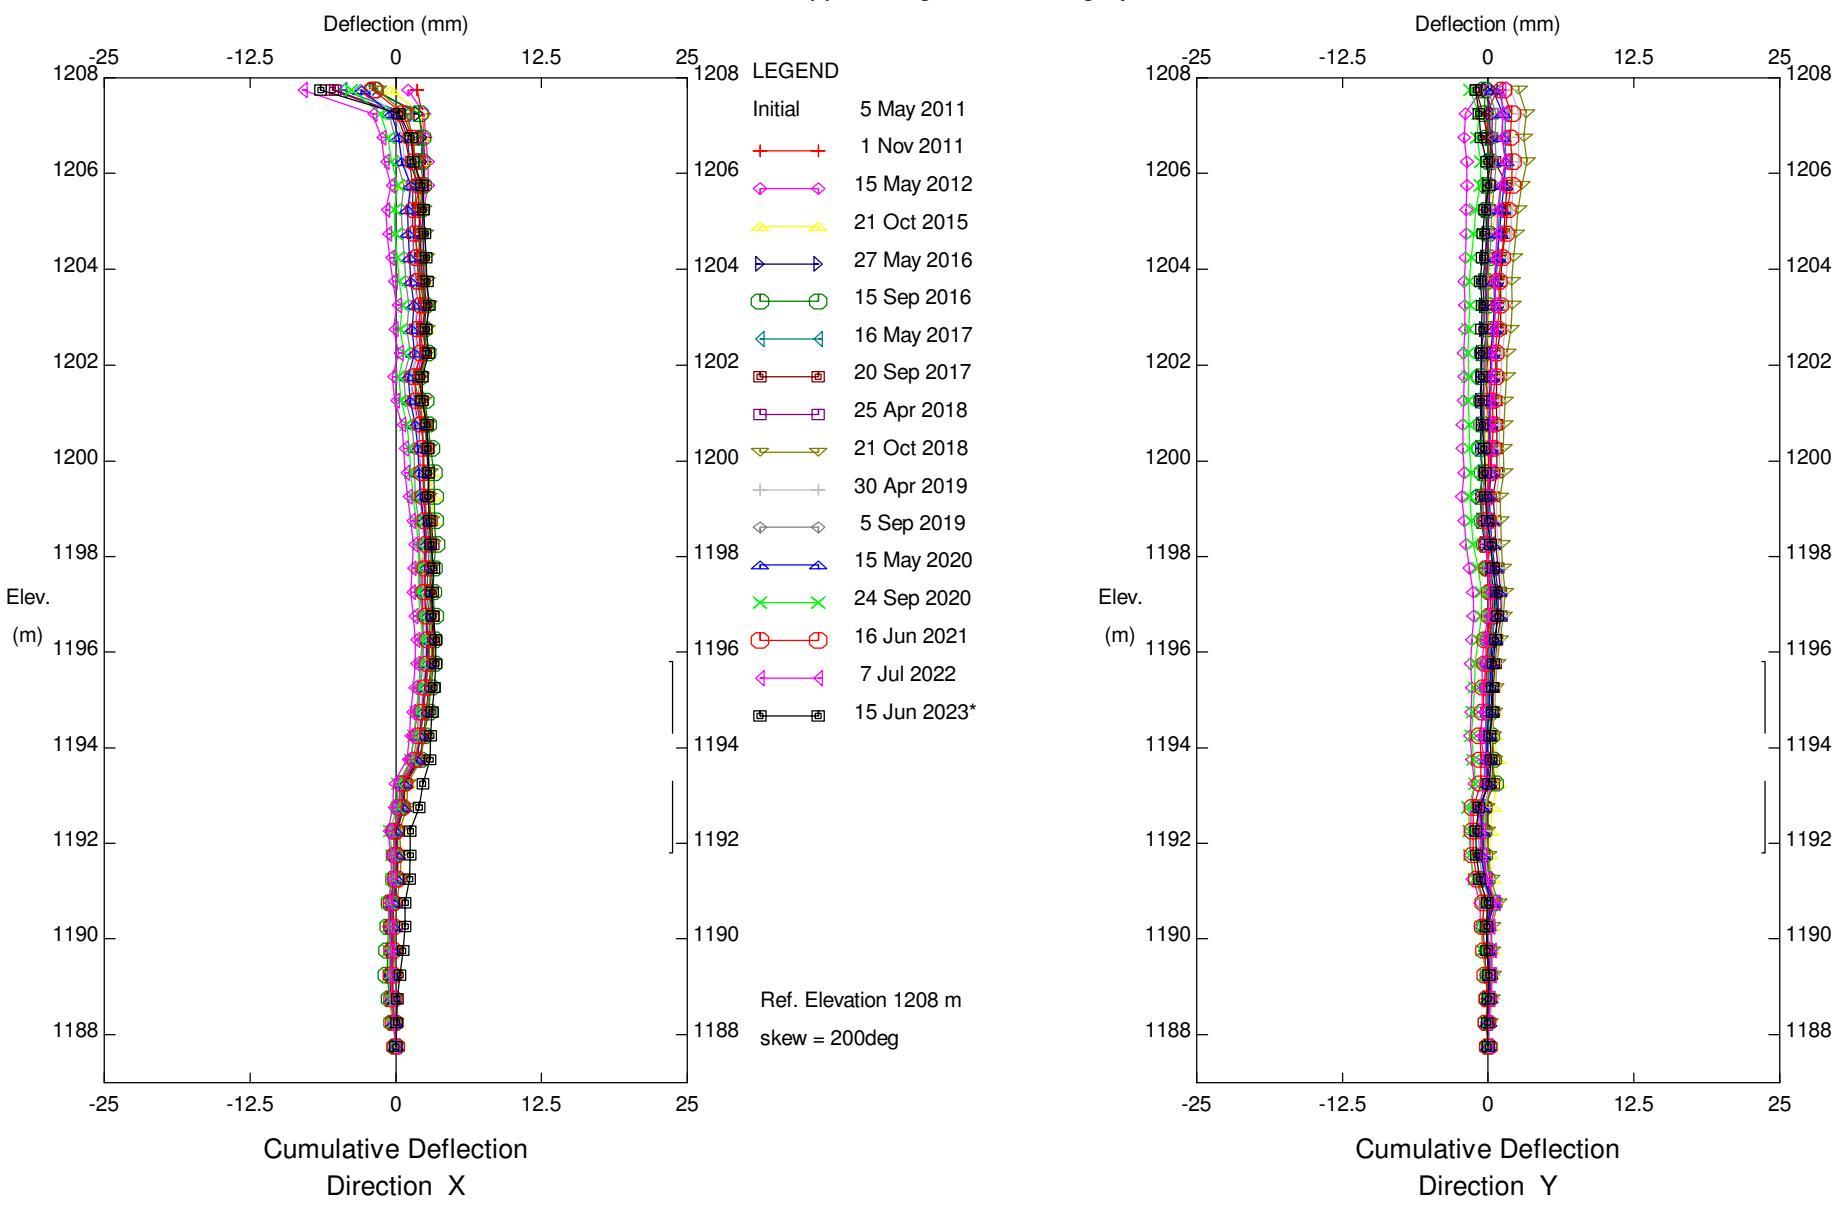
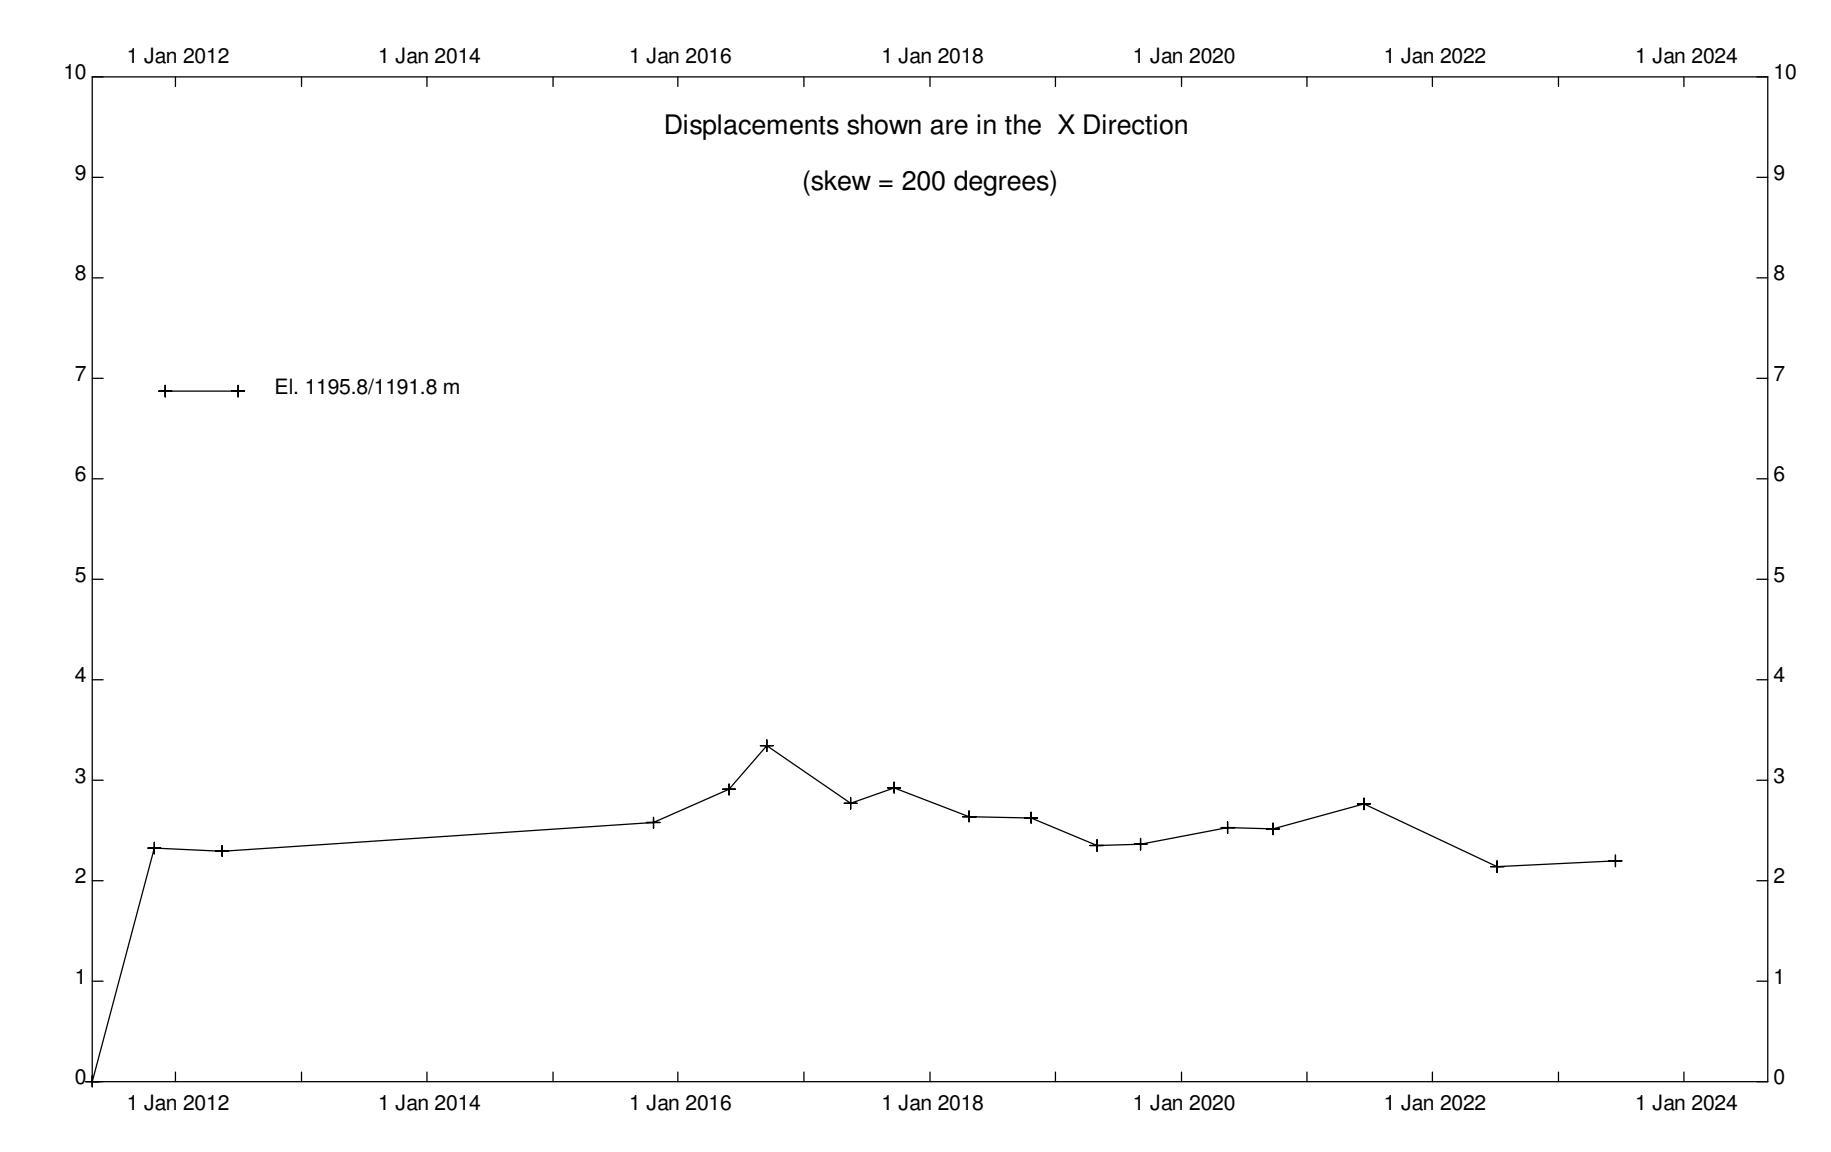
S036; H800:02, Belly River, Inclinometer SI11-02

Movement has been recorded in SI11-02 from an approximate depth of 16 m to 20 m below ground surface (approximately El. 1192 m to El. 1196 m).

Since KCB took over the instrument readings at the site, the rate of movement recorded in SI11-01 and SI11-02 has been slow (less than 1 mm/year overall) and is currently negligible. The negative rate of movement recorded in these instruments during some readings indicates the rate of movement is within the accuracy of the reading equipment.
