# TSB NEWSLETTER

TECHNICAL STANDARDS BRANCH

VOLUME 3, ISSUE 1, FEBRUARY 2004

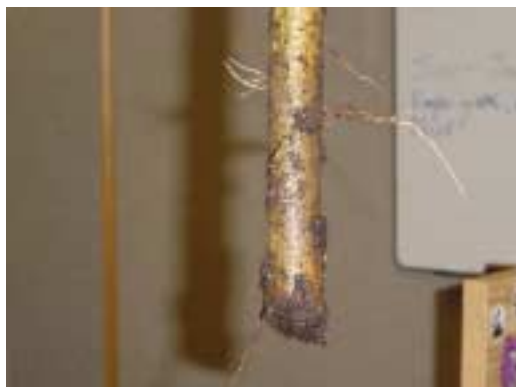
*(A photo showing the development of root growth is provided. The poplar live stake shown was 'planted' in a soil filled pot at the Twin Atria and watered regularly for a period of 8 weeks prior to retrieval. It is interesting to note that the root development occurs along the entire portion of the stake in contact with soil, not just at the angle cut tip.)*

A live poplar stake with root growth after 8 weeks

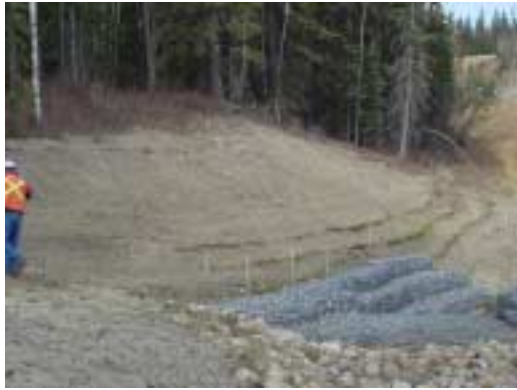
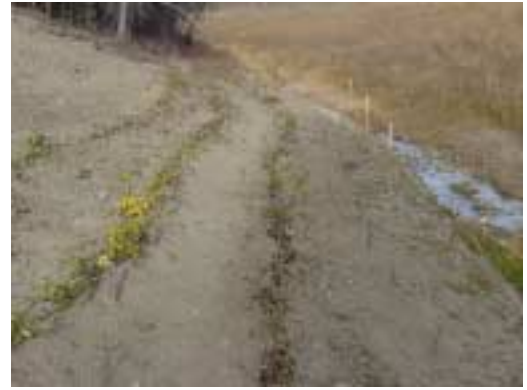
Three rows of willow wattles were installed

An on-site pre-construction meeting was held on October 20. The Ledcor Project Manager and Alberta Transportation (AT) Regional and Technical Standards Branch (TSB) staff were on site for the meeting. Details of slope re-grading and plant placement locations, installation method and requirements were discussed. As minor grading was required to prepare the site for installation of the plantings, a bob-cat dozer was used to undertake this work. Three ditches of about 0.2 m deep and wide were hand dug to accommodate the 0.2 m wattles. Wattles were anchored into the trenches by live poplar stakes. Fill material was placed on top the wattles and lightly tamped. Three crews were utilized. By noon, October 21, all wattles and stakes were placed and the slope was ready to be seeded the following week. A final inspection by AT (Regional and TSB) and Ledcor staff was conducted on October 22 and the work accepted. Pictures were taken and some are shown in the attached photos.

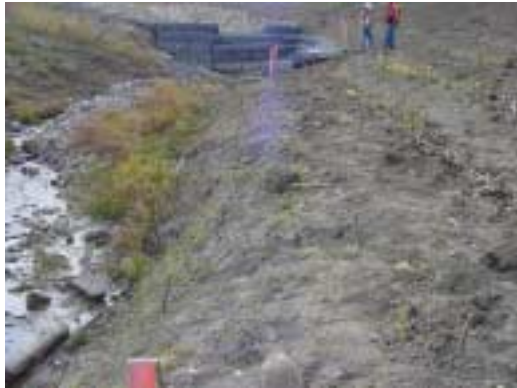
South slope where live stakes and wattles are installed

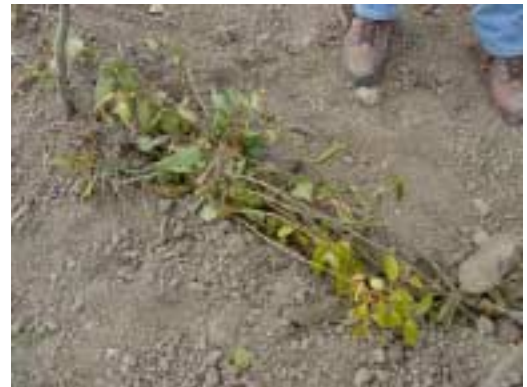
Close up of willow wattle

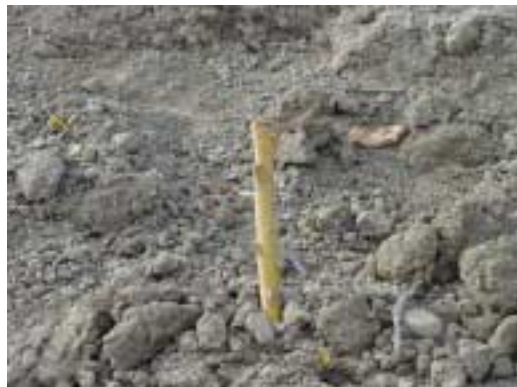
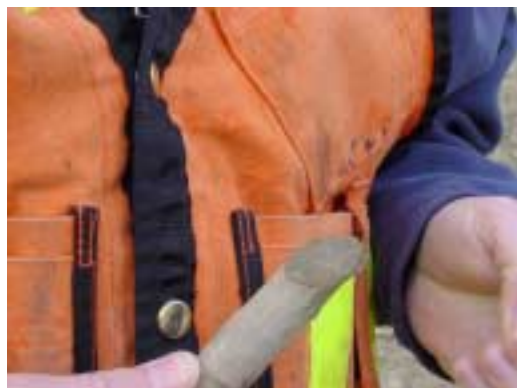
A live poplar stake
