**CRACK PATTERN IN PAVEMENT  
STATIONS 1+780 TO 1+880**

NORTH CENTRAL LANDSLIDE ASSESSMENT

NC1  
WHITECOURT EAST HILL

THURBER PROJECT #15-76-11A

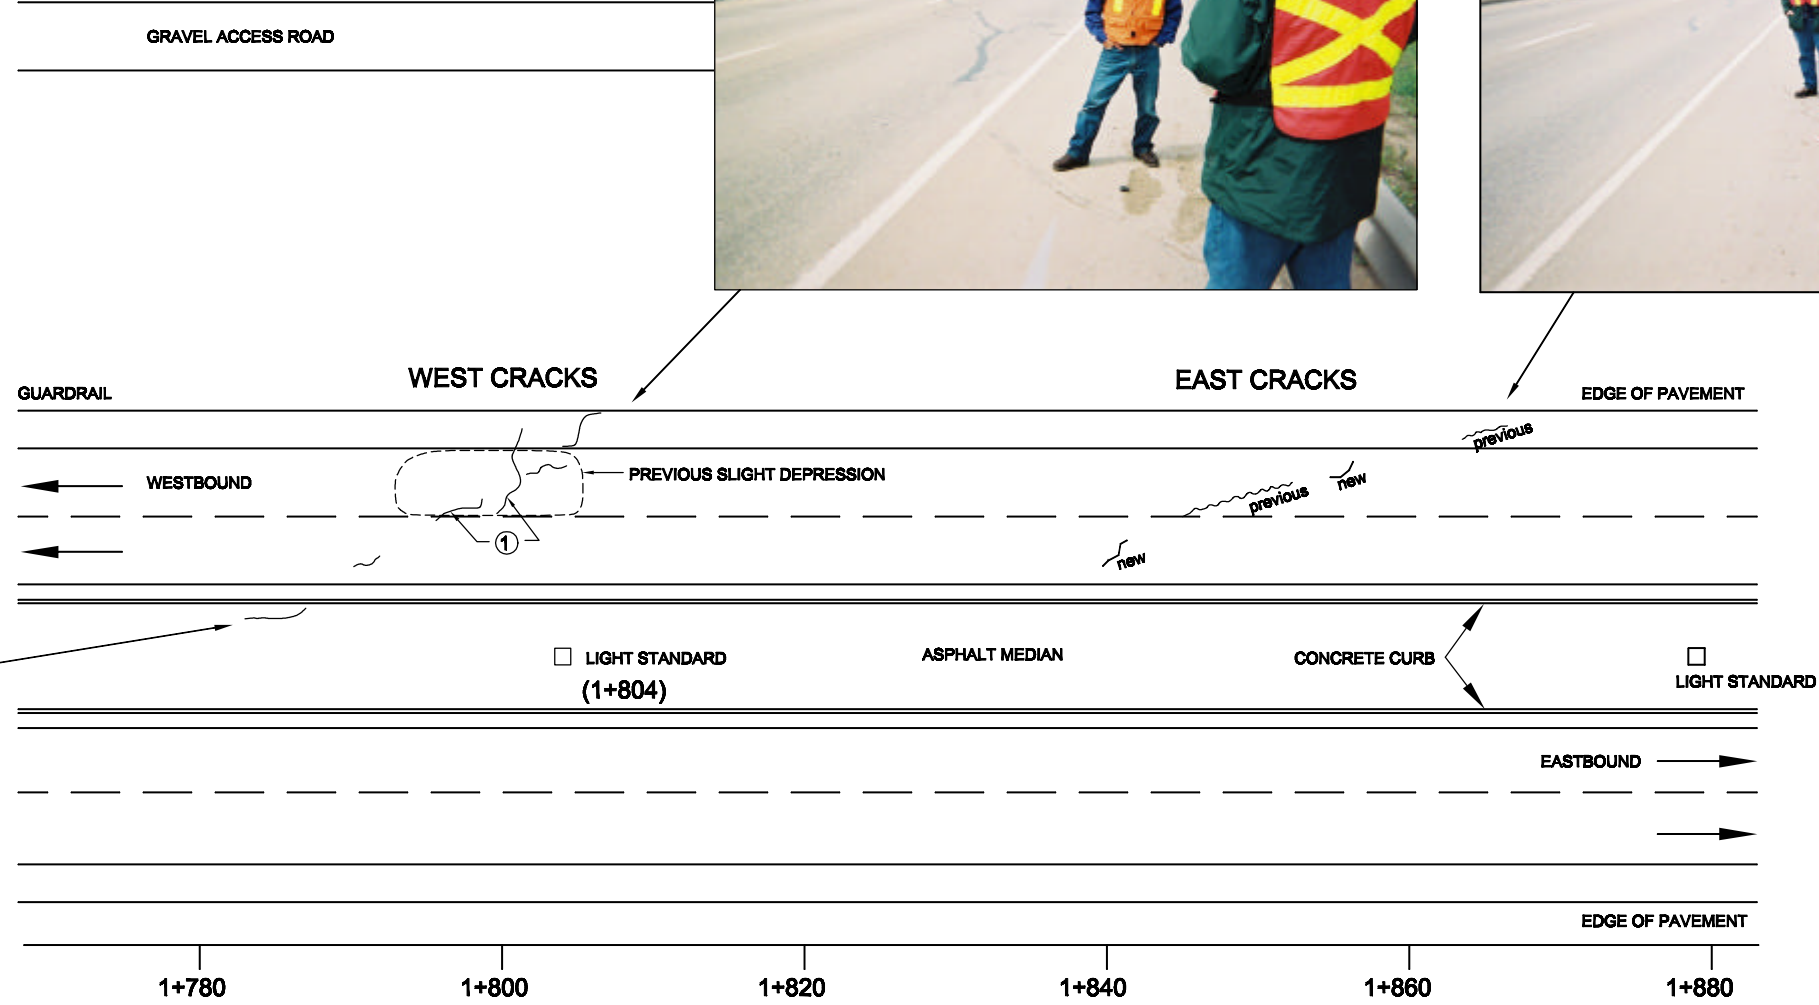
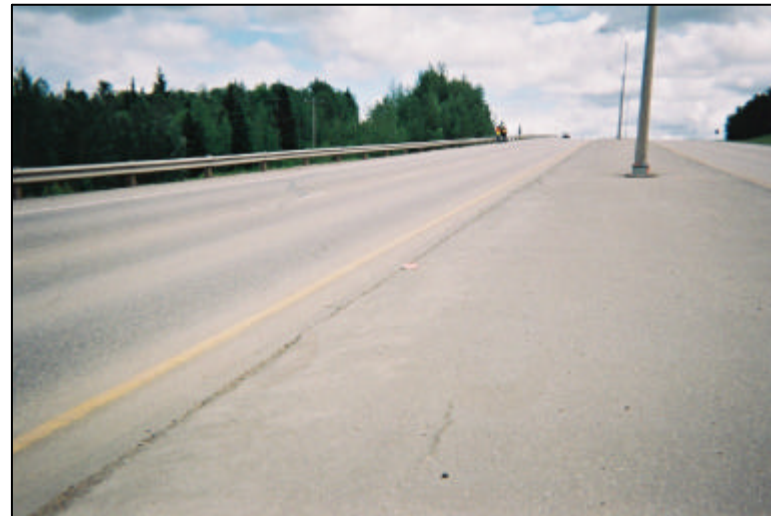
**THURBER**  
DRAWING No. **FIGURE NC1-2**

- ① 3-5mm DIFFERENTIAL DOWN TO THE NORTH
- ⊕ SLOPE INCLINOMETER

LOCATIONS OF FEATURES ARE APPROXIMATE  
WIDTH OF ROADWAY EXAGGERATED  
SCALE 1:500 ALONG ROADWAY ALIGNMENT
