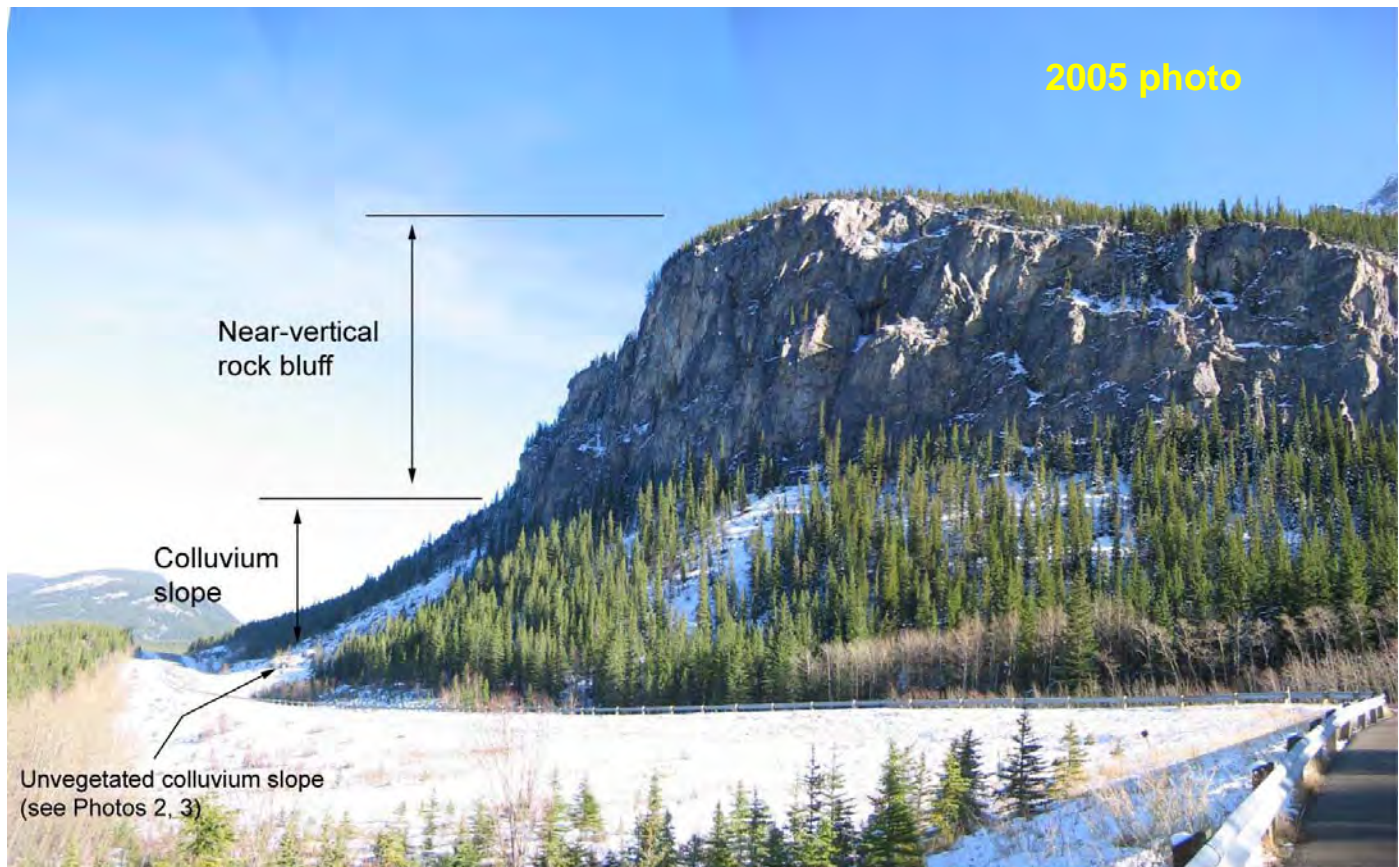
Photo 1 – 2005

General view of the Barrier Bluffs site from the 2005 inspection, illustrating the relative position of the slope (potential rockfall source area) and Highway 40.
